The Maples at Jordan Hills

Level 1 Reserve Study

Report Period – 01/01/2021 – 12/31/2021

Executive Summary – The Maples at Jordan Hills - ID # 12651

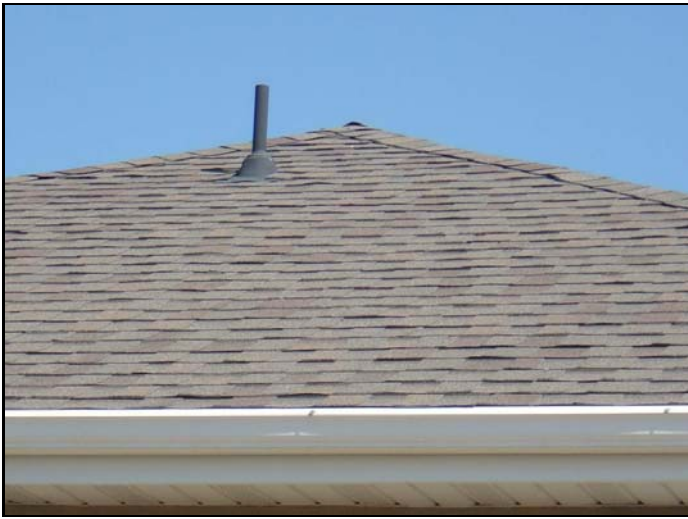
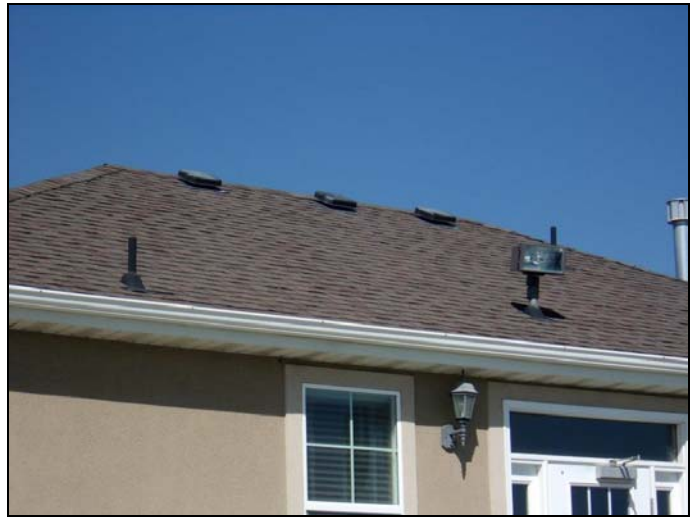
Comp #: 105 Roofs - Replace

The roofs are in good condition. We recommend funding to replace this component approximately every 20 - 25 years. Remaining life based on current age.

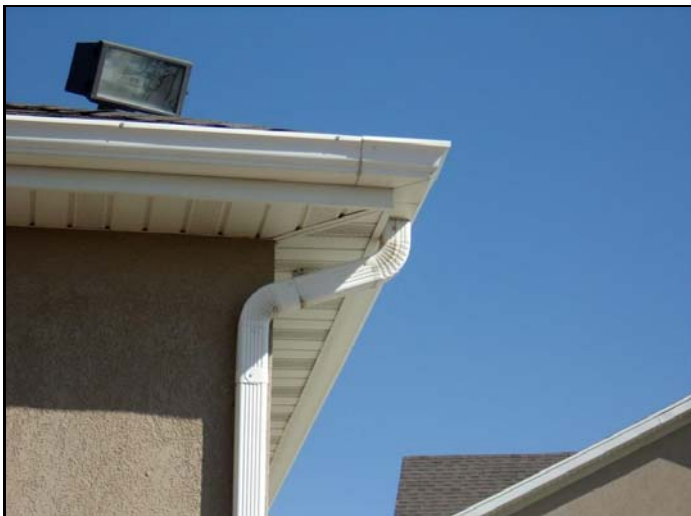
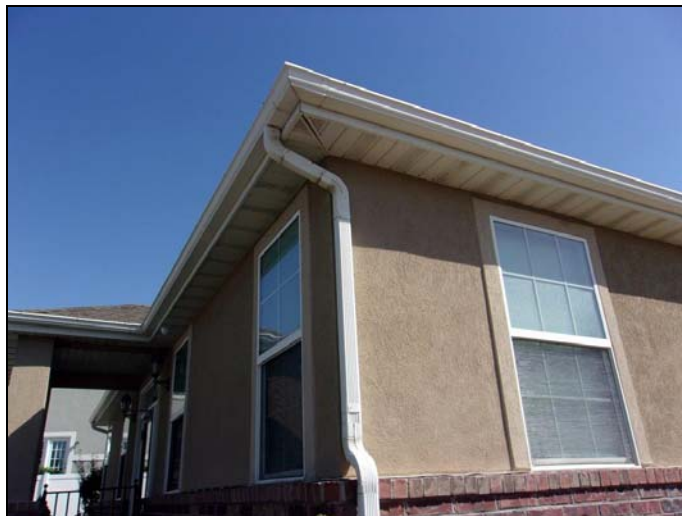
Comp #: 120 Rain Gutters/Downspouts - Replace

The rain gutters and downspouts are in good condition. We recommend funding to replace this component approximately every 25 - 30 years. Remaining life based on current age.

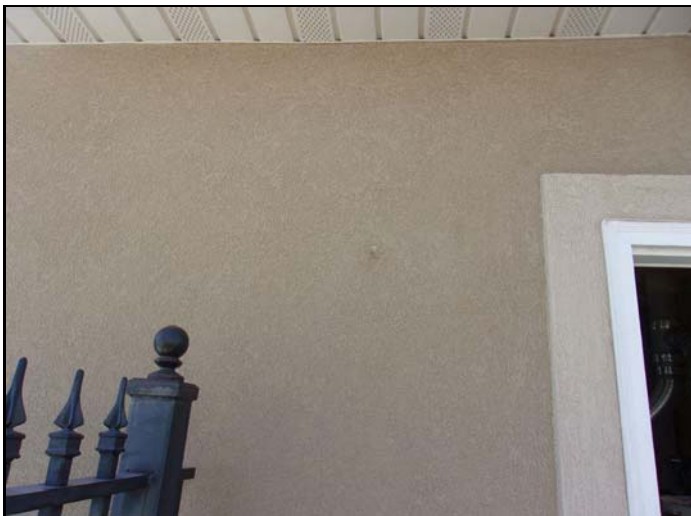
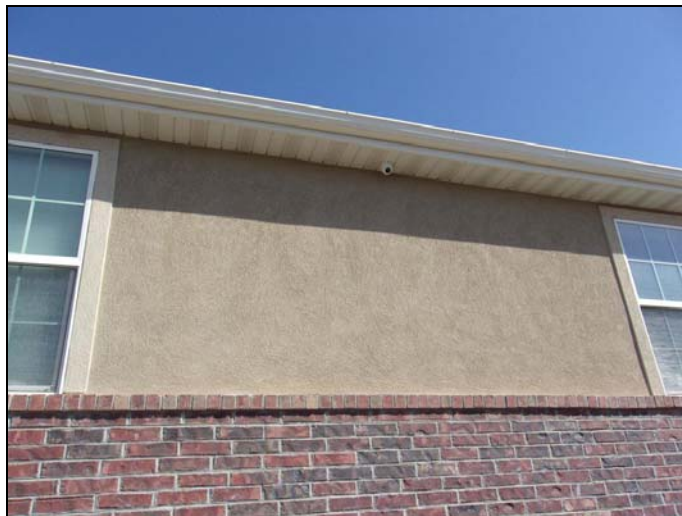
Comp #: 201 Stucco Surfaces - Clubhouse - Repair/Repaint

The stucco surfaces are in fair to poor condition. We recommend funding to repair/repaint this component approximately every 12 - 15 years. Remaining life based on current age.

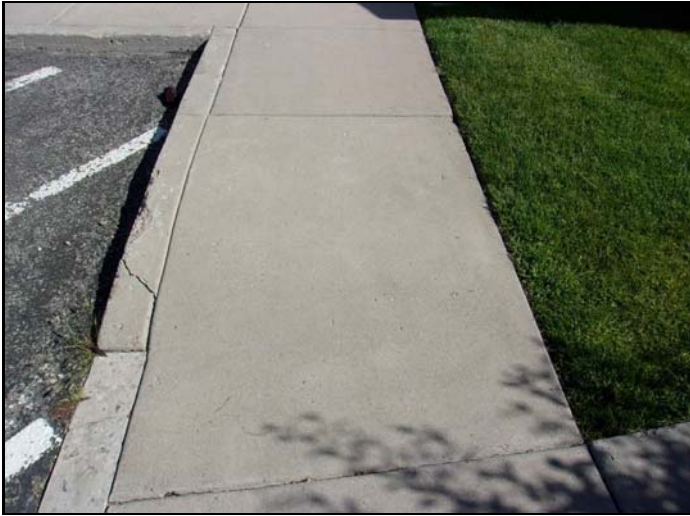
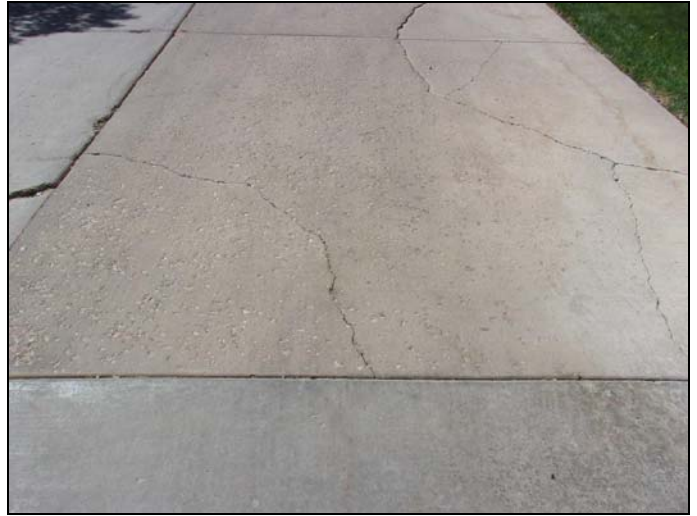
Comp #: 403 Concrete - Partial Repair/Replace

The concrete is in good to poor condition. This component has an extended useful life under normal conditions. We recommend funding to make repairs and partially replace this component approximately every 10 years. Remaining life based on current age.

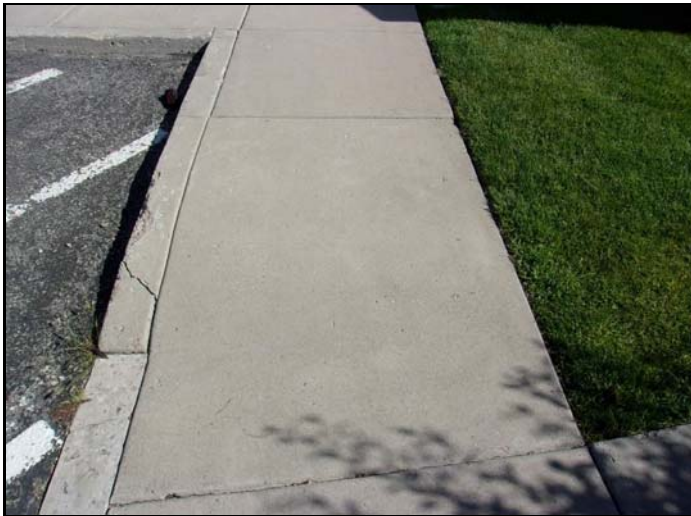
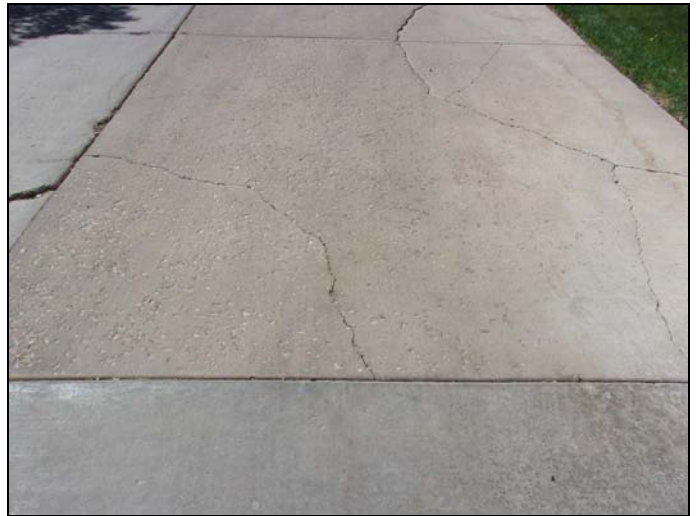
Comp #: 490 Concrete - 2021 - Replace

Research with the client reveals a portion of the concrete will be replaced in 2021. This is a one-time project.

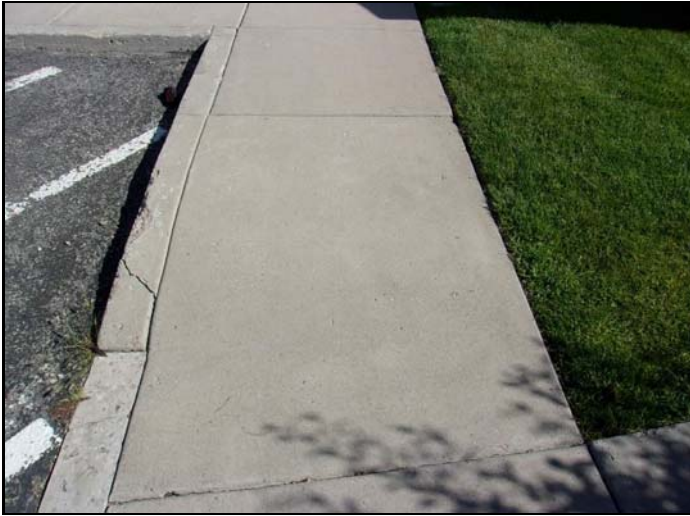
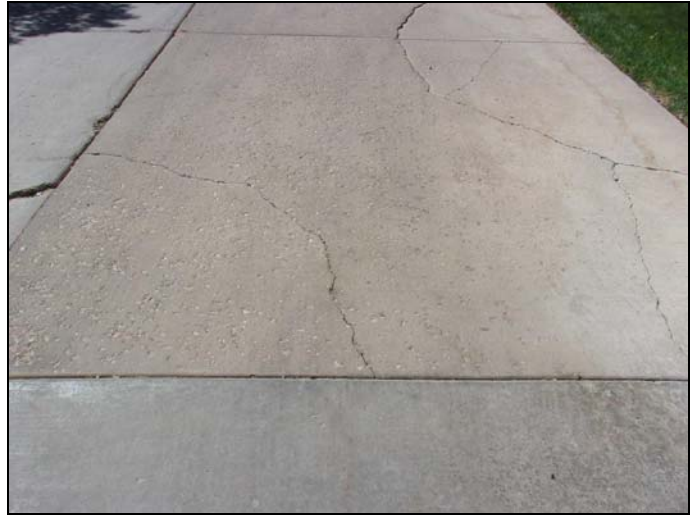
Comp #: 490 Concrete - 2022 - Replace

Research with the client reveals a portion of the concrete will be replaced in 2021. This is a one-time project.

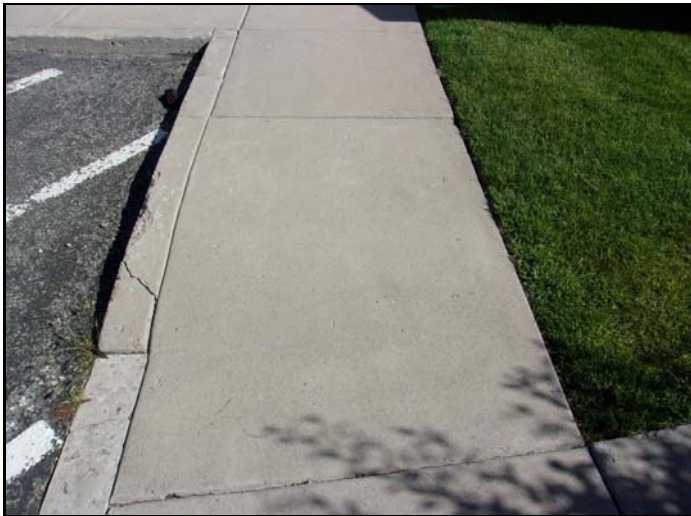
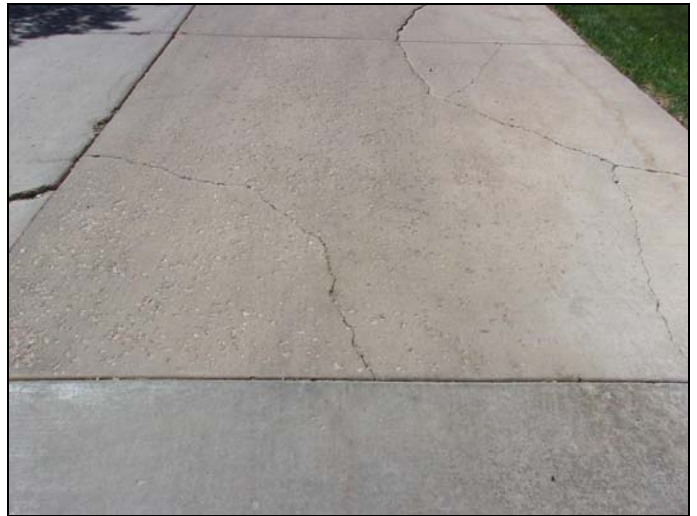
Comp #: 490 Concrete - 2023 - Replace

Research with the client reveals a portion of the concrete will be replaced in 2021. This is a one-time project.

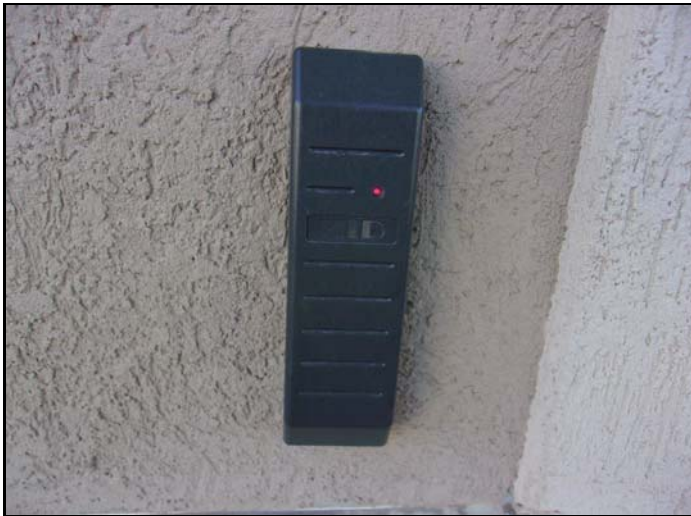
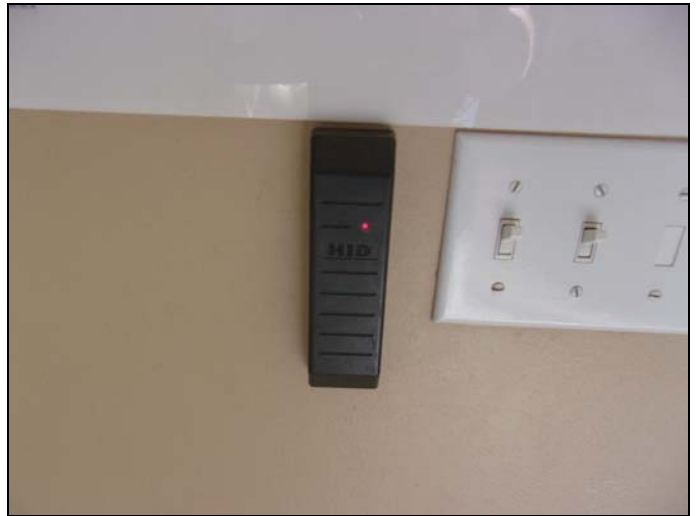
Comp #: 508 Access Control System - Replace

The access control system is in working condition. We recommend funding to replace this component approximately every 10 - 12 years. Remaining life based on current age.

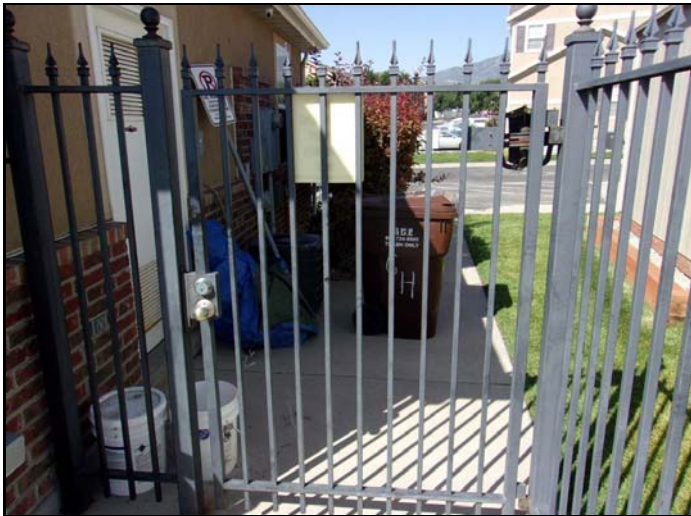
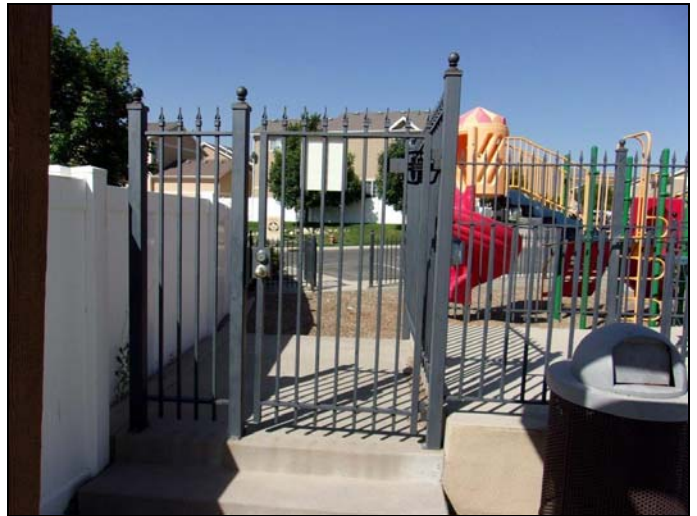
Comp #: 590 Pedestrian Gates - Replace

The pedestrian gates are in fair condition. We recommend funding to replace this component approximately every 25 - 30 years. Remaining life based on current age.

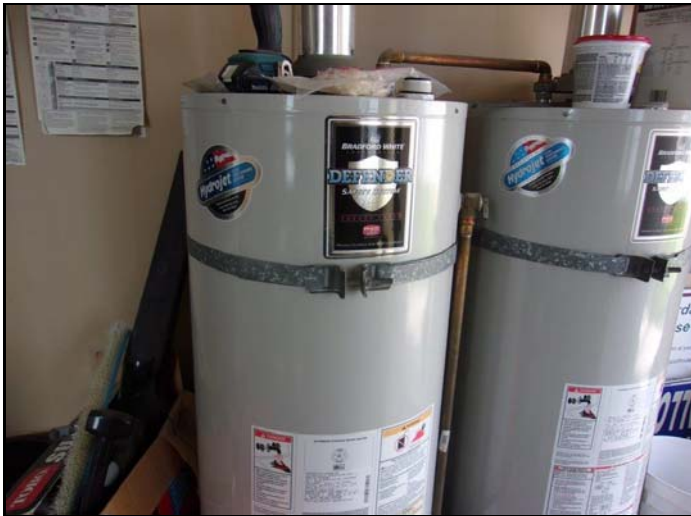
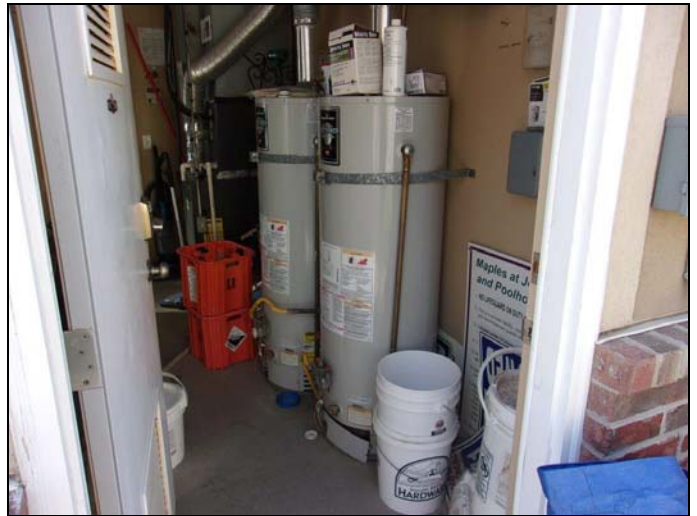
Comp #: 703 Water Heaters - Replace

The water heaters are in working condition. We recommend funding to replace this component approximately every 12 years. Remaining life based on current age.

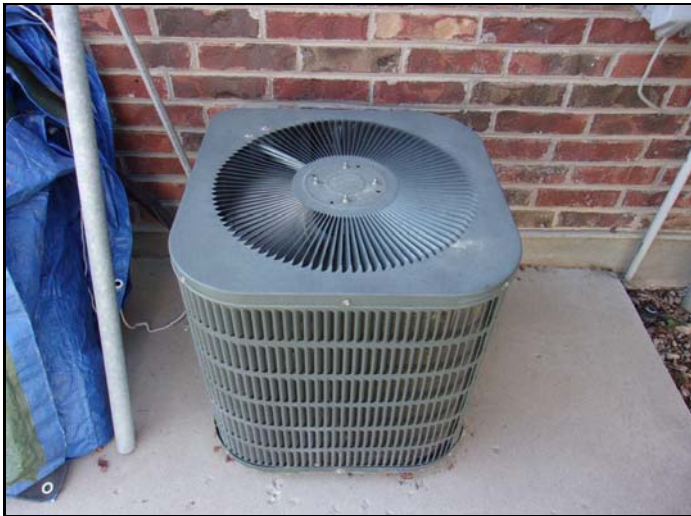
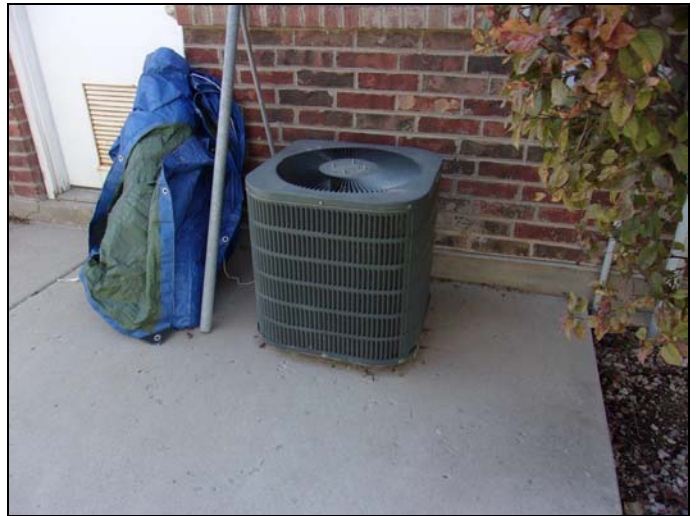
Comp #: 705 HVAC Condenser - Replace

The HVAC condenser is in working condition. We recommend replacing this component approximately every 20 years. Remaining life based on current age.

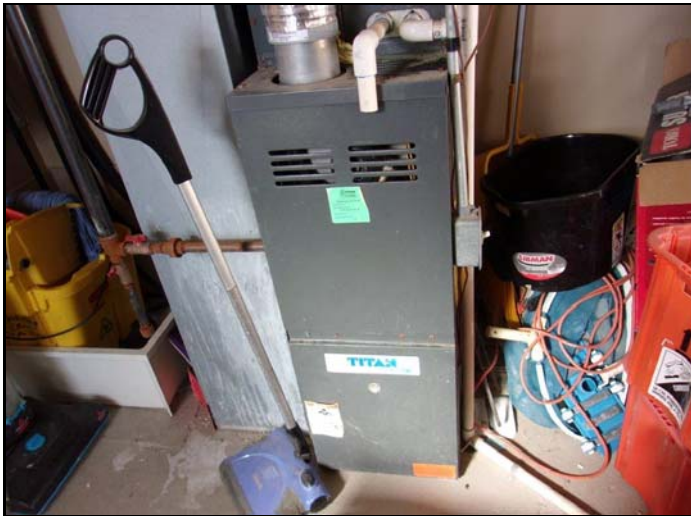
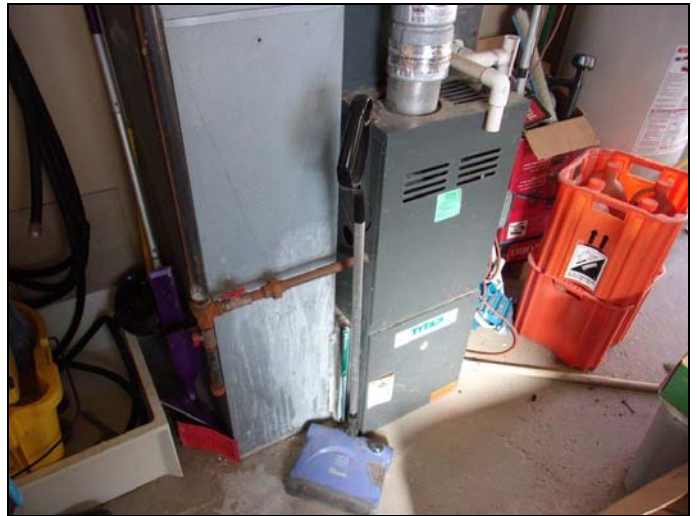
Comp #: 706 HVAC Furnace - Replace

The furnace is in working condition. We recommend funding to replace this component approximately every 20 years. Remaining life based on current age.

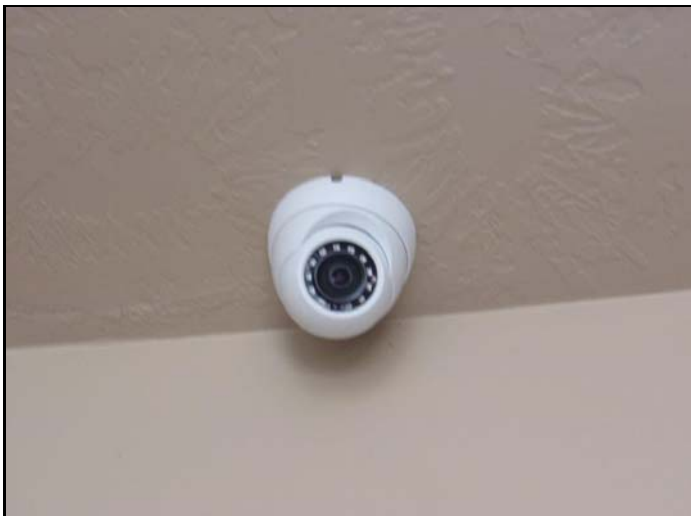
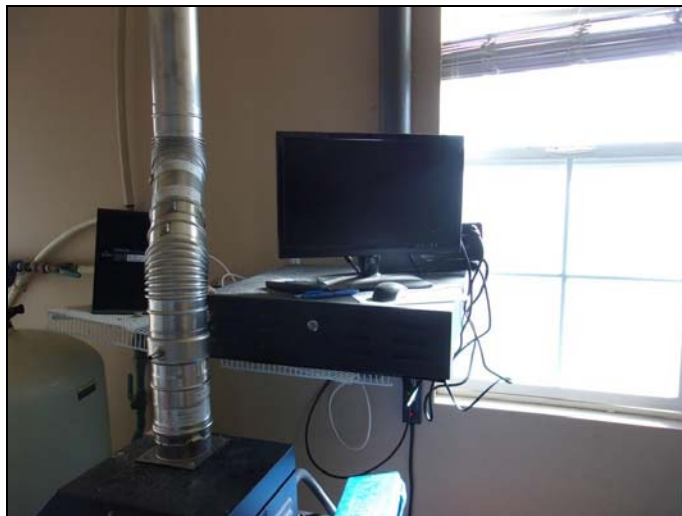
Comp #: 903 Security Camera System - Replace

The security camera system is in working condition. We recommend funding to replace this component approximately every 10 - 12 years. Remaining life based on current age.

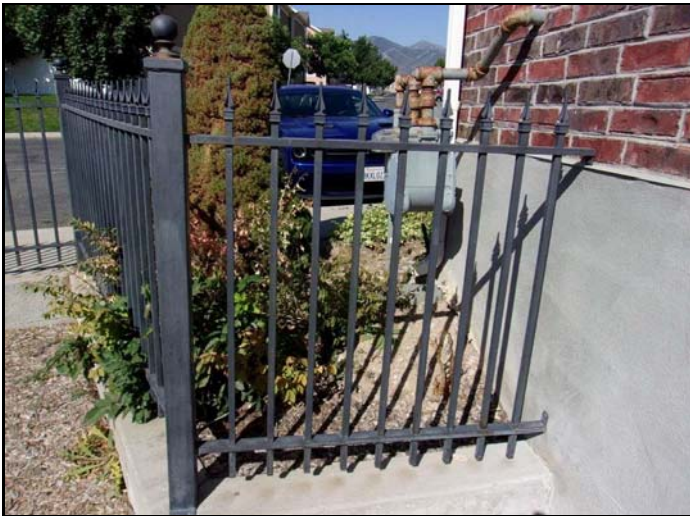
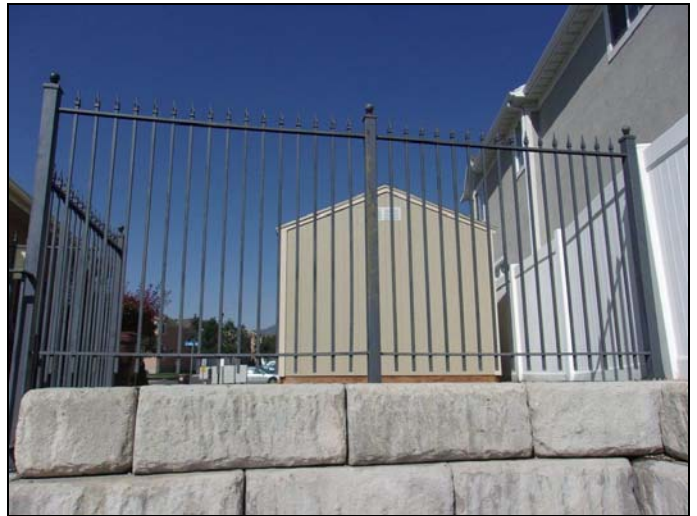
Comp #: 1002 Metal Fencing - Replace

The metal fencing is in good to fair condition. We recommend funding to replace this component approximately every 40 - 50 years. Remaining life based on current age.

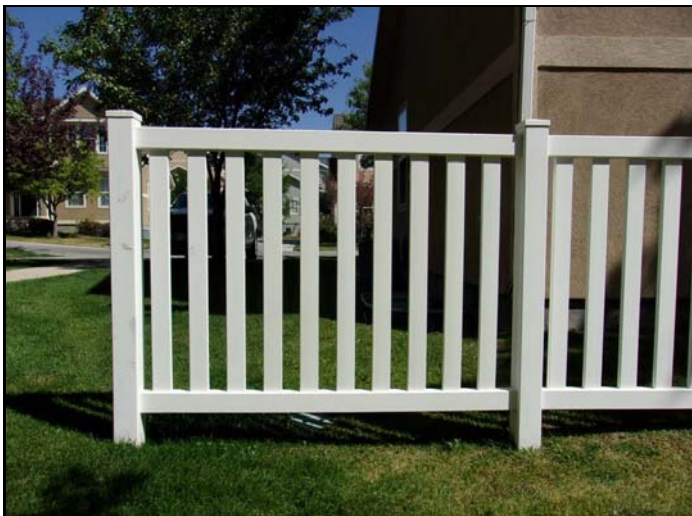
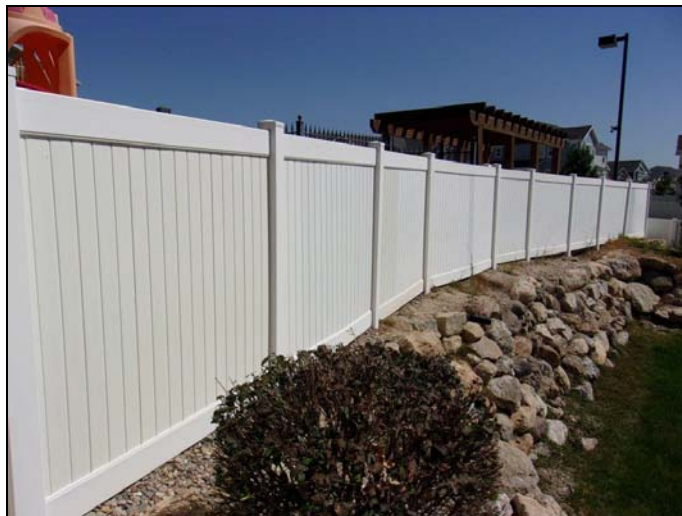
Comp #: 1008 Vinyl Fencing - Replace

The vinyl fencing is in good to fair condition. We recommend funding to replace this component approximately every 25 - 30 years. Remaining life based on current age.

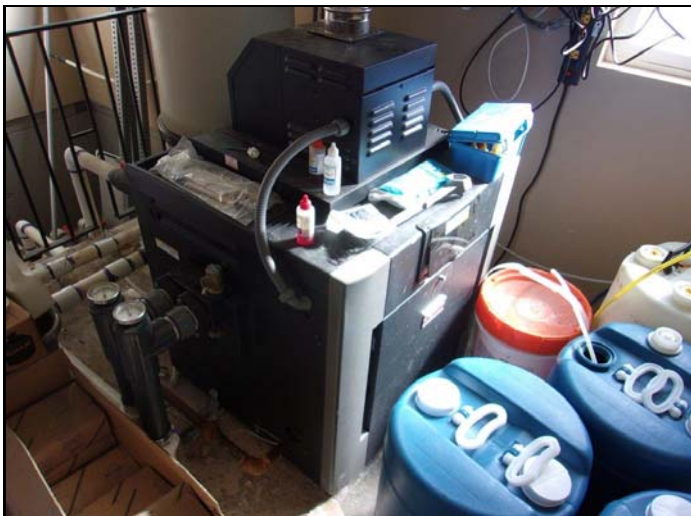
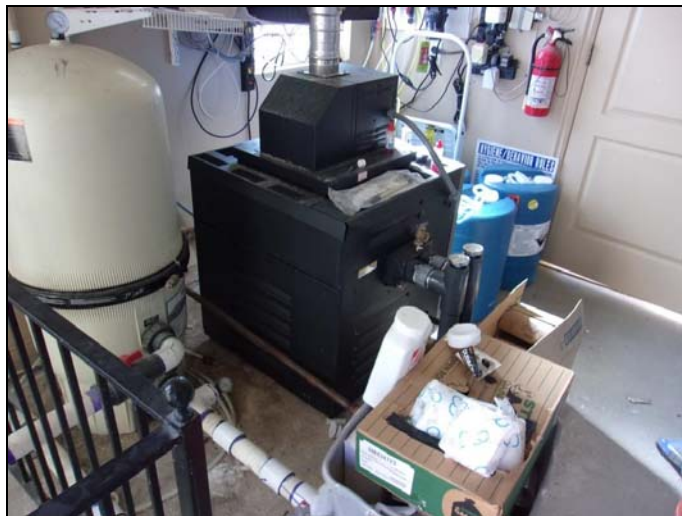
Comp #: 1104 Pool Heater - Replace

The pool heater is in working condition. We recommend funding to replace this component approximately every 12 years. Remaining life based on current age.

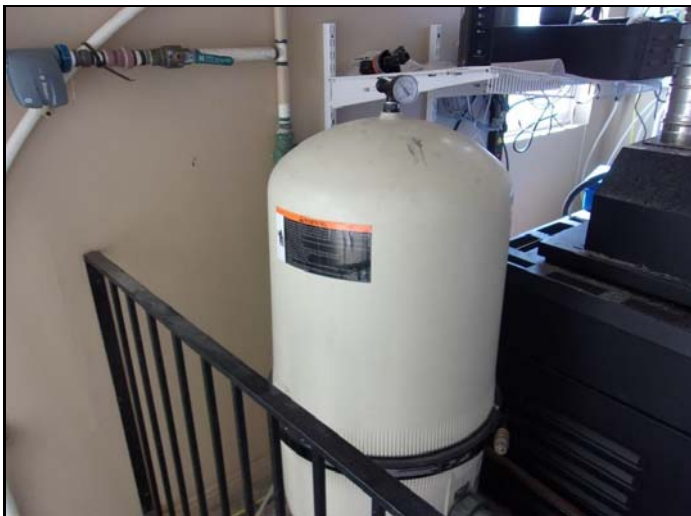
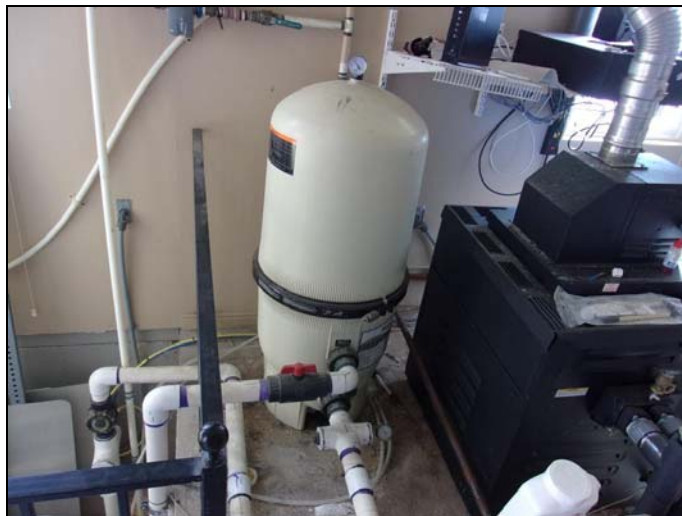
Comp #: 1107 Pool Filter - Replace

The pool filter is in working condition. We recommend funding to replace this component approximately every 12 - 15 years. Remaining life based on current age.

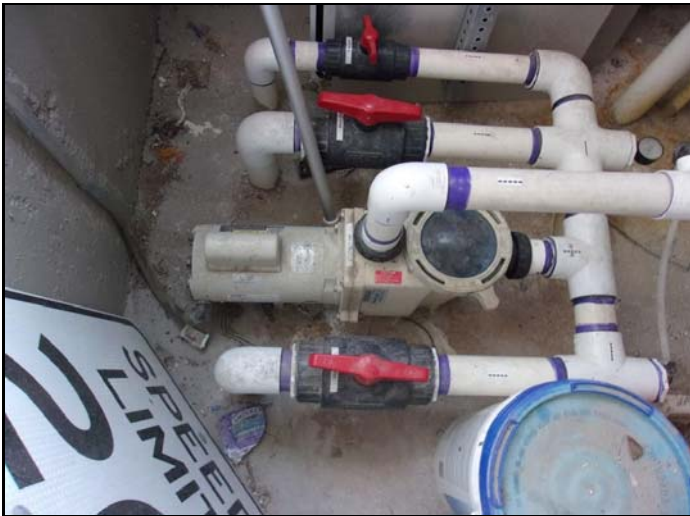
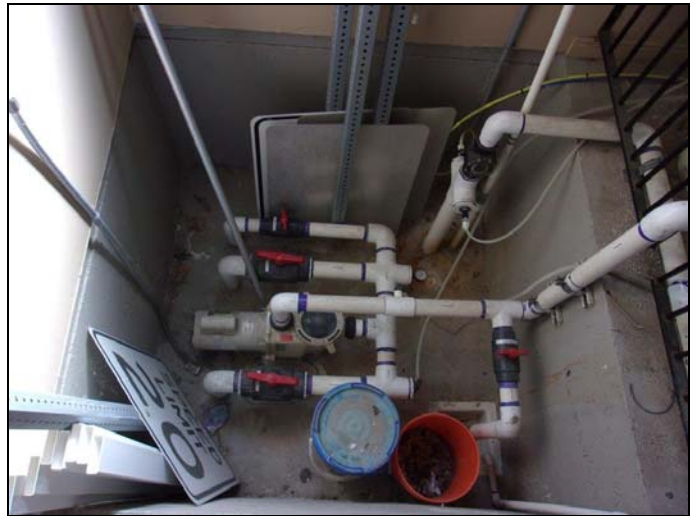
Comp #: 1110 Pool Pump - Replace

The pool pump is in working condition. We recommend funding to replace this component approximately every 8 - 10 years. Remaining life based on current age.

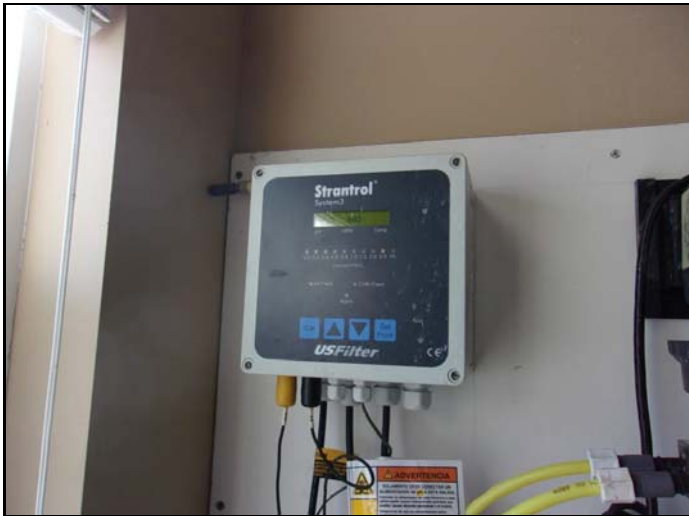
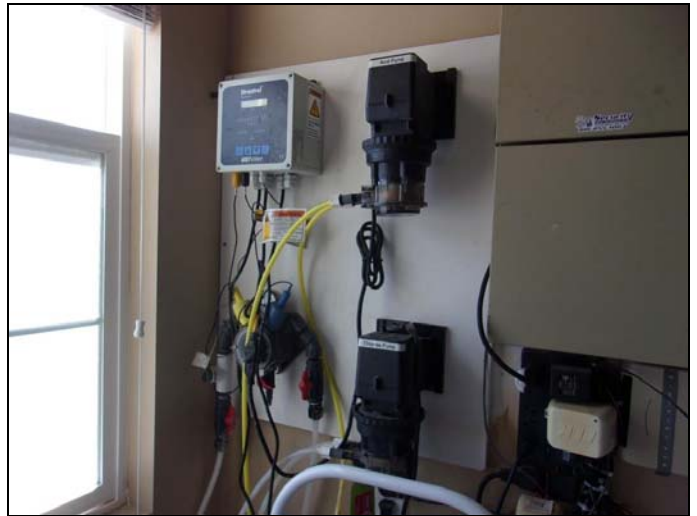
Comp #: 1111 Chemical Controller System - Replace

The chemical controller system is in working condition. We recommend funding to replace this component approximately every 10 - 12 years. Remaining life based on current age.

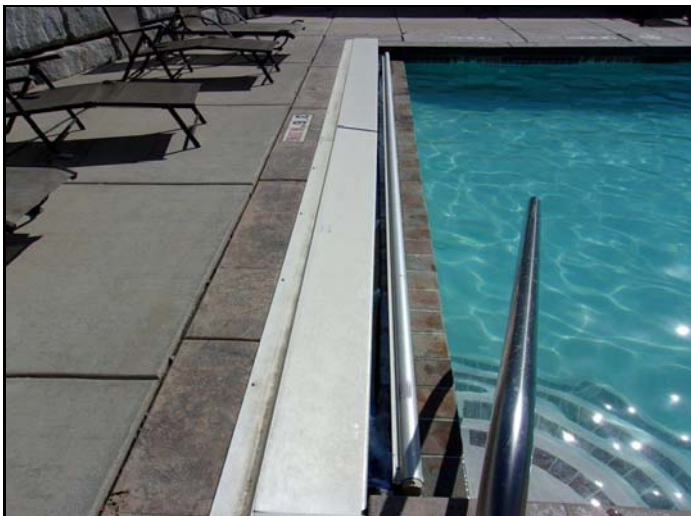
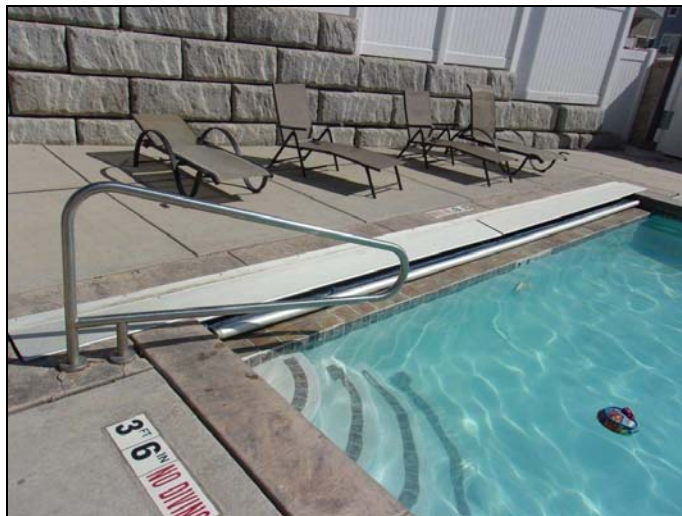
Comp #: 1112 Pool Cover - Replace

Unable to inspect this component at the time of the site visit. We recommend funding to replace this component approximately every 10 years. Remaining life based on current age.

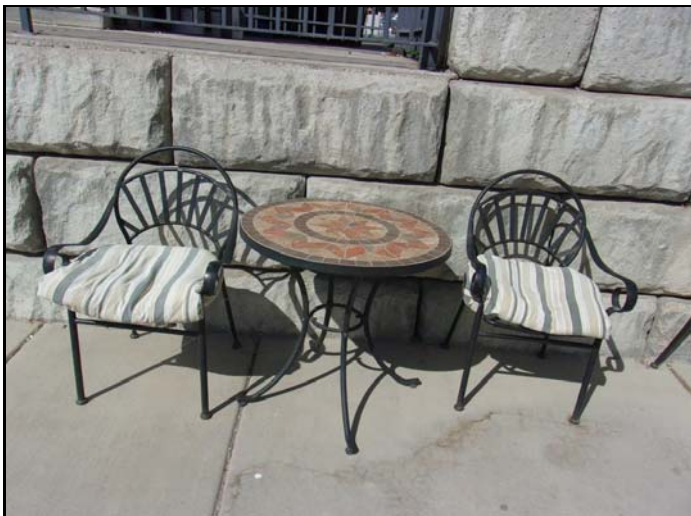
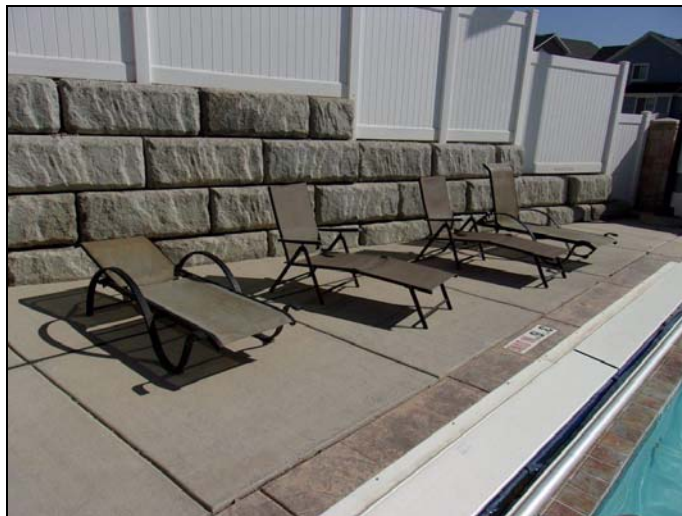
Comp #: 1121 Pool Furniture - Replace

The pool furniture is in good to poor condition. We recommend funding an allowance to make replacements to this component approximately every 6 years. Remaining life based on current age.

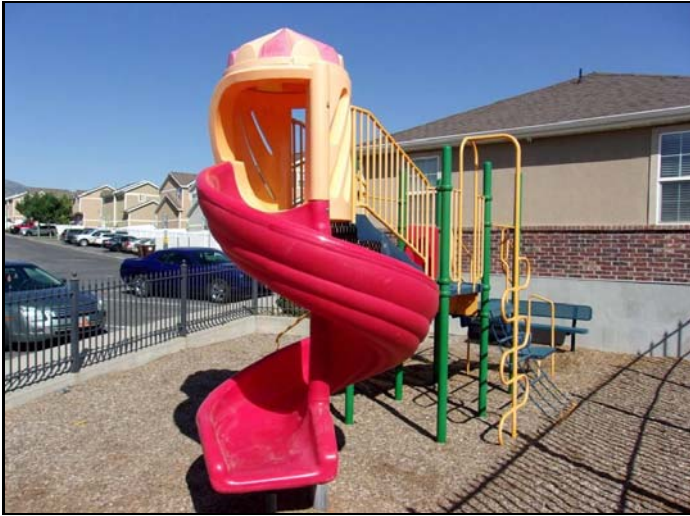
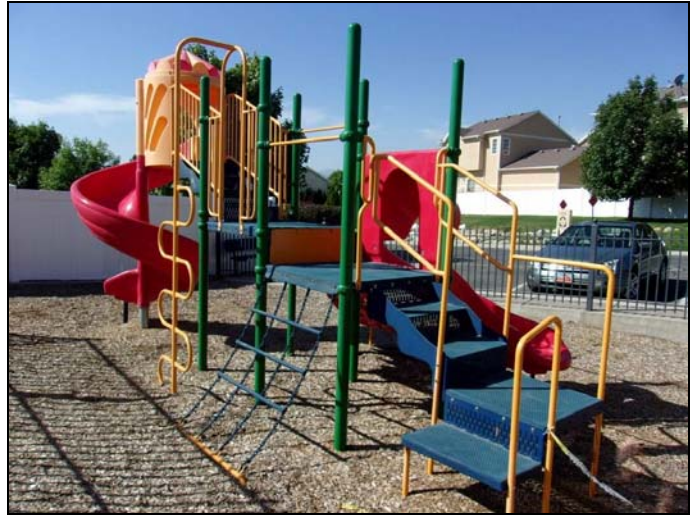
Comp #: 1301 Play Structure - Replace

The play structure is in fair condition. We recommend funding to replace this component approximately every 20 - 25 years. Remaining life based on current age.

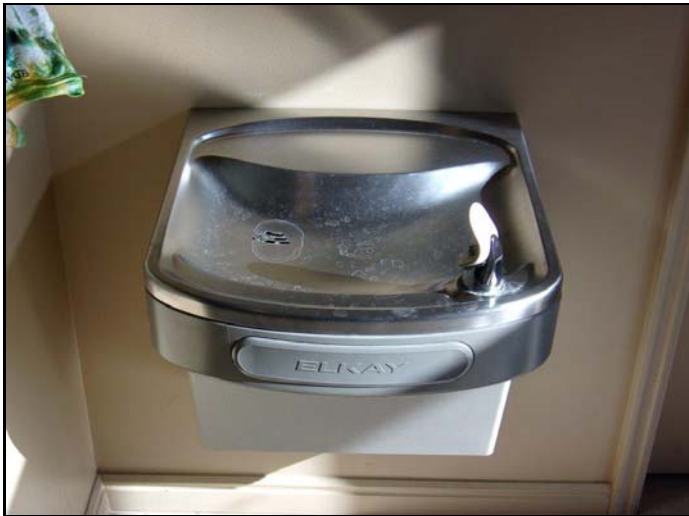
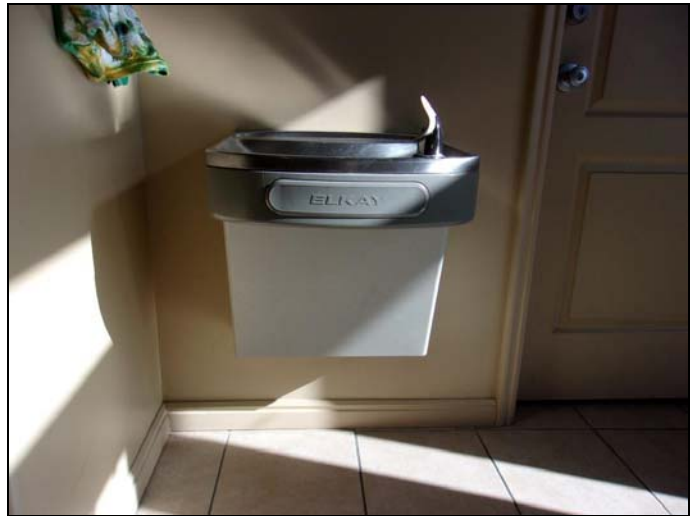
Comp #: 1304 Drinking Fountain - Replace

The drinking fountains are in working condition. We recommend funding to replace this component approximately every 10 - 15 years. Remaining life based on current condition.
