Stoneybrook HOA

Level 2 Reserve Study

Client Reference Number	11190
Property Type	Condominium
Number of Units	48
Fiscal Year End	12/31

Type of Study	Update w/Site Visit
Date of Property Inspection	6/13/2019
Prepared By	Dale Gifford
Analysis Method	Cash Flow
Funding Goal	Full Funding

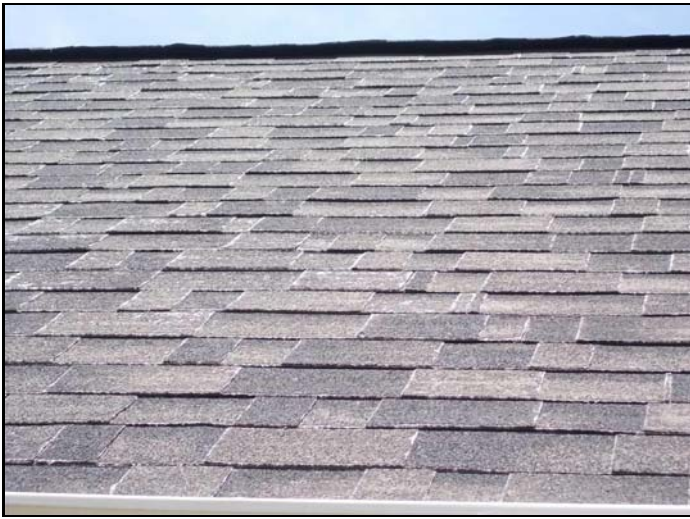
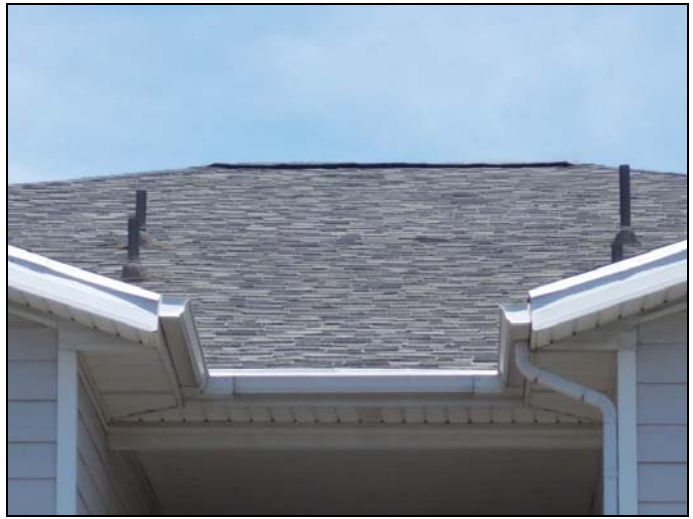
Comp #: 105 Roofs - 2018 - Replace

The roofs are in good condition. We recommend funding to replace this component approximately every 20 - 25 years. Remaining life based on current age.

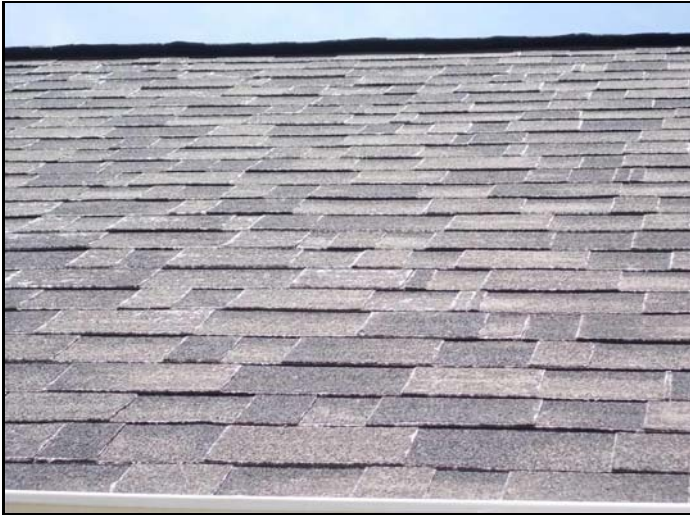
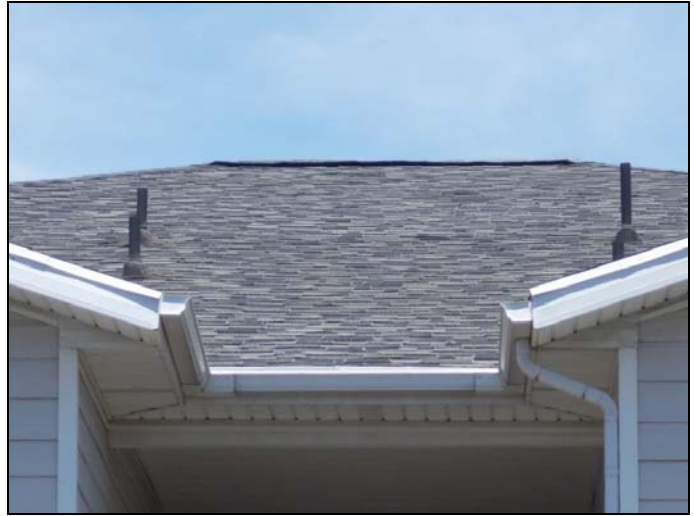
Comp #: 105 Roofs - Replace

The roofs are in fair condition. We recommend funding to replace this component approximately every 20 - 25 years. Remaining life based on current age.

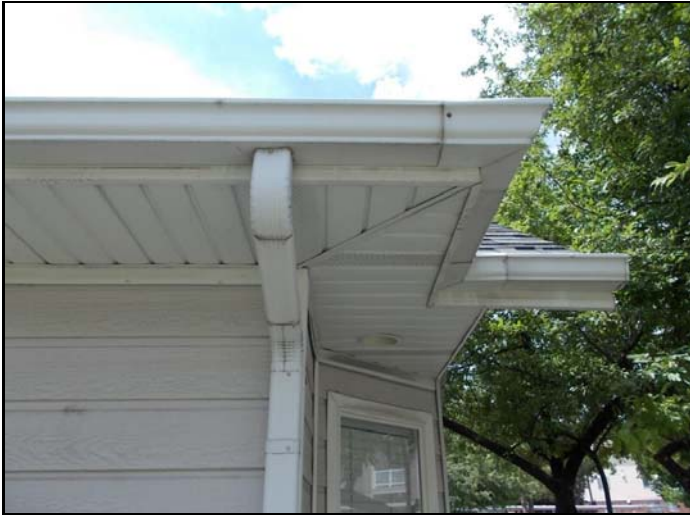
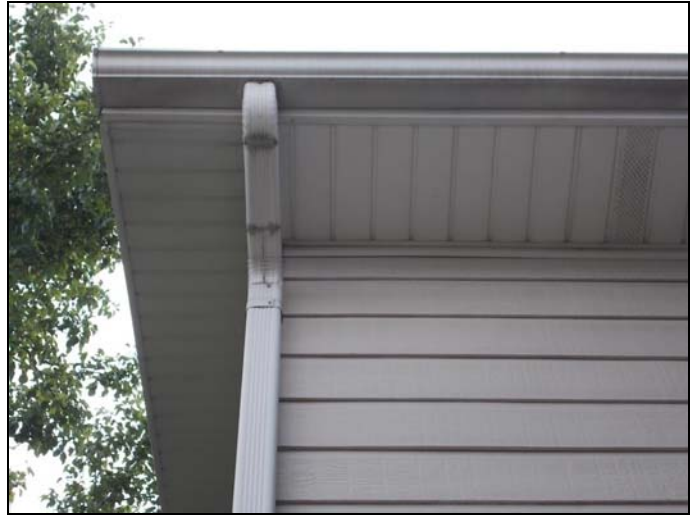
Comp #: 120 Rain Gutters/Downspouts - Replace

The rain gutters and downspouts are in fair condition. We recommend funding to replace this component approximately every 25 - 30 years. Remaining life based on current age.

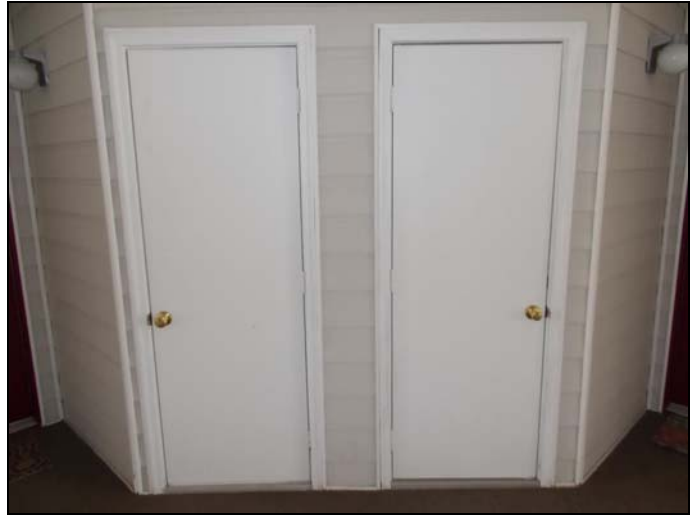
Comp #: 204 Doors - Repaint

The painted door surfaces are in fair condition. We recommend funding to repaint this component approximately every 8 - 10 years. Remaining life based on average condition.

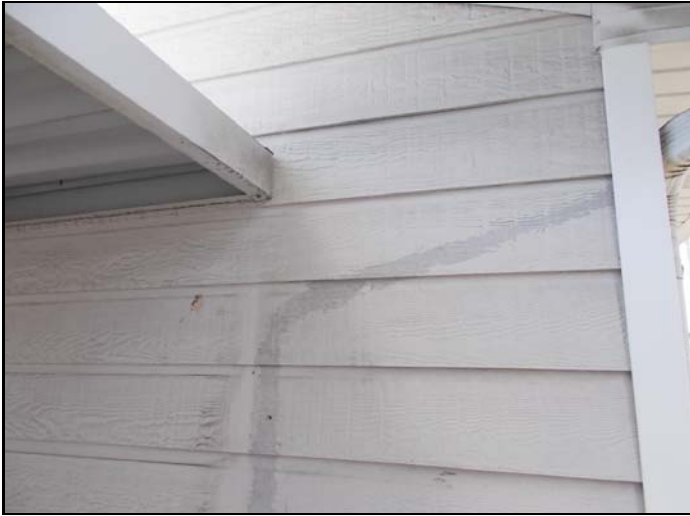
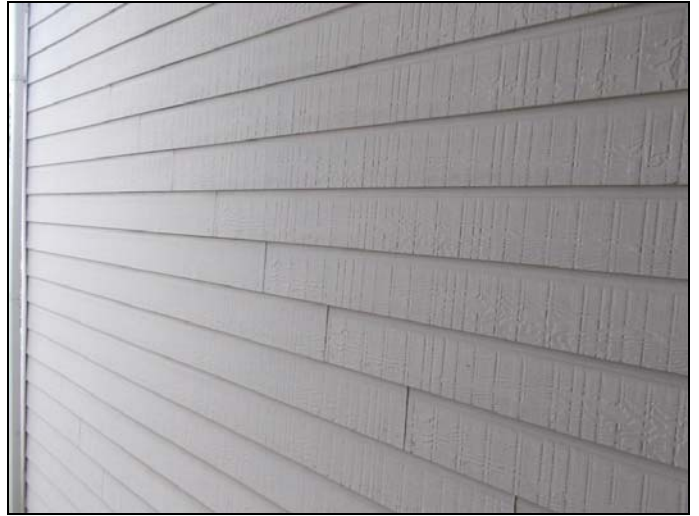
Comp #: 215 Siding - Repair/Repaint

The siding painted surfaces are in fair to poor condition. We recommend funding to repair/repaint this component approximately every 8 - 10 years. Remaining life is based on current age.

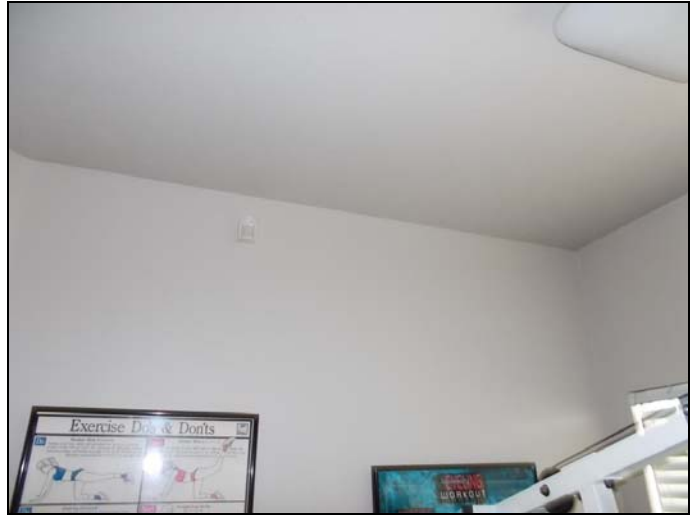
Comp #: 216 Interior Painted Surfaces - Repaint

The interior painted surfaces are in fair condition. We recommend funding to repaint this component approximately every 10 years. Remaining life based on current condition.

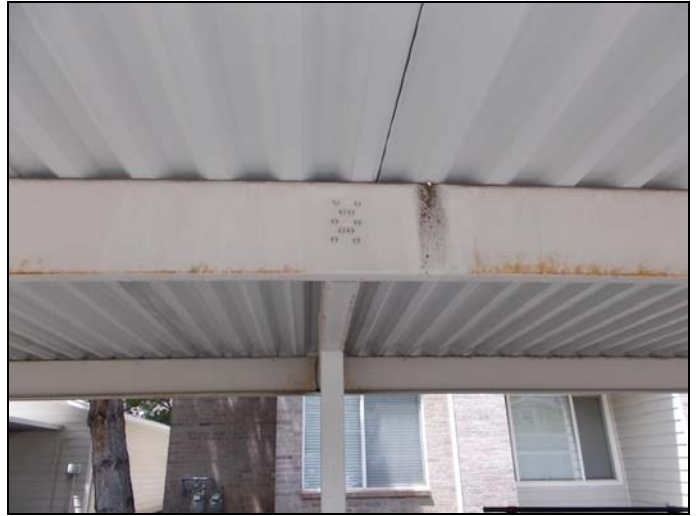
Comp #: 223 Carports - Repaint

The paint on the carport structure is in fair to poor condition. We recommend funding to repaint this component approximately every 8 - 10 years. Remaining life based on current condition.

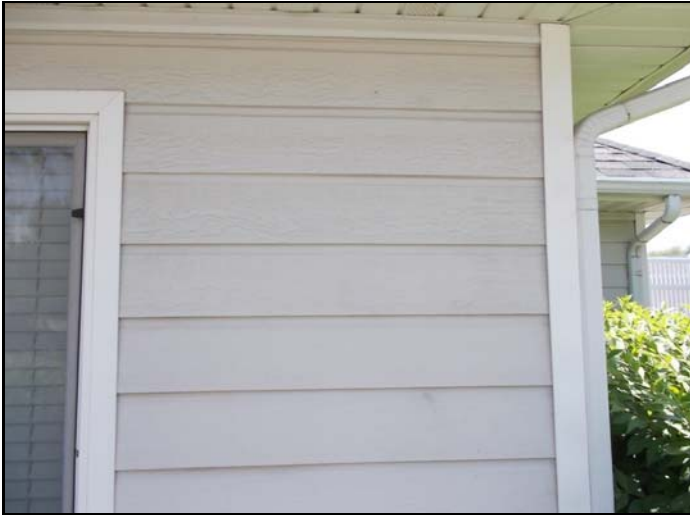
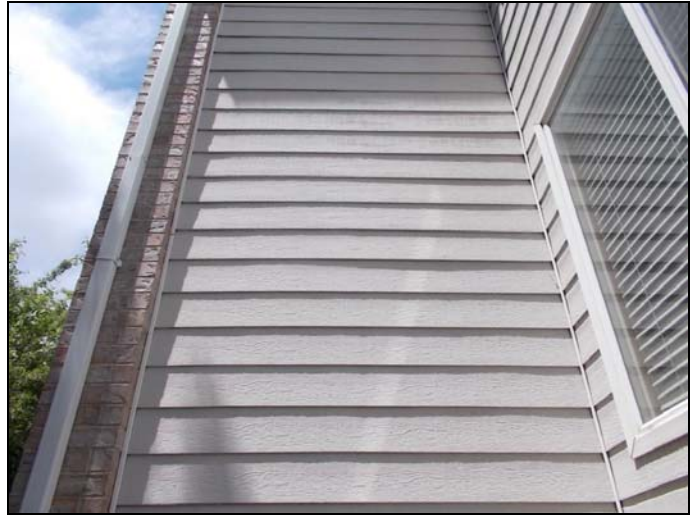
Comp #: 301 Siding - Replace

The siding is in generally good condition. We recommend funding to replace this component approximately every 40 - 50 years. Remaining life is based on current age.

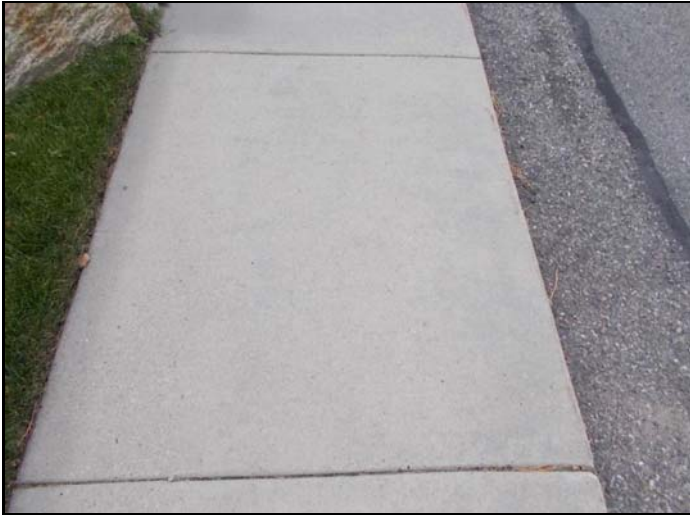
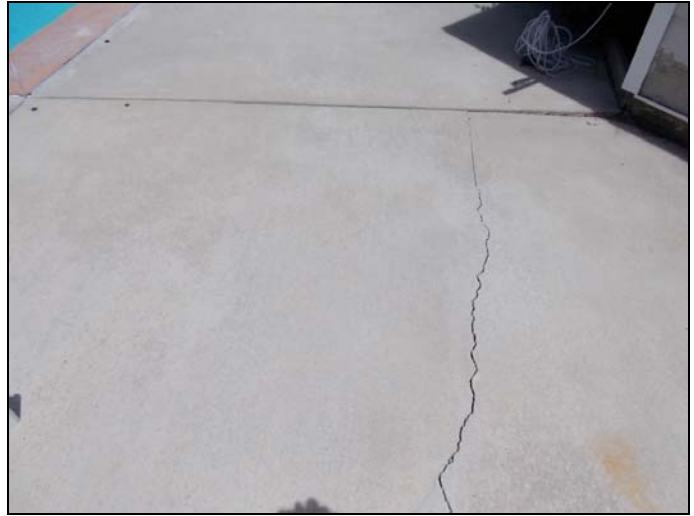
Comp #: 403 Concrete - Repair/Replace

The concrete is in good condition. This component has an extended useful life under normal conditions. We recommend funding to make repairs and partially replace this component approximately every 10 years. Remaining life based on current age.

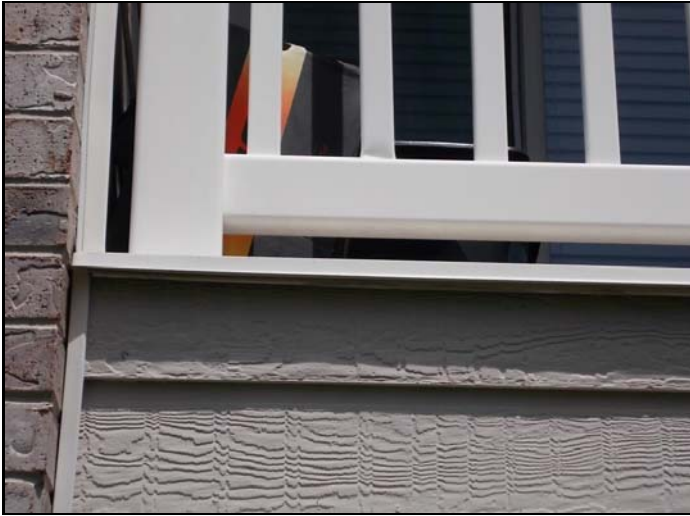
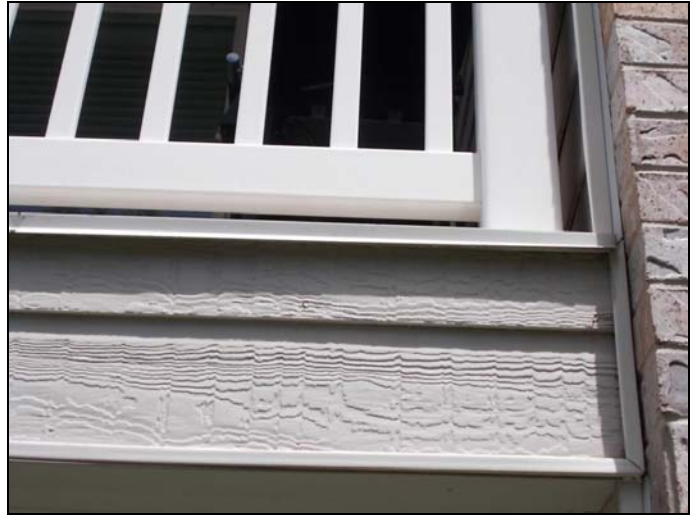
Comp #: 604 Balcony Decks - Repair/Resurface

Unable to inspect the deck surfaces at the time of the inspection. We recommend funding to resurface this component approximately every 15 - 20 years. Remaining life based on current condition.

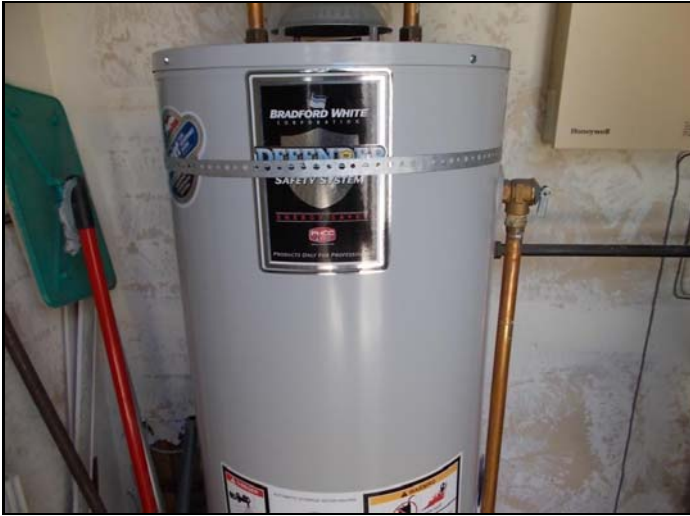
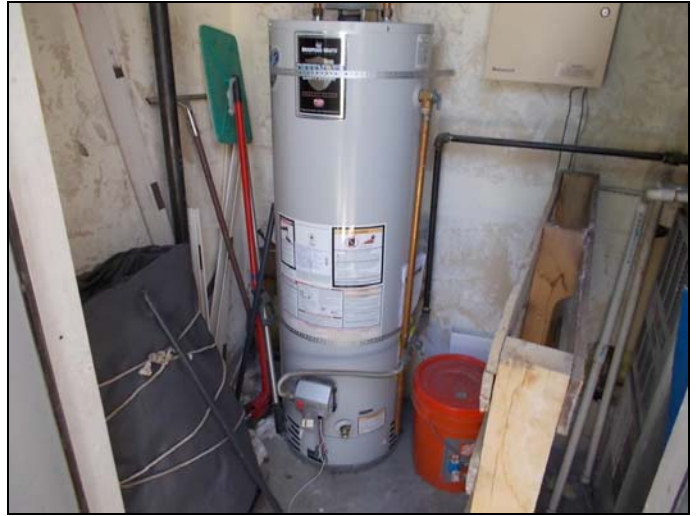
Comp #: 703 Water Heater - Replace

The water heater is in working condition. We recommend funding to replace this component approximately every 12 years. Remaining life based on current age.

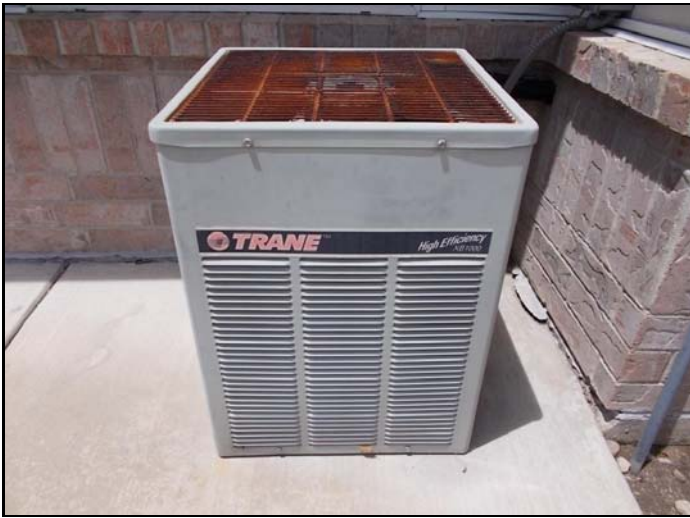
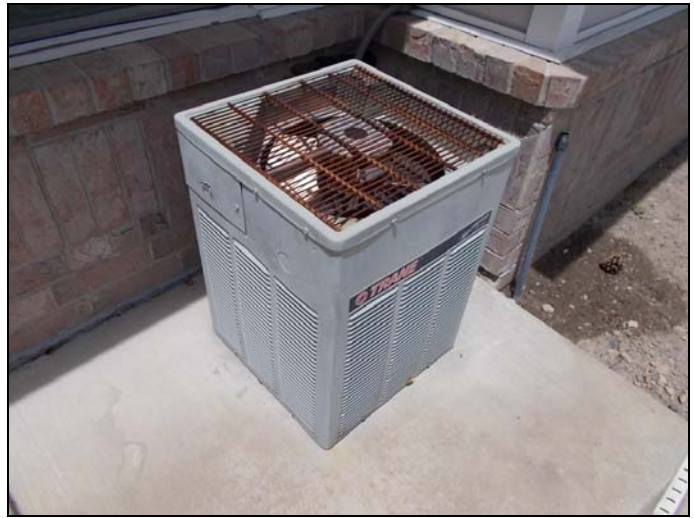
Comp #: 705 HVAC Condenser - Replace

The HVAC condenser is in working condition. We recommend replacing this component approximately every 20 years. Remaining life based on current age.

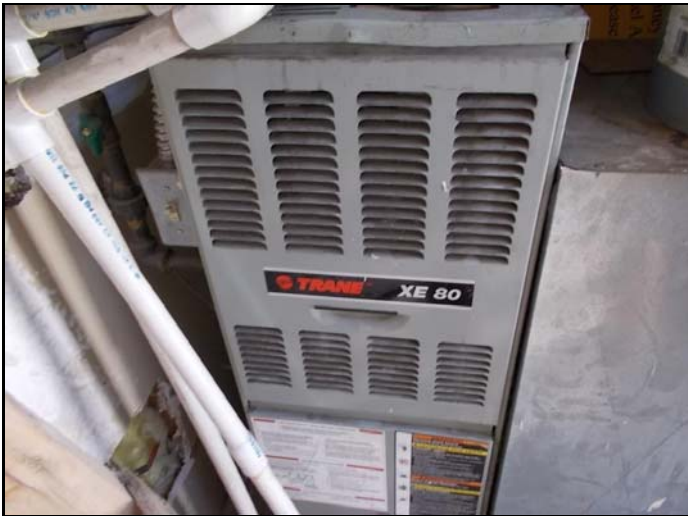
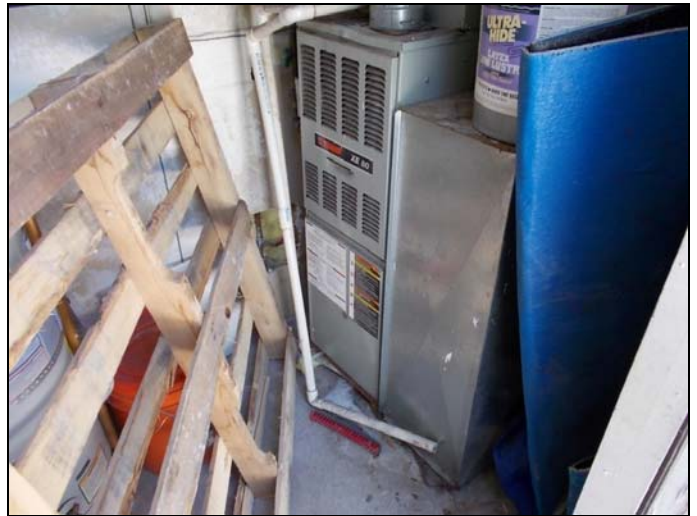
Comp #: 706 HVAC Furnace - Replace

The furnace is in working condition. We recommend funding to replace this component approximately every 20 years. Remaining life based on current age.

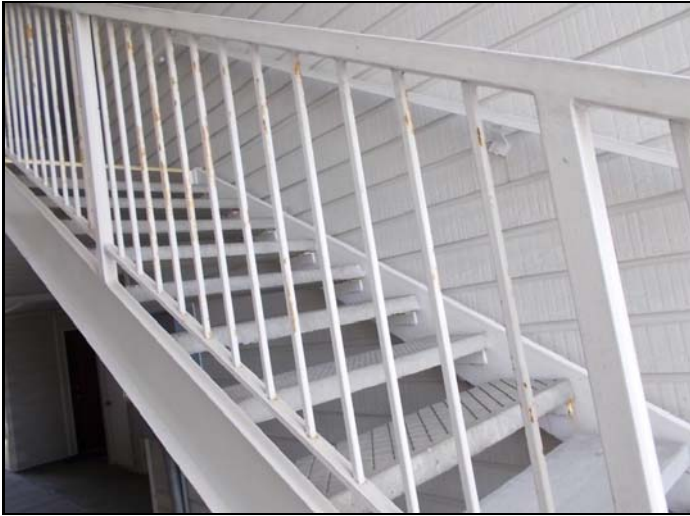
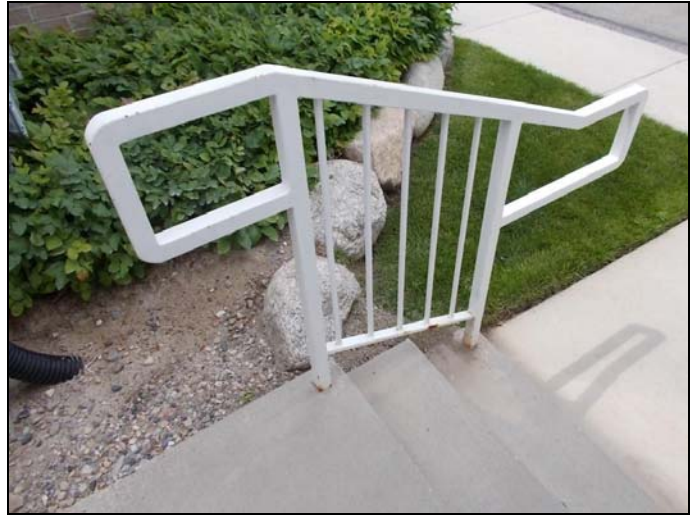
Comp #: 1002 Metal Fencing & Railing - Replace

The metal fencing is in good condition. We recommend funding to replace this component approximately every 40 - 50 years. Remaining life based on current age.

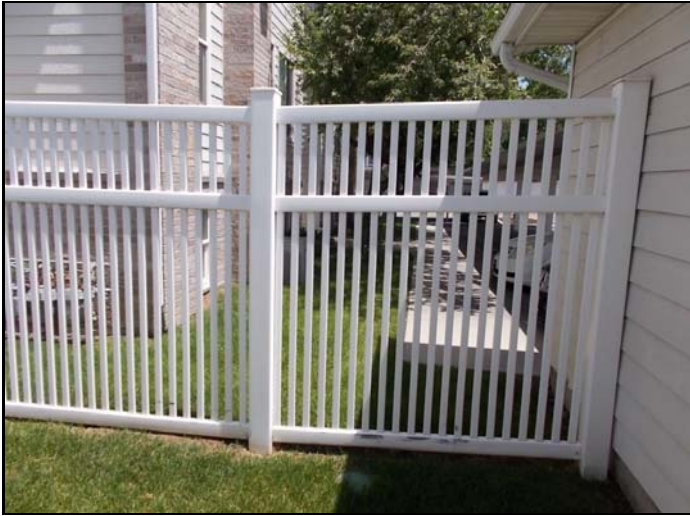
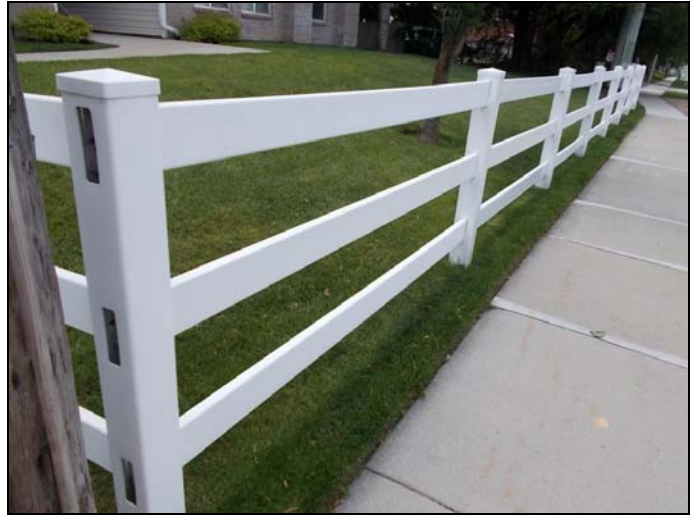
Comp #: 1008 Vinyl Fencing - Replace

The vinyl fencing is in fair condition. We recommend funding to replace this component approximately every 25 - 30 years. Remaining life based on current age.

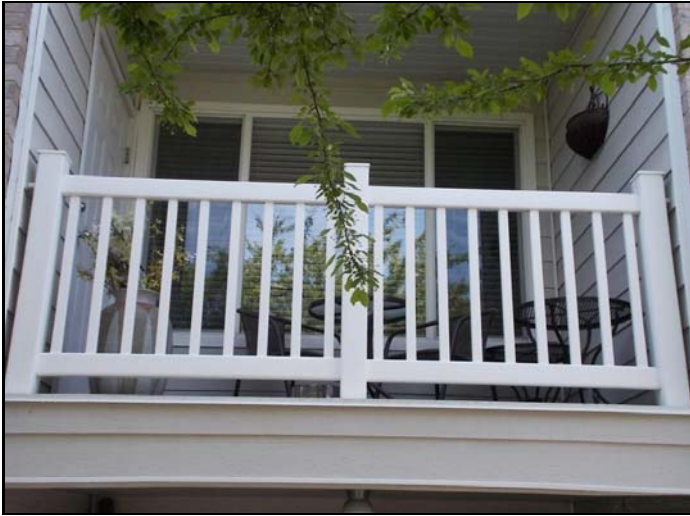
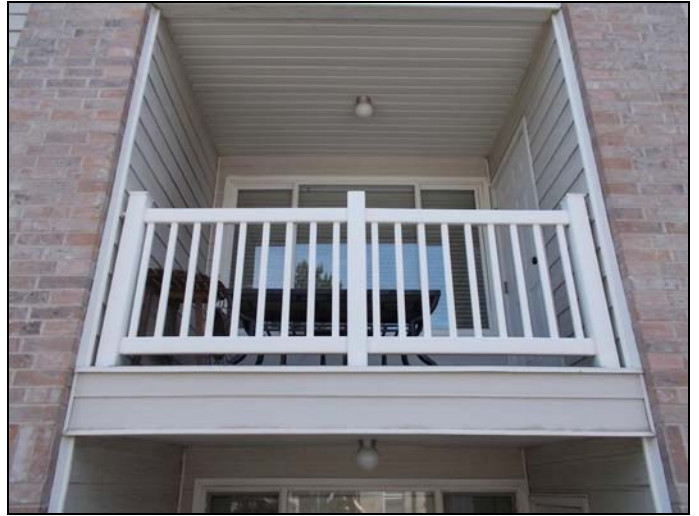
Comp #: 1090 Vinyl Balcony Railing - Replace

The vinyl balcony railing is in fair condition. We recommend funding to replace this component approximately every 25 - 30 years. Remaining life based on current age.

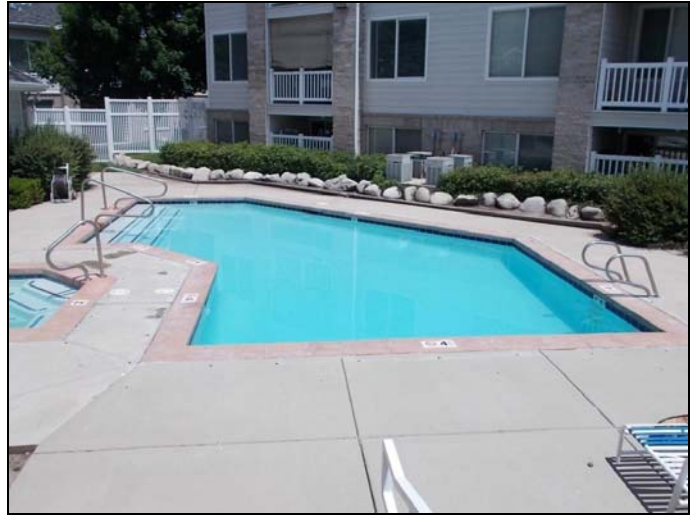
Comp #: 1101 Pool - Resurface

The pool surface is in good condition. We recommend funding to resurface this component every 10 - 12 years. Remaining life based on current age.

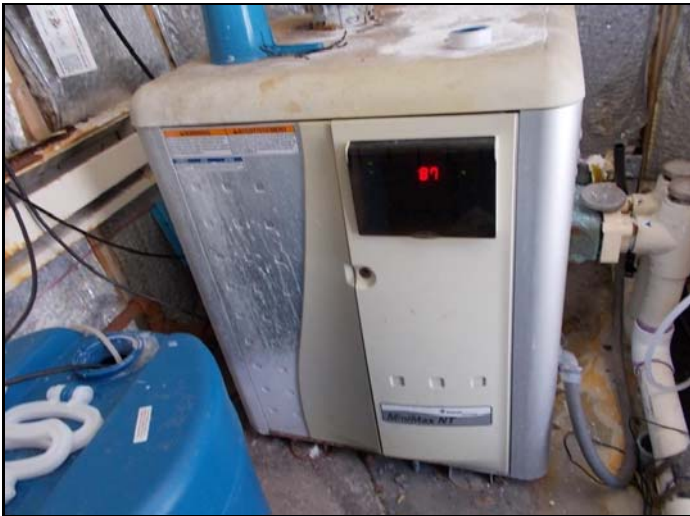
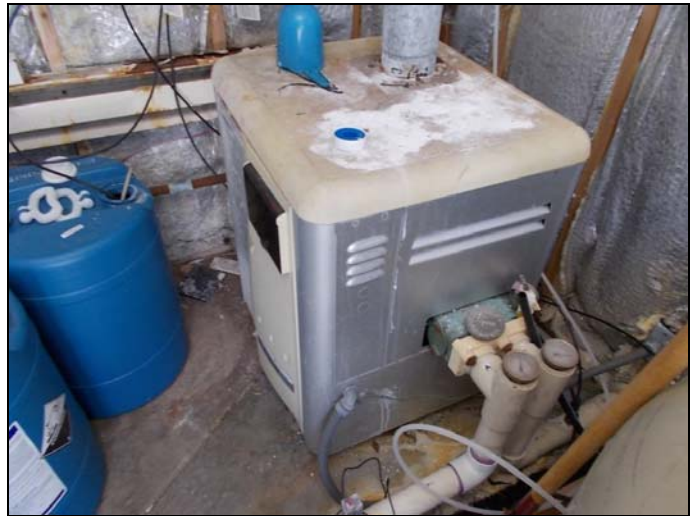
Comp #: 1104 Pool Heater - Replace

The pool heater is in working condition. We recommend funding to replace this component approximately every 12 years. Remaining life based on current age.

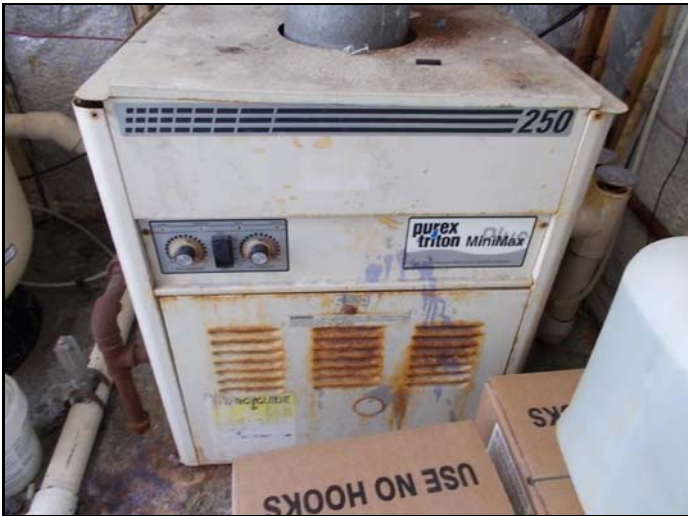
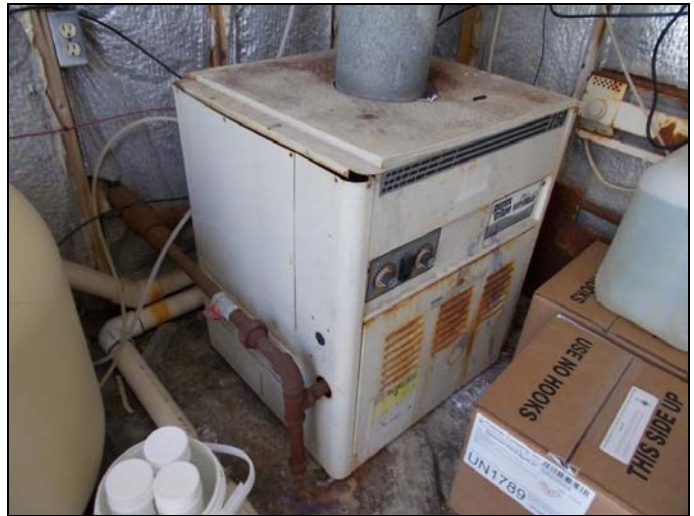
Comp #: 1105 Spa Heater - Replace

The spa heater is in working condition. We recommend funding to replace this component approximately every 12 years. Remaining life is based on current age.

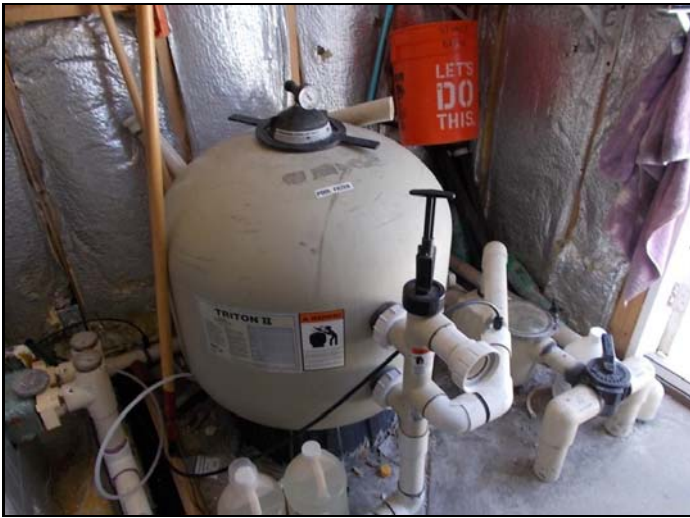
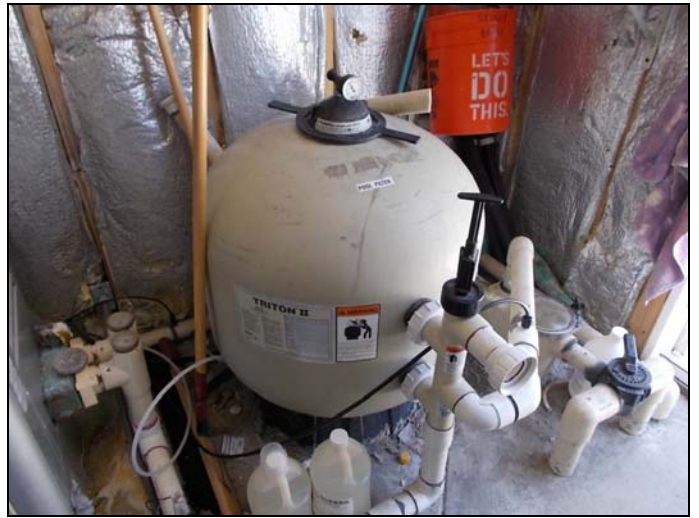
Comp #: 1107 Pool Filter - Replace

The pool filter is in working condition. We recommend funding to replace this component approximately every 12 - 15 years. Remaining life based on current age.

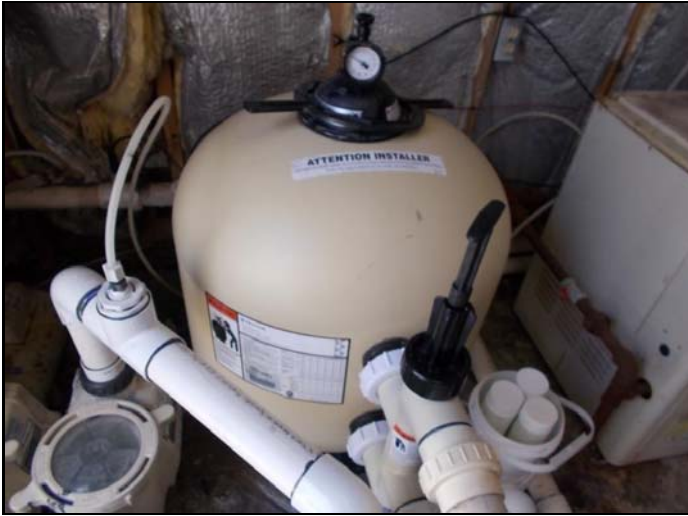
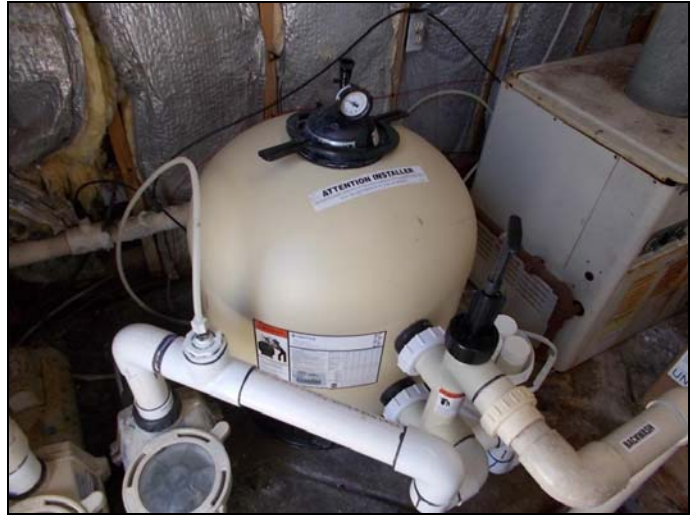
Comp #: 1108 Spa Filter - Replace

The spa filter is in working condition. We recommend funding to replace this component approximately every 12 - 15 years. Remaining life based on current age.

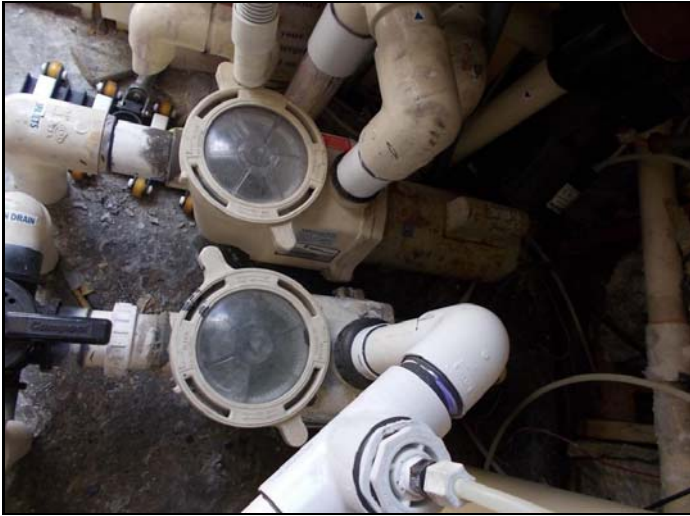
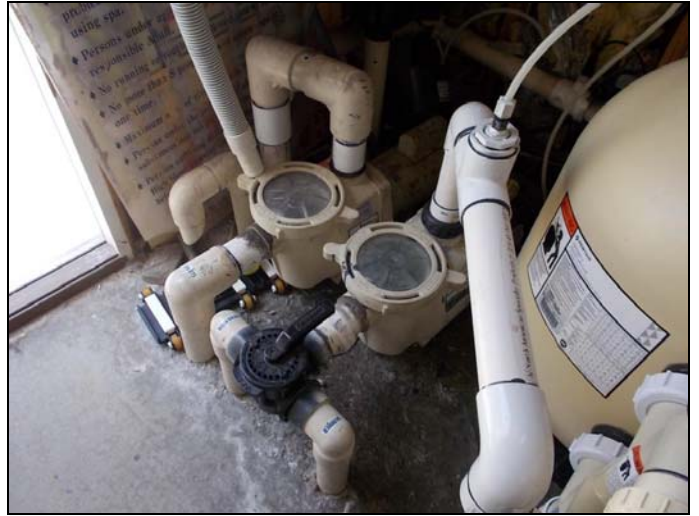
Comp #: 1110 Pool/Spa Pumps - Replace

The pumps are in working condition. We recommend funding to replace this component approximately every 8 - 10 years. Remaining life based on current age.
