Knollwood Condo Association

Level 2 Reserve Study

Report Period – 01/01/2021 – 12/31/2021

Type of Study	Update w/Site Visit
Date of Property Inspection	10/22/2020
Prepared By	Dale Gifford
Analysis Method	Cash Flow
Funding Goal	Full Funding

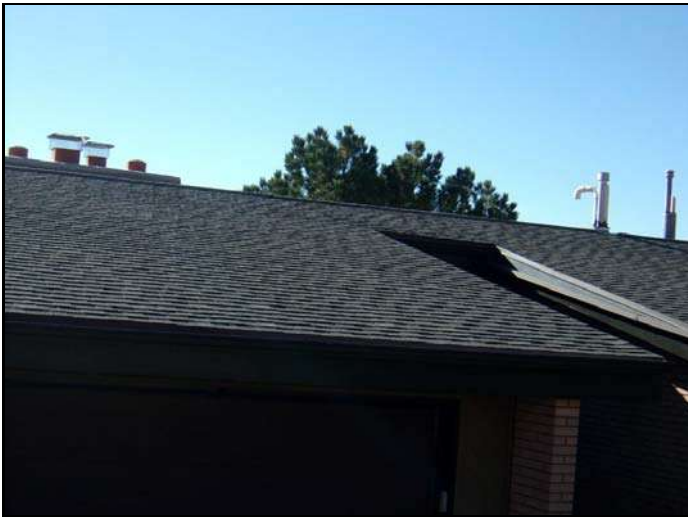
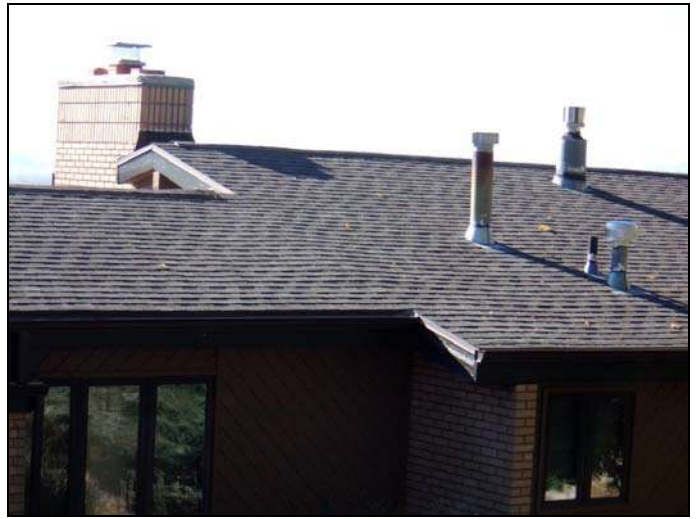
Comp #: 105 Roofs - Replace

The roofs are in good condition. Research with the client reveals the roofing product used has a 40 year warranty and a 40 year useful life. Remaining life based on current age.

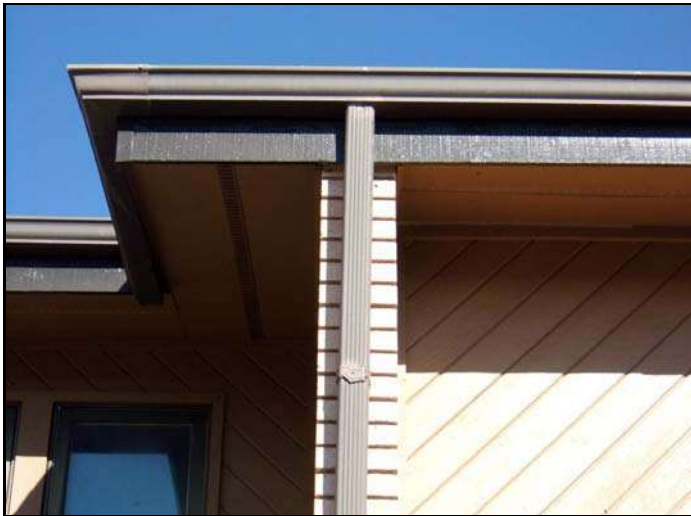
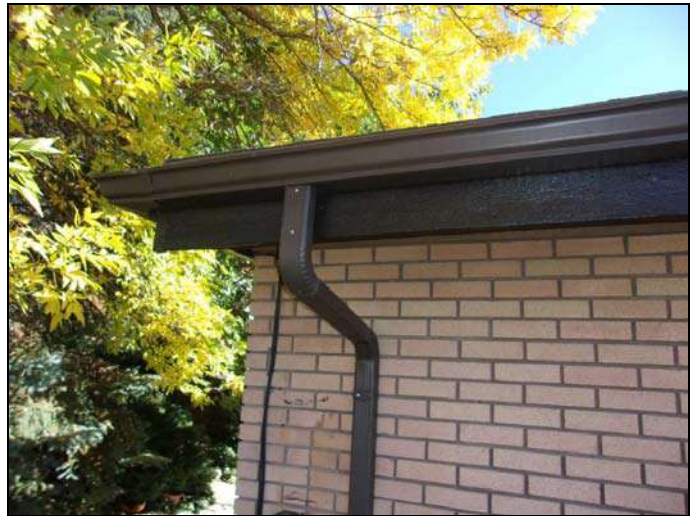
Comp #: 120 Rain Gutters/Downspouts - Replace

The rain gutters and downspouts are in good to fair condition. We recommend funding to replace this component approximately every 25 - 30 years. Remaining life based on current age.

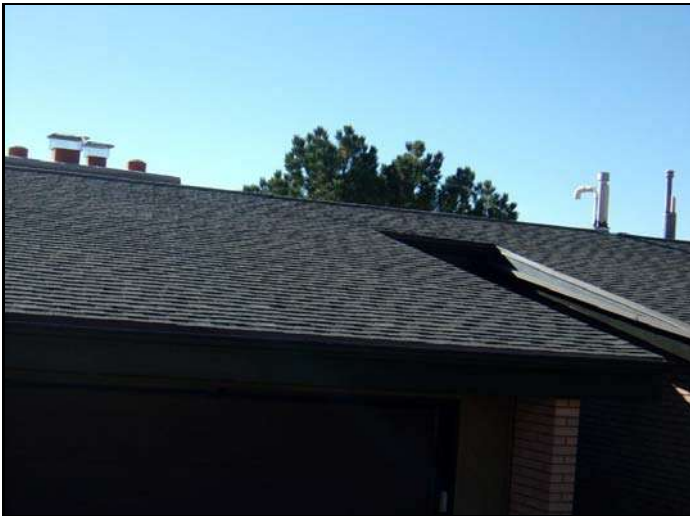
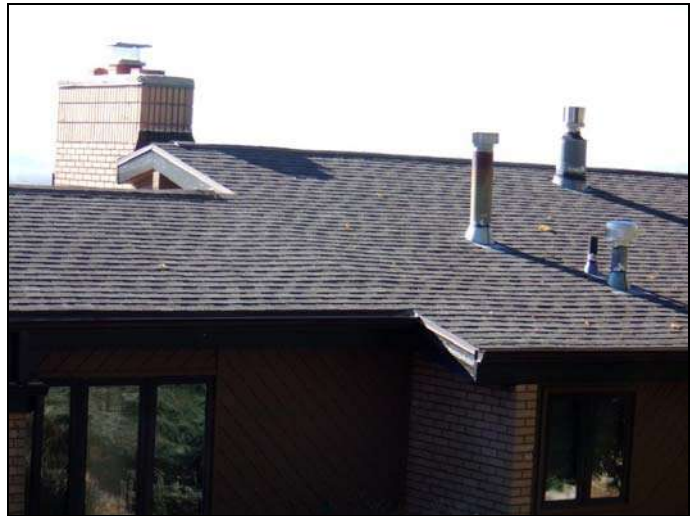
Comp #: 190 Roofs - Repairs

Research with the client reveals plans to repair this component every 10 years.

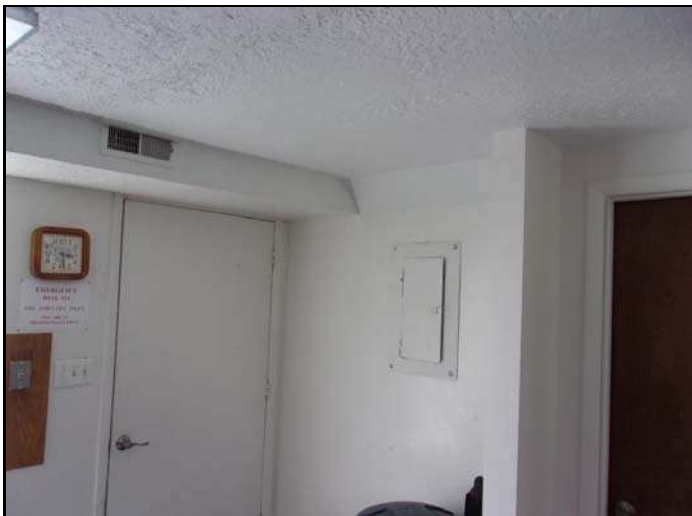
Comp #: 216 Interior Surfaces - Repaint

The interior painted surfaces are in fair condition. We recommend funding to repaint this component approximately every 10 years. Remaining life based on current age and condition.

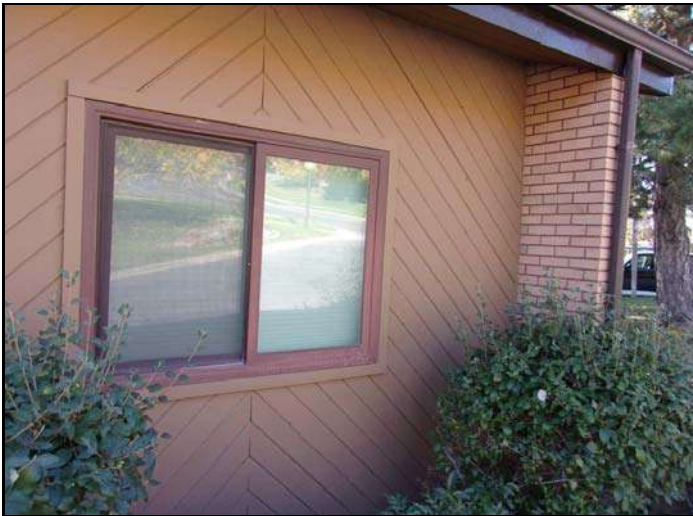
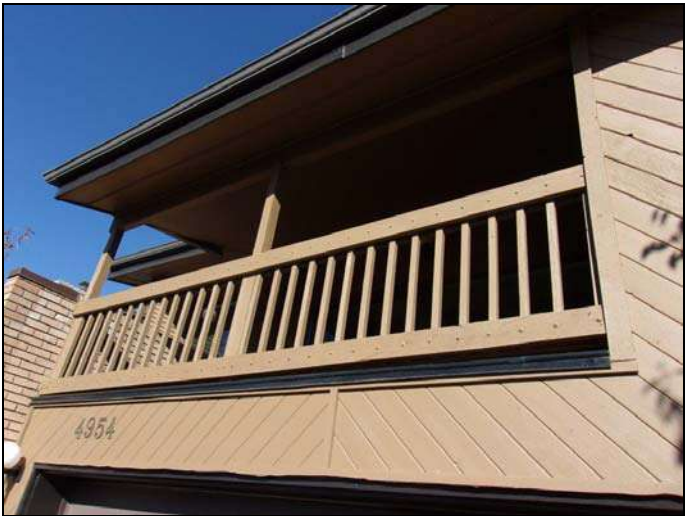
Comp #: 217 Building Exteriors - Repair/Repaint

The painted building exterior surfaces are in good condition. We recommend funding to repair/repaint this component approximately every 8 - 10 years. Remaining life based on current age.

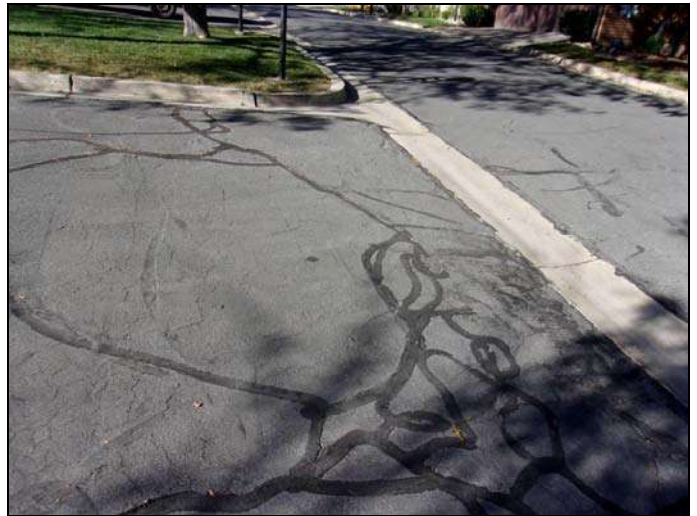
Comp #: 401 Asphalt - Major Rehab

The asphalt surfaces are in fair condition. We recommend funding for a major rehab of this component approximately every 25 - 30 years. Remaining life based on current age and condition.

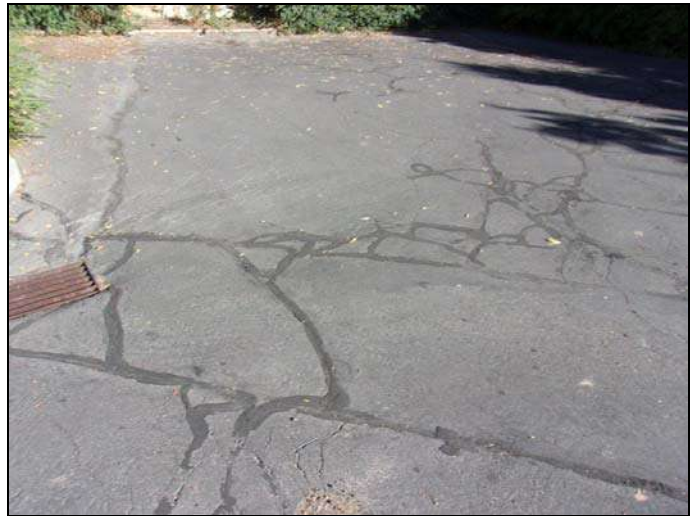
Comp #: 402 Asphalt - Slurry Seal

Research with the client reveals this component will be sealed in 2021. We recommend funding to seal this component approximately every 5 - 7 years. Remaining life based on current age.

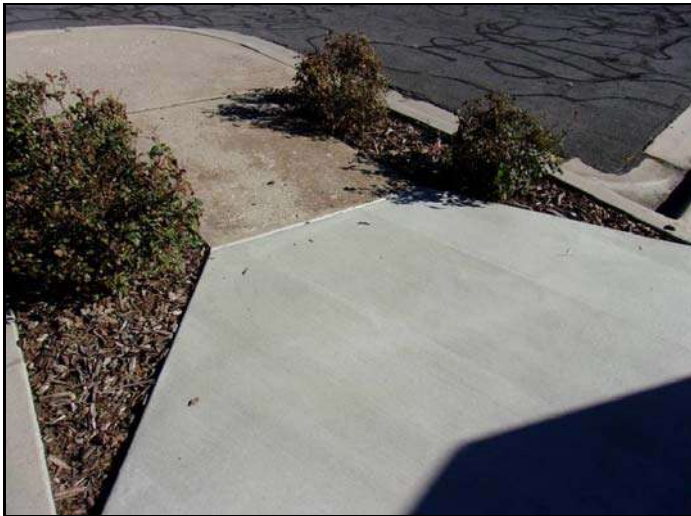
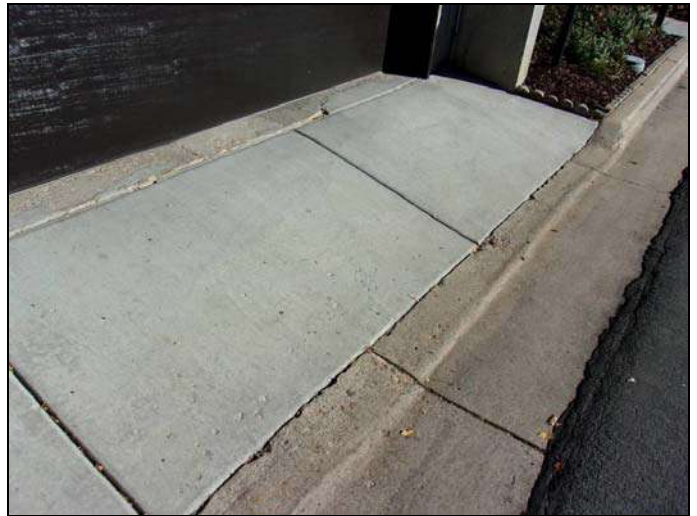
Comp #: 403 Concrete - Repair/Replace

The concrete is generally in fair condition. This component has an extended useful life under normal conditions. We recommend funding to make repairs and partially replace this component approximately every 10 years. Remaining life based on current age.

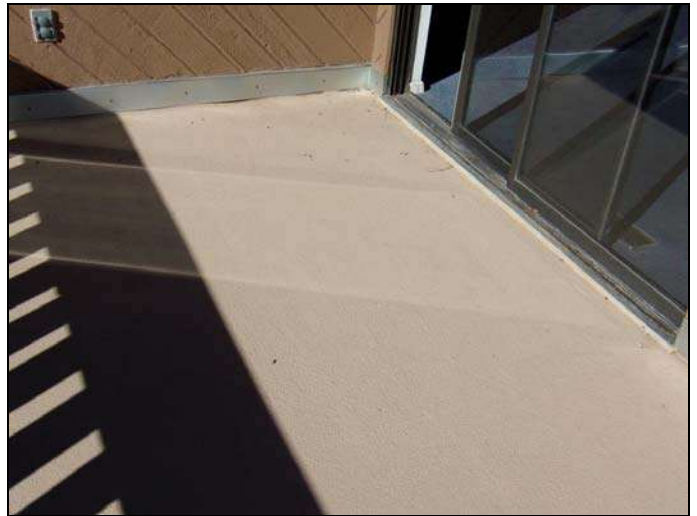
Comp #: 604 Clubhouse Deck - Resurface

The deck surface is in good condition. We recommend funding to resurface this component approximately every 5 years. Remaining life based on current age.

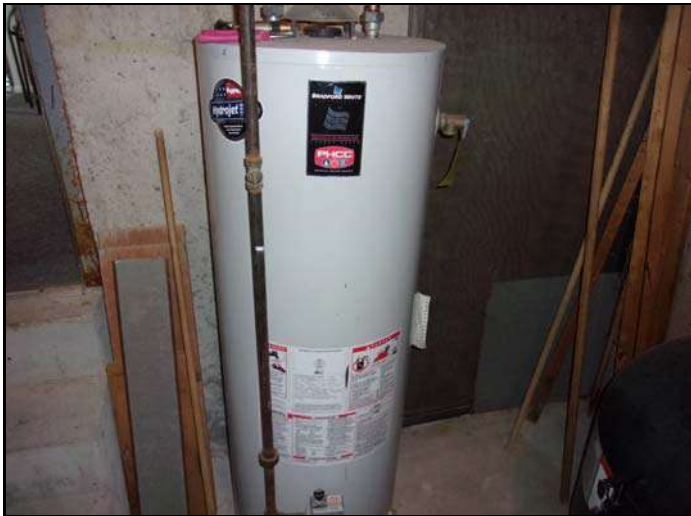
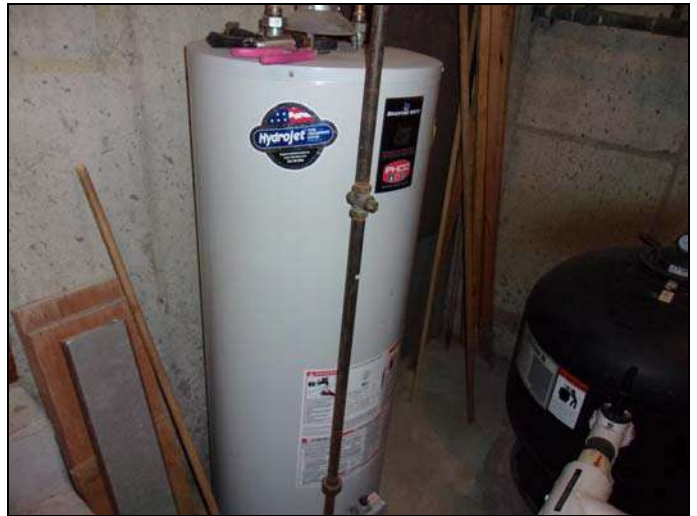
Comp #: 703 Water Heater - Replace

The water heater is in working condition. We recommend funding to replace this component approximately every 12 years. Remaining life based on current age.

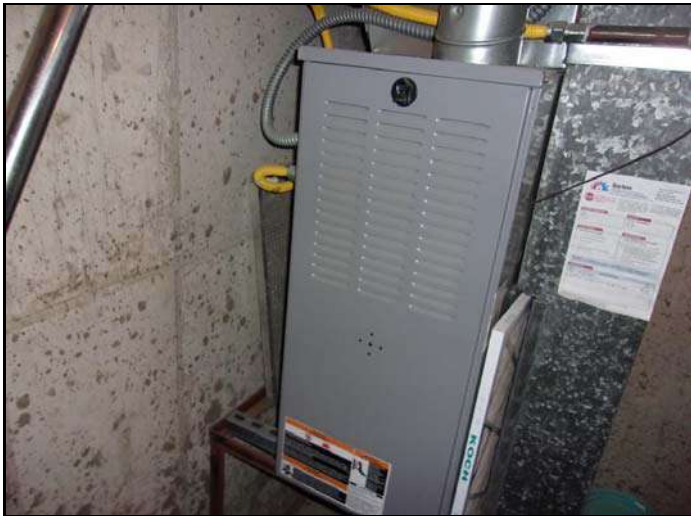
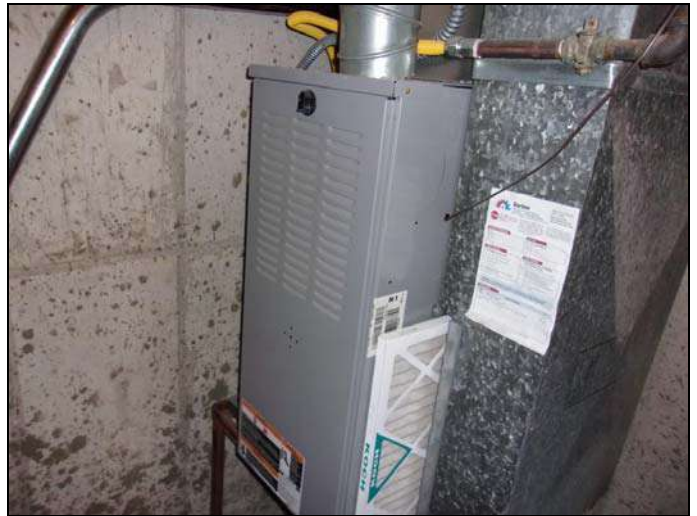
Comp #: 706 HVAC Furnace - Replace

The furnace is in working condition. We recommend funding to replace this component approximately every 20 years. Remaining life based on current age.

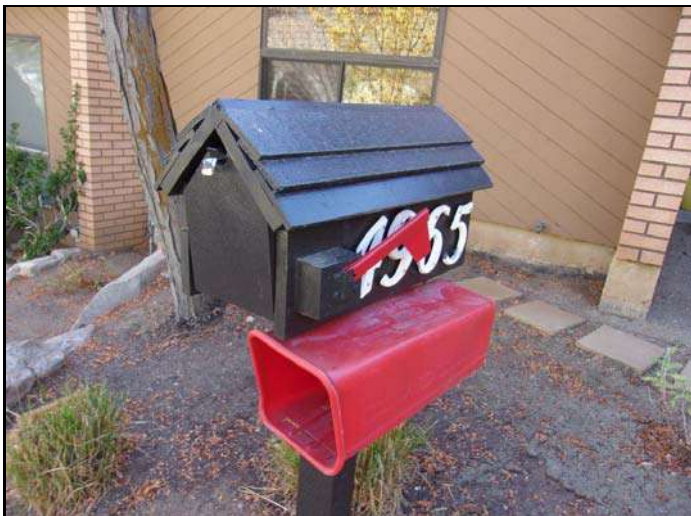
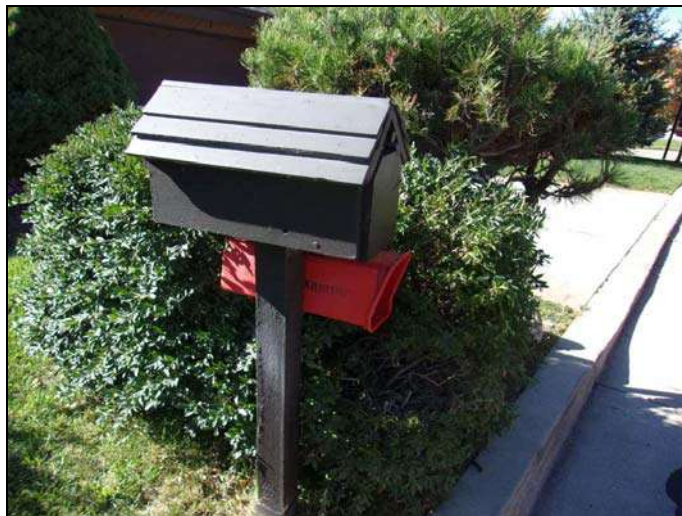
Comp #: 803 Mailboxes - Repair/Replace

The mailboxes are in good to poor condition. Research with the client reveals they are repairing this component in fiscal years 2015-2022. We recommend funding to repair/replace this component approximately every approximately every 15 - 20 years. Remaining life based on average age.

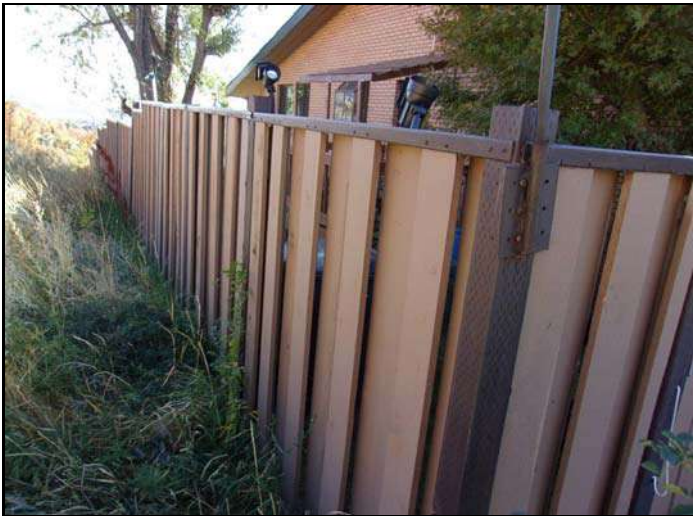
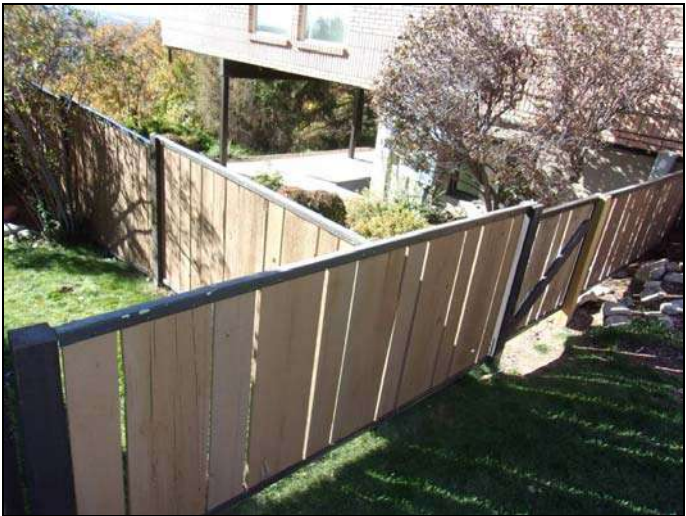
Comp #: 1001 Wood Fencing - Replace

The wood fencing is in good to fair condition. We recommend funding to replace this component approximately every 25 - 30 years. Remaining life based on current age.

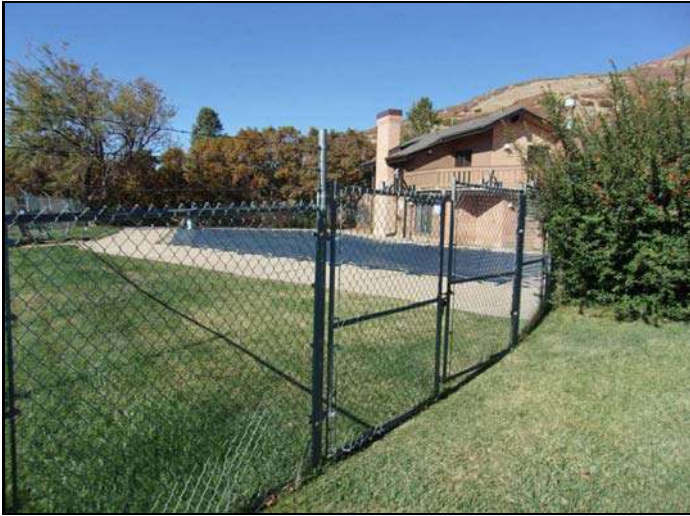
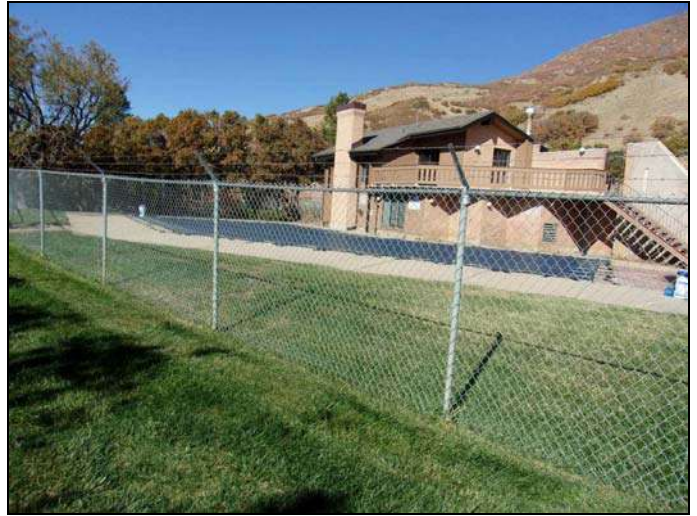
Comp #: 1003 Chain Link Fencing - Pool - Replace

The chain link fencing is in fair condition. We recommend funding to replace this component approximately every 30 - 40 years. Remaining life based on current age.

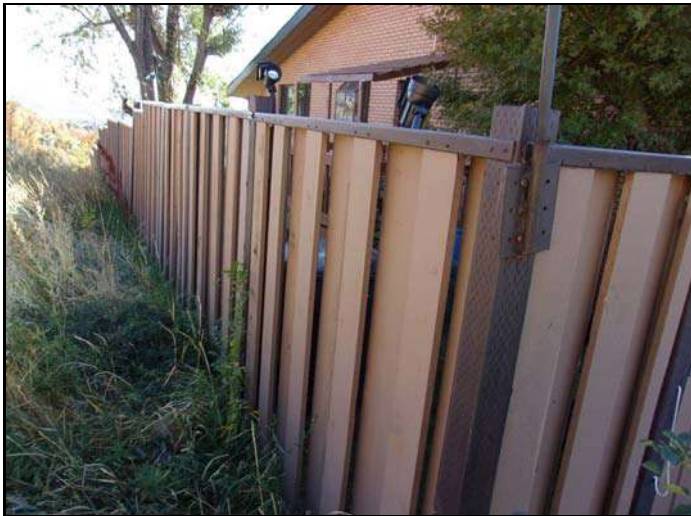
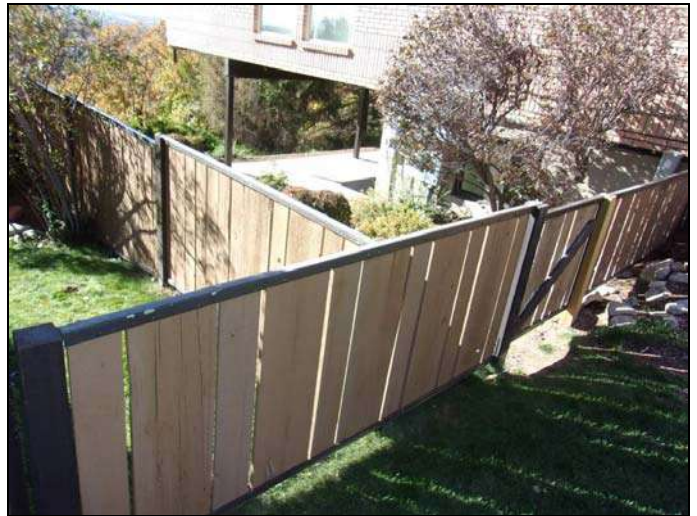
Comp #: 1090 Wood Fencing - 2021 - Repairs

Research with the client reveals they are finishing repairs on this component in 2021 and 2022. This is a one-time project.

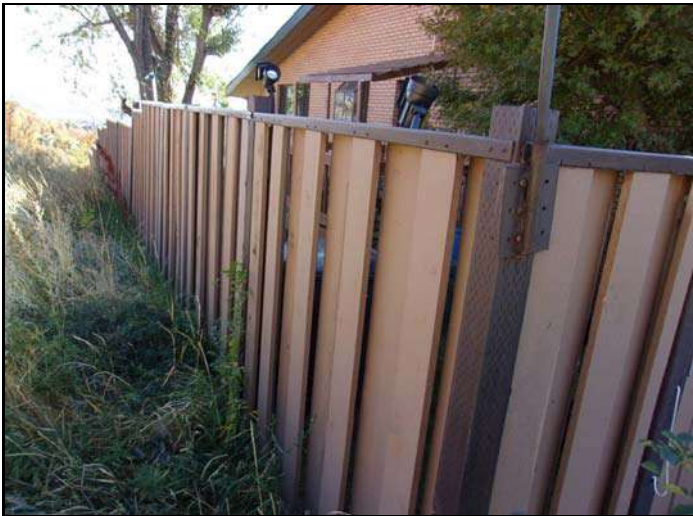
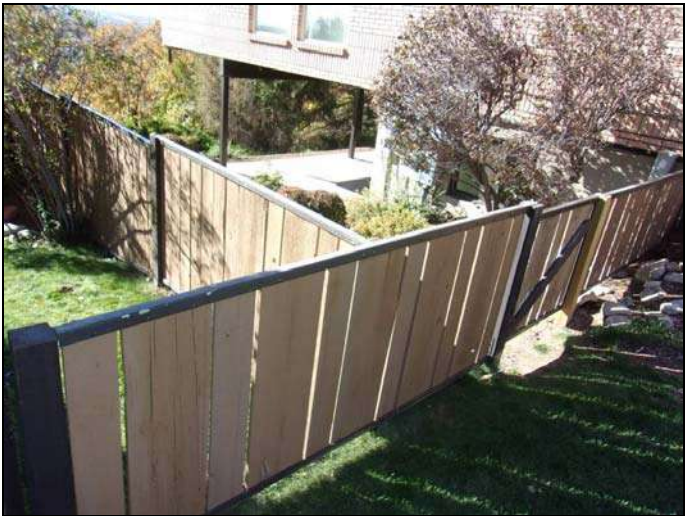
Comp #: 1090 Wood Fencing - 2022 - Repairs

Research with the client reveals they are finishing repairs on this component in 2021 and 2022. This is a one-time project.

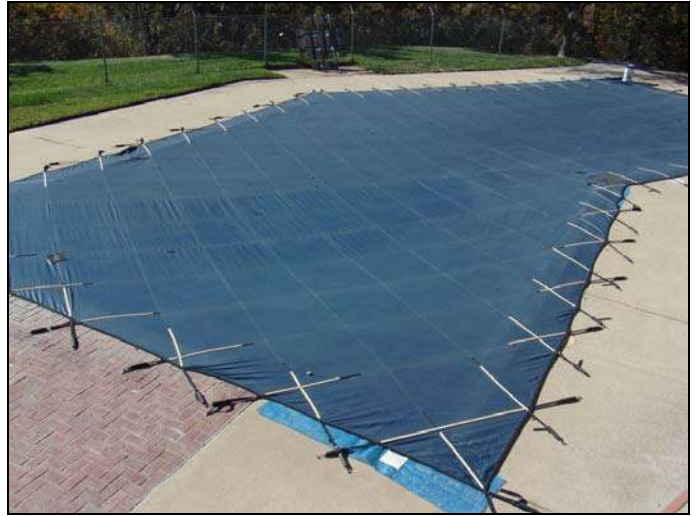
Comp #: 1101 Pool - Resurface

Unable to inspect this component at the time of the site visit. Research with the client reveals this component is in fair condition. We recommend funding to resurface this component every 10 - 12 years. Remaining life based on current age.

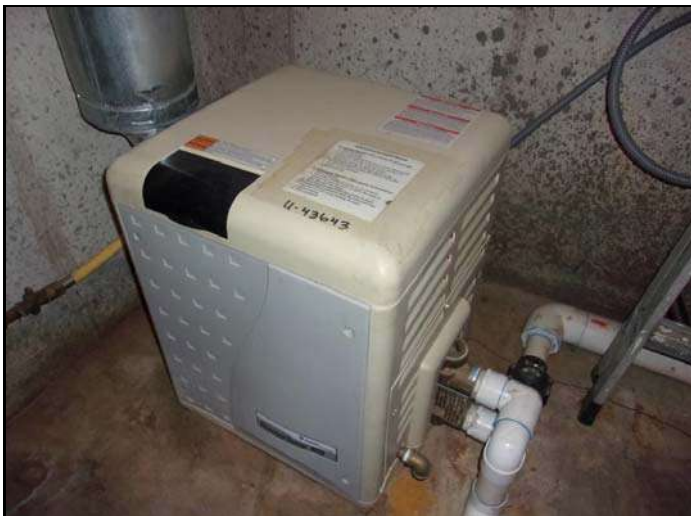
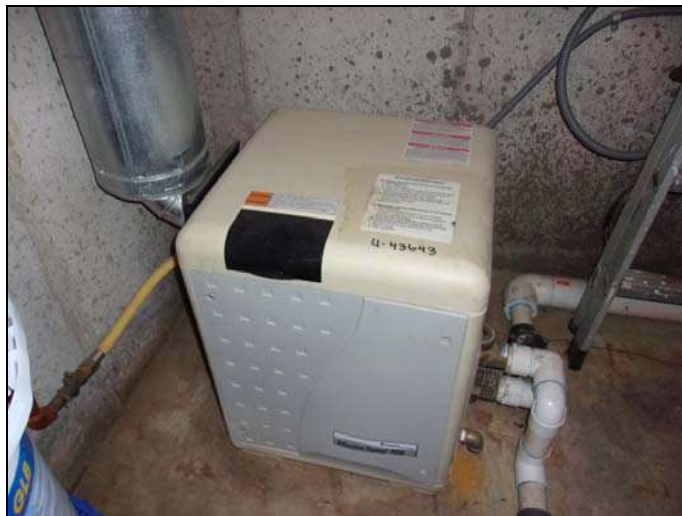
Comp #: 1104 Pool Heater - Replace

The pool heater is in working condition. We recommend funding to replace this component approximately every 12 years. Remaining life based on current age.

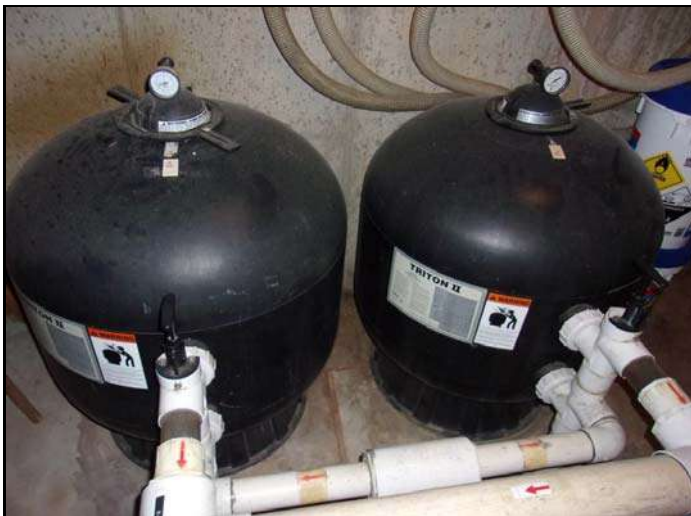
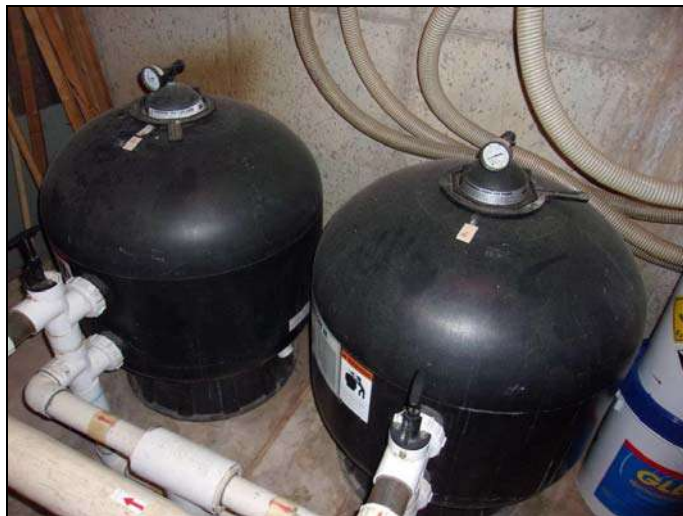
Comp #: 1107 Pool Filters - Replace

The pool filters are in working condition. We recommend funding to replace this component approximately every 12 - 15 years. Remaining life based on current age and condition.

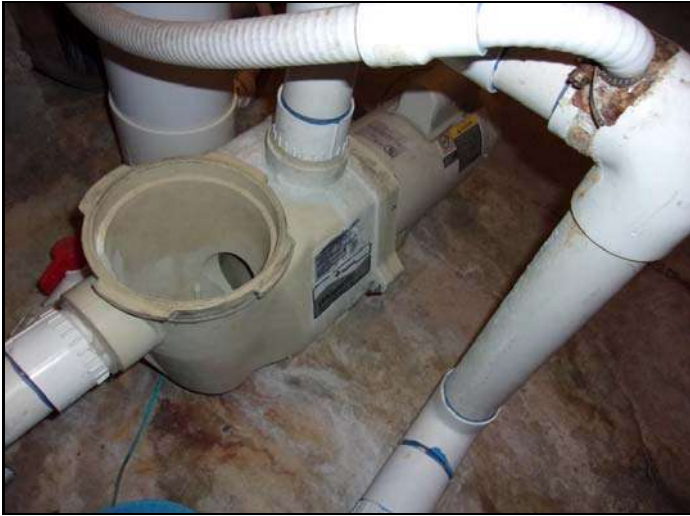
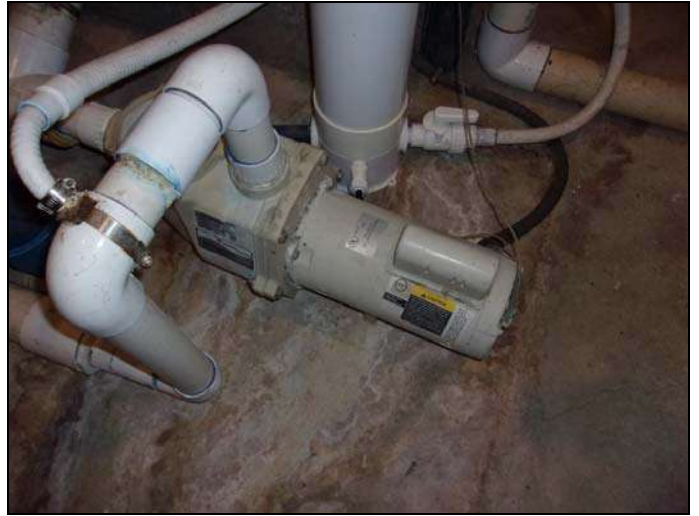
Comp #: 1110 Pool Pump - Replace

The pool pump is in working condition. We recommend funding to replace this component approximately every 8 - 10 years. Remaining life based on current age and condition.

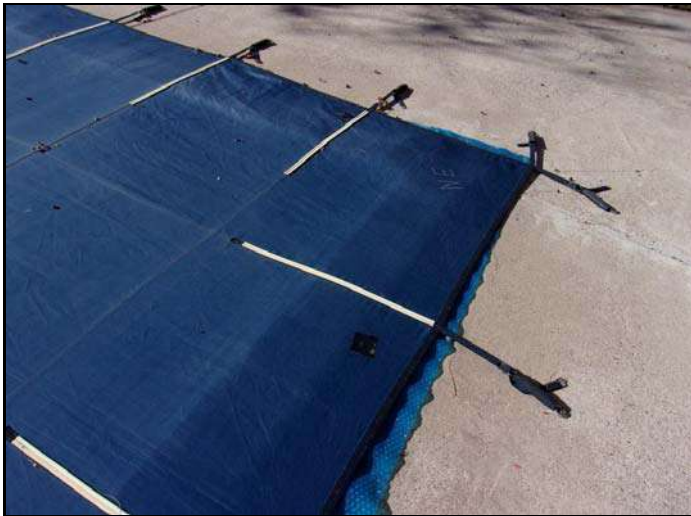
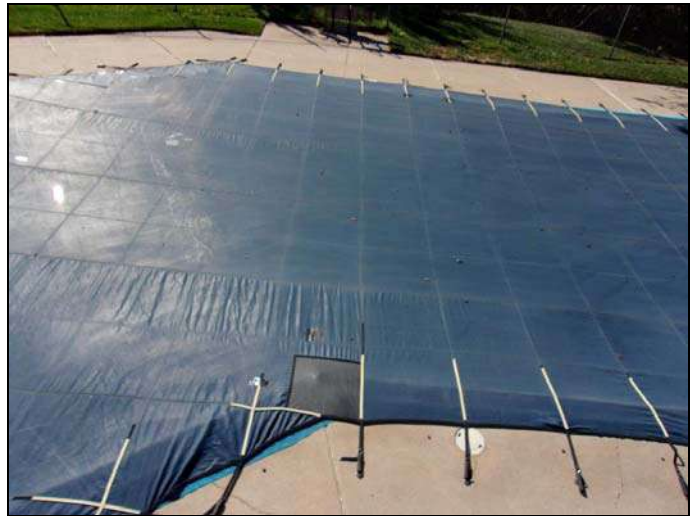
Comp #: 1112 Pool Cover - Replace

The pool cover appears to be in fair condition. We recommend funding to replace this component approximately every 10 years. Remaining life based on current condition.

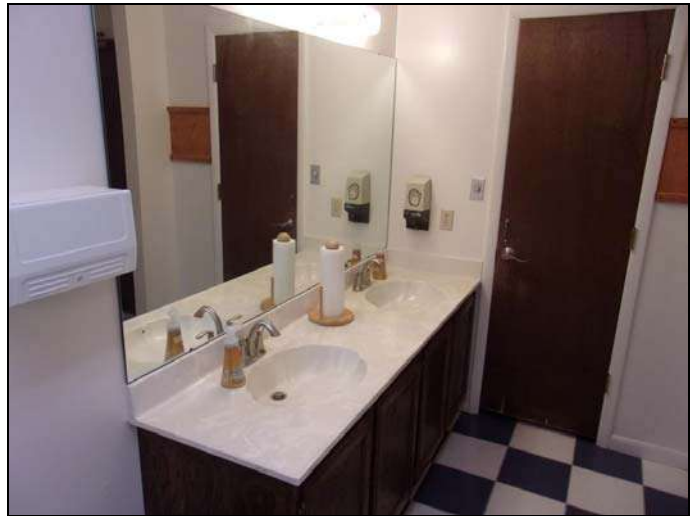
Comp #: 1413 Restrooms - Remodel

The restrooms have passed their useful life but are still in functional condition. We recommend funding to remodel this component approximately every 20 years. Remaining life based on current age and condition.

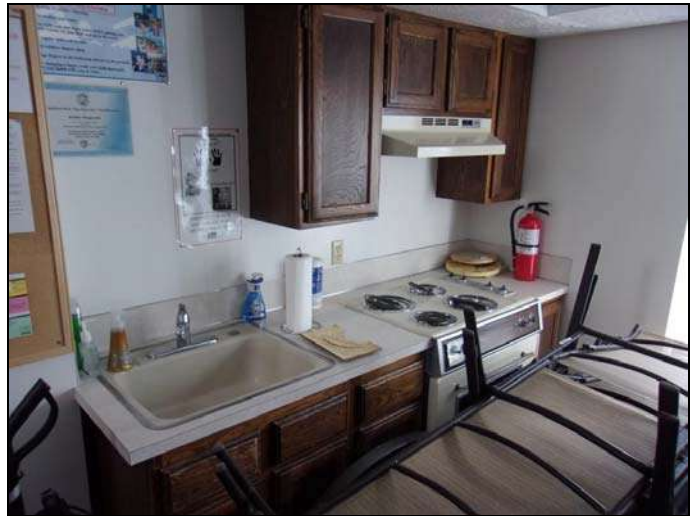
Comp #: 1417 Kitchenette - Remodel

The kitchenette has passed its useful life but is still in functional condition. We recommend funding to remodel this component approximately every 20 years. Remaining life based on current age and condition.

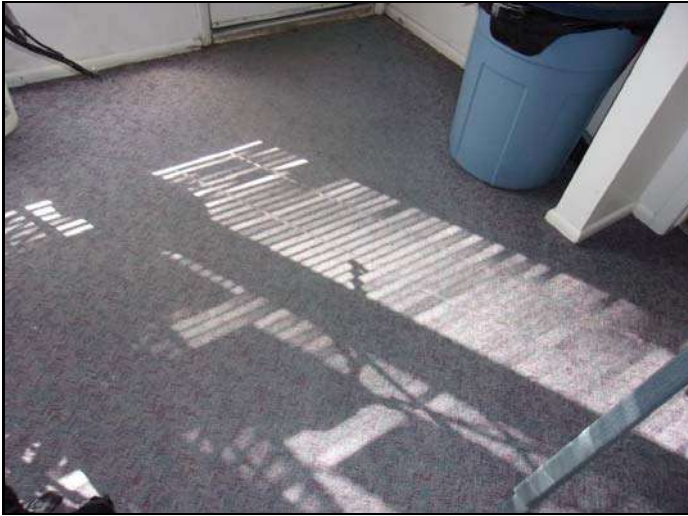
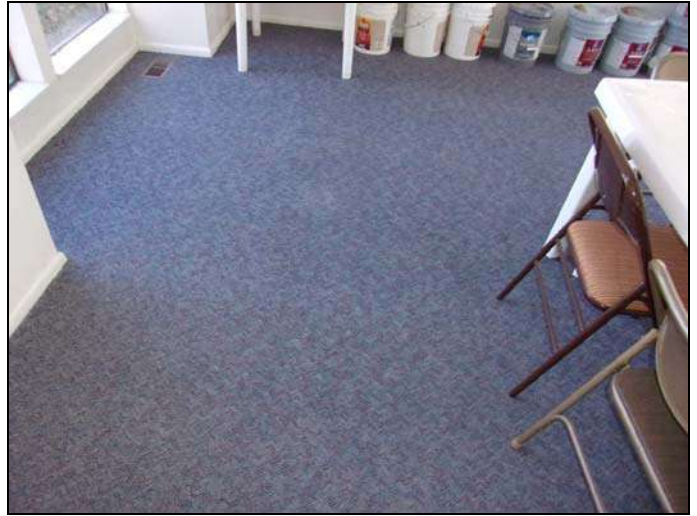
Comp #: 1501 Carpeting - Replace

The carpeting is in fair condition. We recommend funding to replace this component approximately every 8 - 10 years. Remaining life based on current age and condition.
