Spring View Farms HOA

Level 1 Reserve Study

Report prepared on – Monday, May 01, 2023

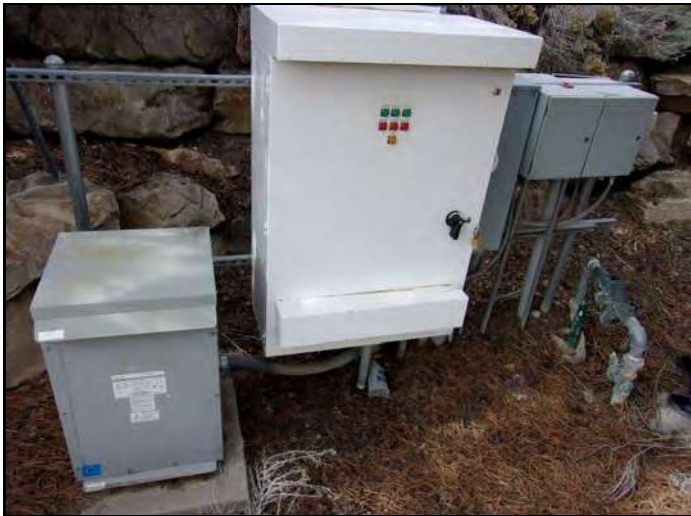
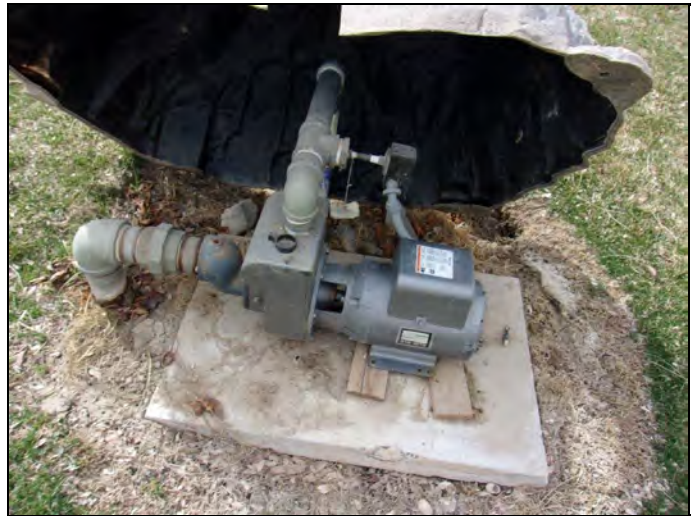
Comp #: 713 Entrance Water Pump System - Replace

The pump systems are in working condition. Research with the client reveals this component is replace every 2 - 3 years. Remaining life based on current age.

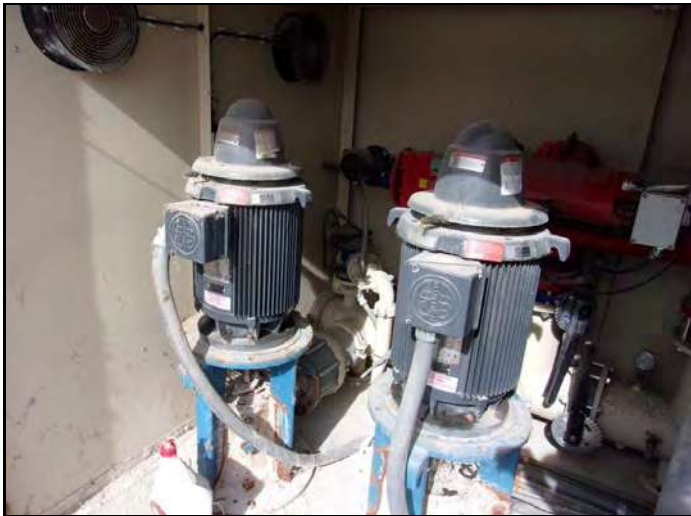
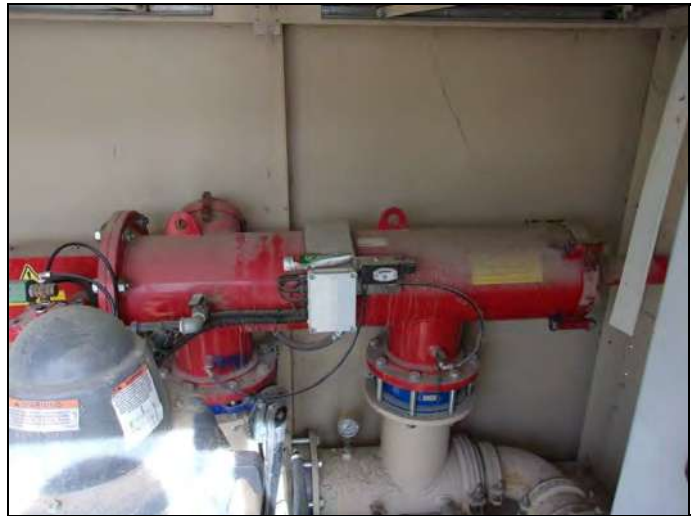
Comp #: 714 Secondary Water Pump System - East - Replace

The pumps system is in working condition. We recommend funding to replace this component approximately every 10 - 15 years. Remaining life based on current age.

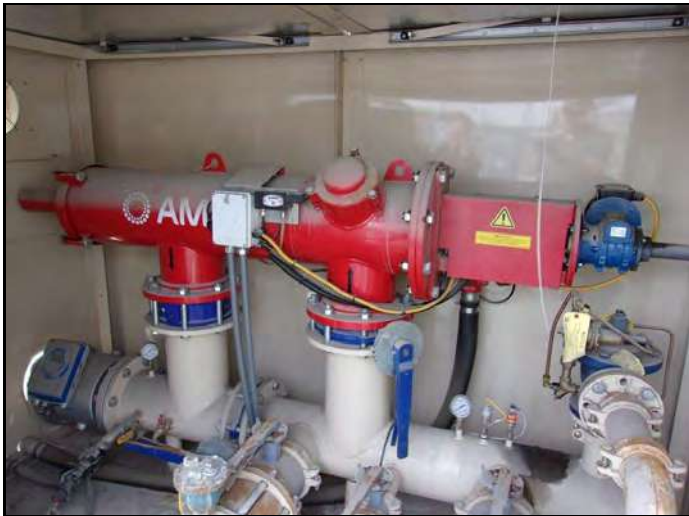
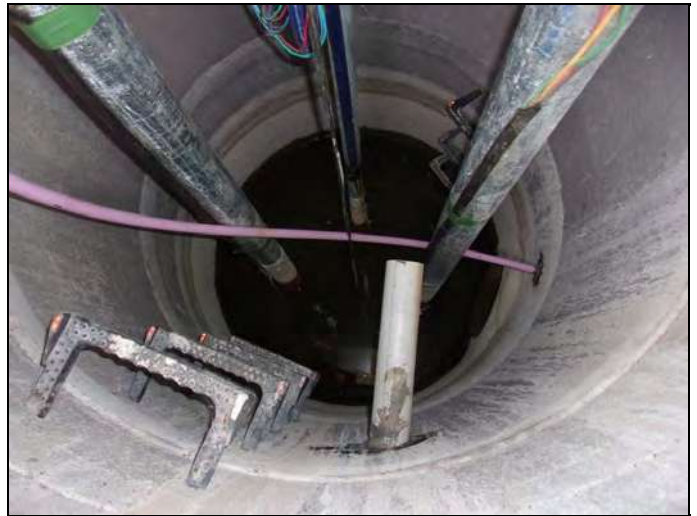
Comp #: 715 Secondary Water Pump System - West - Replace

The pumps system is in working condition. We recommend funding to replace this component approximately every 10 - 15 years. Remaining life based on current age.

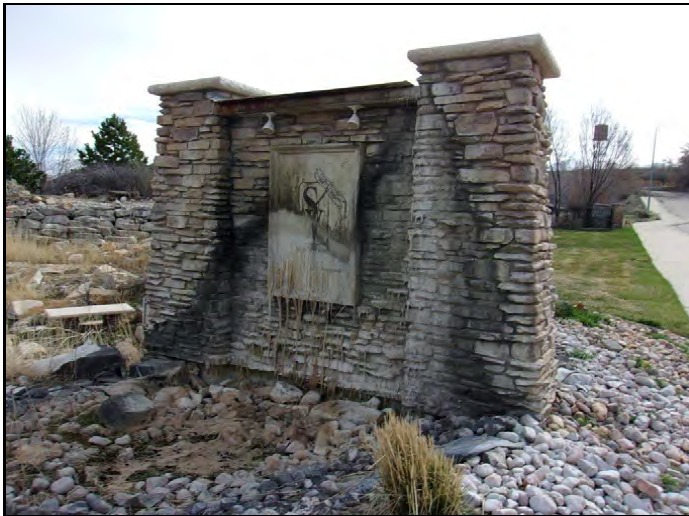
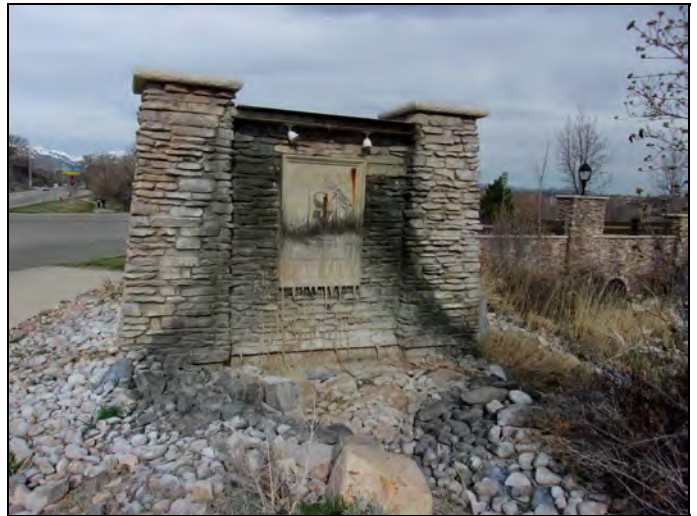
Comp #: 801 Monument Sign - Refurbish

The monument sign is in fair to poor condition. We recommend funding to refurbish this component approximately every 15 - 20 years. Remaining life is based on current age.

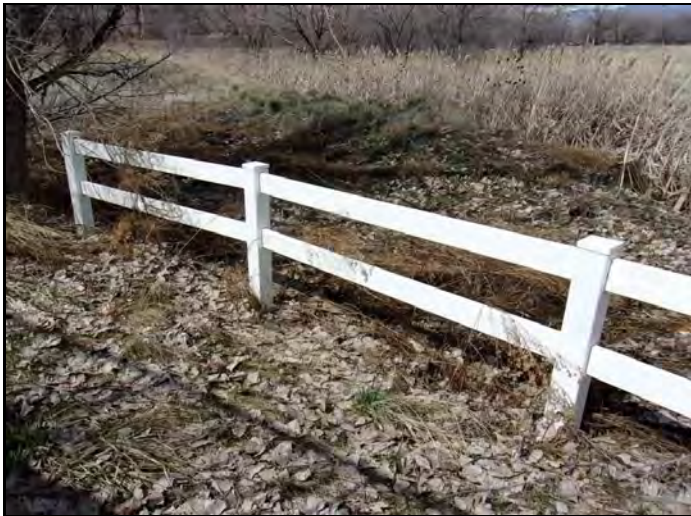
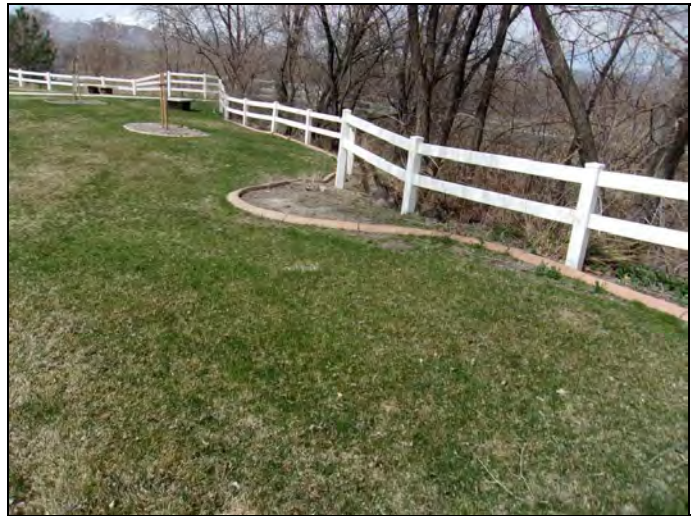
Comp #: 1008 Vinyl Rail Fencing - 2006 - Replace

The vinyl fencing is in good to fair condition. We recommend funding to replace this component approximately every 25 - 30 years. Remaining life based on current age.

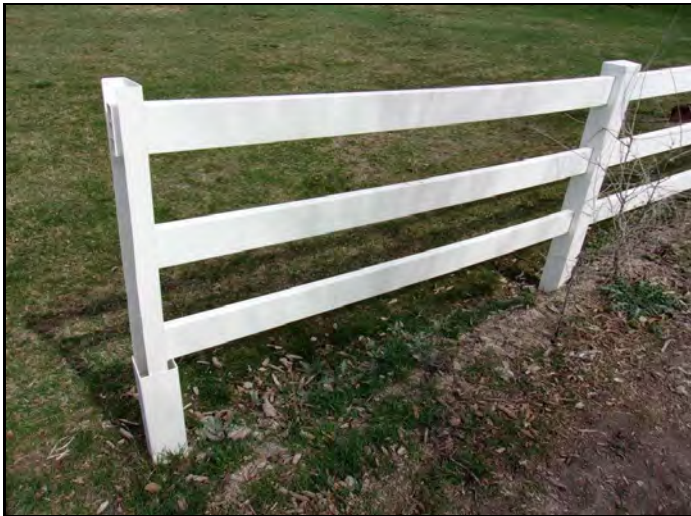
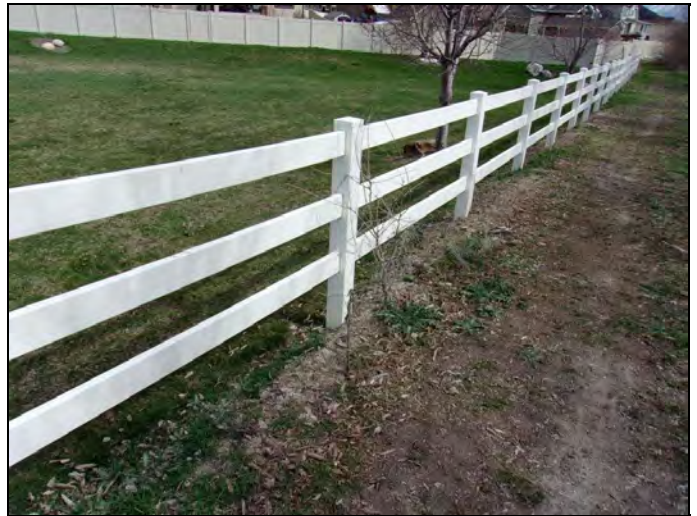
Comp #: 1008 Vinyl Rail Fencing - 2014 - Replace

The vinyl fencing is in good to fair condition. We recommend funding to replace this component approximately every 25 - 30 years. Remaining life based on current age.

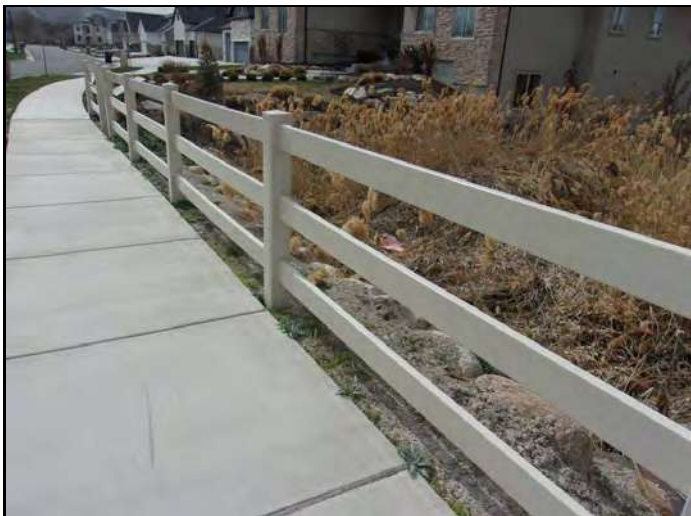
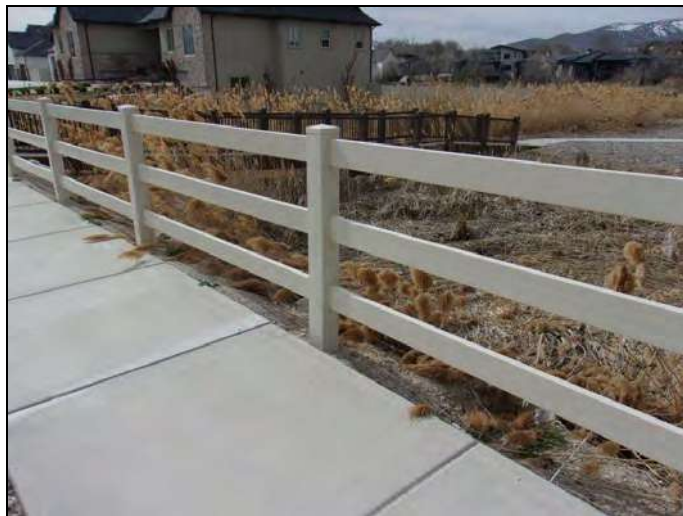
Comp #: 1008 Vinyl Rail Fencing - 2018 - Replace

The vinyl fencing is in good condition. We recommend funding to replace this component approximately every 25 - 30 years. Remaining life based on current age.

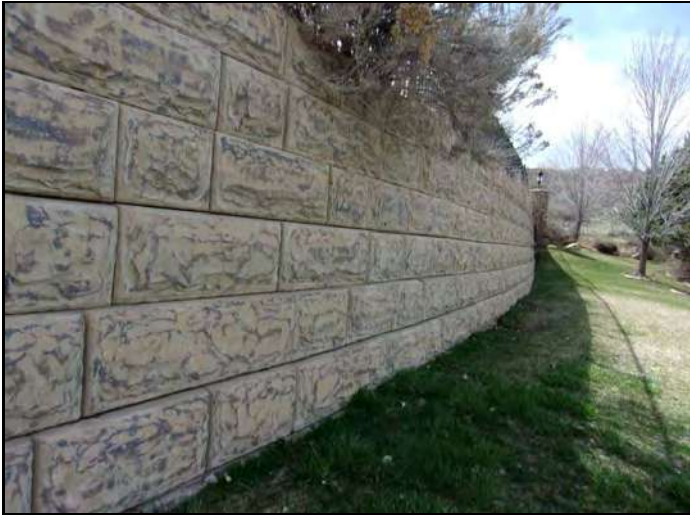
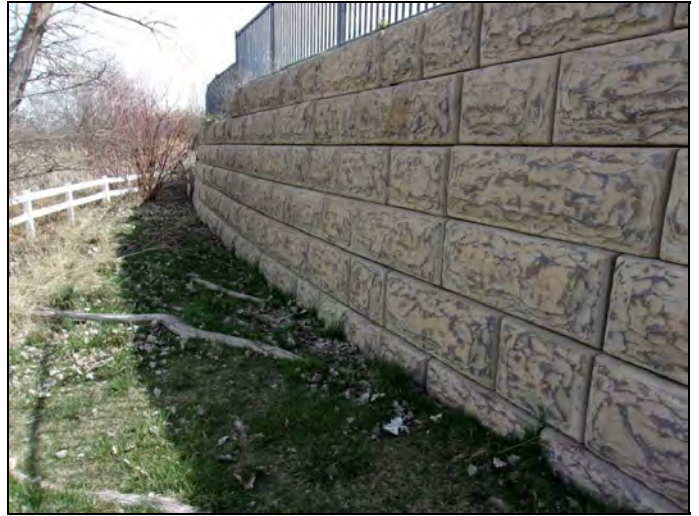
Comp #: 1011 Retaining Wall - Replace

This component has an extended useful life. Make repairs as necessary as an operating expense. No reserve funding necessary.

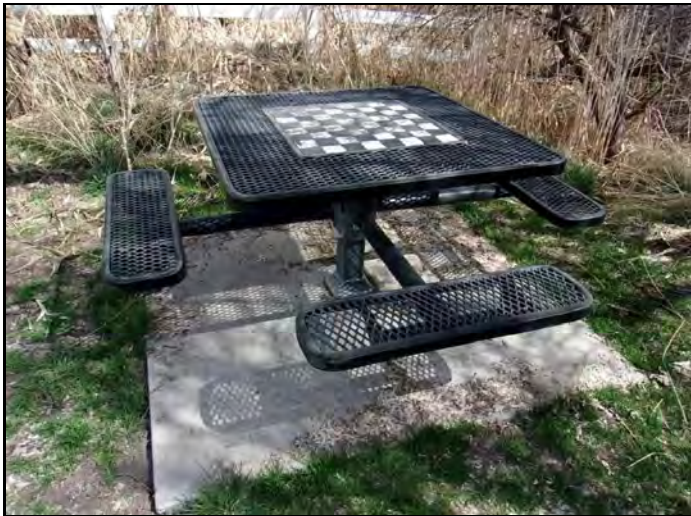
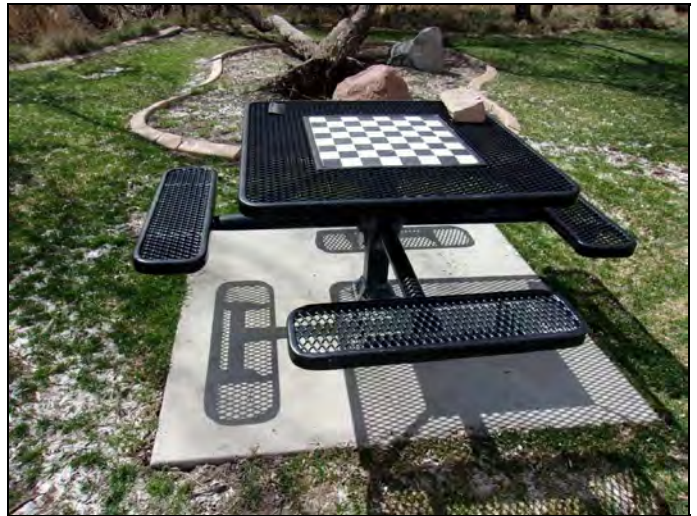
Comp #: 1306 Picnic Tables - 2006 - Replace

The picnic tables are in fair condition. We recommend funding to replace this component approximately every 10 - 15 years. Remaining life based on current age and condition.

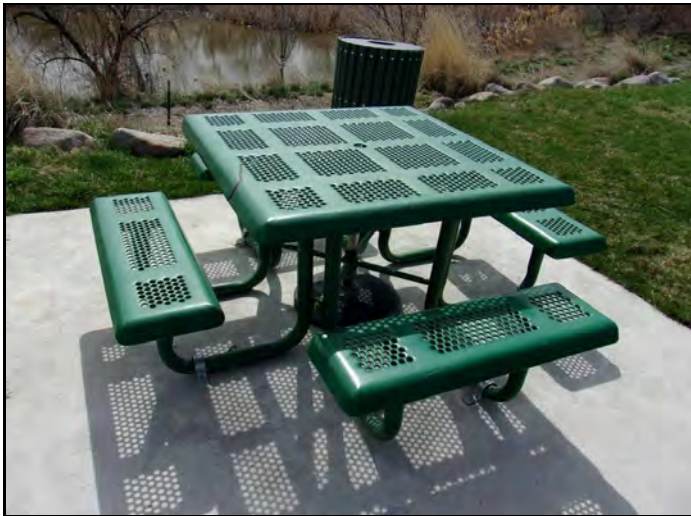
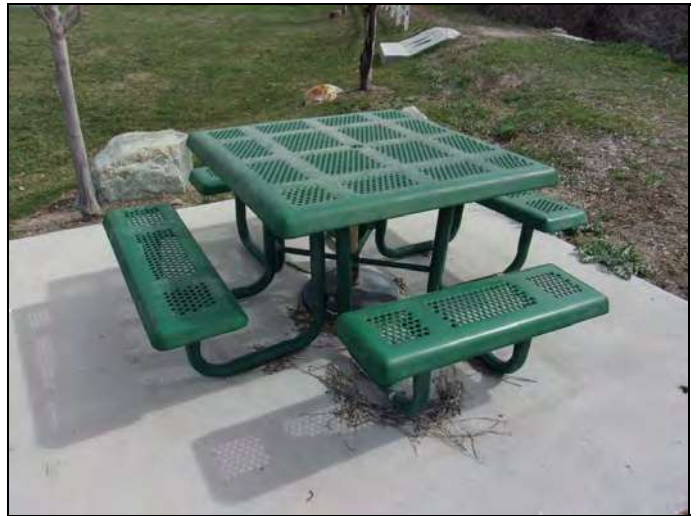
Comp #: 1306 Picnic Tables - 2014 - Replace

The picnic tables are in fair to poor condition. We recommend funding to replace this component approximately every 10 - 15 years. Remaining life based on current age and condition.

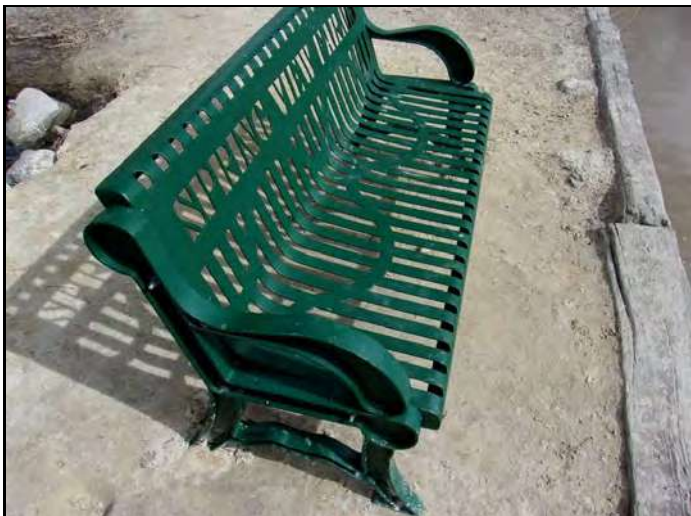
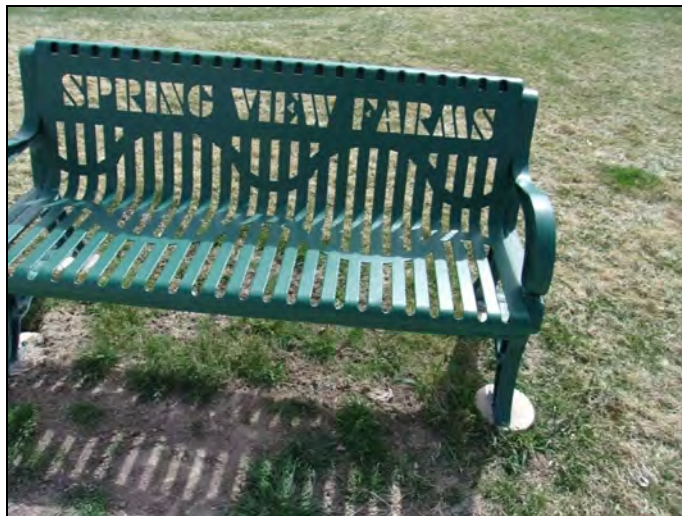
Comp #: 1307 Metal Benches - Replace

The benches are in good condition. We recommend funding to replace this component approximately every 15 - 20 years. Remaining life based on current age.

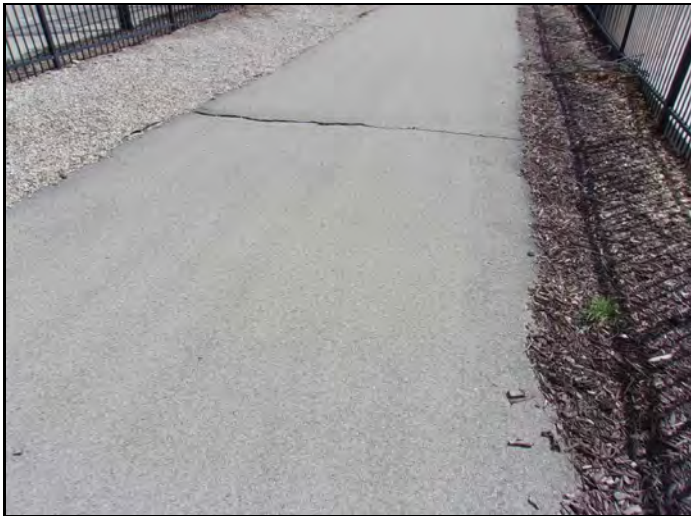
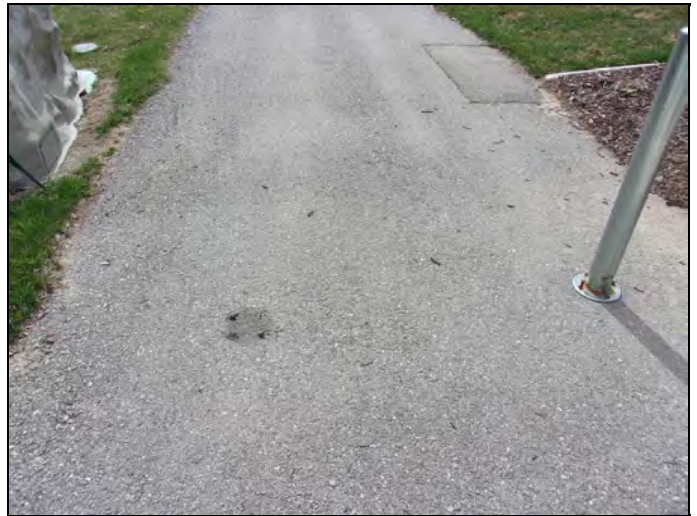
Comp #: 1312 Asphalt Trails - Repair/Seal

The asphalt trail repair/seal is in poor condition. We recommend funding to repair/seal this component approximately every 6 years. Remaining life based on current condition.

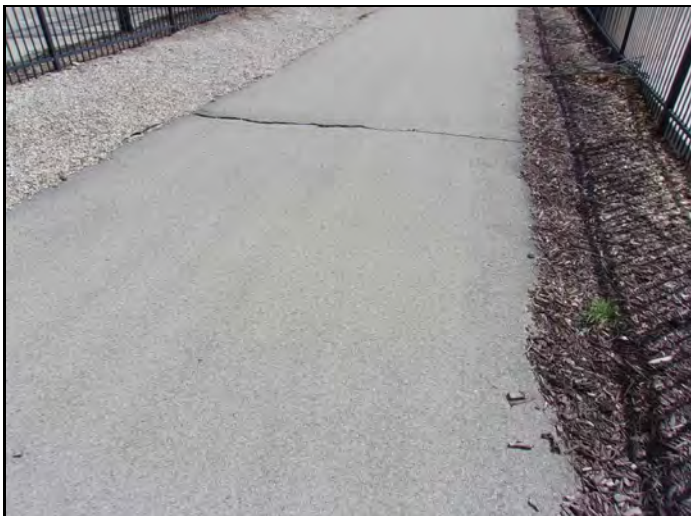
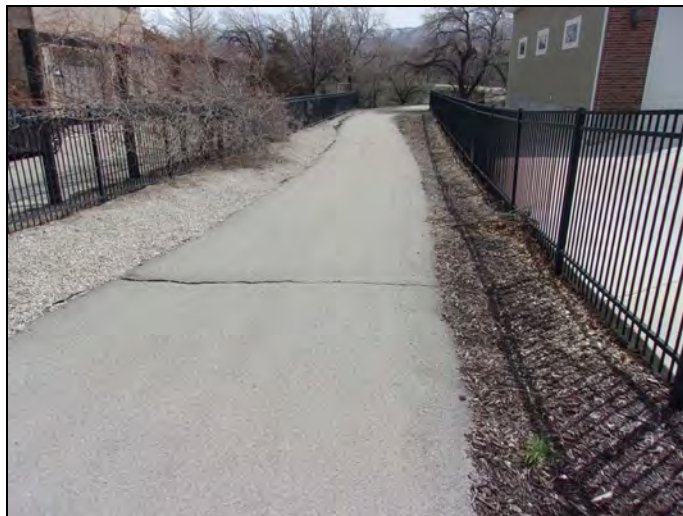
Comp #: 1390 Asphalt Trails - 2005 - Replace

The asphalt trail is in fair condition. We recommend funding to replace this component approximately every 25 - 30 years. Remaining life based on current age.

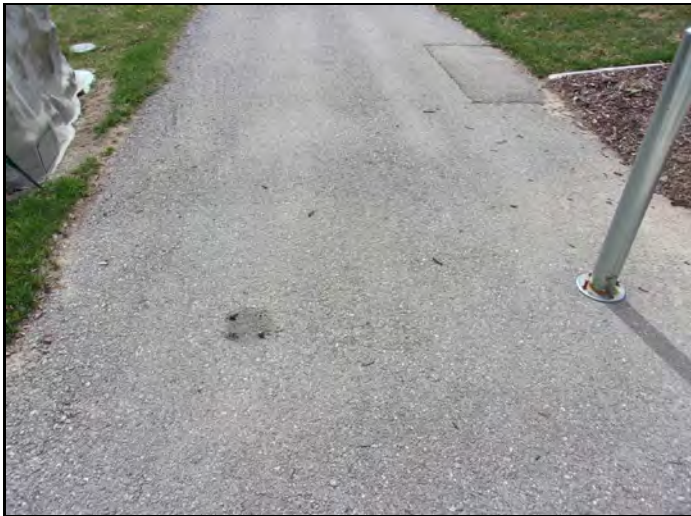
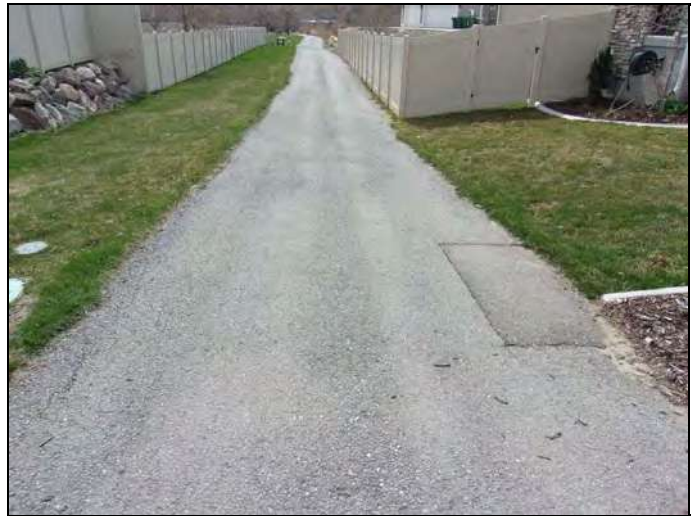
Comp #: 1390 Asphalt Trails - 2014 - Replace

The asphalt trail is in fair condition. We recommend funding to replace this component approximately every 25 - 30 years. Remaining life based on current age.

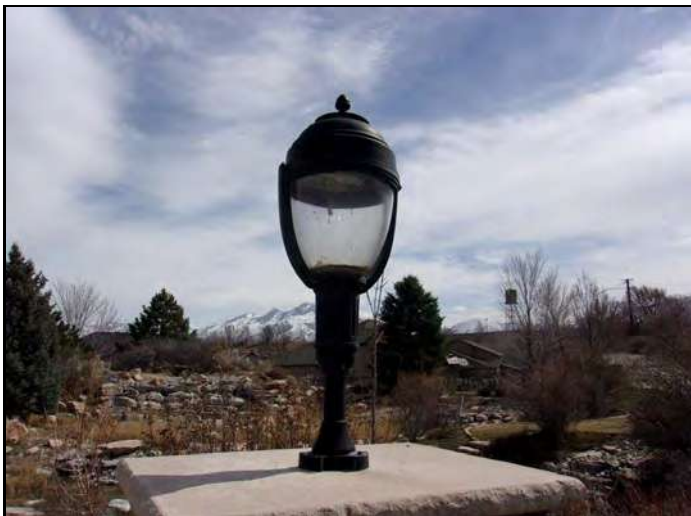
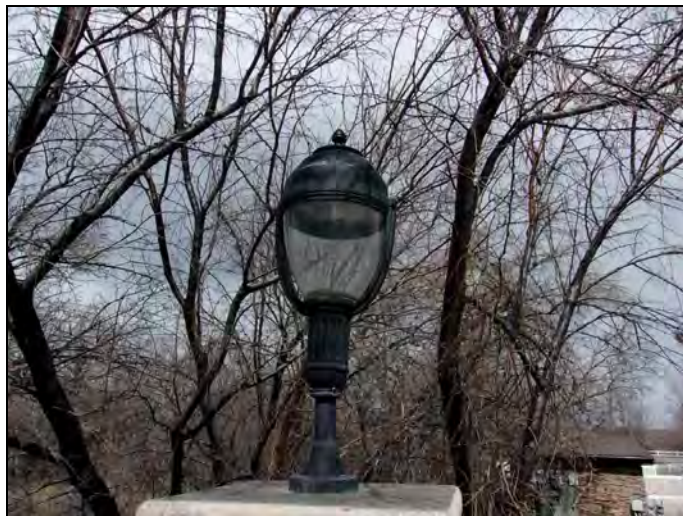
Comp #: 1602 Exterior Light Fixtures - Replace

The exterior light fixtures are in fair condition. We recommend funding to replace this component approximately every 16 - 20 years. Remaining life based on current age.

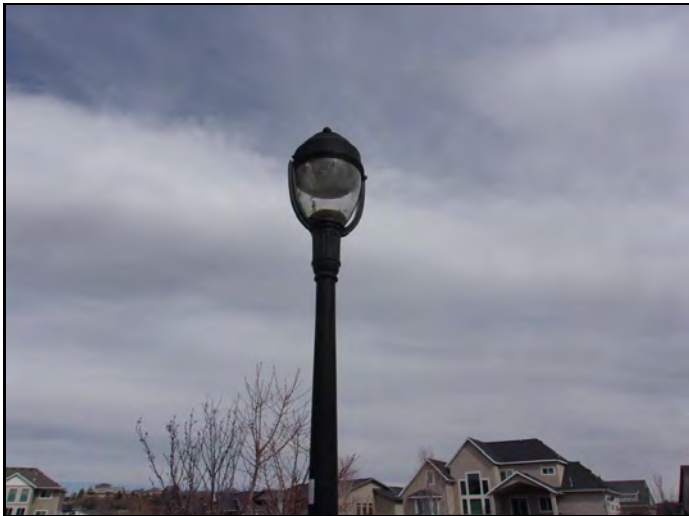
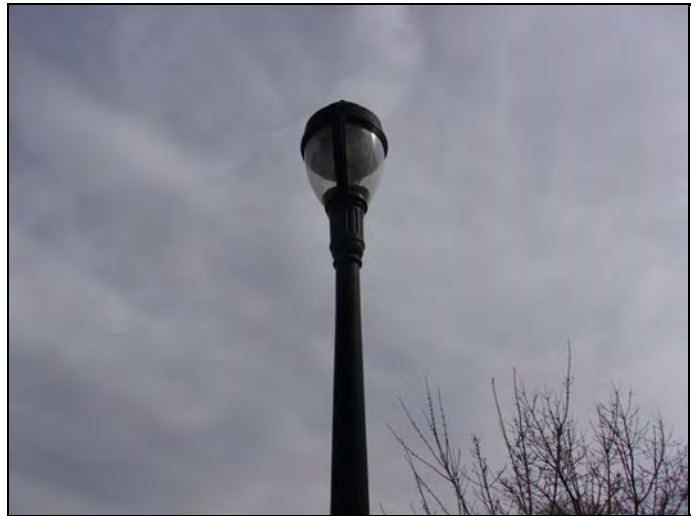
Comp #: 1604 Pole Lights - Replace

The pole light is in good condition. We recommend funding to replace these pole light fixtures, poles and to refurbish the electrical approximately every 16 - 20 years. Remaining life based on current age.

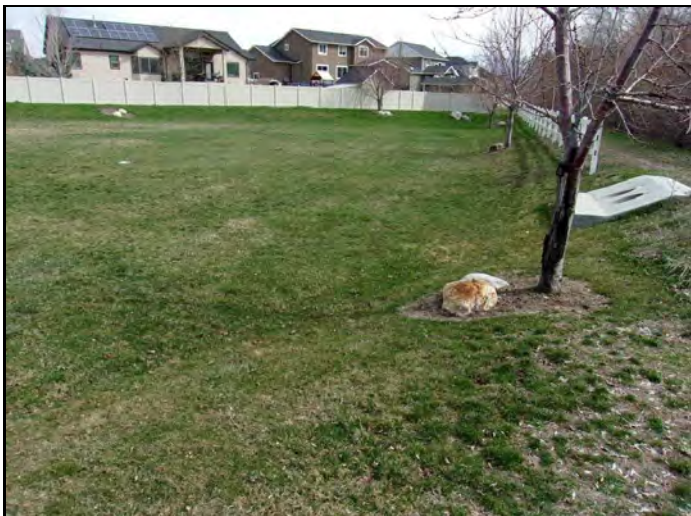
Comp #: 1812 Landscaping & Irrigation System - Renovate

The landscaping and irrigation system are in fair condition. We recommend funding for an allowance to renovate this component approximately every 20 years. Remaining life based on current age.

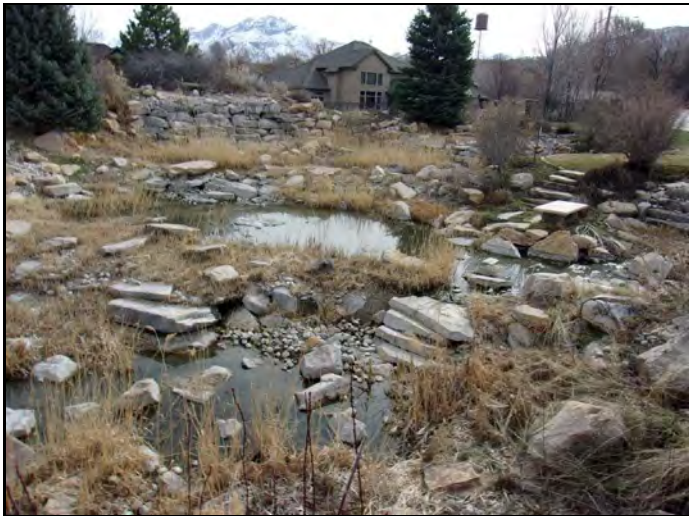
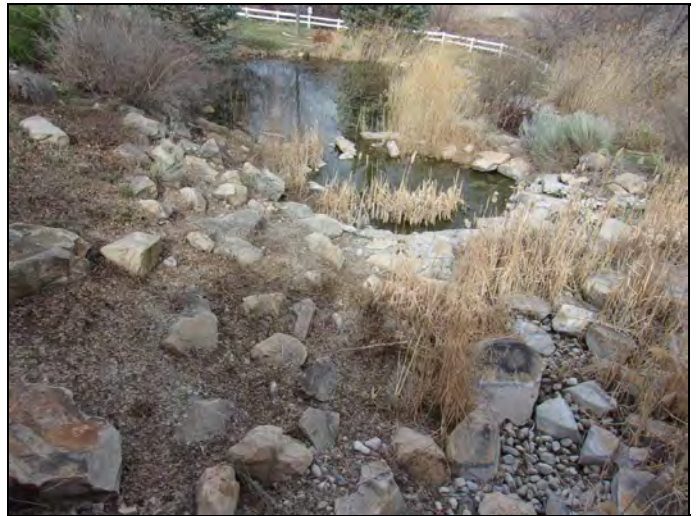
Comp #: 2201 Entrance Pond Liner - East - Replace

The ponds appear to be in good to fair condition. We recommend funding to replace this component approximately every 30 years. Remaining life based on current age.

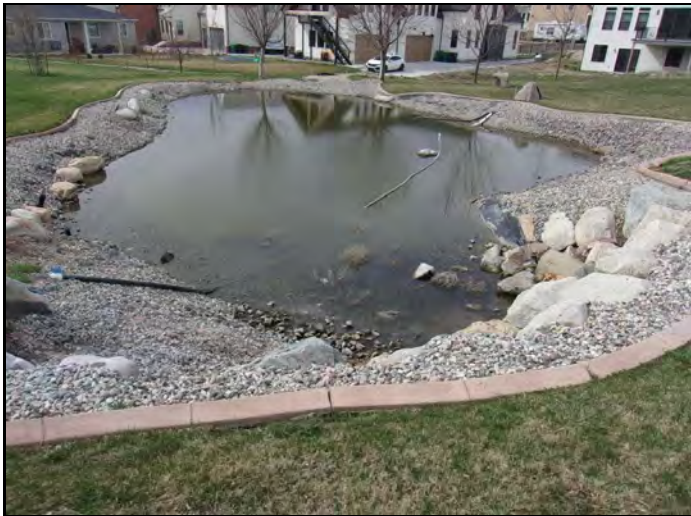
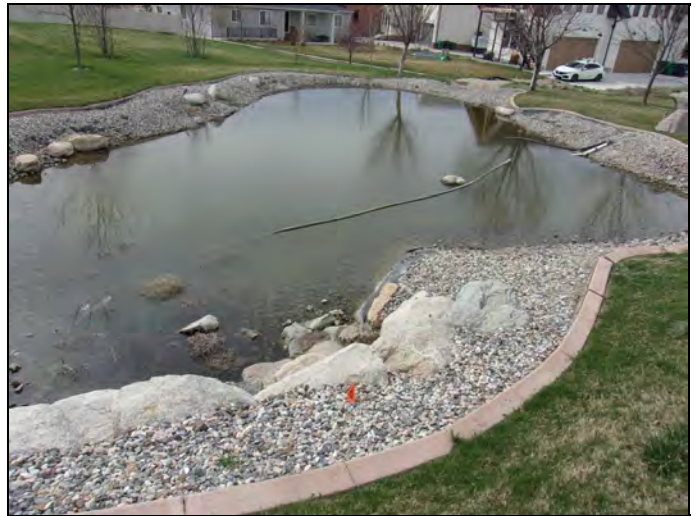
Comp #: 2201 Entrance Pond Liner - West - Replace

The pond appears to be in good condition. We recommend funding to replace this component approximately every 30 years. Remaining life based on current age.

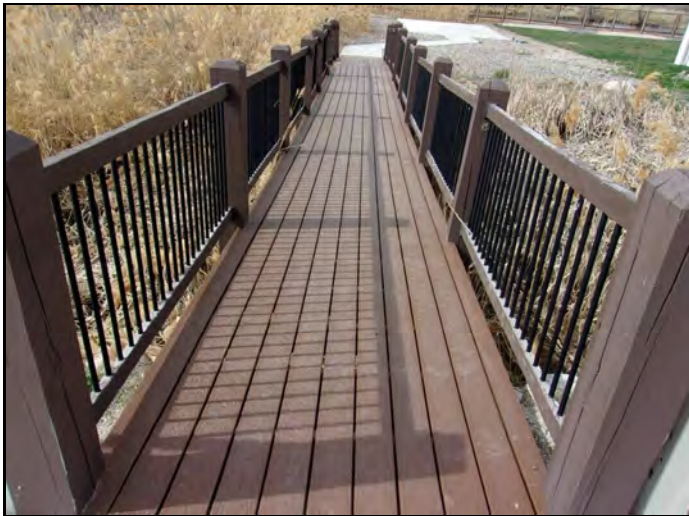
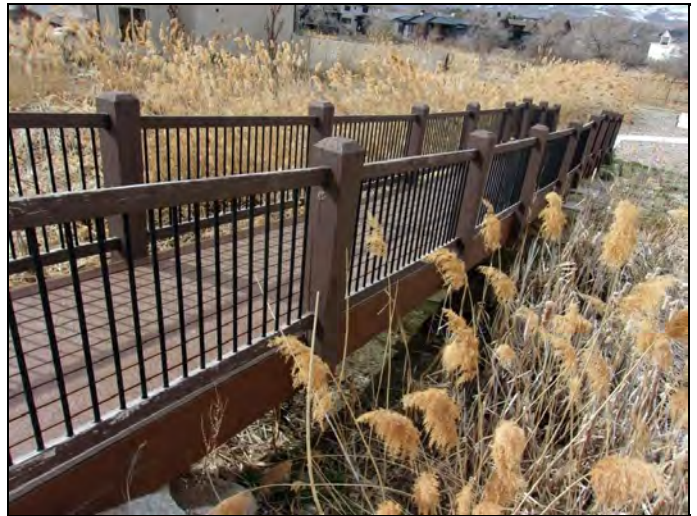
Comp #: 2302 Bridge - Bird Refuge - Replace

The bridge appears to be in good condition. We recommend funding to replace this component approximately every 20 - 30 years. Remaining life based on current age.

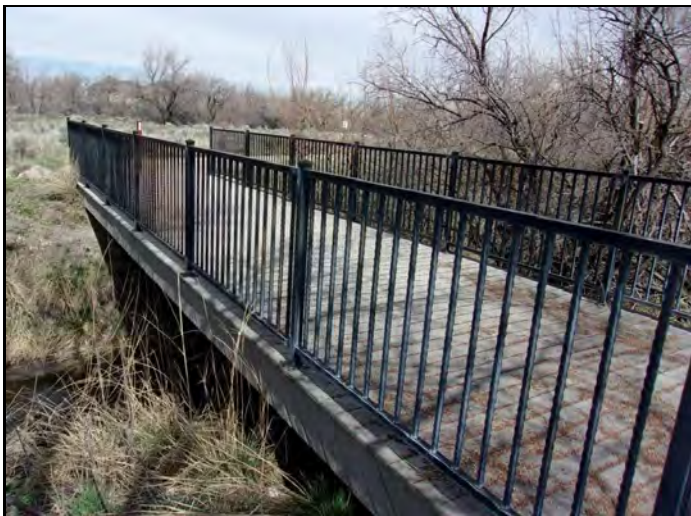
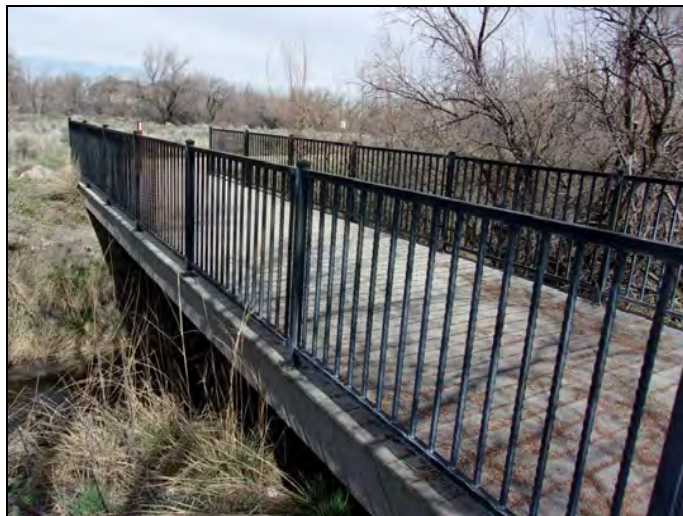
Comp #: 2302 Bridge - Spring View - Replace

The bridge appears to be in fair condition. We recommend funding to replace this component approximately every 20 - 30 years. Remaining life based on current age.
