# Millstone Manor Condo Association

## Level 2 Reserve Study

**Report Period – 01/31/2026 – 12/31/2026**

## Executive Summary – Millstone Manor Condo Association – ID # 10612

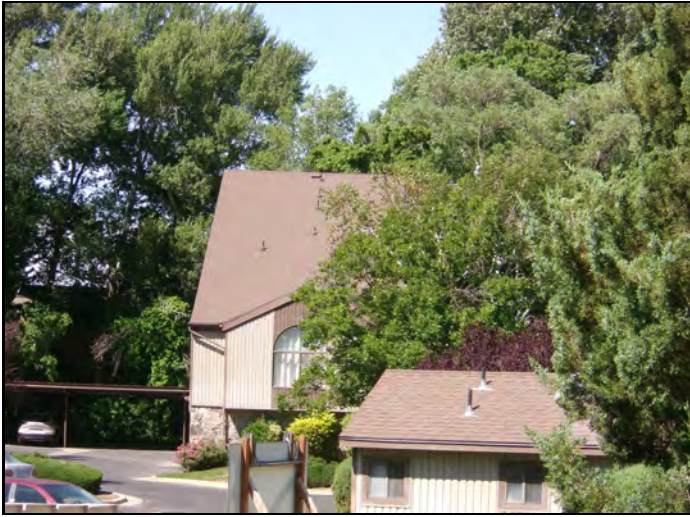
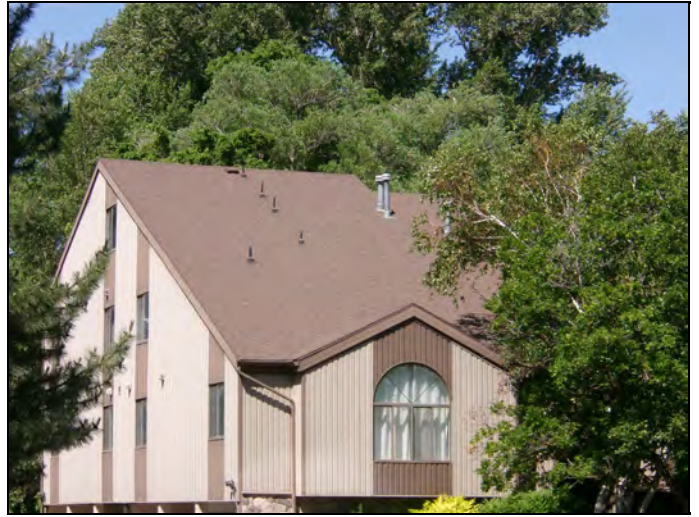
Comp #: 105    Roofs - Bldgs 1 - Replace

*Location:*            **Building Roofs**

Research with the client reveals this component will be completed in 2026. We recommend funding to replace this component approximately every 20 - 25 years. Remaining life based on current age.

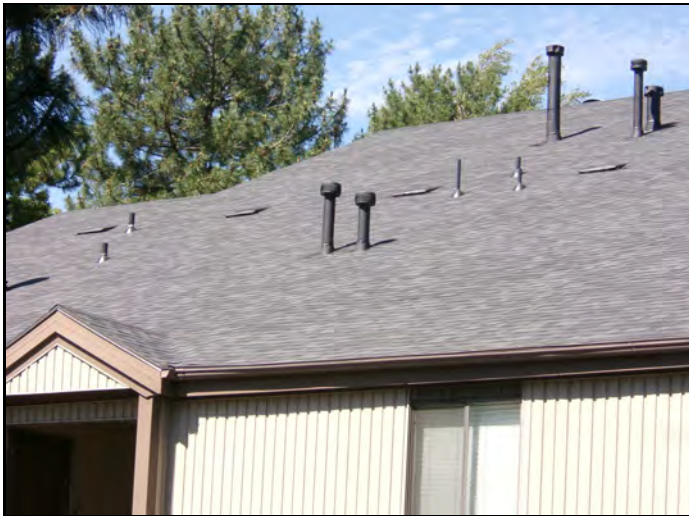
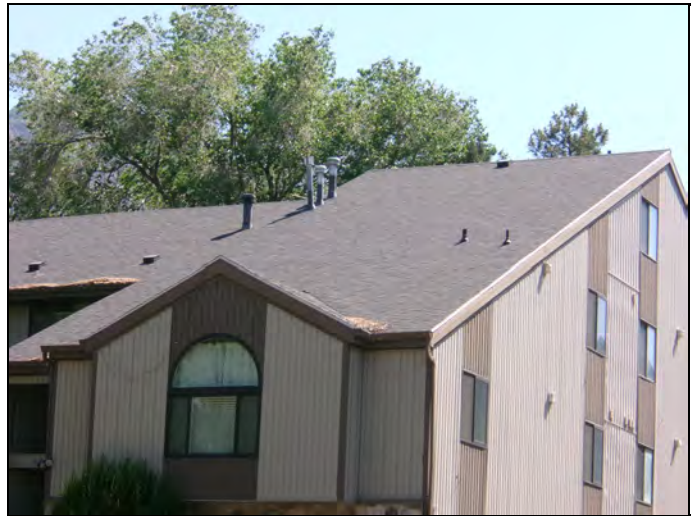
Comp #: 105    Roofs - Bldgs 2 - Replace

*Location:*            **Building Roofs**

Research with the client reveals this component was completed in 2025. We recommend funding to replace this component approximately every 20 - 25 years. Remaining life based on current age.

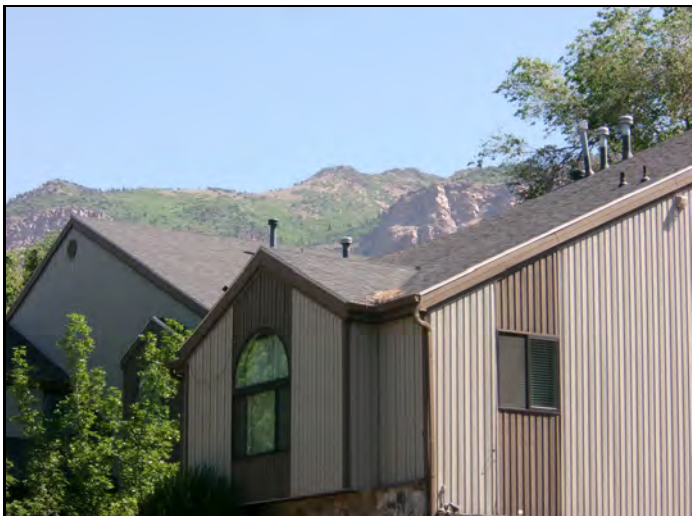
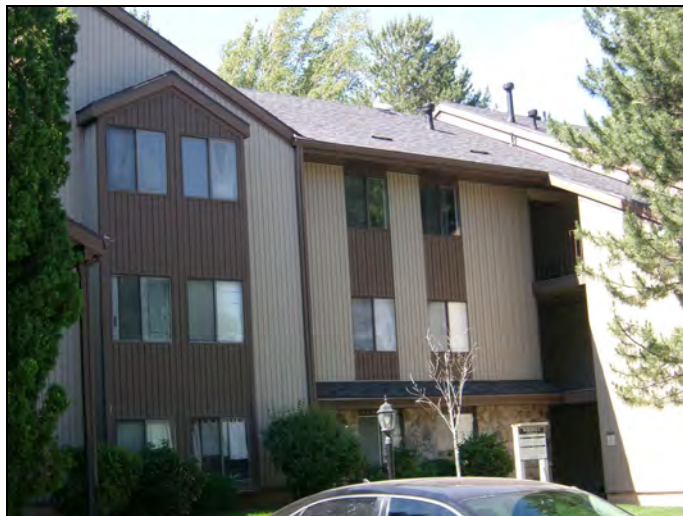
Comp #: 105    Roofs - Bldgs 3 & 4 - Replace

The roofs appear to be in good condition. We recommend funding to replace this component approximately every 20 - 25 years. Remaining life based on current age.

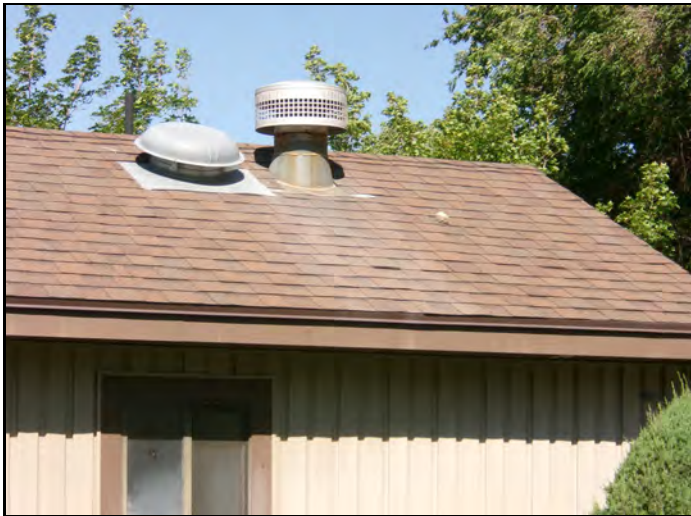
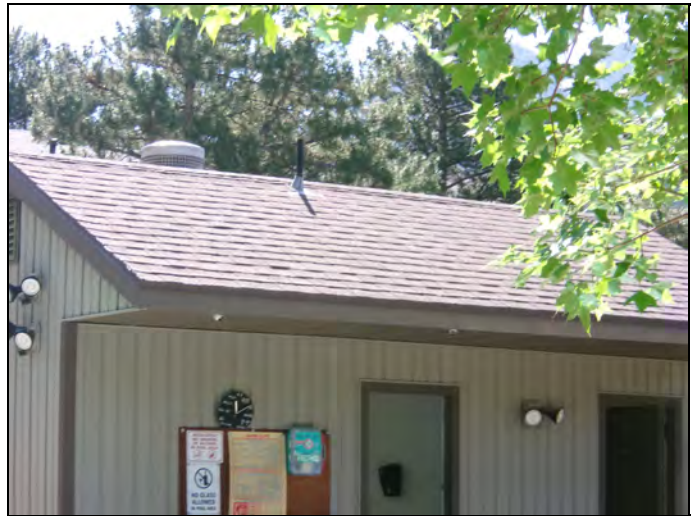
Comp #: 105    Roofs - Pool - Replace

*Location:*            **Pool Building Roof**

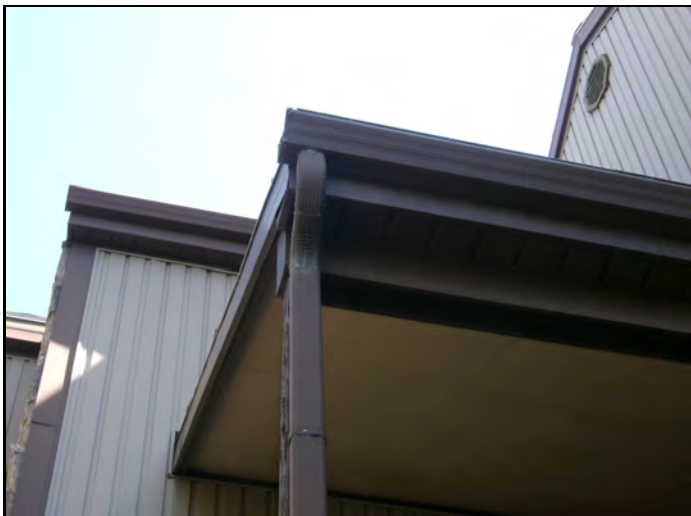
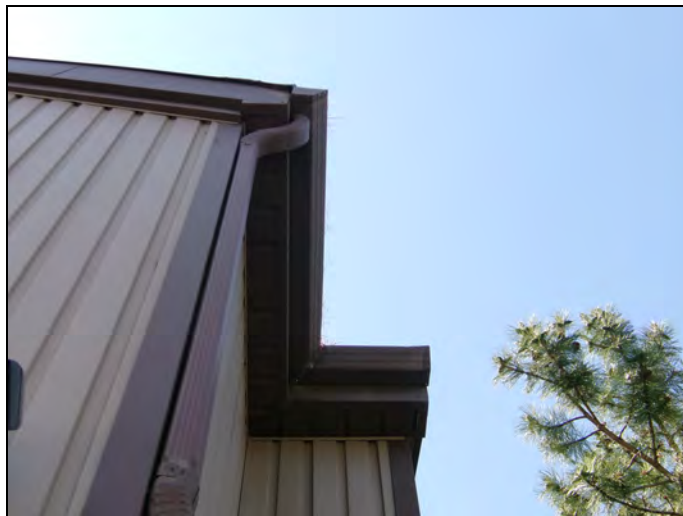
Comp #: 120 Rain Gutters/Downspouts - Replace

*Location:* **Building Roofs**

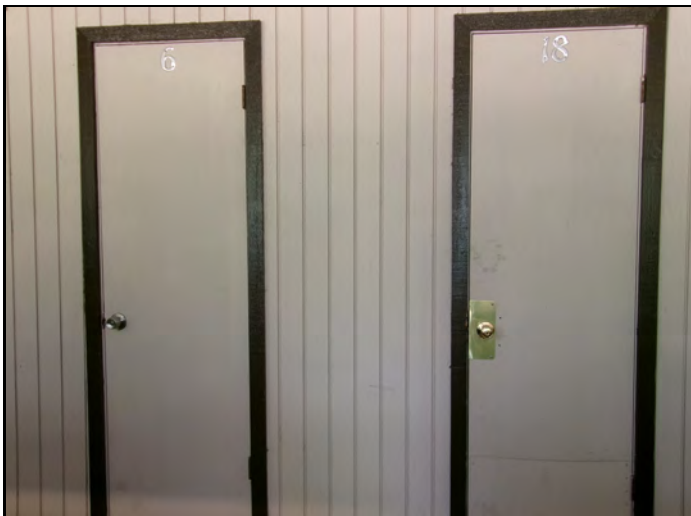
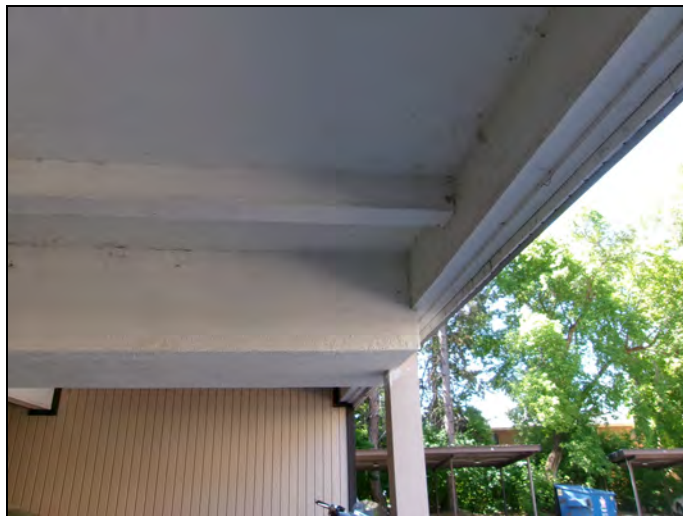
Comp #: 203 Garage Surfaces - Repair/Repaint

*Location:* **Garage Interiors**

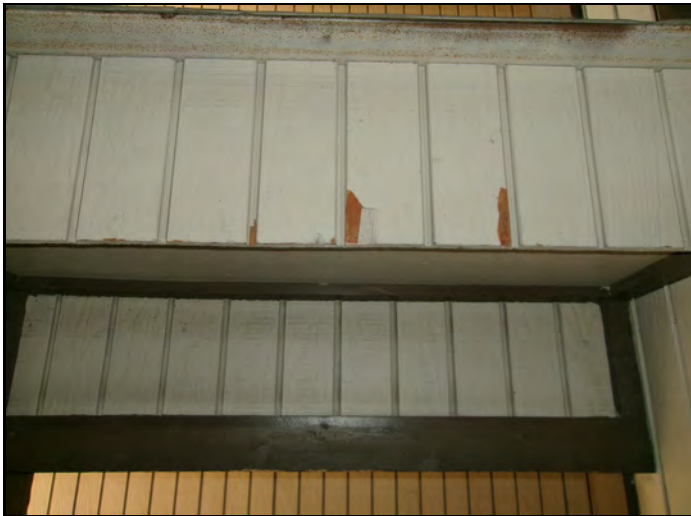
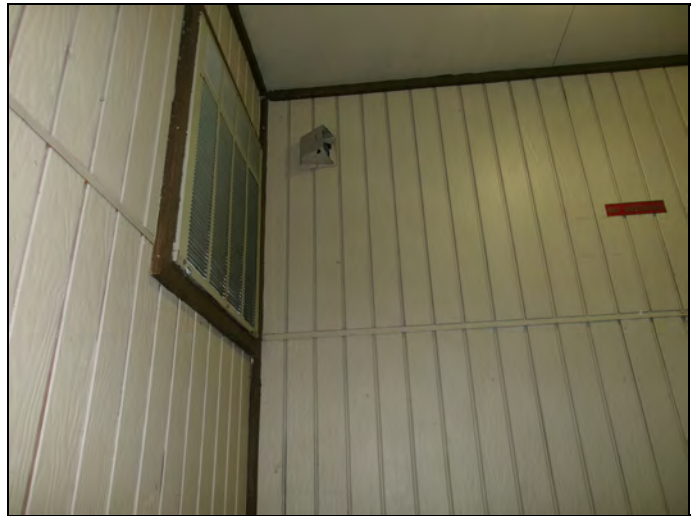
Comp #: 215 Breezeways & Stairwells - Repair/Repaint

*Location:* **Breezeways, Stairwells & Pool Building**

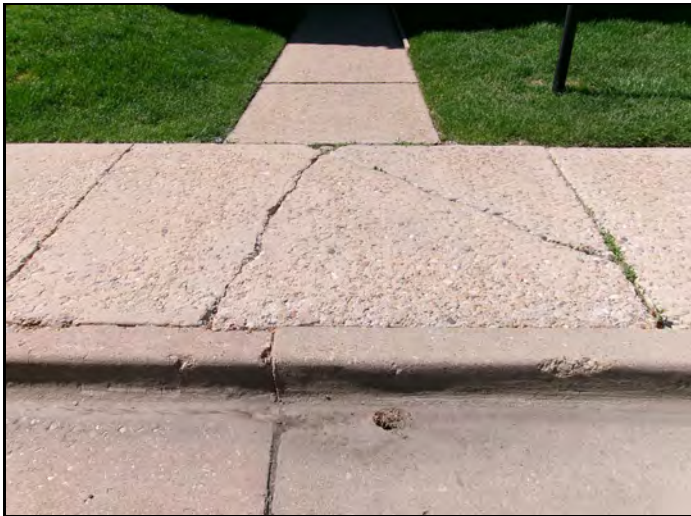
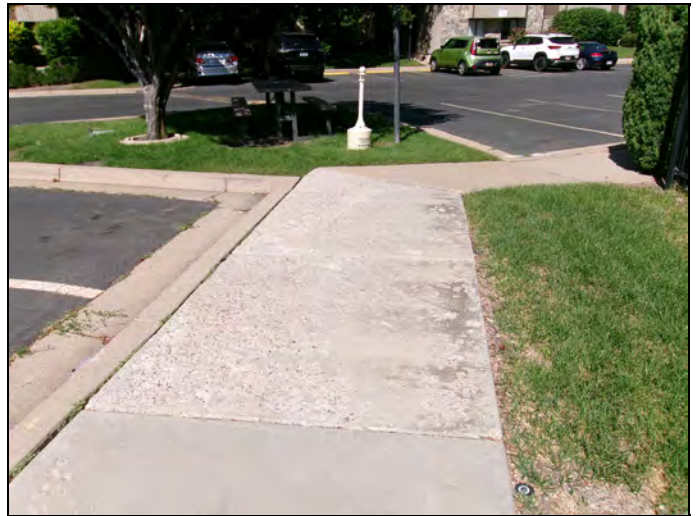
Comp #: 403 Concrete - Repair/Replace

*Location:* **Garages, Pool Deck & Sidewalks**

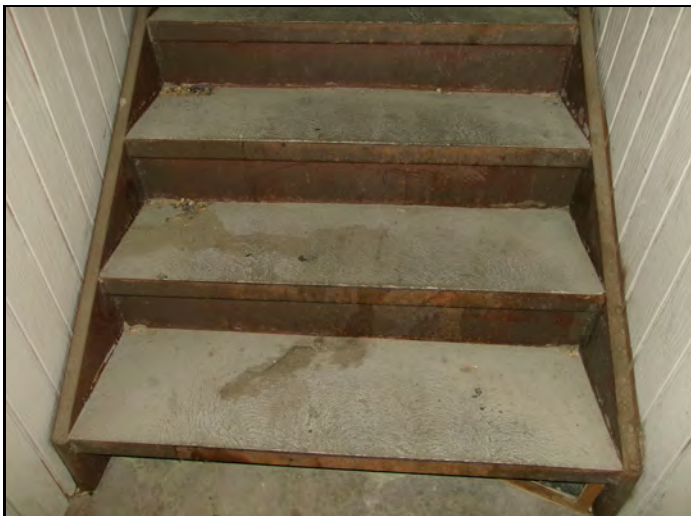
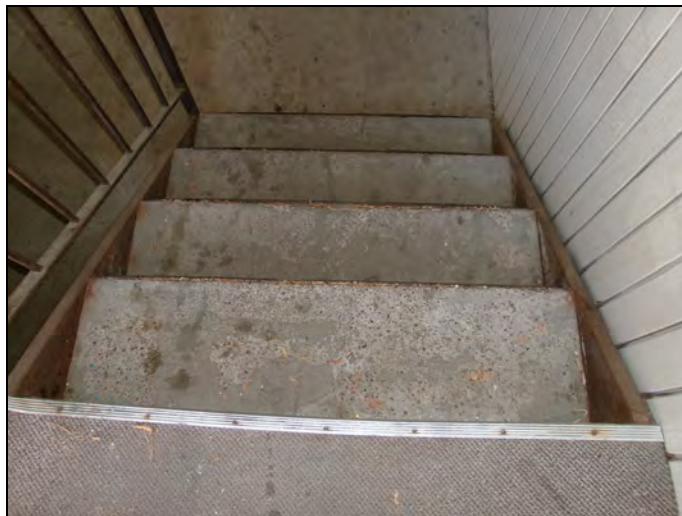
Comp #: 690 Stair Treads - Replace

*Location:* **Building Stairwells**

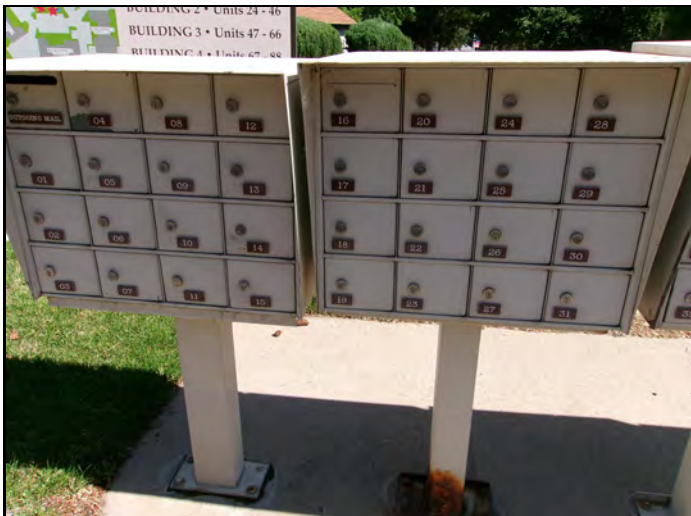
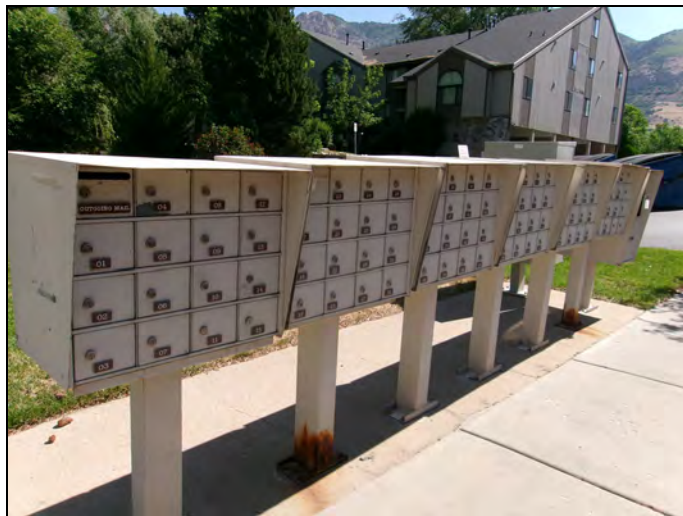
## Comp #: 803 Mailboxes - Replace

Typically these mailboxes are owned and maintained by the postal service. No reserve funding necessary.
