# **The Terraces at Holladay Condominiums**

## **Level 2 Reserve Study**

**Report Period – 01/01/2025 – 12/31/2025**

| <b>Date of Property Inspection</b> | <b>7/17/2024</b> |

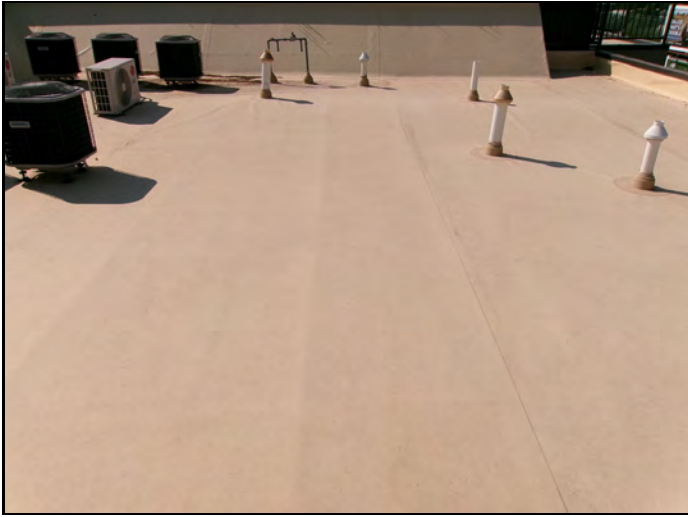
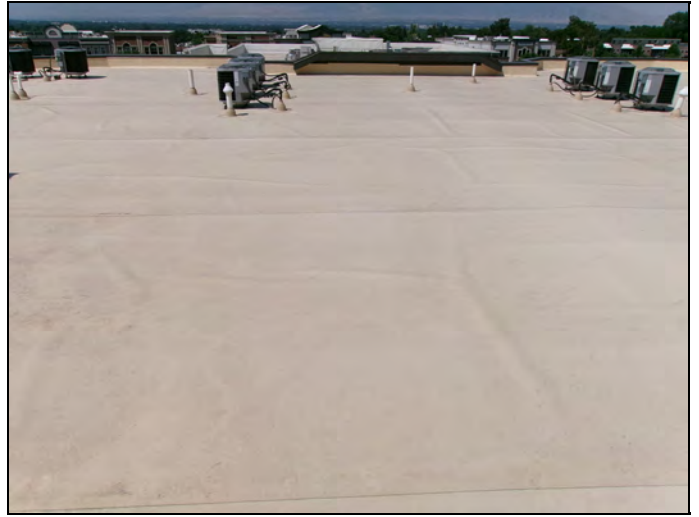
Comp #: 104 Flat Roofs - Replace

The flat roofs appear to be in good condition. We recommend funding to replace this component approximately every 20 - 25 years. Remaining life based on current age.

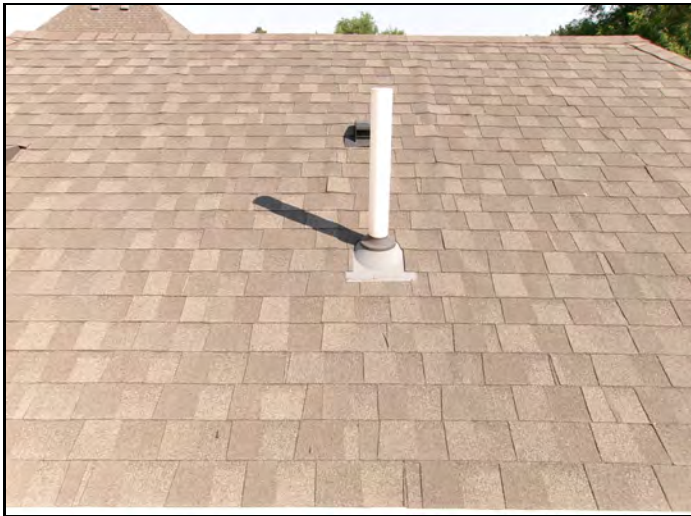
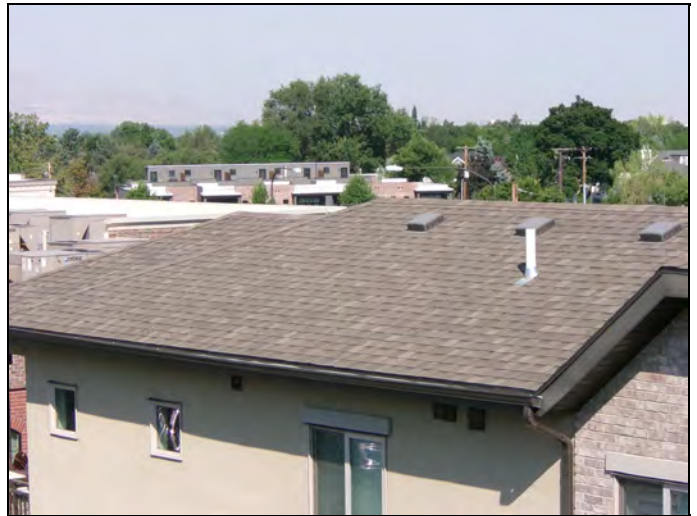
Comp #: 105 Shingle Roofs - Replace

The roofs appear to be in good condition. We recommend funding to replace this component approximately every 20 - 25 years. Remaining life based on current age.

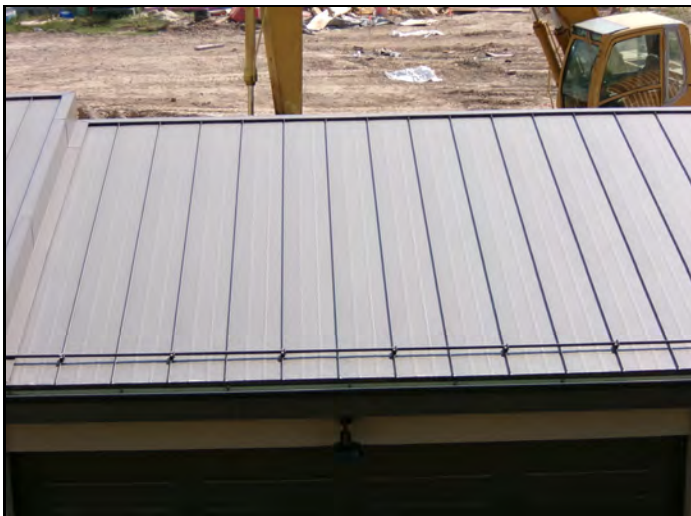
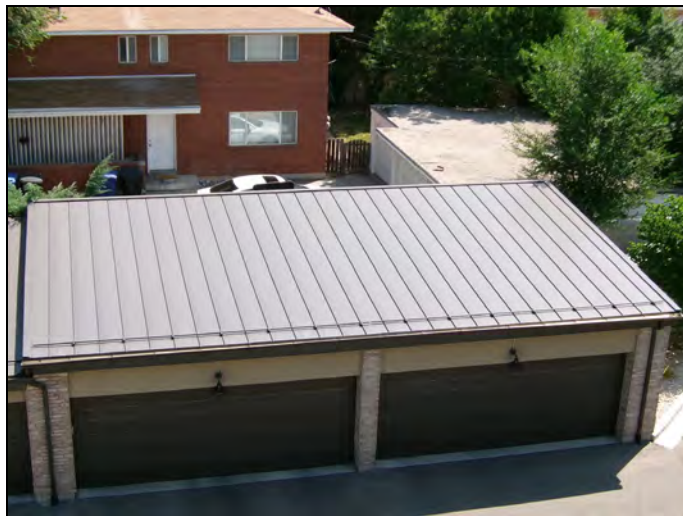
Comp #: 108 Metal Roofs - Replace

The metal roofs are in good condition. We recommend funding to replace this component approximately every 50 - 60 years. Remaining life based on current age.

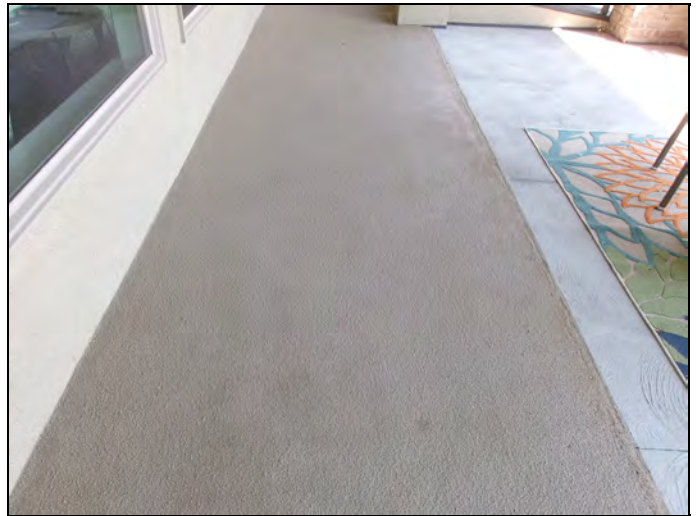
Comp #: 604 Walkways - 3rd Floor - Resurface

The walkway surfaces are in good condition. We recommend funding to resurface this component approximately every 15 - 20 years. Remaining life based on current age.

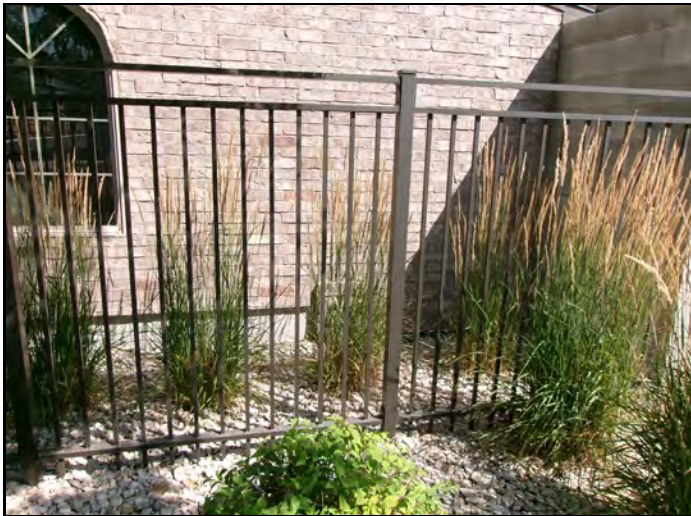
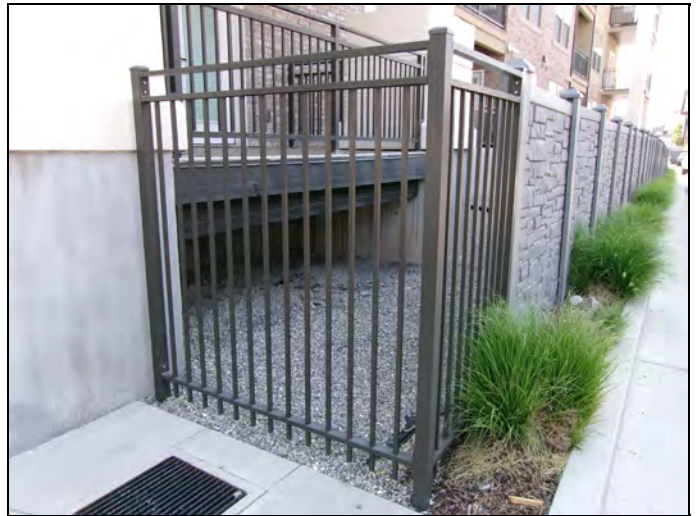
## Comp #: 1002 Metal Fencing - Replace

The metal fencing is in good condition. We recommend funding to replace this component approximately every 40 - 50 years. Remaining life based on current age.

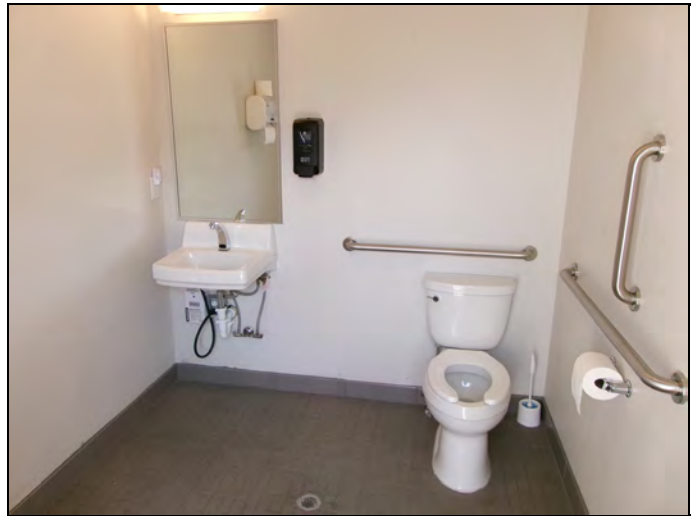
## Comp #: 1413 Restroom - Remodel

The restroom is in in good to fair condition. We recommend funding to remodel this component approximately every 20 years. Remaining life based on current age.

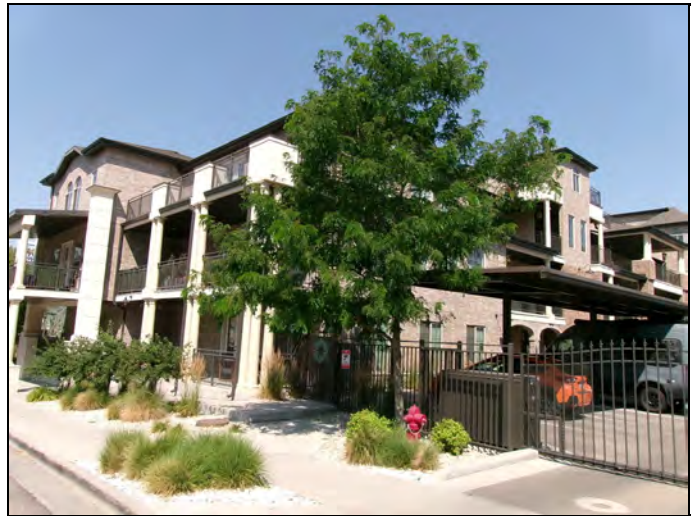
## Comp #: 1812 Landscaping & Irrigation System - Renovate

The landscaping and irrigation system are in good condition. We recommend funding for an allowance to renovate the landscaping and irrigation system approximately every 20 years. Remaining life based on current age.

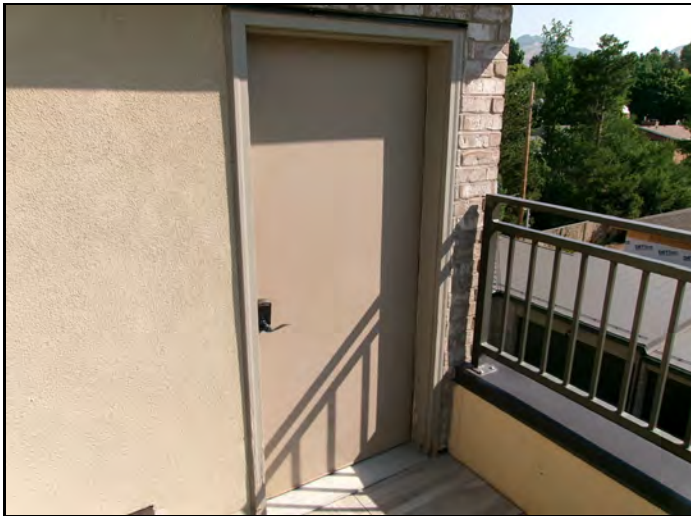
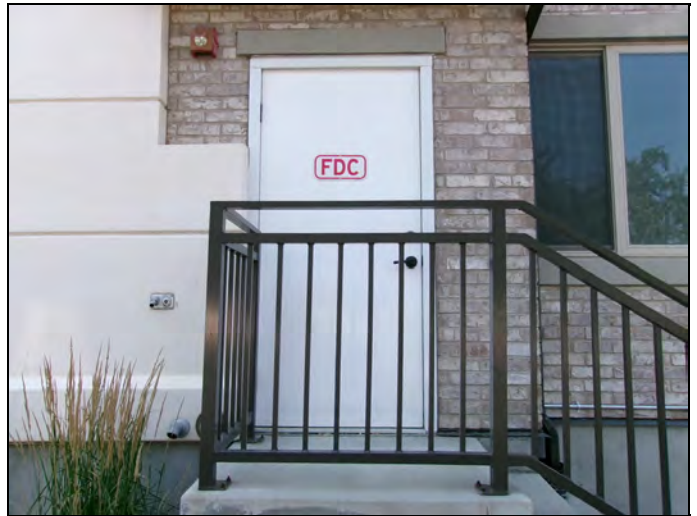
## Comp #: 2304 Exterior Doors - Replace

The doors are in good condition. We recommend funding to replace this component approximately every 40 - 50 years. Remaining life based on current age.
