# Wyngate Townhomes

## Level 2 Reserve Study

**Report Period – 1/1/2012 – 12/31/2012**

<b>Date of Property Inspection</b>	<b>12/16/2011</b>
<b>Prepared By</b>	<b>Dale Gifford</b>
<b>Analysis Method</b>	<b>Cash Flow</b>
<b>Funding Goal</b>	<b>Full Funding</b>

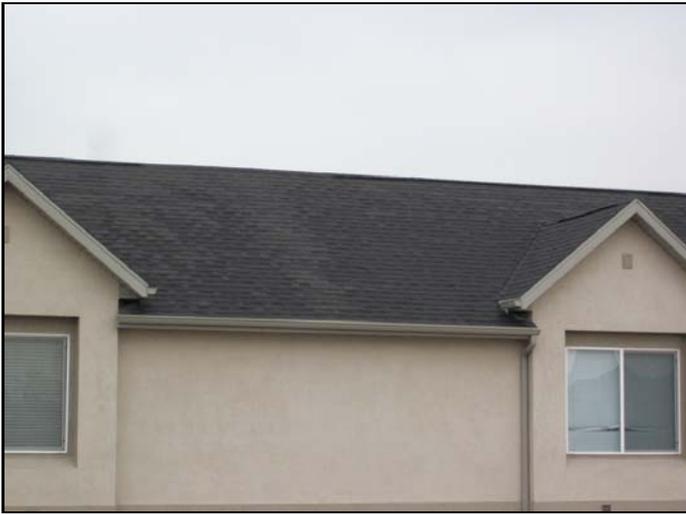
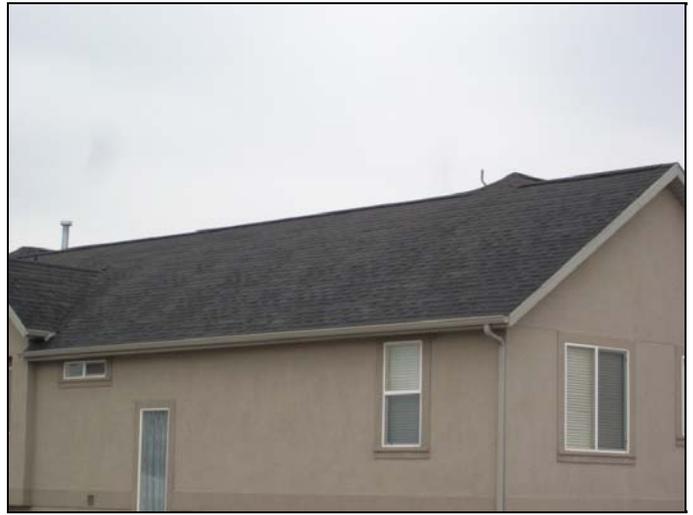
Comp #: 105 Pitched Roof - Comp Shingle - Replace

The roofs are in good condition. No problems were noted at the time of the inspection. Typically this type of roofing material has a useful life of approximately 25 years. Inspect roofs regularly and make local repairs as necessary as an operating expense to ensure full life from this component. Remaining life based on current age.

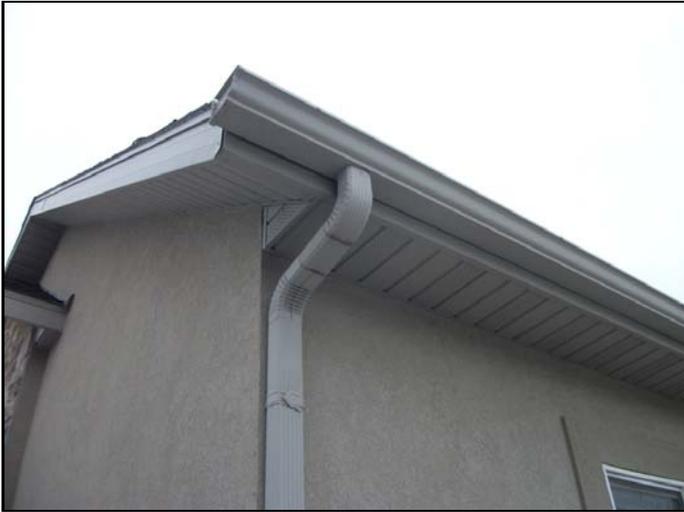
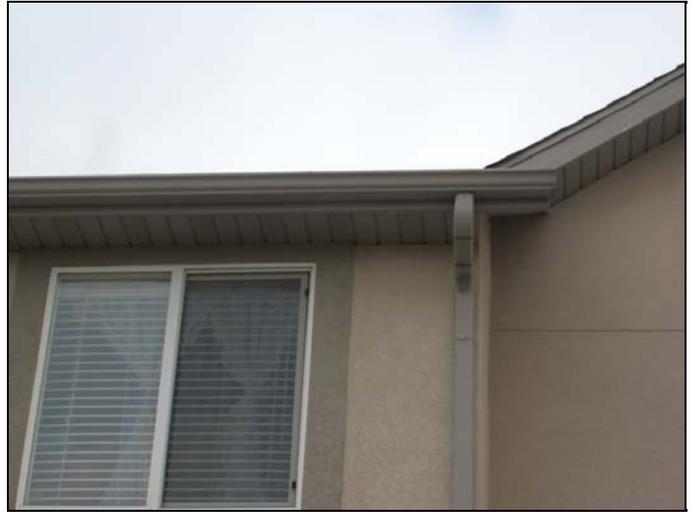
Comp #: 120 Rain Gutters/Downspouts - Replace

The rain gutters and downspouts are in good condition. No problems were noted at the time of the inspection. We recommend replacing the rain gutters and downspouts at the same time as the roof replacement (see Comp# 105 Pitched Roof - Comp Shingle - Replace) to ensure proper function and to take advantage of the cost savings benefits. We recommend funding to replace these gutters and downspouts every 25 years. Remaining life based on current age.

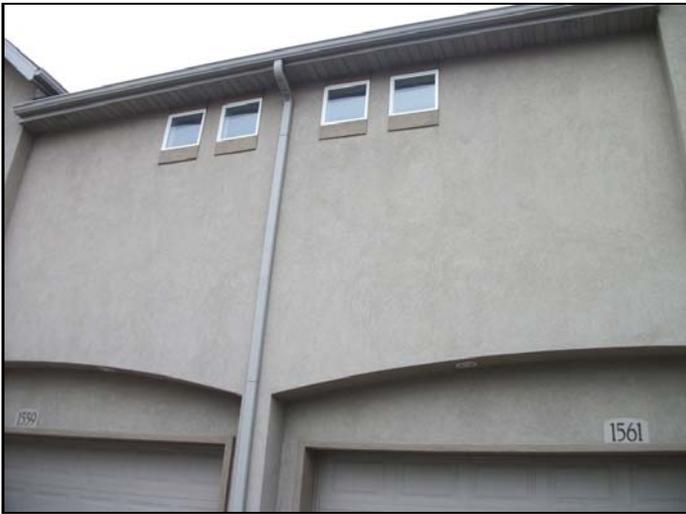
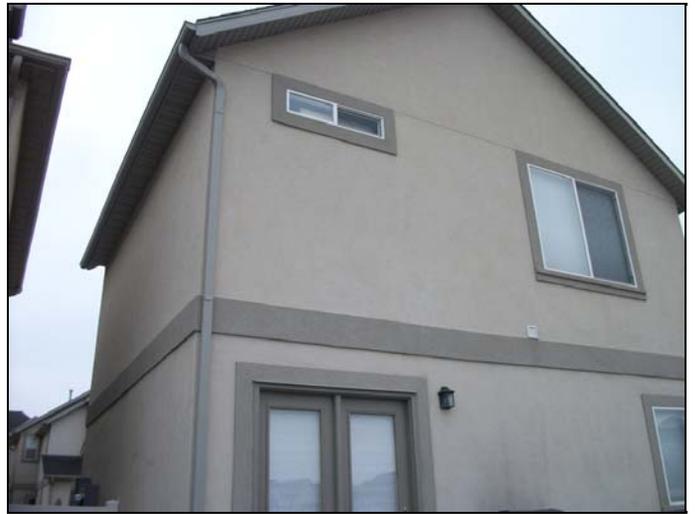
Comp #: 201 Buildings - Repaint

The stucco surfaces are generally in good to fair condition. Minor cracking and discoloration were noted at the time of the inspection. Stucco surfaces should typically be repainted approximately every 10 to 12 years to protect the stucco surface and maintain appearance. Remaining life based on current age.

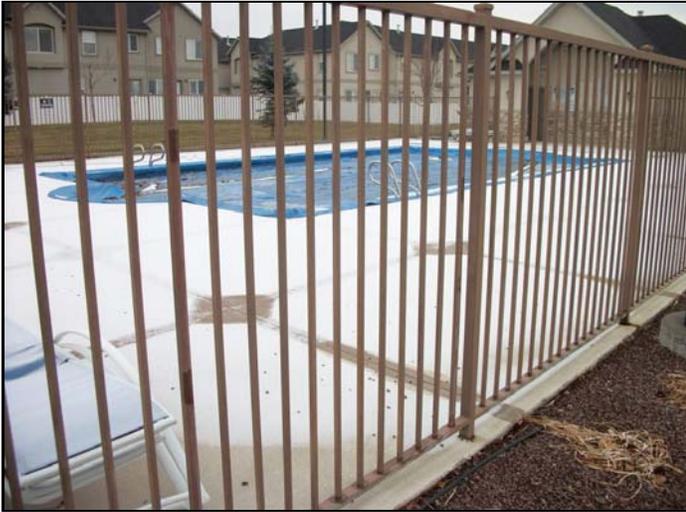
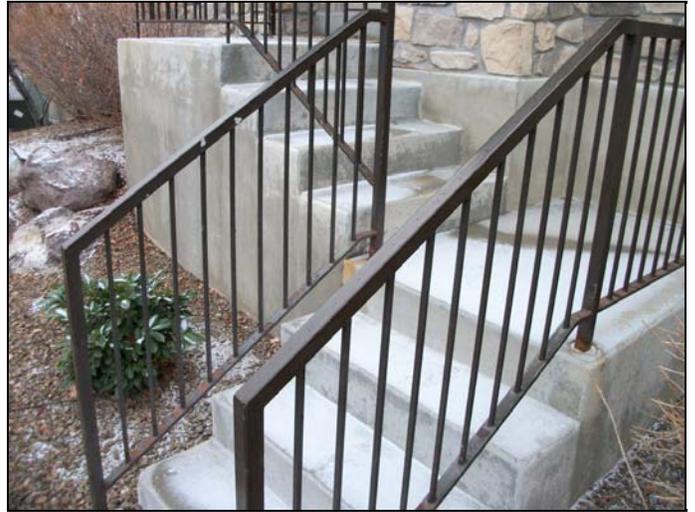
Comp #: 207 Wrought Iron Fencing - Repaint

The painted metal fencing surfaces are in generally fair condition. Minor areas of rust, fading and thinning paint were noted at the time of the inspection. Repaint this component approximately every 5 years to maintain appearance and protect metal surfaces. Remaining life based on current condition.

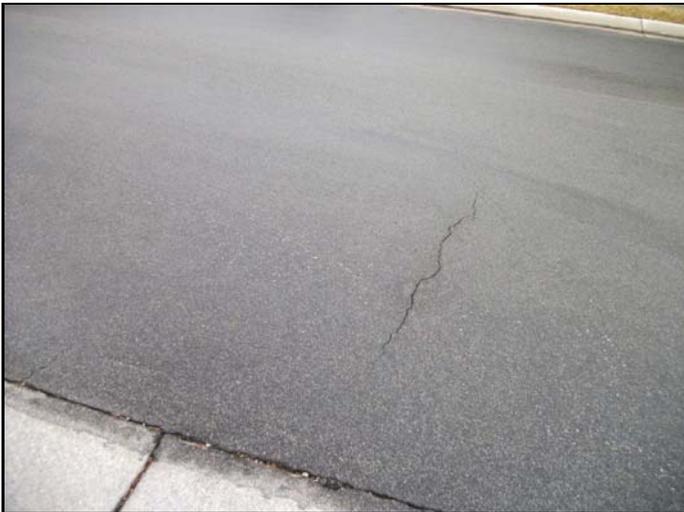
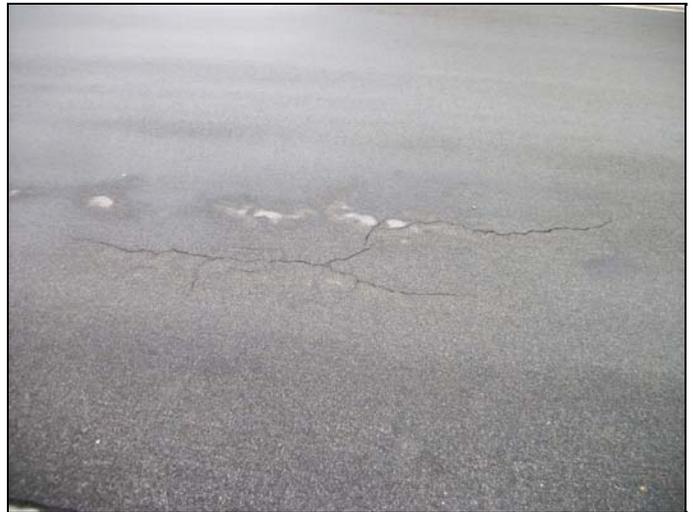
Comp #: 401 Asphalt - Overlay

The asphalt streets are in good condition. Minor cracking was noted at the time of the inspection. Asphalt overlay generally has a useful life of 20 - 25 years. Maintain seal coat schedule to ensure full useful life (see Comp# 402 Asphalt - Seal Coat). Remaining life based on current age.

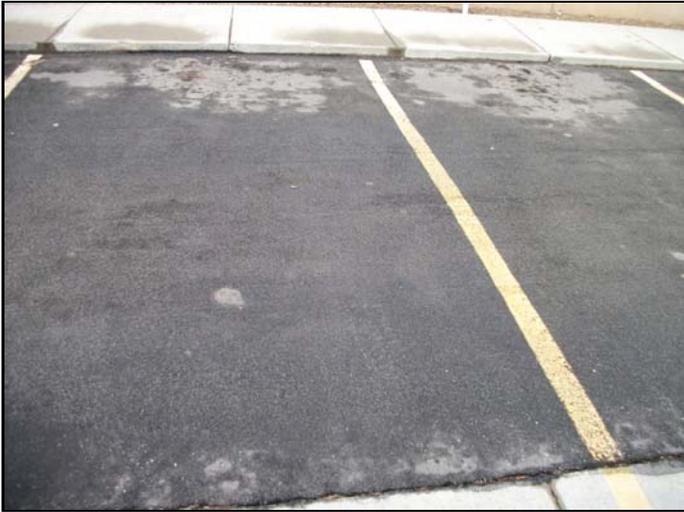
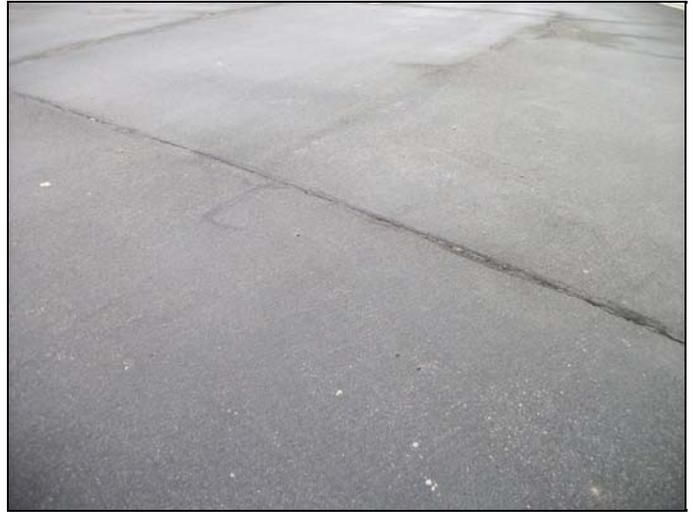
Comp #: 402 Asphalt - Seal Coat

The asphalt seal coat is in fair condition. Minor cracking was noted at the time of the inspection. Seal asphalt surfaces regularly to prevent premature overlay (see Comp# 401 Asphalt - Overlay). Asphalt surfaces should be sealed every 3 to 5 years. Remaining life based on current age.

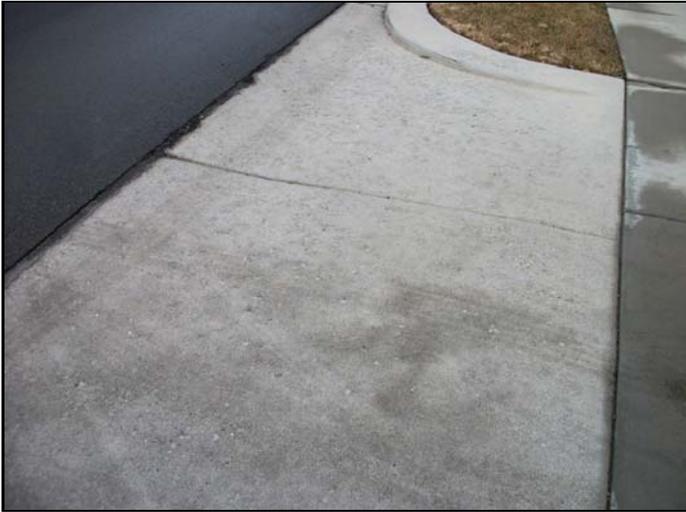
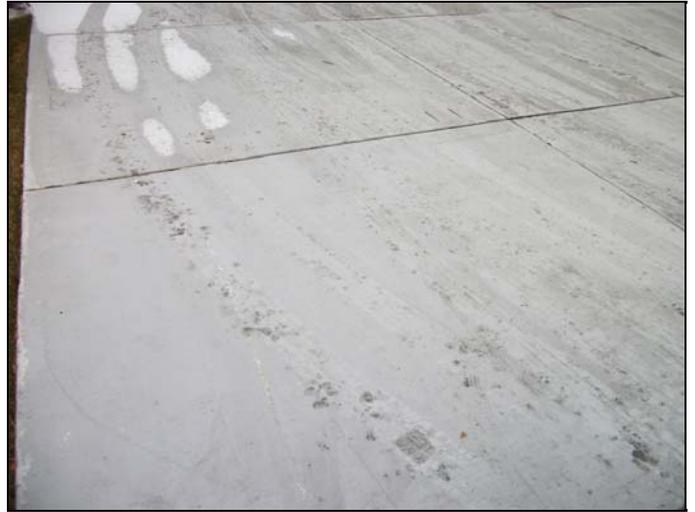
Comp #: 403 Concrete - Repair/Replace

The concrete is generally in good condition. Areas of cracking and spalling were noted at the time of the inspection. No expectation to completely replace the concrete surfaces. We recommend making local repairs as necessary as an operating expense and funding to make more significant repairs approximately every 10 years. Remaining life based on current age and condition.

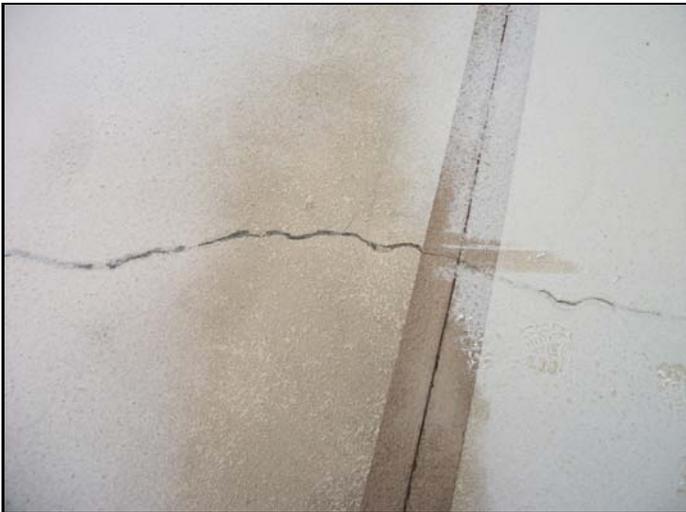
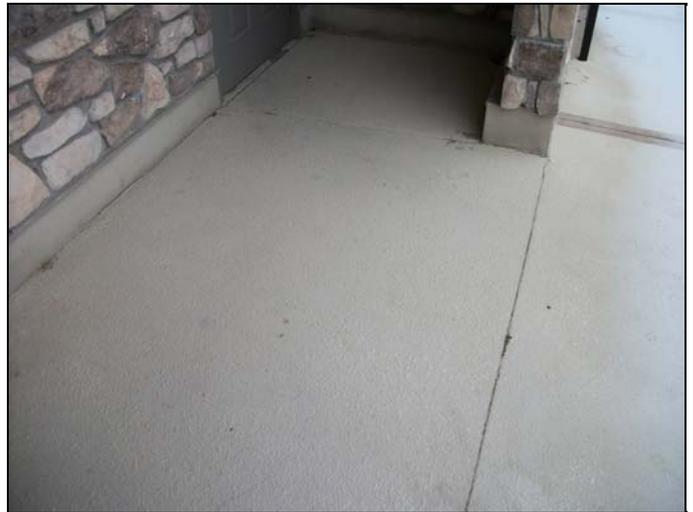
Comp #: 603 Kool Deck - Reseal

The kool deck pool deck coating is in good to fair condition. Minor cracking was noted but no significant surface loss or unusual wear was noted at the time of the inspection. Expect to reseal this deck material approximately every 3 to 5 years depending on use and wear. Remaining life based on current condition.

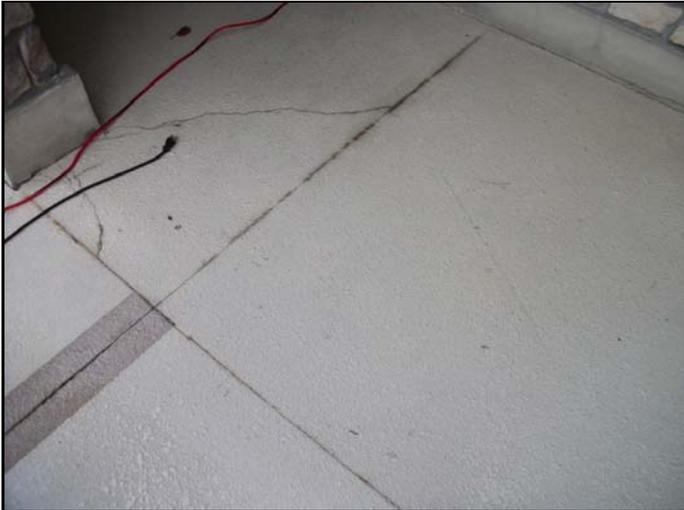
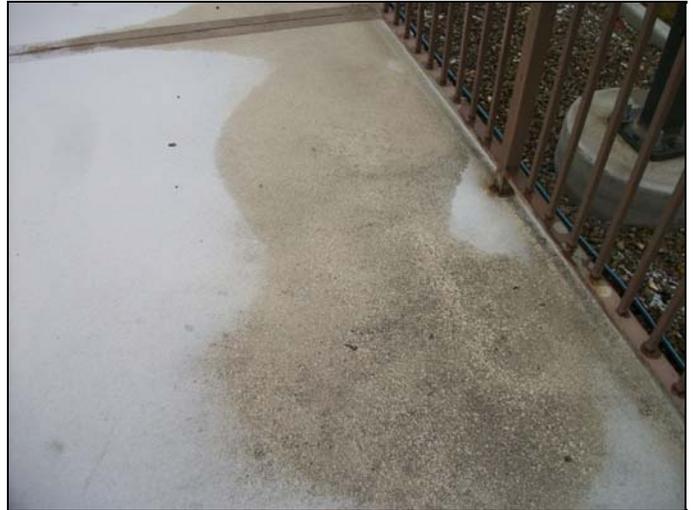
Comp #: 604 Kool Deck - Resurface

The kool deck pool deck coating is in good to fair condition. Minor cracking was noted but no significant surface loss or unusual wear was noted at the time of the inspection. With regular sealing (see Comp# 603 Kool Deck - Reseal) expect a useful life of approximately 20 years from this surface. Remaining life based on current age.

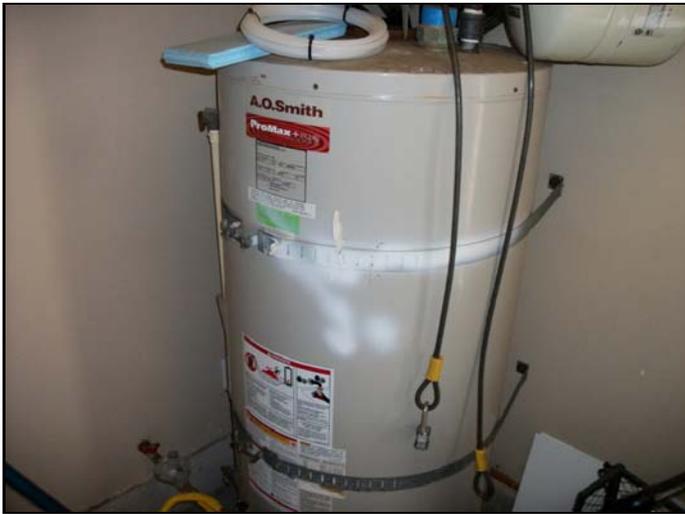
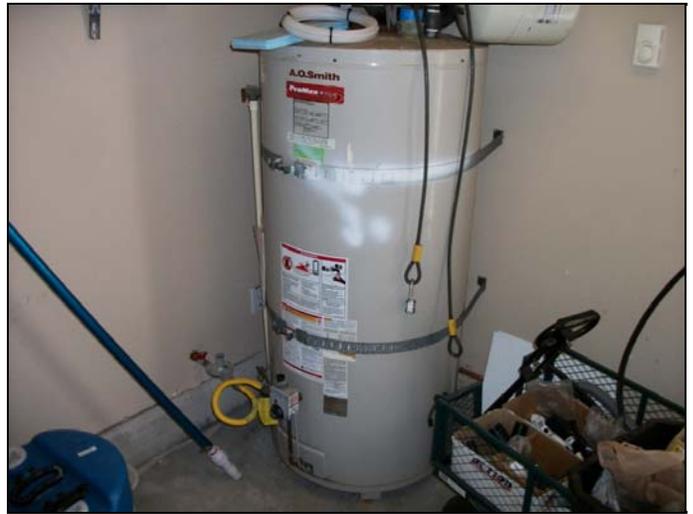
Comp #: 703 Water Heater - Replace

The water heater is in fair condition. No problems were noted or reported at the time of the inspection. Expect a typical useful life of approximately 12 years from this component. Remaining life based on current age.

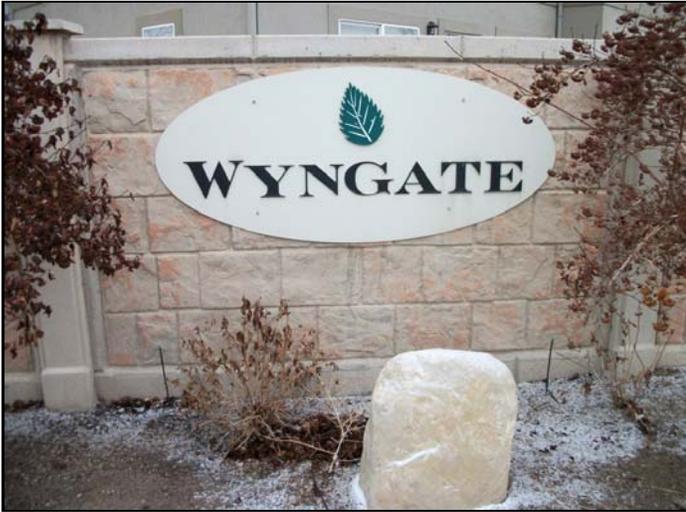
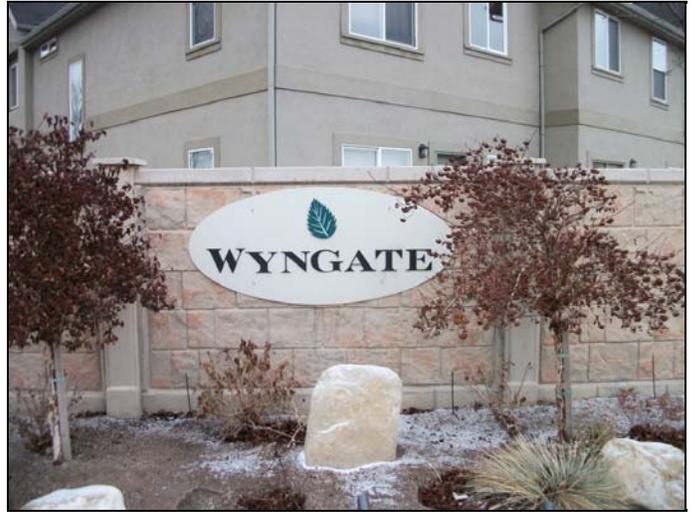
Comp #: 801 Monument Sign - Rebuild

The monument sign is in good condition. No problems were noted at the time of the inspection. We recommend refurbishing this component approximately every 18 years to ensure appearance and to keep up with current decorative tastes. Remaining life is based on current age.

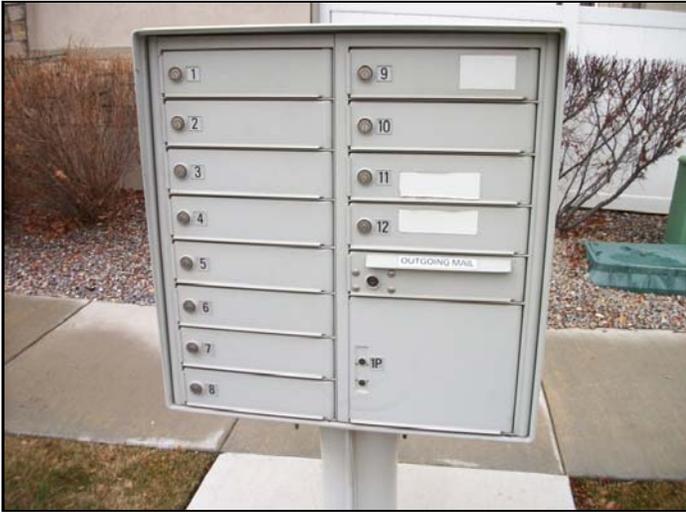
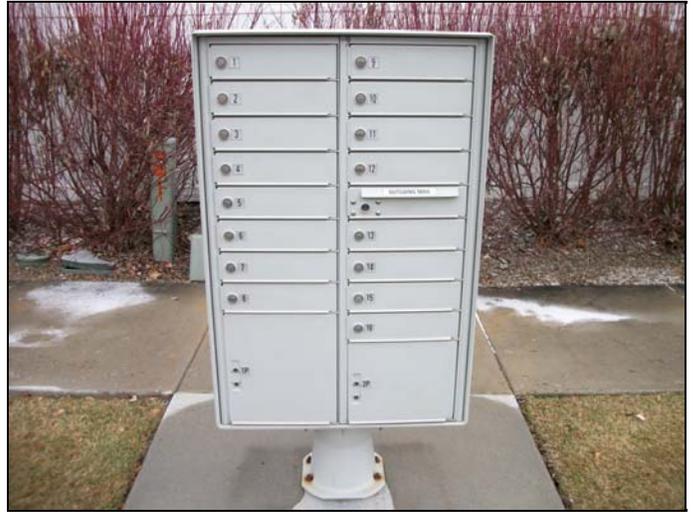
Comp #: 803 Mailboxes - Replace

The mailboxes are in good condition. Typically these mailboxes are owned and maintained by the postal service. No reserve funding necessary.

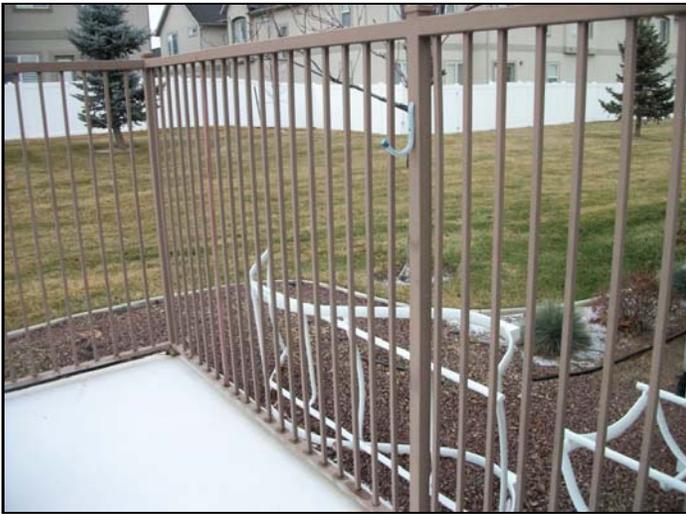
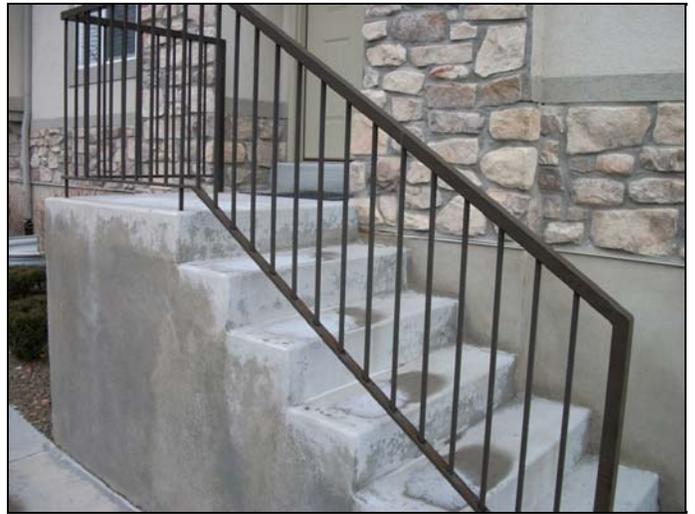
Comp #: 1002 Wrought Iron Fencing - Replace

The metal fencing is in good condition. Minor areas of rust, fading and thinning paint were noted at the time of the inspection. With regular painting and maintenance, expect a useful life of 25 to 30 years from this component. Remaining life based on current age.

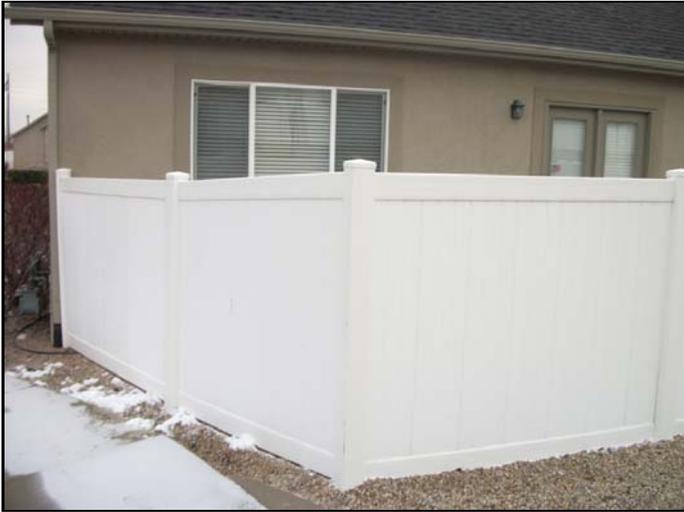
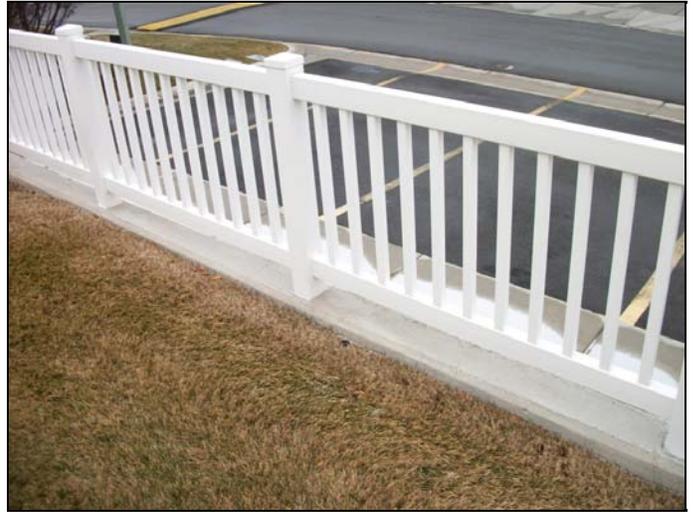
Comp #: 1008 Vinyl Fencing - Replace

The vinyl fencing is in good condition. No warped or broken areas were noted at the time of the inspection. This type of fencing material has a relatively long useful life. Reserve to replace the vinyl fencing every 25 years. Remaining life based on current age.

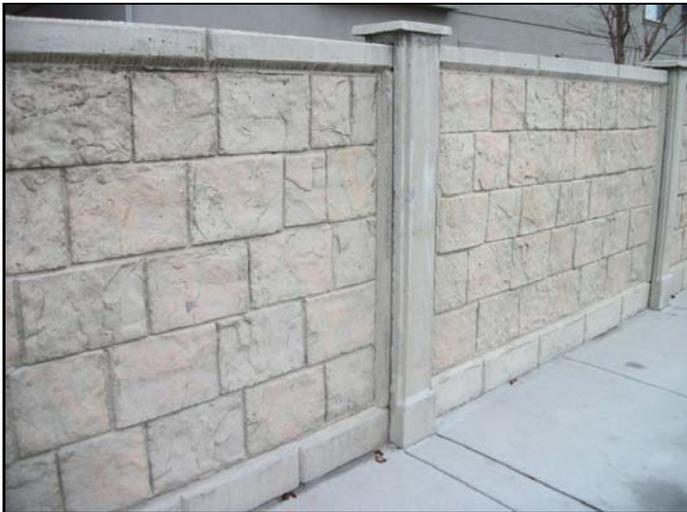
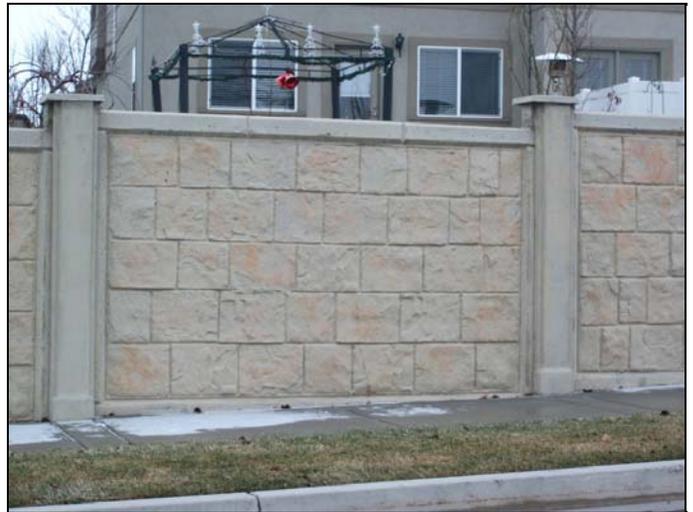
Comp #: 1012 Prefab Concrete Fence - Replace

The prefab concrete fencing is in good condition. No significant cracking or structural problems were noted at the time of the inspection. This type of fencing should have an extended useful life under normal conditions. Reserve funding is not appropriate.

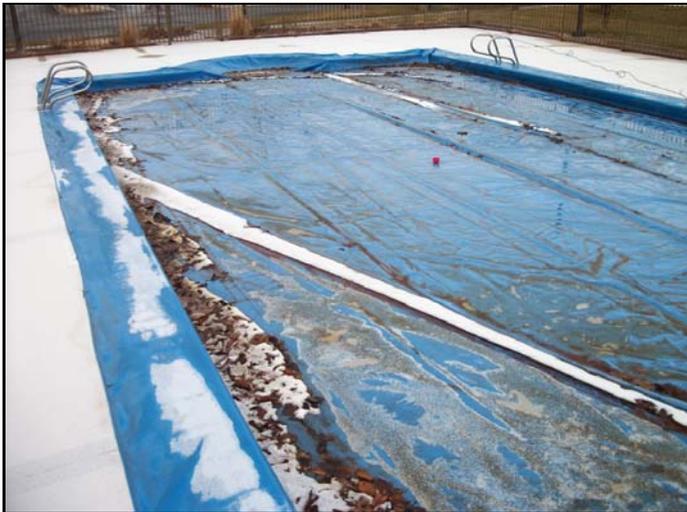
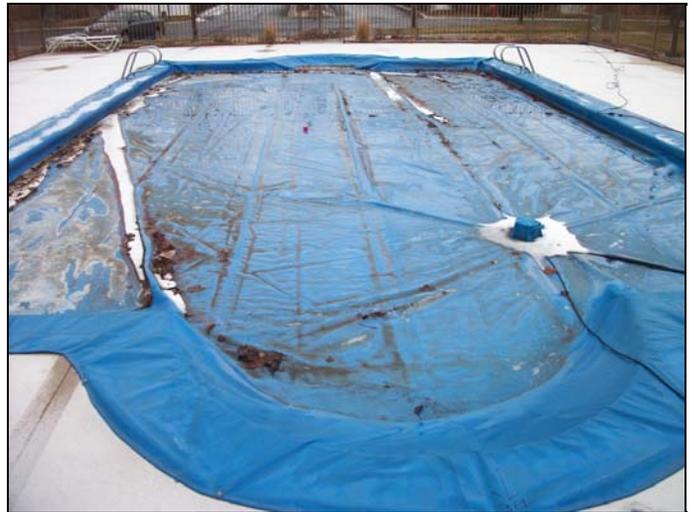
Comp #: 1101 Pool - Resurface

Unable to inspect pool surface at the time of inspection. Research with the Client reveals the pool surface is in good condition. Perform regular, professional maintenance and keep debris from collecting at the bottom to ensure full life from this component. We recommend funding to resurface the pool every 10 to 12 years depending on use and wear. Remaining life based on current age.

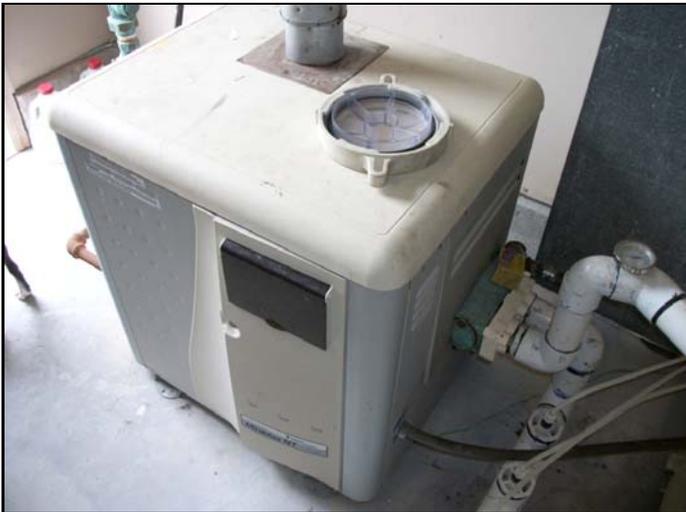
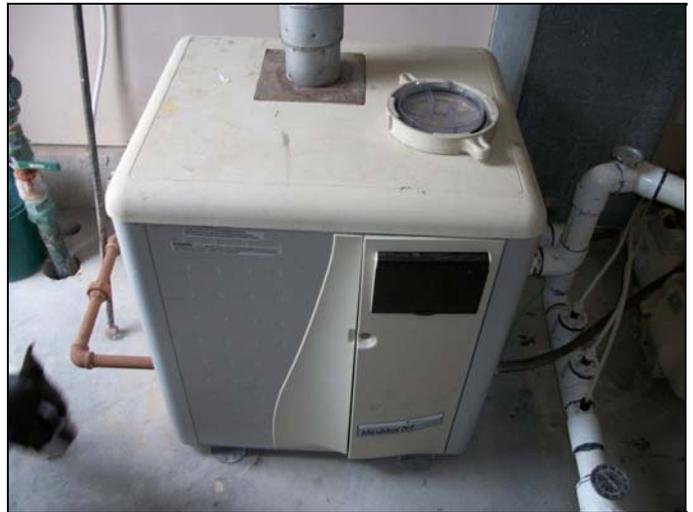
Comp #: 1104 Pool Heater - Replace

The pool heater is in good condition. No problems were reported at the time of the inspection. This type of pool heater typically has a useful life of approximately 12 years. Remaining life based on current age.

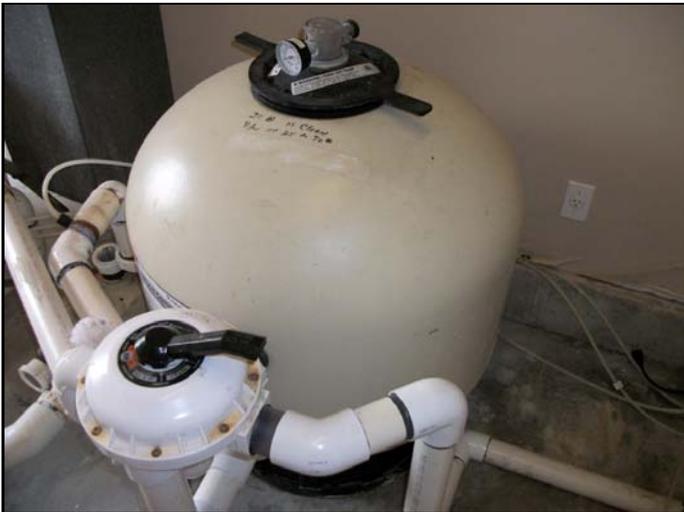
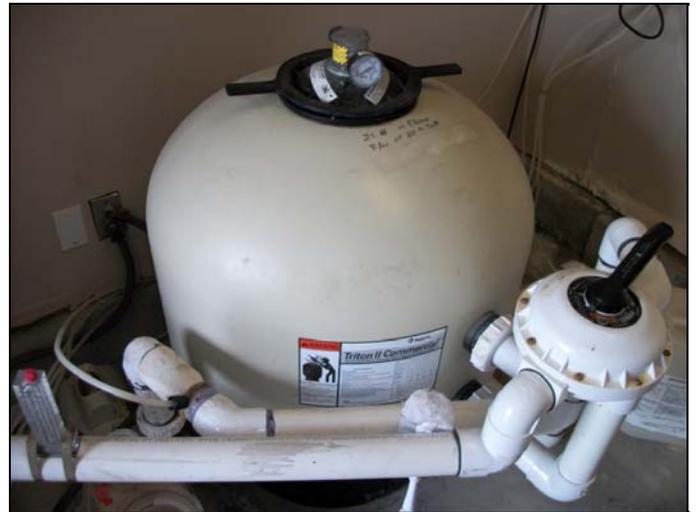
Comp #: 1107 Pool Filter - Replace

The pool filter is in good condition. No problems were reported at the time of inspection. This type of pool filter has a life expectancy of approximately 12 years. Remaining life based on current age.

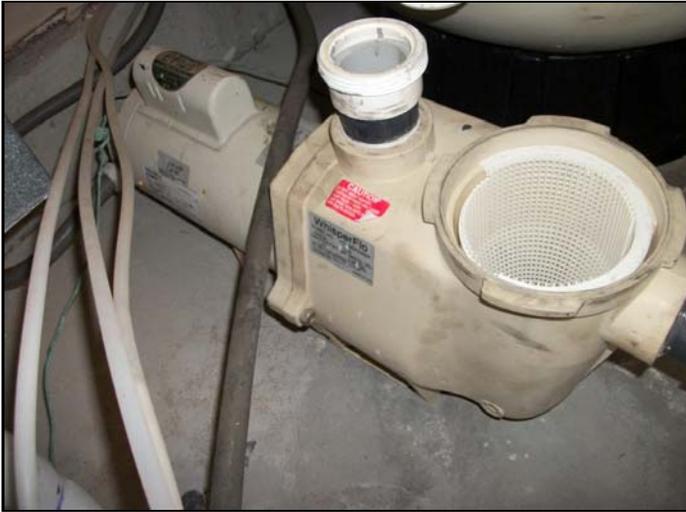
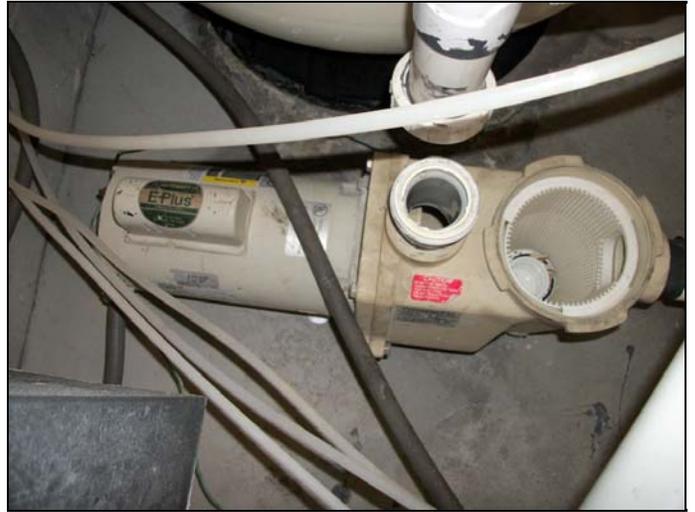
Comp #: 1110 Pool Pump - Replace

The pool pump is in good condition. We recommend funding to replace this pump approximately every 5 years. Replace motors as necessary as an operating expense. Remaining life based on current age and condition.

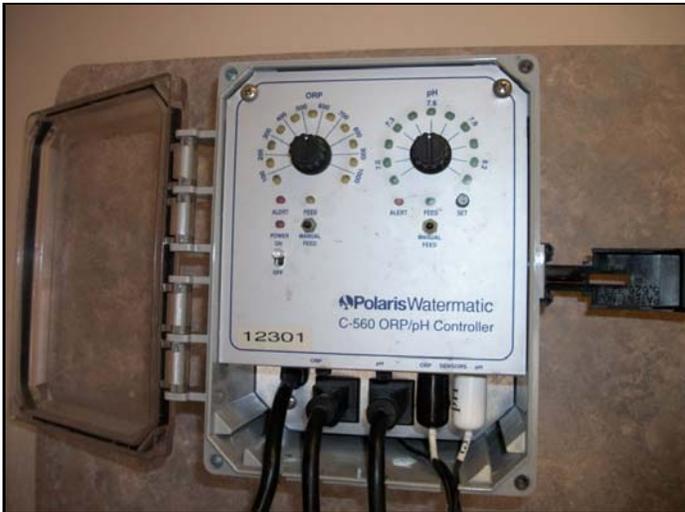
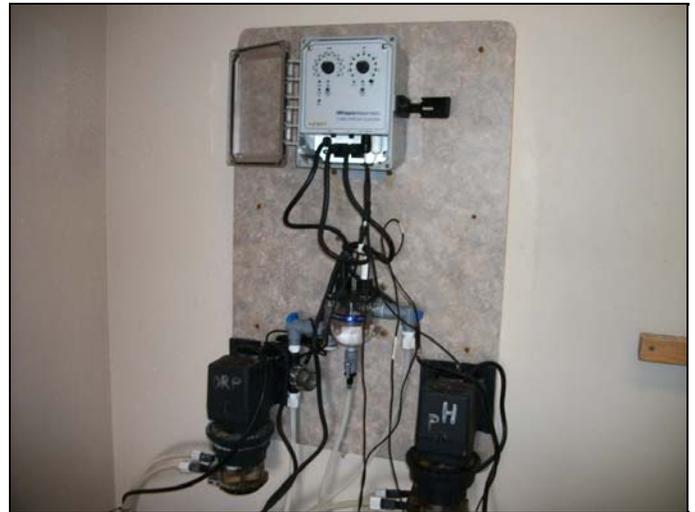
Comp #: 1111 Pool Chlorinator - Replace

The pool chlorinator system is in good condition. No problems were reported at time of the inspection. We recommend funding to replace this system approximately every 8 years to ensure proper function and to keep up with current technology. Remaining life based on current age and condition.

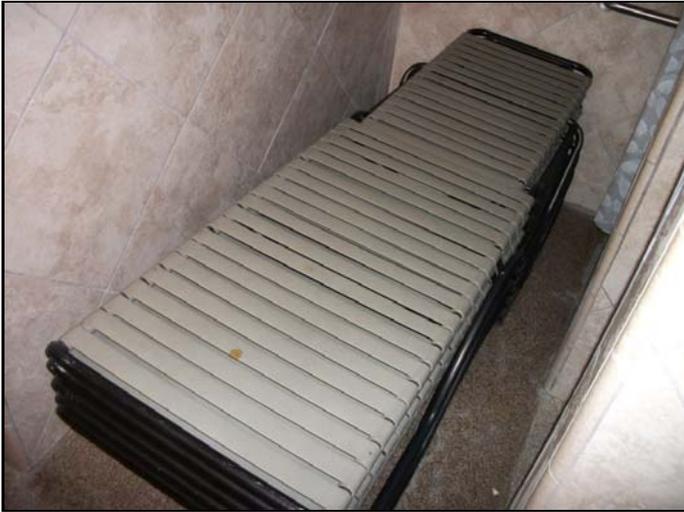
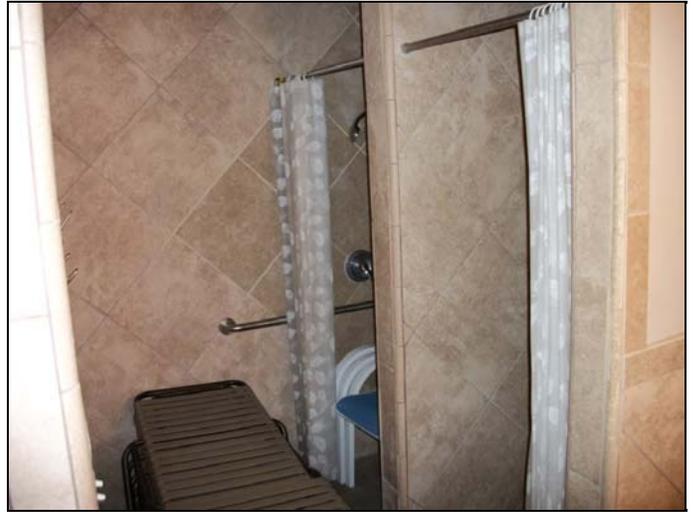
Comp #: 1121 Pool Furniture - Replace

The pool furniture is in good condition. Minor discoloration and wear were noted at the time of inspection. Expect a useful life of approximately 6 years from this component. Remaining life based on current age.

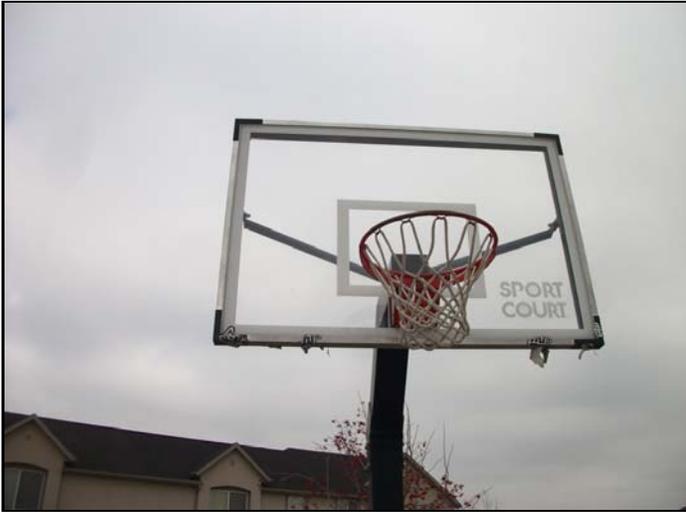
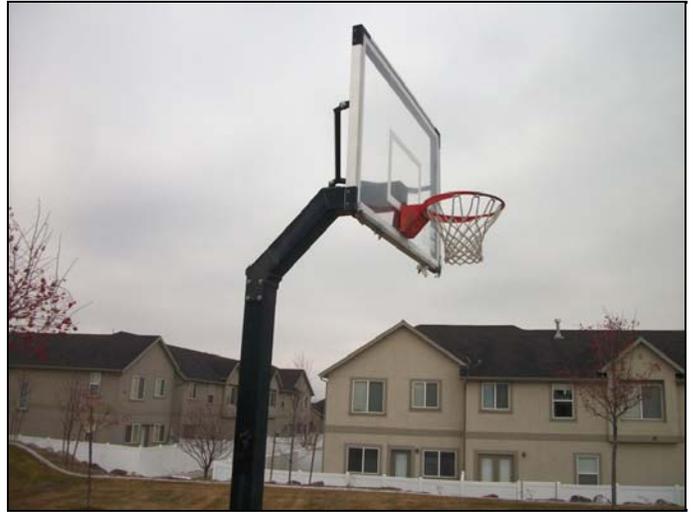
Comp #: 1207 Basketball Equipment - Replace

The basketball equipment is in good condition. There is no expectation to replace the pole. We recommend funding to replace the backboard and rim approximately every 12 years. Remaining life is based on current age.

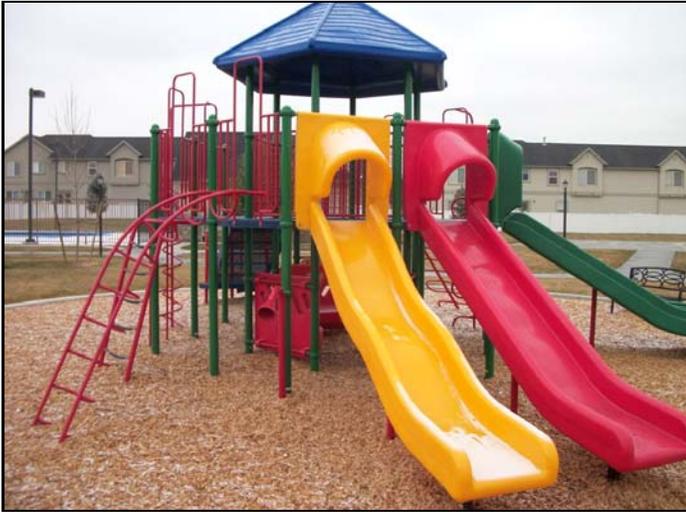
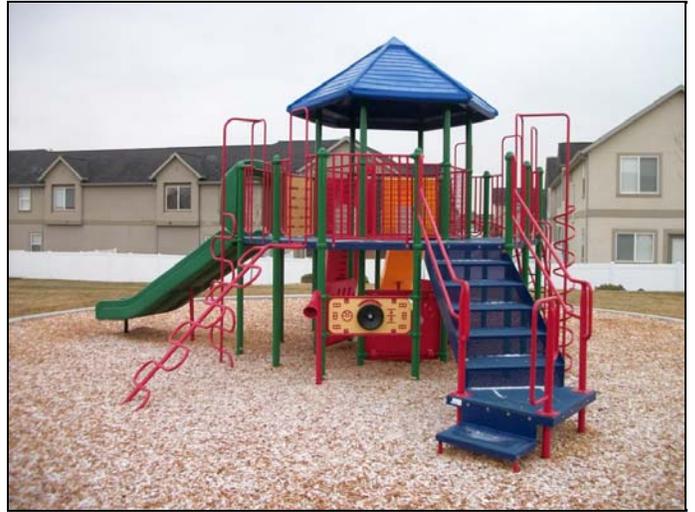
Comp #: 1301 Play Structure - Replace

The play structure is in good condition. No significant signs of wear or damage were noted at the time of the inspection. Expect a useful life of approximately 20 years from this component. Remaining life based on current age.

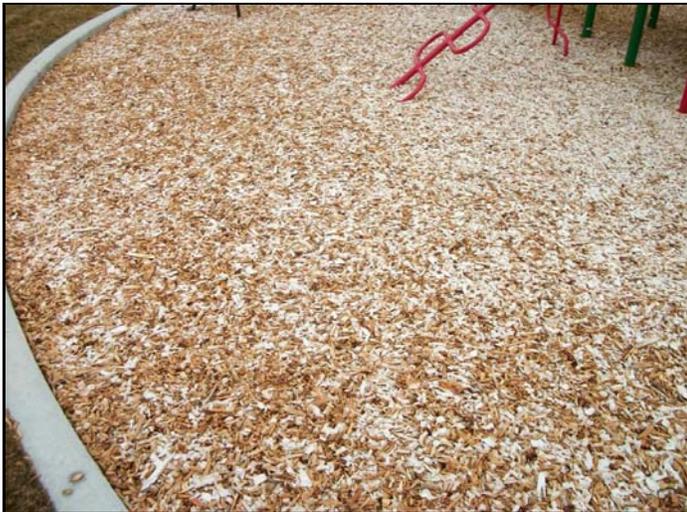
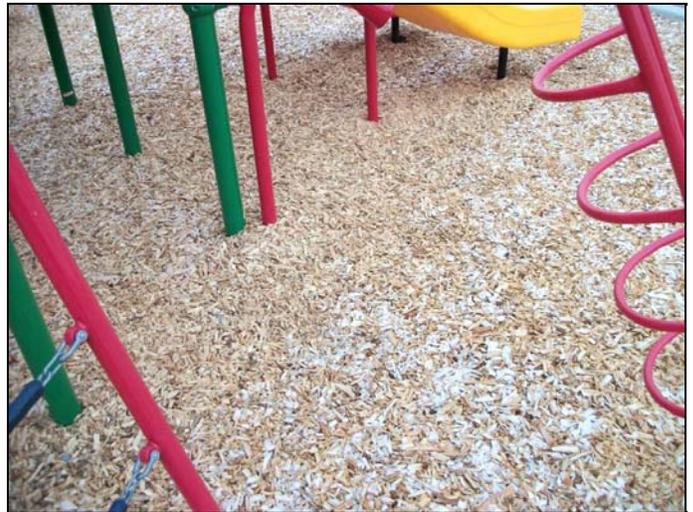
Comp #: 1303 Play Area Groundcover - Refill

The play area groundcover is in good condition. No problems were noted at the time of the inspection. Bed is full and even with no material deterioration noted. Expect to refill groundcover bed approximately every 3 to 5 years to maintain appearance and ensure proper function as a safety component. Remaining life is based on current age and condition.
