Chase Creek Condominiums

Level 1 Reserve Study

Report Period – 1/1/2010 – 12/31/2010

Date of Property Inspection	October 21, 2009
Prepared By	Robert Forney
Analysis Method	Cash Flow
Funding Goal	Full Funding

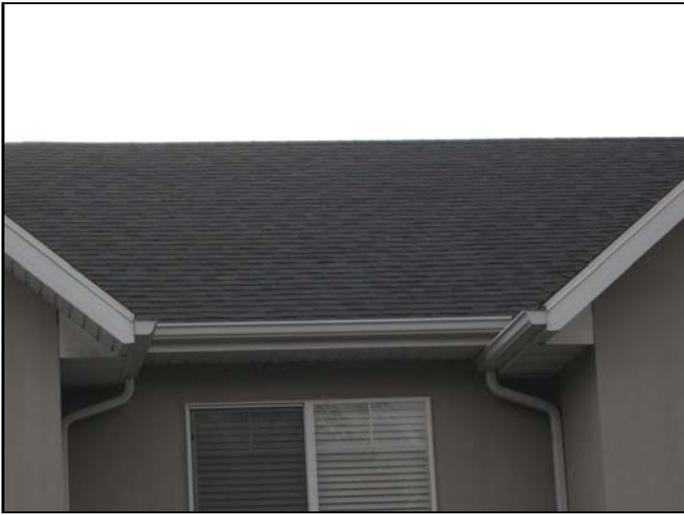
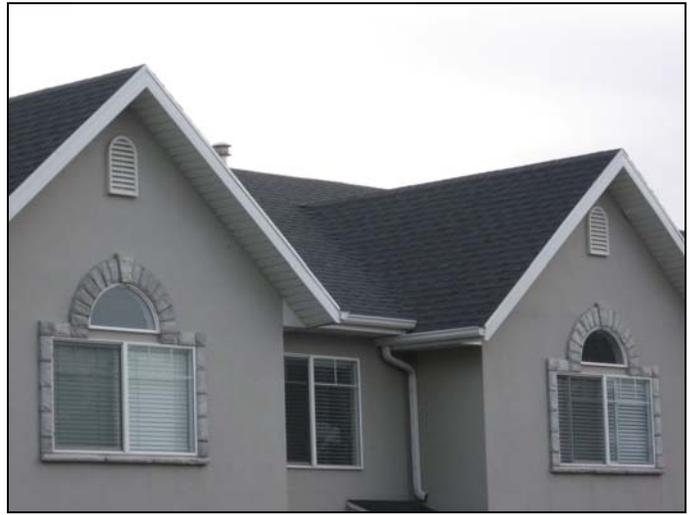
Comp #: 105 Pitched Roof - Comp Shingle - Replace

All shingles are intact and in good condition with no problems noted at time of inspection. Typically this type of roofing material has a useful life of approximately 20 years. Inspect roofs regularly and make local repairs as necessary as an operating issue to ensure full life from this component. Remaining life based on current age and condition.

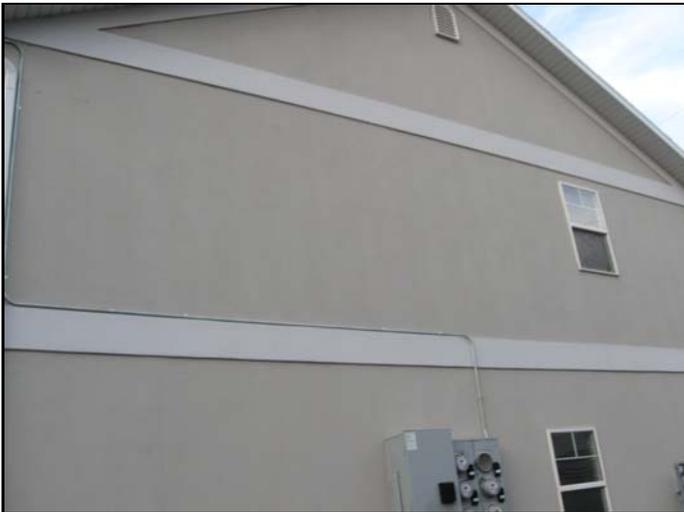
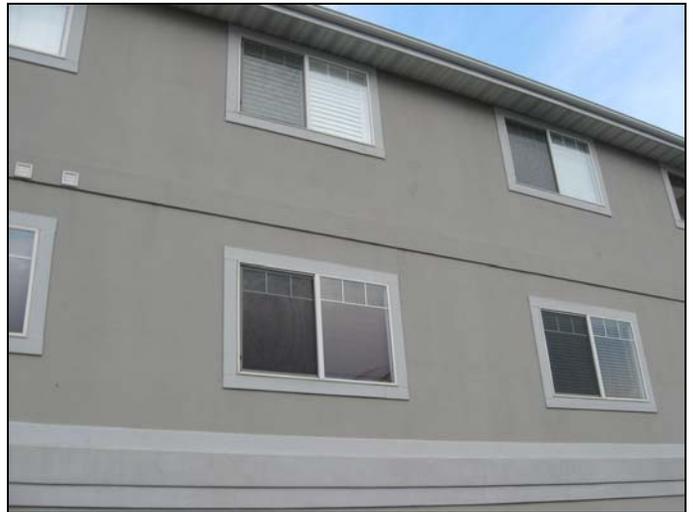
Comp #: 201 Stucco Surfaces - Repaint

Painted stucco surfaces are generally in good condition, no significant staining or discoloration noted. Stucco surfaces should typically be repainted approximately every 12 years to protect stucco surface and maintain appearance. Remaining life based on current condition.

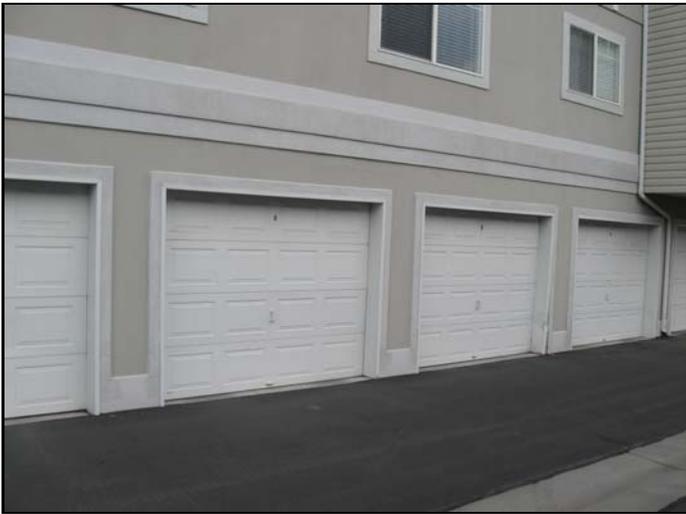
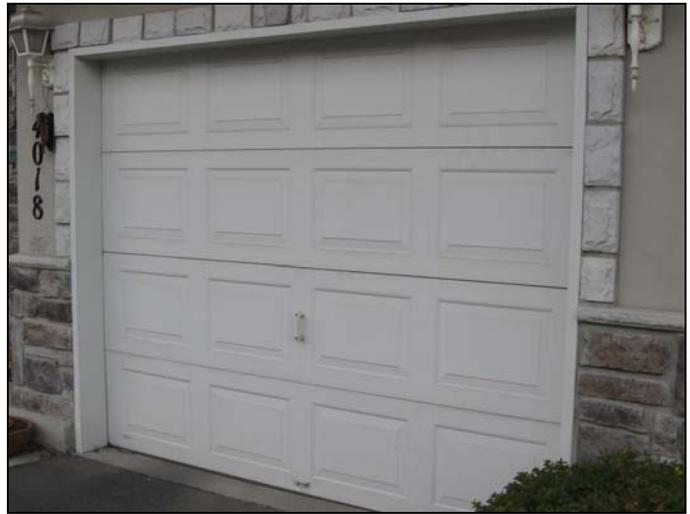
Comp #: 206 Garage Doors - Repaint

Doors are in good condition. No significant marking or paint loss noted. Expect to repaint these doors approximately every 6 years to maintain appearance. Remaining life based on current condition.

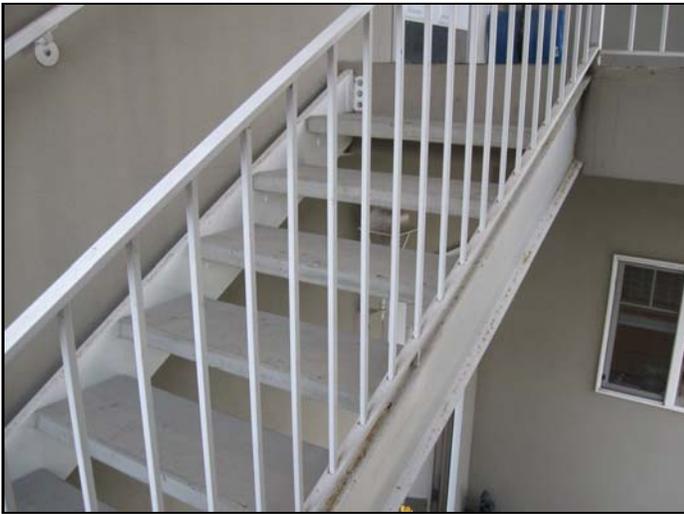
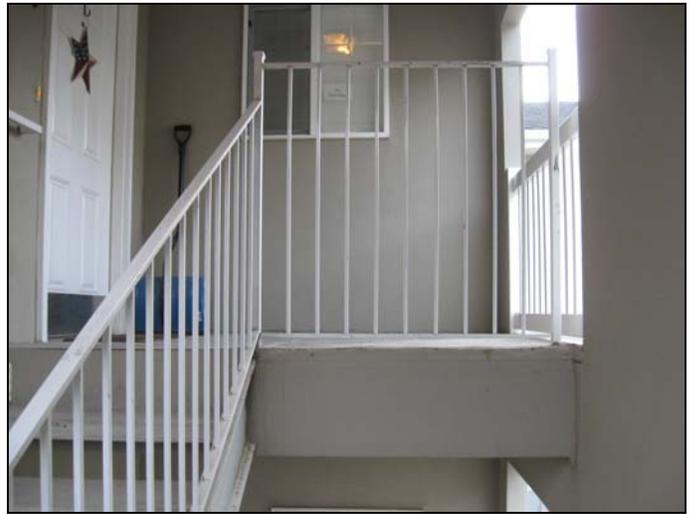
Comp #: 207 Wrought Iron Railings - Repaint

Painted wrought iron surfaces are in good condition, no rusting or paint loss noted. Repaint this component approximately every 5 years to maintain appearance and protect metal surfaces. Remaining life based on current condition.

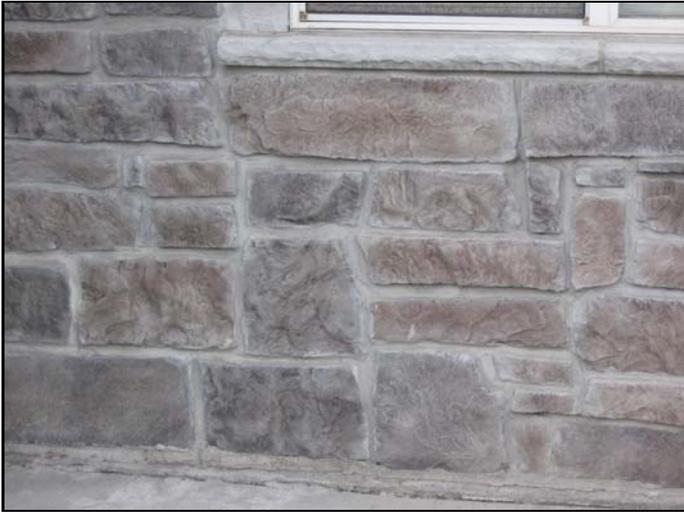
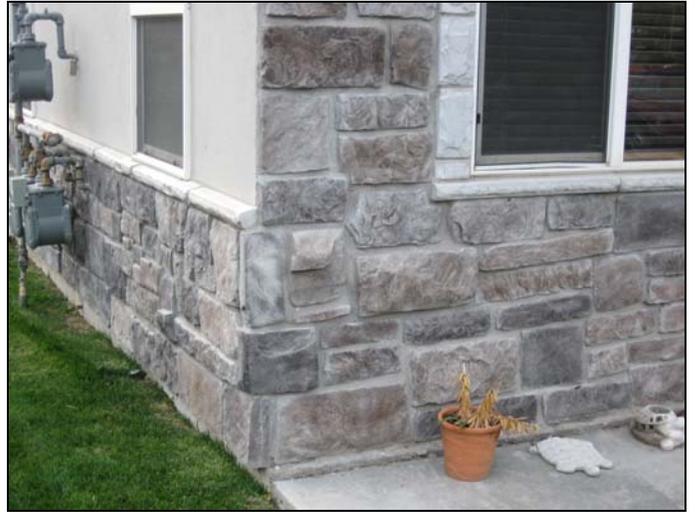
Comp #: 390 Rock Facade - Repair

Rock façade is in good condition with no missing pieces or other appearance concerns noted at time of inspection. We recommend funding to make repairs to this component approximately every 15 years. Remaining useful life based on current age.

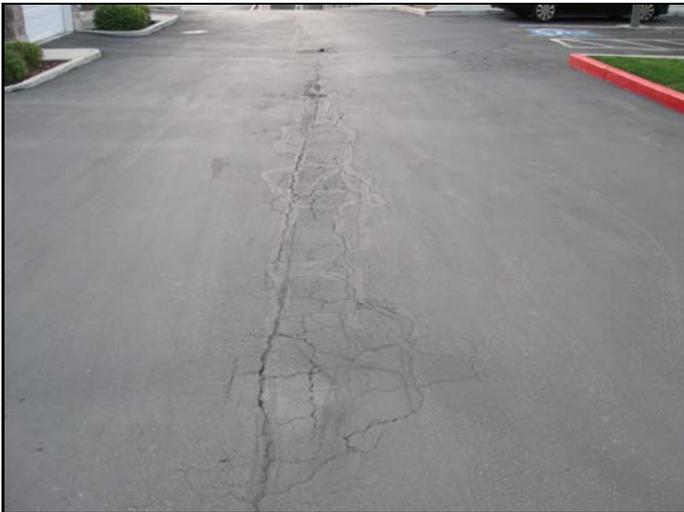
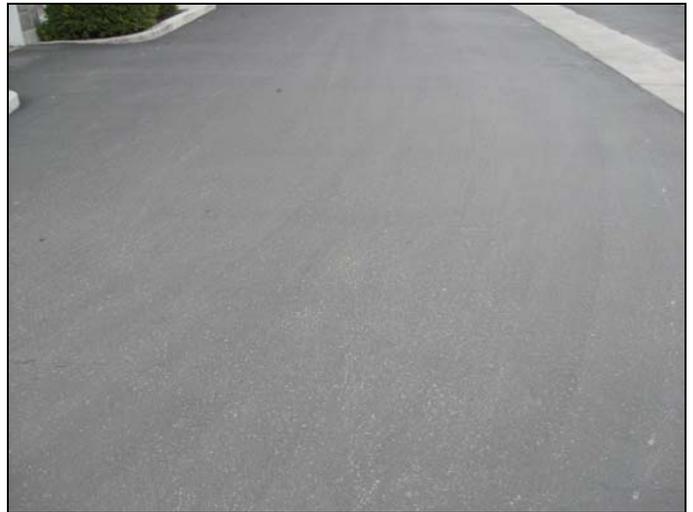
Comp #: 401 Asphalt - Overlay

Asphalt streets are in good condition. No cracking or structural problems noted at the time of inspection. Seal these streets regularly (see Comp# 402 Asphalt - Slurry Seal) to protect surface and ensure full life.

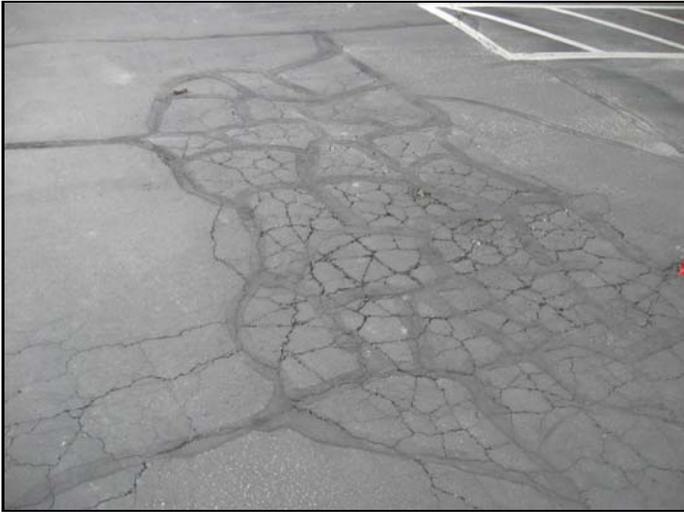
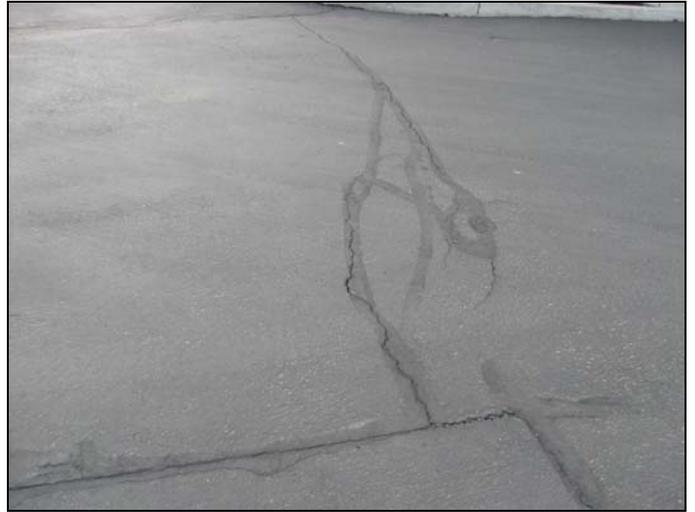
Comp #: 402 Asphalt - Slurry Seal

Asphalt seal coat is in good to fair condition. No significant raveling or surface loss noted. Seal asphalt surfaces regularly to prevent premature overlay (see Comp# 401 Asphalt - Overlay). Remaining life based on current age and condition.

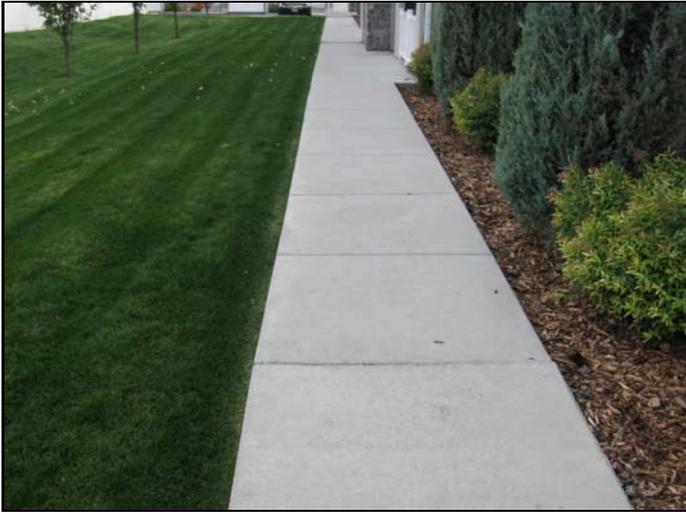
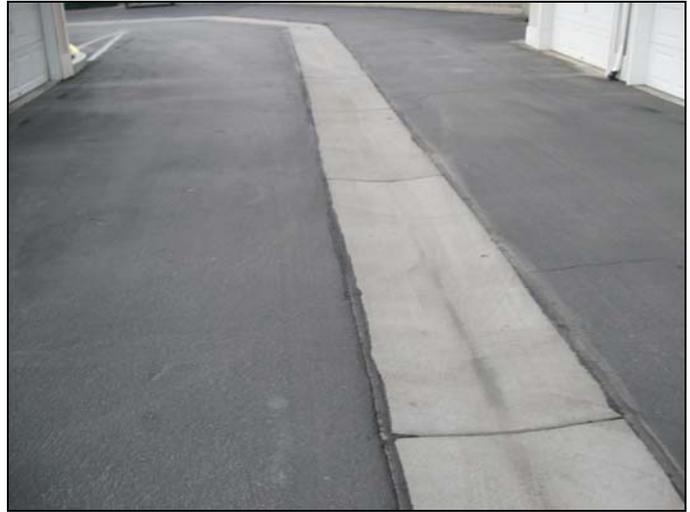
Comp #: 403 Concrete - Repair/Replace

Concrete is generally in good condition. No significant cracking or structural problems noted at the time of inspection. No expectation to completely replace the concrete surfaces. We recommend making local repairs as necessary as an operating expense and funding to make more significant repairs approximately every 10 years.

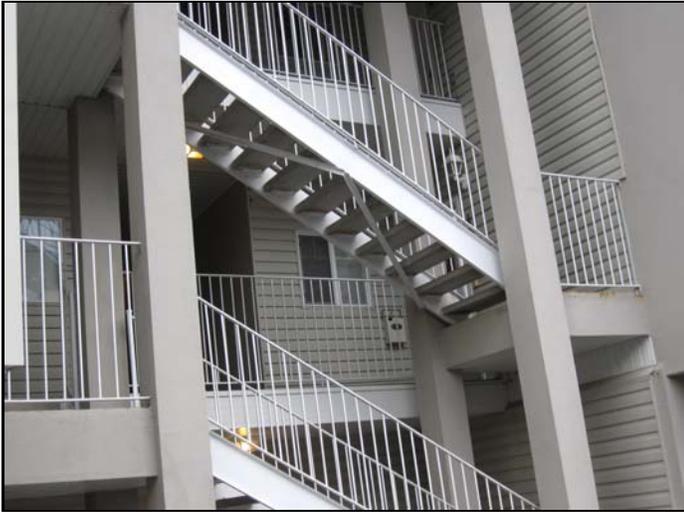
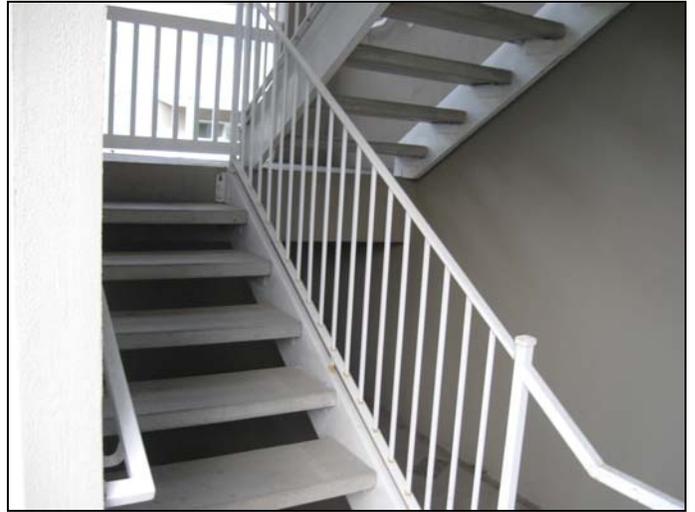
Comp #: 1002 Wrought Iron Railings - Repair/Replace

Fencing is in good condition. No significant rusting or structural problems noted at the time of inspection. With regular painting and maintenance, expect a useful life of 20 to 25 years from this component. Remaining life based on current age.

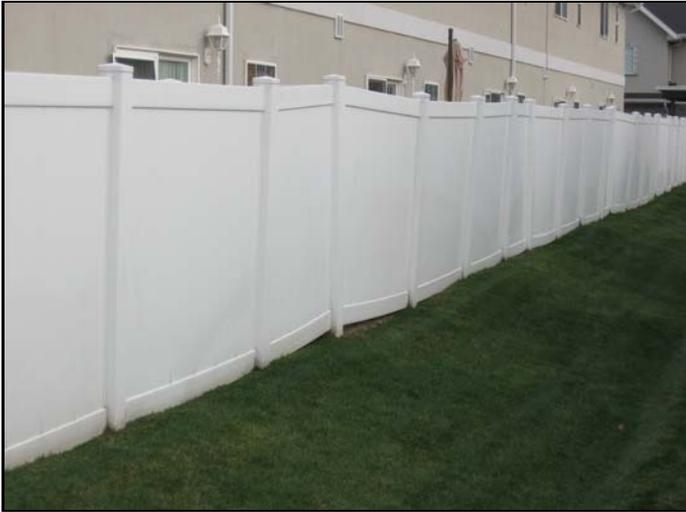
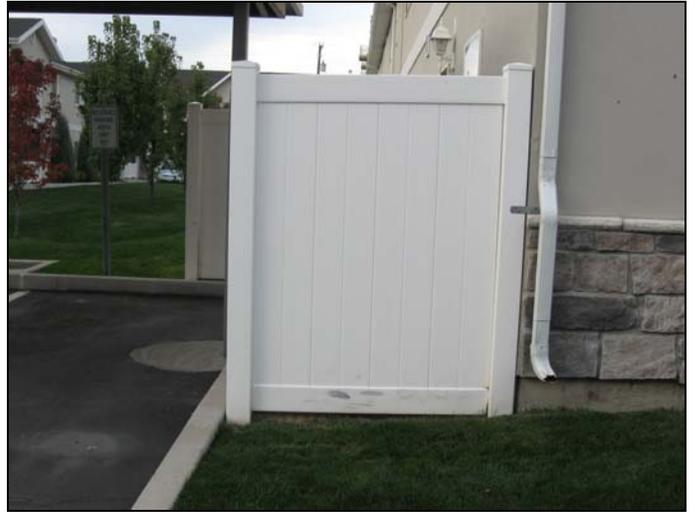
Comp #: 1008 PVC Vinyl Fencing - Replace (Board)

Fencing was observed to be in good condition at the time of inspection. We recommend funding to replace this type of fencing on an 18-year schedule. Remaining life based on current age.

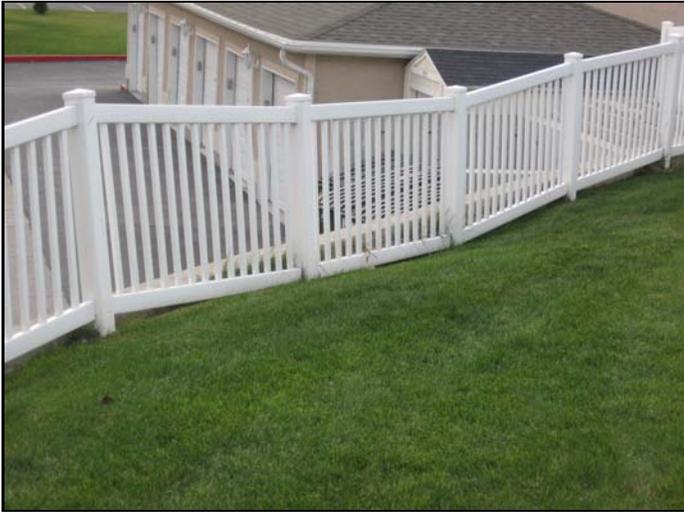
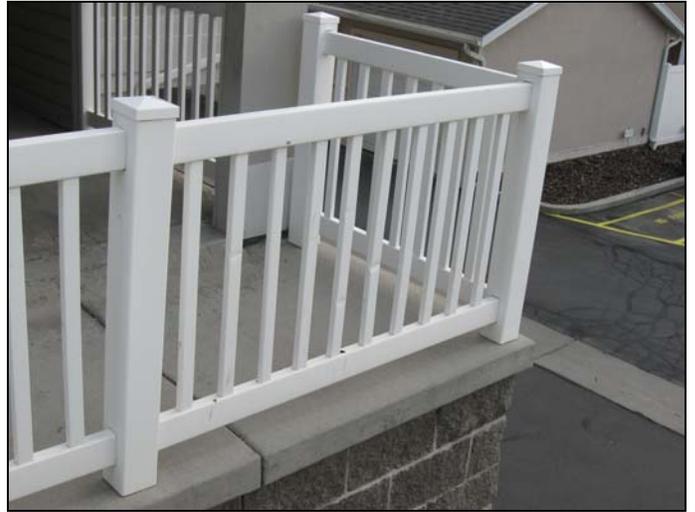
Comp #: 1009 PVC Vinyl Fencing - Replace (Picket)

This line item is for the replacement of the common area picket fencing as well as the balcony and landing railings. Although this component may reach an extended life we recommend funding to completely replace it approximately every 15 years to ensure appearance and stability.

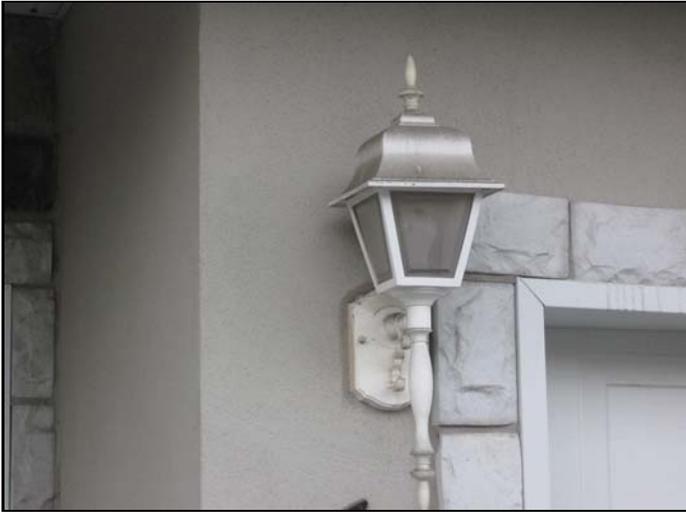
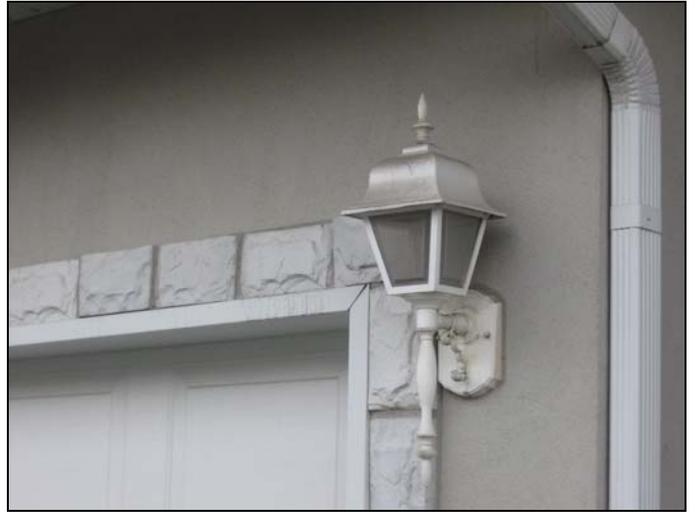
Comp #: 1602 Exterior Wall Mount Lights - Replace

Lights are generally in good condition. No significant pitting or discoloration noted. Expect to replace these lights approximately every 16 years to maintain appearance. Remaining life based on current age and condition.

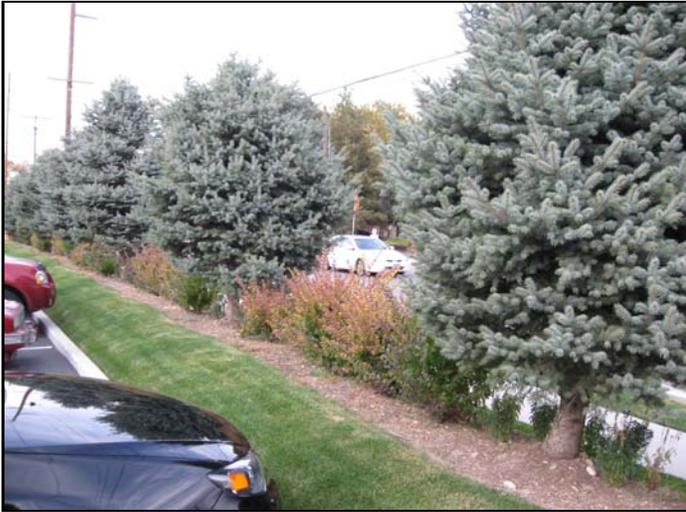
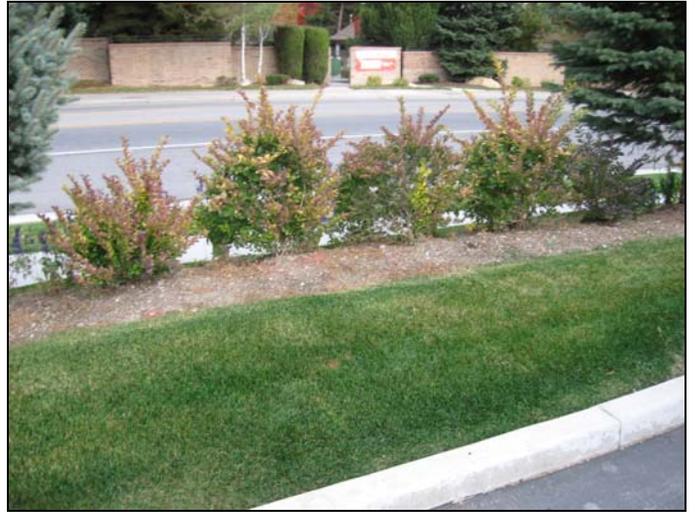
Comp #: 1812 Landscaping - Renovate

Landscaping is in good condition. We recommend funding for an allowance to make repairs to the irrigation system as well as upgrade and generally refurbish the landscaping to maintain appearance and keep up with current decorative tastes.
