# Hill Farm

## Level 1 Reserve Study

**Report Period – 01/01/2021 – 12/31/2021**

**Report prepared on – Monday, June 22, 2020**

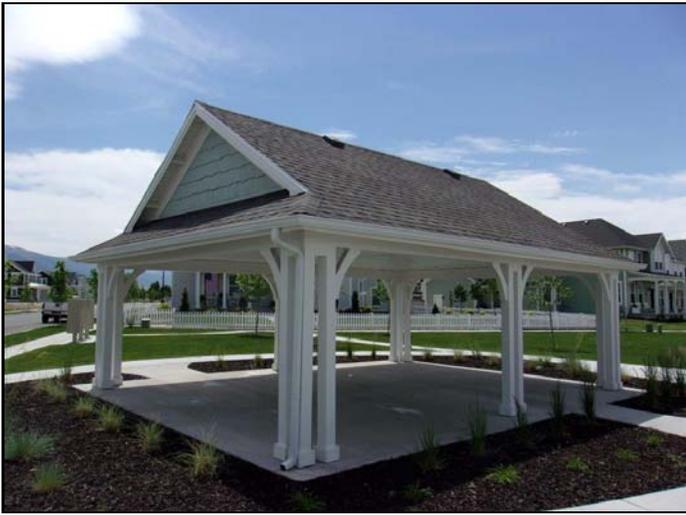
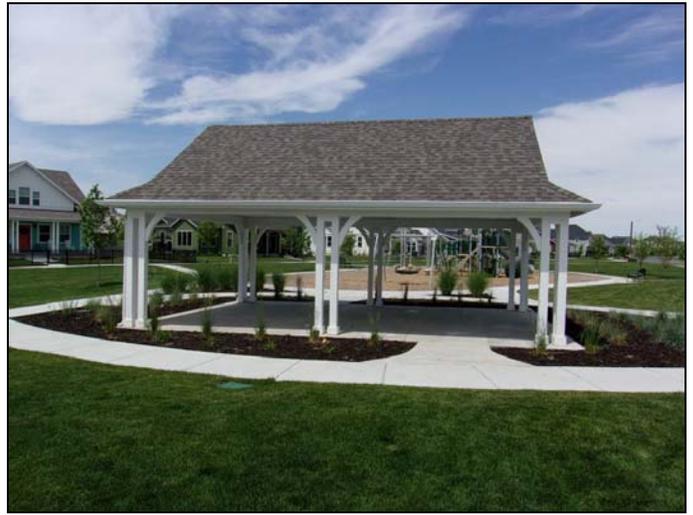
Comp #: 105 Pavilion Roof - Replace

*Location:* Pavilion Roof

The roof is in good condition. We recommend funding to replace this component approximately every 20 - 25 years. Remaining life based on current age.

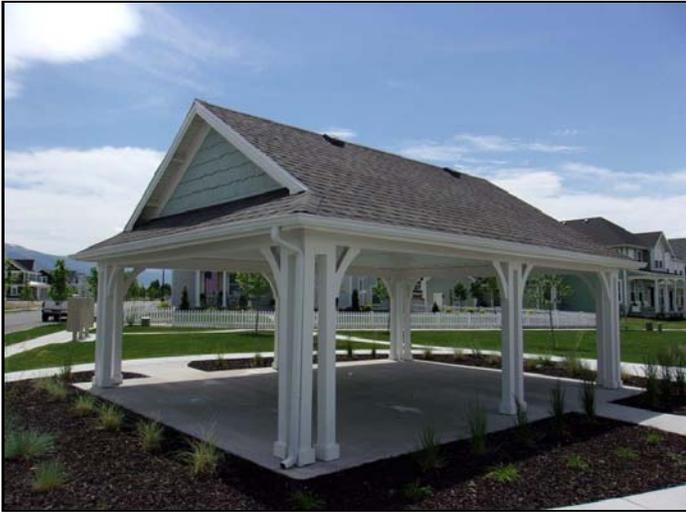
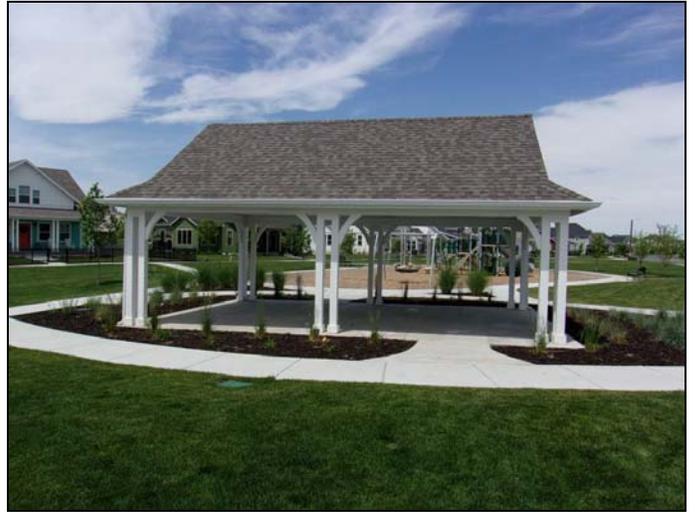
Comp #: 120 Pavilion Rain Gutters/Downspouts - Replace

*Location:* Pavilion Exterior

The rain gutters and downspouts are in good condition. We recommend funding to replace this component approximately every 25 - 30 years. Remaining life based on current age.

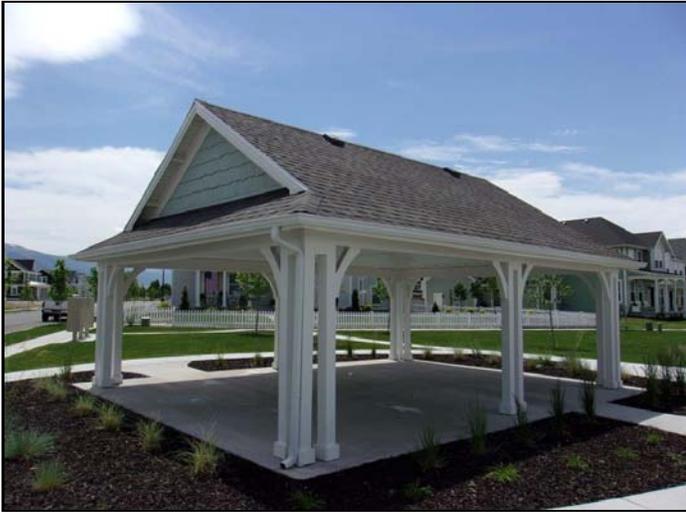
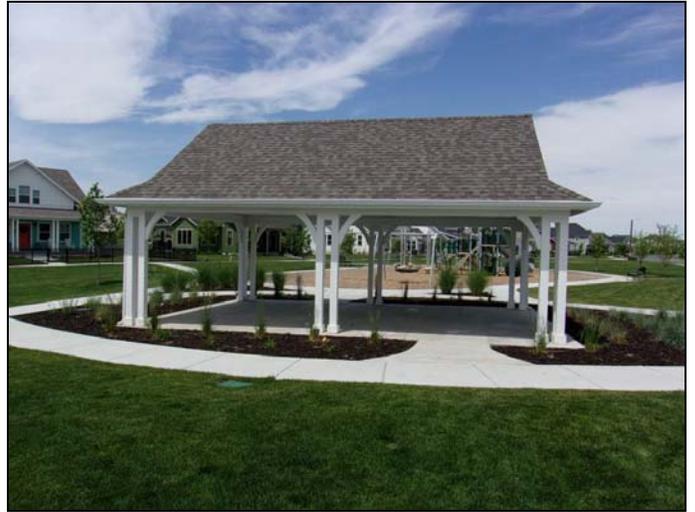
Comp #: 215 Pavilion - Repair/Repaint

*Location:* Pavilion Exterior

The painted surfaces are in good condition. We recommend funding to repair/repaint this component approximately every 8 - 10 years. Remaining life is based on current age.

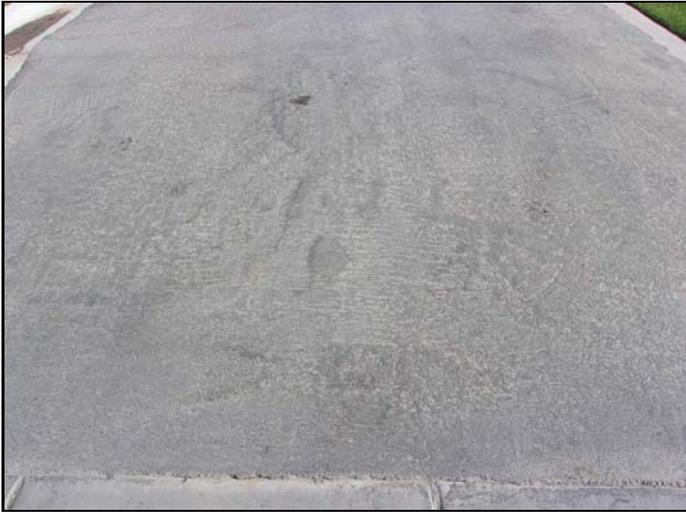
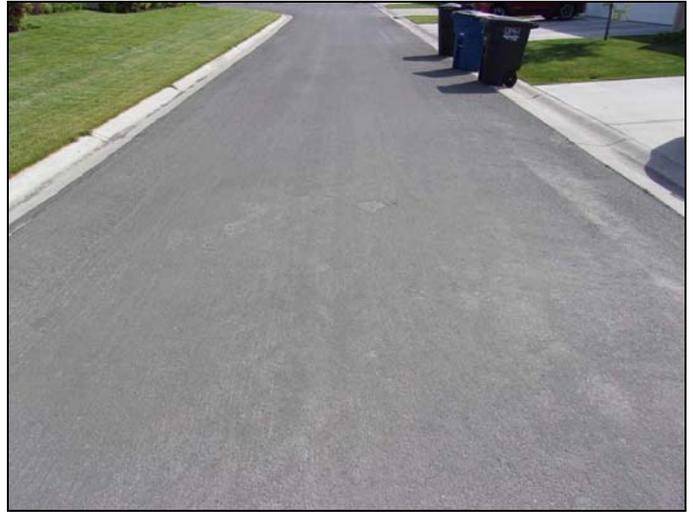
Comp #: 401 Asphalt - Major Rehab

*Location:* **Community Alleys**

The asphalt surfaces are generally in good condition. We recommend funding for a major rehab of this component approximately every 25 - 30 years. Remaining life based on current average age.

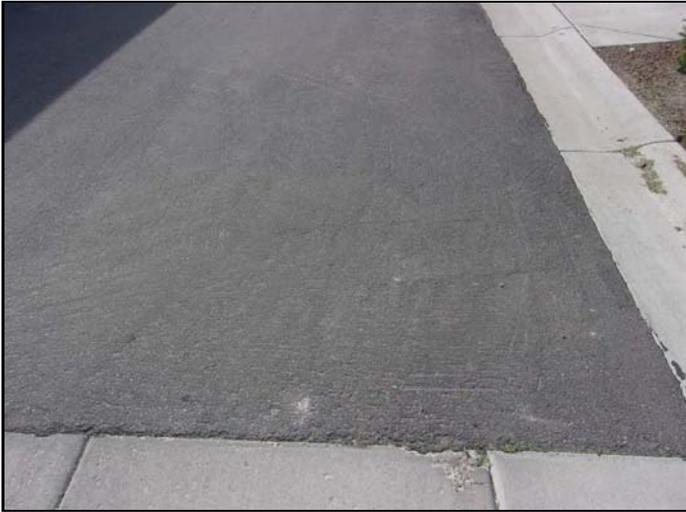
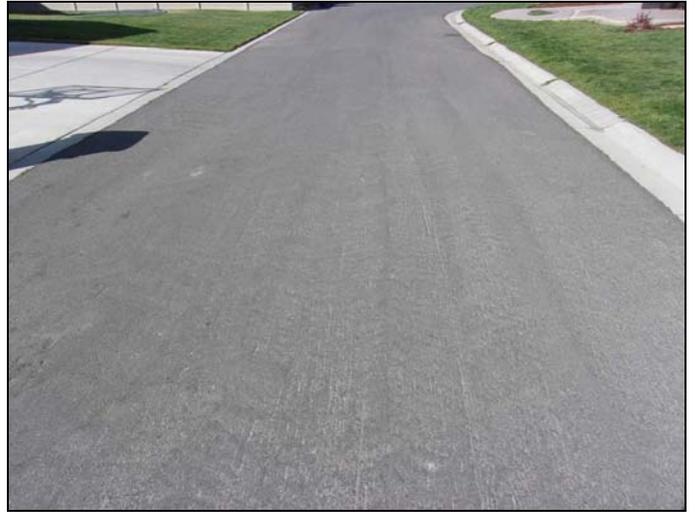
Comp #: 402 Asphalt - Seal Coat

*Location:* **Community Alleys**

The asphalt seal coat is in fair to poor condition. We recommend funding to seal this component approximately every 3 - 5 years. Remaining life based on current condition.

Projects programmed to occur this fiscal year (FY2021) include asphalt seal coat (Comp# 402). We have programmed an estimated \$24,500 in reserve expenditures toward the completion of these projects. (See page 15)

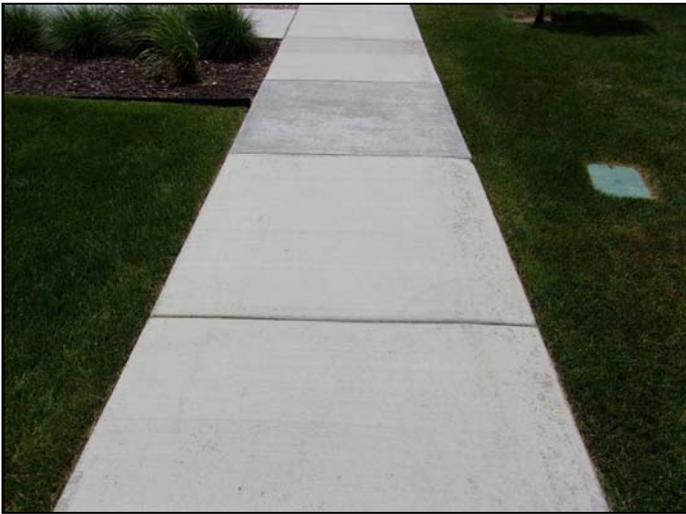
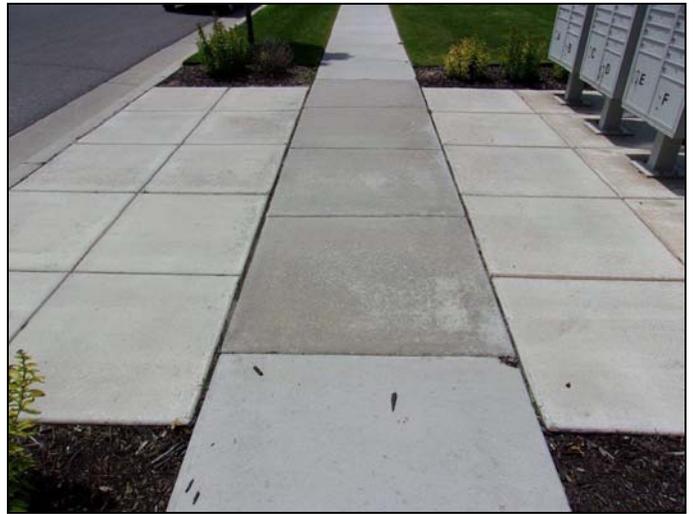
Comp #: 403 Concrete - Repair/Replace

*Location:* **Sidewalks**

The concrete is generally in good condition. This component has an extended useful life under normal conditions. We recommend funding to make repairs and partially replace this component approximately every 10 years. Remaining life based on current age.

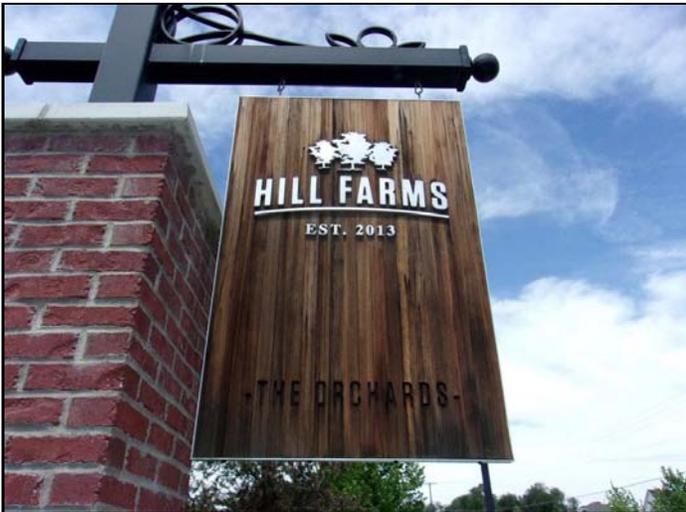
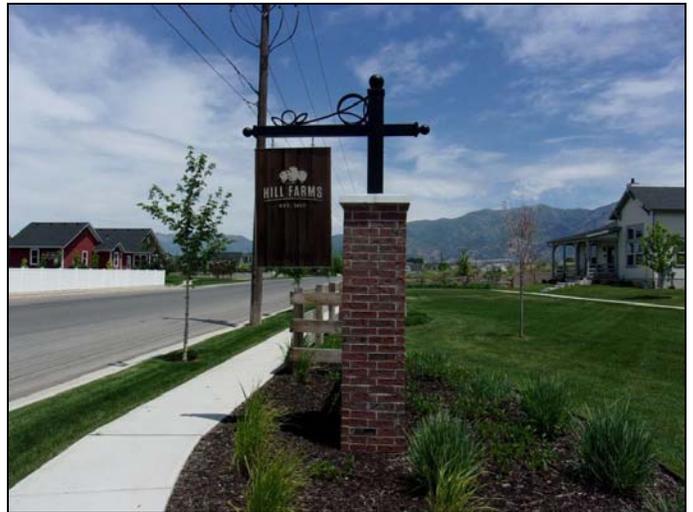
Comp #: 801 Monument Signs - Replace

*Location:* **Common Area**

The monument signs are in good to fair condition. We recommend funding to replace this component approximately every 15 - 20 years. Remaining life is based on current age.

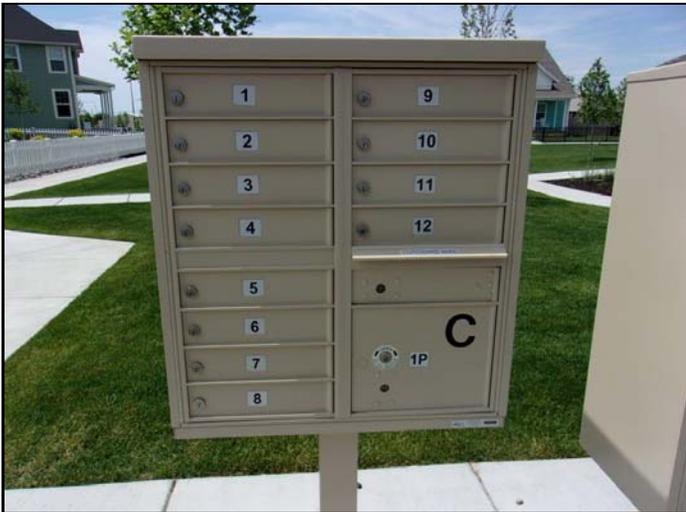
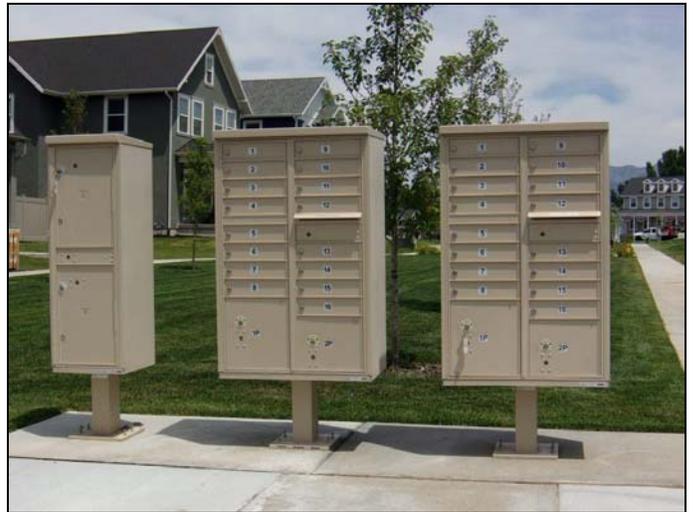
Comp #: 803 Mailboxes - Replace

*Location:* **Common Area**

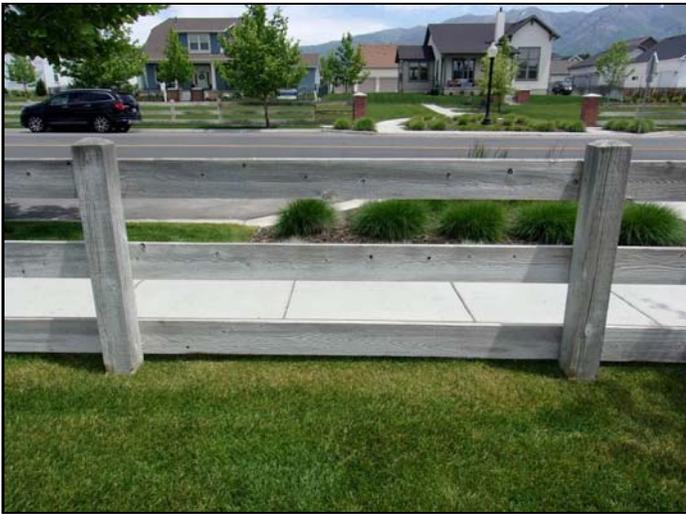
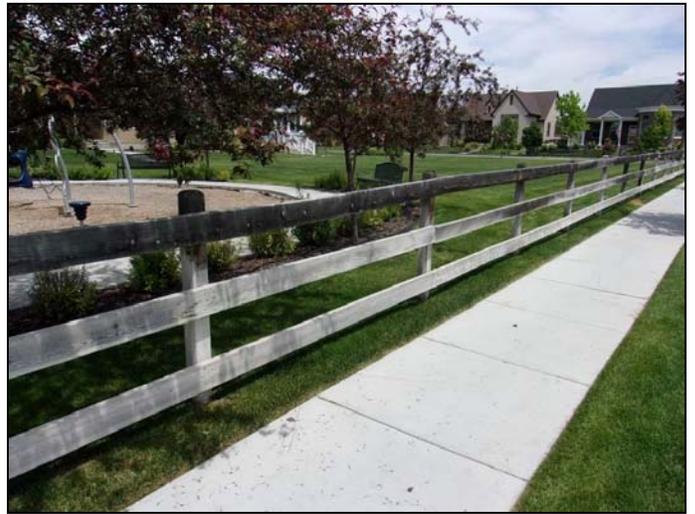
Comp #: 1009 Split Rail Fencing - Replace

*Location:* **Common Area**

The split rail fencing is in good to fair condition. We recommend funding to replace this component approximately every 15 - 20 years. Remaining life based on current age.

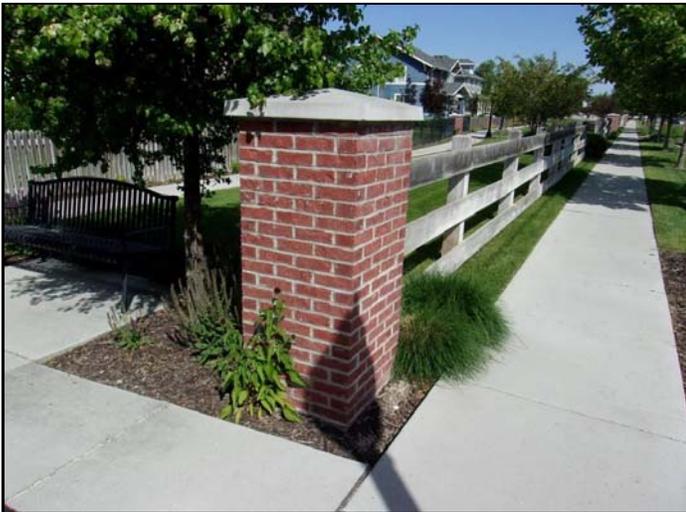
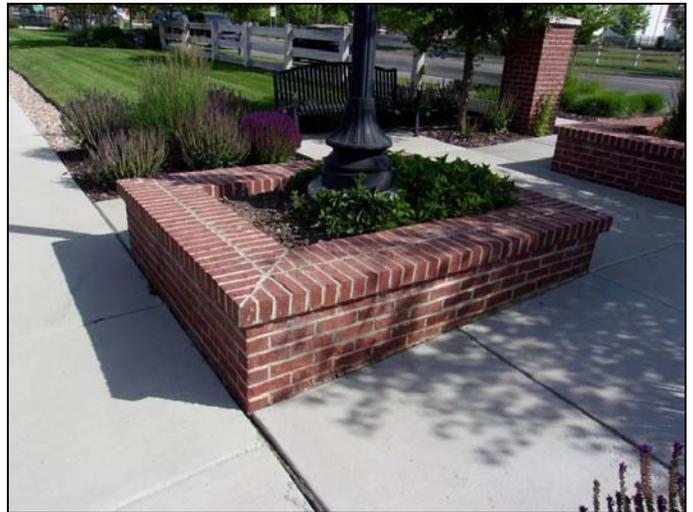
Comp #: 1090 Brick Columns & Planter Boxes - Replace

*Location:* **Common Area**

This component has an extended useful life under normal conditions. Repair as necessary as an operating expense. No reserve funding necessary.

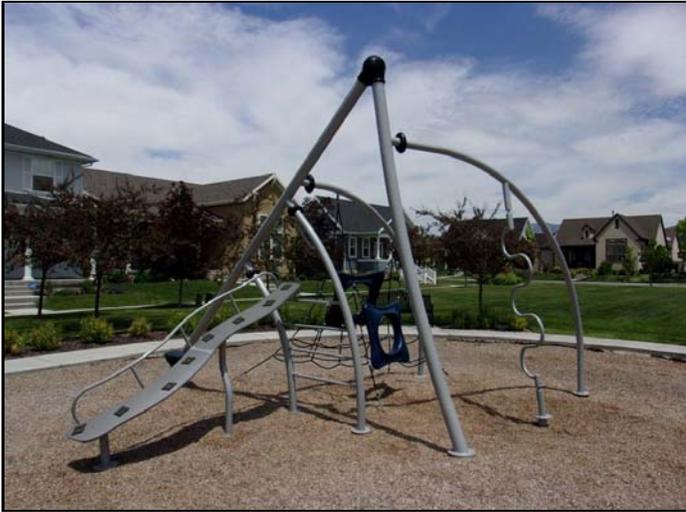
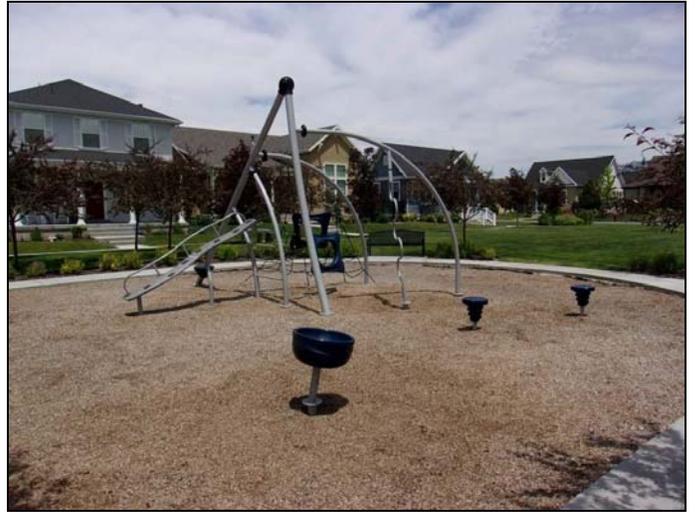
Comp #: 1301 Play Structures - 2015 - Replace

*Location:* **Southwest Play Area**

The play structures are in good condition. We recommend funding to replace this component approximately every 20 - 25 years. Remaining life based on current age.

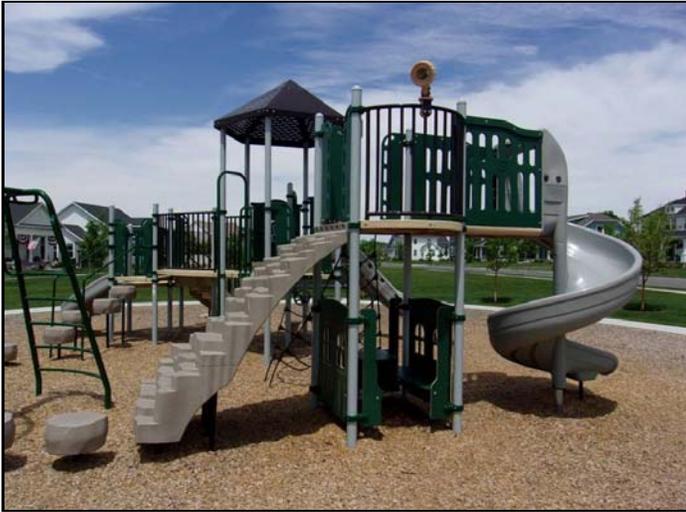
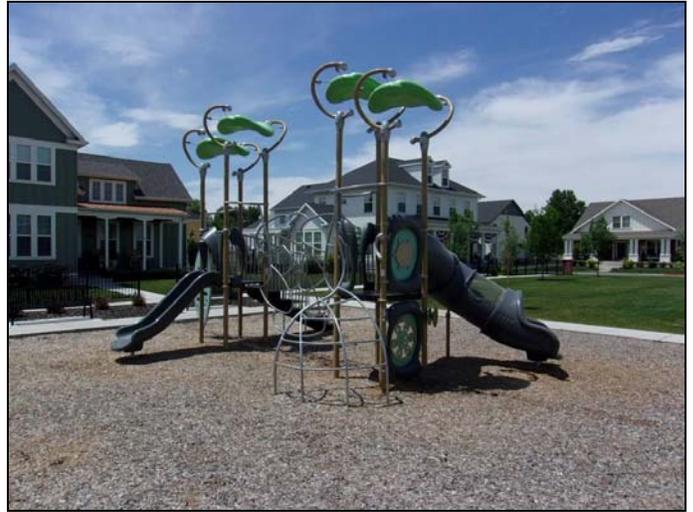
Comp #: 1301 Play Structures - 2018 - Replace

*Location:* **North & Southeast Play Areas**

The play structures are in good condition. We recommend funding to replace this component approximately every 20 - 25 years. Remaining life based on current age.

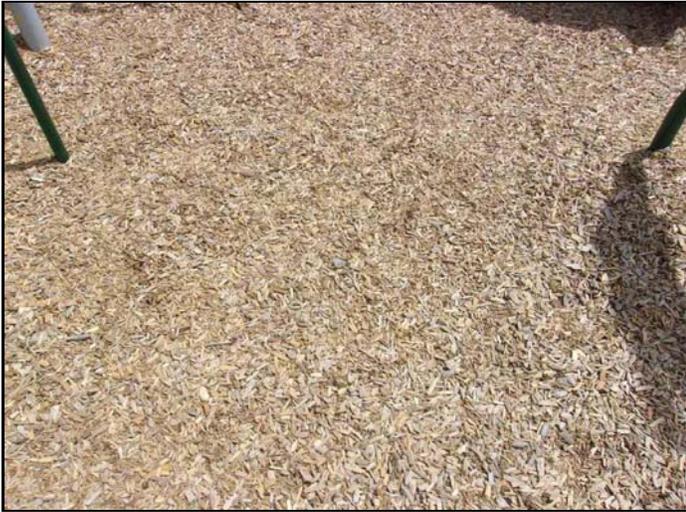
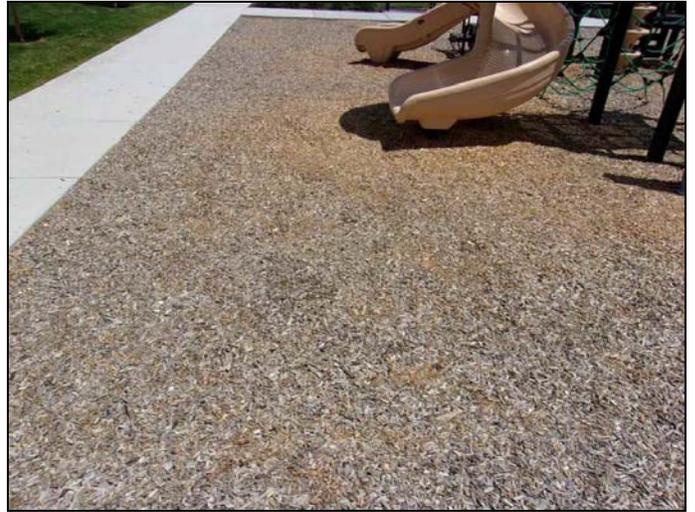
Comp #: 1303 Play Area Groundcover - Refill

*Location:* **Play Area**

The play area groundcover is in good to fair condition. We recommend funding to refill this component approximately every 3 - 5 years. Remaining life is based on current age.

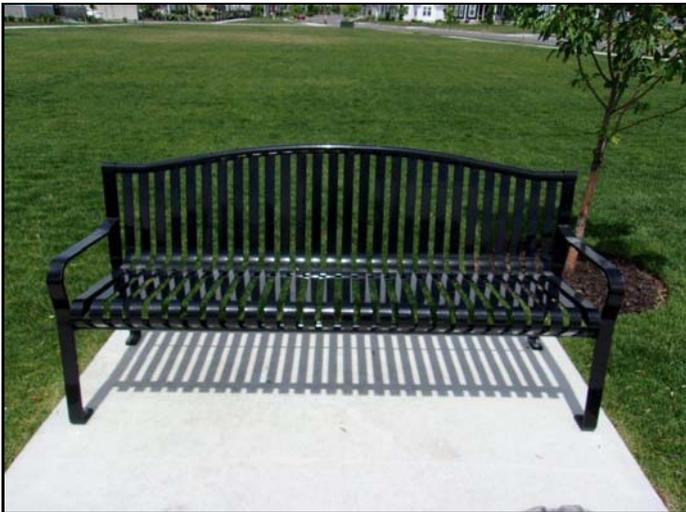
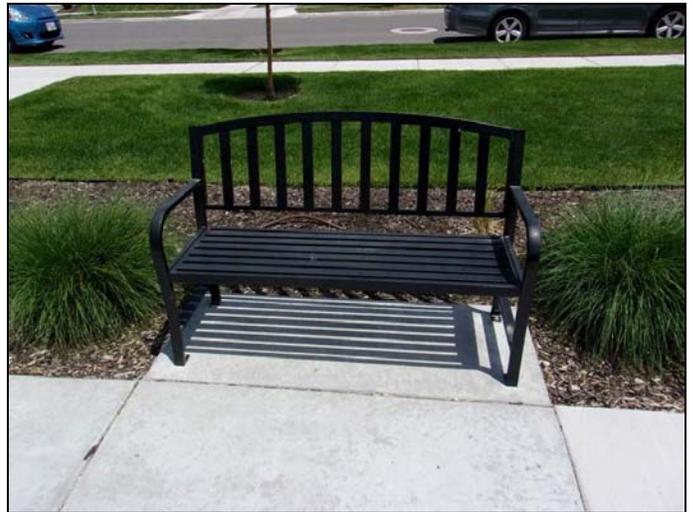
Comp #: 1307 Benches - Replace

*Location:* **Common Area**

The benches are in good condition. We recommend funding to replace this component approximately every 15 - 20 years. Paint as necessary as an operating expense. Remaining life based on current age.

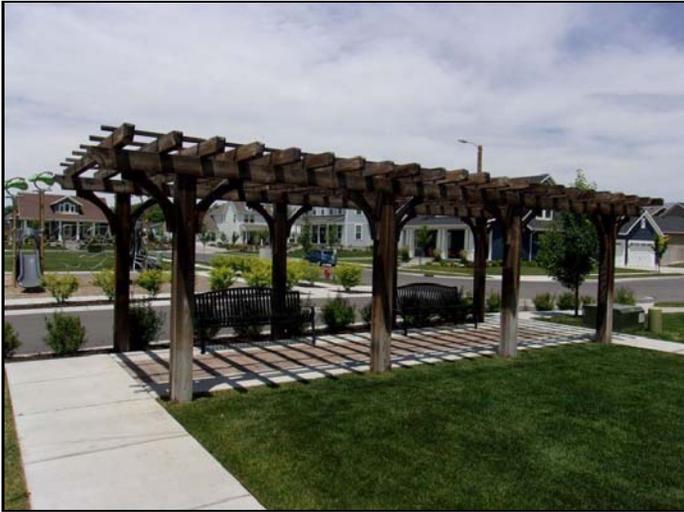
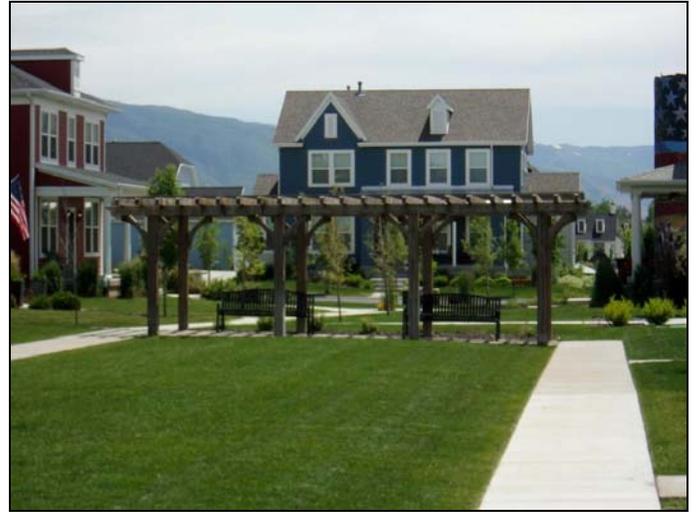
Comp #: 1309 Pergolas - Replace

*Location:* **Common Area**

The pergolas are in good condition. We recommend funding to replace this component approximately every 25 - 30 years. Remaining life based on current age.

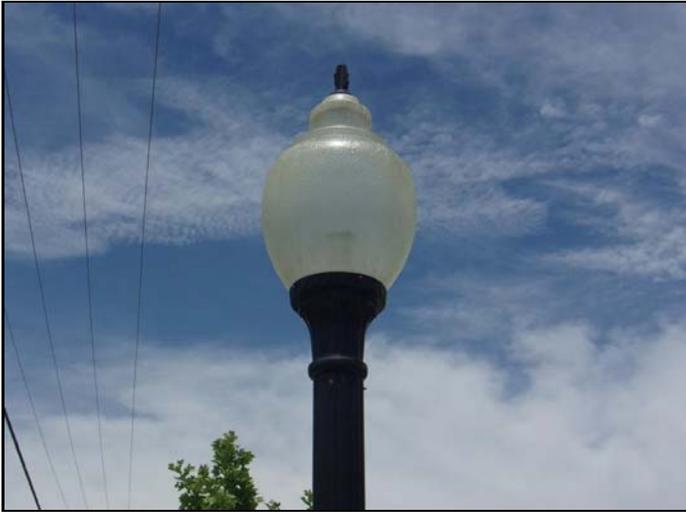
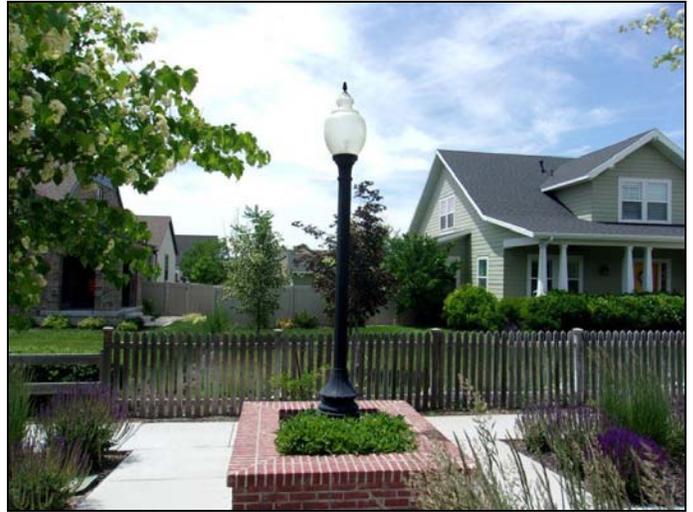
Comp #: 1609 Street Light Fixtures - Replace

*Location:* **Common Area**

The street light fixtures are in good condition. No expectation to replace the light poles. Paint poles as necessary as an operating expense. We recommend funding to replace this component approximately every 20 years. Remaining life based on current age.

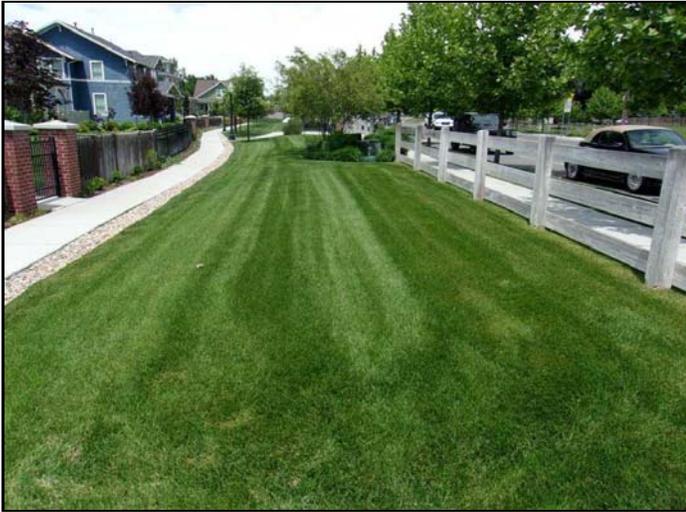
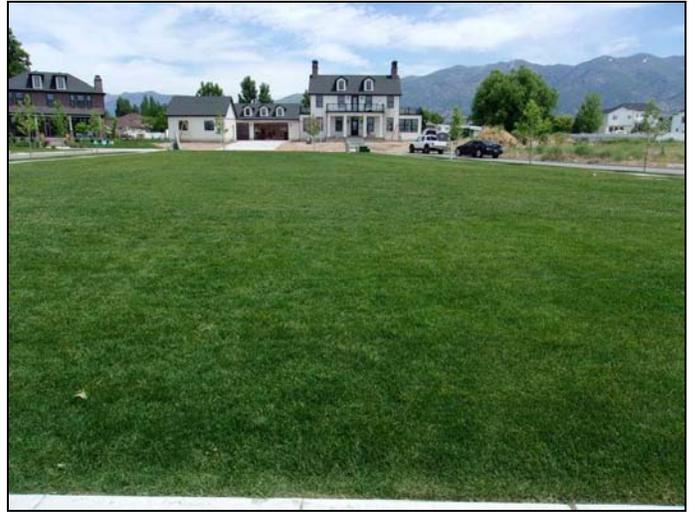
Comp #: 1812 Landscaping & Irrigation System - Renovate

*Location:* **Common Area**

The landscaping and irrigation system are in good condition. We recommend funding for an allowance to renovate the landscaping and irrigation system approximately every 20 years. Remaining life based on current age.
