South Willow Creek HOA

Level 2 Reserve Study

Report Period – 01/01/2023 – 12/31/2023

Executive Summary – South Willow Creek HOA - ID # 12490

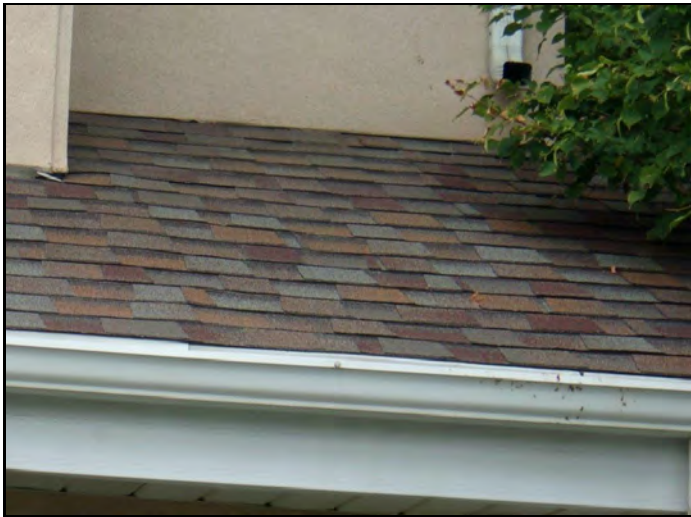
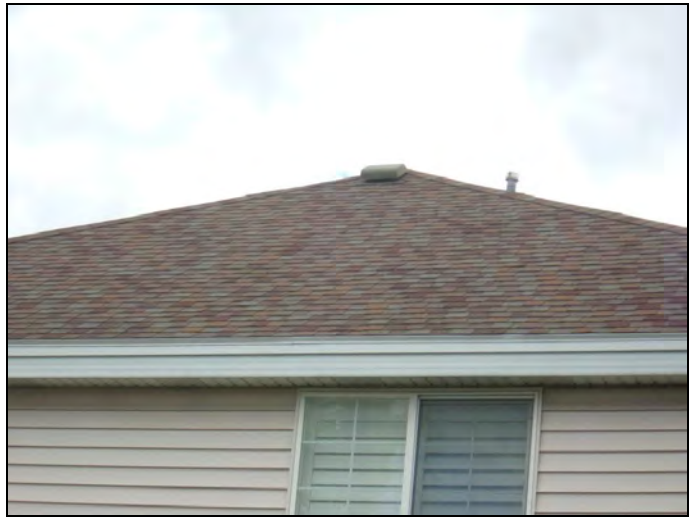
Comp #: 105 Roofs - Replace

Location: **Building Roofs**

Research with the client reveals they plan to start roof replacements in 2024. We recommend funding to replace this component approximately every 20 - 25 years. Remaining life based on current age.

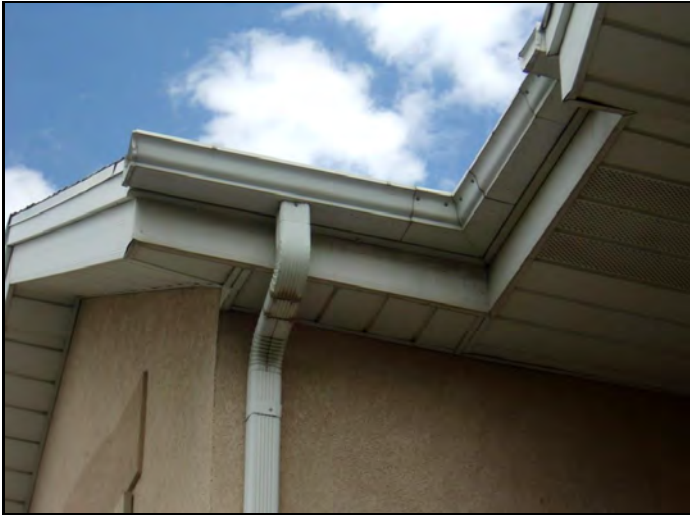
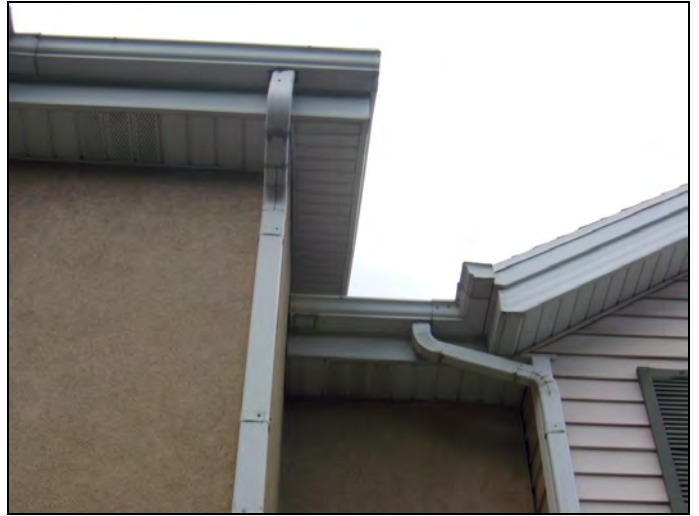
Comp #: 120 Rain Gutters/Downspouts - Replace

Location: **Building Roofs**

The rain gutters and downspouts are in good to fair condition. We recommend funding to replace this component approximately every 25 - 30 years. Remaining life based on current age.

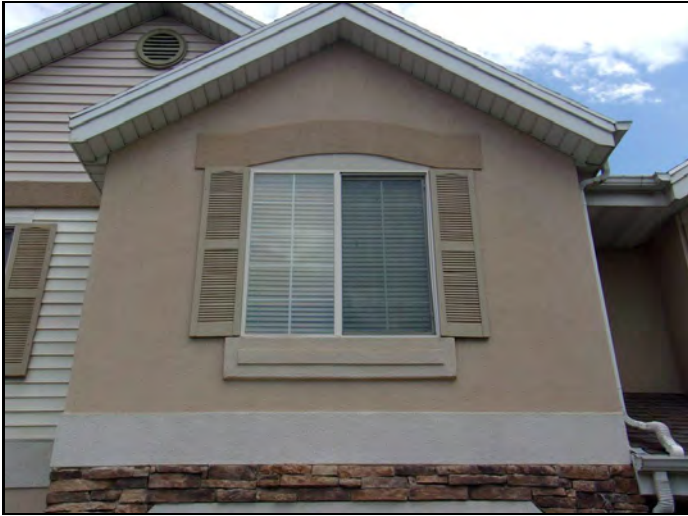
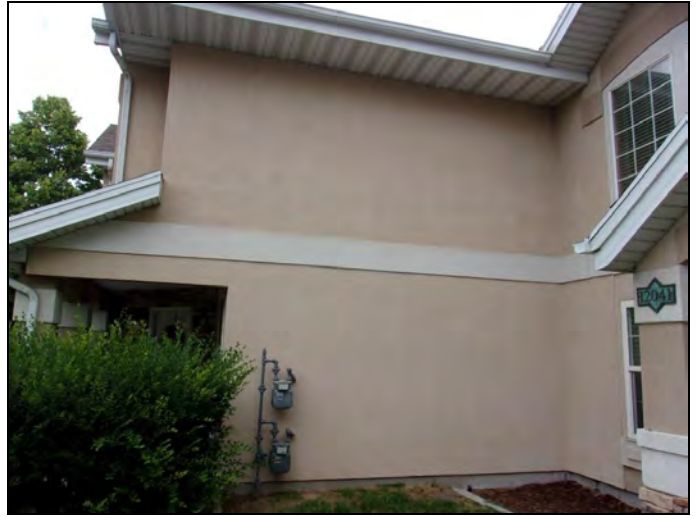
Comp #: 201 Stucco Surfaces - Repair/Repaint

Location: **Building Exteriors**

The stucco surfaces are in fair condition. We recommend funding to repair/repaint this component approximately every 12 - 15 years. Remaining life based on current age..

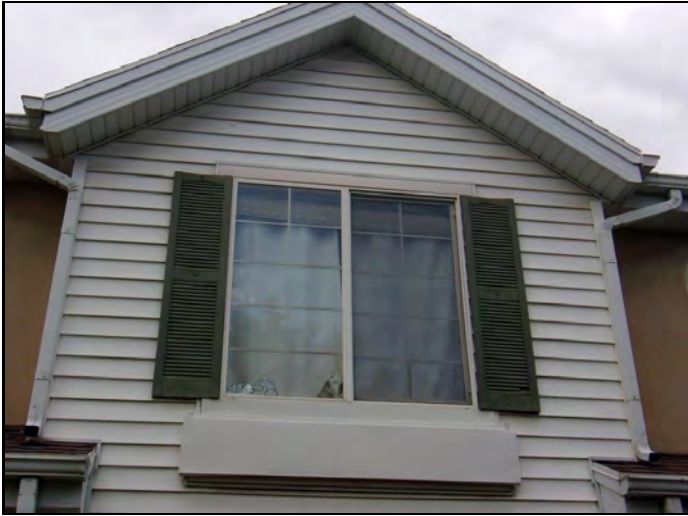
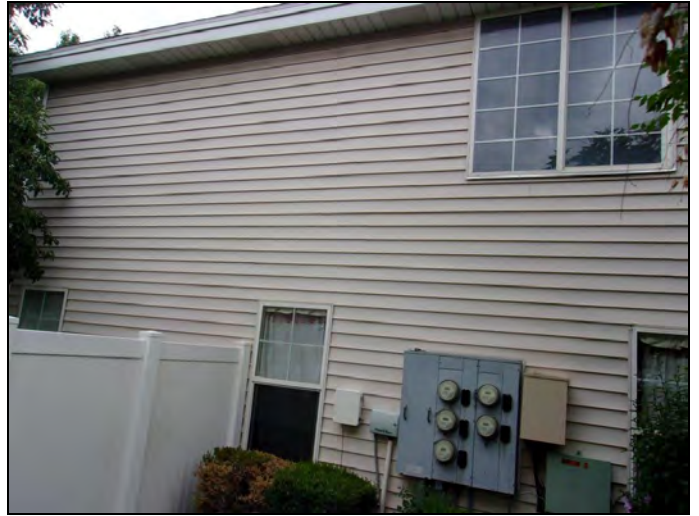
Comp #: 302 Vinyl Siding - Replace

Location: **Building Exteriors**

The vinyl siding is in good to fair condition. We recommend funding to replace this component approximately every 40 - 50 years. Remaining life based on current age.

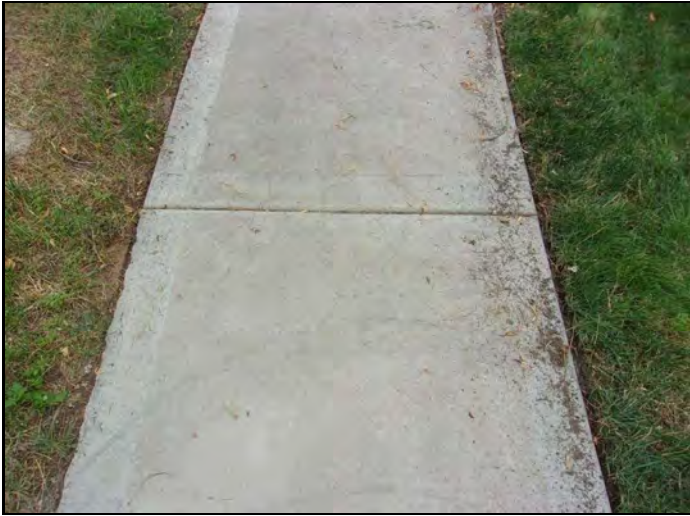
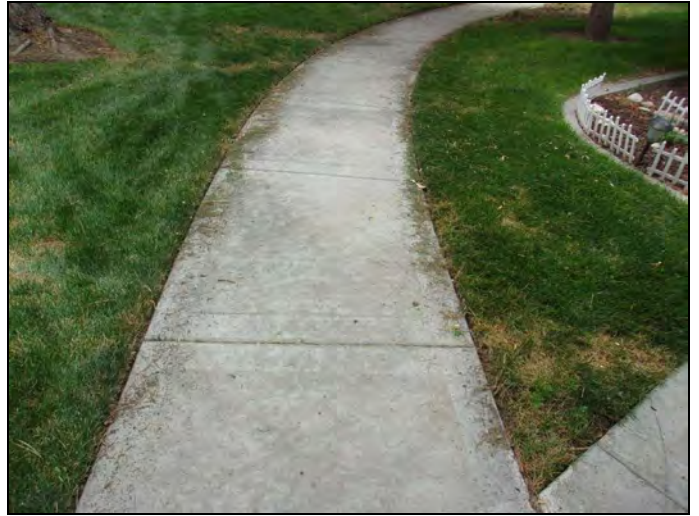
Comp #: 403 Concrete - Repair/Replace

Location: **Community Curb, Gutter & Sidewalks**

The concrete is generally in good condition. This component has an extended useful life under normal conditions. We recommend funding to make repairs and partially replace this component approximately every 10 years. Remaining life based on current age.

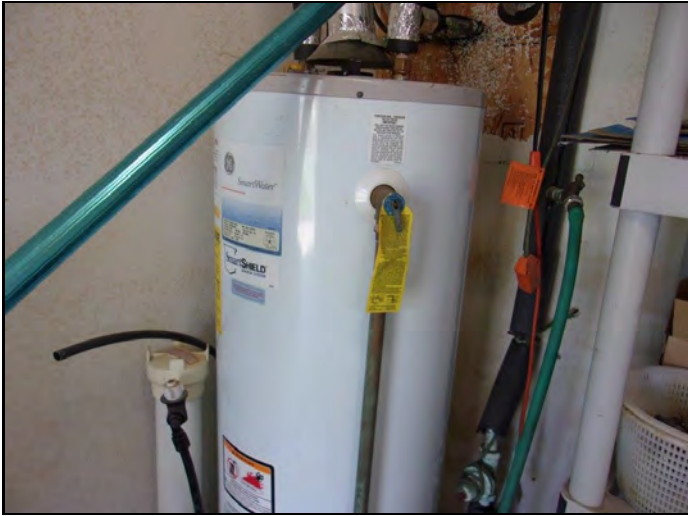
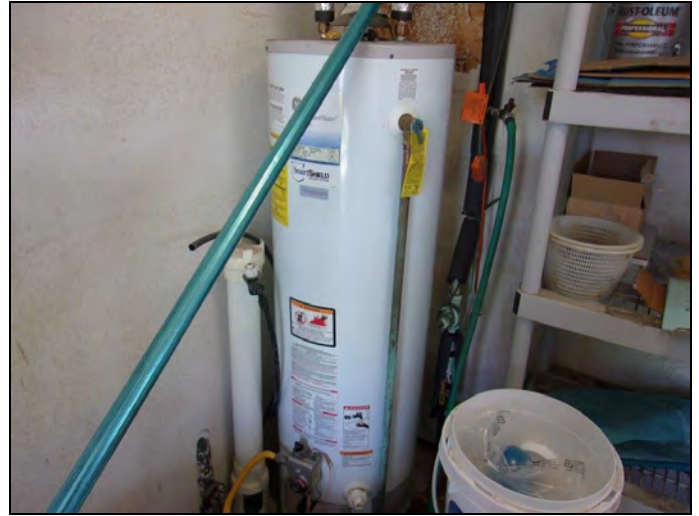
Comp #: 703 Water Heater - Replace

Location: **Pool Equipment Room**

Due to the minimal cost of replacing this component, reserve funding is not appropriate. Replace as necessary as an operating expense.

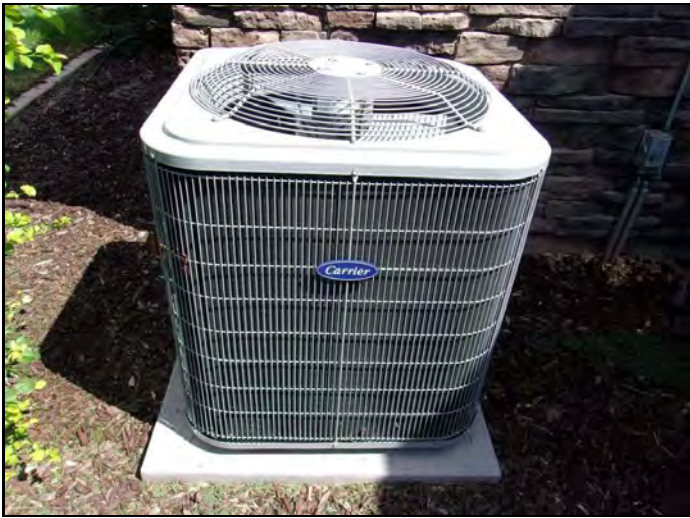
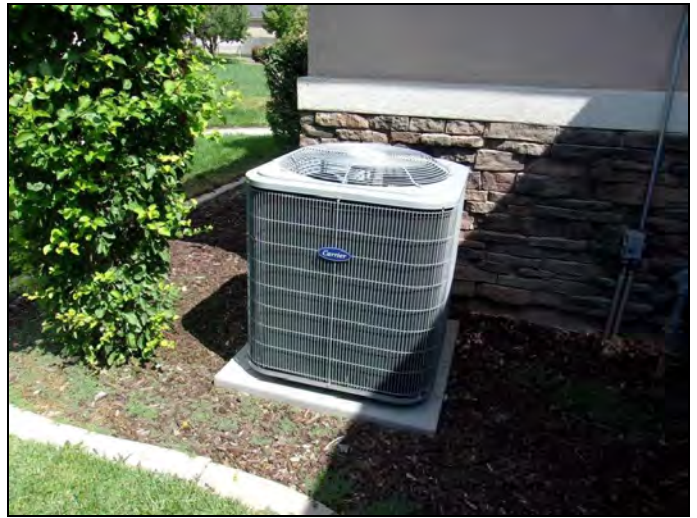
Comp #: 705 HVAC Condenser - Replace

Location: **Adjacent to Clubhouse**

The HVAC condenser is in working condition. We recommend replacing this component approximately every 20 years. Remaining life based on current age.

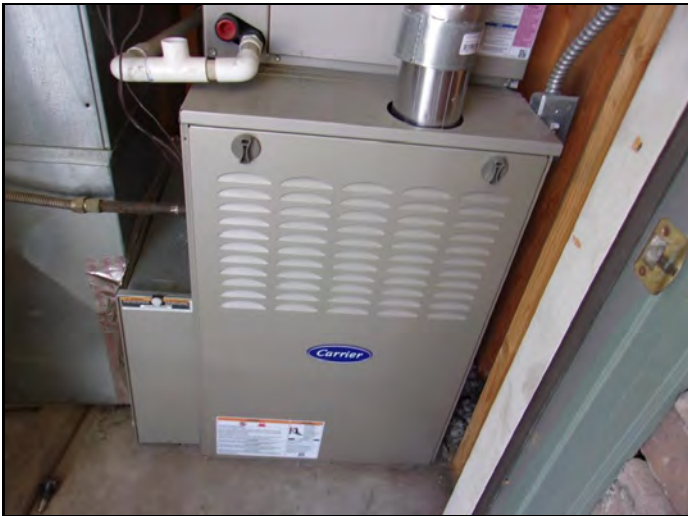
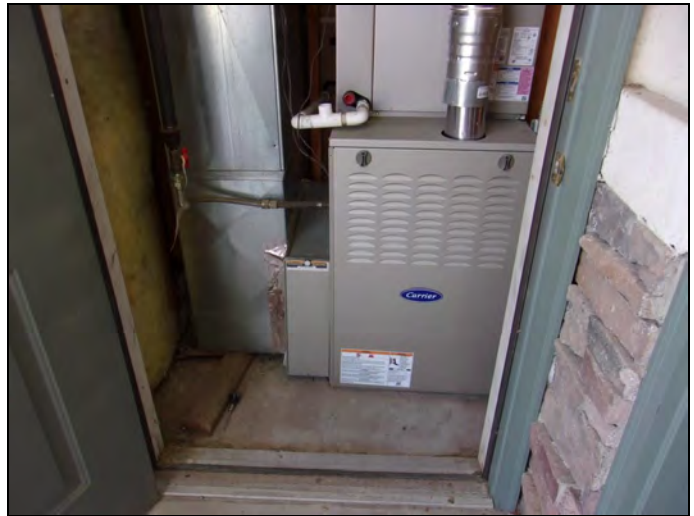
Comp #: 706 HVAC Furnace - Replace

Location: **Furnace Closet**

The furnace is in working condition. We recommend funding to replace this component approximately every 20 years. Remaining life based on current age.

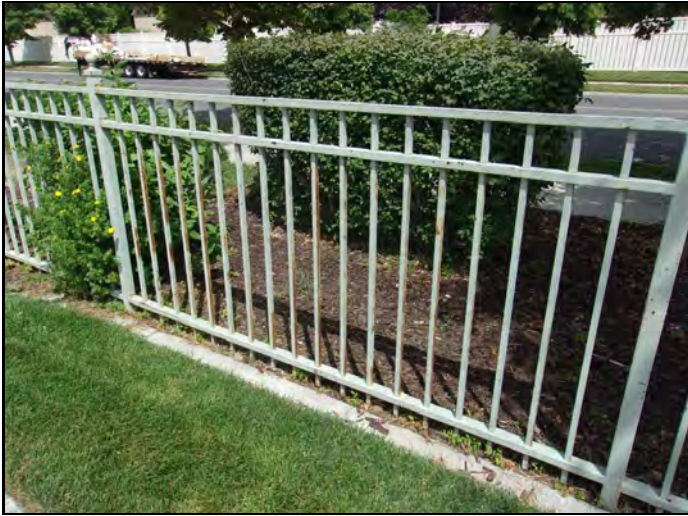
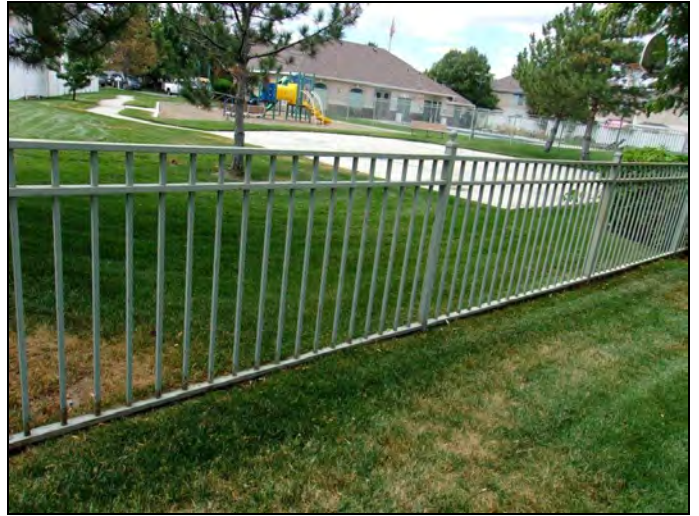
Comp #: 1002 Metal Fencing - Replace

Location: **Community & Pool Perimeter**

The metal fencing is in good to fair condition. We recommend funding to replace this component approximately every 40 - 50 years. Remaining life based on current age.

Quantity description:
430 Linear ft. - Perimeter
240 Linear ft. - Pool Area
670 Linear ft. - Total Fencing

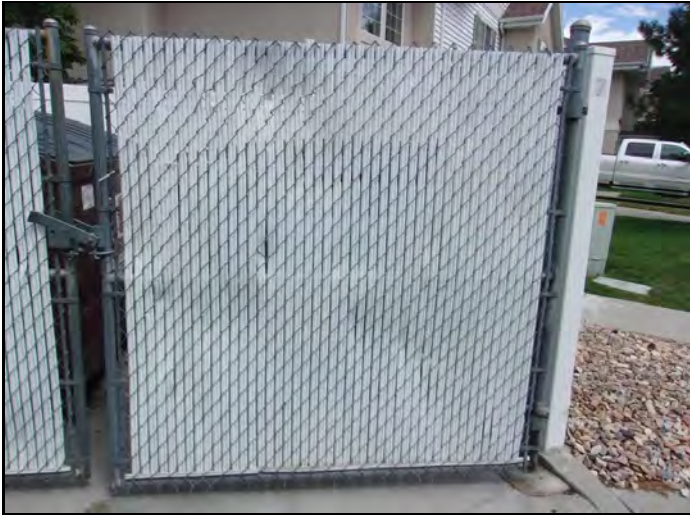
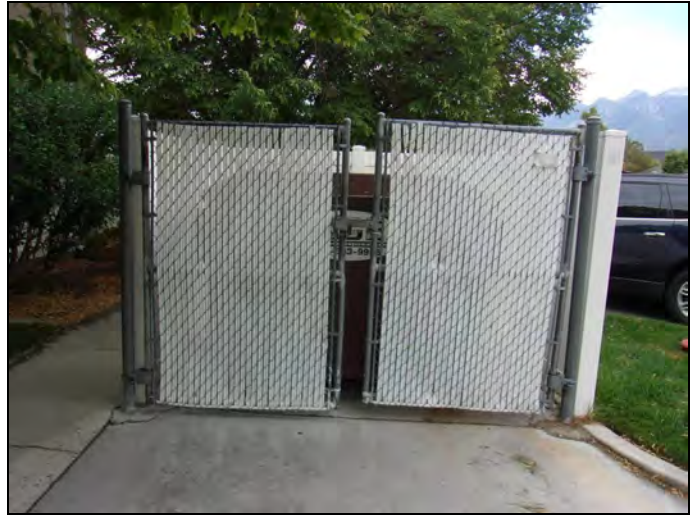
Comp #: 1003 Chain Link Fencing - Replace

Location: **Dumpster Enclosures**

The chain link fencing is in good condition. We recommend funding to replace this component approximately every 30 - 40 years. Remaining life based on current age.

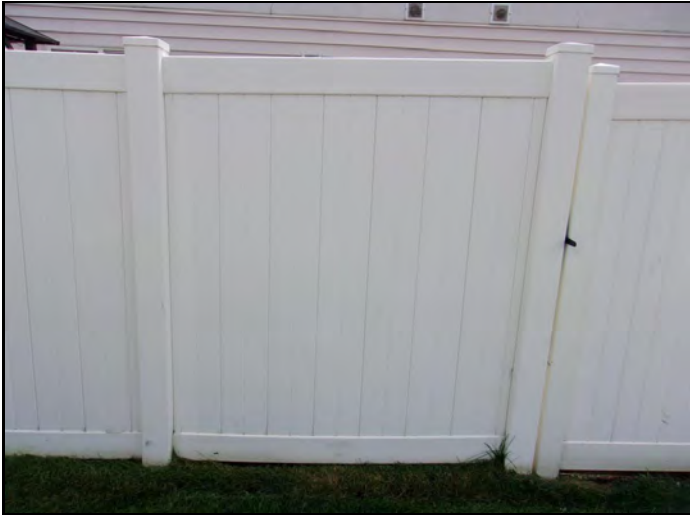
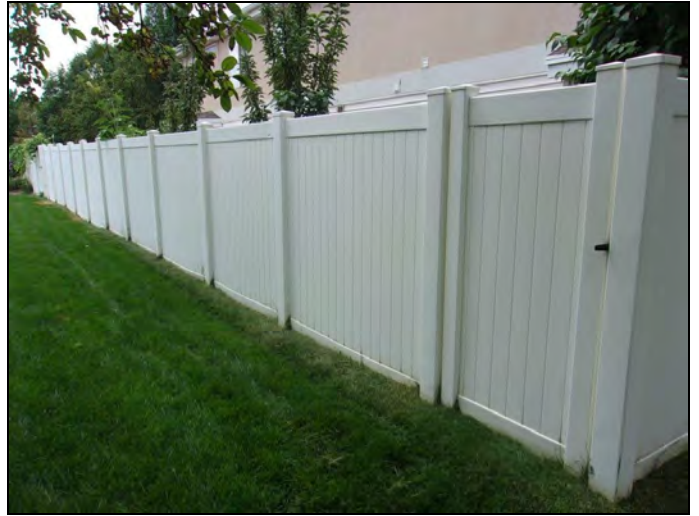
Comp #: 1008 Vinyl Fencing - Replace

Location: **Backyards, Dumpster Areas & Perimeter**

The vinyl fencing is in good to fair condition. We recommend funding to replace this component approximately every 25 - 30 years. Remaining life based on current age.

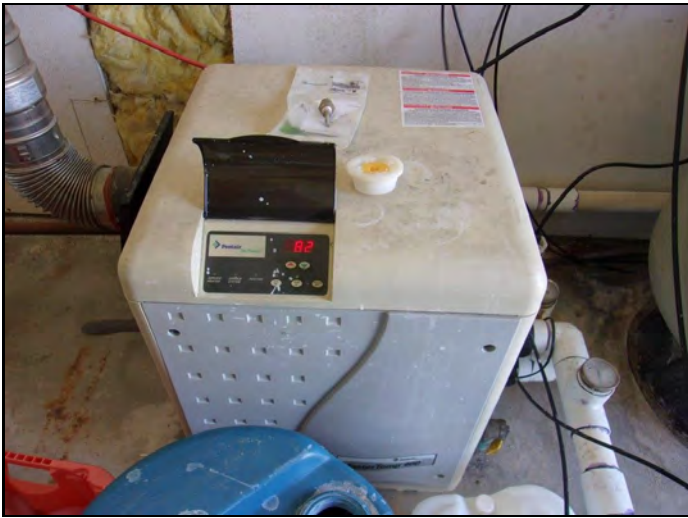
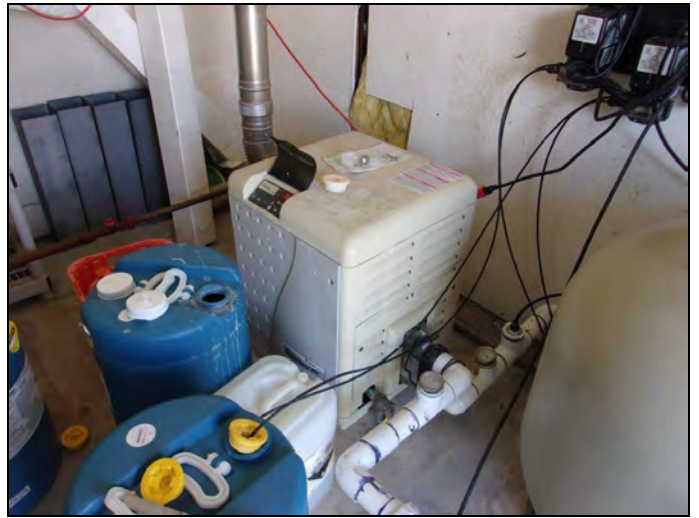
Comp #: 1104 Pool Heater - Replace

Location: **Pool Equipment Room**

The pool heater is in working condition. We recommend funding to replace this component approximately every 12 years. Remaining life based on current age.

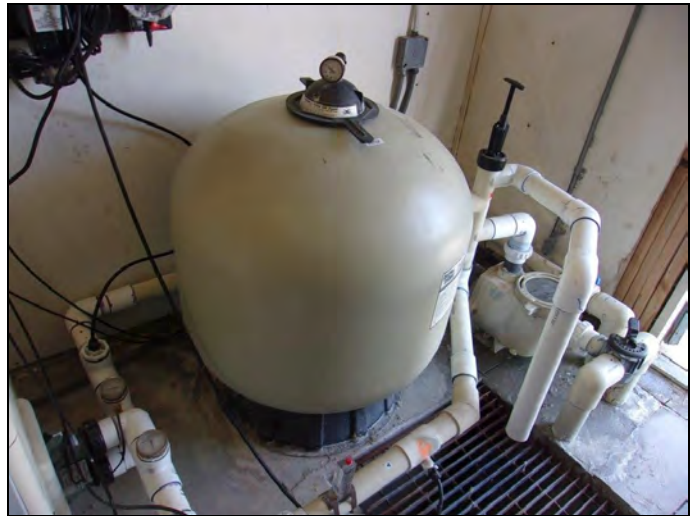
Comp #: 1107 Pool Filter - Replace

Location: **Pool Equipment Room**

Due to the minimal cost of replacing this component, reserve funding is not appropriate. Replace as necessary as an operating expense.

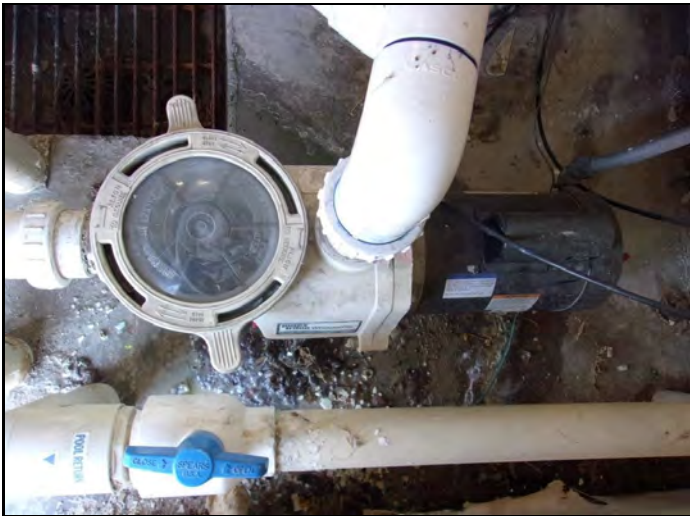
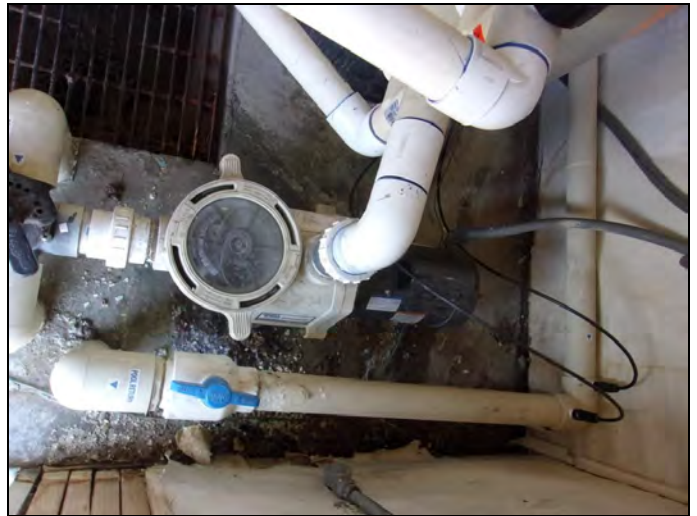
Comp #: 1110 Pool Pump - Replace

Location: **Pool Equipment Room**

Due to the minimal cost of replacing this component, reserve funding is not appropriate. Replace as necessary as an operating expense.

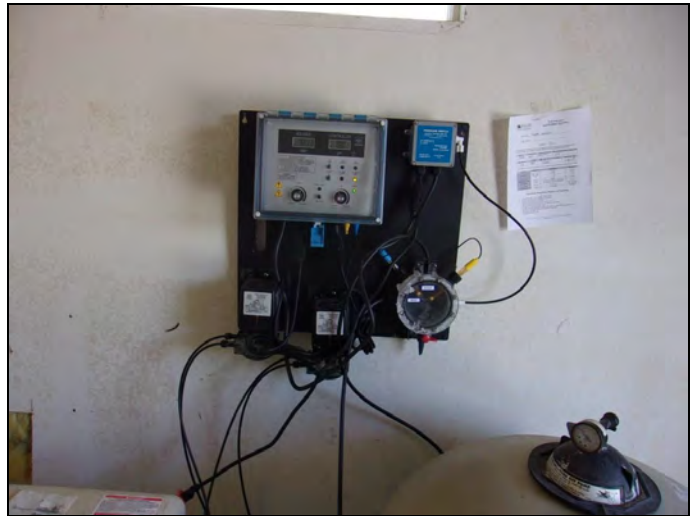
Comp #: 1111 Pool Chemical Controller System - Replace

Location: Pool Equipment Room

The pool chemical controller system is in working condition. We recommend funding to replace this component approximately every 10 - 12 years. Remaining life based on current age.

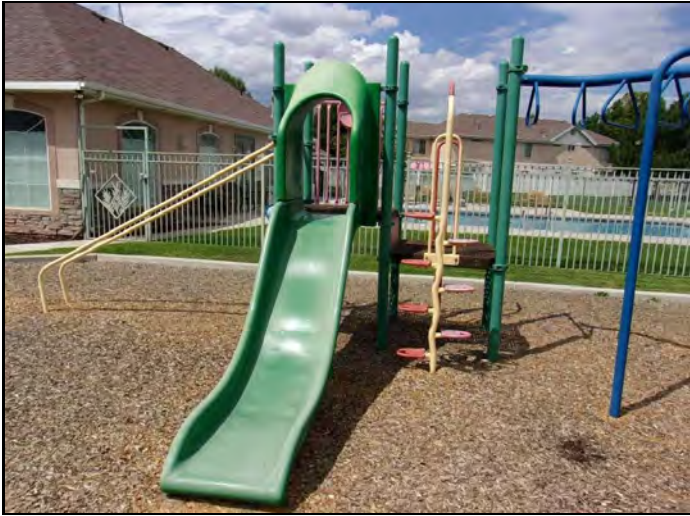
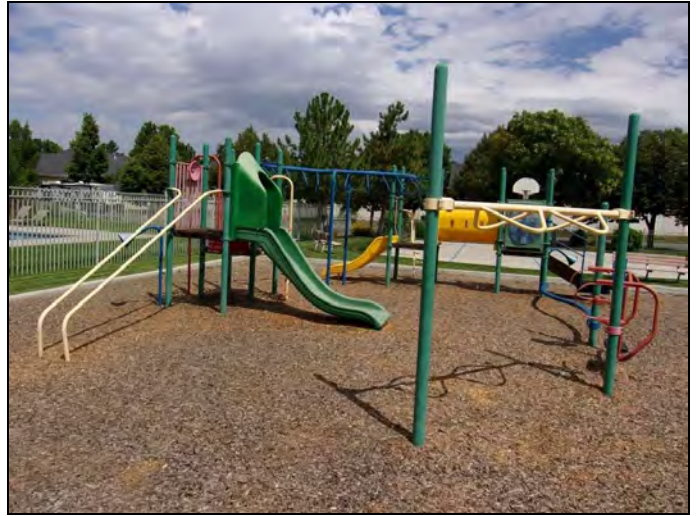
Comp #: 1301 Play Structure - Replace

Location: **Play Areas**

The play structure is generally in fair condition. We recommend funding to replace this component approximately every 20 - 25 years. Remaining life based on current age and condition.

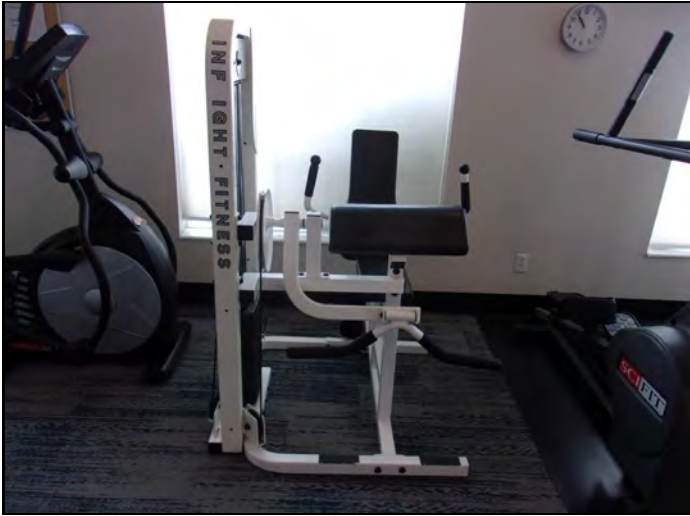
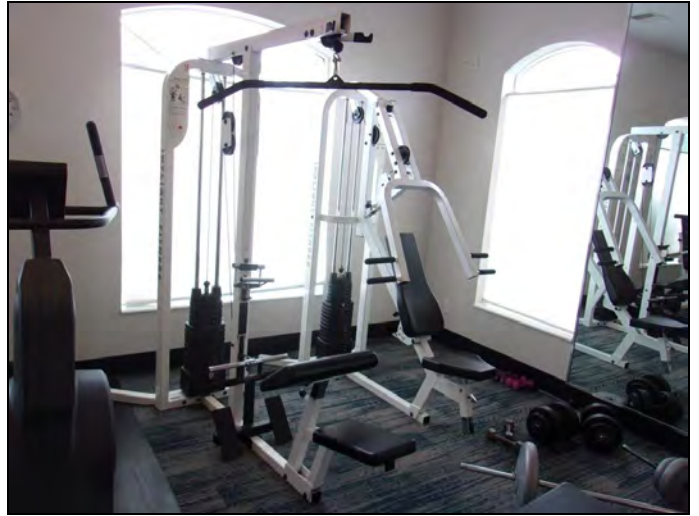
Comp #: 1406 Fitness Equipment - Replace

Location: Clubhouse Fitness Room

The fitness equipment is in working condition. We recommend funding to replace this component approximately every 15 years. Remaining life based on current age and condition.

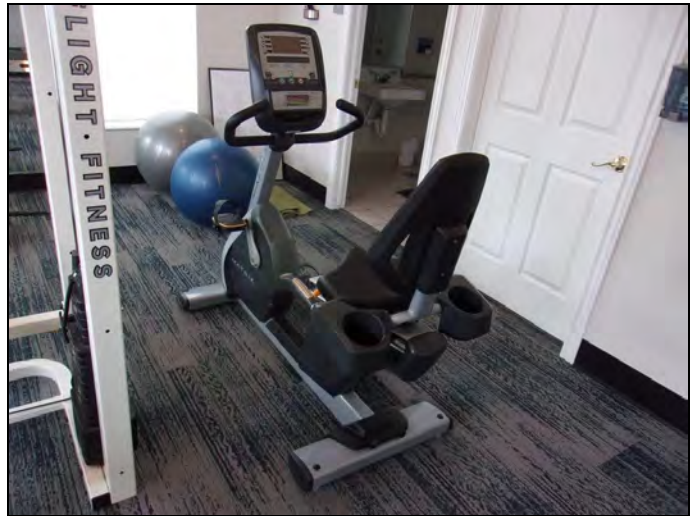
Comp #: 1407 Cardio Equipment - Replace

Location: Clubhouse Fitness Room

The cardio fitness equipment is in working condition. We recommend funding to replace this component approximately every 8 - 10 years. Remaining life based on current age and condition.
