Wyngate Townhomes

Level 2 Reserve Study

Executive Summary – Wyngate Townhomes - ID # 10993

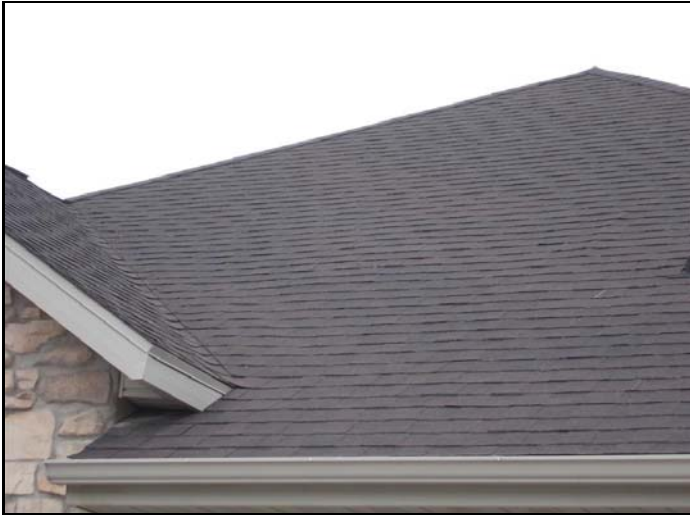
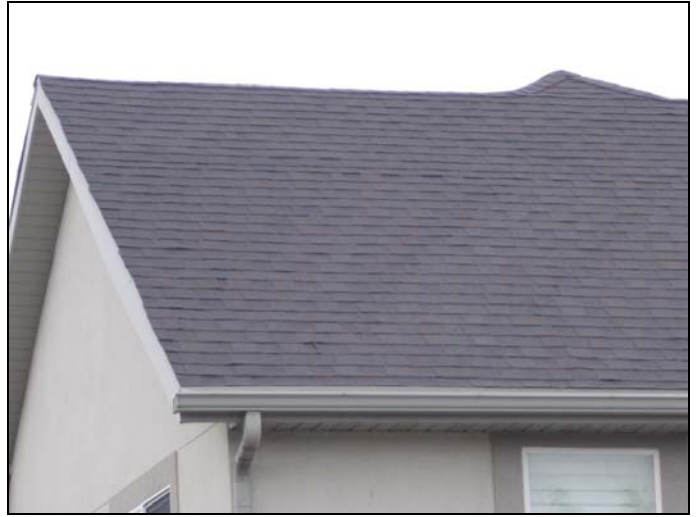
Comp #: 105 Roofs - 2003 - Replace

The roofs are in good to fair condition. We recommend funding to replace this component approximately every 20 - 25 years. Remaining life based on current age.

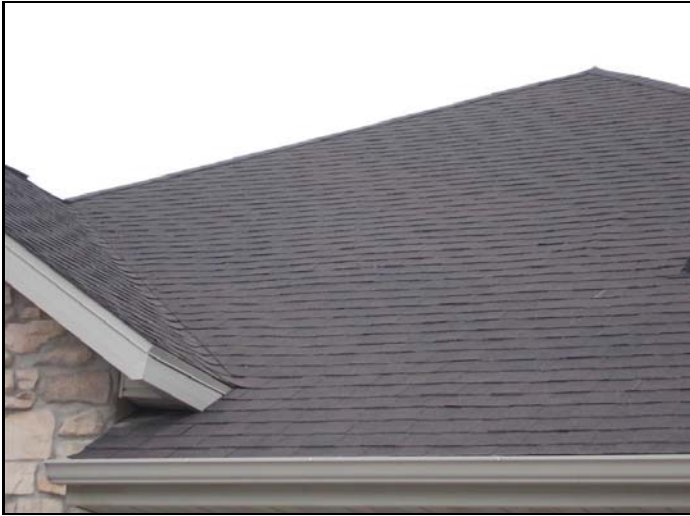
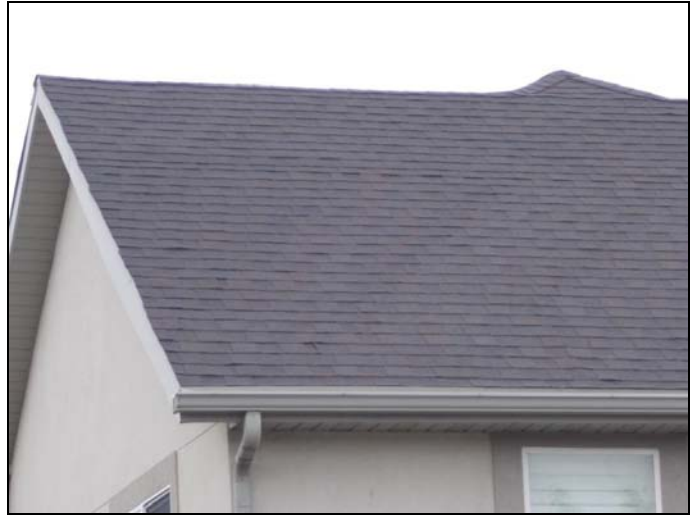
Comp #: 105 Roofs - 2004 - Replace

The roofs are in good to fair condition. We recommend funding to replace this component approximately every 20 - 25 years. Remaining life based on current age.

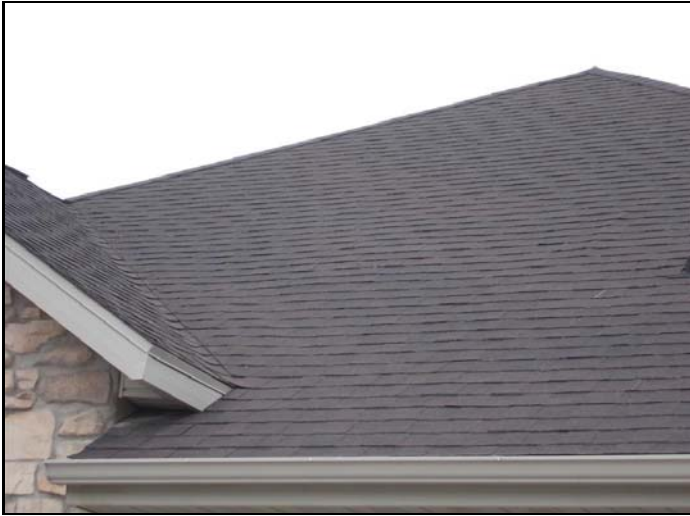
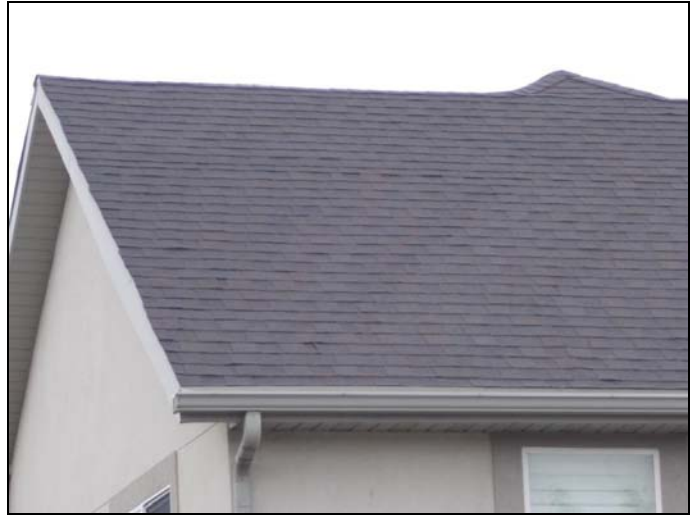
Comp #: 105 Roofs - 2005 - Replace

The roofs are in good to fair condition. We recommend funding to replace this component approximately every 20 - 25 years. Remaining life based on current age.

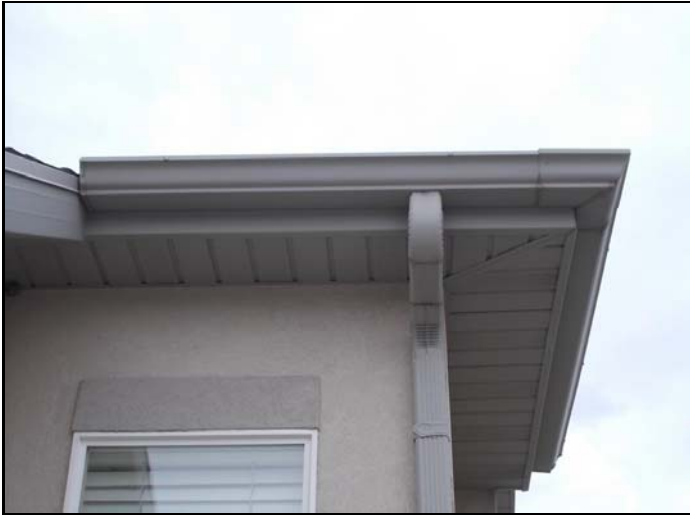
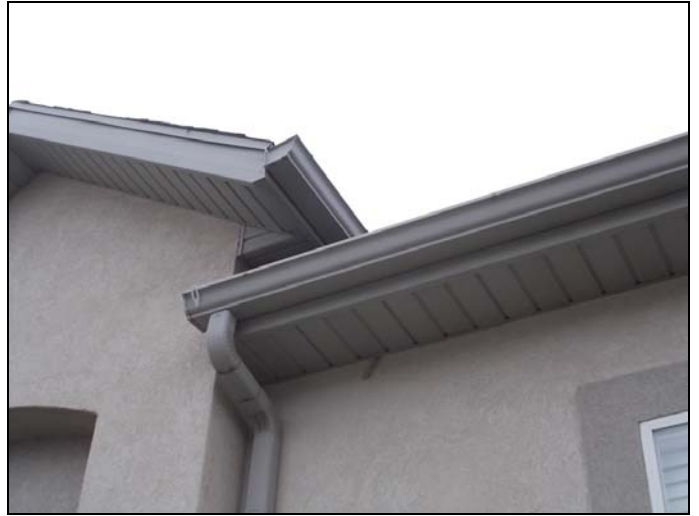
Comp #: 120 Rain Gutters/Downspouts - Replace

The rain gutters and downspouts are in good condition. We recommend funding to replace this component approximately every 25 - 30 years. Remaining life based on current age.

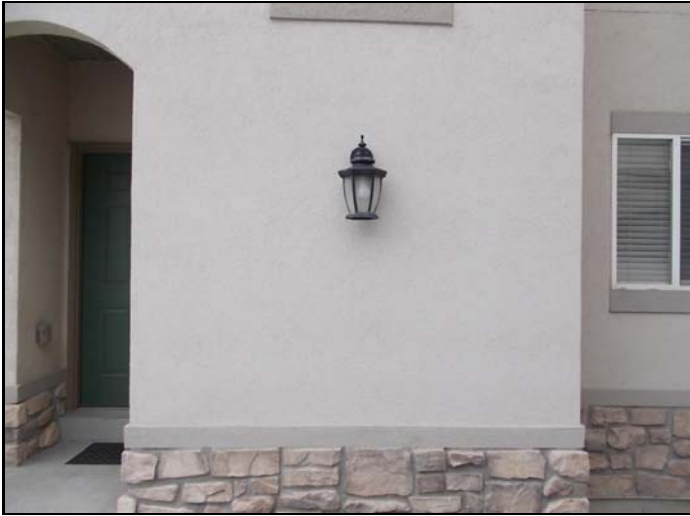
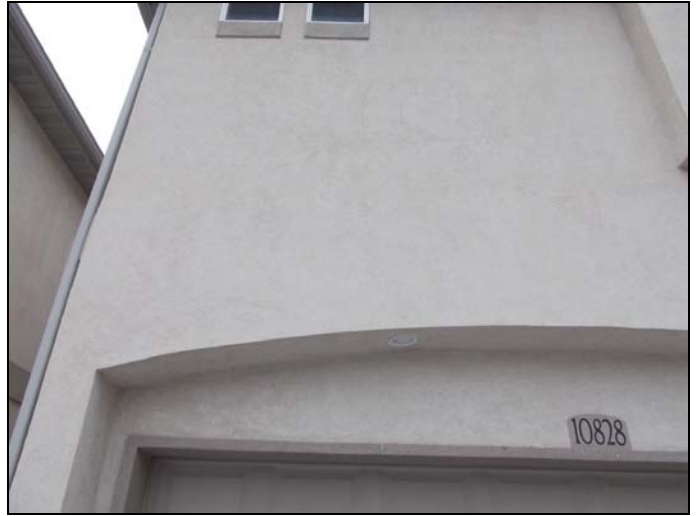
Comp #: 201 Stucco Surfaces - Repair/Repaint

The stucco surfaces are in fair condition. We recommend funding to repair/repaint this component approximately every 12 - 15 years. Remaining life based on current age.

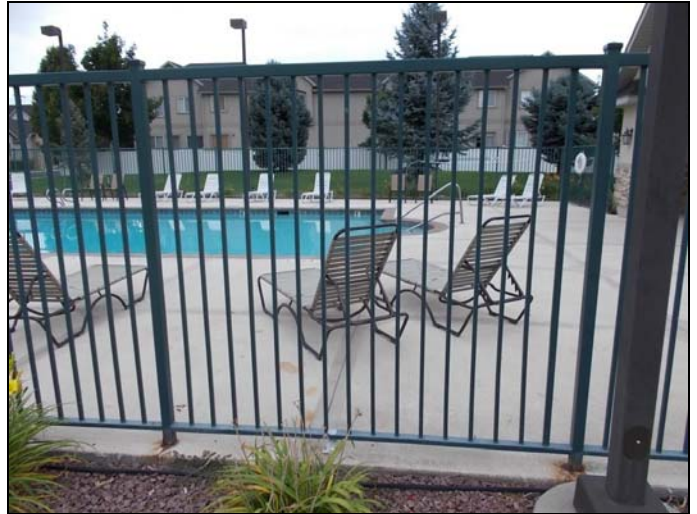
Comp #: 207 Metal Surfaces - Repaint

The painted metal fencing surfaces are in poor condition. We recommend funding to repaint this component approximately every 6 years. Remaining life based on current condition.

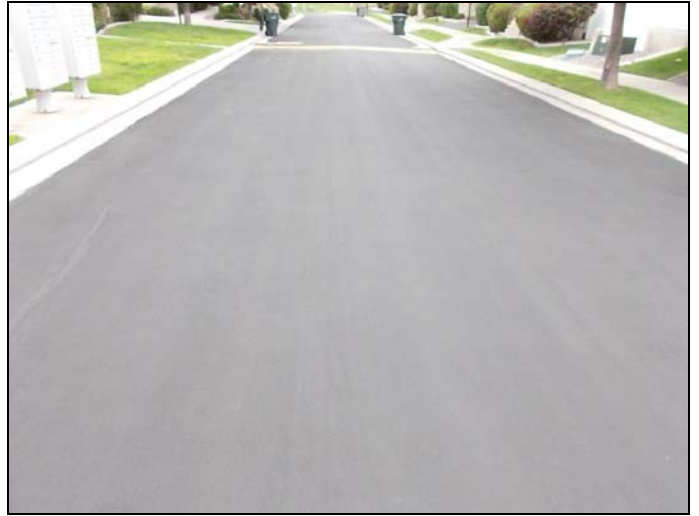
Comp #: 401 Asphalt - Major Rehab

The asphalt surfaces are in good to fair condition. We recommend funding for a major rehab of this component approximately every 25 - 30 years. Remaining life based on current age.

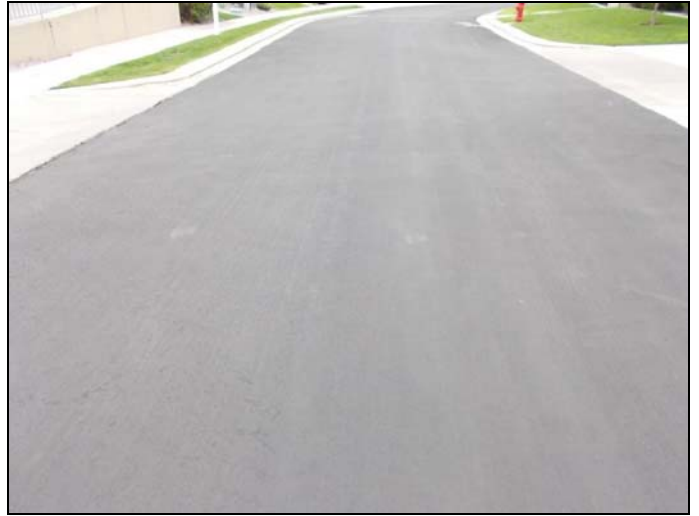
Comp #: 402 Asphalt - Seal Coat

The asphalt seal coat is in good condition. We recommend funding to seal this component approximately every 3 - 5 years. Remaining life based on current condition.

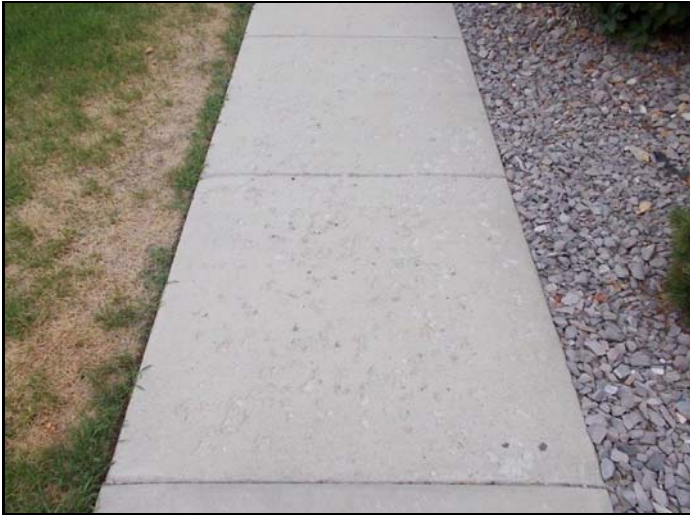
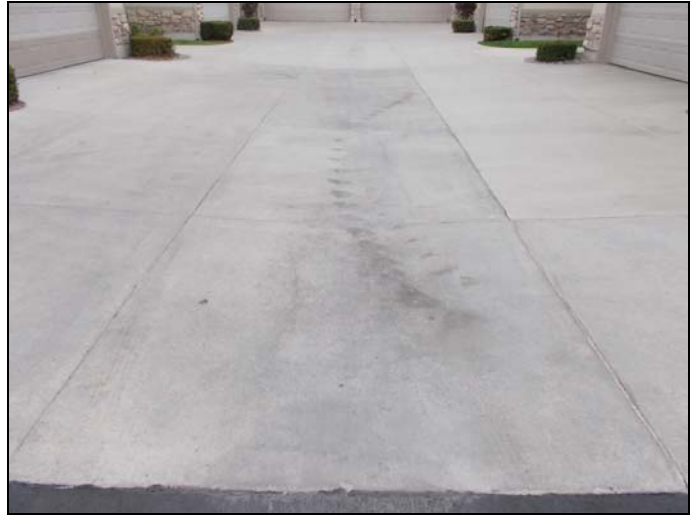
Comp #: 403 Concrete - Partial Repair/Replace

The concrete is generally in good condition. This component has an extended useful life under normal conditions. We recommend funding to make repairs and partially replace this component approximately every 10 years. Remaining life based on current age.

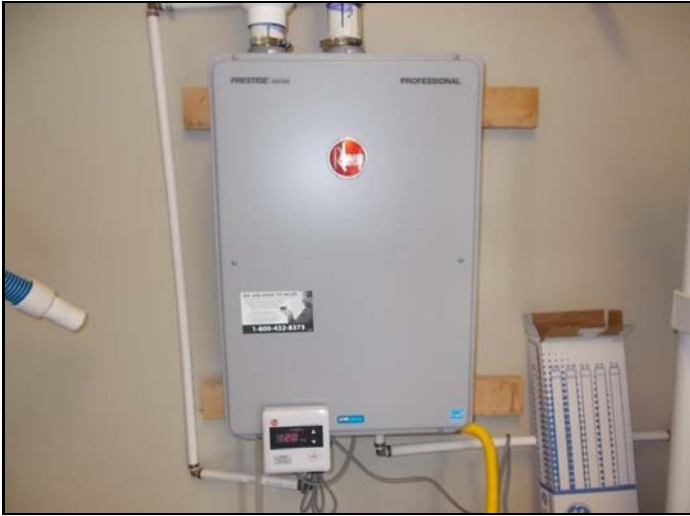
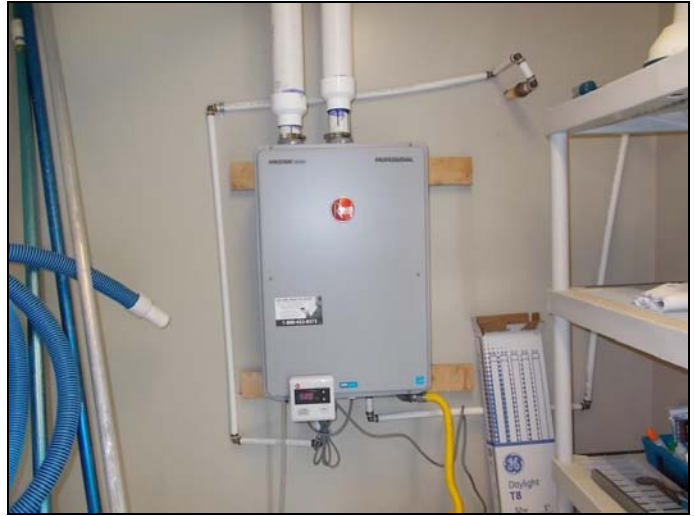
Comp #: 703 Water Heater - Replace

The water heater is in working condition. We recommend funding to replace this component approximately every 12 years. Remaining life based on current age.

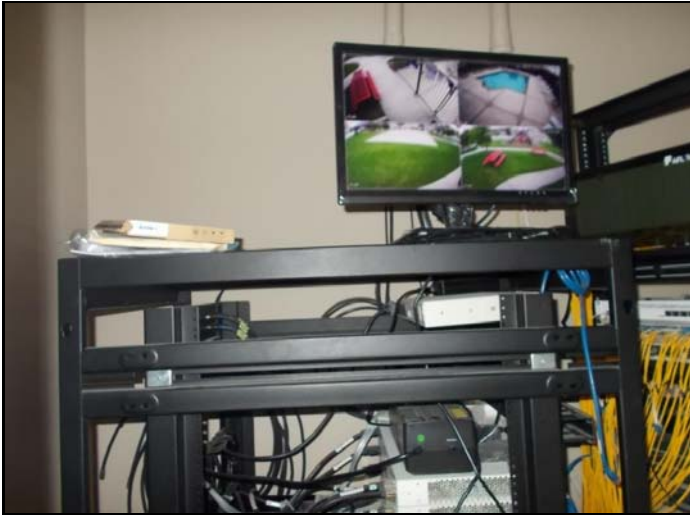
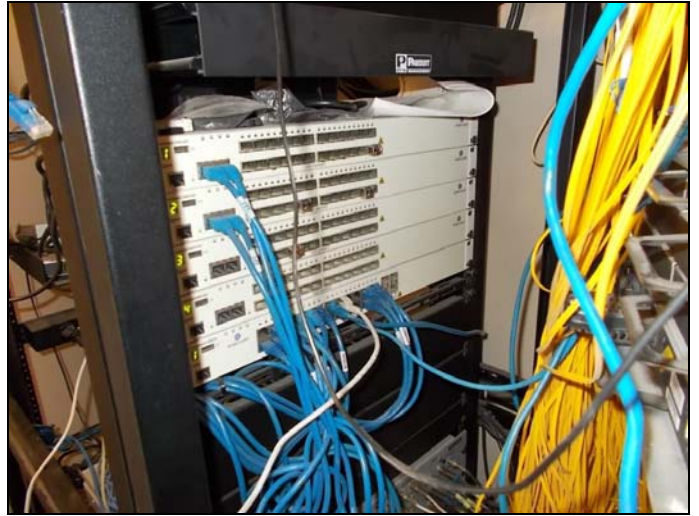
Comp #: 903 Security Camera System - Replace

The security camera system is in working condition. We recommend funding to replace this component approximately every 10 - 12 years. Remaining life based on current age.

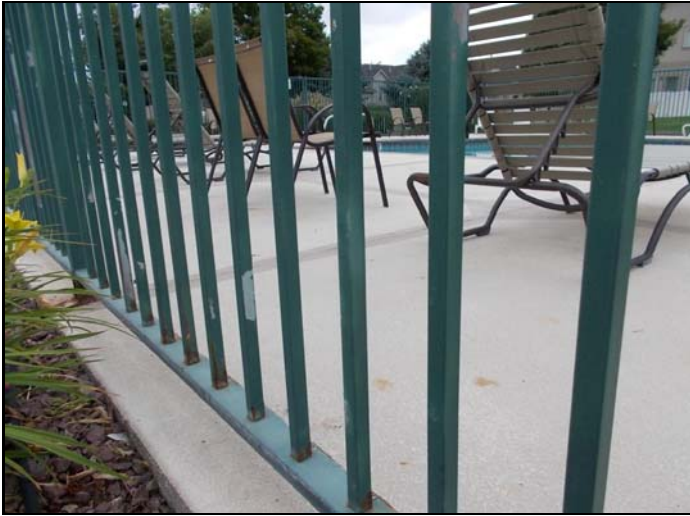
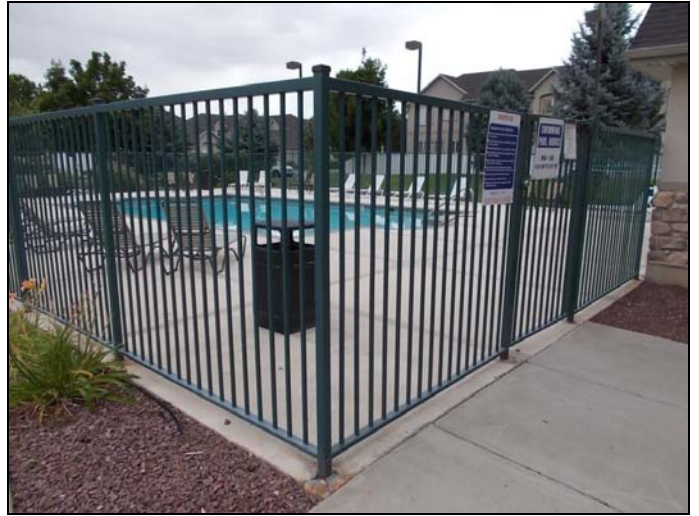
Comp #: 1002 Metal Fencing - Replace

Research with the client reveals this component is being replaced in 2019. We recommend funding to replace this component approximately every 40 - 50 years. Remaining life based on current age.

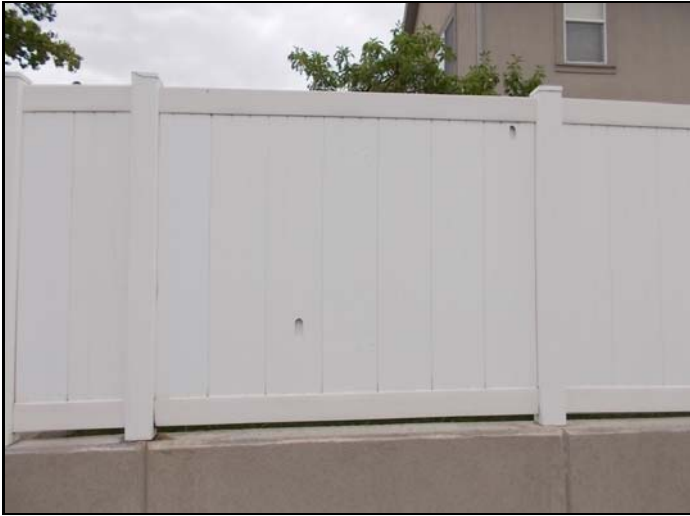
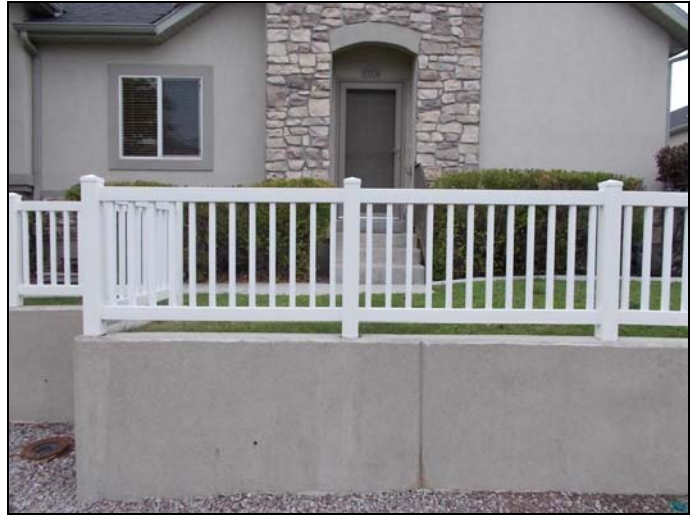
Comp #: 1008 Vinyl Fencing - Replace

The vinyl fencing is in good to fair condition. We recommend funding to replace this component approximately every 25 - 30 years. Remaining life based on current age.

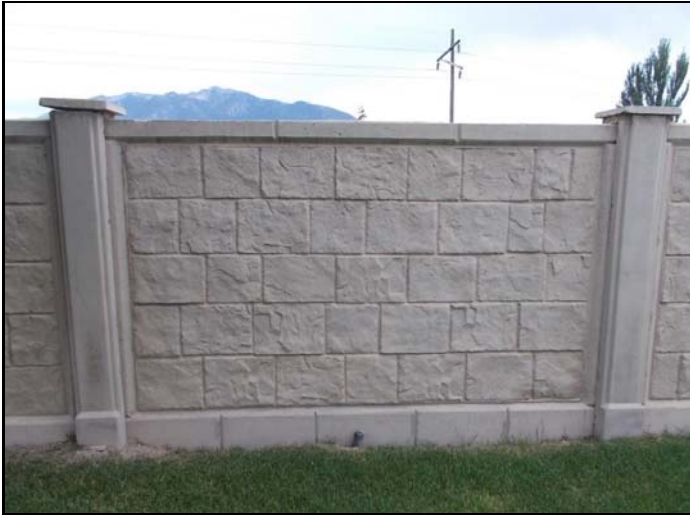
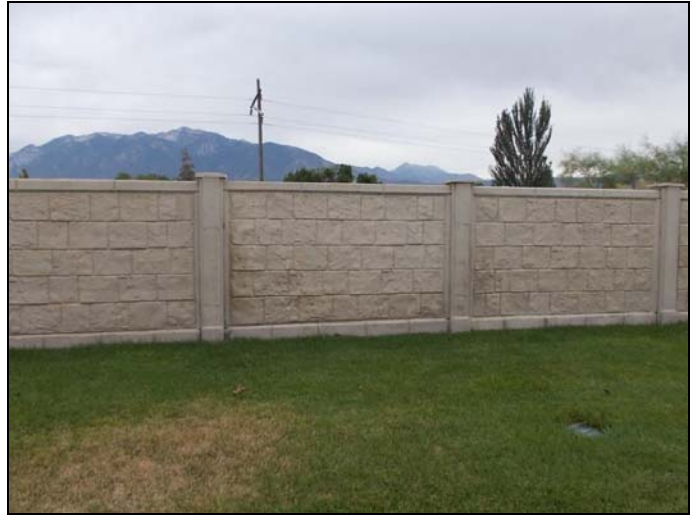
Comp #: 1012 Prefab Concrete Fence - Replace

The prefabricated concrete fence is in good condition. This type of component should have an extended useful life under normal conditions. Reserve funding is not appropriate.

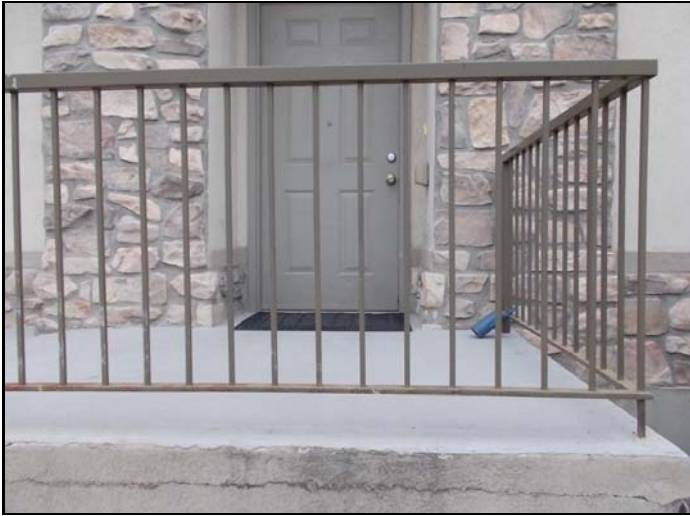
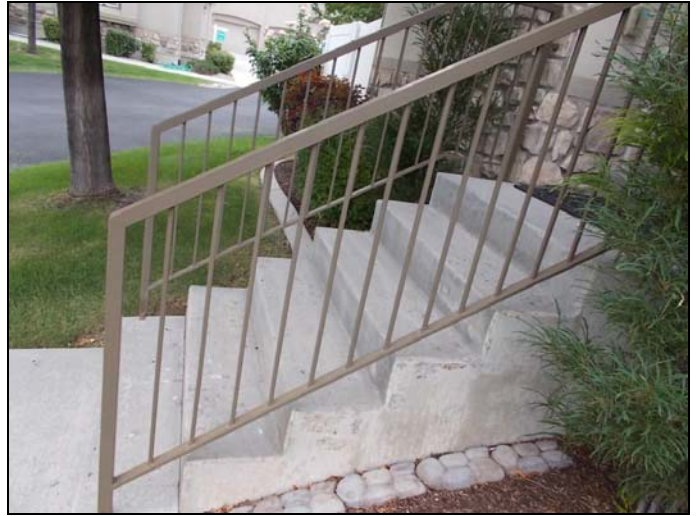
Comp #: 1090 Metal Railing - Replace

The metal railing is in good to fair condition. We recommend funding to replace this component approximately every 40 - 50 years. Remaining life based on current age.

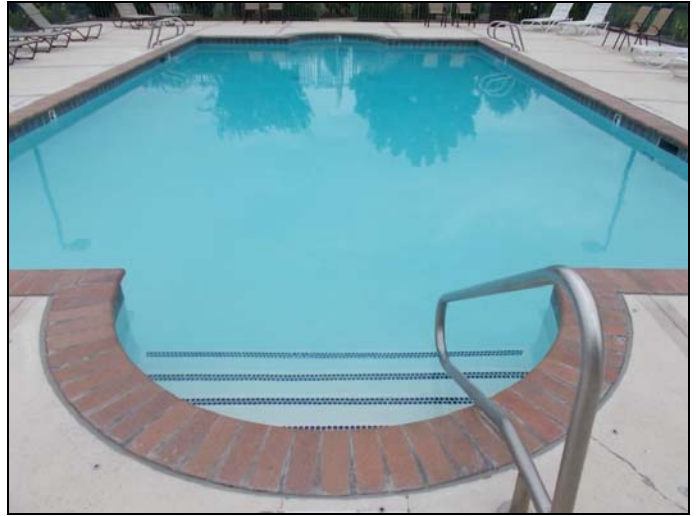
Comp #: 1101 Pool - Resurface

The pool surface is in good condition. We recommend funding to resurface this component every 10 - 12 years. Remaining life based on current age.

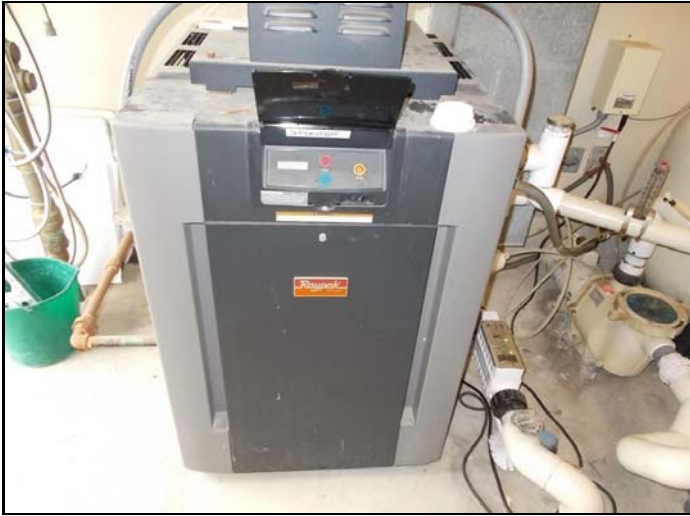
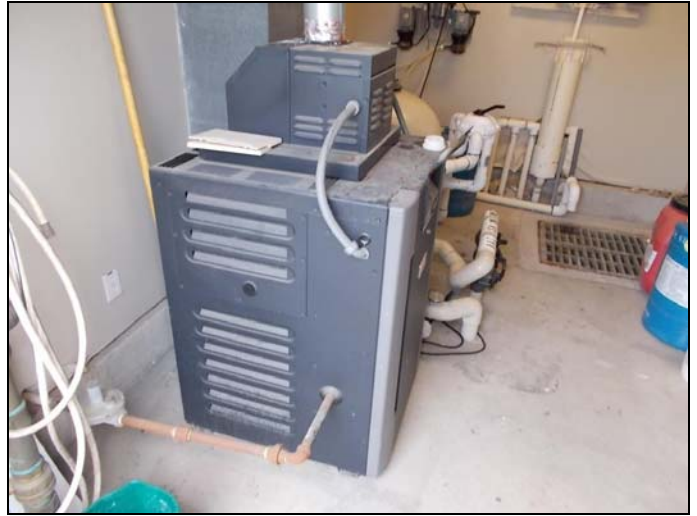
Comp #: 1104 Pool Heater - Replace

The pool heater is in working condition. We recommend funding to replace this component approximately every 12 years. Remaining life based on current age.

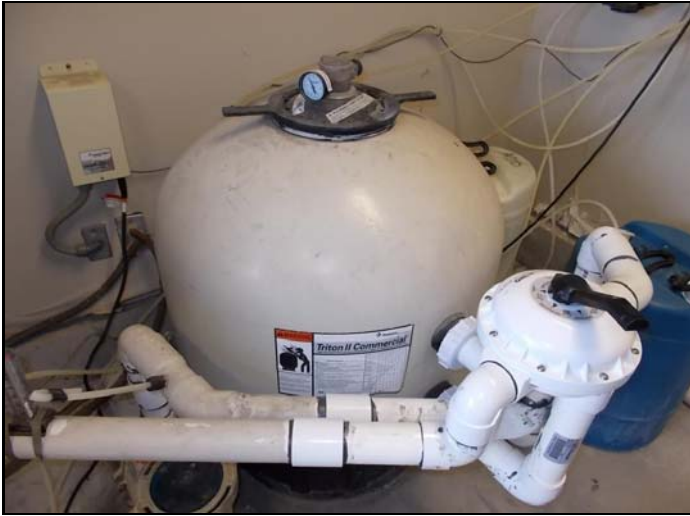
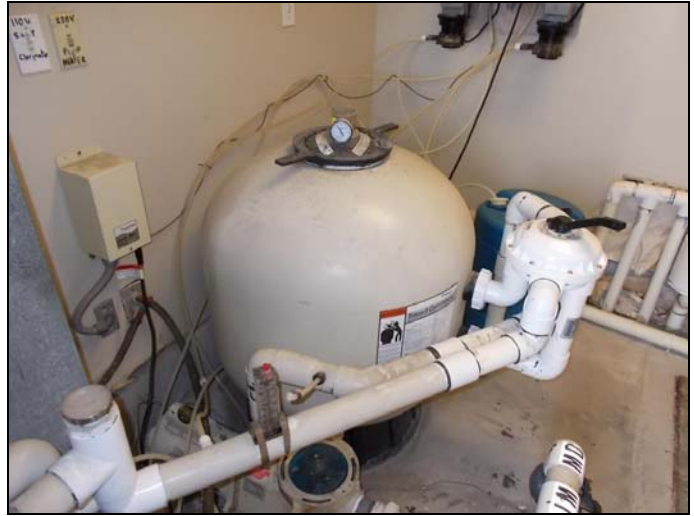
Comp #: 1107 Pool Filter - Replace

The pool filter is in working condition. We recommend funding to replace this component approximately every 12 - 15 years. Remaining life based on current age.

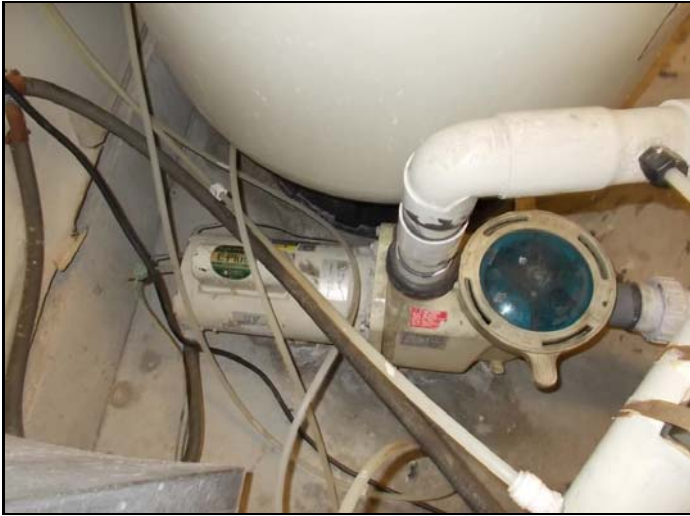
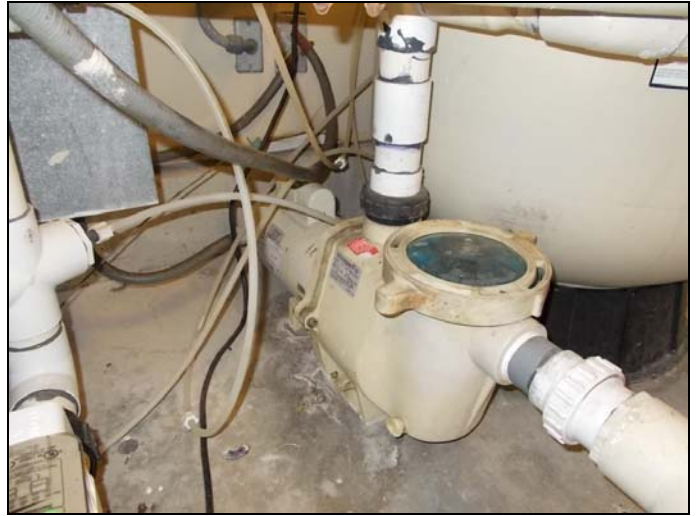
Comp #: 1110 Pool Pump - Replace

The pool pump is in working condition. We recommend funding to replace this component approximately every 8 - 10 years. Remaining life based on current age.

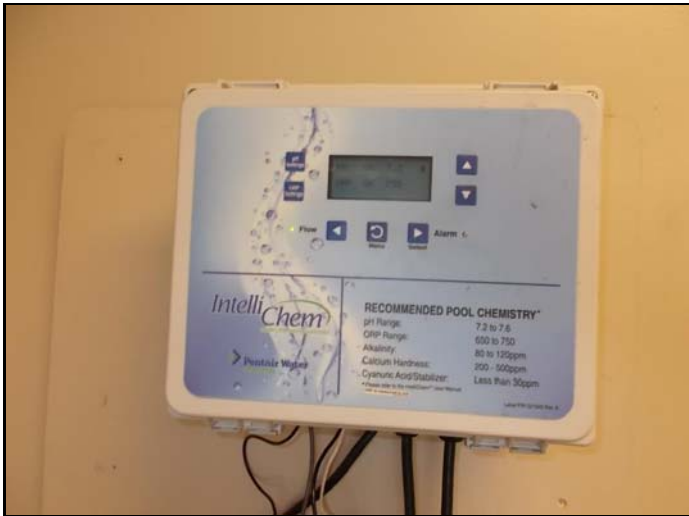
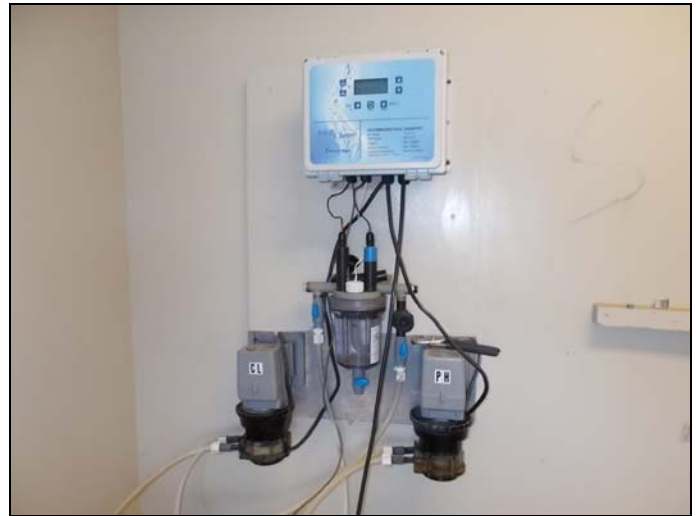
Comp #: 1111 Pool Chemical Controller System - Replace

The chemical controller system is in working condition. We recommend funding to replace this component approximately every 10 - 12 years. Remaining life based on current age.

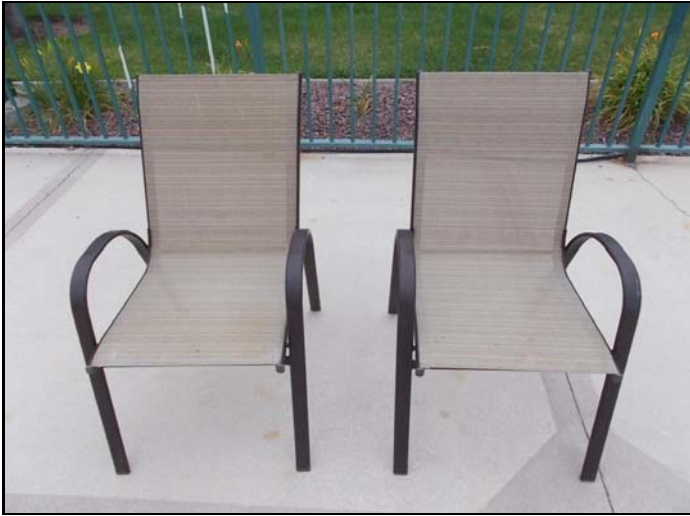
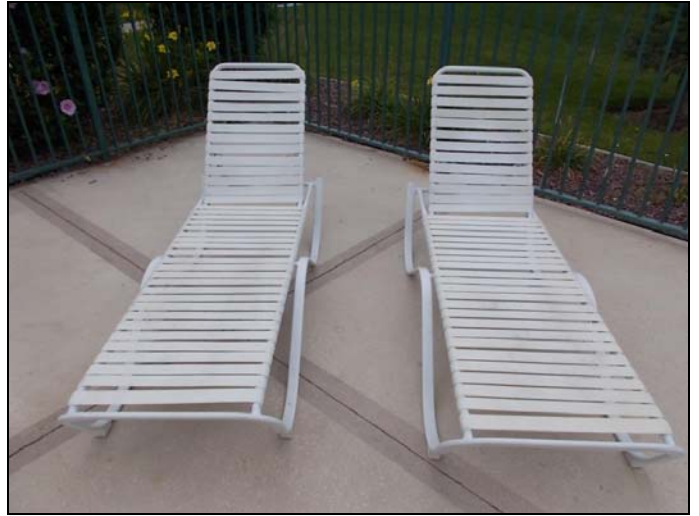
Comp #: 1121 Pool Furniture - Replace

The pool furniture is in fair condition. Research with the client reveals this component is partially replaced each year.

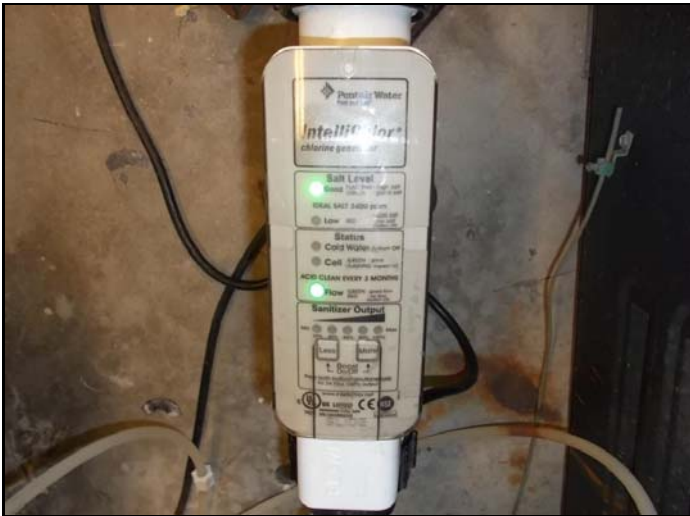
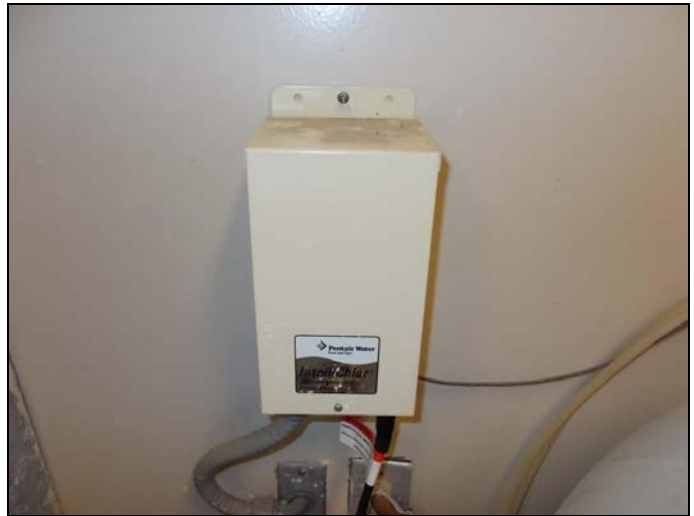
Comp #: 1190 Chlorine Generating System - Replace

The pool chlorine generation system is in good condition. We recommend funding to replace this system approximately every 15 years. Remaining life based on current age.
