# Courtyard at Angel Street

## Level 1 Reserve Study

**Report Period – 01/01/2024 – 12/31/2024**

## Executive Summary – Courtyard at Angel Street - ID # 19062

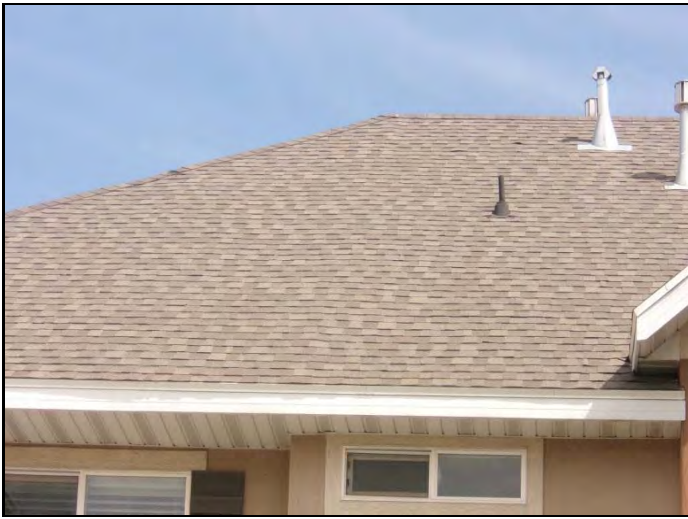
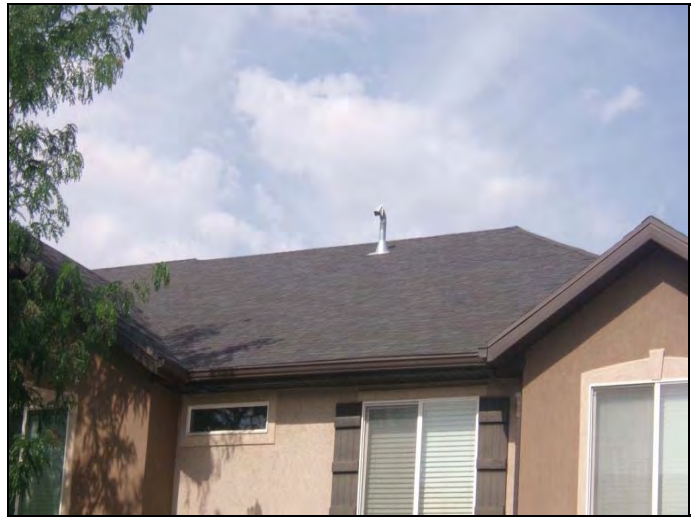
Comp #: 105    Roofs - Replace

The roofs appear to be in good to fair condition. We recommend funding to replace this component approximately every 20 - 25 years. Remaining life based on current age.

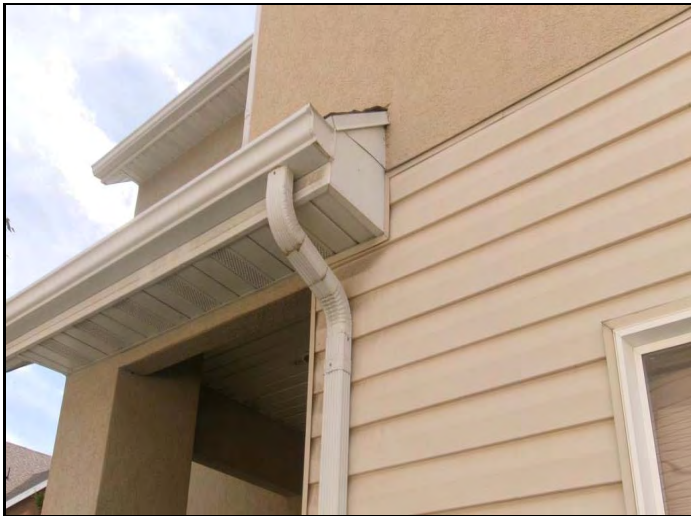
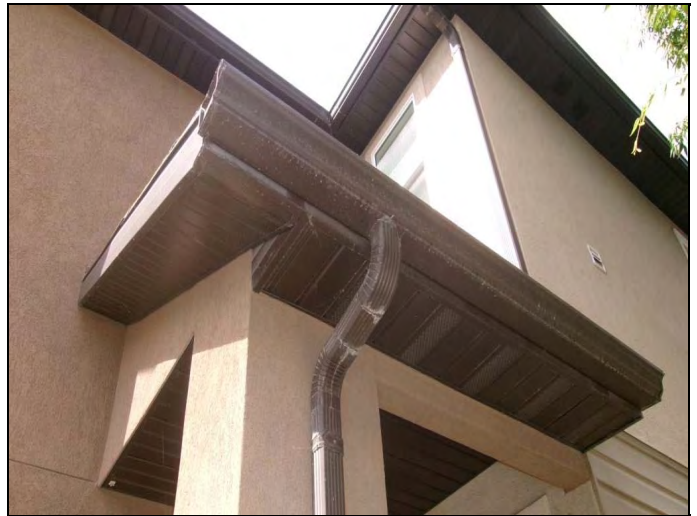
Comp #: 120 Rain Gutters/Downspouts - Replace

The rain gutters and downspouts are in fair condition. We recommend funding to replace this component approximately every 25 - 30 years. Remaining life based on current age.

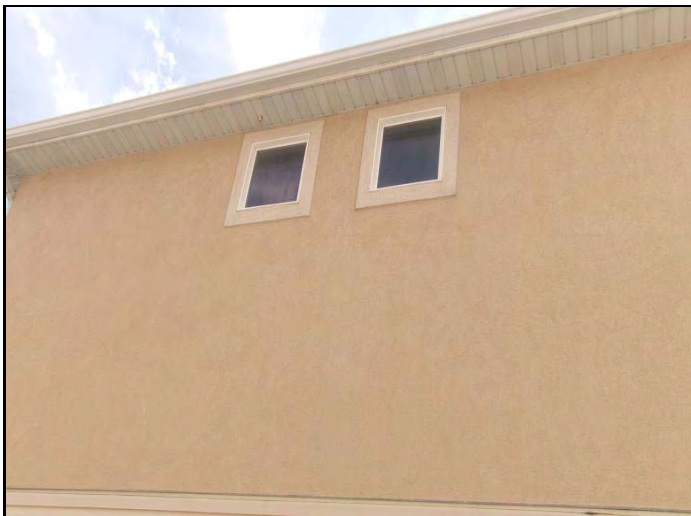
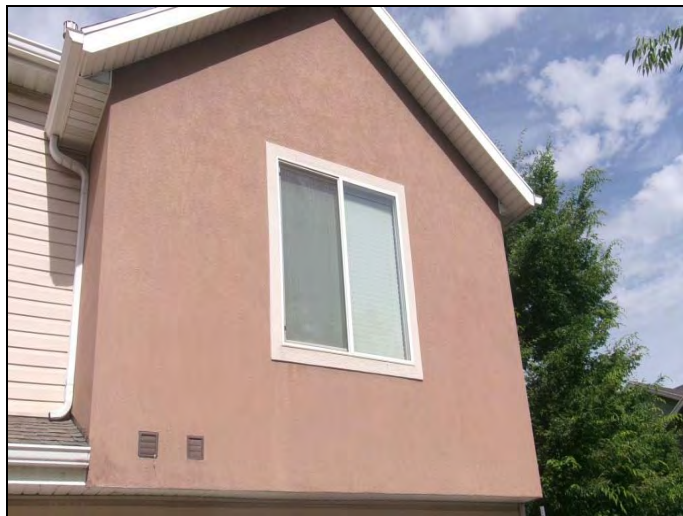
Comp #: 201 Stucco Surfaces - Repair/Repaint

The stucco surfaces are in good condition. We recommend funding to repair/repaint this component approximately every 12 - 15 years. Remaining life based on current age.

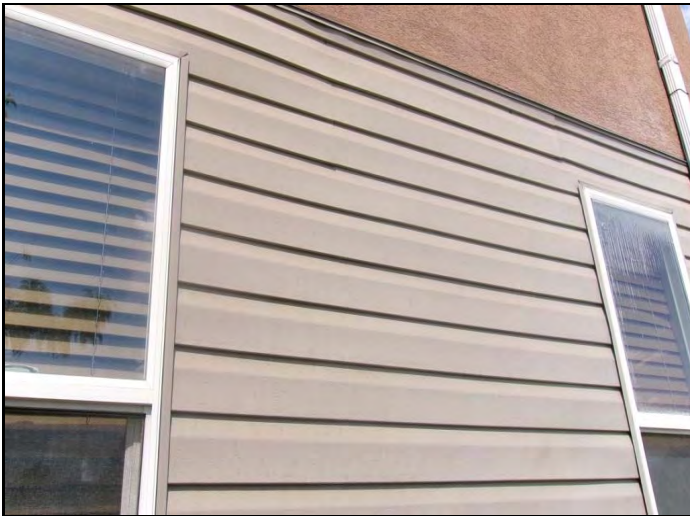
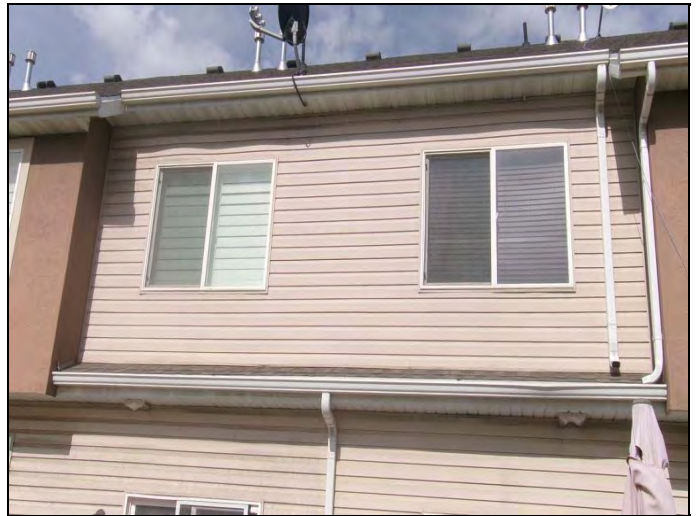
Comp #: 302 Vinyl Siding - Replace

The vinyl siding is generally in good to fair condition. We recommend funding to replace this component approximately every 40 - 50 years. Remaining life based on current age.

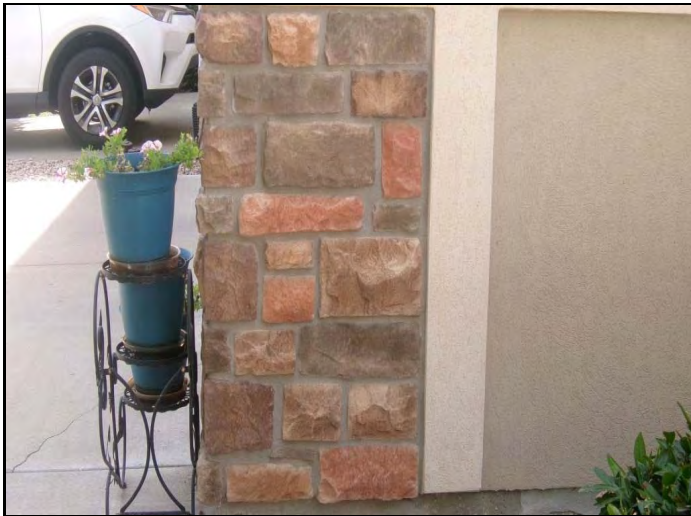
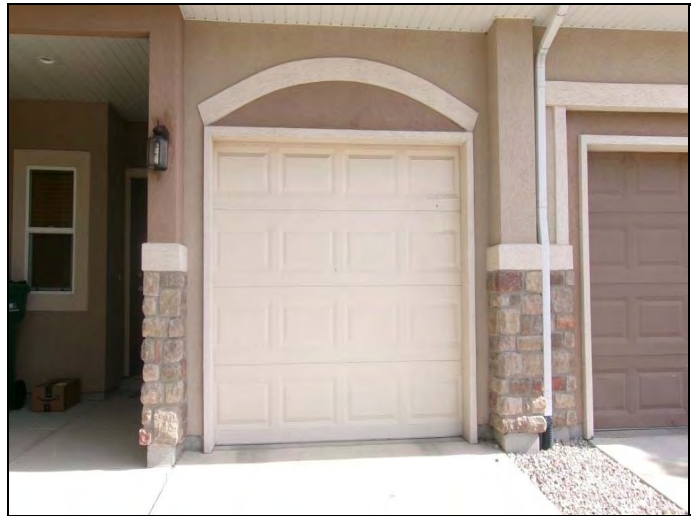
Comp #: 390 Faux Stone Façade - Replace

This component has an extended useful life. We recommend making repairs as necessary as an operating expense. No reserve funding necessary.

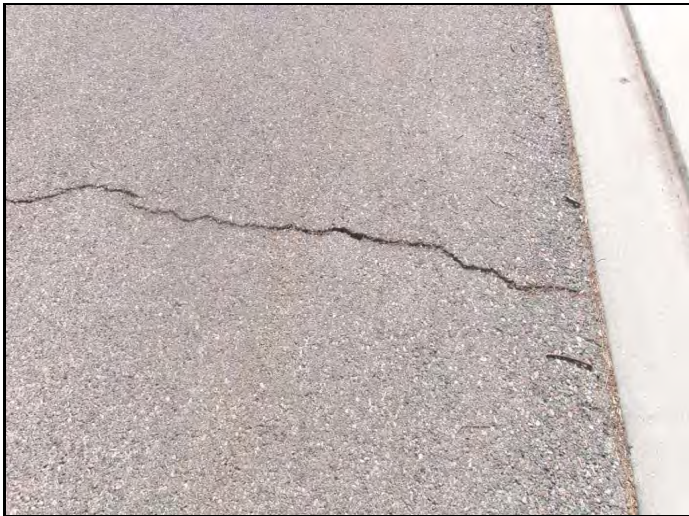
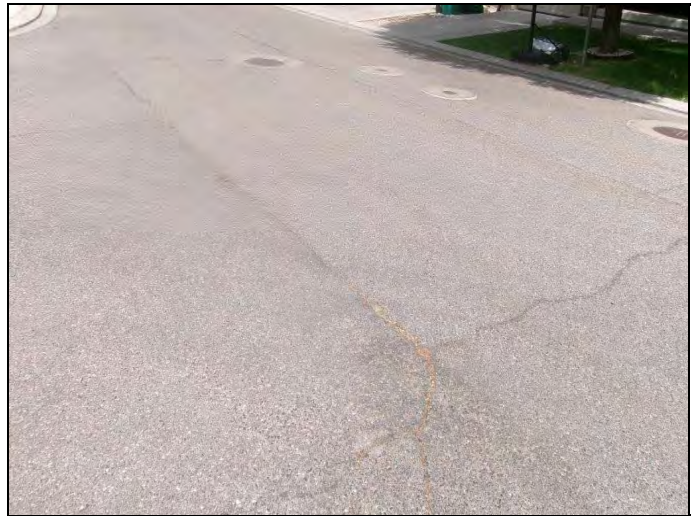
Comp #: 401 Asphalt - Major Rehab

The asphalt surfaces are generally in good condition. We recommend funding for a major rehab of this component approximately every 25 - 30 years. Remaining life based on current age.

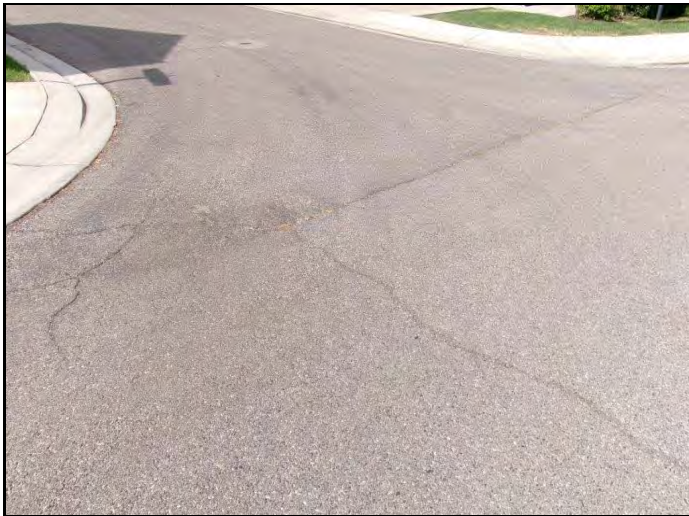
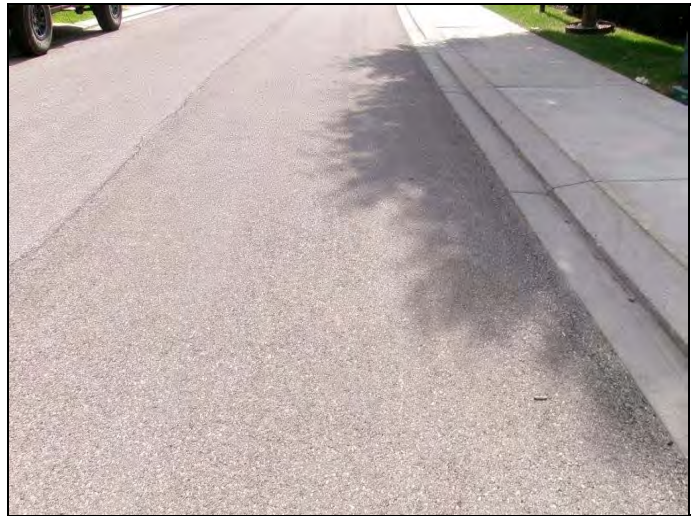
Comp #: 402 Asphalt - Seal Coat

The asphalt seal coat is in poor condition. We recommend funding to seal this component approximately every 3 - 5 years. Remaining life based on current condition.

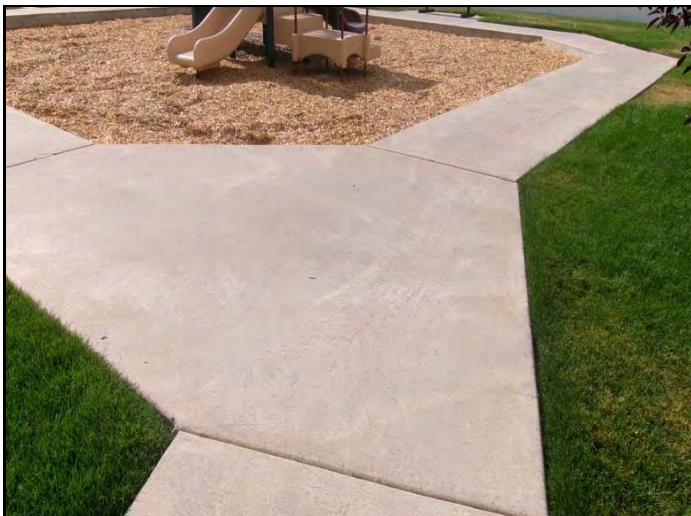
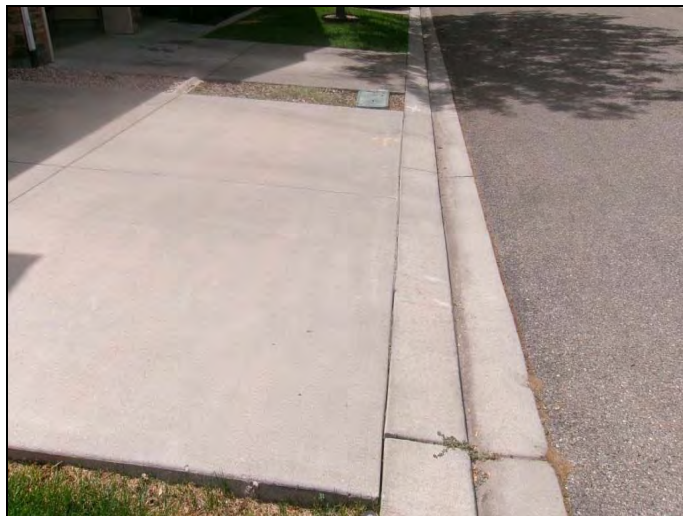
Comp #: 403 Concrete - Partial Repair/Replace

The concrete is generally in good condition. This component has an extended useful life under normal conditions. We recommend funding to make repairs and partially replace this component approximately every 10 years. Remaining life based on current age.

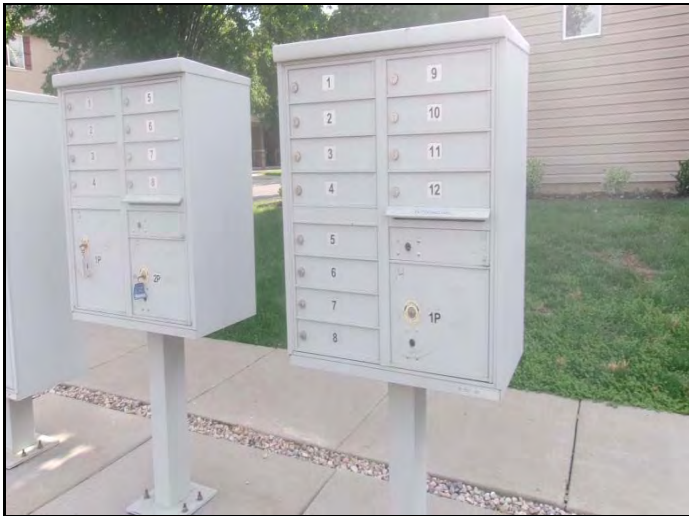
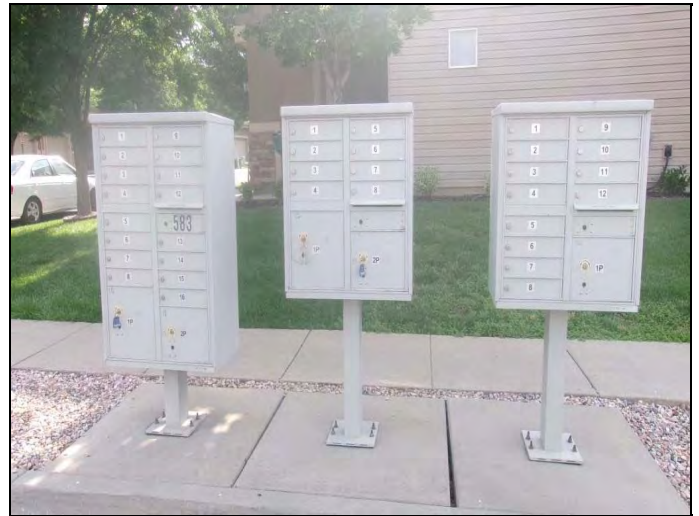
Comp #: 803 Mailboxes - Replace

Typically these mailboxes are owned and maintained by the postal service. No reserve funding necessary.

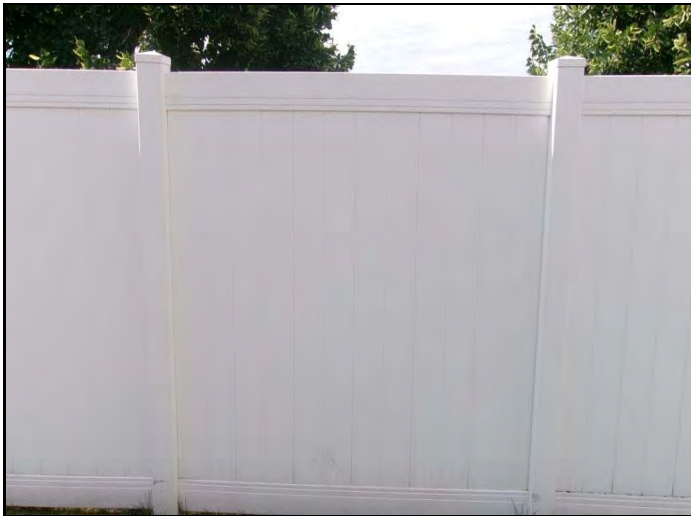
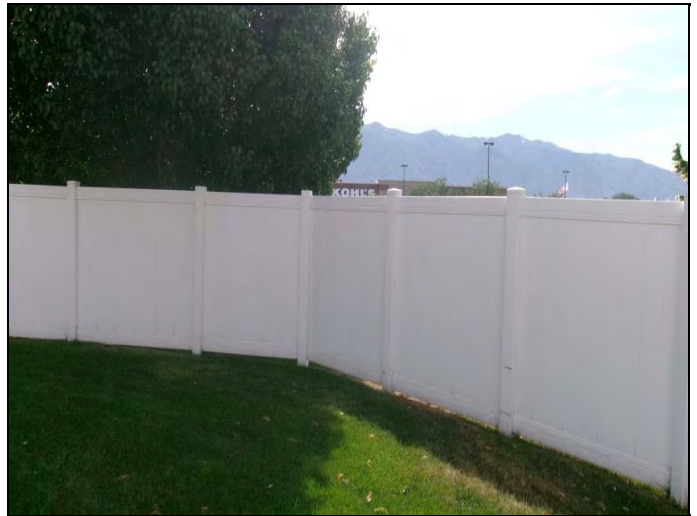
Comp #: 1008 Vinyl Fencing - Replace

The vinyl fencing is in good to fair condition. We recommend funding to replace this component approximately every 25 - 30 years. Remaining life based on current age.

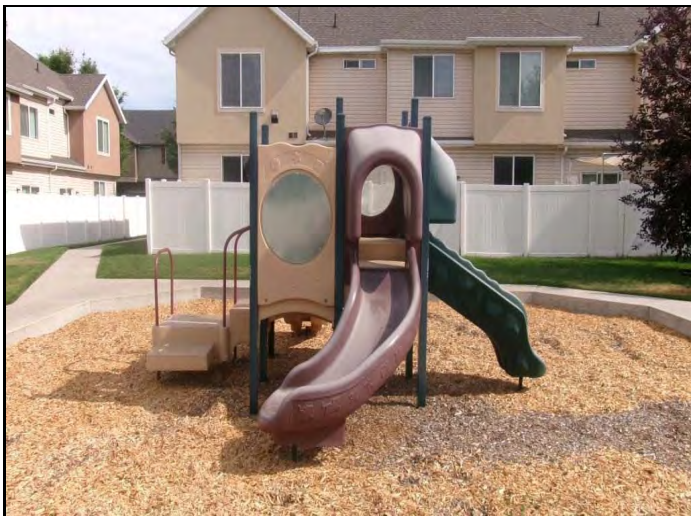
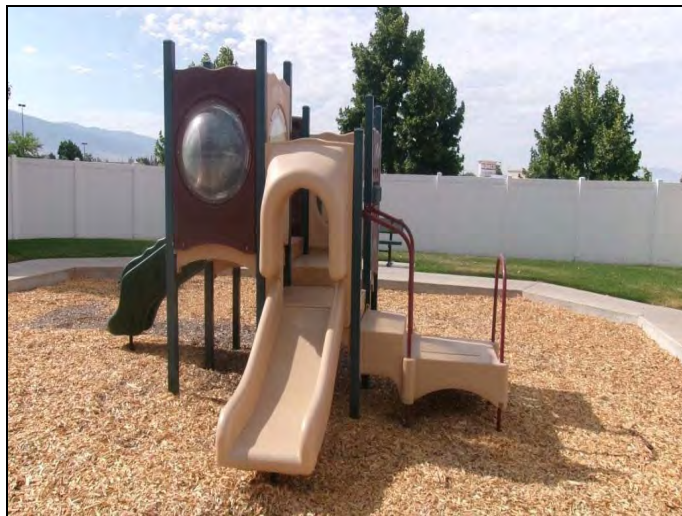
## Comp #: 1301 Play Structure - Replace

The play structure is in fair condition. We recommend funding to replace this component approximately every 20 - 25 years. Remaining life based on current age.

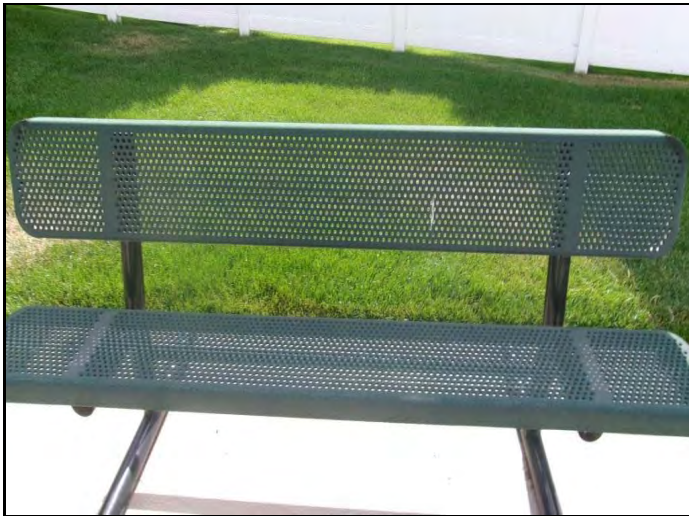
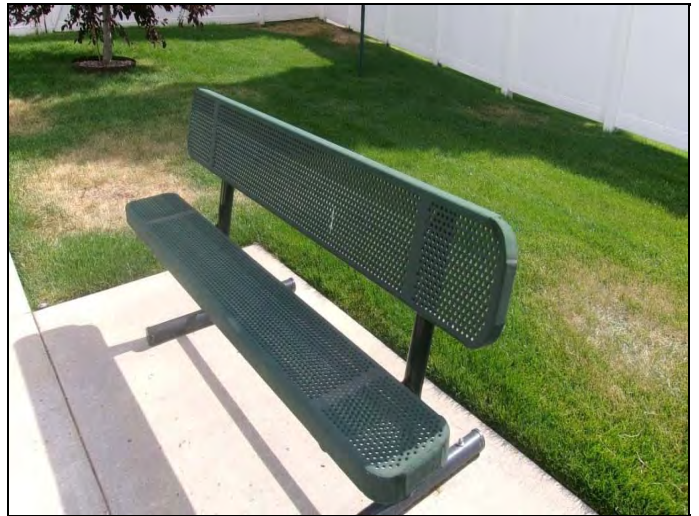
Comp #: 1307 Benches - Replace

Research with the client reveals this component is replaced as necessary as an operating expense.

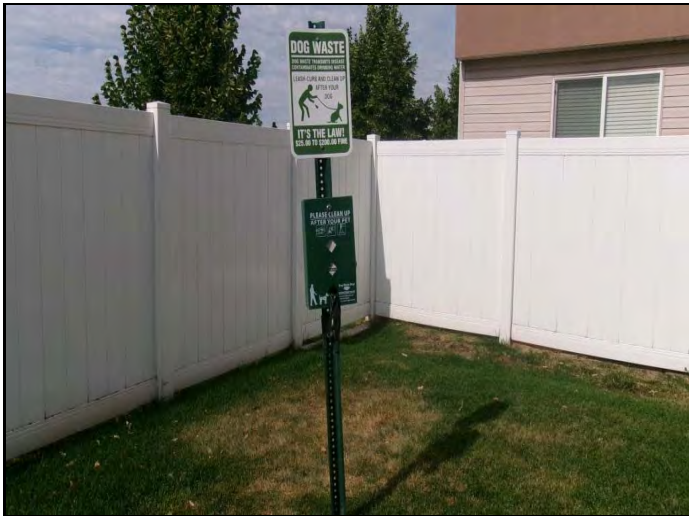
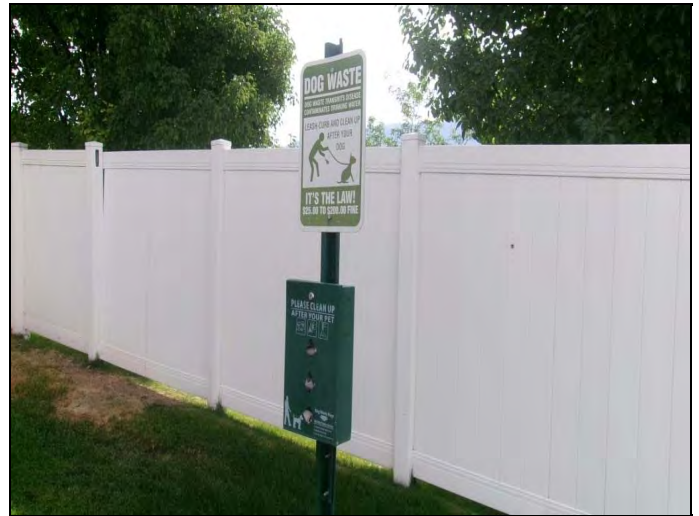
Comp #: 1390 Pet Waste Stations

Research with the client reveals this component is replaced as necessary as an operating expense.

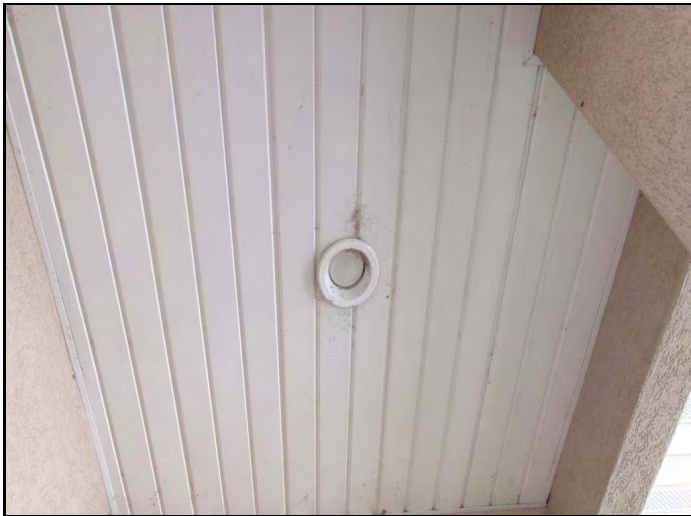
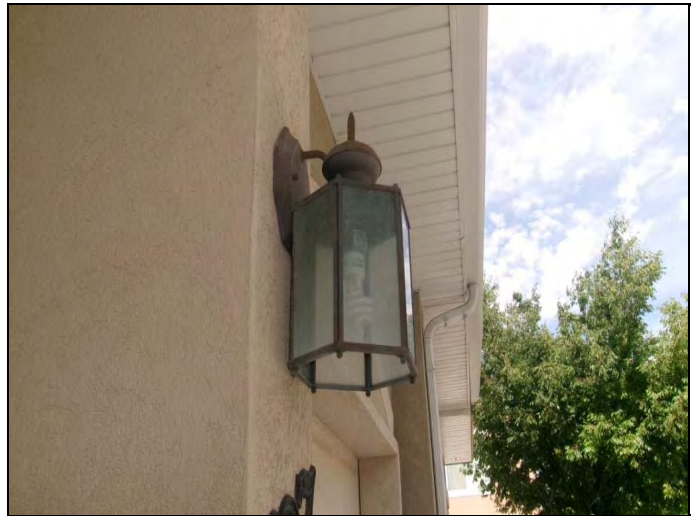
Comp #: 1602 Exterior Light Fixtures - Replace

The exterior light fixtures are in fair condition. We recommend funding to replace this component approximately every 16 - 20 years. Remaining life based on current age.

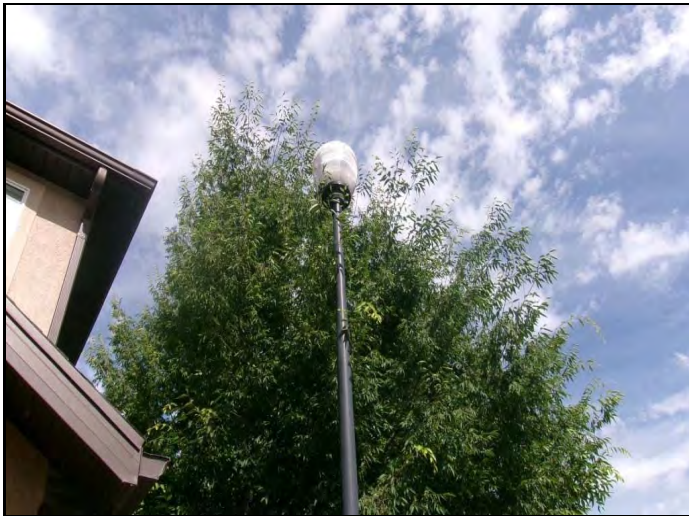
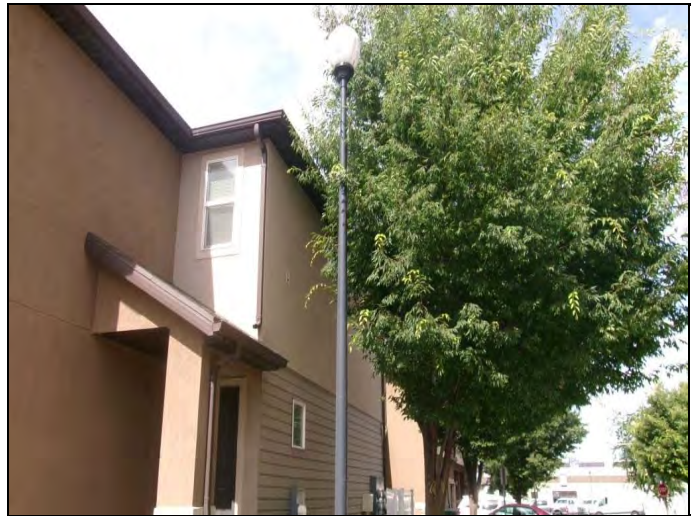
Comp #: 1609 Street Light Fixture - Replace

Research with the client reveals this component is replaced as necessary as an operating expense.

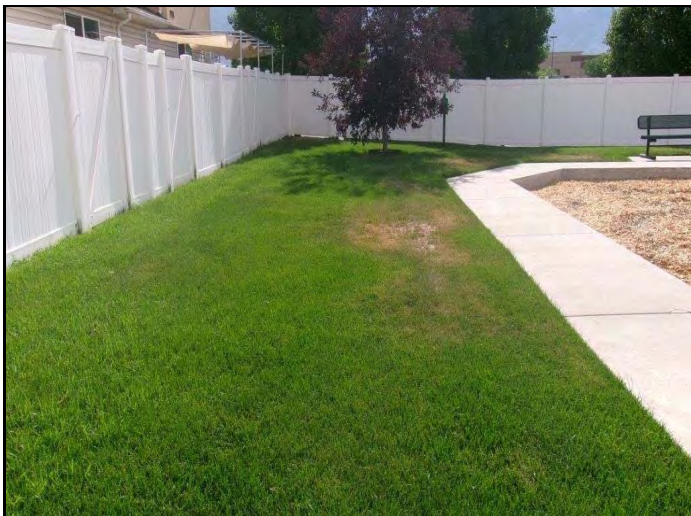
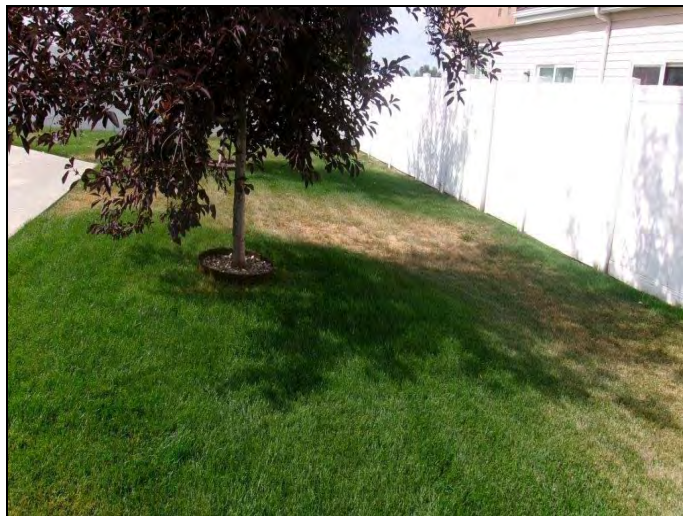
Comp #: 1812 Landscaping & Irrigation System - Renovate

The landscaping and irrigation system appear to be in good to fair condition. We recommend funding for an allowance to renovate this component approximately every 20 years. Remaining life based on current age.
