# Coldwater Creek

## Level 2 Reserve Study

**Report Period – 01/01/2025 – 12/31/2025**

## Executive Summary – Coldwater Creek - ID # 12273

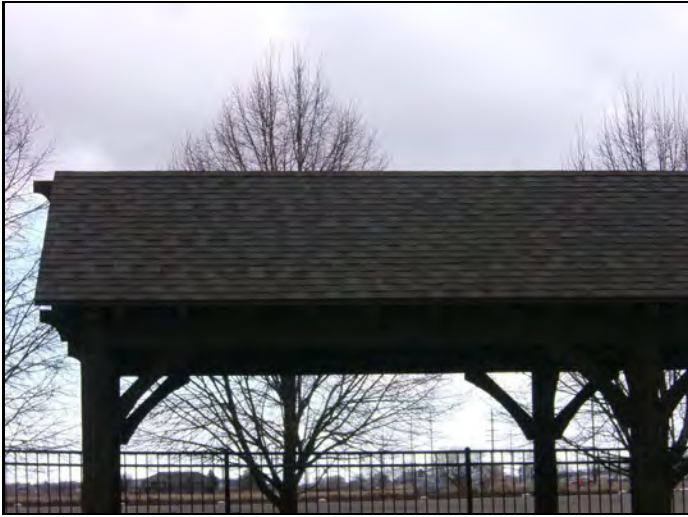
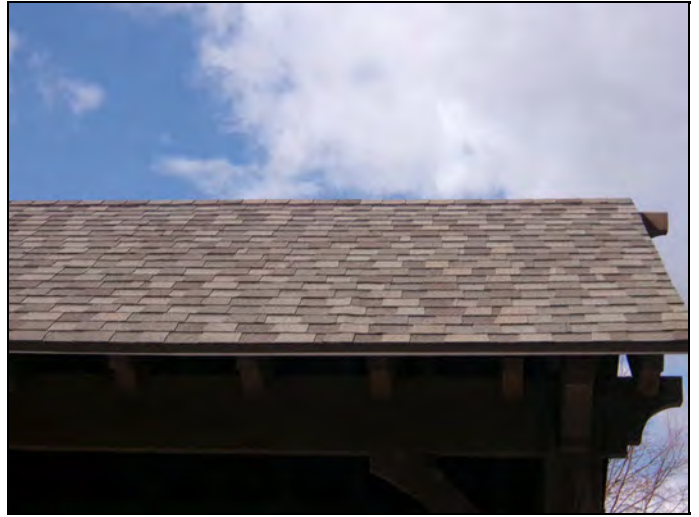
Comp #: 105 Pavilion Roof - Replace

*Location:* Pavilion Roof

The roofs appear to be in good condition. We recommend funding to replace this component approximately every 20 - 25 years. Remaining life based on current age.

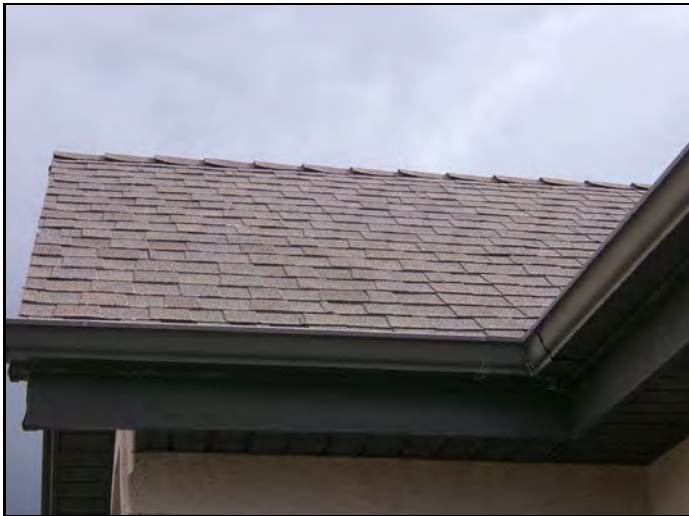
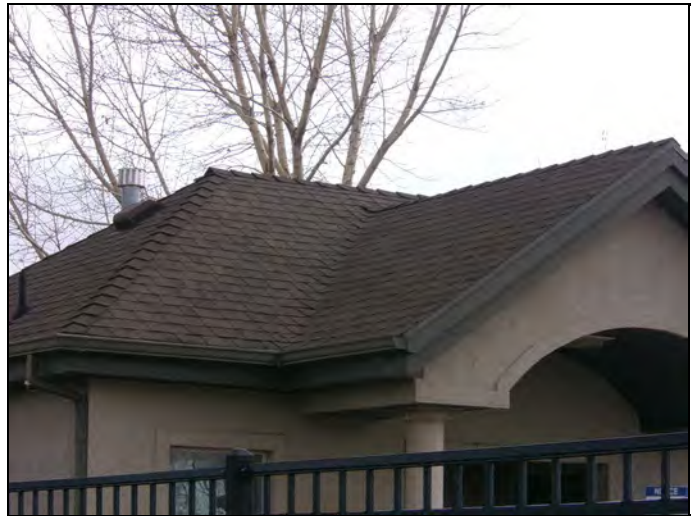
Comp #: 105 Pool Building Roof - Replace

*Location:* **Pool Building Roof**

The roofs appear to be in fair condition. We recommend funding to replace this component approximately every 20 - 25 years. Remaining life based on current age.

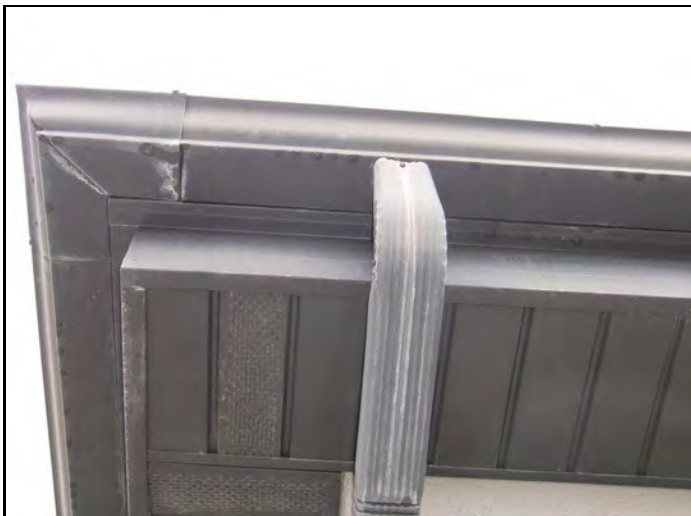
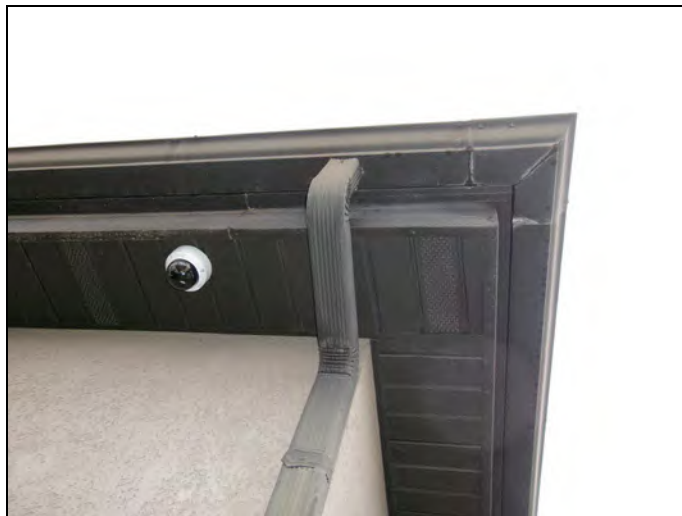
Comp #: 120 Rain Gutters/Downspouts - Replace

*Location:* **Pool Building Exterior**

The rain gutters and downspouts appear to be in good to fair condition. We recommend funding to replace this component approximately every 25 - 30 years. Remaining life based on current age.

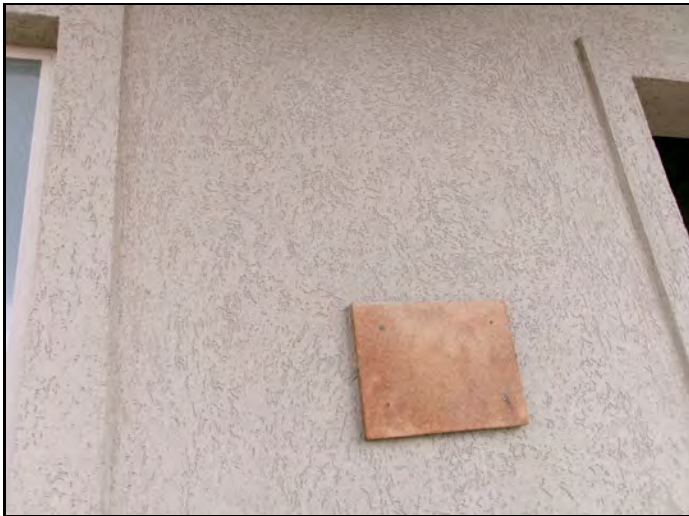
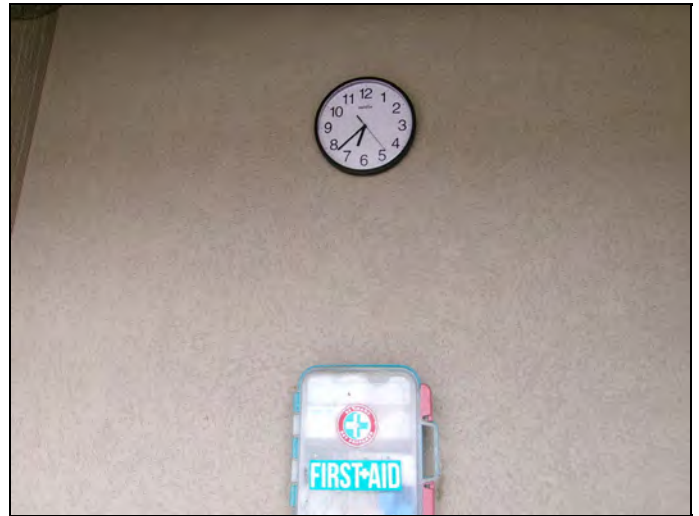
Comp #: 201 Stucco Surfaces - Repair/Repaint

*Location:* **Pool Building Exterior**

Due to the minimal cost of maintaining this component, reserve funding is not appropriate. Repair/repaint as necessary as an operating expense. No reserve funding necessary.

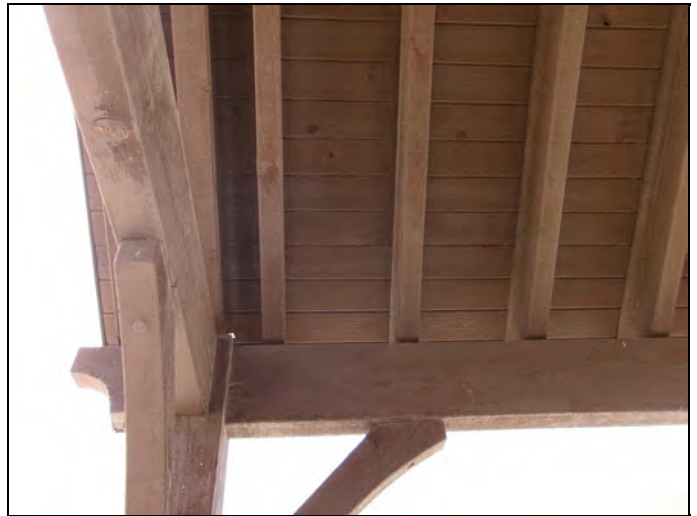
Comp #: 202 Pavilion - Repaint

*Location:* **Pavilion**

Research with the client reveals this component is being replaced in 2026. We recommend funding to repaint this component approximately every 4 - 6 years. Remaining life based on current condition.

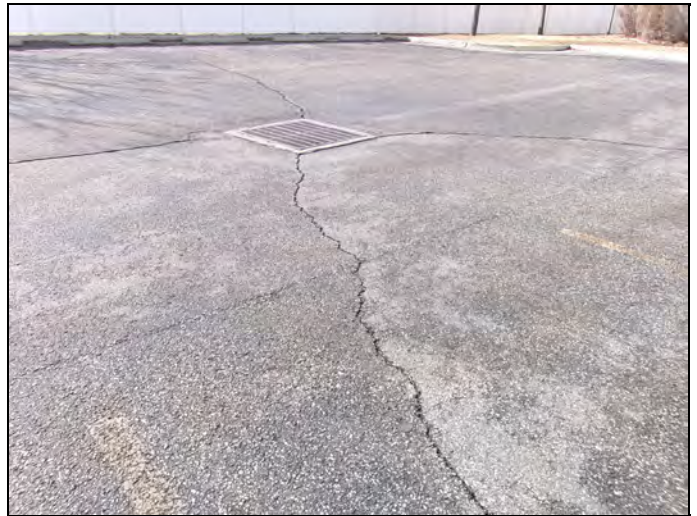
Comp #: 401 Asphalt - Major Rehab

*Location:* **Pool Parking Lots**

The asphalt surfaces are in good to fair condition. We recommend funding for a major rehab of this component approximately every 25 - 30 years. Remaining life based on current age.

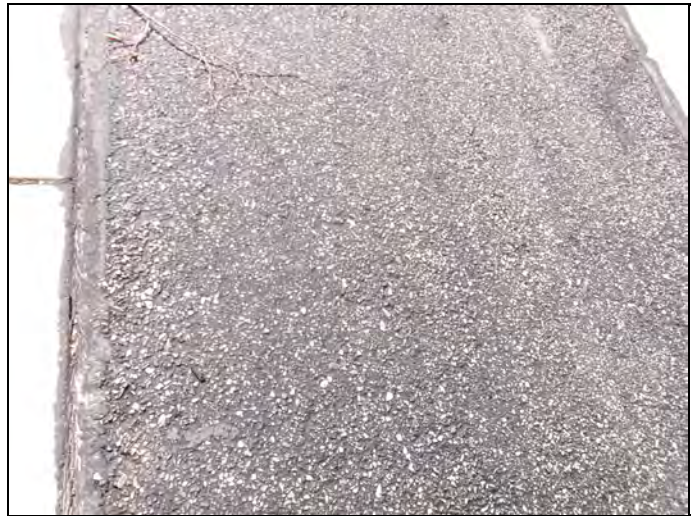
Comp #: 402 Asphalt - Seal Coat

*Location:* **Pool Parking Lots**

The asphalt seal coat is in poor condition. We recommend funding to seal this component approximately every 3 - 5 years. Remaining life based on current condition.

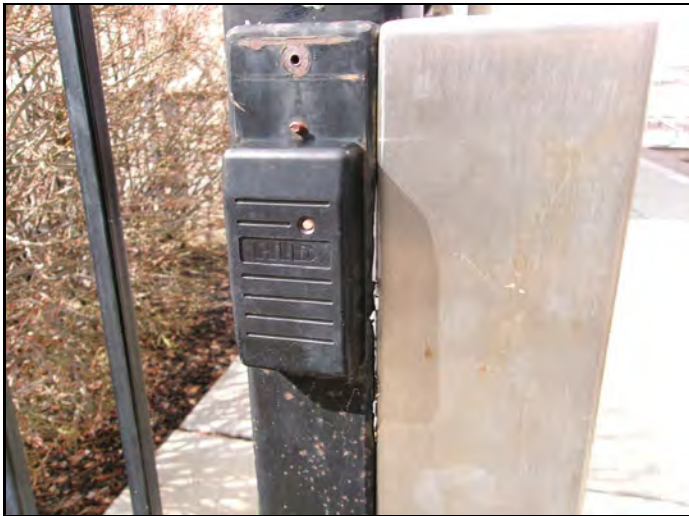
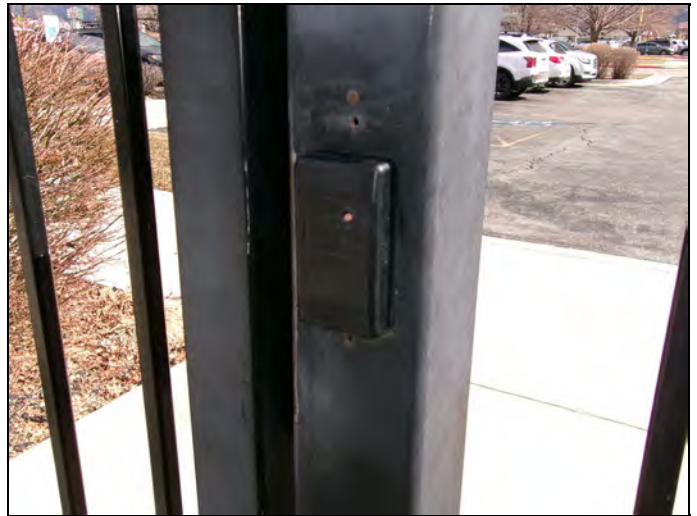
Comp #: 508 Access Control System - Replace

*Location:* **Pool Entrance**

The access control system is in working condition. We recommend funding to replace this component approximately every 10 - 12 years. Remaining life based on current age.

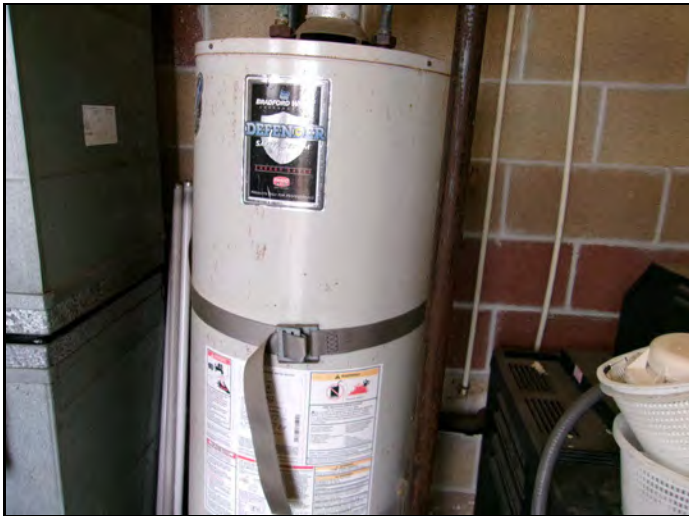
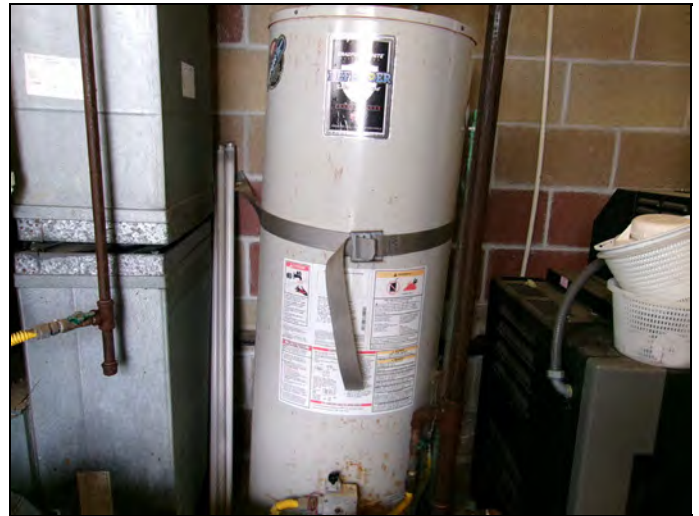
Comp #: 703 Water Heater - Replace

*Location:* Pool Equipment Room

Research with the client reveals this component is being replaced in 2026. We recommend funding to replace this component approximately every 12 years. Remaining life based on current age.

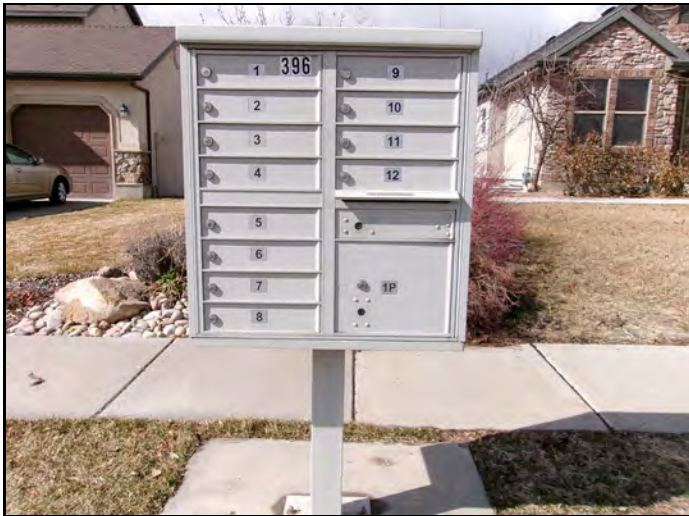
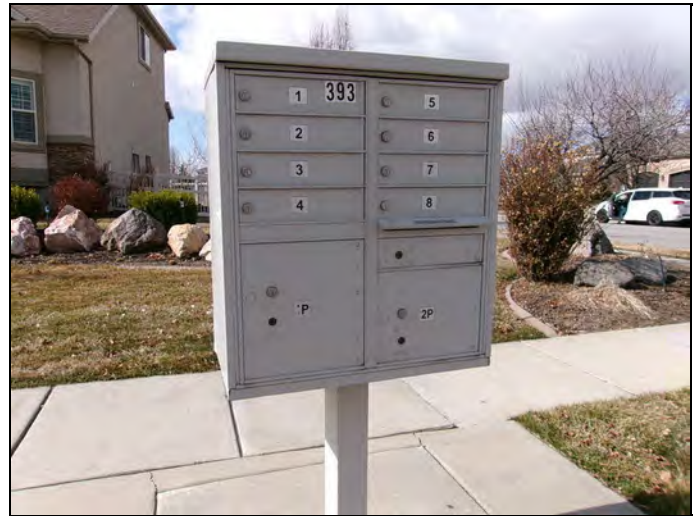
Comp #: 803 Mailboxes - Replace

*Location:* **Adjacent to Community Streets**

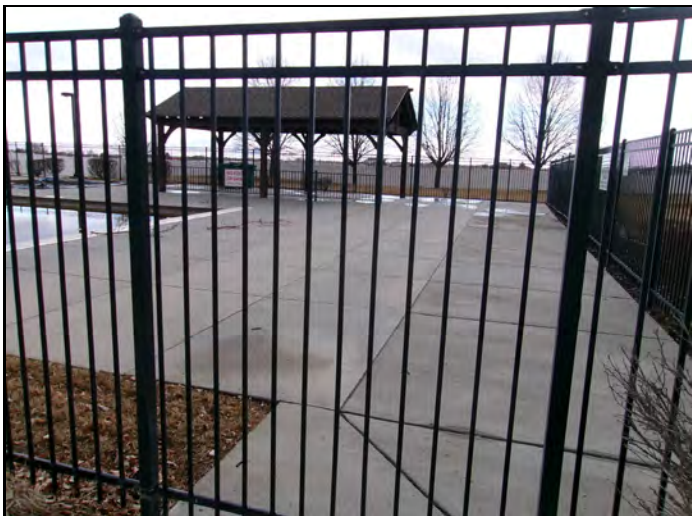
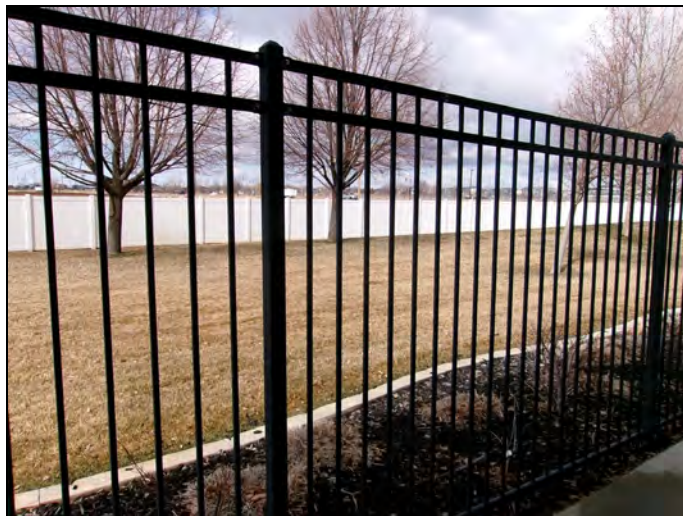
Comp #: 1002 Metal Fencing - Replace

*Location:* **Pool Area**

The metal fencing is in good to fair condition. We recommend funding to replace this component approximately every 40 - 50 years. Remaining life based on current age.

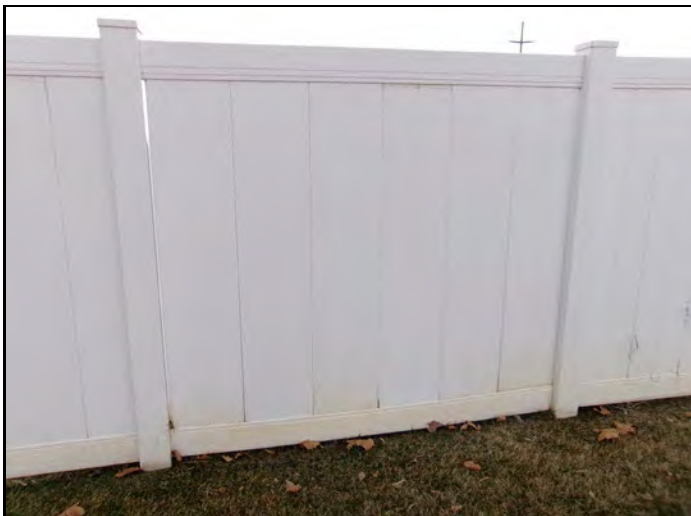
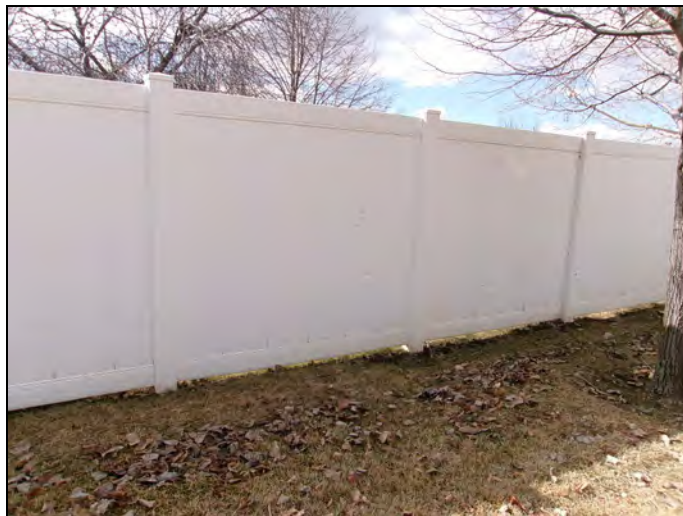
Comp #: 1008 Vinyl Fencing - Replace

*Location:* **Common Area**

The vinyl fencing is in good to fair condition. We recommend funding to replace this component approximately every 25 - 30 years. Remaining life based on current age.

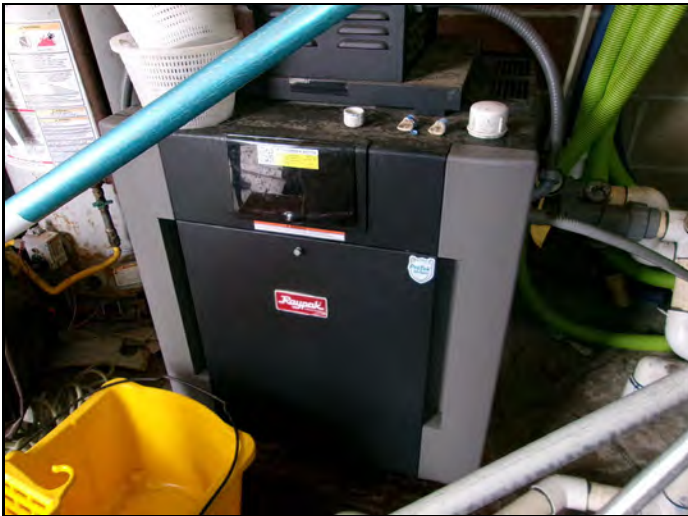
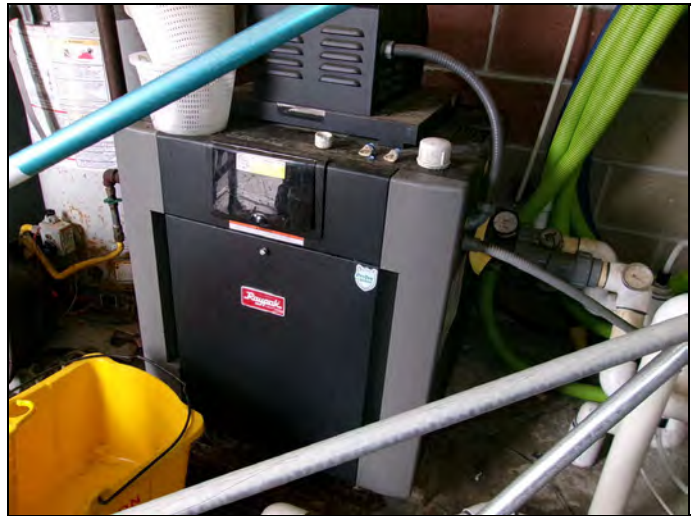
## Comp #: 1104 Pool Heater - Replace

*Location:* **Pool Equipment Room**

The pool heater is in working condition. We recommend funding to replace this component approximately every 12 years. Remaining life based on current age.

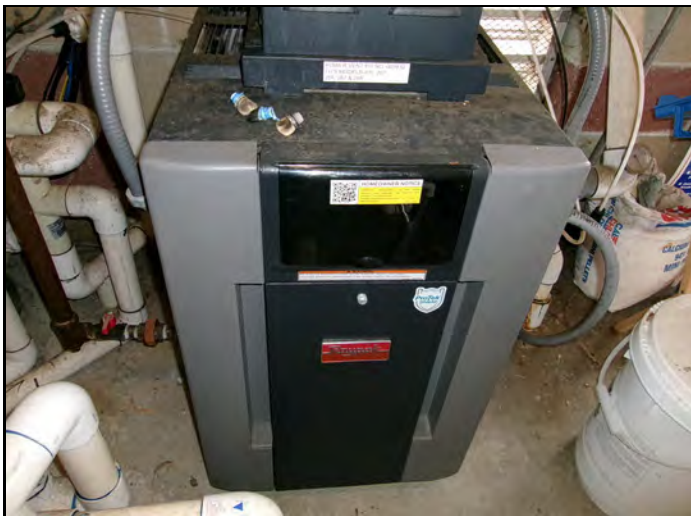
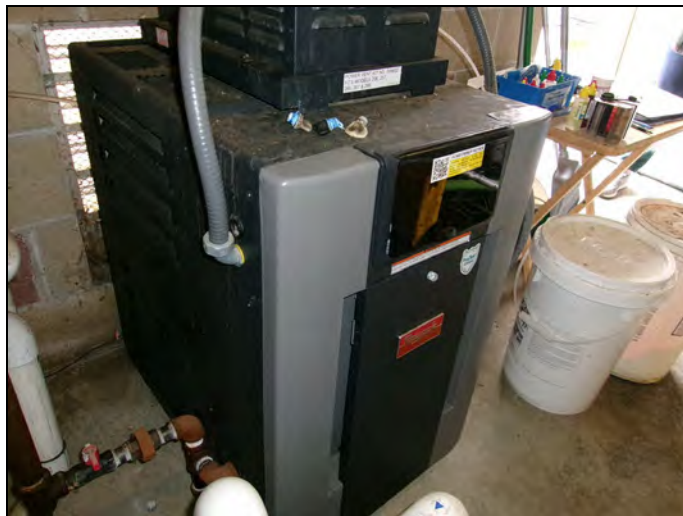
Comp #: 1106 Wading pool Heater - Replace

*Location:* **Pool Equipment Room**

The wading pool heater is in working condition. We recommend funding to replace this component approximately every 12 years. Remaining life based on current age.

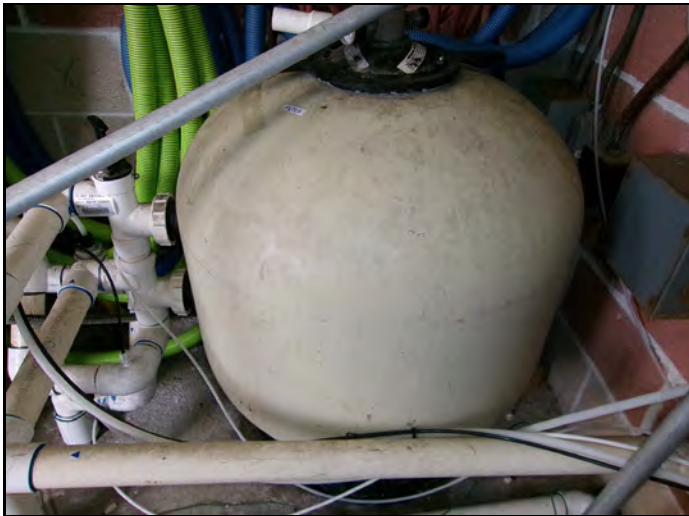
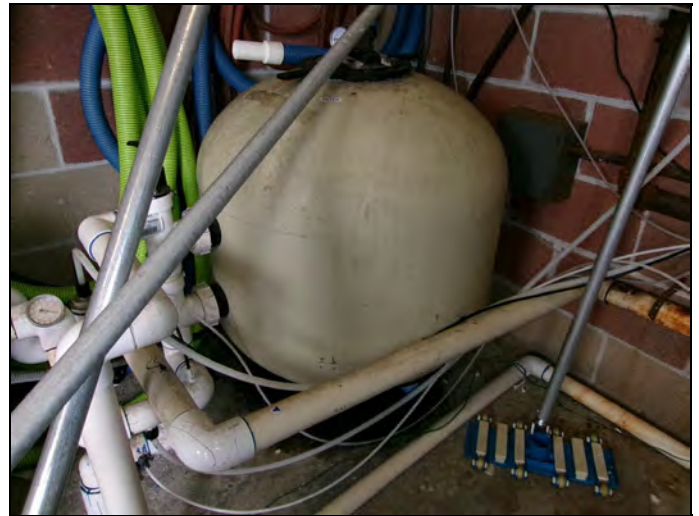
Comp #: 1107 Pool Filter - Replace

*Location:* **Pool Equipment Room**

The pool filter is in working condition. We recommend funding to replace this component approximately every 12 - 15 years. Remaining life based on current age and condition.

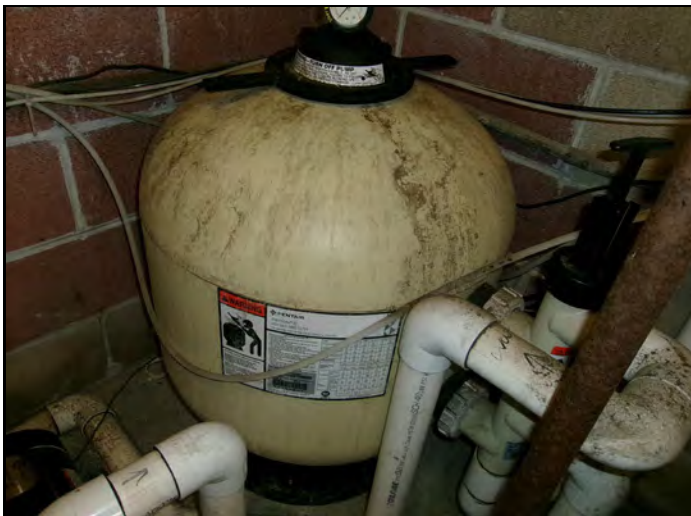
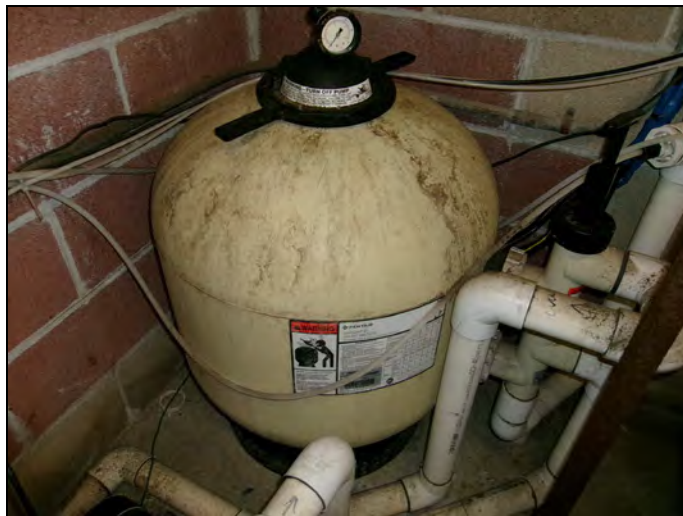
Comp #: 1109 Wading Pool Filter - Replace

*Location:* Pool Equipment Room

The wading pool filter is in working condition. We recommend funding to replace this component approximately every 12 - 15 years. Remaining life based on current age.

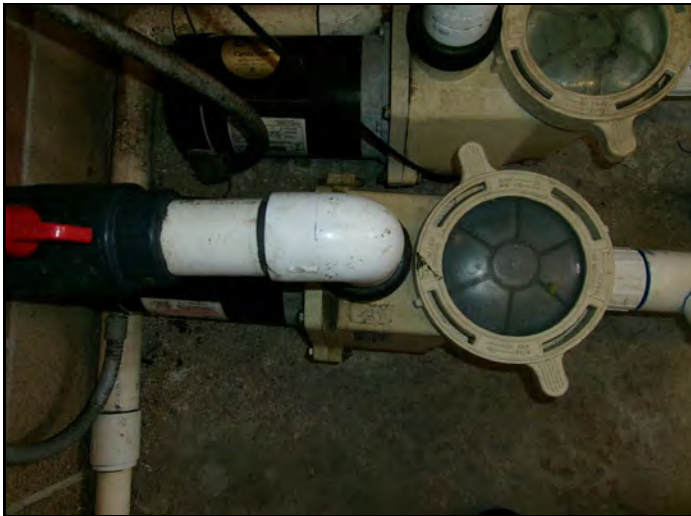
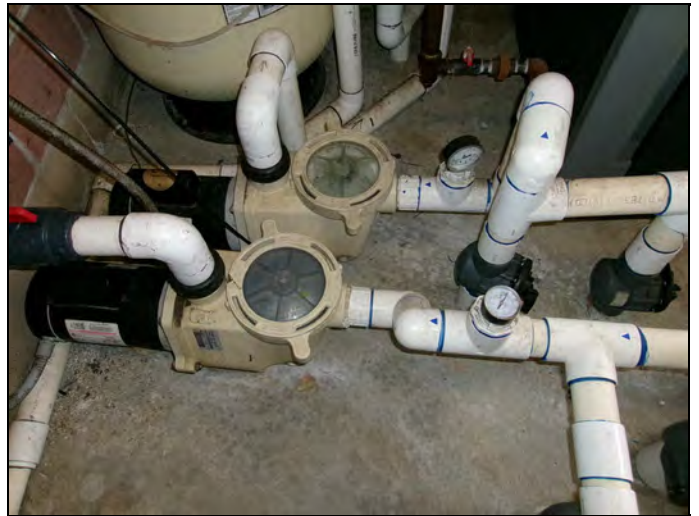
## Comp #: 1110 Pool Pumps - Replace

*Location:* **Pool Equipment Room**

Research with the client reveals the pump motors were replaced in 2023. We recommend funding to replace this component approximately every 8 - 10 years. Remaining life based on current age.

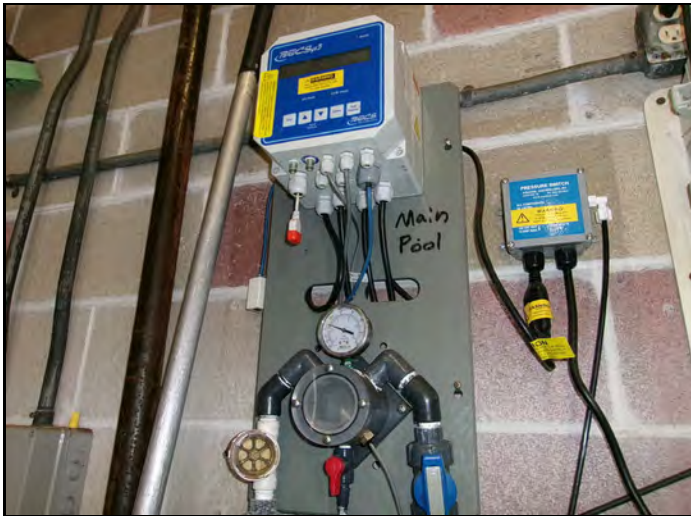
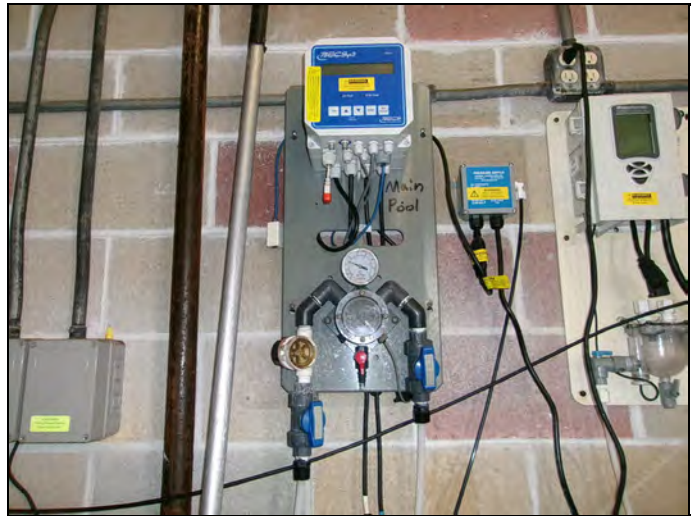
## Comp #: 1111 Pool Chemical System - Replace

*Location:* **Pool Equipment Room**

The chemical controller system is in working condition. We recommend funding to replace this component approximately every 10 - 12 years. Remaining life based on current age.

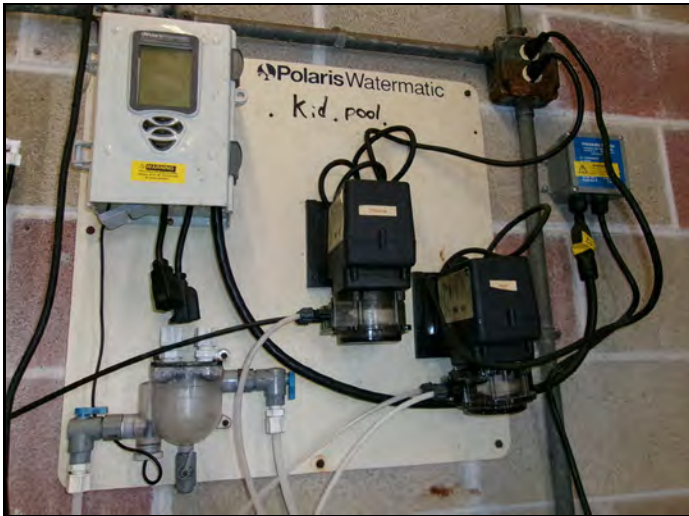
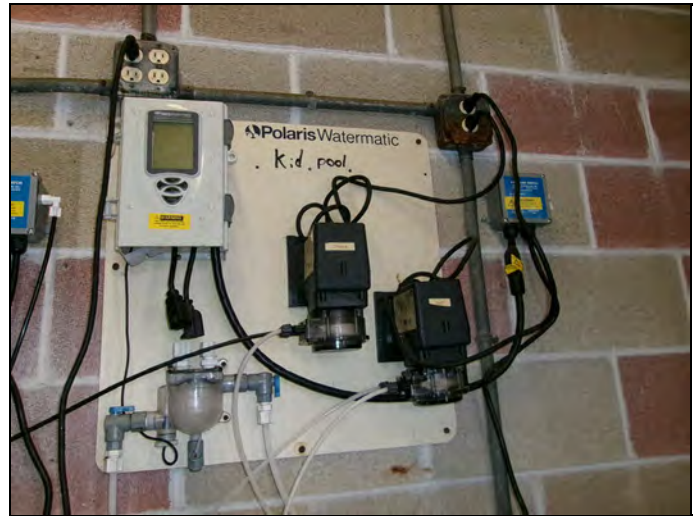
Comp #: 1111 Wading Pool Chemical System - Replace

*Location:* Pool Equipment Room

Research with the client reveals this component is being replaced in 2026. We recommend funding to replace this component approximately every 10 - 12 years. Remaining life based on current age.

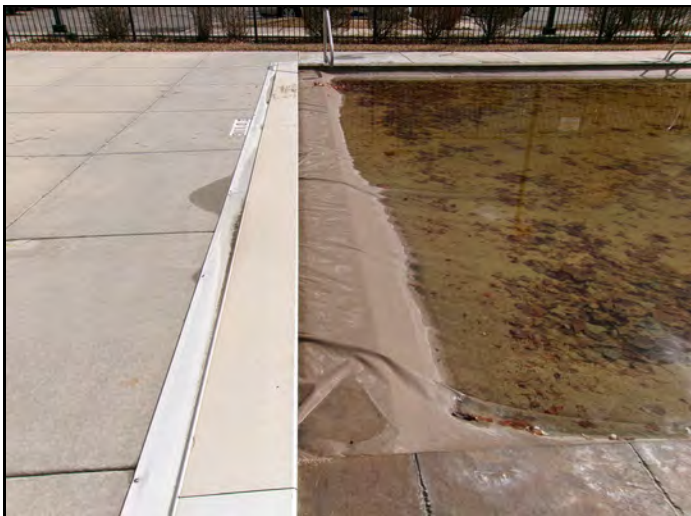
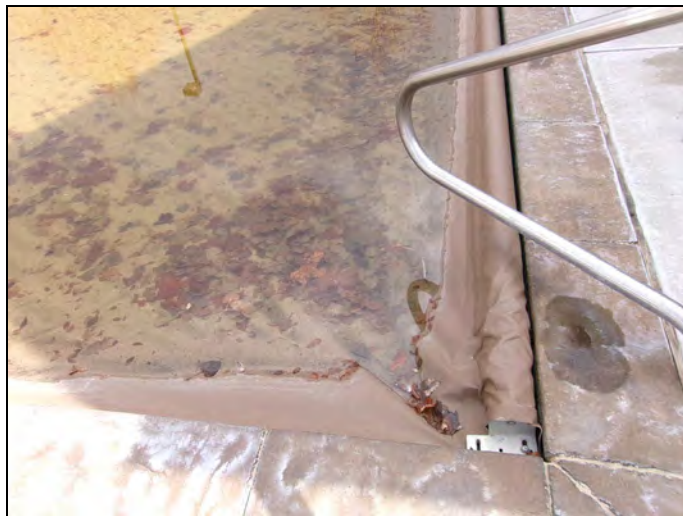
## Comp #: 1112 Pool Cover - Replace

*Location:* **Pool Area**

Research with the client reveals this component was replaced in 2023. We recommend funding to replace this component approximately every 10 years. Remaining life based on current age.

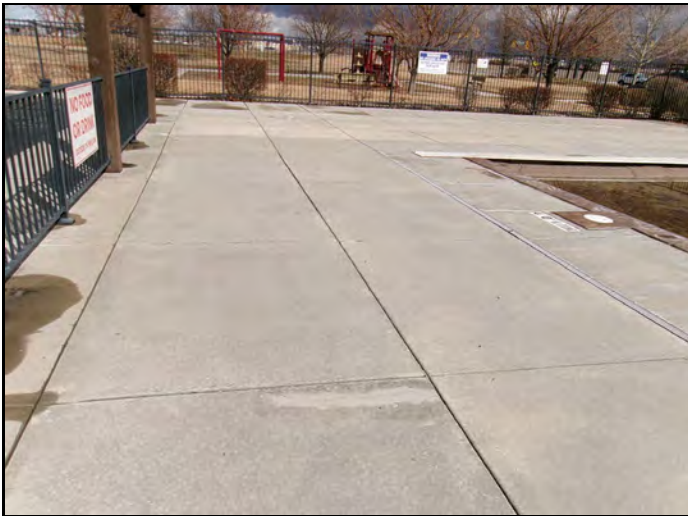
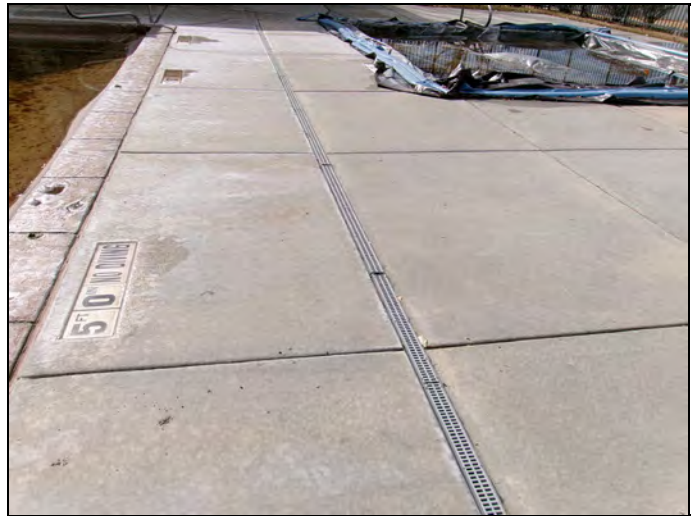
## Comp #: 1116 Pool Deck - Replace

*Location:* **Pool Area**

The pool deck is in good condition. We recommend funding to replace this component approximately every 40 - 50 years. Remaining life based on current age.

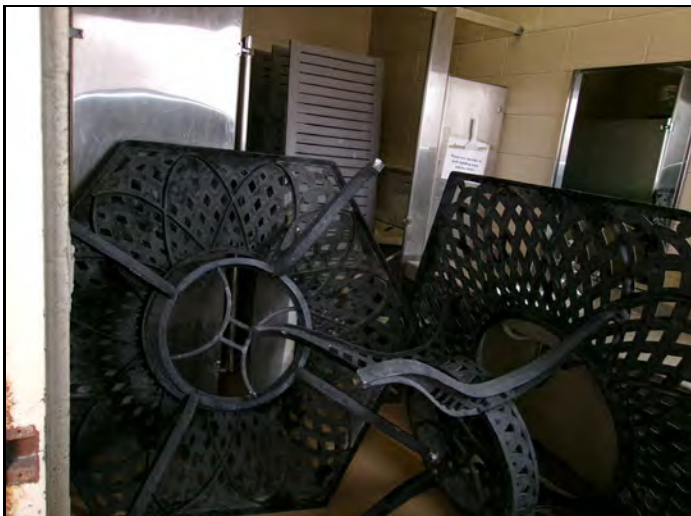
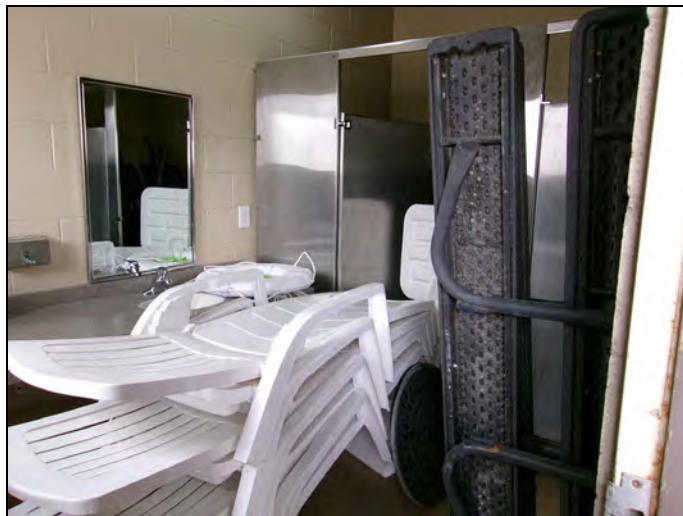
## Comp #: 1121 Pool Furniture - Replace

*Location:* **Pool Area**

The pool furniture is in good to fair condition. We recommend funding an allowance to make replacements to this component approximately every 6 years. Remaining life based on current age and condition.

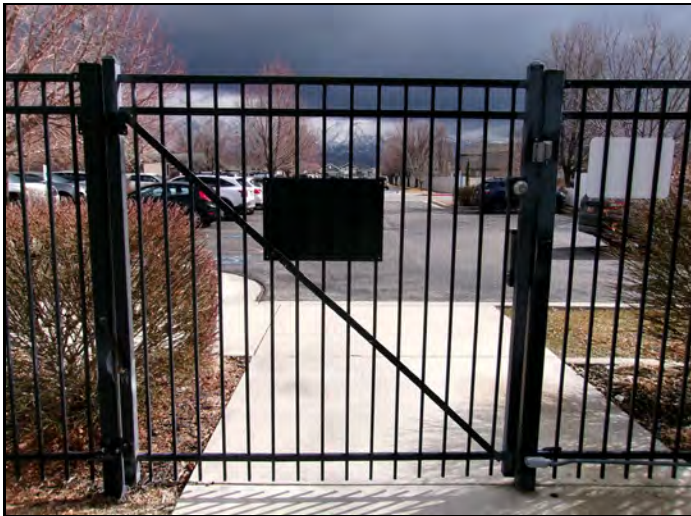
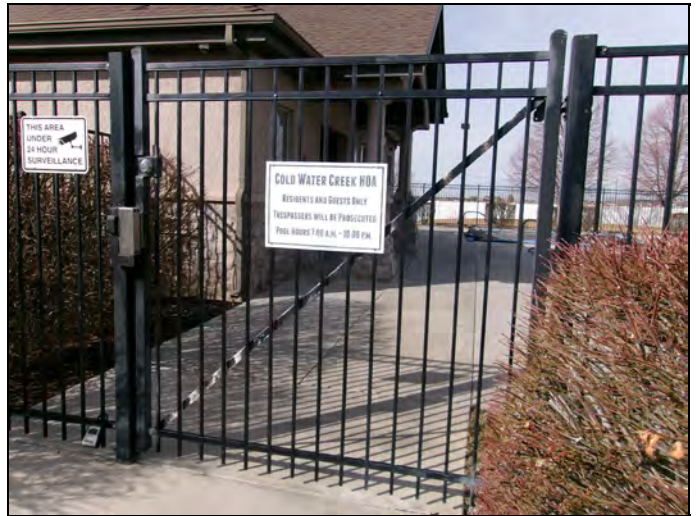
## Comp #: 1190 Pool Gate - Replace

*Location:* **Pool Area**

The pool gates are in good condition. We recommend funding to completely replace this component approximately every 25 - 30 years. Remaining life based on current age.

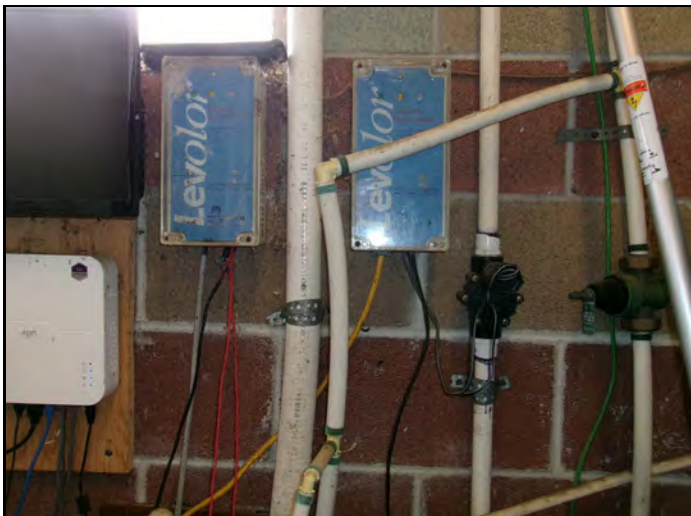
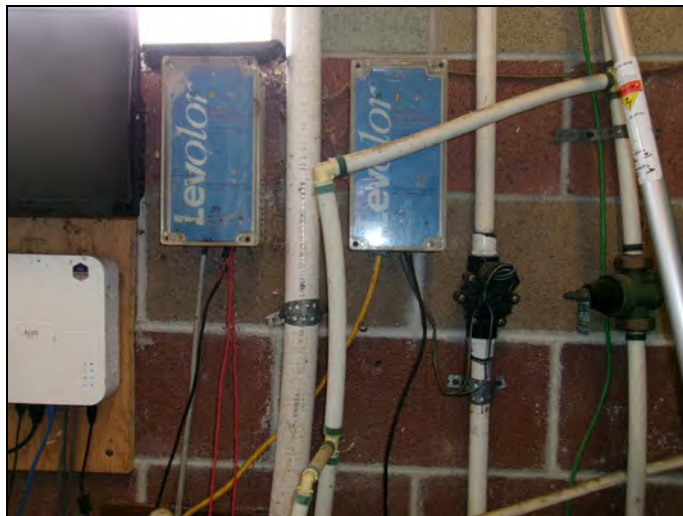
Comp #: 1190 Water Level Controllers - Replace

*Location:* **Pool Equipment Room**

Due to the minimal cost of replacing this component, reserve funding is not appropriate. Replace as necessary as an operating expense. No reserve funding necessary.

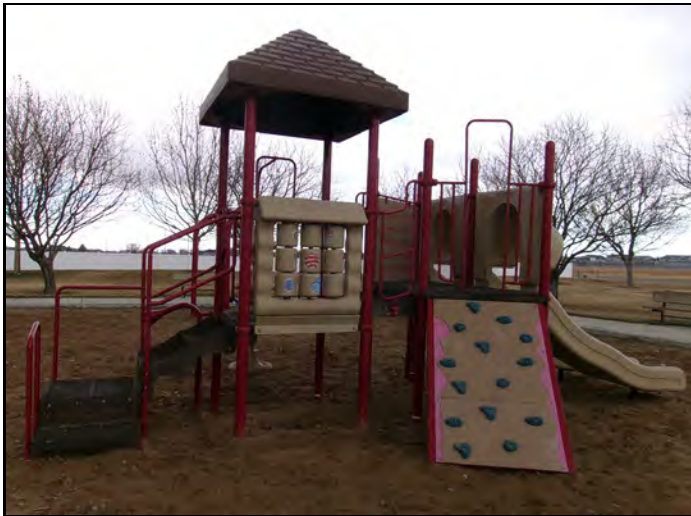
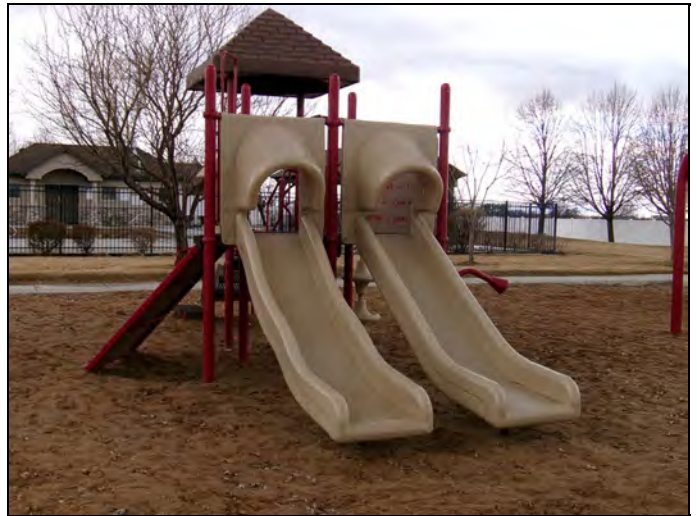
Comp #: 1301 Play Structure - Replace

*Location:* **Playground Area**

The play structure is in good to fair condition. We recommend funding to replace this component approximately every 20 - 25 years. Remaining life based on current age.

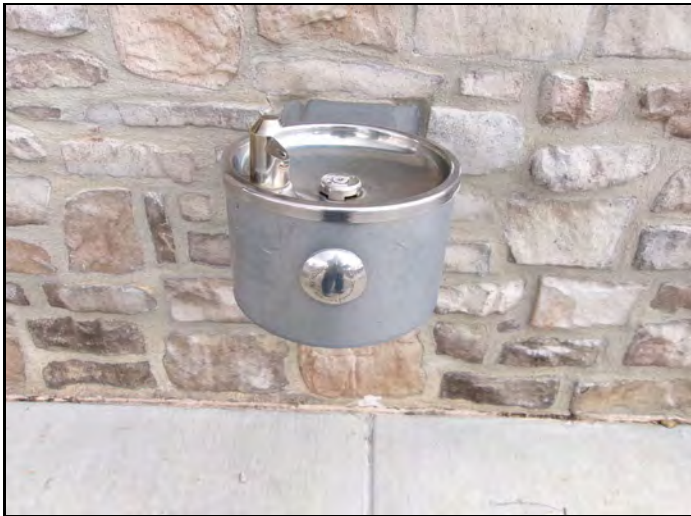
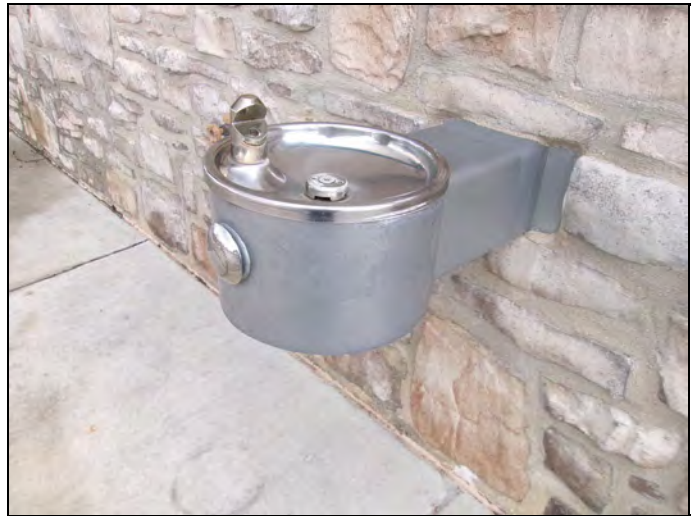
Comp #: 1304 Drinking Fountain - Replace

*Location:* **Pool Area**

Due to the minimal cost of replacing this component, reserve funding is not appropriate. Replace as necessary as an operating expense.

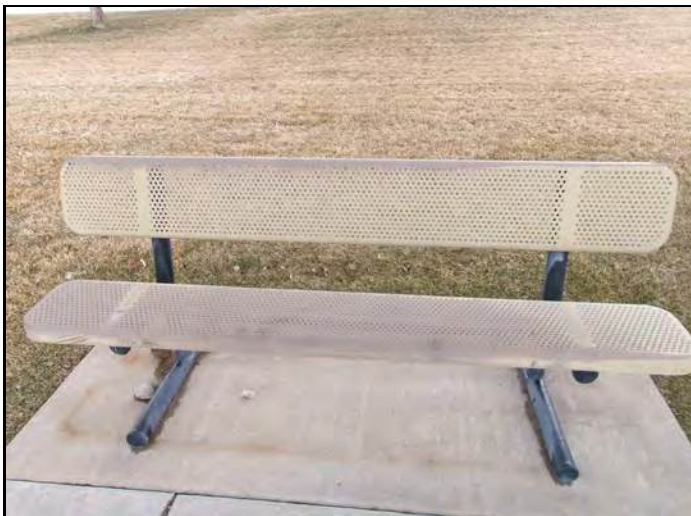
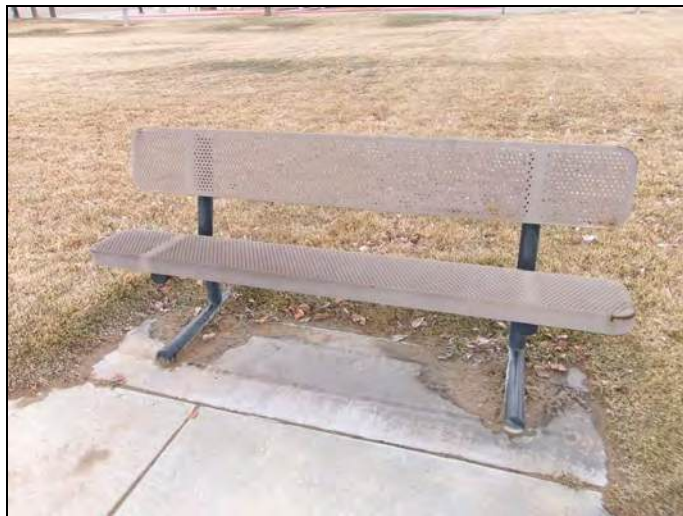
## Comp #: 1307 Benches - Replace

*Location:* **Playground Area**

The benches are in fair condition. We recommend funding to replace this component approximately every 10 - 15 years. Remaining life based on current age and condition.

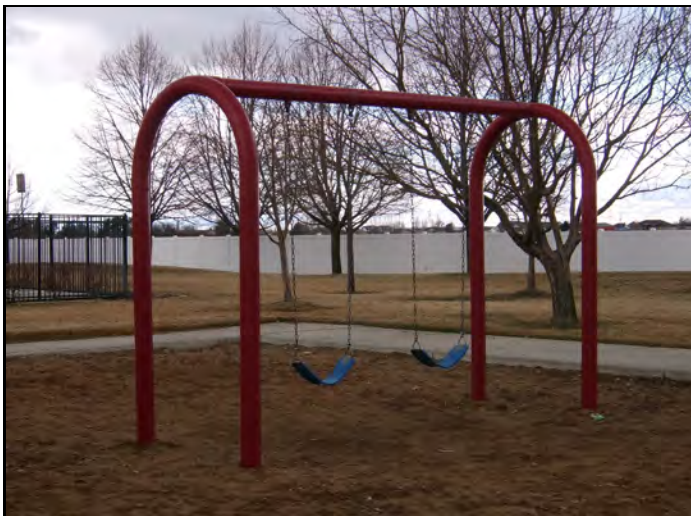
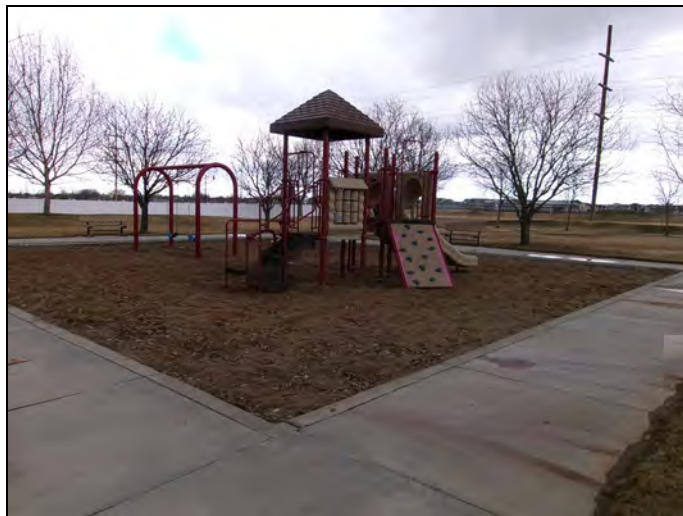
Comp #: 1390 Swing Set - Replace

*Location:* **Playground Area**

The swing set is in good condition. We recommend funding to replace this component approximately every 30 - 40 years. Remaining life based on current age.

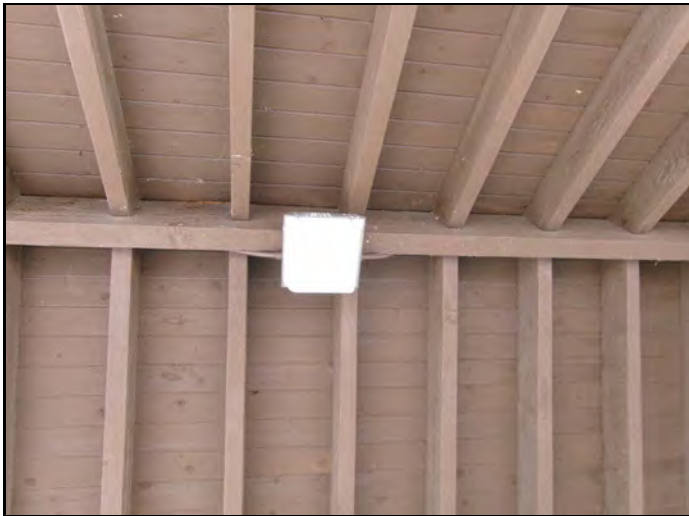
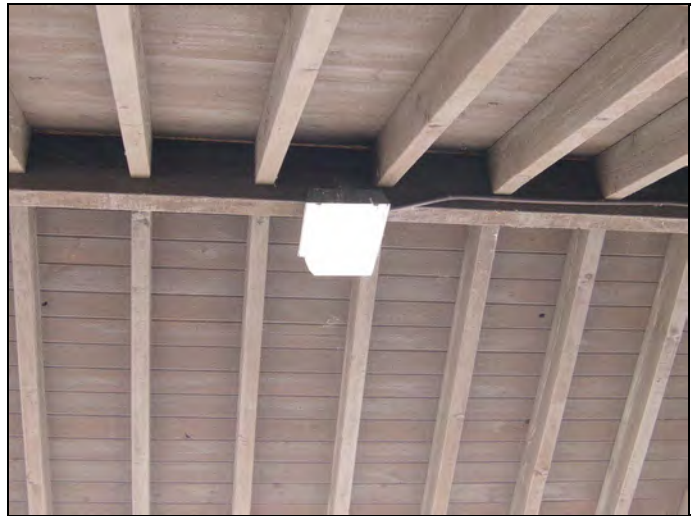
Comp #: 1602 Pavilion Light Fixtures - Replace

*Location:* **Pavilion**

Due to the minimal cost of replacing this component, reserve funding is not appropriate. Replace as necessary as an operating expense.

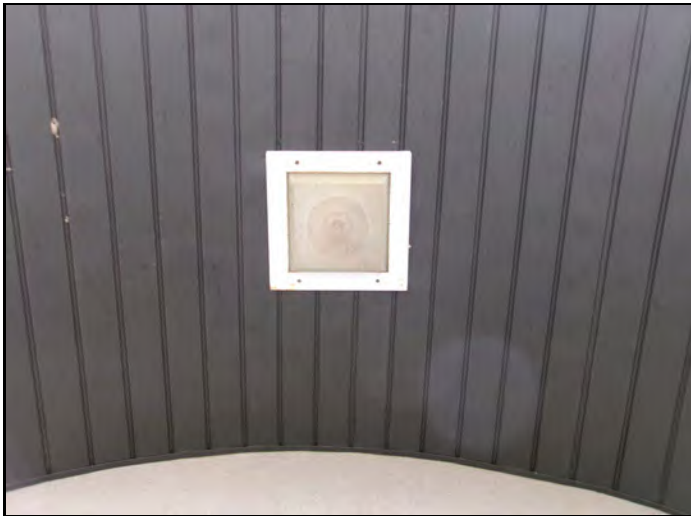
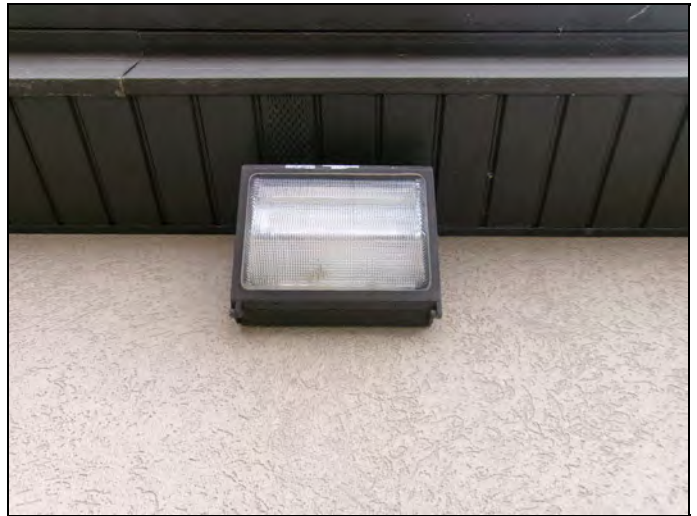
Comp #: 1602 Pool Building Light Fixtures - Replace

*Location:* **Pool Building Exterior**

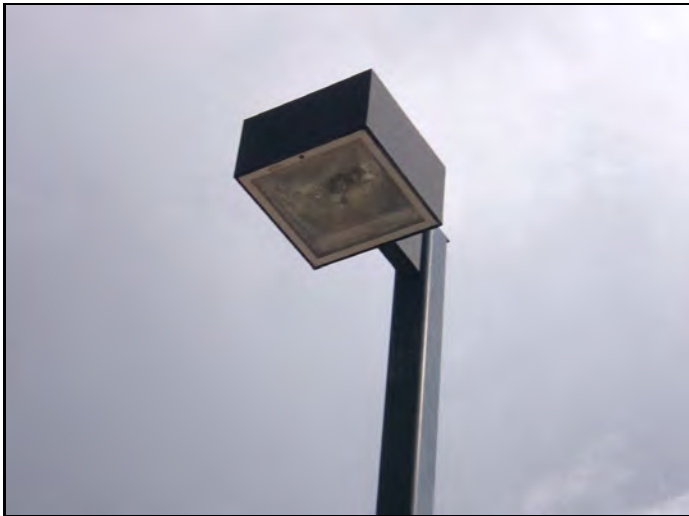
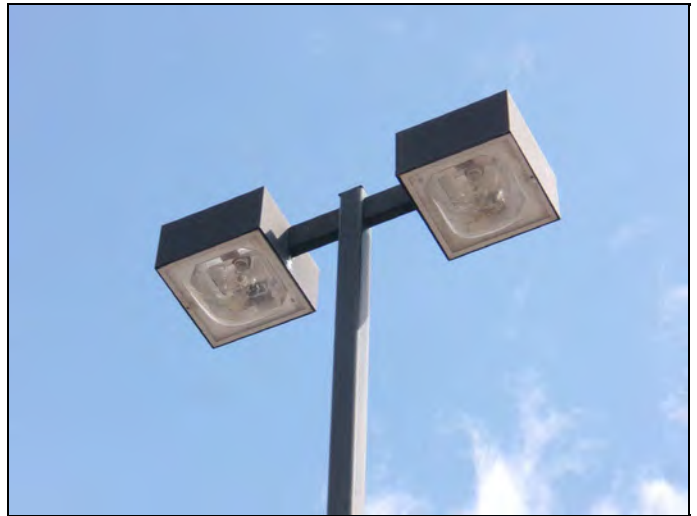
Comp #: 1609 Street Light Fixtures - Replace

*Location:* **Common Area, Adjacent to Streets**
