# Coldwater Creek

## Level 2 Reserve Study

**Report Period – 01/01/2025 – 12/31/2025**

## Executive Summary – Coldwater Creek - ID # 12273

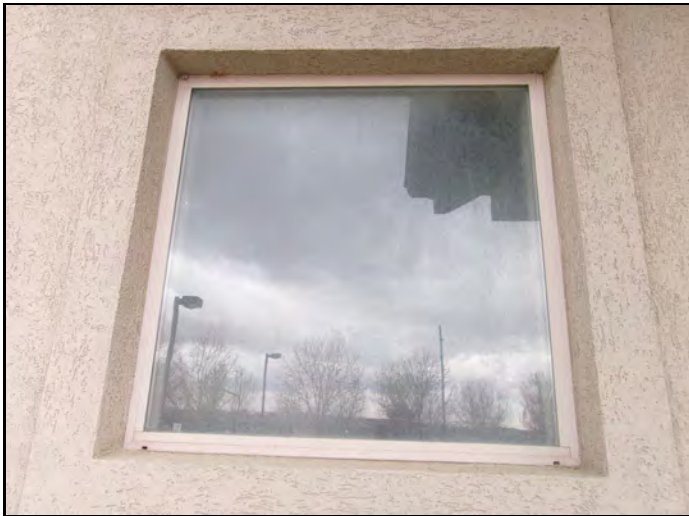
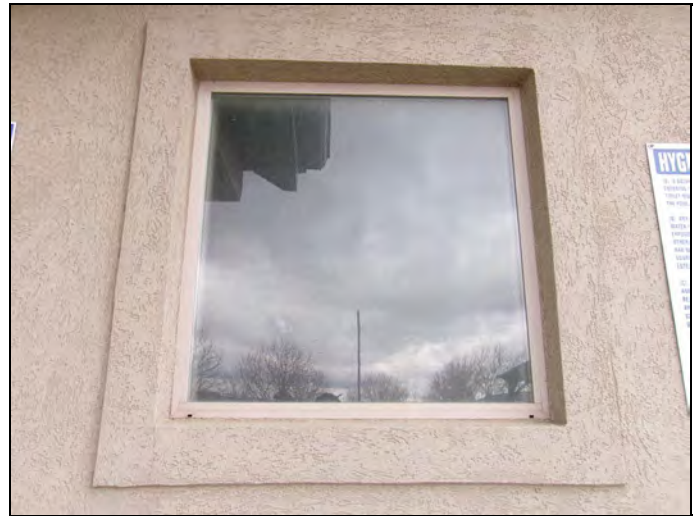
## Comp #: 2303 Windows - Replace

*Location:* **Pool House**

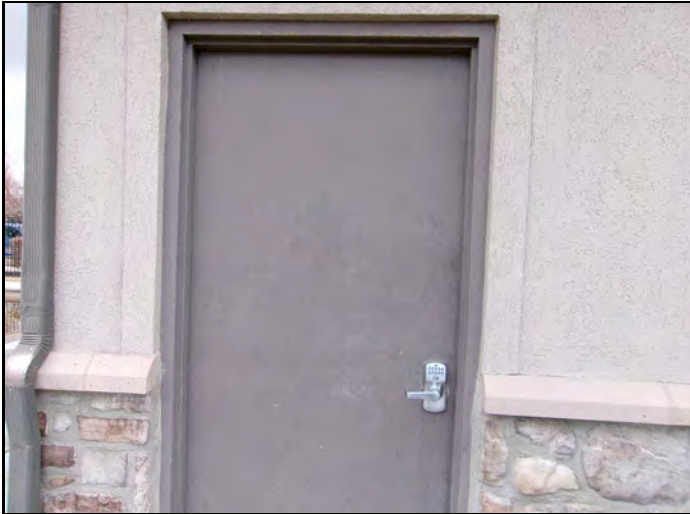
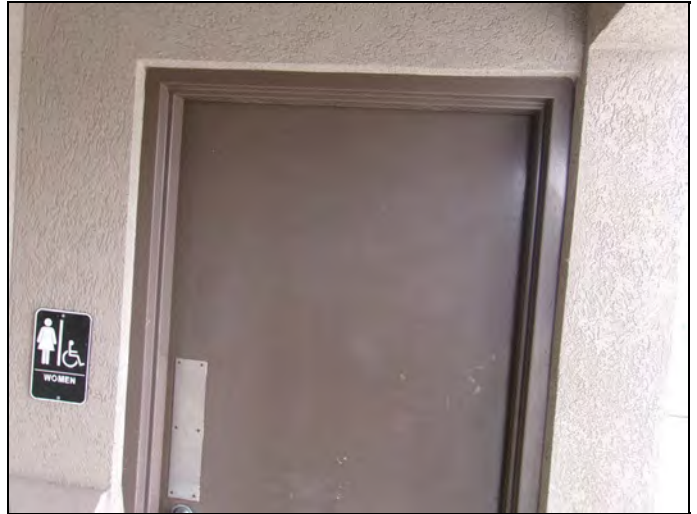
## Comp #: 2304 Exterior Doors - Replace

*Location:* **Pool House**
