Bridgewood Manor HOA

Level 1 Reserve Study

Report Period – 01/01/2015 – 12/31/2015

Date of Property Inspection	3/18/2015
Prepared By	Dale Gifford
Analysis Method	Cash Flow
Funding Goal	Full Funding

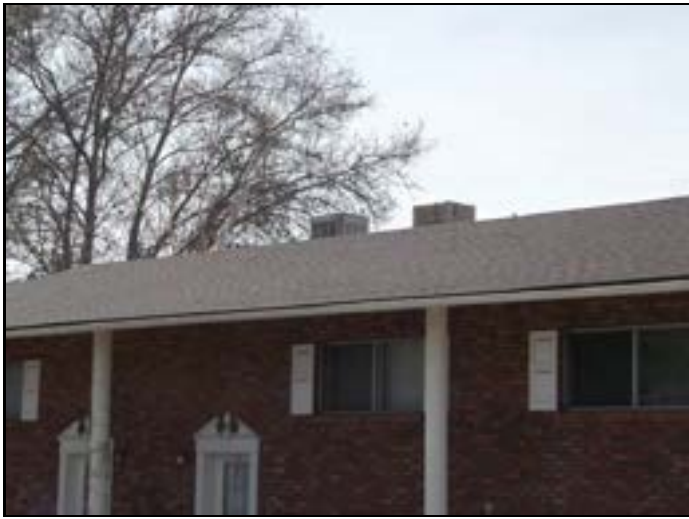
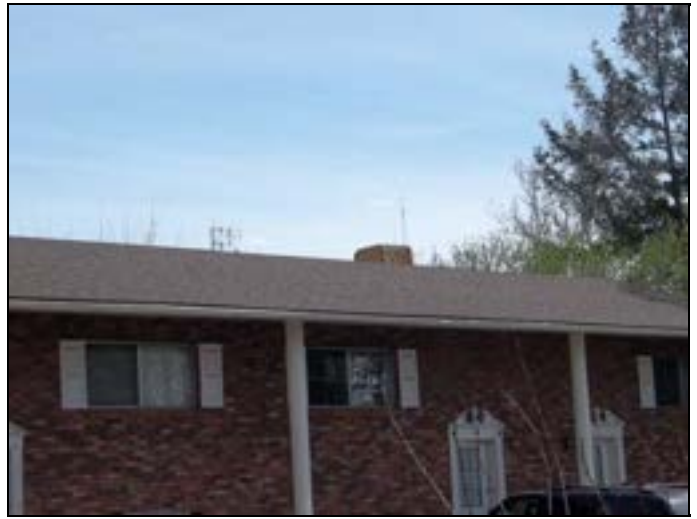
Comp #: 105 Pitched Roof - Bldg 1, 3, 4, 7 & 9 - Replace

The roofs are in good condition. No problems were noted at the time of the inspection. Typically this type of roofing material has a useful life of approximately 20 - 25 years. Inspect this component regularly and make local repairs as necessary as an operating expense to ensure full life from this component. Remaining life based on current age.

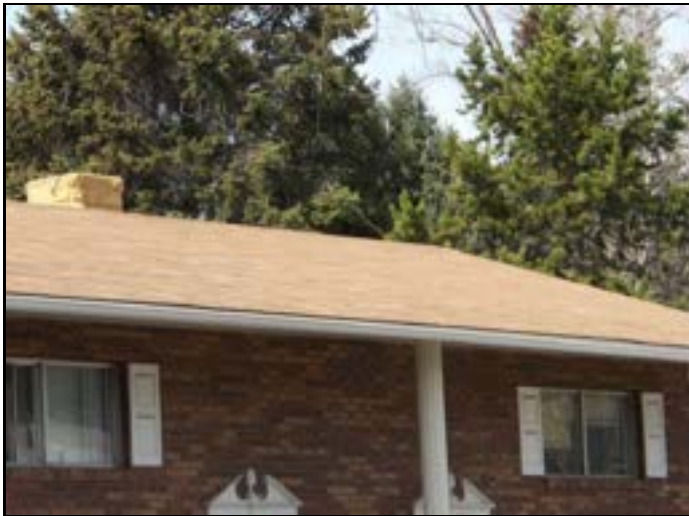
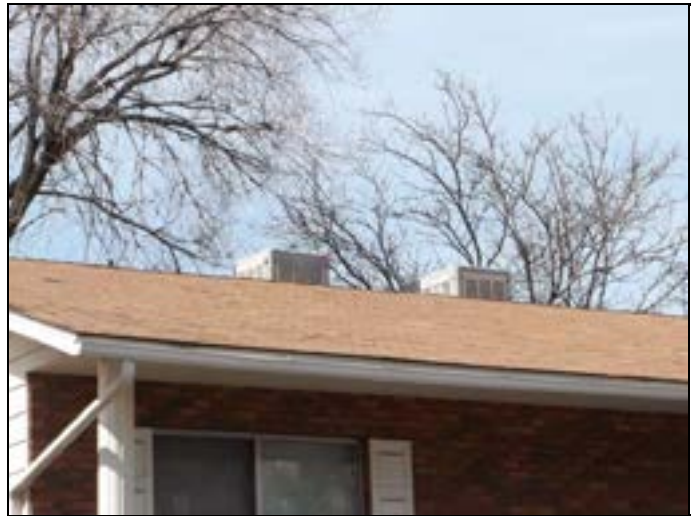
Comp #: 105 Pitched Roof - Bldg 1, 4, 6, 10 & Pool - Replace

The roofs are in fair condition. Typically this type of roofing material has a useful life of approximately 20 - 25 years. Inspect this component regularly and make local repairs as necessary as an operating expense to ensure full life from this component. Remaining life based on current age.

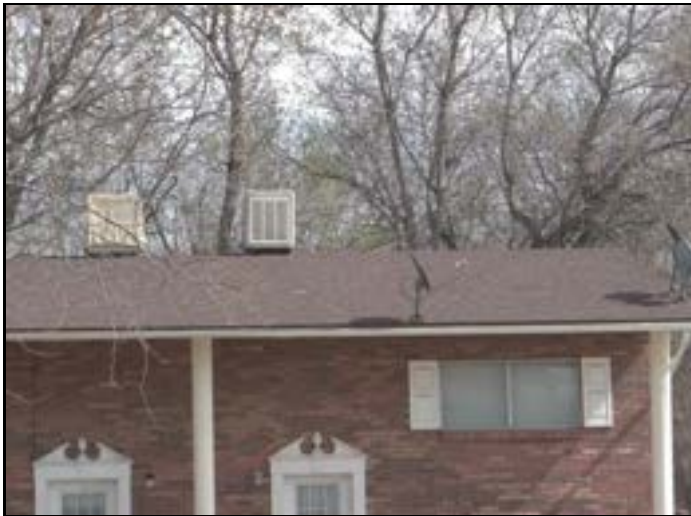
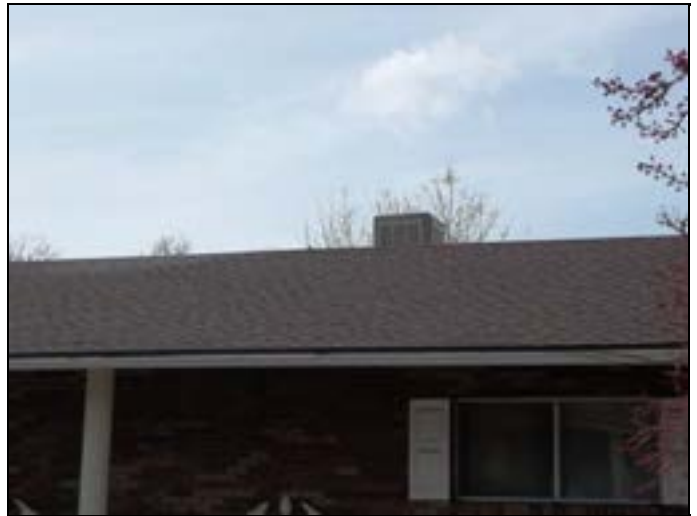
Comp #: 105 Pitched Roof - Bldg 2 & 5 - Replace

The roofs are in good condition. Typically this type of roofing material has a useful life of approximately 20 - 25 years. Inspect this component regularly and make local repairs as necessary as an operating expense to ensure full life from this component. Remaining life based on current age.

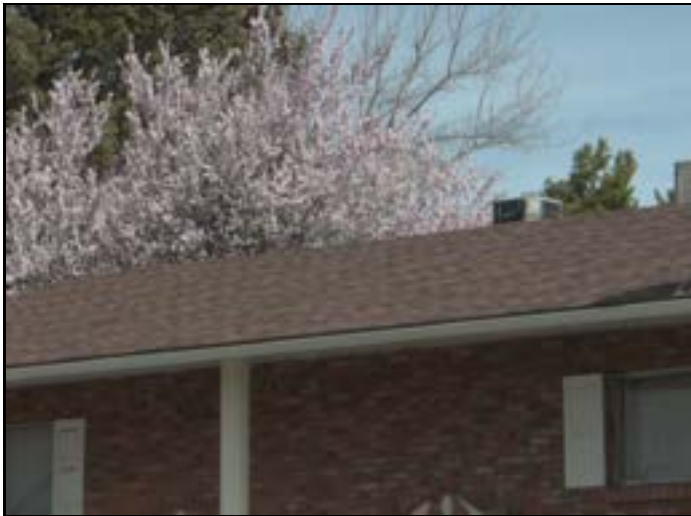
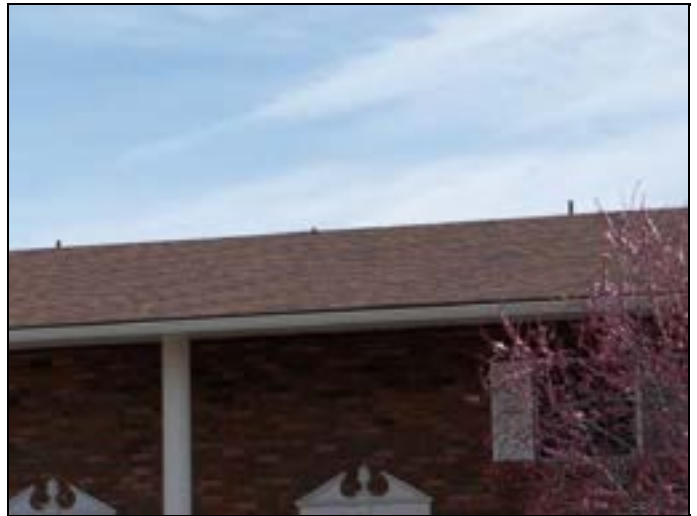
Comp #: 105 Pitched Roof - Bldg 8 - Replace

The roof is in good condition. No problems were noted at the time of the inspection. Typically this type of roofing material has a useful life of approximately 20 - 25 years. Inspect this component regularly and make local repairs as necessary as an operating expense to ensure full life from this component. Remaining life based on current age.

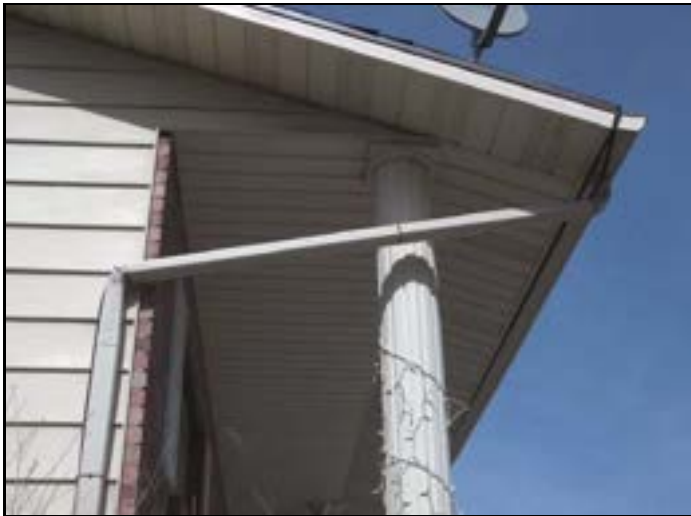
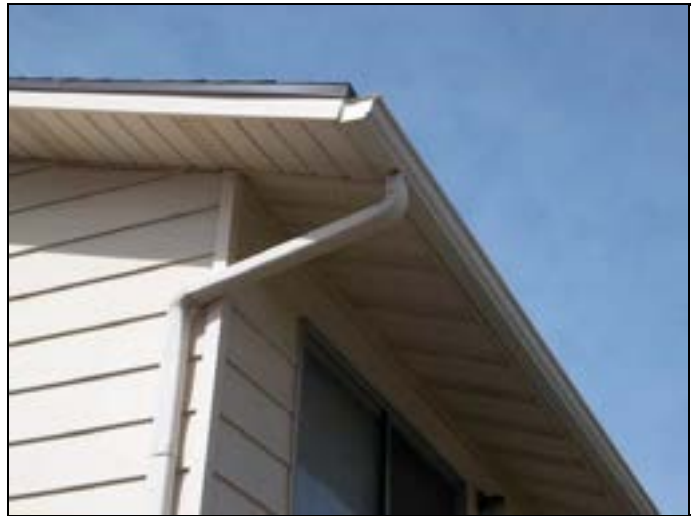
Comp #: 120 Rain Gutters/Downspouts - Replace

The rain gutters and downspouts are in good to poor condition. The association has been replacing this component as necessary as an operating expense.

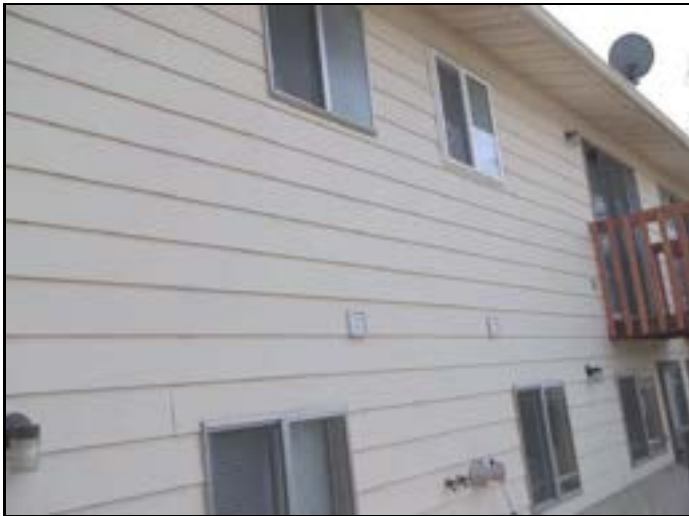
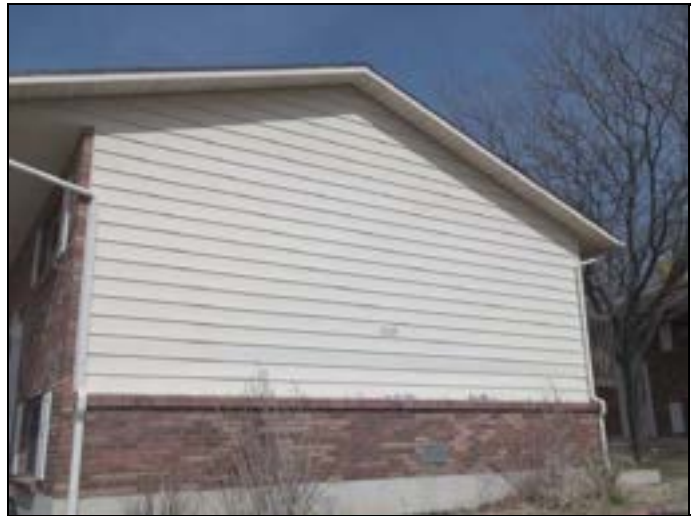
Comp #: 304 Metal Siding - Replace

The metal siding is in fair condition. Areas of fading and missing paint were noted at the time of the inspection. Although this component may reach an extended life, we recommend funding to replace this component every 40 - 50 years to maintain appearance. Remaining life based on current age.

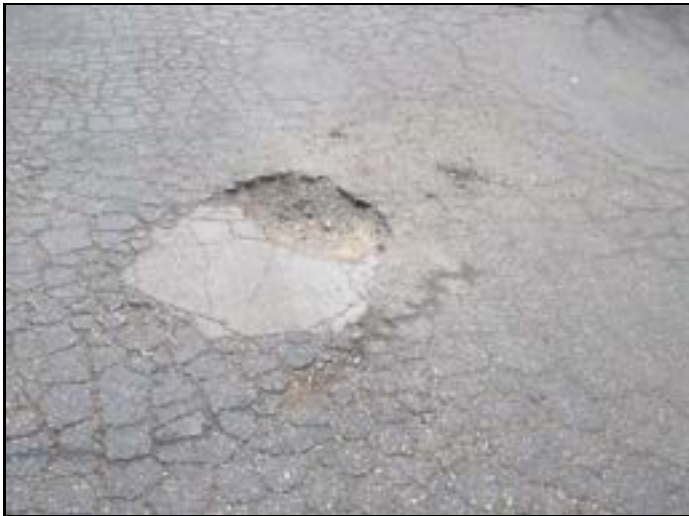
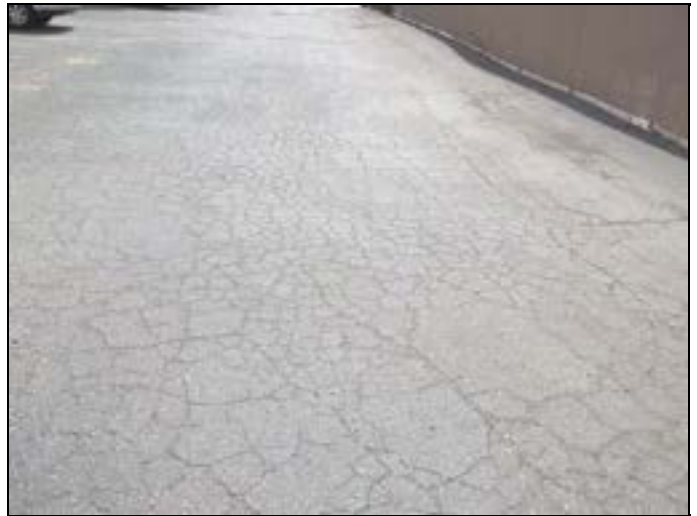
Comp #: 401 Asphalt - Overlay

The asphalt surfaces are in poor condition. We recommend funding to replace the asphalt surfaces in fiscal year 2015. The life and cost information for this component are based upon this replacement in 2015. We recommend funding to overlay this component approximately every 20 - 25 years. Maintain seal coat schedule to ensure full useful life (see Comp# 402 Asphalt - Seal Coat). Remaining life based on current age.

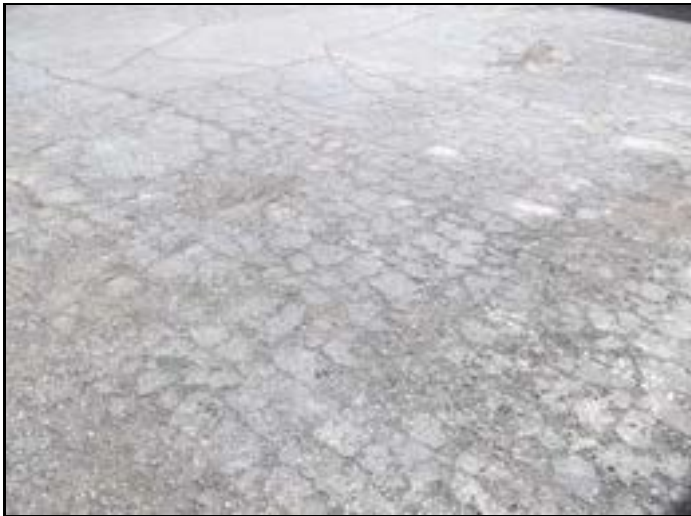
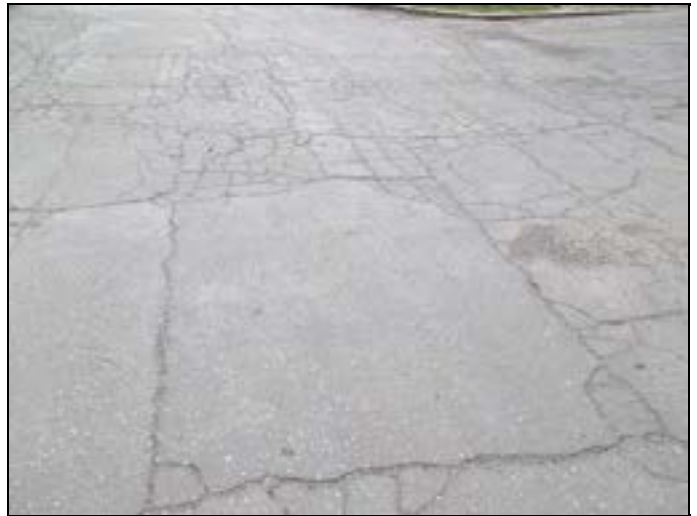
Comp #: 402 Asphalt - Seal Coat

The asphalt seal coat is in poor condition. We recommend funding to replace the asphalt surfaces in fiscal year 2015. The life and cost information for this component are based upon this replacement in 2015. Seal asphalt surfaces regularly to prevent premature overlay (see Comp# 401 Asphalt - Overlay). We recommend funding to seal this component approximately every 3 - 5 years. Remaining life based on current condition.

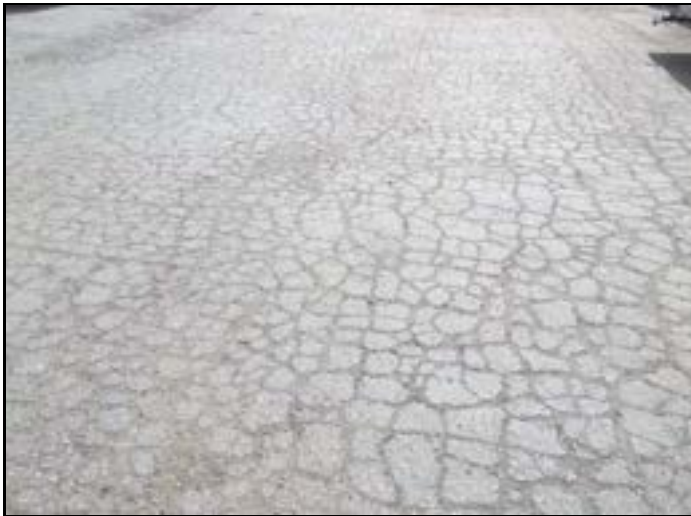
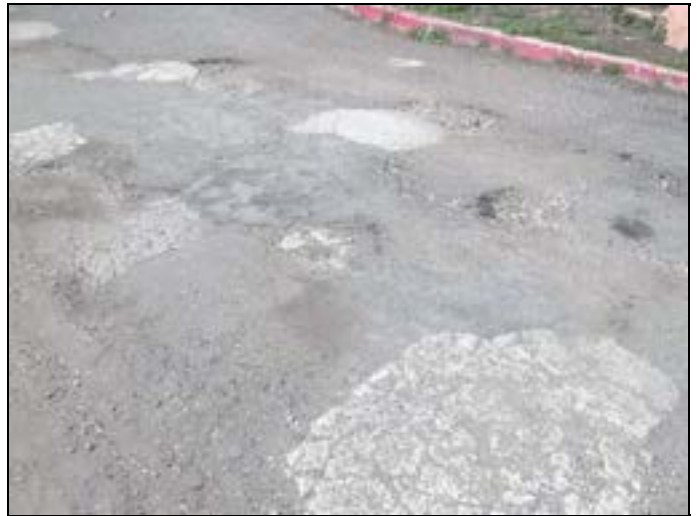
Comp #: 490 Asphalt - Replace

The asphalt surfaces are in poor condition. We recommend funding to replace the asphalt surfaces in fiscal year 2015. This component is a one time project to replace the asphalt surfaces.

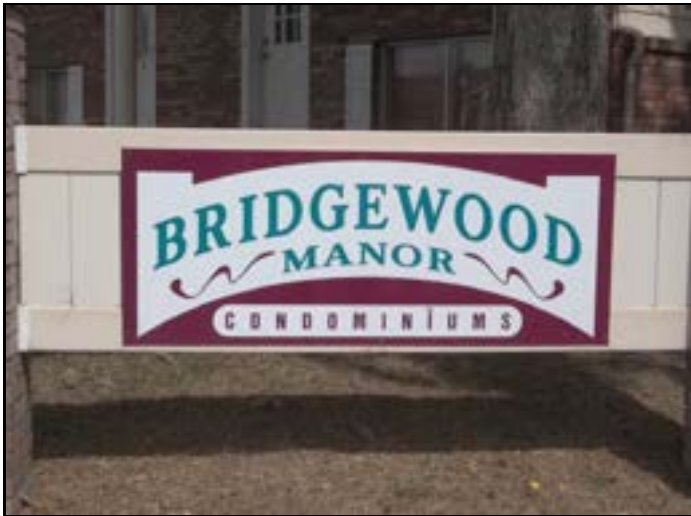
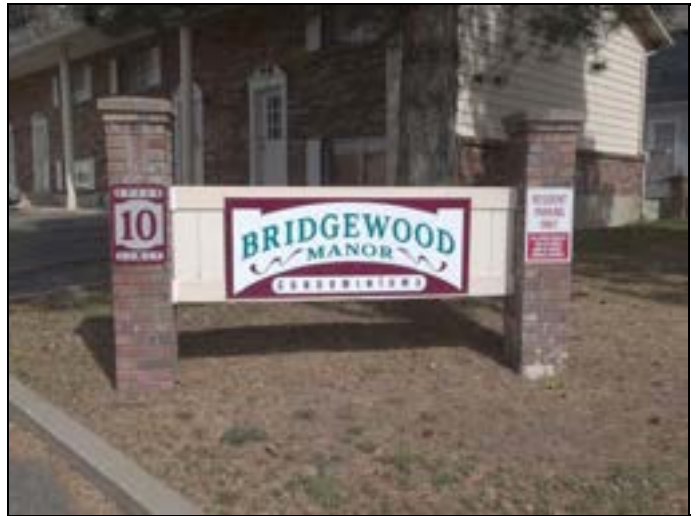
Comp #: 801 Monument Sign - Refurbish

The monument sign is in good condition. We recommend funding to refurbish this component approximately every 18 years to ensure appearance. Remaining life is based on current condition.

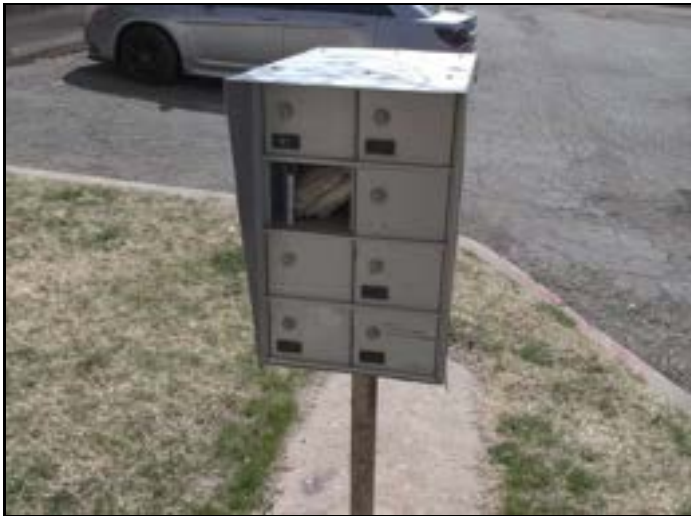
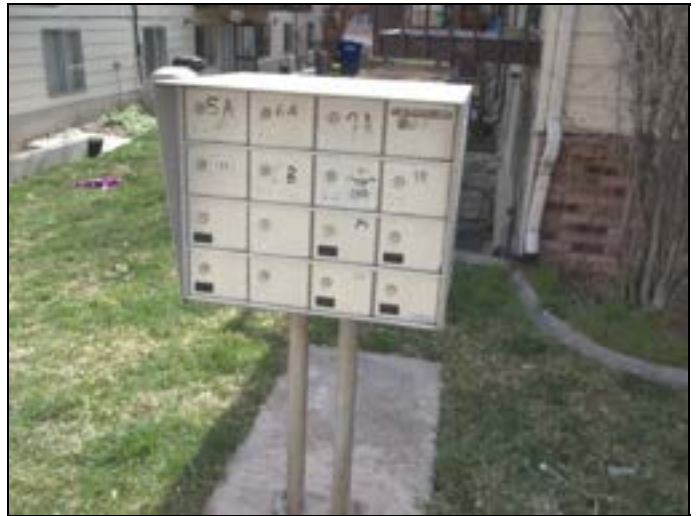
Comp #: 803 Mailboxes - Replace

The mailboxes are in fair condition. We recommend funding to replace this component approximately every 18 - 20 years assuming normal use and wear. Remaining life based on current condition.

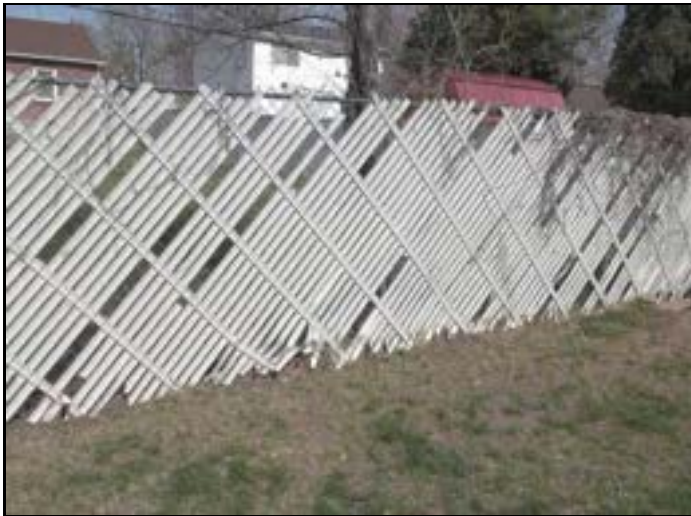
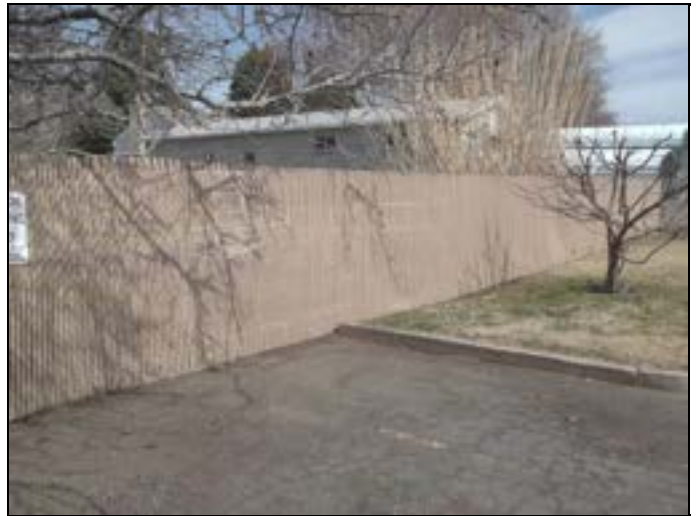
Comp #: 1003 Chain Link Fencing - Repair/Replace

The chain link fencing is in good to poor condition. Areas of damage, broken slats and missing slats were noted at the time of the inspection. Typically this component has an extended useful life under normal conditions. We are funding for an allowance to make repairs/replacements to this component approximately every 10 years. Remaining life based on current condition.

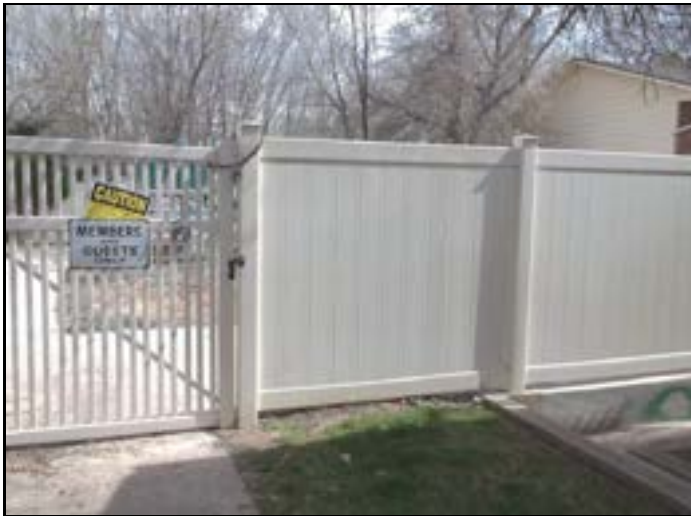
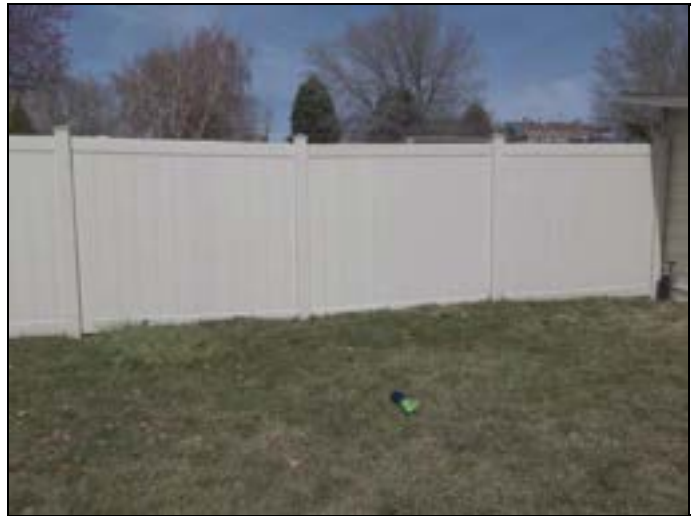
Comp #: 1008 Vinyl Fencing - Replace

The vinyl fencing is in good to fair condition. Areas of minor damage were noted at the time of the inspection. We recommend funding to replace this component approximately every 25 - 30 years. Remaining life based on current age

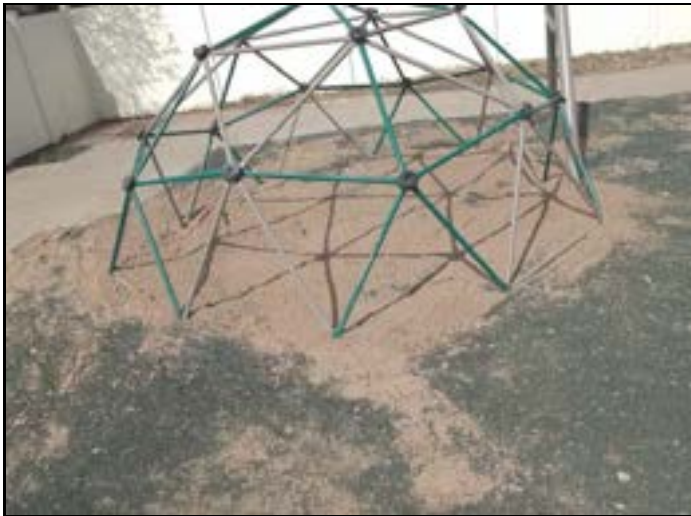
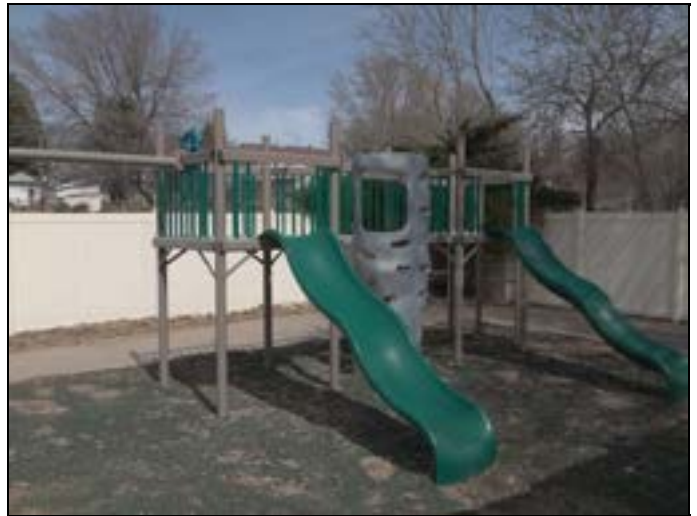
Comp #: 1301 Play Structures - Replace

The play structures are in good condition. We recommend funding to replace this component approximately every 15 - 20 years. Remaining life based on current age.

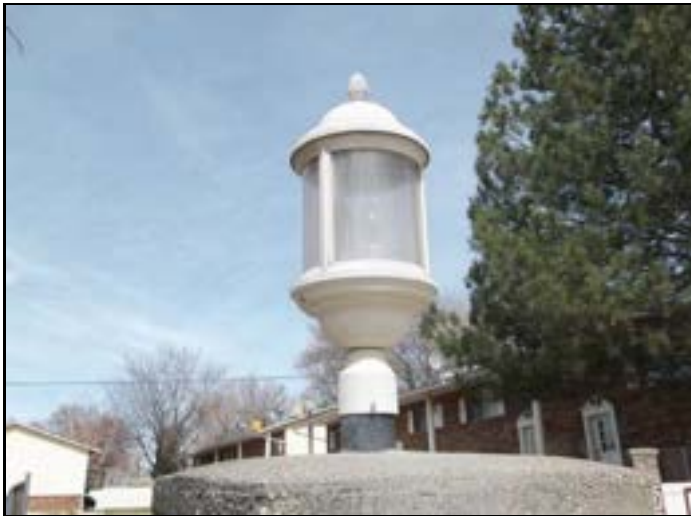
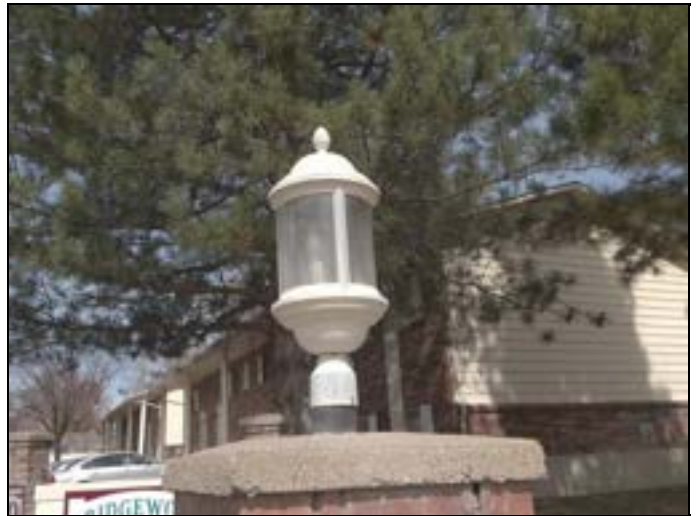
Comp #: 1604 Pole Lights - Replace

The pole lights are in poor condition. Due to the minimal replacement cost of this component, we recommend replacing as necessary as an operating expense. No reserve funding necessary.

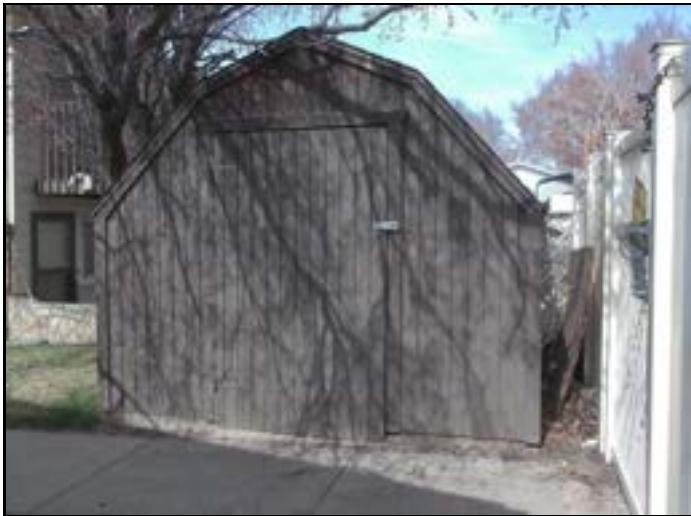
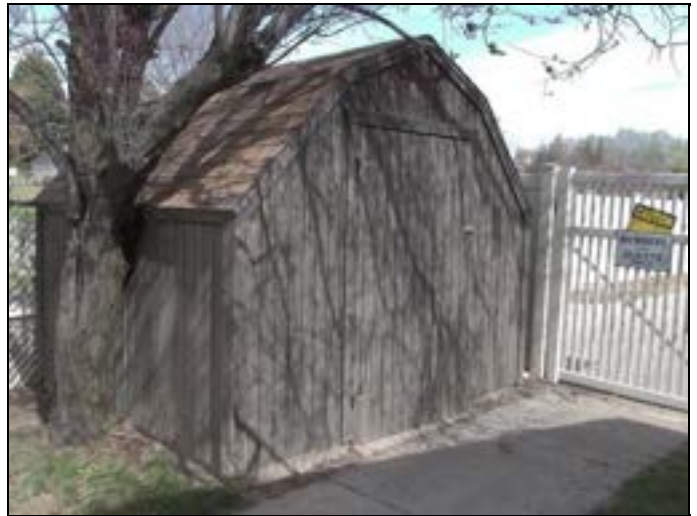
Comp #: 2301 Shed - Refurbish

The shed exterior is in poor condition. Due to the minimal cost of roofing and painting this component, we recommend roofing and painting as necessary as an operating expense. No reserve funding necessary.
