theRuth

Level 1 Reserve Study

Client Reference Number	18606
Property Type	Townhouse
Number of Units	18
Fiscal Year End	12/31

Type of Study	Full Study
Date of Property Inspection	9/16/2019
Prepared By	Dale Gifford
Analysis Method	Cash Flow
Funding Goal	Full Funding

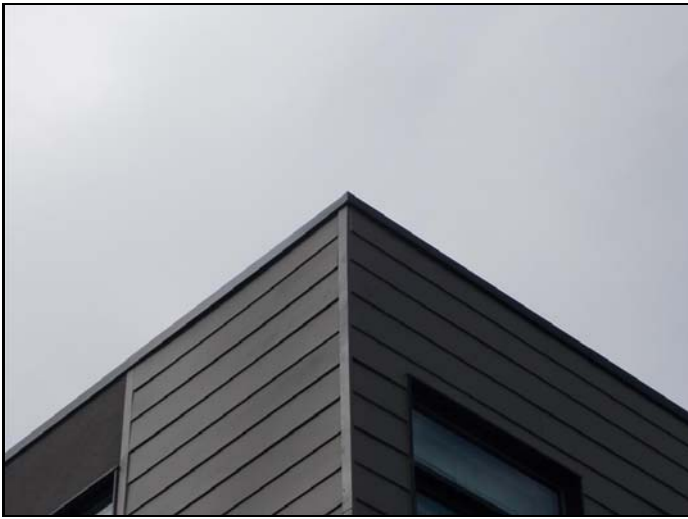
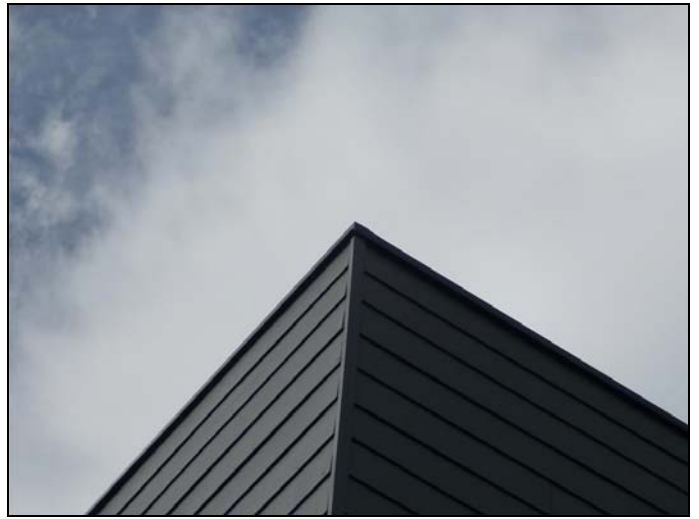
Comp #: 104 Flat Roof - Replace

Location: **Building Roofs**

Unable to inspect this component at the time of the site visit. We recommend funding to replace this component approximately every 20 - 25 years. Remaining life based on current age.

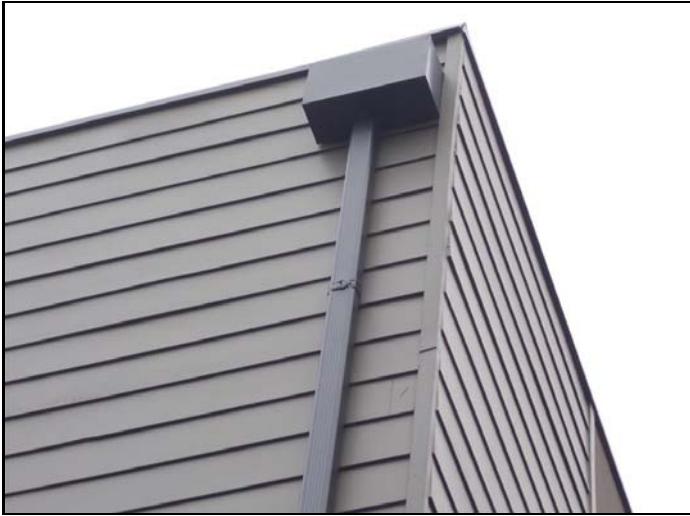
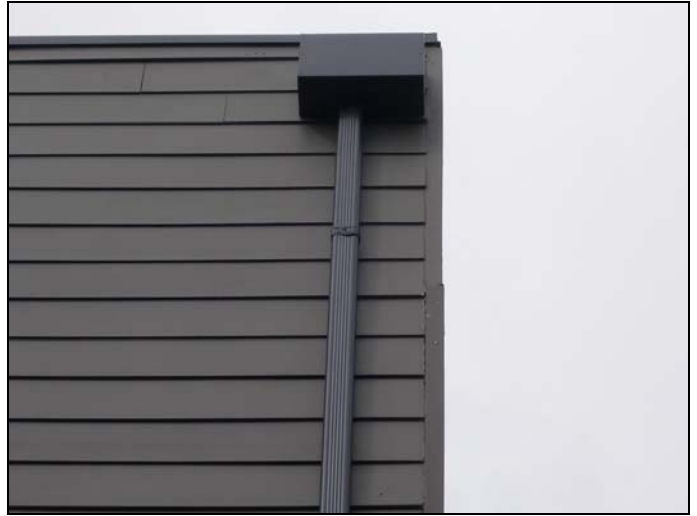
Comp #: 120 Rain Gutters/Downspouts - Replace

Location: **Building Exteriors**

The rain gutters and downspouts are in good condition. We recommend funding to replace this component approximately every 25 - 30 years. Remaining life based on current age.

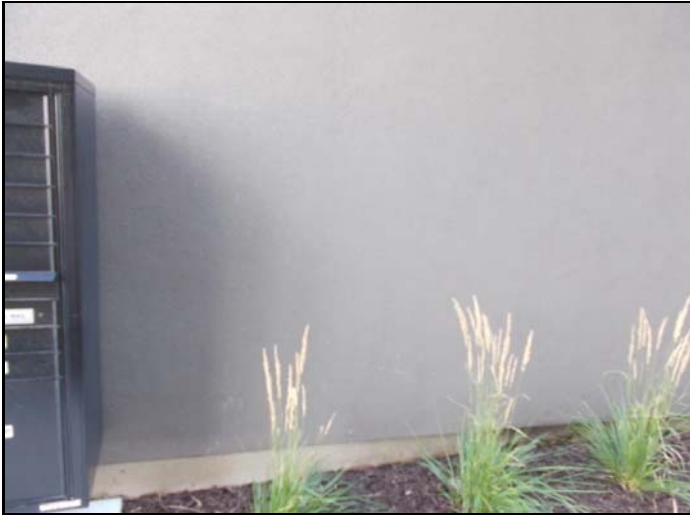
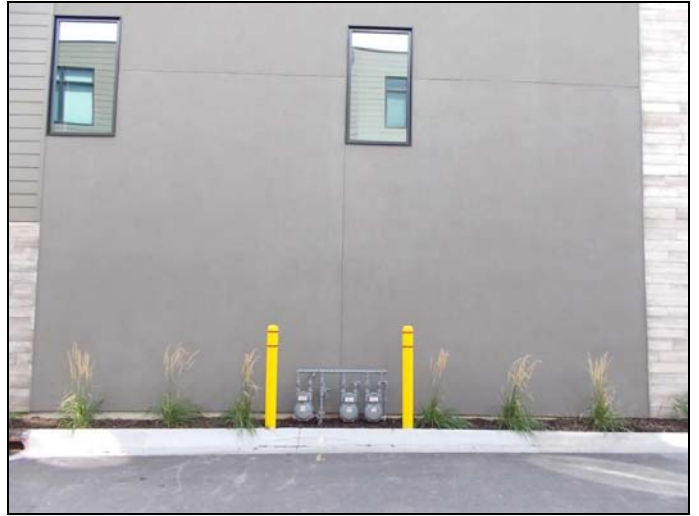
Comp #: 201 Stucco Surfaces - Repair/Repaint

Location: **Building Exteriors**

The stucco surfaces are in good condition. We recommend funding to repair/repaint this component approximately every 12 - 15 years. Remaining life based on current age.

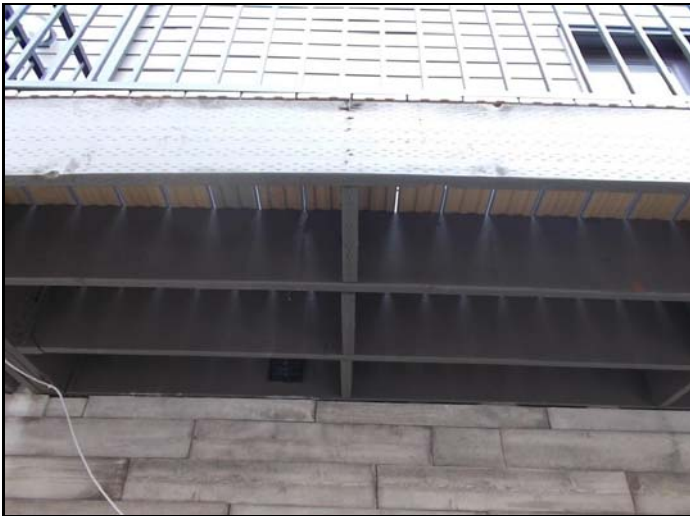
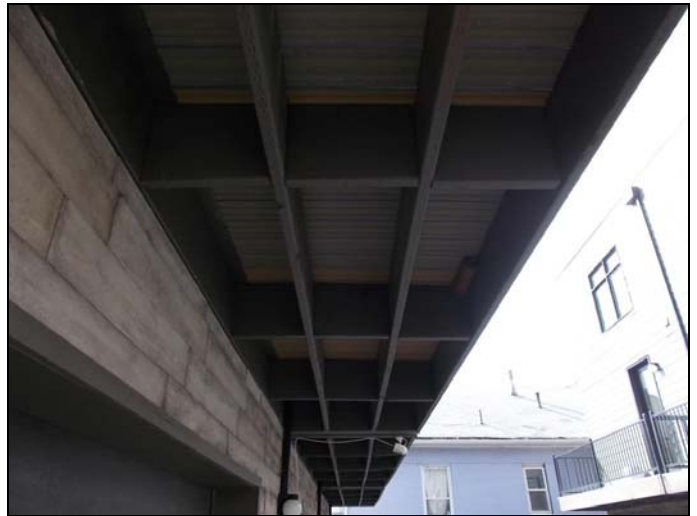
Comp #: 202 Wood Supports - Repaint

Location: **Unit Rear Balconies**

The painted wood trim surfaces are in good condition. We recommend funding to repaint this component approximately every 4 - 6 years. Remaining life based on current age.

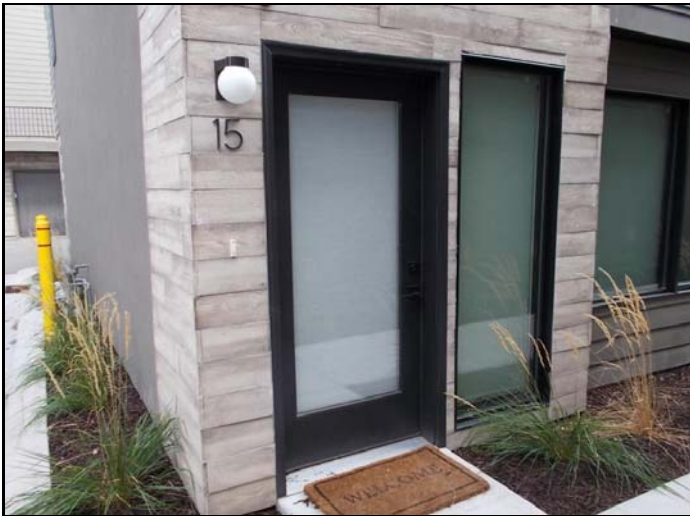
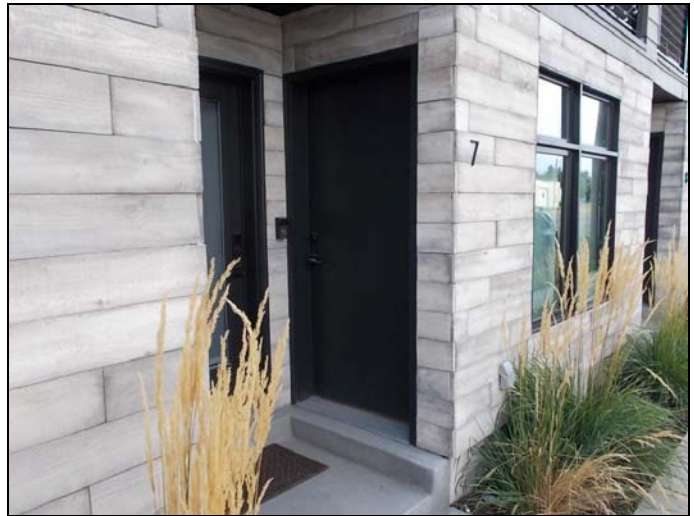
Comp #: 204 Doors - Repaint

Location: **Unit Entrances & Balconies**

The painted door surfaces are in good condition. We recommend funding to repaint this component approximately every 6 - 8 years. Remaining life based on current age.

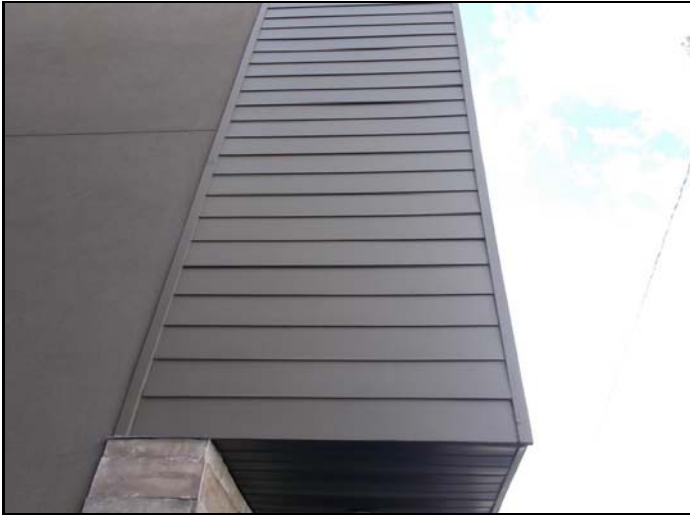
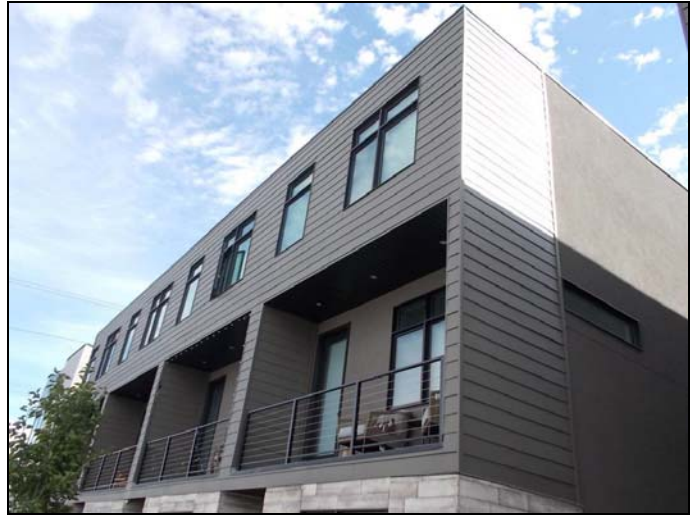
Comp #: 215 Siding - Repair/Repaint

Location: **Building Exteriors**

The siding painted surfaces are in good condition. We recommend funding to repair/repaint this component approximately every 8 - 10 years. Remaining life is based on current age.

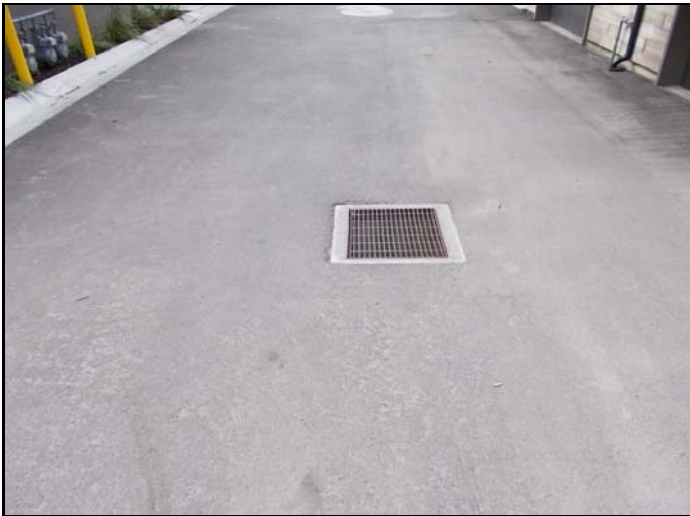
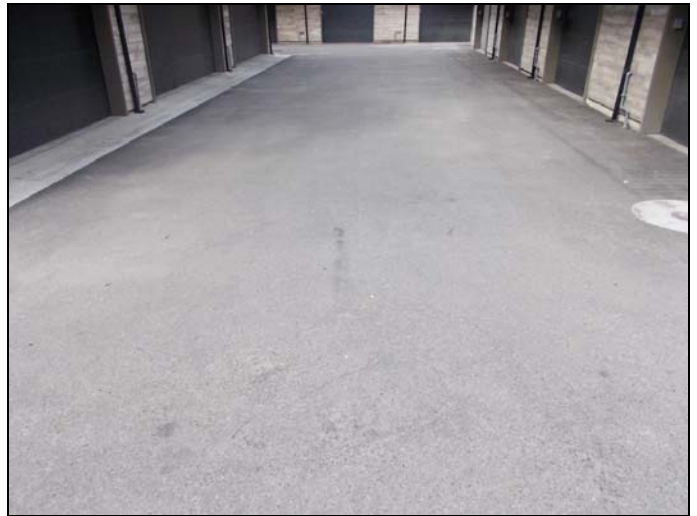
Comp #: 401 Asphalt - Major Repairs

Location: **Community Streets**

The asphalt surfaces are in good condition. We recommend funding for a major rehab of this component approximately every 25 - 30 years. Remaining life based on current age.

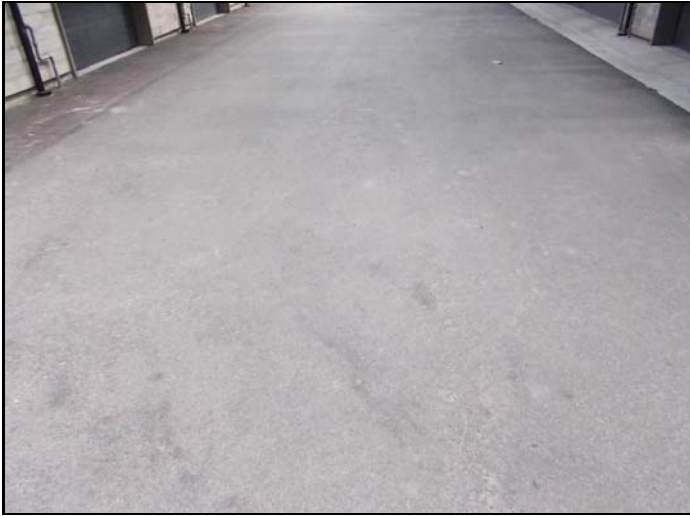
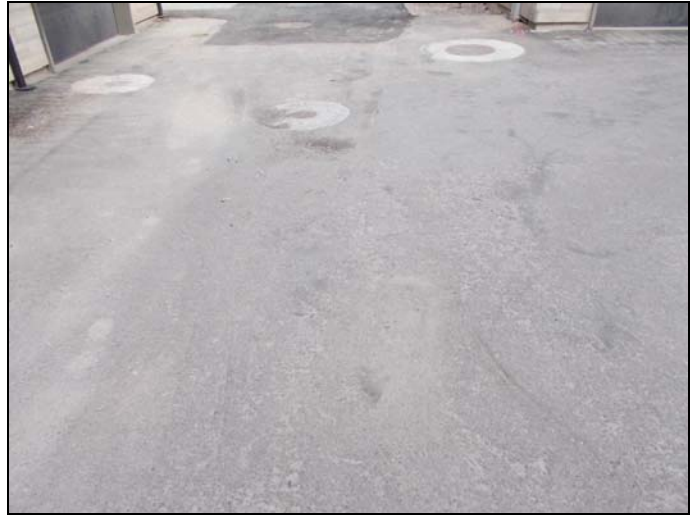
Comp #: 402 Asphalt - Seal Coat

Location: **Community Streets**

Research with the client reveals this component is scheduled to be sealed in 2022. We recommend funding to seal this component approximately every 3 - 5 years. Remaining life based on current condition.

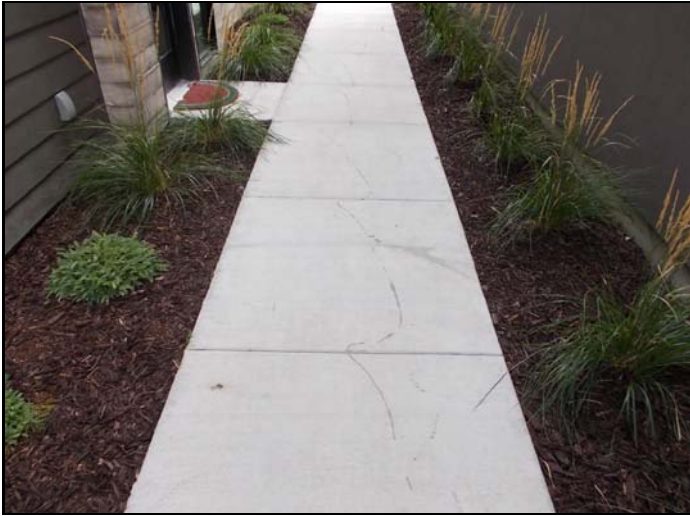
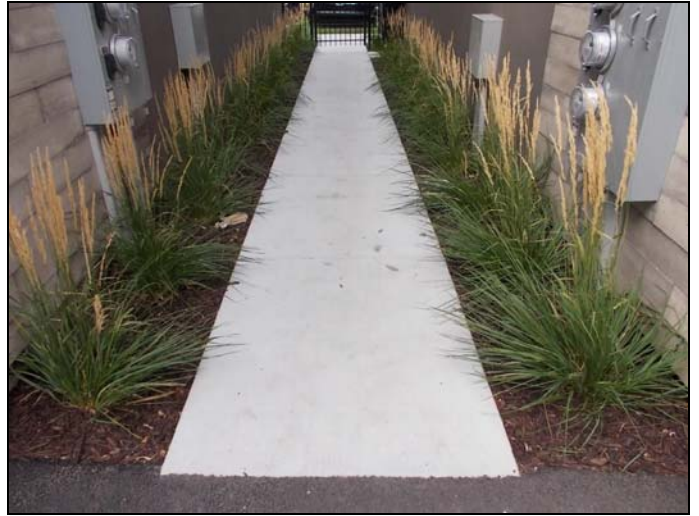
Comp #: 403 Concrete - Partial Repair/Replace

Location: **Community Sidewalks**

The concrete is in good condition. This component has an extended useful life under normal conditions. We recommend funding to make repairs and partially replace this component approximately every 10 years. Remaining life based on current age.

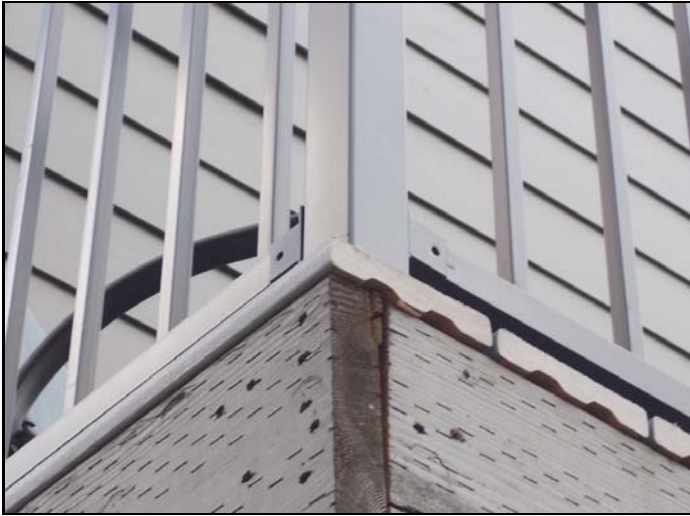
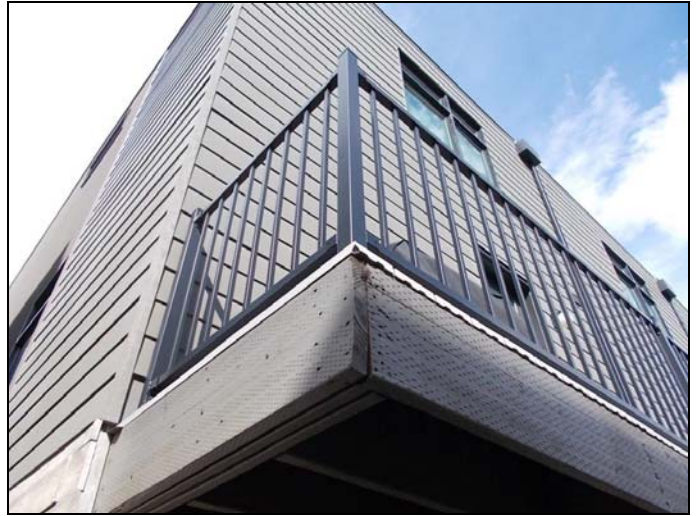
Comp #: 609 Balconies - Repair/Replace

Location: **Unit Rear Balconies**

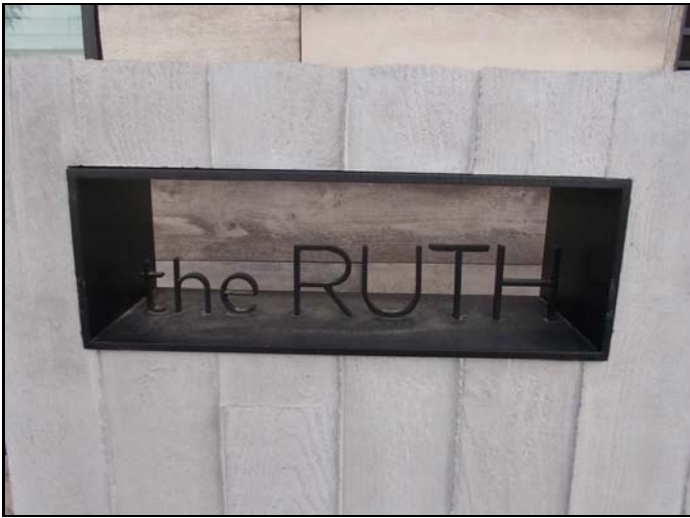
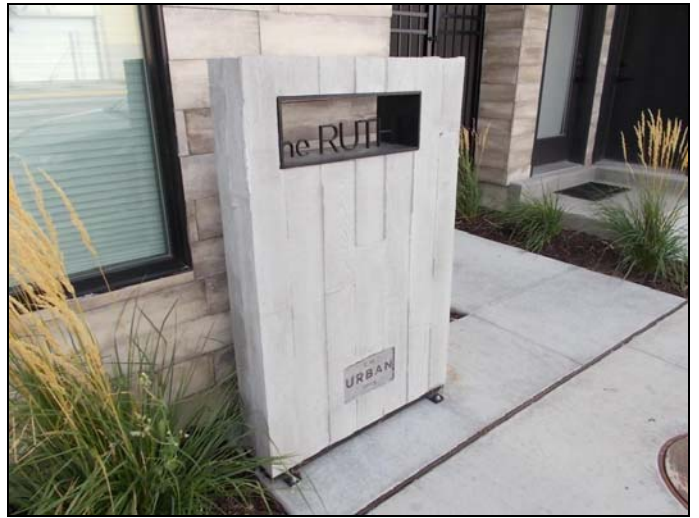
Comp #: 801 Monument Sign - Refurbish

Location: **West Entrance**

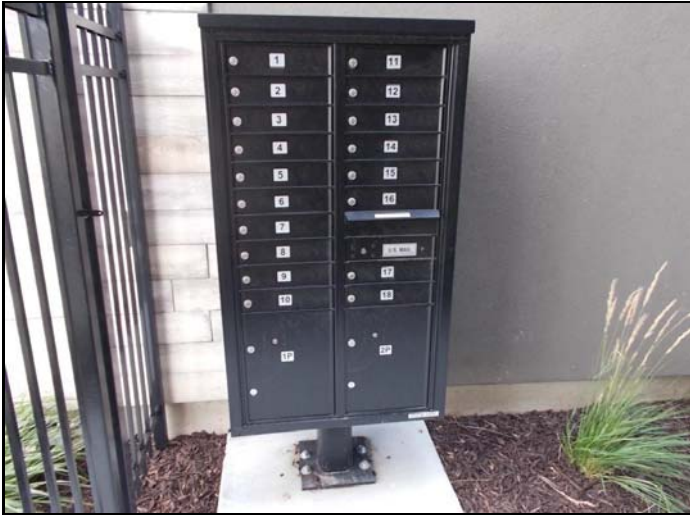
Comp #: 803 Mailbox Clusters - Replace

Location: **Common Area**

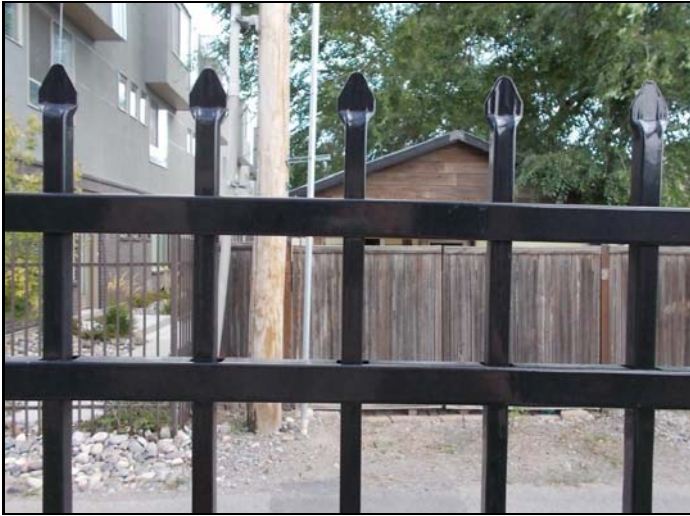
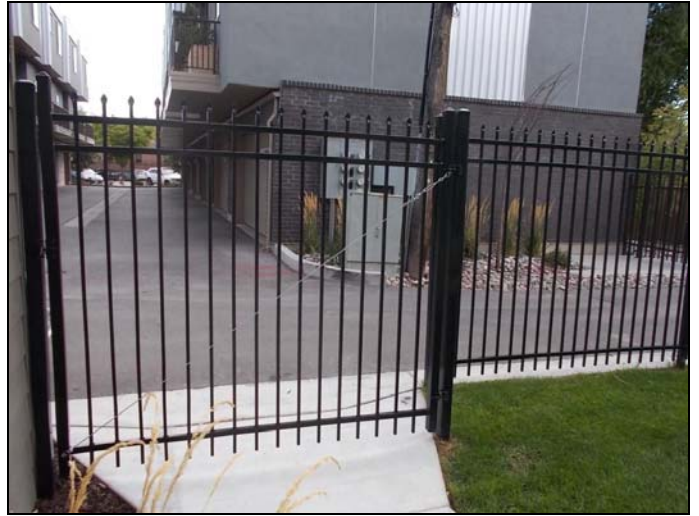
Comp #: 1002 Metal Fencing - Replace

Location: **Community Perimeter**

The metal fencing is in good condition. We recommend funding to replace this component approximately every 40 - 50 years. Remaining life based on current age.

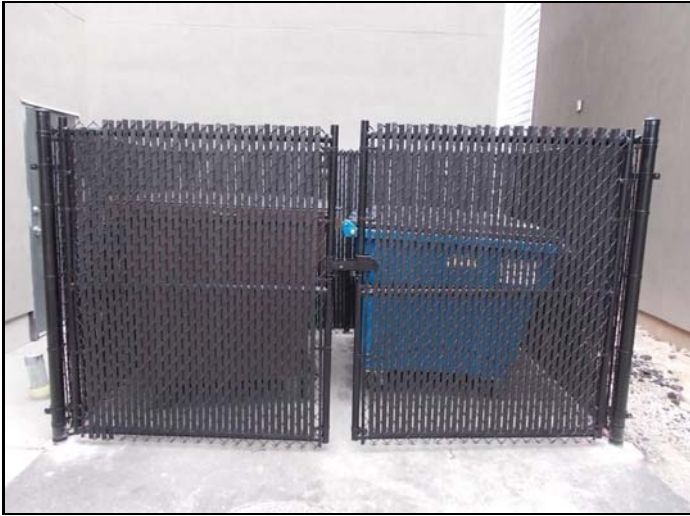
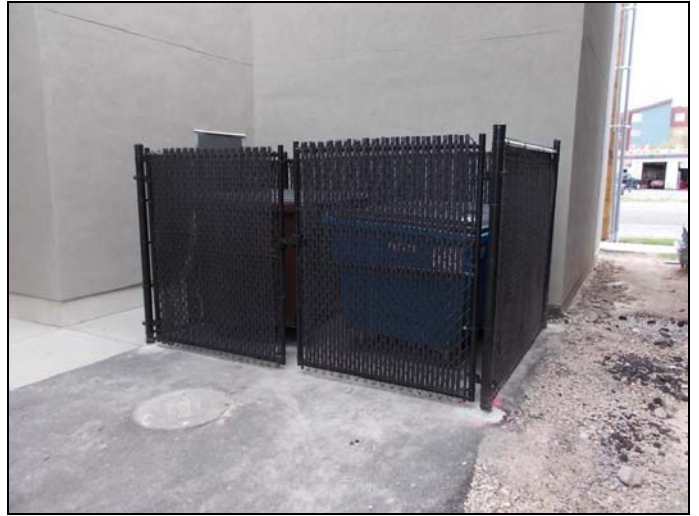
Comp #: 1003 Chain Link Fencing - Replace

Location: **Dumpster Enclosure**

The chain link fencing is in good condition. We recommend funding to replace this component approximately every 30 - 40 years. Remaining life based on current age.

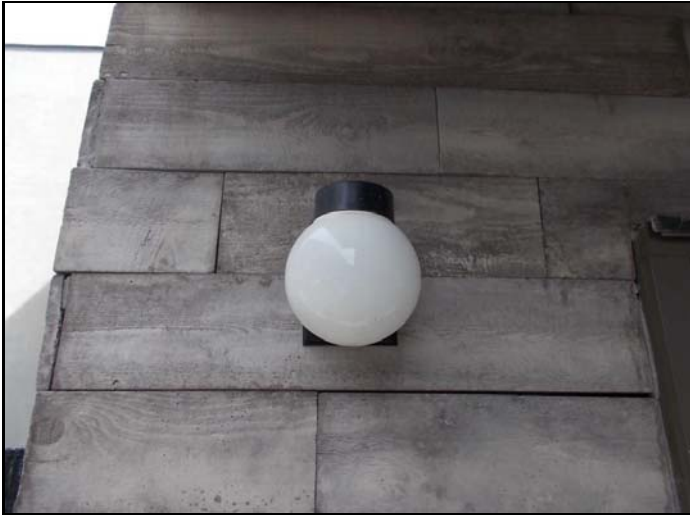
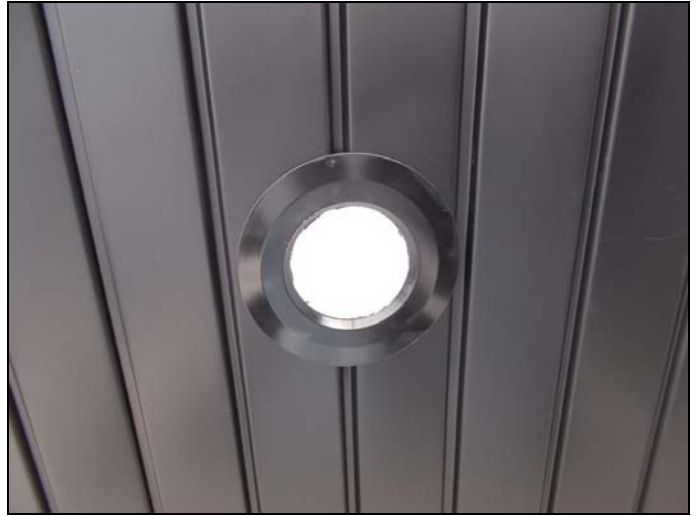
Comp #: 1602 Exterior Light Fixtures - Replace

Location: **Building Exteriors**

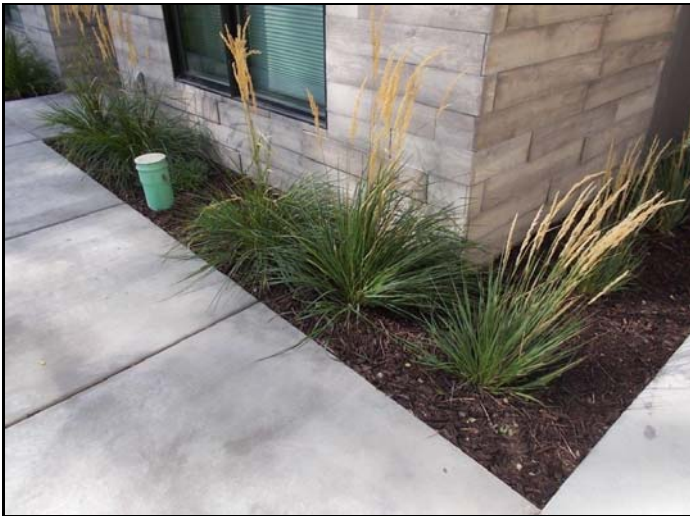
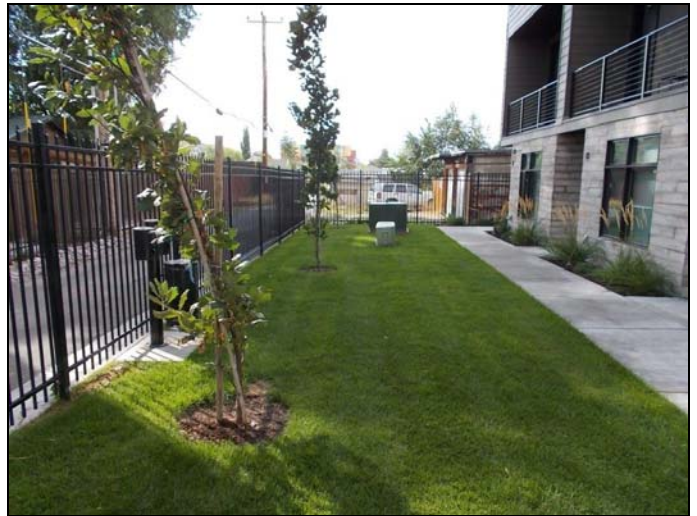
Comp #: 1812 Landscaping & Irrigation System - Renovate

Location: **Common Area**

The landscaping and irrigation system are in good condition. We recommend funding for an allowance to renovate the landscaping and irrigation system approximately every 20 years. Remaining life based on current age.
