Jordan Meadows

Level 1 Reserve Study

Client Reference Number	10201
Property Type	Townhouse
Number of Units	80
Fiscal Year End	12/31

Type of Study	Full Study
Date of Property Inspection	11/14/2019
Prepared By	Dale Gifford
Analysis Method	Cash Flow
Funding Goal	Full Funding

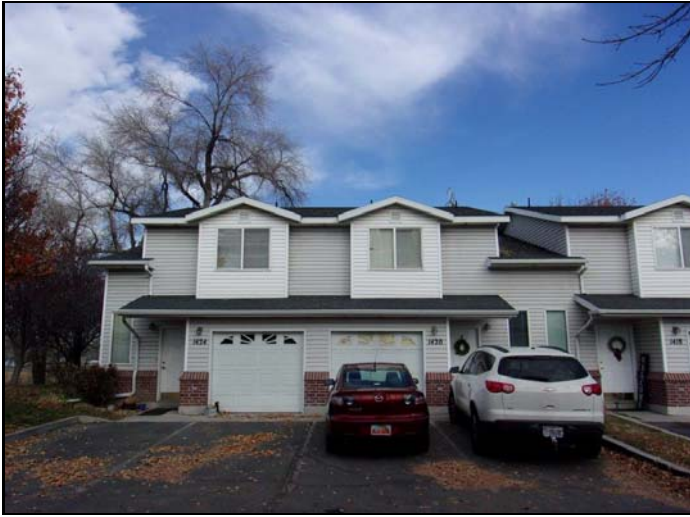
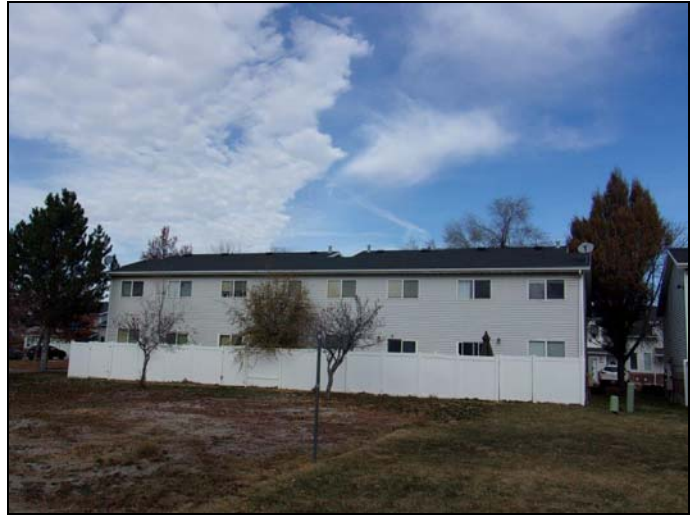
Comp #: 105 Roofs - Replace

Location: **Building Roofs**

The roofs are in fair condition. We recommend funding to replace this component approximately every 20 - 25 years. Remaining life based on current age.

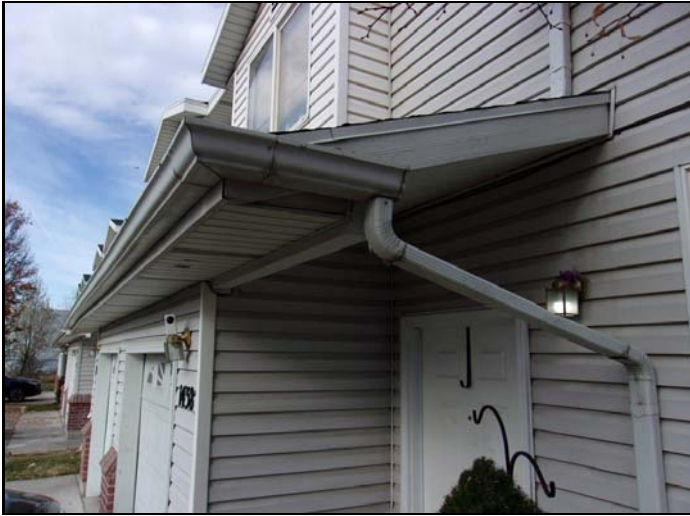
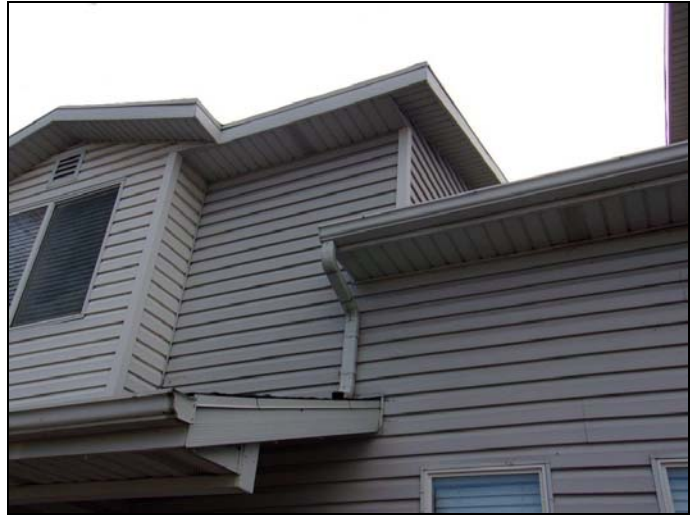
Comp #: 120 Rain Gutters/Downspouts - Replace

Location: **Building Exteriors**

The rain gutters and downspouts are in fair condition. We recommend funding to replace this component approximately every 25 - 30 years. Remaining life based on current age.

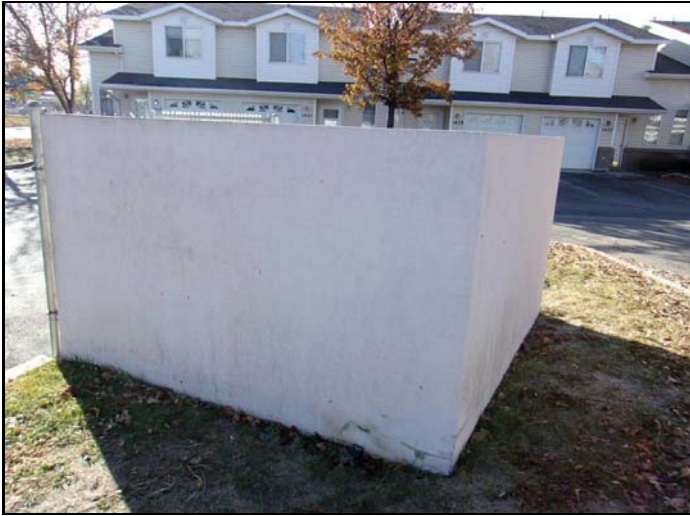
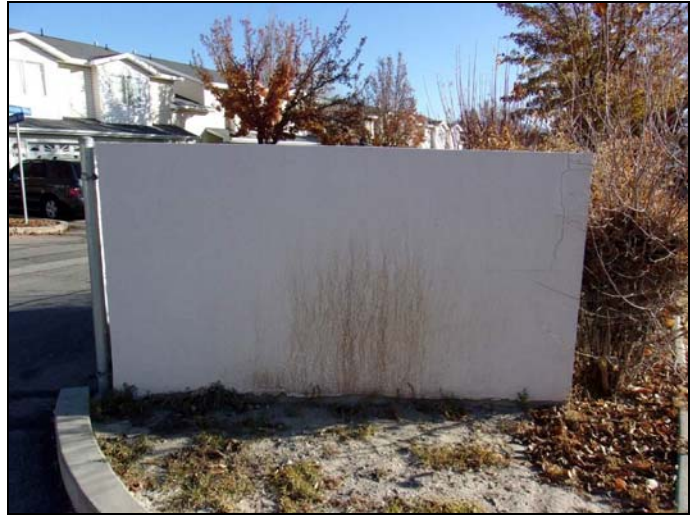
Comp #: 208 Block & Stucco Walls - Repair/Repaint

Location: **Dumpster Enclosures**

Due to the minimal cost of maintaining this component, reserve funding is not appropriate. Repair and repaint this component as necessary as an operating expense.

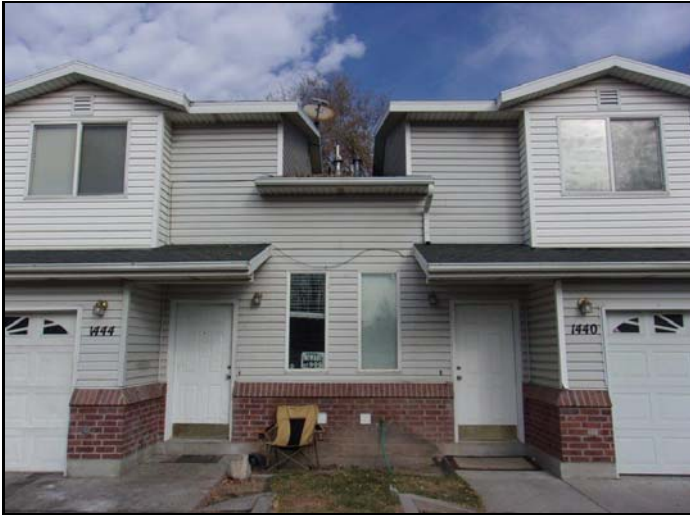
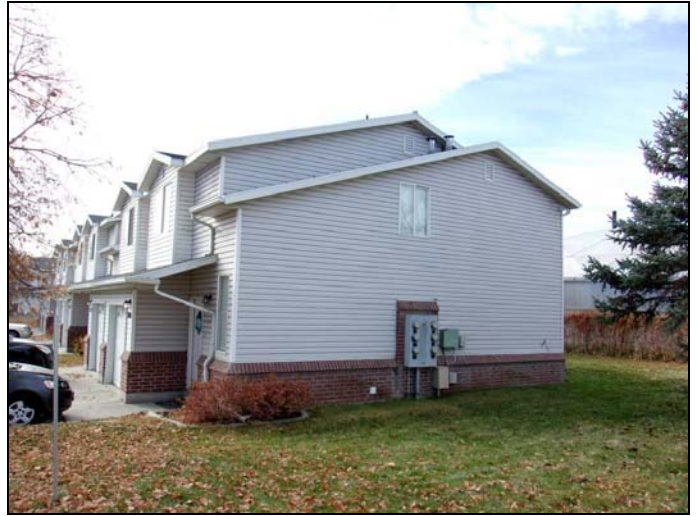
Comp #: 302 Vinyl Siding - Replace

Location: **Building Exteriors**

The vinyl siding is in good to fair condition. We recommend funding to replace this component approximately every 40 - 50 years. Remaining life based on current age.

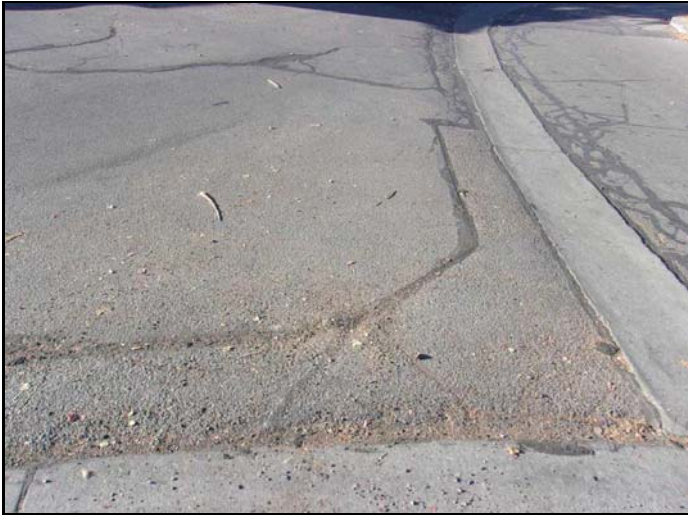
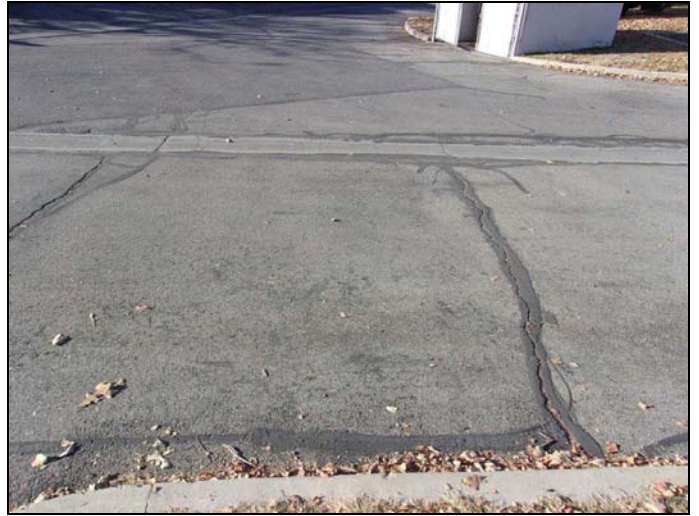
Comp #: 401 Asphalt - Major Rehab

Location: **Community Streets**

The asphalt surfaces are generally in good to fair condition. We recommend funding for a major rehab of this component approximately every 25 - 30 years. Remaining life based on current age.

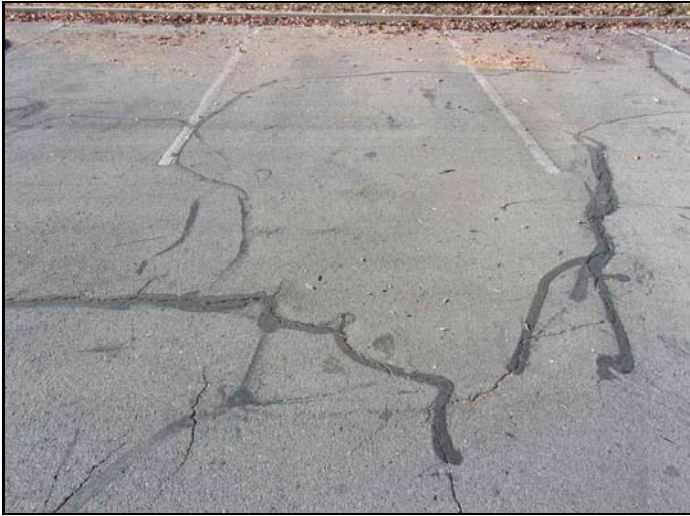
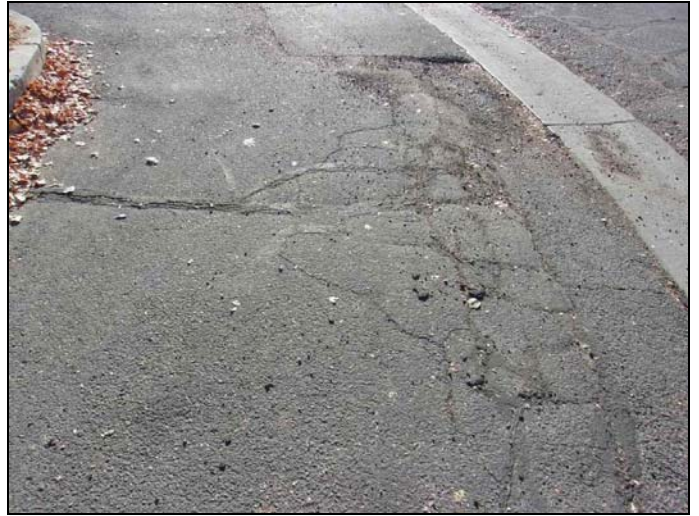
Comp #: 402 Asphalt - Seal Coat

Location: **Community Streets**

The asphalt seal coat is in poor condition. We recommend funding to seal this component approximately every 3 - 5 years. Remaining life based on current condition.

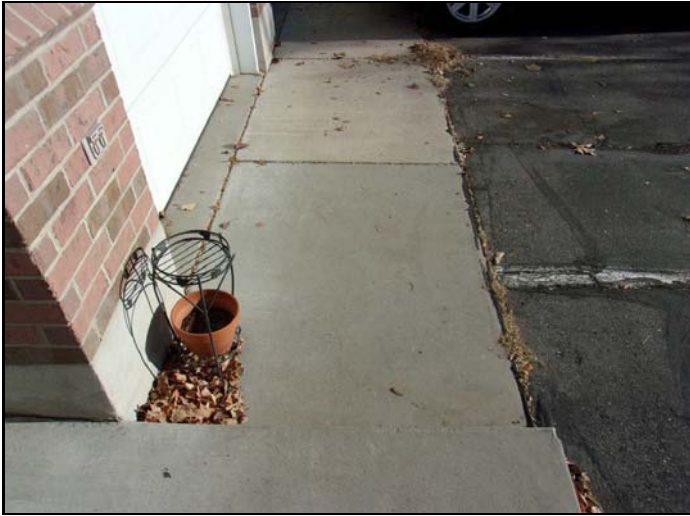
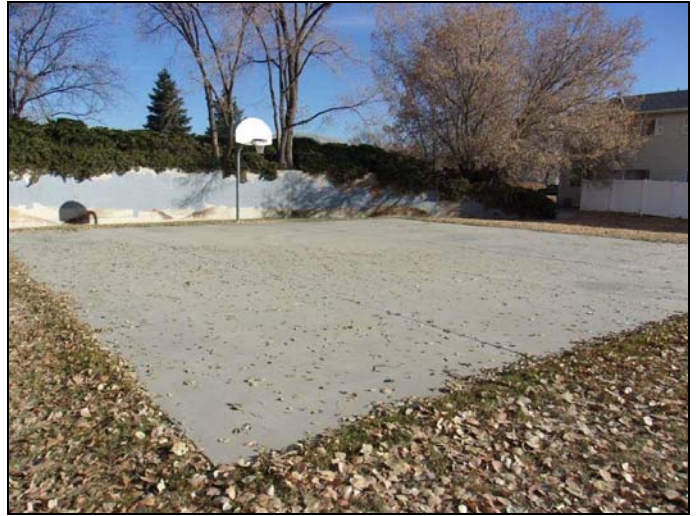
Comp #: 403 Concrete - Partial Repair/Replace

Location: **Basketball Court & Sidewalks**

The concrete is generally in good condition. This component has an extended useful life under normal conditions. We recommend funding to make repairs and partially replace this component approximately every 10 years. Remaining life based on current age.

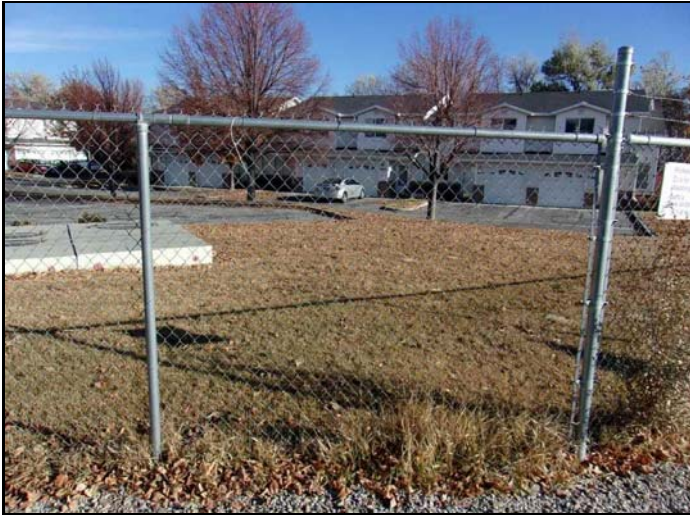
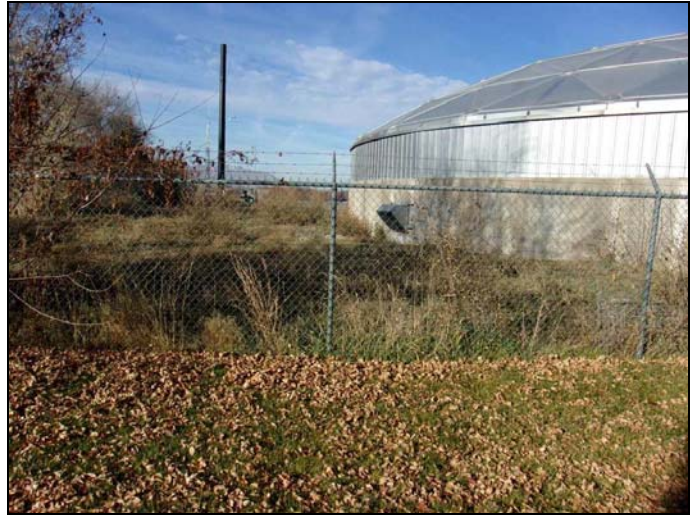
Comp #: 1003 Chain Link Fencing - Replace

Location: **Perimeter**

The chain link fencing is in good to fair condition. We recommend funding to replace this component approximately every 30 - 40 years. Remaining life based on current age.

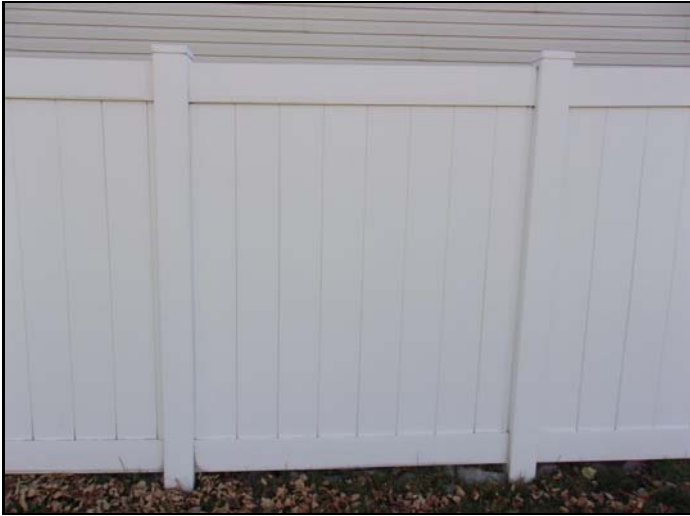
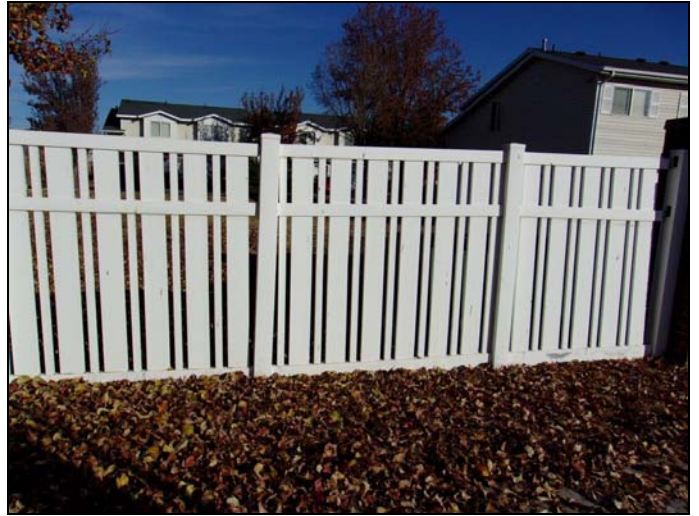
Comp #: 1008 Vinyl Fencing - Replace

Location: **Backyards & Perimeter**

The vinyl fencing is in good to fair condition. We recommend funding to replace this component approximately every 25 - 30 years. Remaining life based on current age.

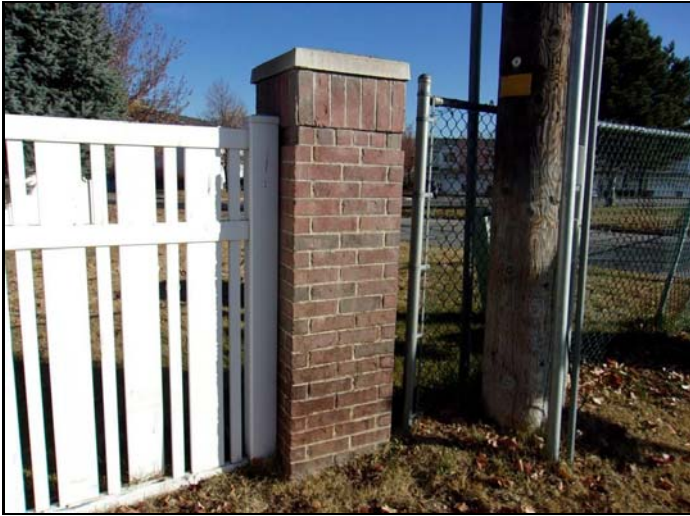
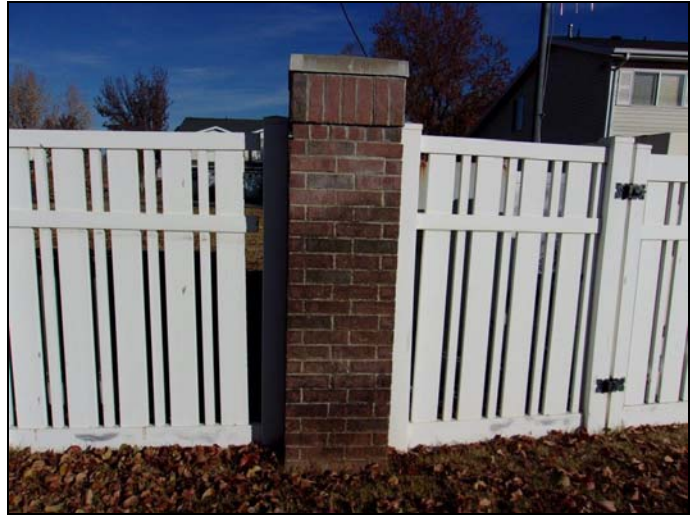
Comp #: 1090 Brick Columns - Replace

Location: **South Perimeter**

These component has an extended useful life under normal conditions. Repair as necessary as an operating expense. No reserve funding necessary.

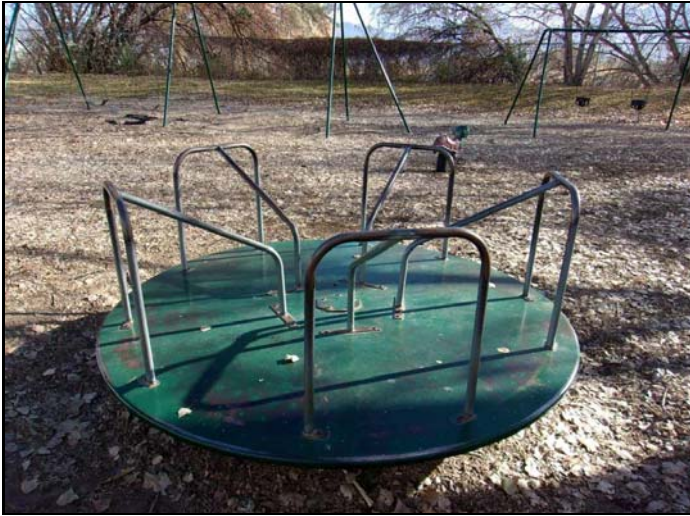
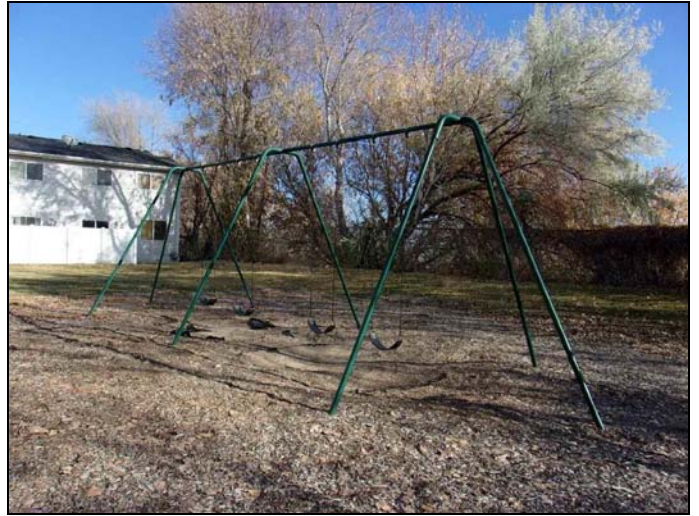
Comp #: 1301 Play Structures - Replace

Location: **Play Area**

The play structures are in good to fair condition. We recommend funding to replace this component approximately every 20 - 30 years. Remaining life based on current age.

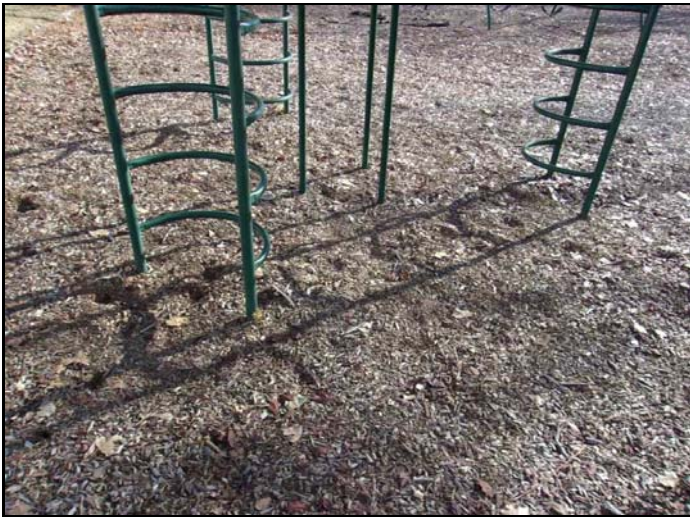
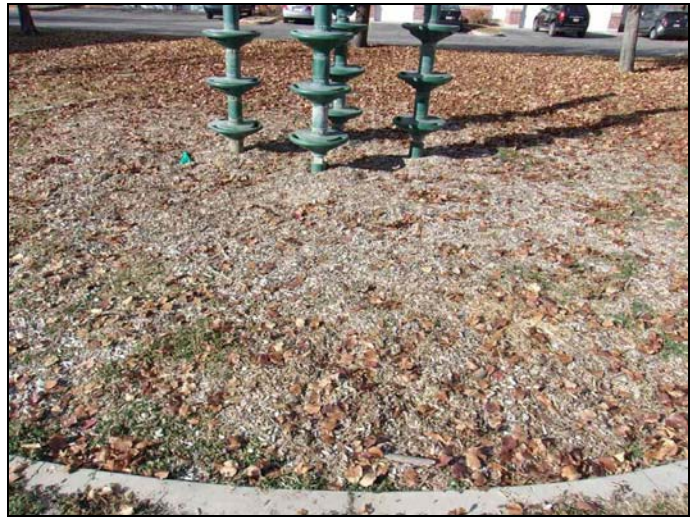
Comp #: 1303 Play Area Groundcover - Refill

Location: **Play Area**

The play area groundcover is in fair to poor condition. We recommend funding to refill this component approximately every 3 - 5 years. Remaining life is based on current age.

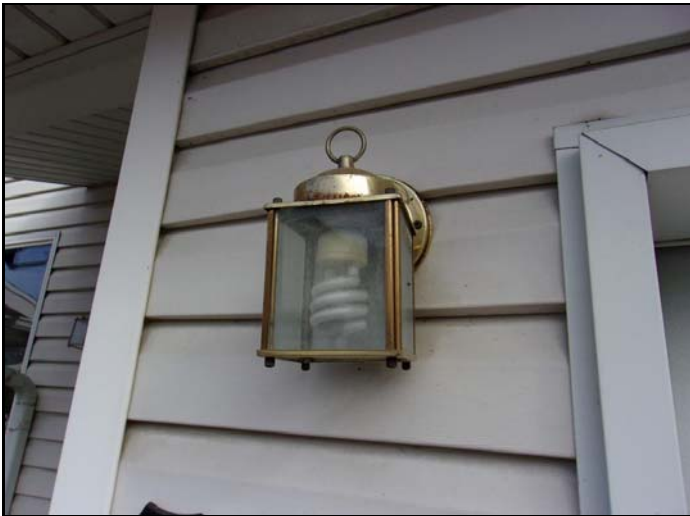
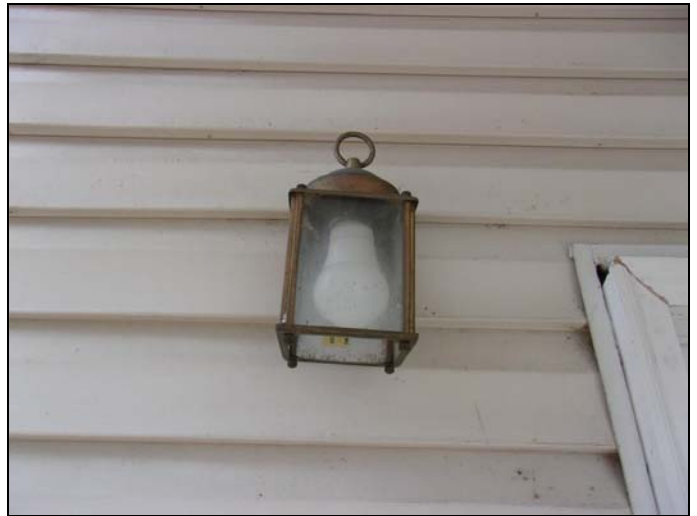
Comp #: 1602 Exterior Light Fixtures - Replace

Location: **Building Exteriors**

The exterior light fixtures are in good condition. We recommend funding to replace this component approximately every 16 - 20 years. Remaining life based on current age.

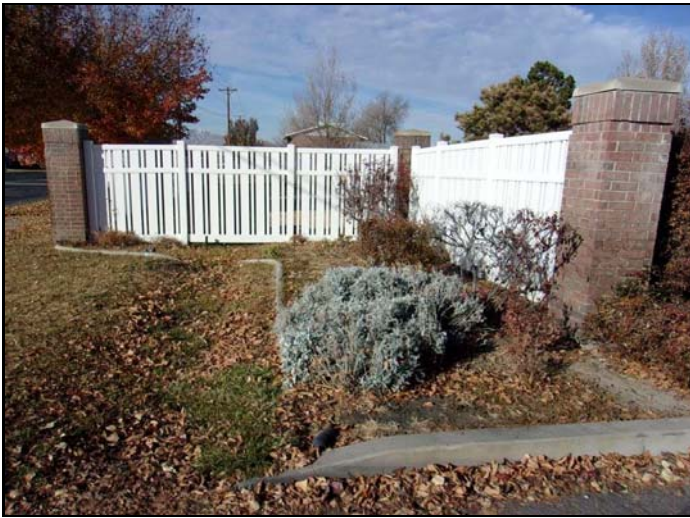
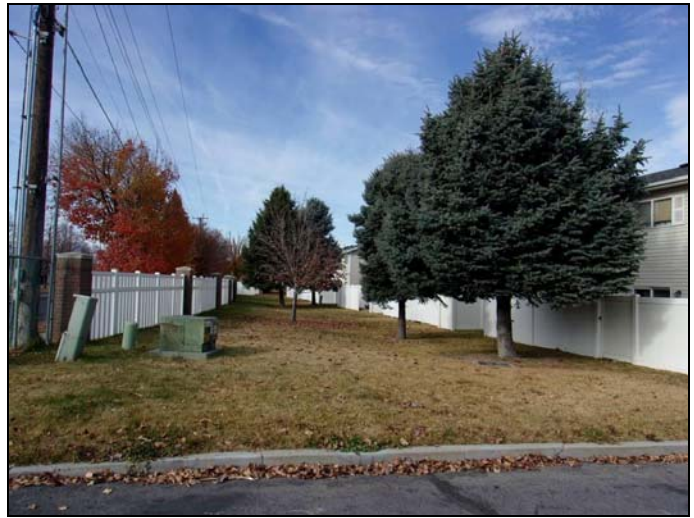
Comp #: 1812 Landscaping & Irrigation System - Renovate

Location: **Common Area**

The landscaping and irrigation system are generally in good to fair condition. We recommend funding for an allowance to renovate the landscaping and irrigation system approximately every 20 years. Remaining life based on current age.
