Hill Farm

Level 1 Reserve Study

Client Reference Number	18113
Property Type	Single Family Homes
Number of Units	281
Fiscal Year End	12/31

Type of Study	Full Study
Date of Property Inspection	09/26/2023
Prepared By	Dale Gifford
Analysis Method	Cash Flow
Funding Goal	Full Funding

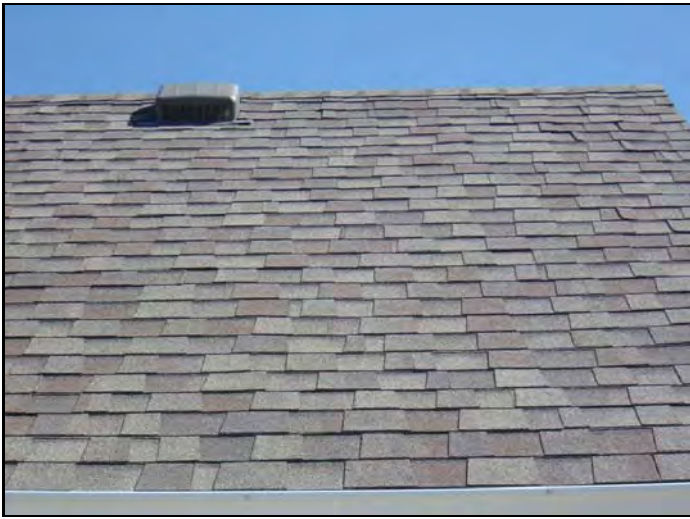
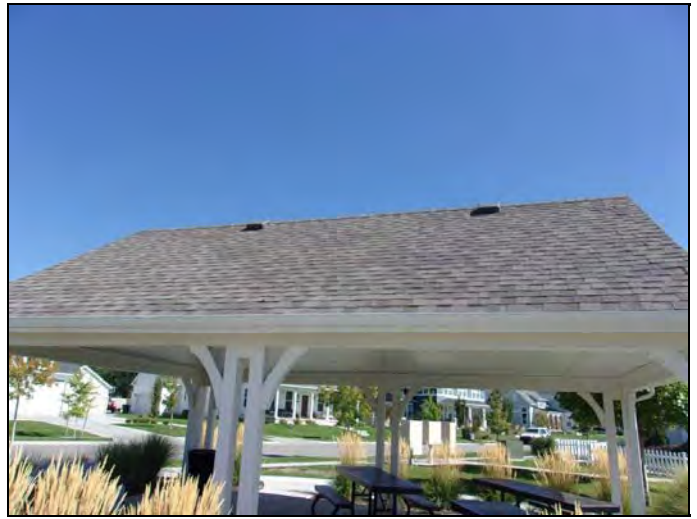
Comp #: 105 Pavilion Roof & Gutter - Replace

Location: **Pavilion Roof**

The roof appears to be in good condition. We recommend funding to replace this component approximately every 20 - 25 years. Remaining life based on current age.

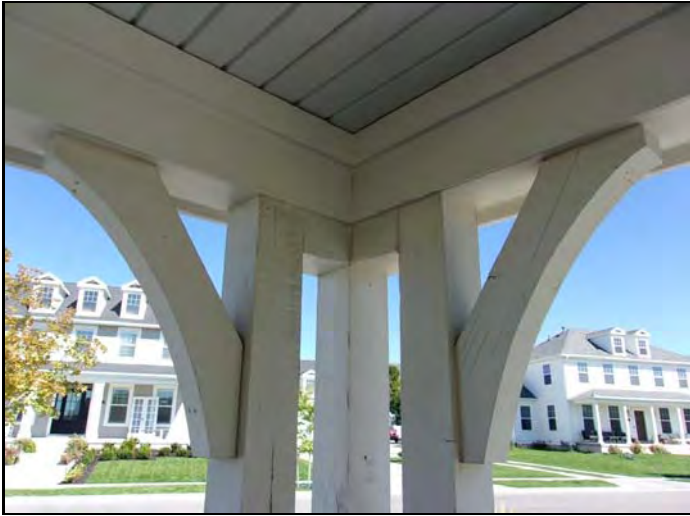
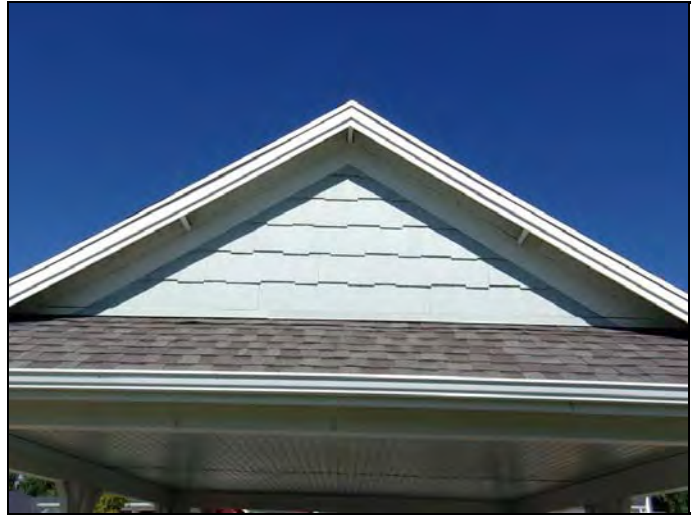
Comp #: 215 Pavilion - Repair/Repaint

Location: **Pavilion Exterior**

The painted surfaces are in fair condition. We recommend funding to repair/repaint this component approximately every 8 - 10 years. Remaining life is based on current age.

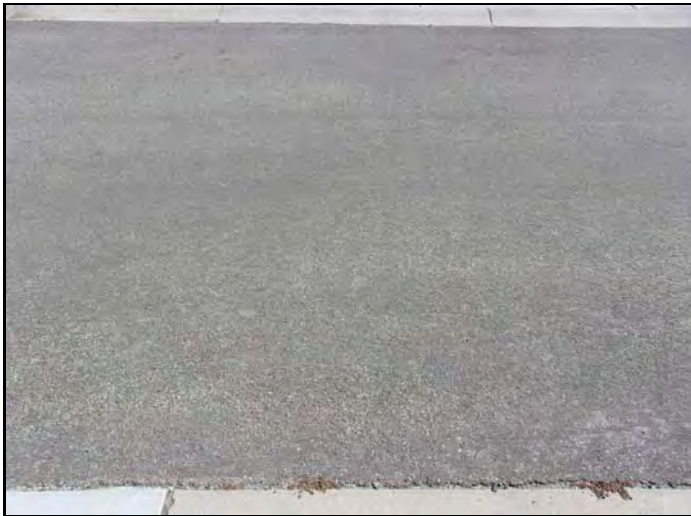
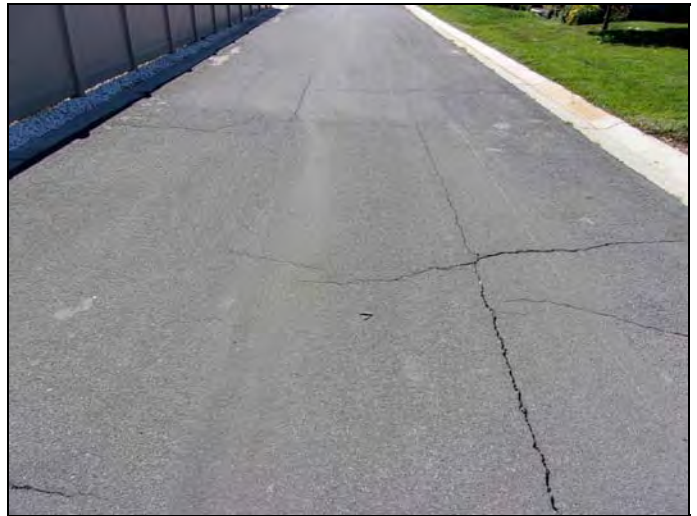
Comp #: 401 Asphalt - 2014-2018 - Major Rehab

Location: **Community Alleys**

The asphalt surfaces are in good condition. We recommend funding for a major rehab of this component approximately every 25 - 30 years. Remaining life based on average age.

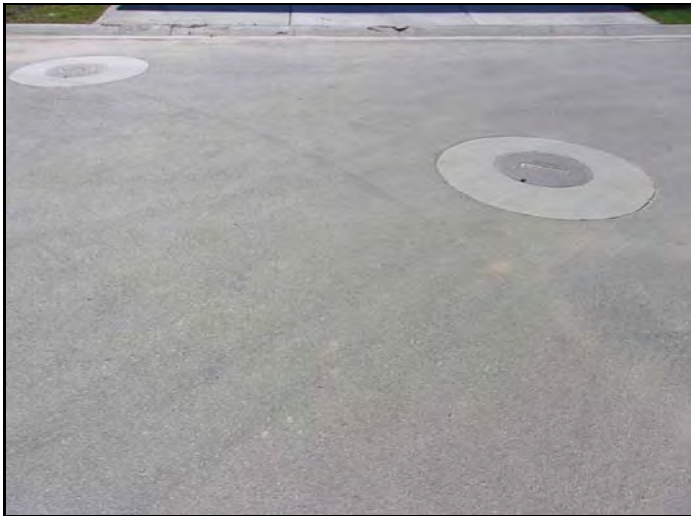
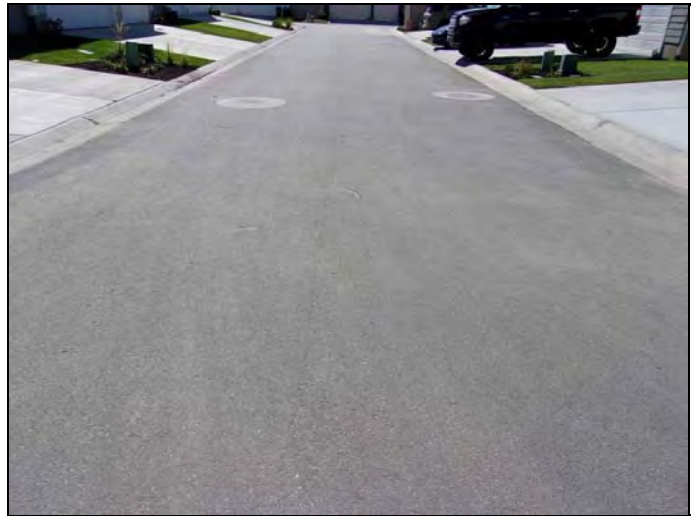
Comp #: 401 Asphalt - 2022 - Major Rehab

Location: **Phase 7**

The asphalt surfaces are in good condition. We recommend funding for a major rehab of this component approximately every 25 - 30 years. Remaining life based on current age.

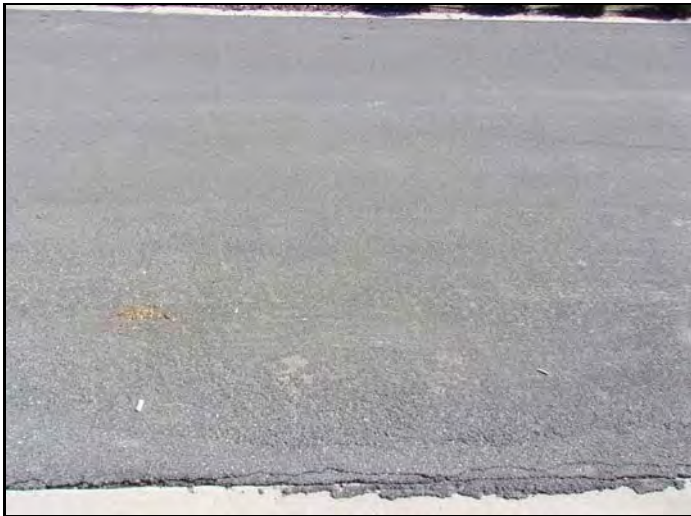
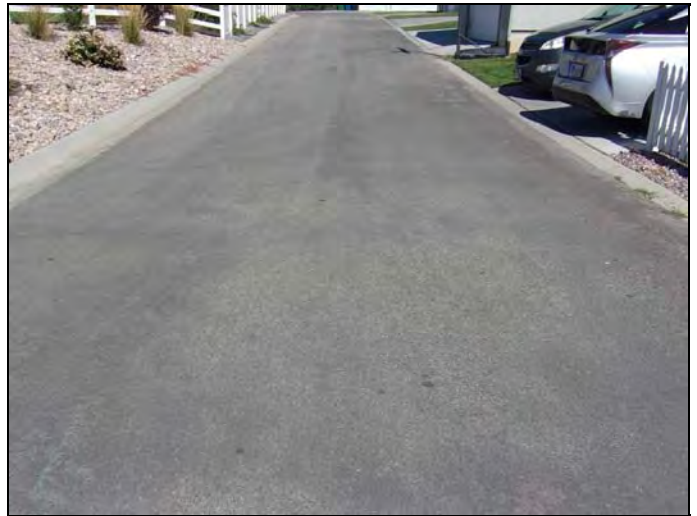
Comp #: 402 Asphalt - Seal Coat

Location: **Community Alleys**

The asphalt seal coat is in poor condition. We recommend funding to seal this component approximately every 3 - 5 years. Remaining life based on current condition.

Projects programmed to occur this fiscal year (FY2024) include asphalt seal coat (Comp# 402). We have programmed an estimated \$36,500 in reserve expenditures toward the completion of these projects. (See page 15)

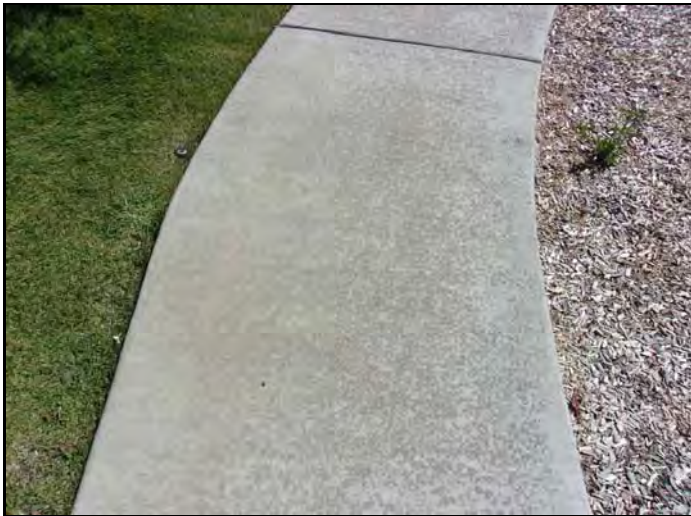
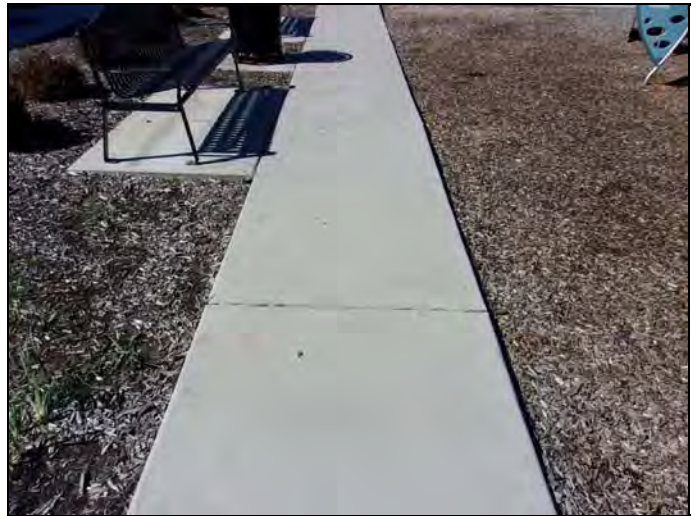
Comp #: 403 Concrete - Repair/Replace

Location: **Sidewalks**

The concrete is in good condition. This component has an extended useful life under normal conditions. We recommend funding to make repairs and partially replace this component approximately every 10 years. Remaining life based on average age.

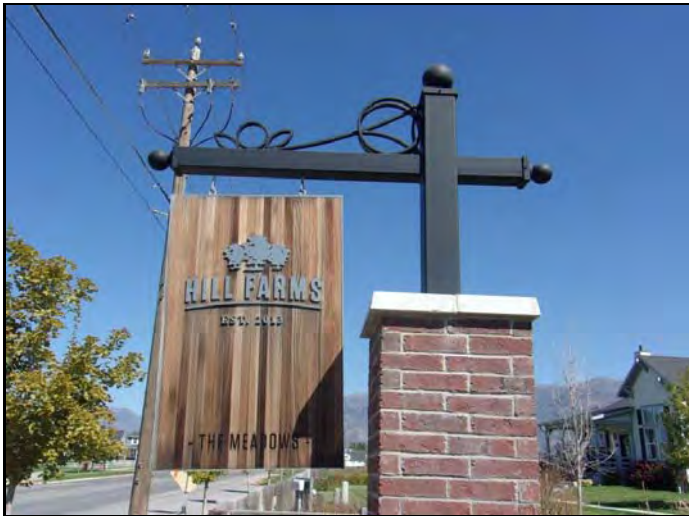
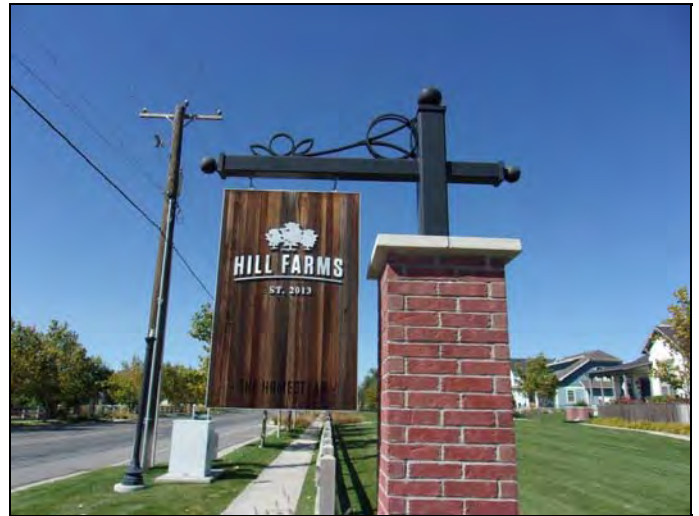
Comp #: 801 Community Signs - Replace

Location: **Common Area**

The signs is in good to fair condition. We recommend funding to replace this component approximately every 15 - 20 years. Remaining life is based on average age.

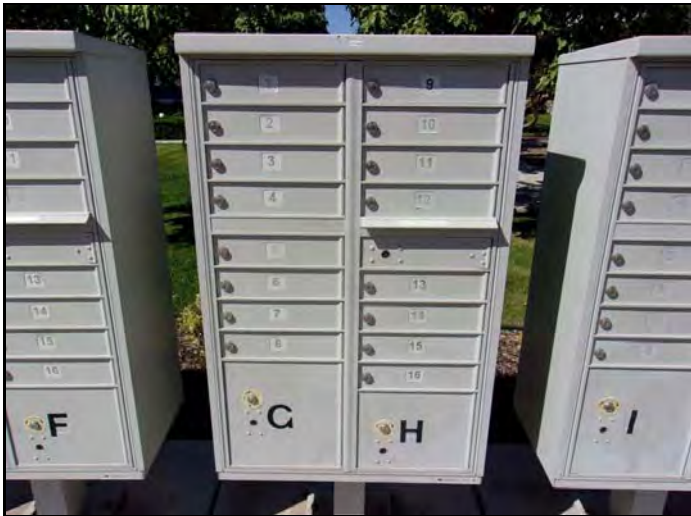
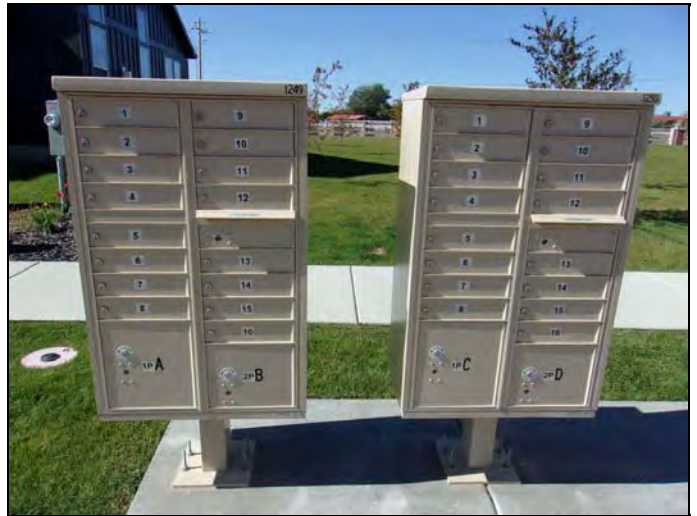
Comp #: 803 Mailboxes - Replace

Location: **Common Area**

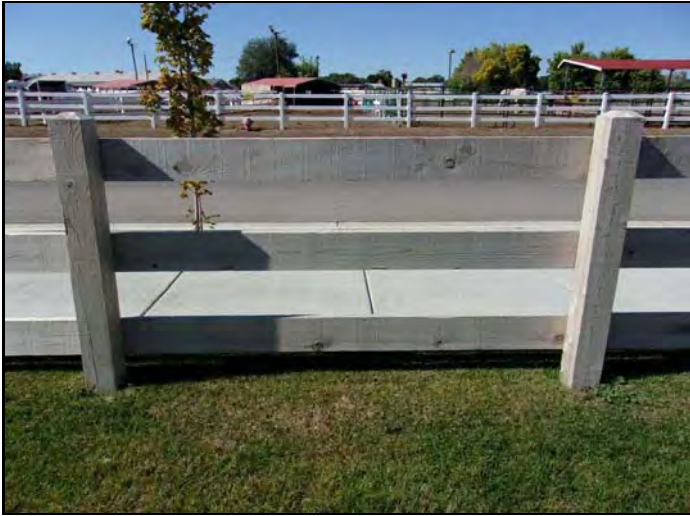
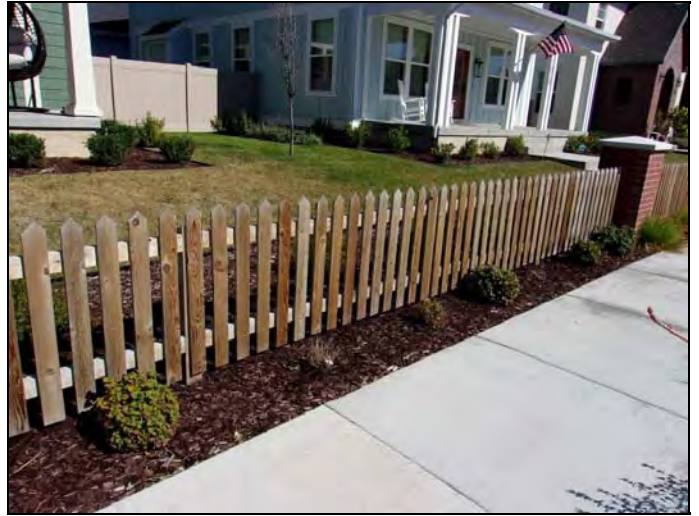
Comp #: 1001 Wood Fencing - Replace

Location: **Phase 7**

The wood fencing is in good condition. We recommend funding to replace this component approximately every 25 - 30 years. Remaining life based on current age.

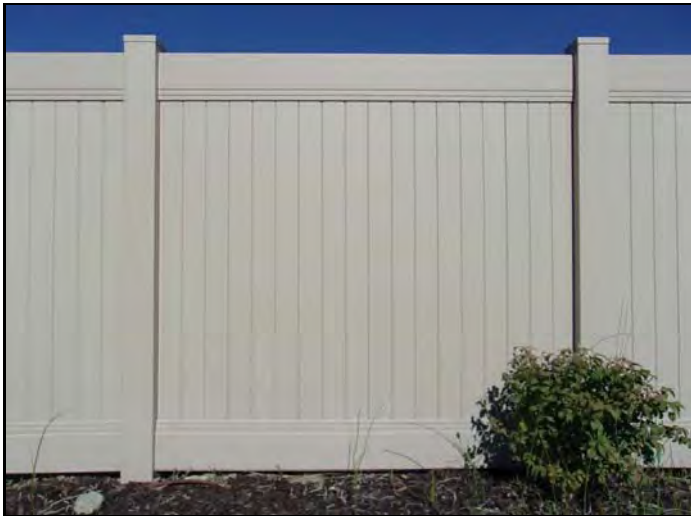
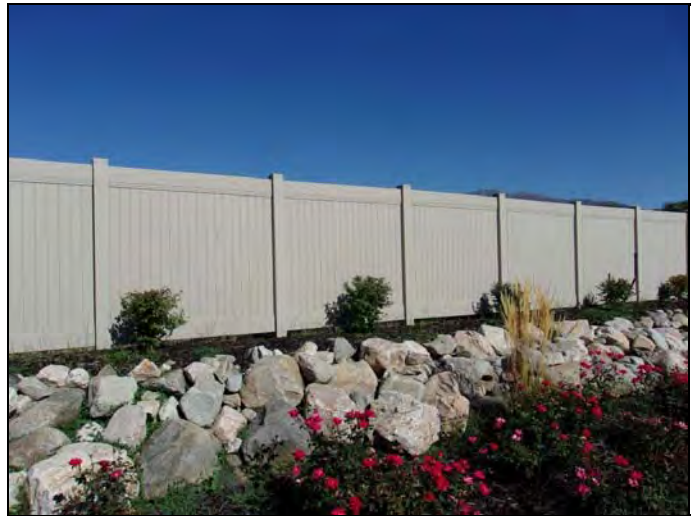
Comp #: 1008 Vinyl Fencing - Replace

Location: **Phase 7**

The vinyl fencing is in good condition. We recommend funding to replace this component approximately every 25 - 30 years. Remaining life based on current age.

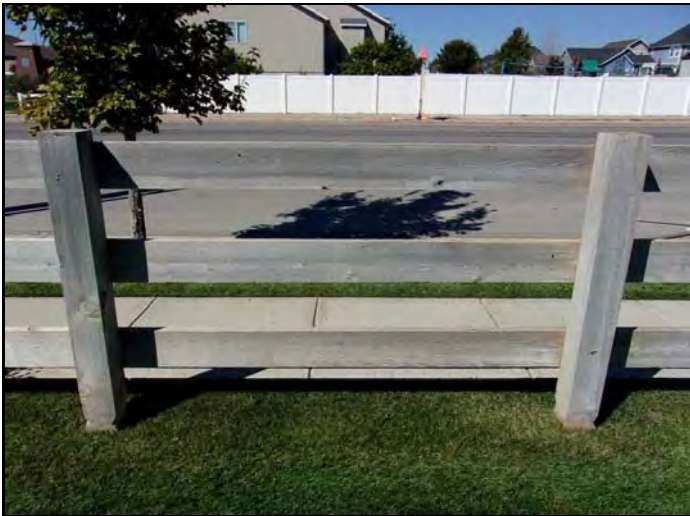
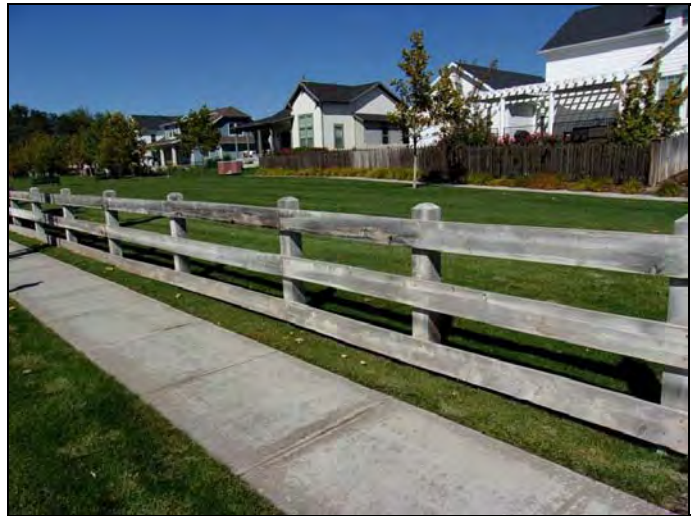
Comp #: 1009 3 Rail Fencing - Replace

Location: **Common Area**

The three rail fence is in good to fair condition. We recommend funding to replace this component approximately every 25 - 30 years. Remaining life based on current age.

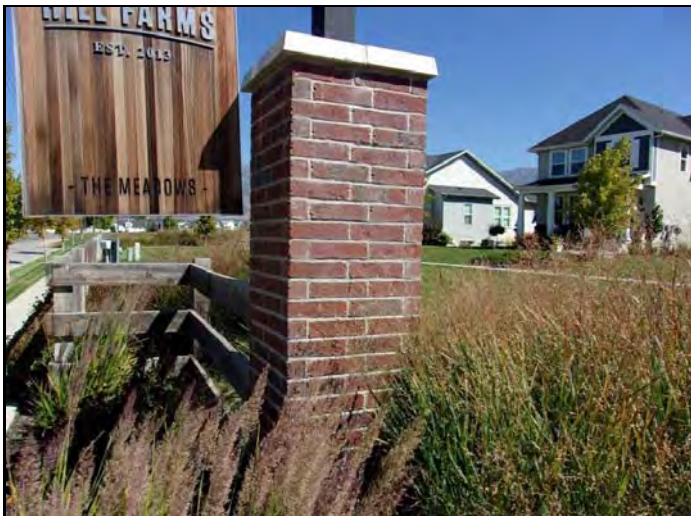
Comp #: 1090 Brick Columns & Planter Boxes - Replace

Location: **Common Area**

This component has an extended useful life under normal conditions. Repair as necessary as an operating expense. No reserve funding necessary.

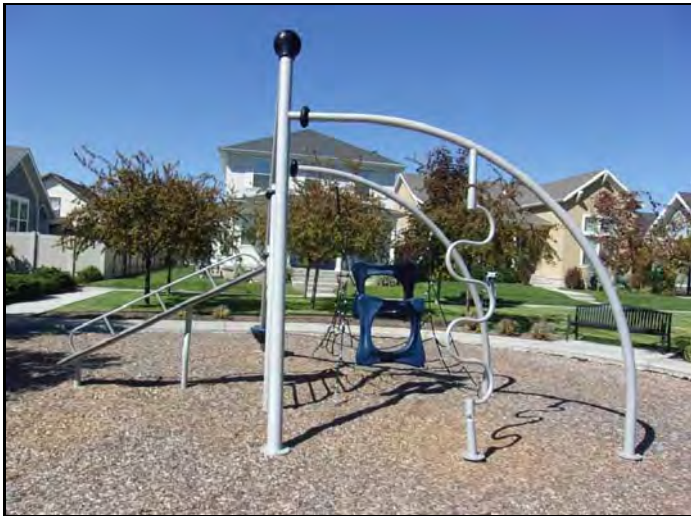
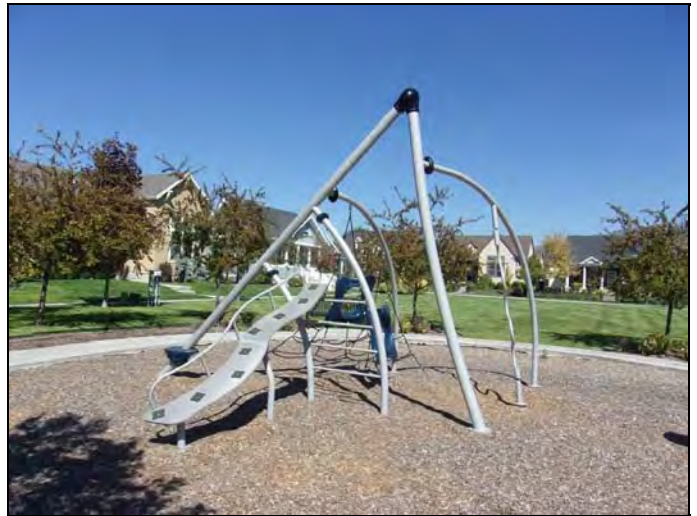
Comp #: 1301 Play Structures - 2015 - Replace

Location: **Orchard Harvest Drive**

The play structures are in good condition. We recommend funding to replace this component approximately every 20 - 25 years. Remaining life based on current age.

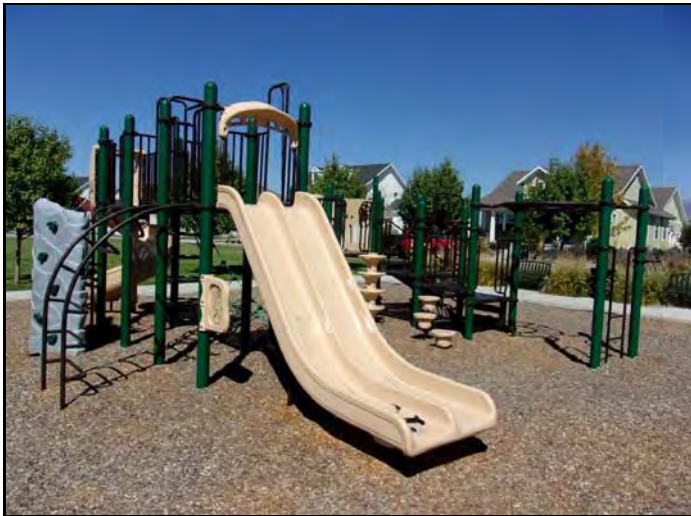
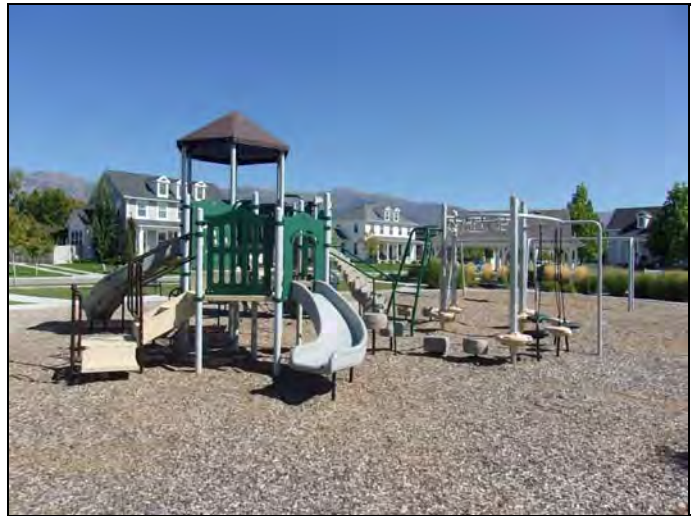
Comp #: 1301 Play Structures - 2018 - Replace

Location: **Havenwood, Hill Farms, & Richards**

The play structures are in good condition. We recommend funding to replace this component approximately every 20 - 25 years. Remaining life based on current age.

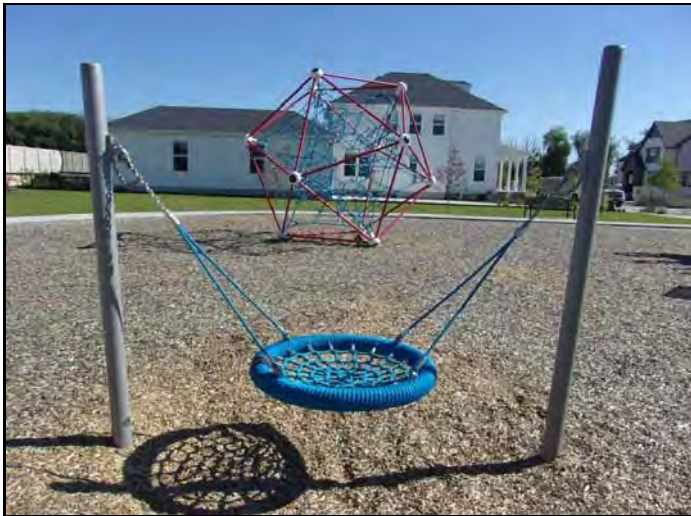
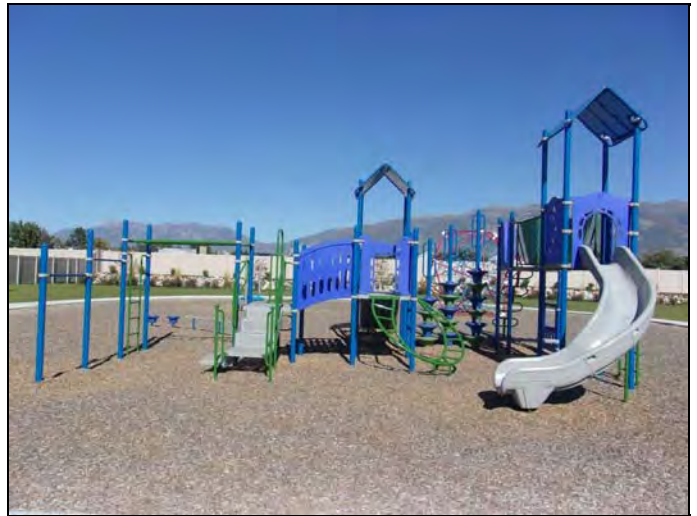
Comp #: 1301 Play Structures - 2022 - Replace

Location: **Phase 7**

The play structure is in good condition. We recommend funding to replace this component approximately every 20 - 25 years. Remaining life based on current age.

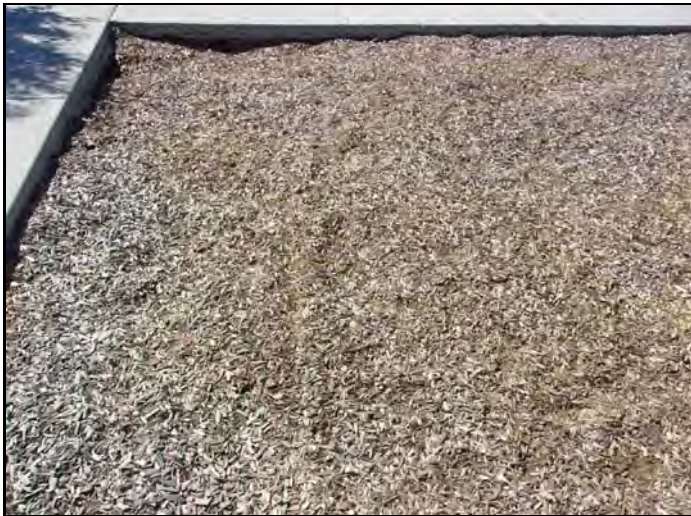
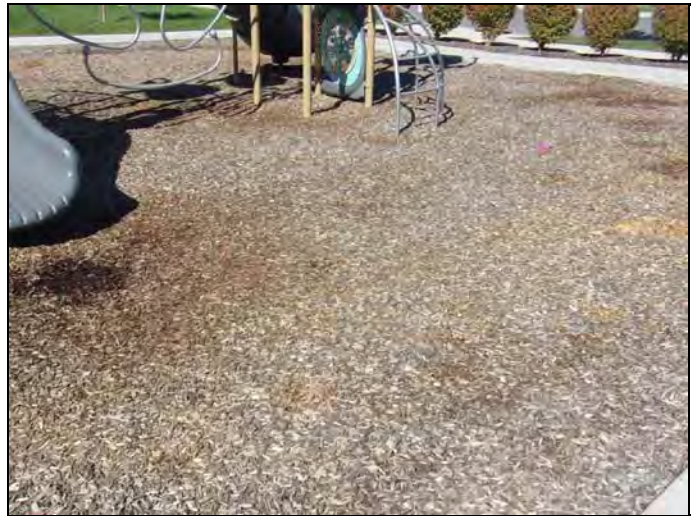
Comp #: 1303 Play Area Groundcover - Refill

Location: **Play Areas**

The play area groundcover is in good to fair condition. We recommend funding to refill this component approximately every 3 - 5 years. Remaining life is based on current age.

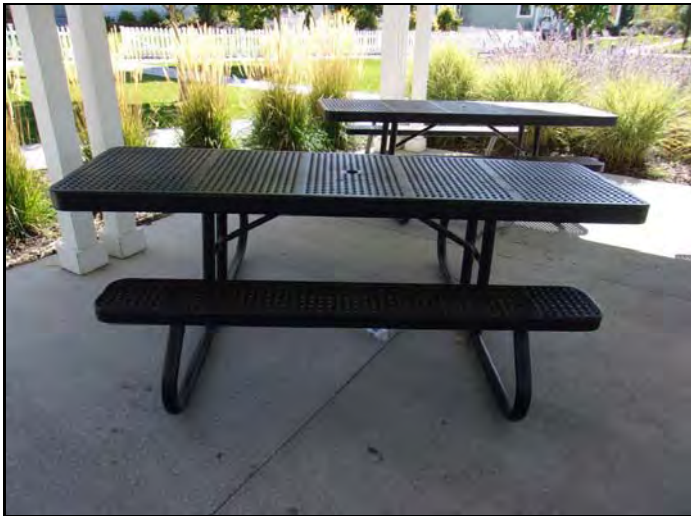
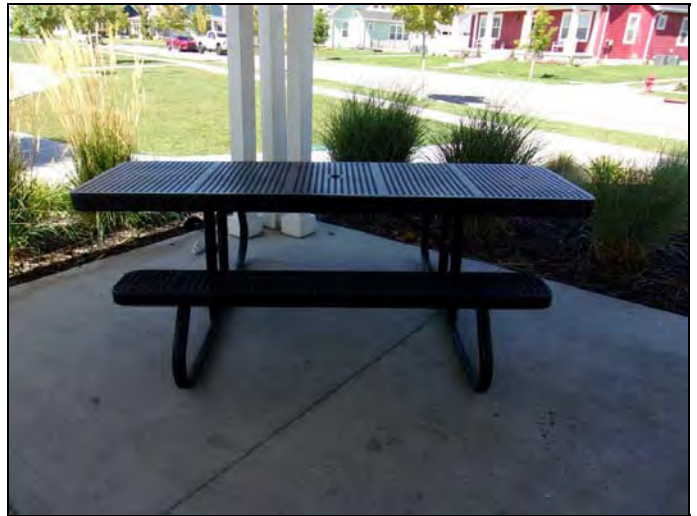
Comp #: 1306 Picnic Tables - Replace

Location: **Pavilion Area on Hill Farms Lane**

The picnic tables are in good condition. We recommend funding to replace this component approximately every 15 - 20 years. Remaining life based on current age.

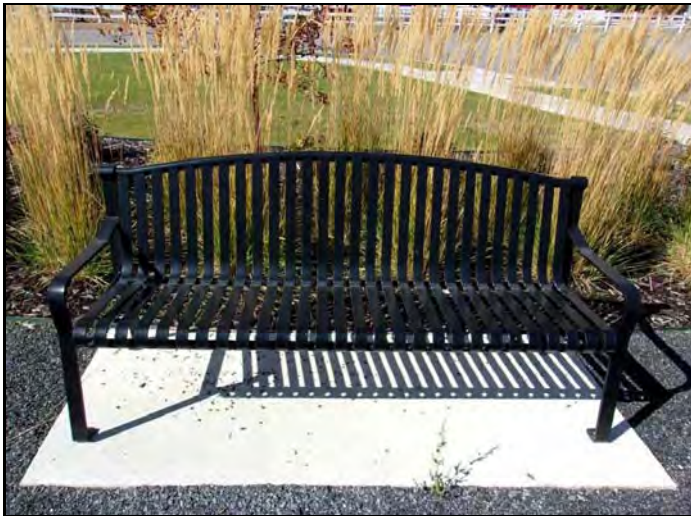
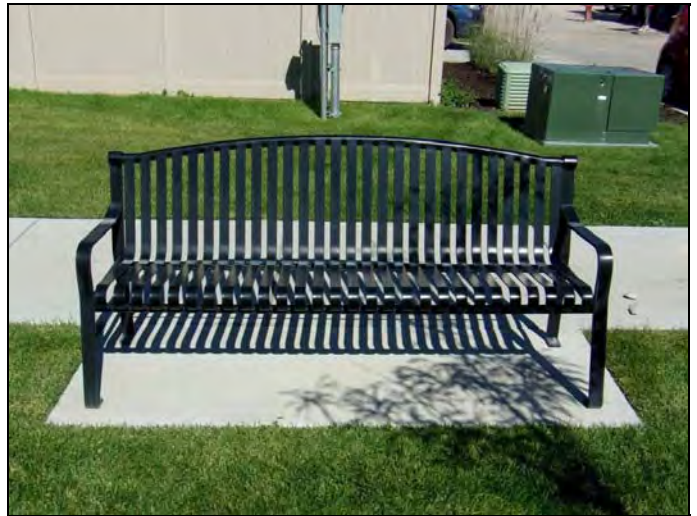
Comp #: 1307 Benches - 2022 - Replace

Location: **Phase 7**

The benches are in good condition. We recommend funding to replace this component approximately every 15 - 20 years. Remaining life based on current age.

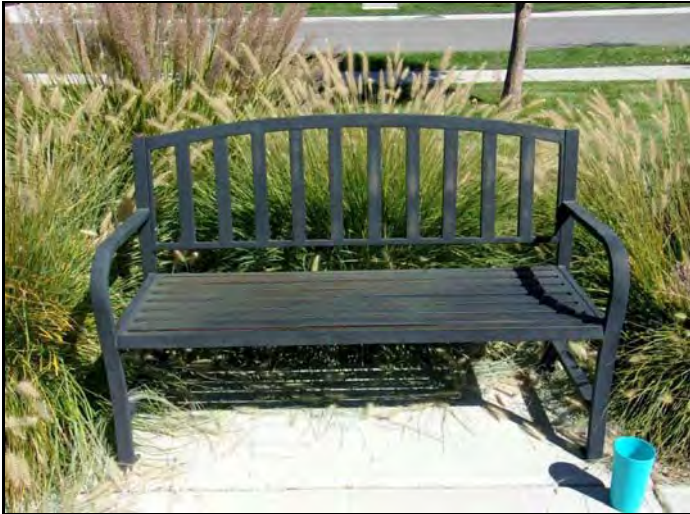
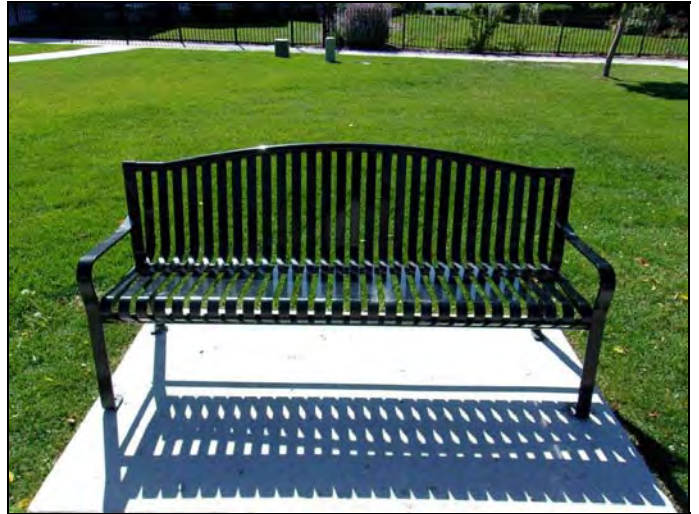
Comp #: 1307 Benches - Replace

Location: **Common Area**

The benches are in good to fair condition. We recommend funding to replace this component approximately every 15 - 20 years. Remaining life based on current age.

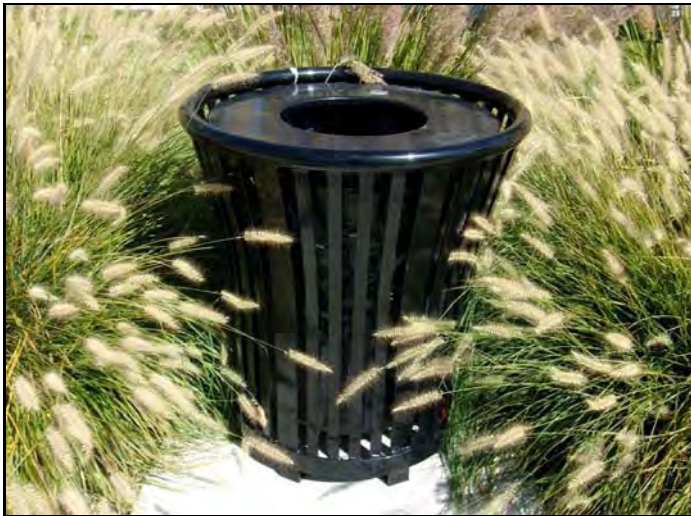
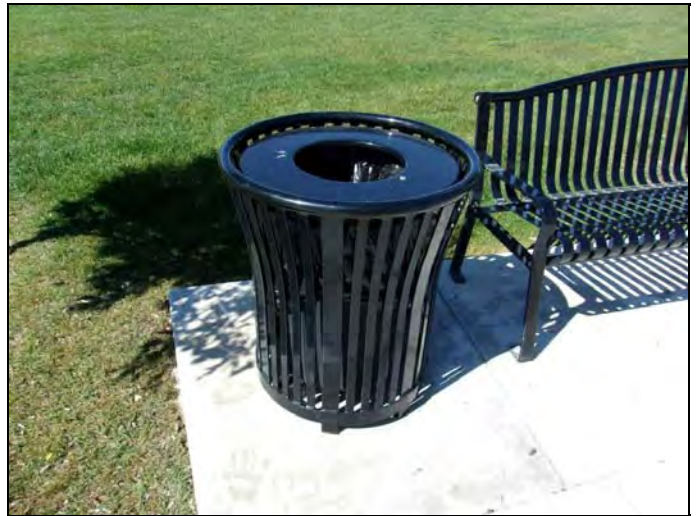
Comp #: 1308 Trash Receptacles - Replace

Location: **Common Areas**

The trash receptacles are in good condition. We recommend funding to replace this component approximately every 15 - 20 years. Remaining life based on current age.

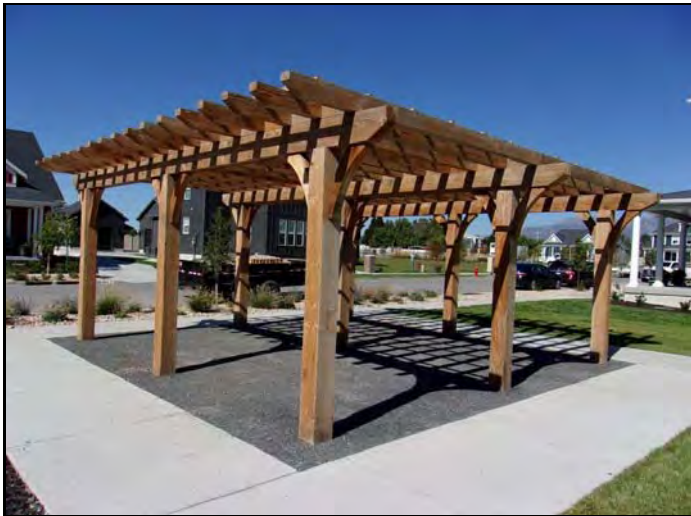
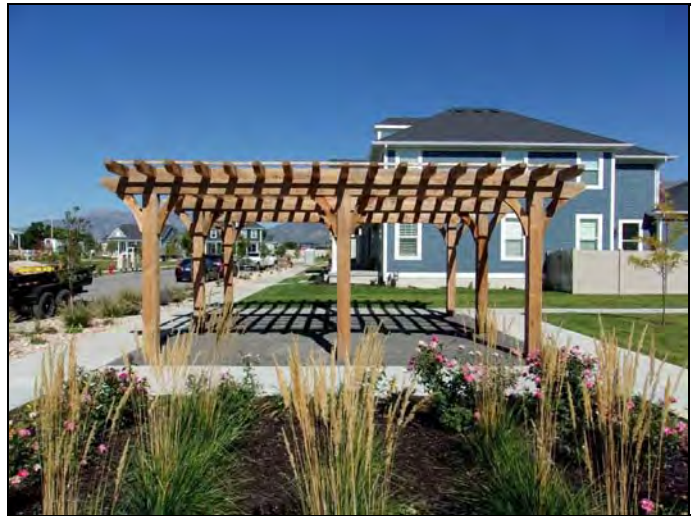
Comp #: 1309 Pergola - 2022 - Replace

Location: Phase 7

The pergola is in good condition. We recommend funding to replace this component approximately every 25 - 30 years. Remaining life based on current age.

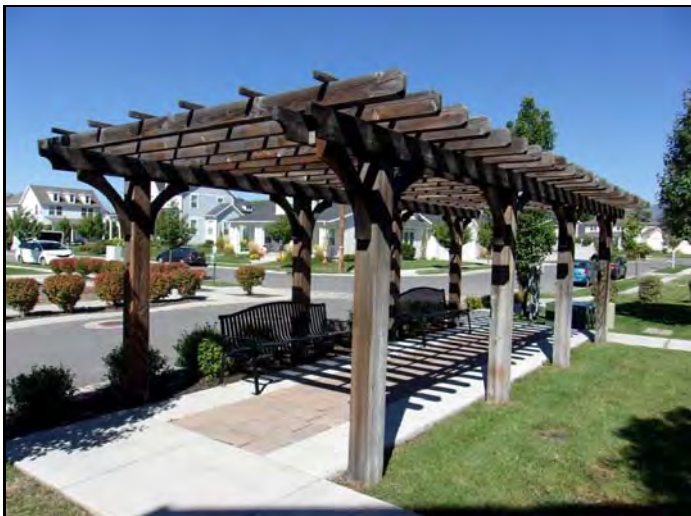
Comp #: 1309 Pergolas - Replace

Location: **Common Area**

The pergolas are in good condition. We recommend funding to replace this component approximately every 25 - 30 years. Remaining life based on current age.

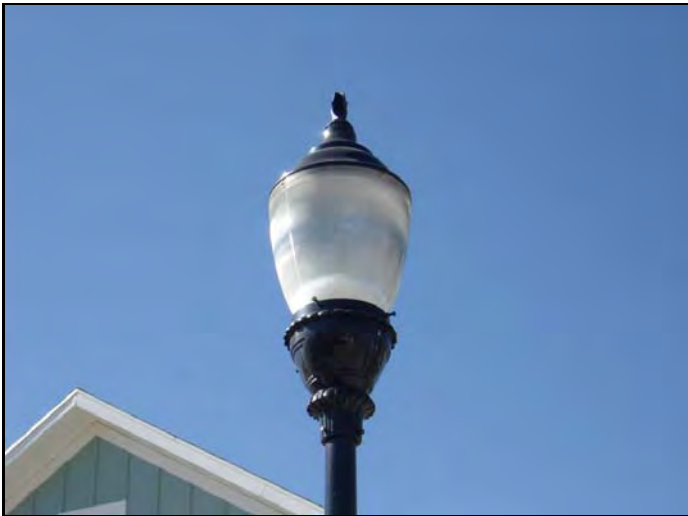
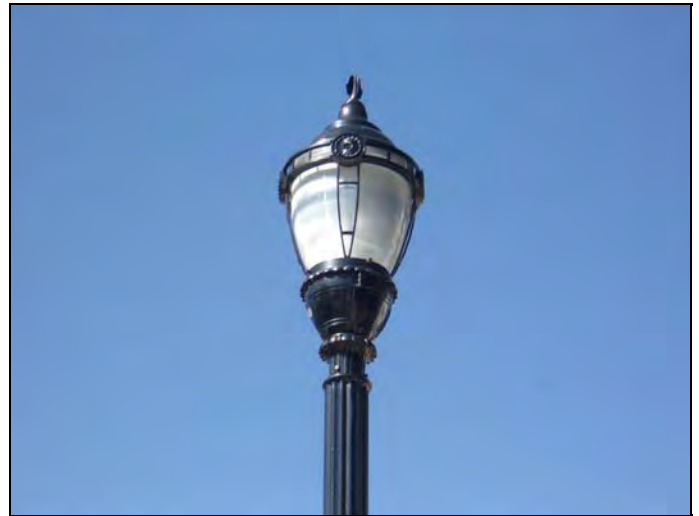
Comp #: 1609 Street Light Fixtures - 2022 - Replace

Location: **Phase 7**

The street light fixtures are in good condition. No expectation to replace the light poles. Paint poles as necessary as an operating expense. We recommend funding to replace this component approximately every 20 years. Remaining life based on current age.

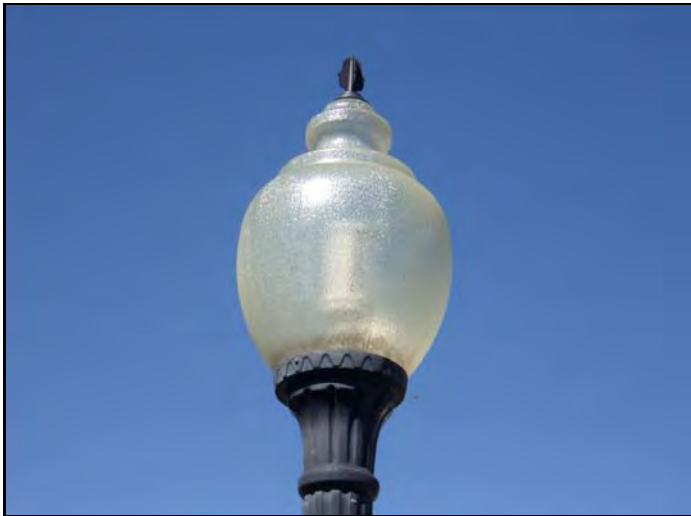
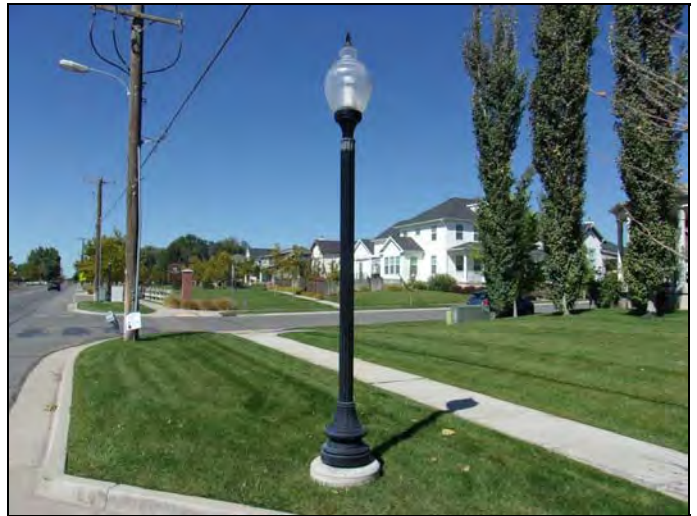
Comp #: 1609 Street Light Fixtures - Replace

Location: **Common Area**

The street light fixtures are in good to fair condition. No expectation to replace the light poles. Paint poles as necessary as an operating expense. We recommend funding to replace this component approximately every 20 years. Remaining life based on current age.

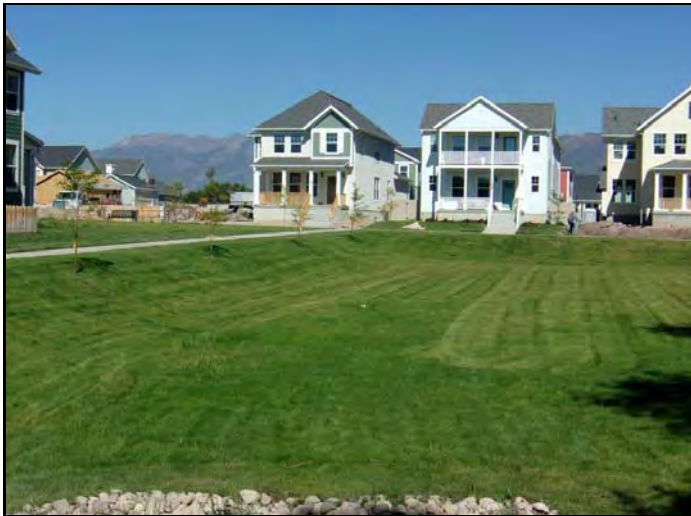
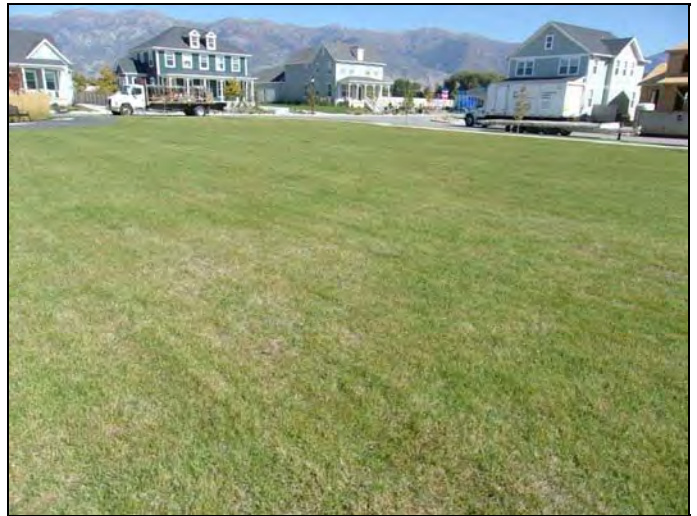
Comp #: 1812 Landscaping & Irrigation System - 2022 - Renovate

Location: **Phase 7**

The landscaping and irrigation system appear to be in good condition. We recommend funding for an allowance to renovate this component approximately every 20 years. Remaining life based on current age.

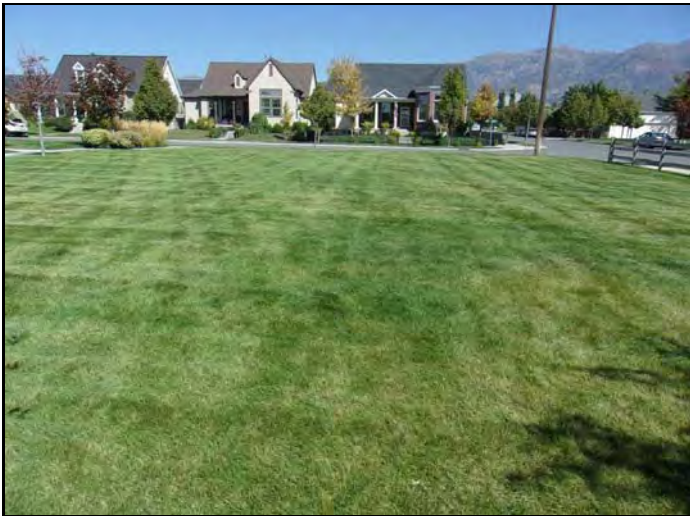
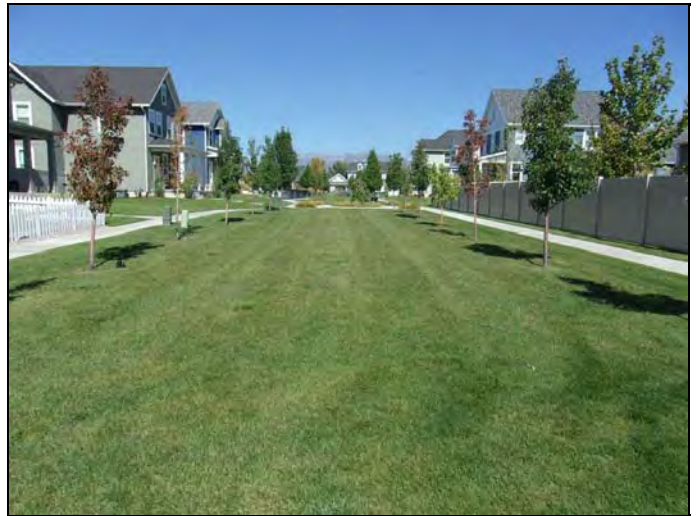
Comp #: 1812 Landscaping & Irrigation System - Renovate

Location: **Common Area**

The landscaping and irrigation system appear to be in good condition. We recommend funding for an allowance to renovate this component approximately every 20 years. Remaining life based on current age.
