# Donner Crest HOA

## Level 2 Reserve Study

Type of Study	Update w/Site Visit
Date of Property Inspection	1/3/2019
Prepared By	Dale Gifford
Analysis Method	Cash Flow
Funding Goal	Full Funding

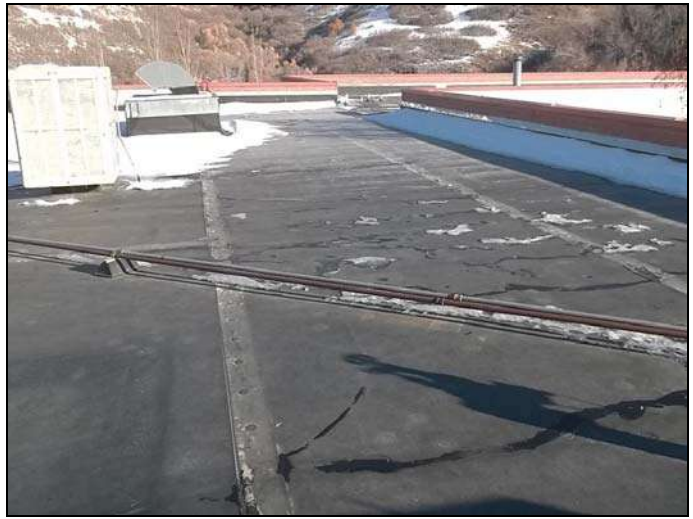
Comp #: 104 Flat Roof - Replace

The flat roofs are in good condition. We recommend funding to replace this component approximately every 20 - 25 years. Remaining life based on current age.

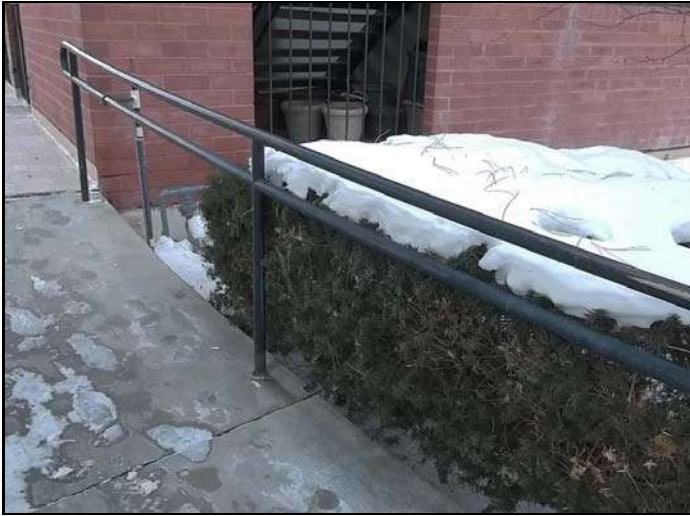
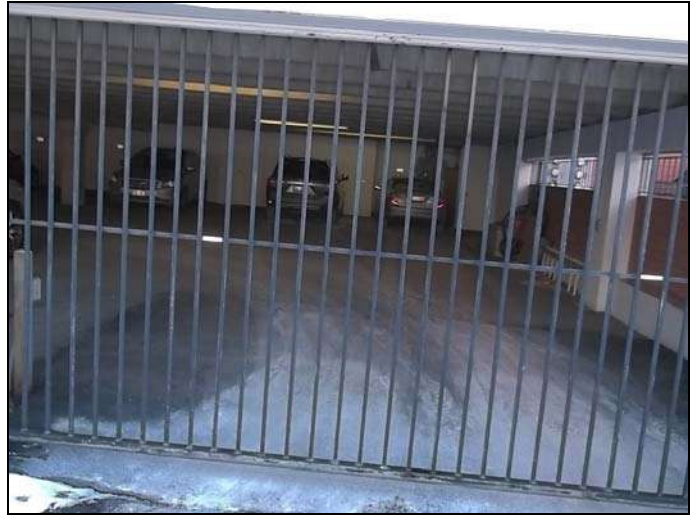
Comp #: 207 Metal Fencing & Railing - Repaint

Research with the client reveals this component will be painted in 2019. We recommend funding to repaint this component approximately every 6 years. Remaining life based on current age.

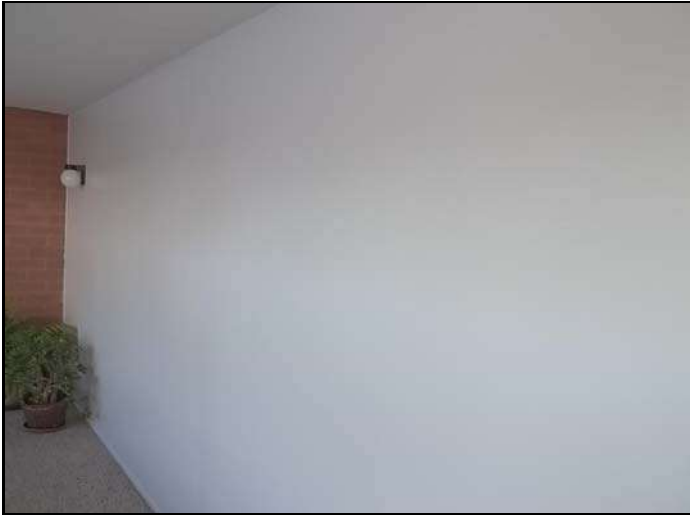
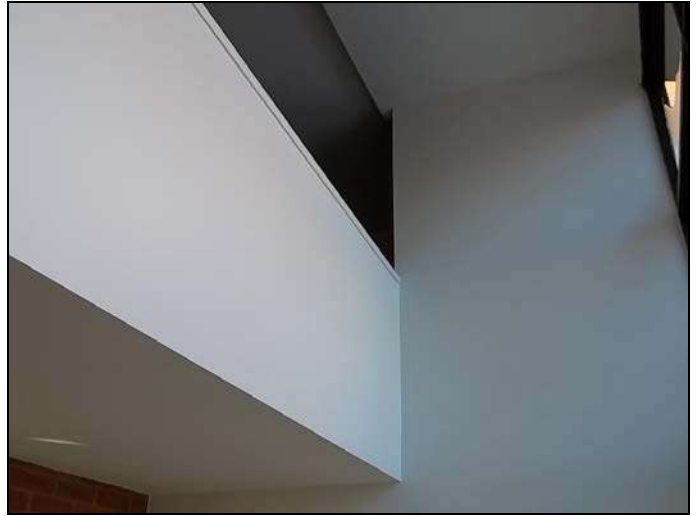
Comp #: 216 Interior Surfaces - Repaint

Research with the client reveals this component will be painted in 2019. We recommend funding to repaint this component approximately every 10 years. Remaining life based on current age.

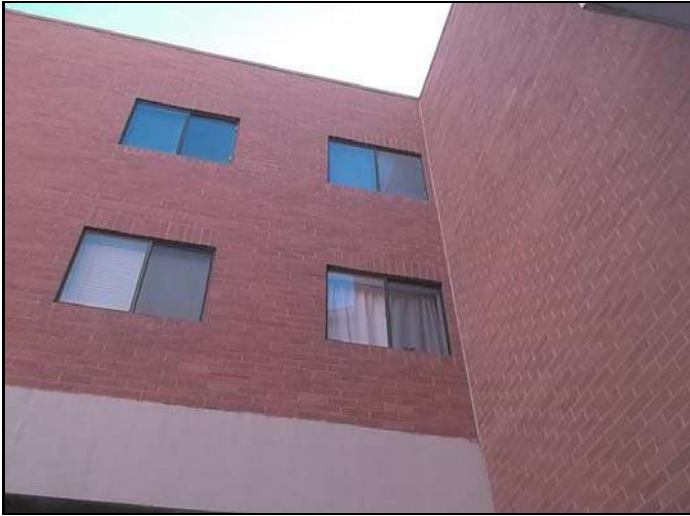
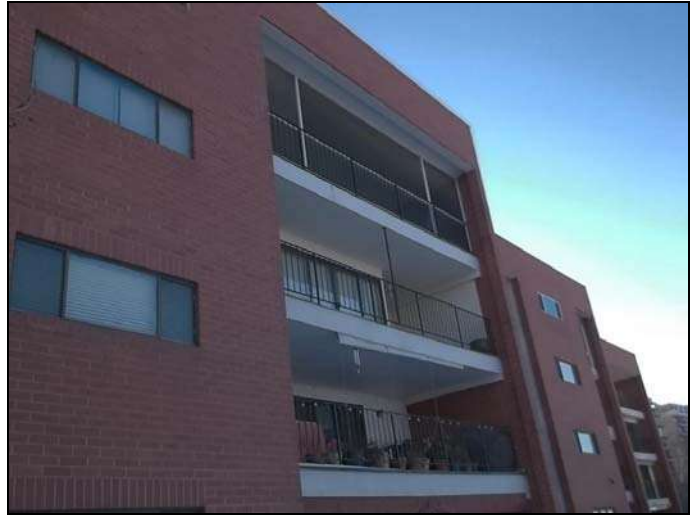
Comp #: 219 Brick - Repair/Seal

The brick work are in generally good condition. We recommend funding to repair and seal this component approximately every 30 years. Remaining life based on current age.

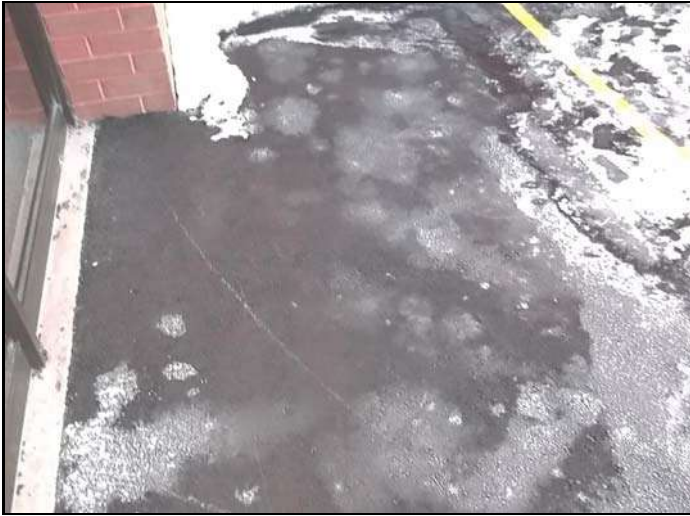
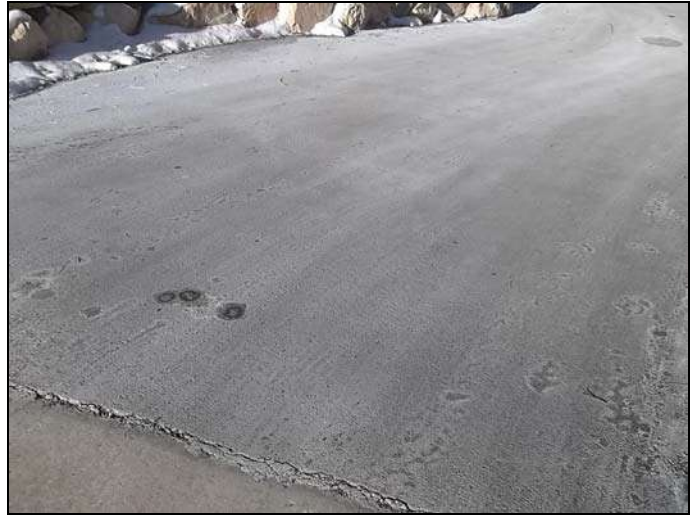
Comp #: 401 Asphalt - Exterior - Major Rehab

The asphalt surfaces are in good condition. We recommend funding for a major rehab of this component approximately every 20 - 25 years. Remaining life based on current age.

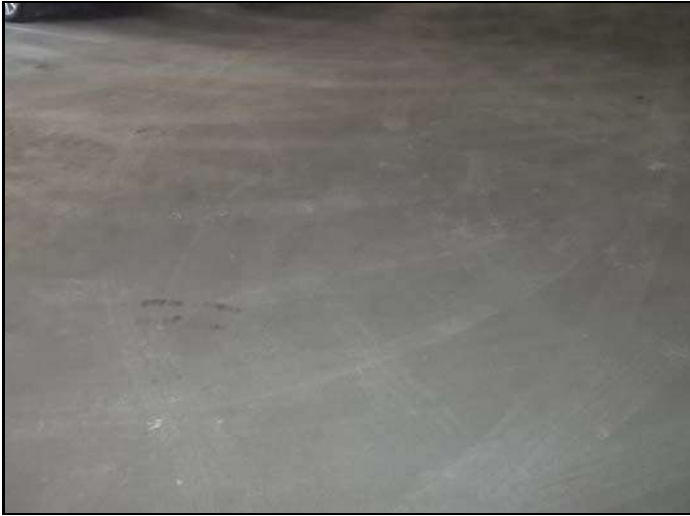
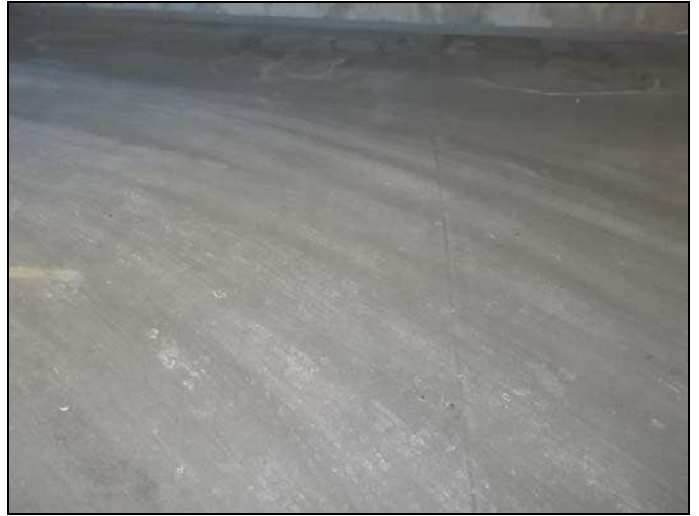
Comp #: 401 Asphalt - Interior - Major Rehab

Research with the client reveals this will receive an overlay in the near future. We recommend funding for a major rehab of this component approximately every 20 - 25 years. Remaining life based on current age.

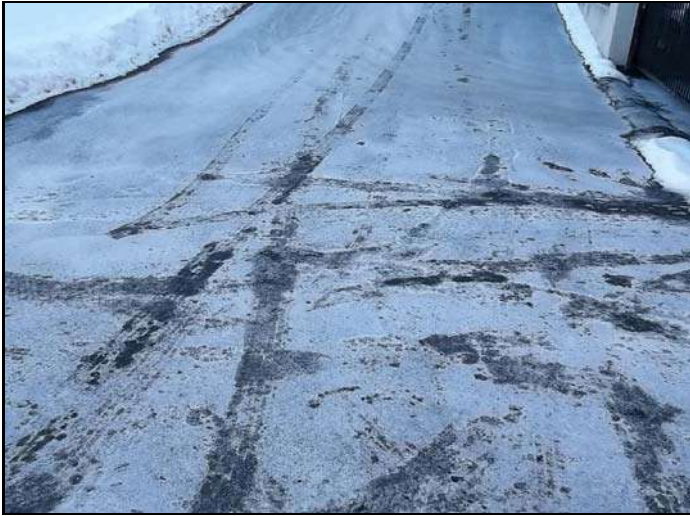
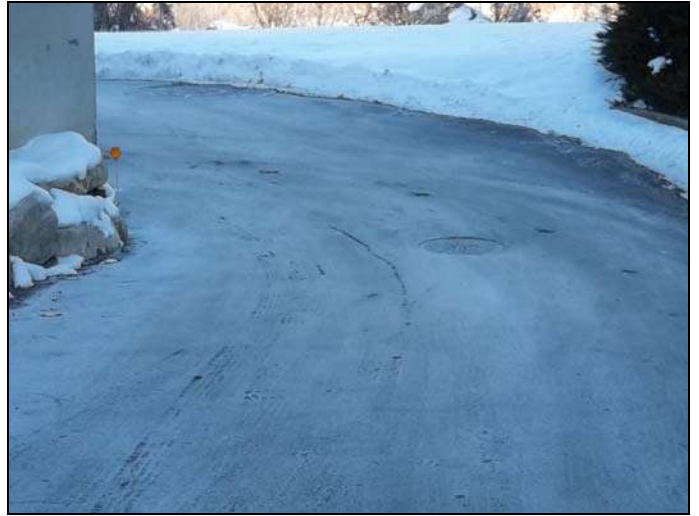
Comp #: 402 Asphalt - Exterior - Seal Coat

The asphalt seal coat is in poor condition. We recommend funding to seal this component approximately every 3 - 5 years. Remaining life based on current condition.

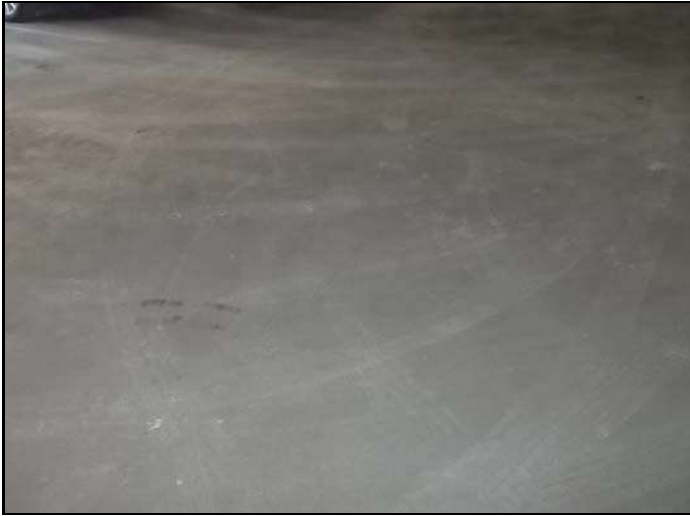
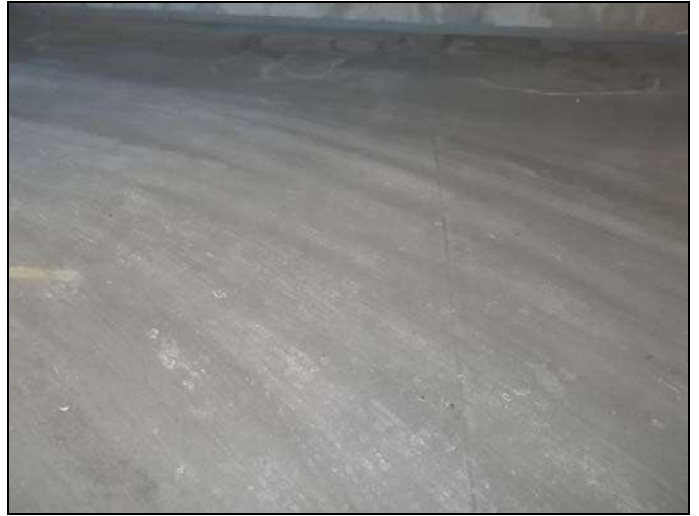
Comp #: 402 Asphalt - Interior - Seal Coat

The asphalt seal coat is in poor condition. We recommend funding to seal this component approximately every 3 - 5 years. Remaining life based on current condition.

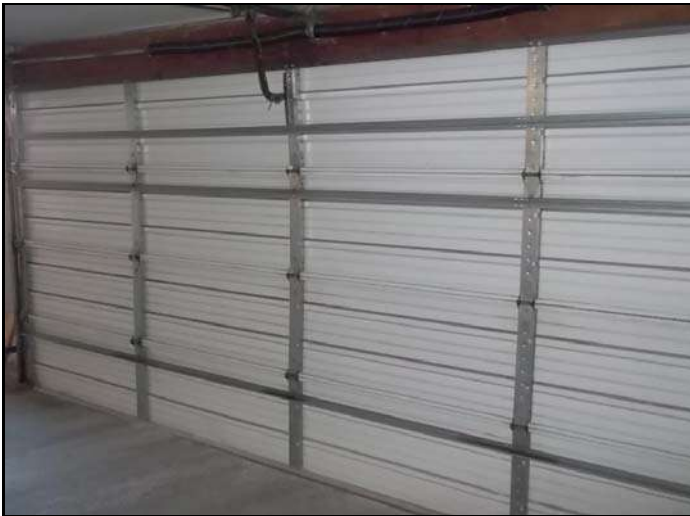
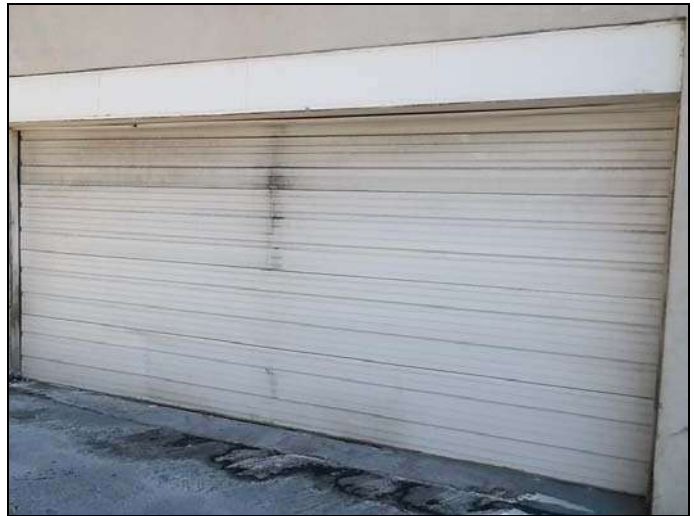
Comp #: 502 Garage Door - Upper - Replace

Research with the client reveals this component will need to be replaced in the near future. We recommend funding to replace this component approximately every 20 years. Remaining life based on current age.

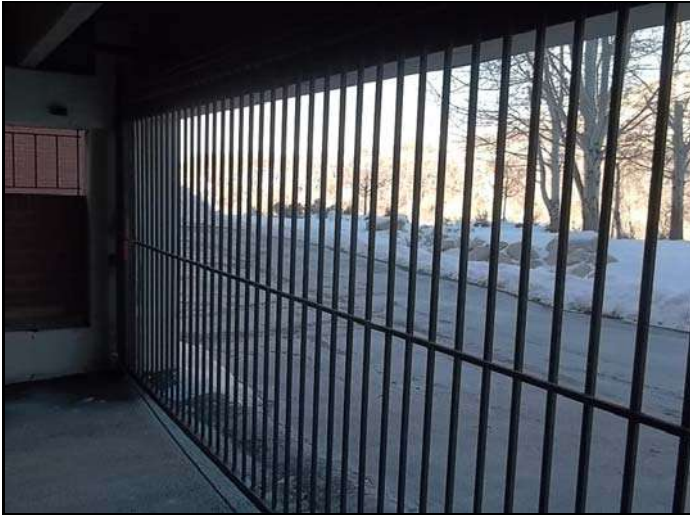
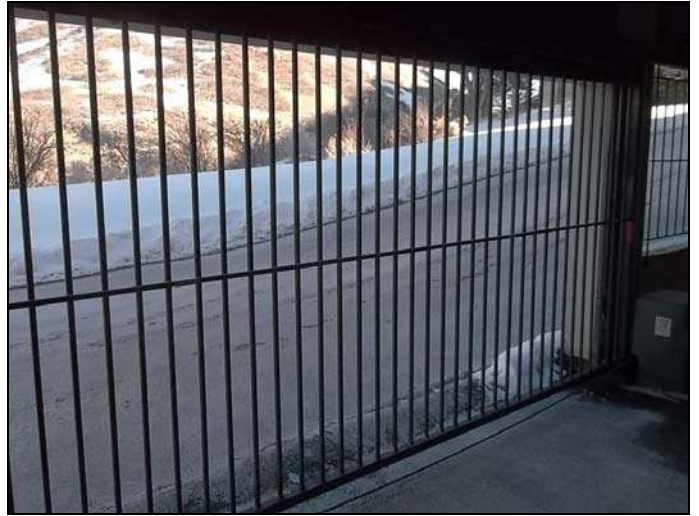
Comp #: 504 Vehicle Gate - Lower - Replace

The vehicle gate is in good condition. We recommend funding to completely replace this component approximately every 25 - 30 years. Remaining life based on current age.

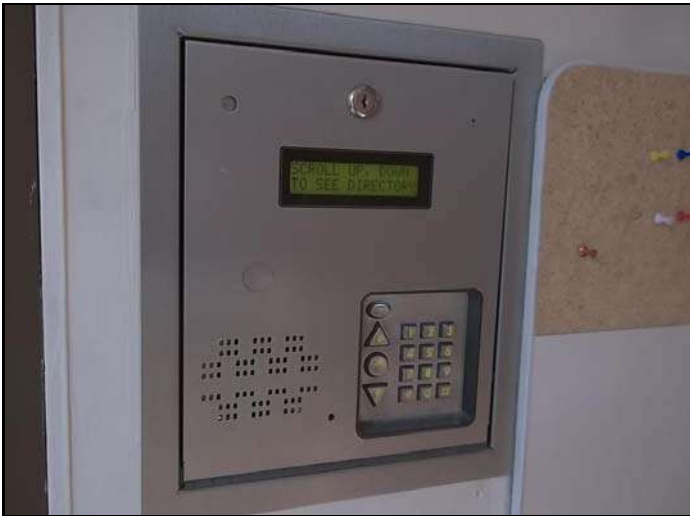
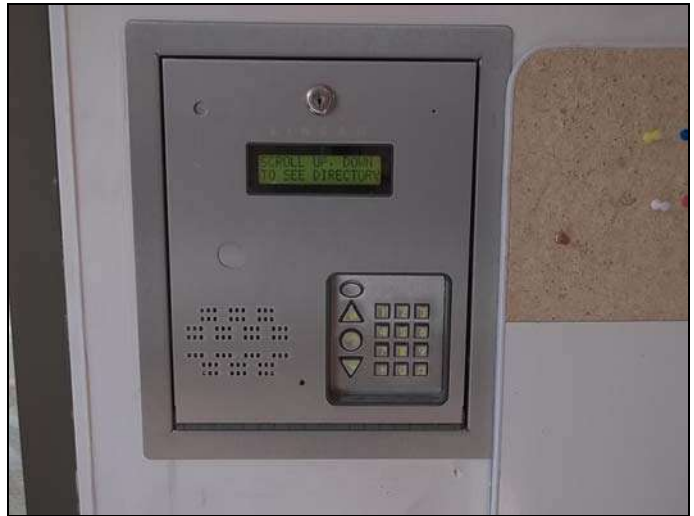
Comp #: 506 Phone Entry System - Replace

The phone entry system is in working condition. We recommend funding to replace this component approximately every 12 years. Remaining life based on current age.

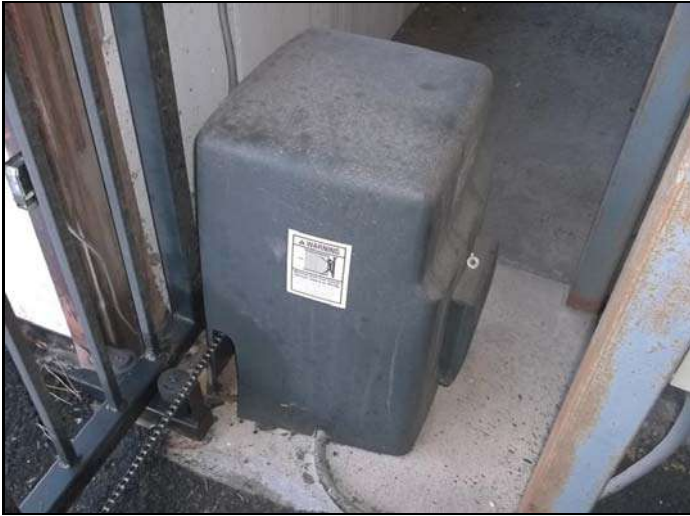
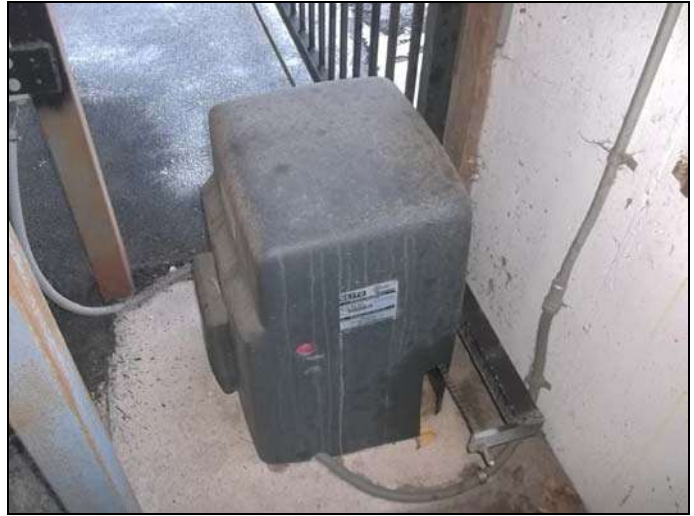
Comp #: 507 Vehicle Gate Operator - Replace

The vehicle gate operator is in working condition. We recommend funding to replace this component approximately every 12 years. Remaining life based on current age.

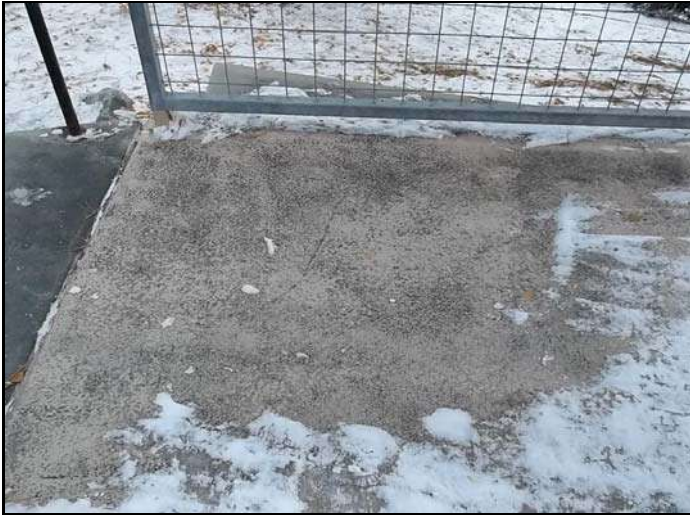
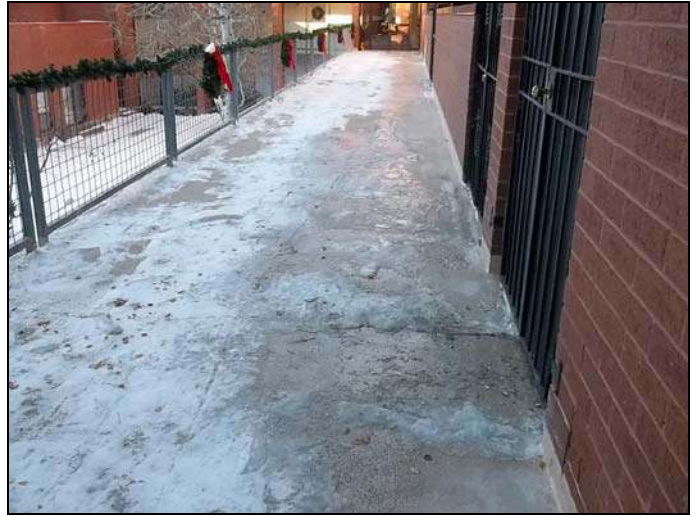
Comp #: 603 Concrete - Reseal

The sidewalk painted surfaces are in fair condition. We recommend painting this component approximately every 5 years. Remaining life based on current condition.

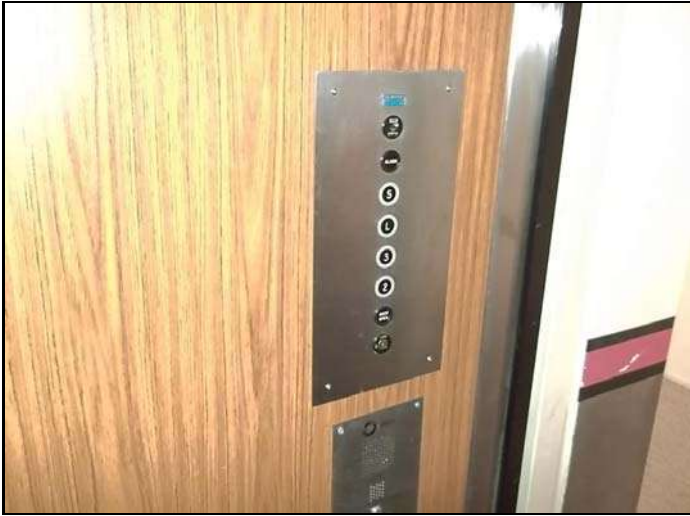
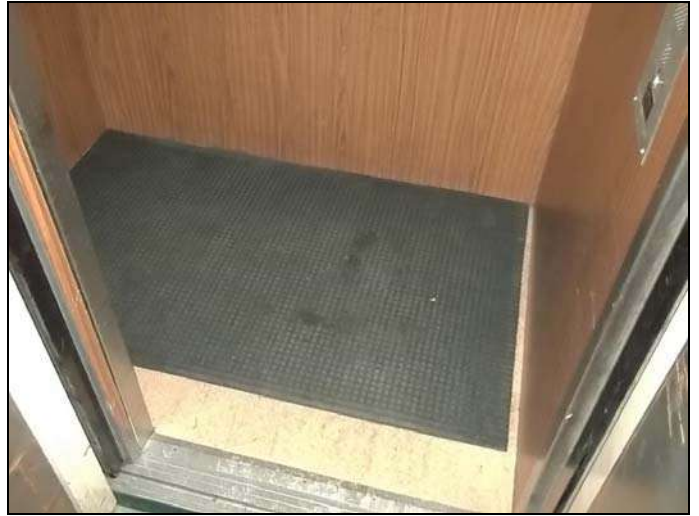
Comp #: 707 Elevator - Modernize

The elevator is in working condition. We recommend funding to modernize this component approximately every 25 - 30 years. Modernization consists of controller replacement, door package upgrade, and control panel replacement. Remaining life based on current condition.

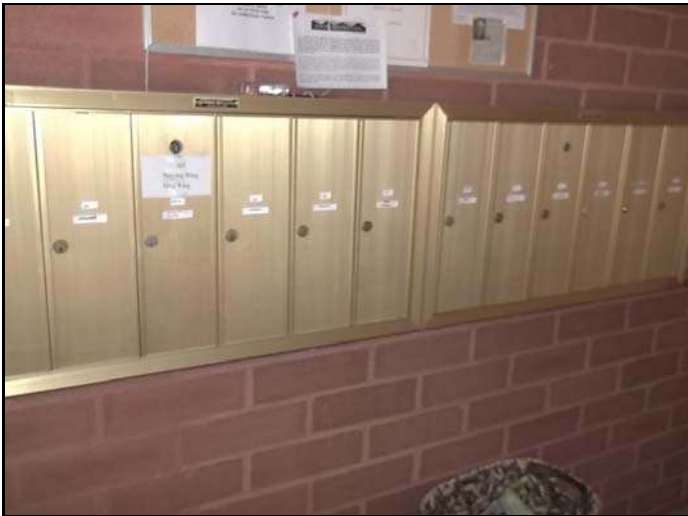
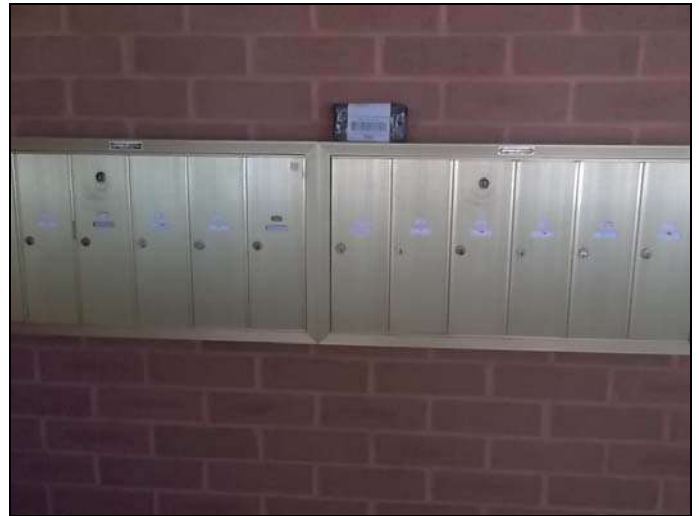
Comp #: 803 Mailboxes - Replace

The mailboxes are older but still in functional condition. We recommend funding to replace this component approximately every 20 - 25 years. Remaining life based on current condition.

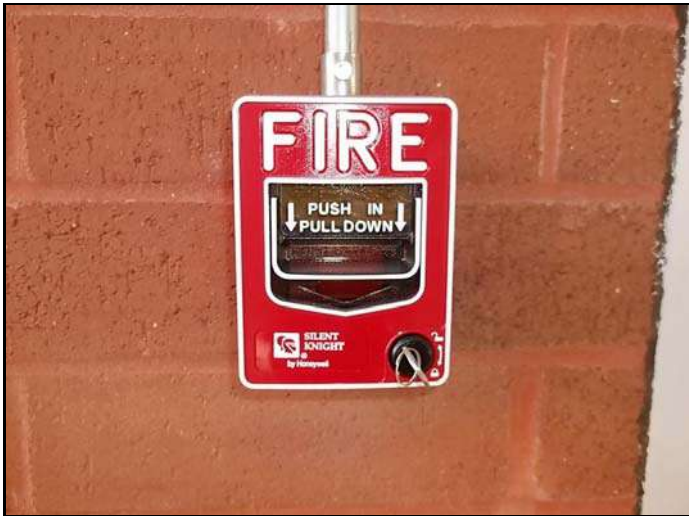
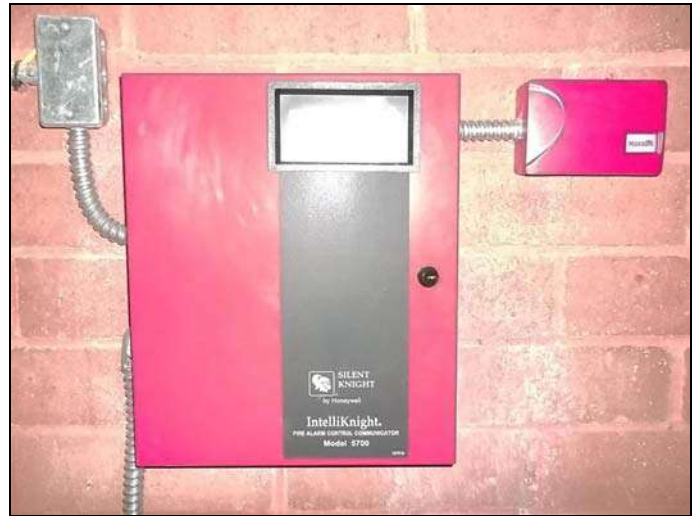
Comp #: 901 Fire Protection System - Renovate

Although the fire protection system is designed to last the life of the community we recommend funding for an allowance to renovate this component approximately every 20 years to ensure proper function and to keep up with current technology and code requirements. Perform regular, professional inspections and repairs as an operating expense. Remaining life based on current age.

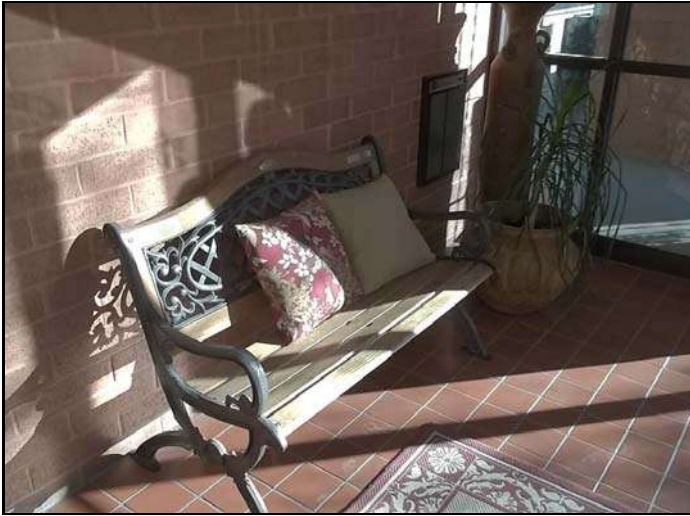
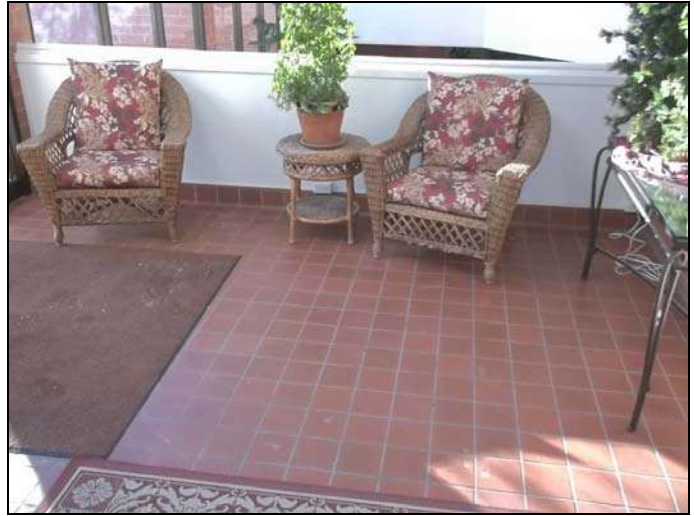
Comp #: 1415 Lobby - Remodel

The lobby is in good condition. We recommend funding to remodel this component approximately every 10 years. Remaining life based on current age.

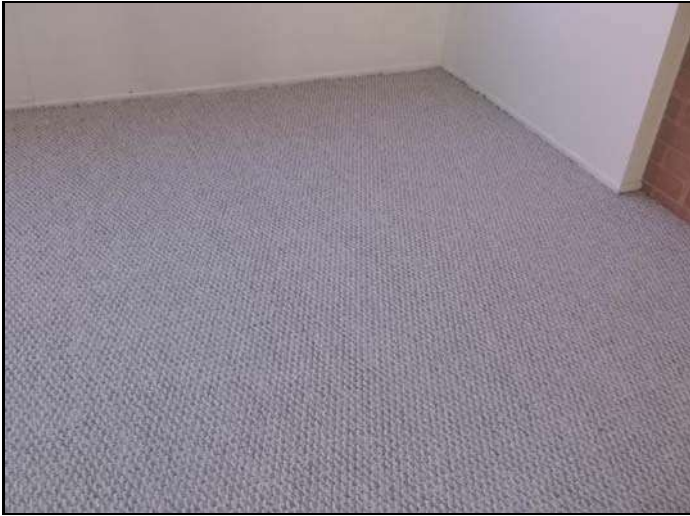
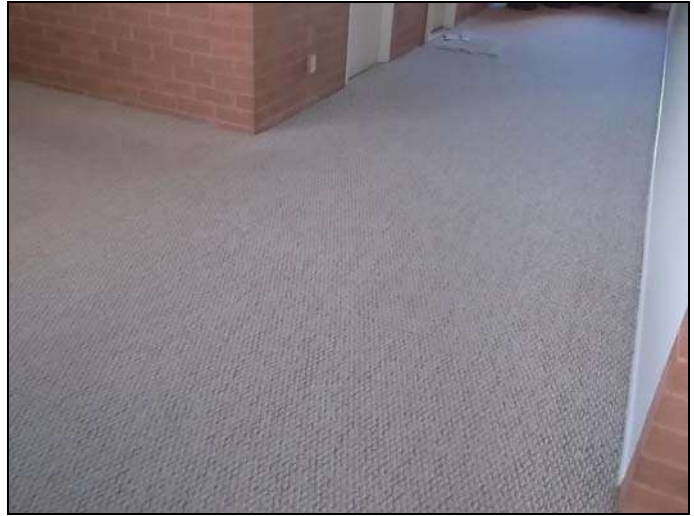
Comp #: 1501 Carpeting - Replace

Research with the client reveals this component will be replaced in 2019. We recommend funding to replace this component approximately every 8 - 10 years. Remaining life based on current age.

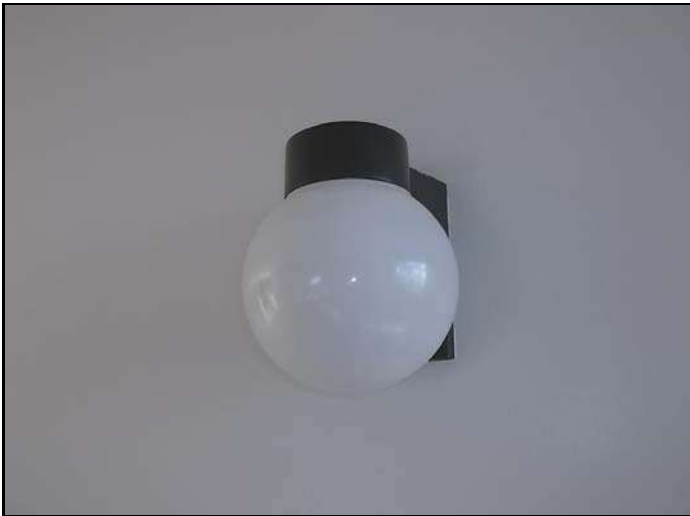
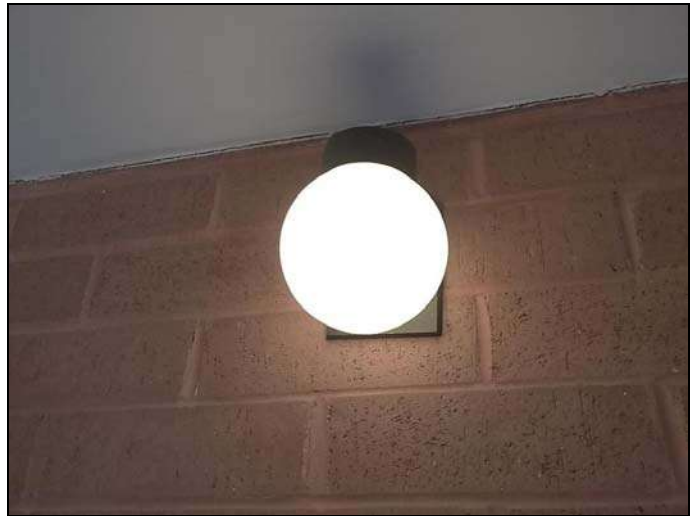
Comp #: 1601 Interior Light Fixtures - Replace

The interior light fixtures are in good to fair condition. We recommend funding to replace this component approximately every 20 - 25 years. Remaining life based on current age and condition.
