The Park Master

Level 1 Reserve Study

Report Period – 01/01/2025 – 12/31/2025

Executive Summary – The Park Master - ID # 19327

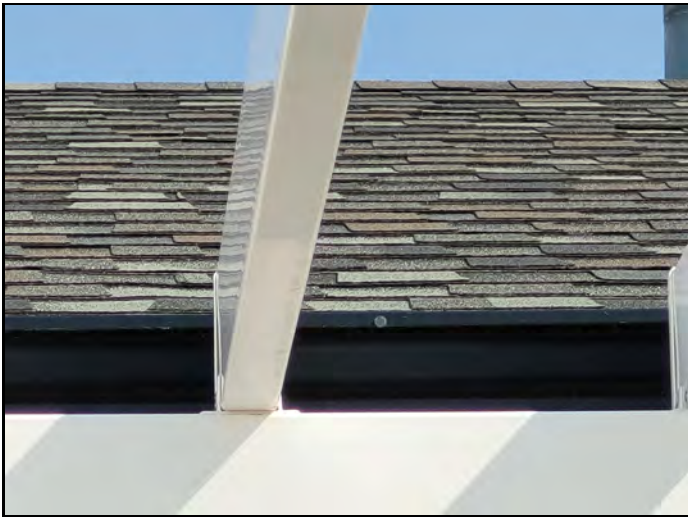
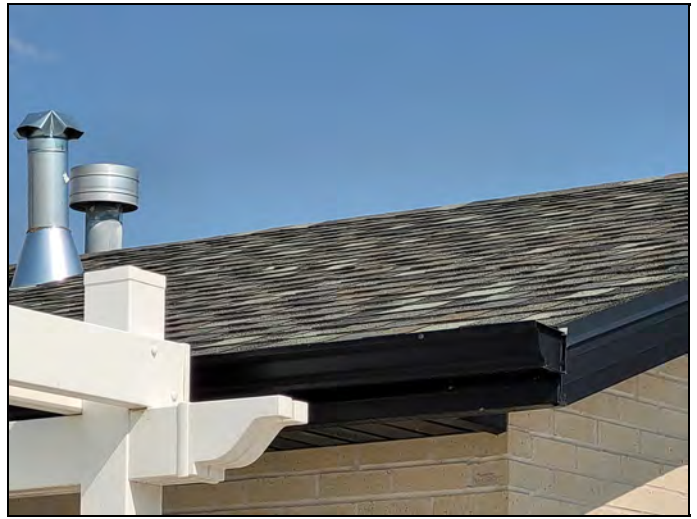
Comp #: 105 Roofs - Replace

Location: **Pool Building**

The roof appears to be in good condition. We recommend funding to replace this component approximately every 20 - 25 years. Remaining life based on current age.

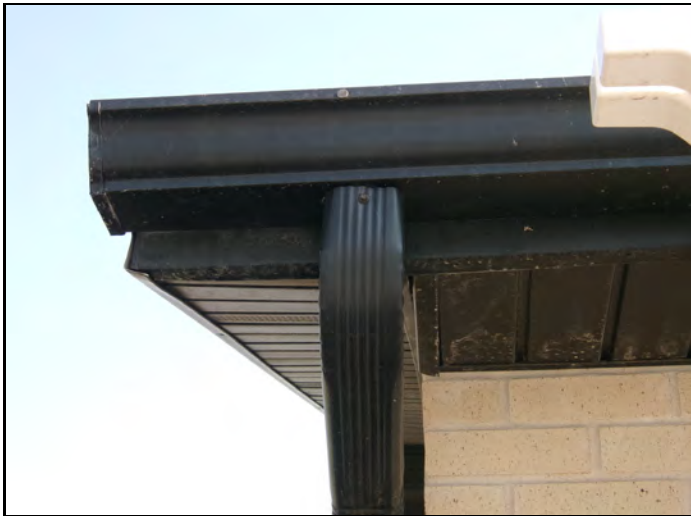
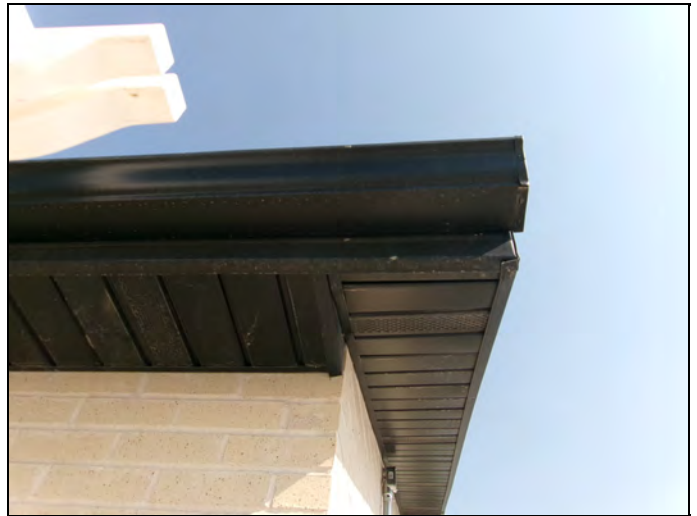
Comp #: 120 Rain Gutters/Downspouts - Replace

Location: **Pool Building**

Due to the minimal cost of replacing this component, reserve funding is not appropriate. Replace as necessary as an operating expense.

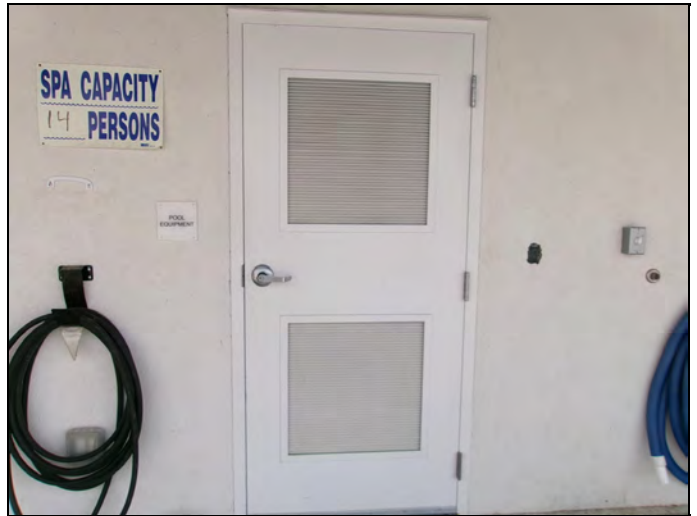
Comp #: 201 Stucco Surfaces - Repair/Repaint

Location: **Pool Building**

Due to the minimal cost of repairing/repainting this component, reserve funding is not appropriate. Repair/repaint as necessary as an operating expense.

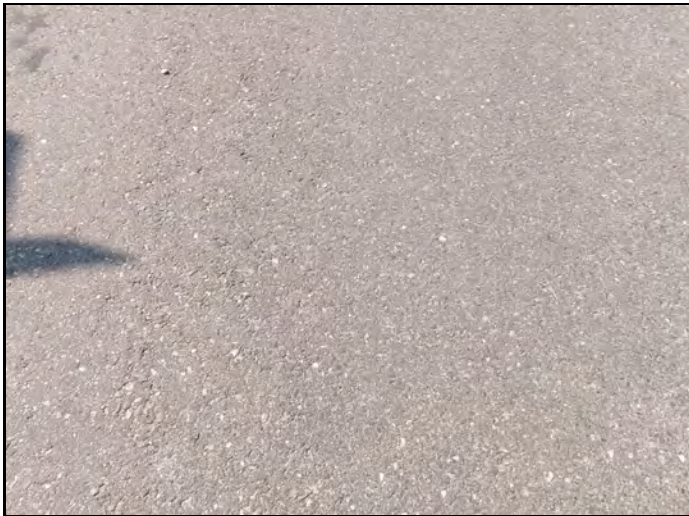
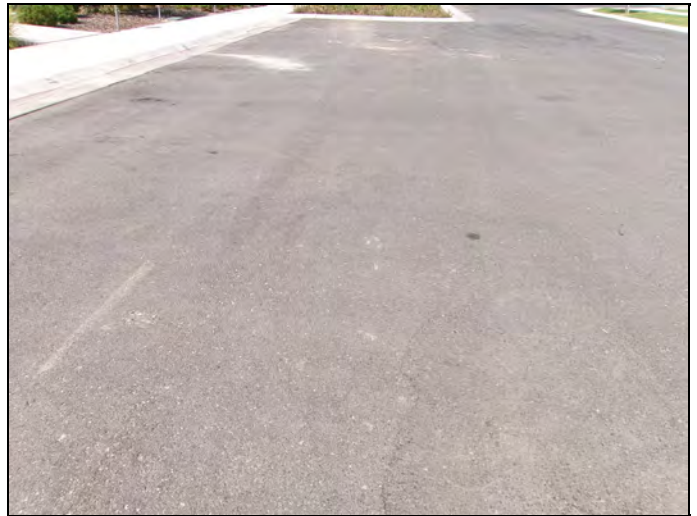
Comp #: 401 Asphalt - Major Rehab

Location: **Community Streets**

The asphalt surfaces are in good condition. We recommend funding for a major rehab of this component approximately every 25 - 30 years. Remaining life based on current age.

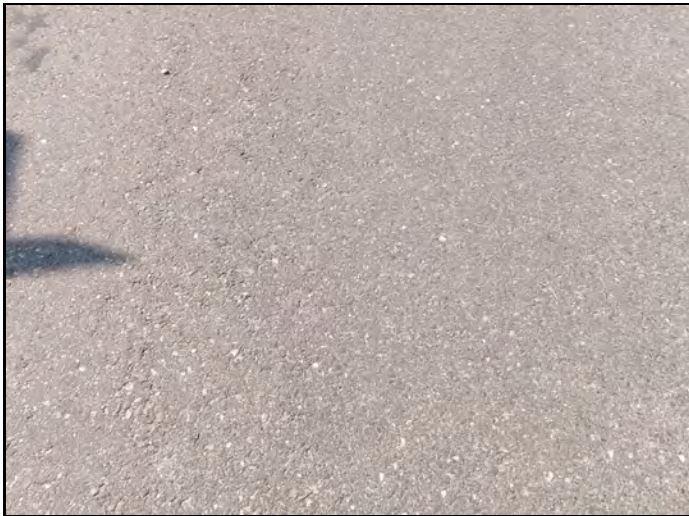
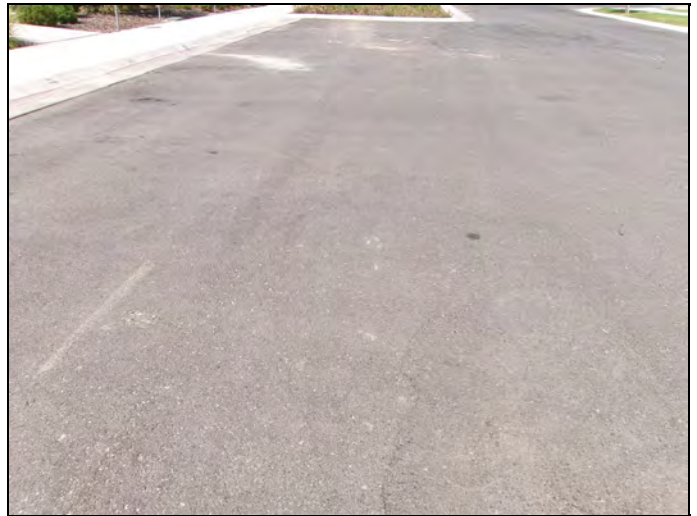
Comp #: 402 Asphalt - Seal Coat

Location: **Community Streets**

The asphalt seal coat is in poor condition. We recommend funding to seal this component approximately every 3 - 5 years. Remaining life based on current condition.

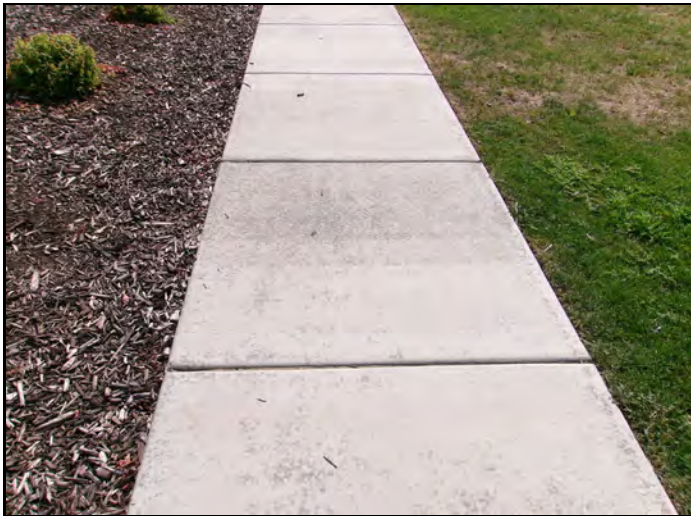
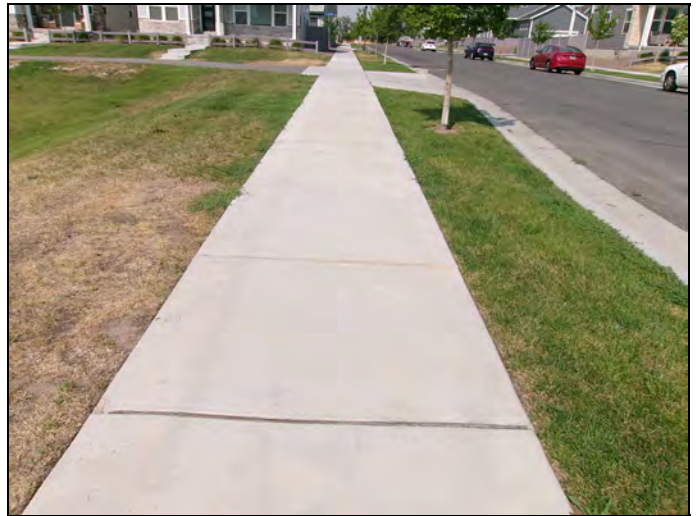
Comp #: 403 Concrete - Partial Repair/Replace

Location: **Common Area**

The concrete is in good condition. This component has an extended useful life under normal conditions. We recommend funding to make repairs and partially replace this component approximately every 10 years. Remaining life based on current age.

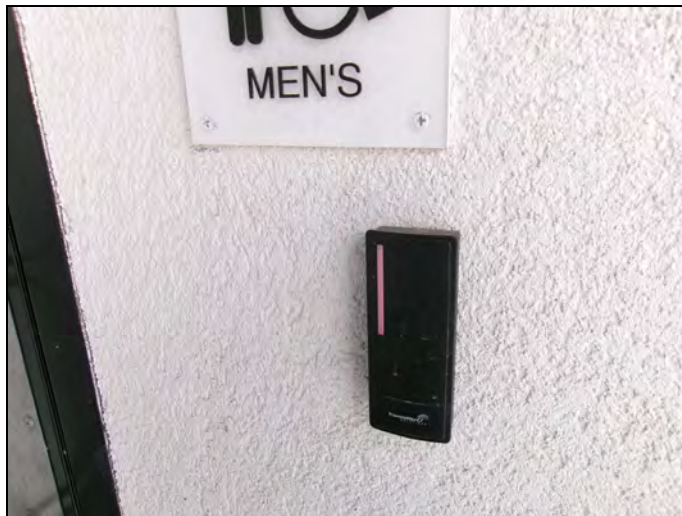
Comp #: 508 Access Control System - Replace

Location: **Pool Area**

The access control system is in working condition. We recommend funding to replace this component approximately every 10 - 12 years. Remaining life based on current age.

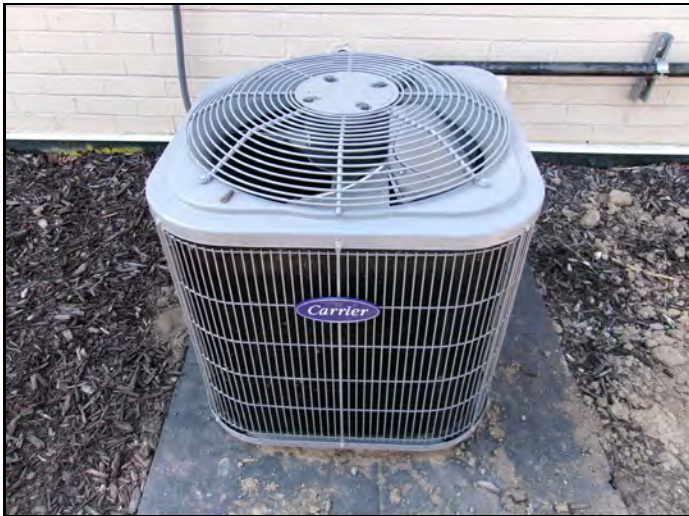
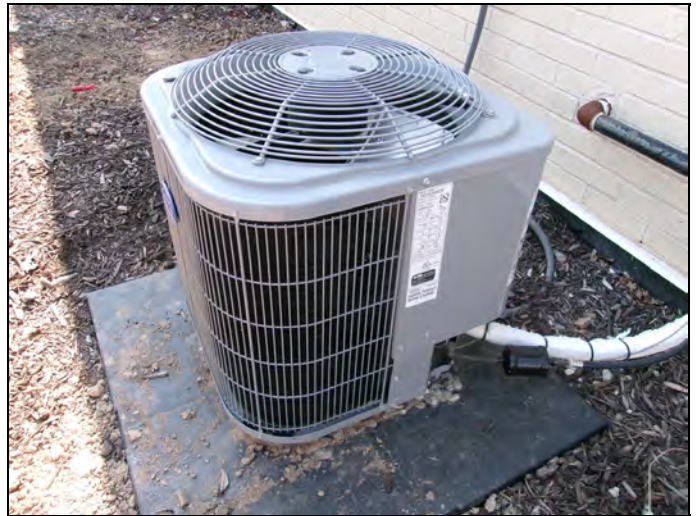
Comp #: 705 HVAC System - Replace

Location: **Pool Building**

The HVAC system is in working condition. We recommend replacing this component approximately every 20 years. Remaining life based on current age.

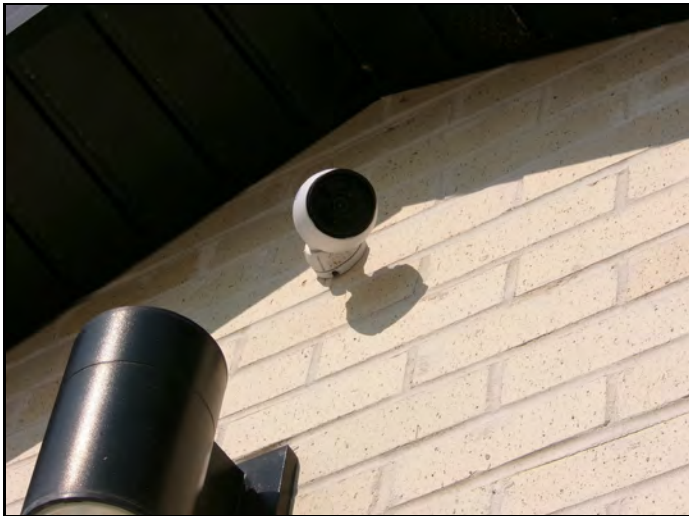
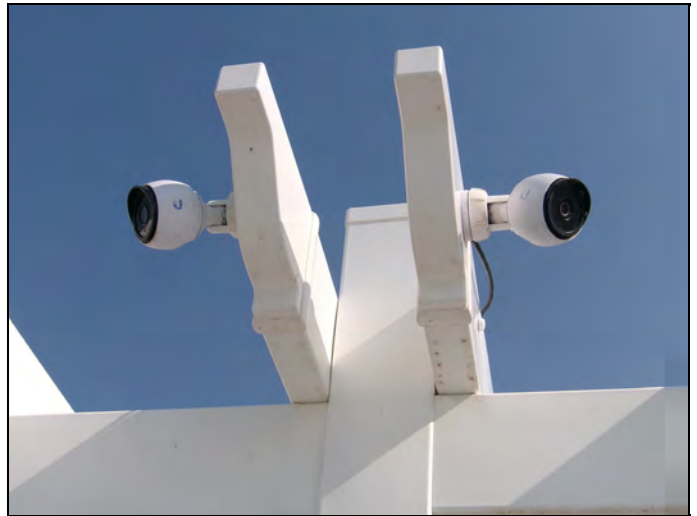
Comp #: 903 Security Camera System - Replace

Location: **Pool Area**

The security camera system is in working condition. We recommend funding to replace this component approximately every 10 - 12 years. Remaining life based on current age.

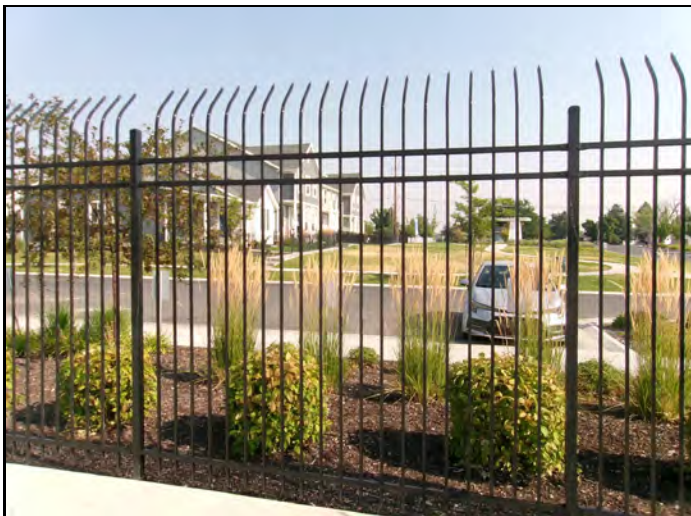
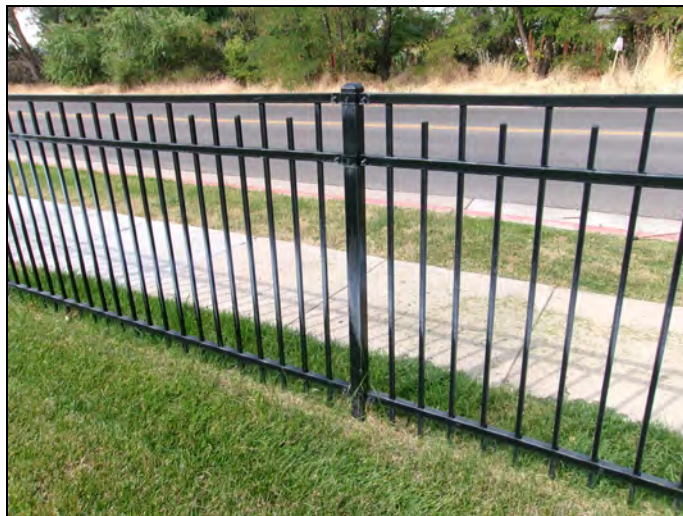
Comp #: 1002 Metal Fencing - Replace

Location: **Common Area**

The metal fencing is in good condition. We recommend funding to replace this component approximately every 40 - 50 years. Remaining life based on current age.

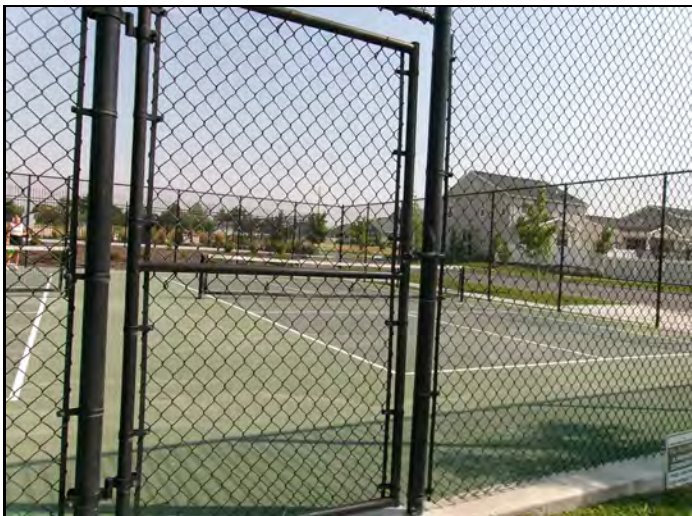
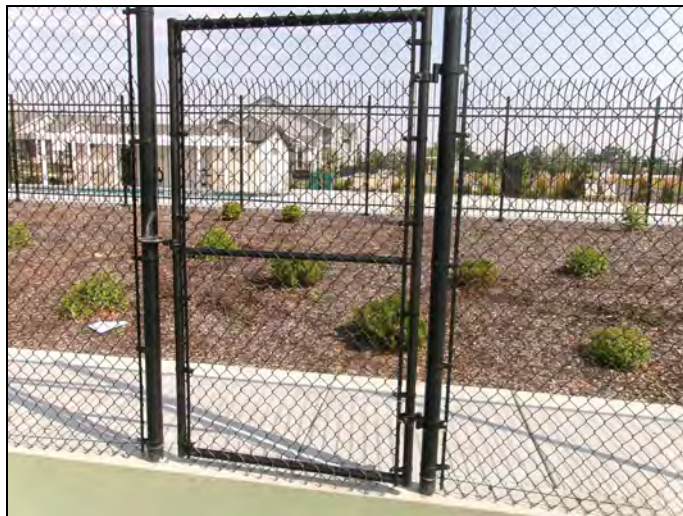
Comp #: 1003 Chain Link Fencing - Replace

Location: **Pickleball Court**

The chain link fencing is in good condition. We recommend funding to replace this component approximately every 30 - 40 years. Remaining life based on current age.

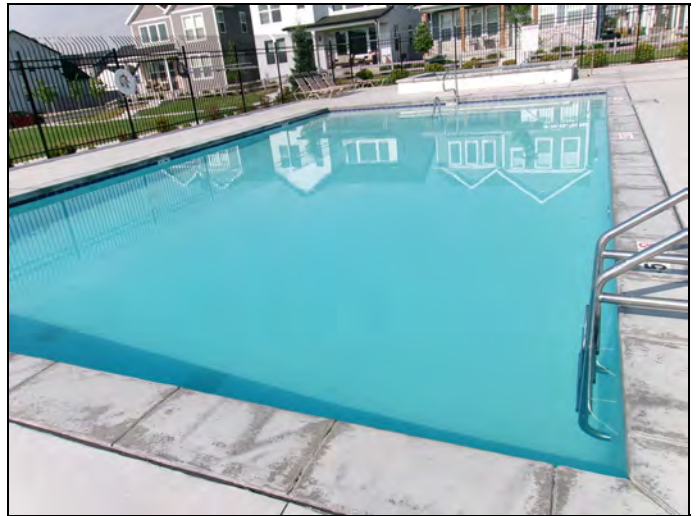
Comp #: 1101 Pool - Resurface

Location: **Pool Area**

The pool surface is in good condition. We recommend funding to resurface this component every 10 - 12 years. Remaining life based on current age.

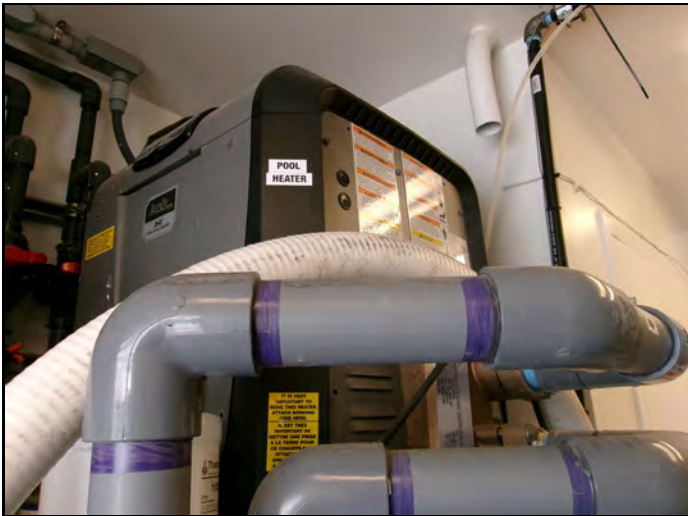
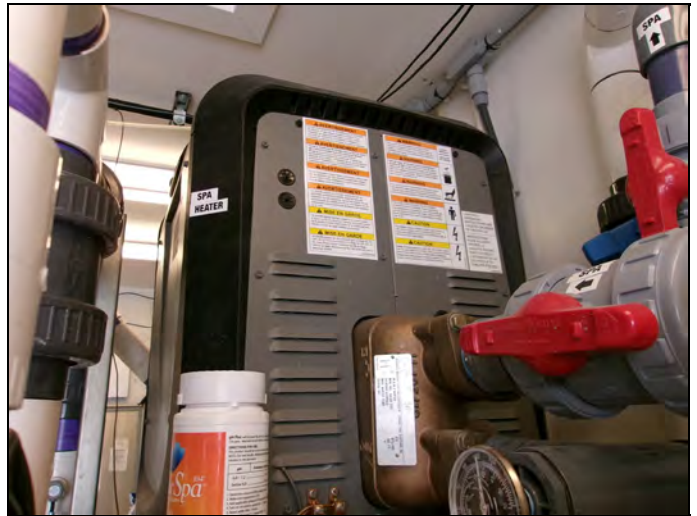
Comp #: 1104 Pool & Spa Heaters - Replace

Location: **Pool Equipment Room**

The heaters are in working condition. We recommend funding to replace this component approximately every 12 years. Remaining life based on current age.

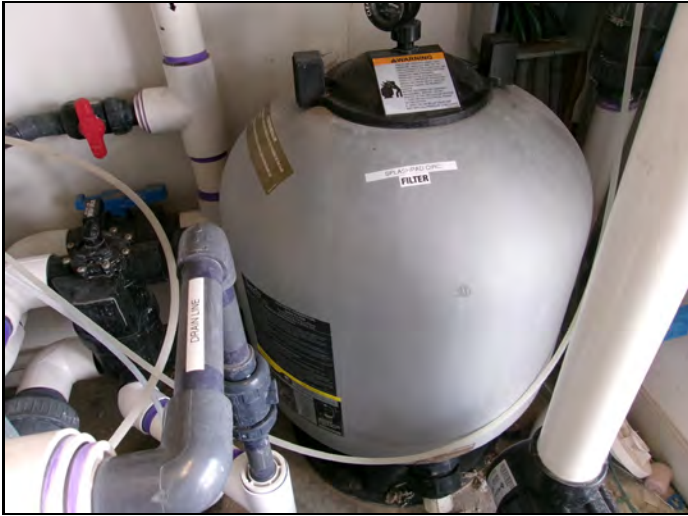
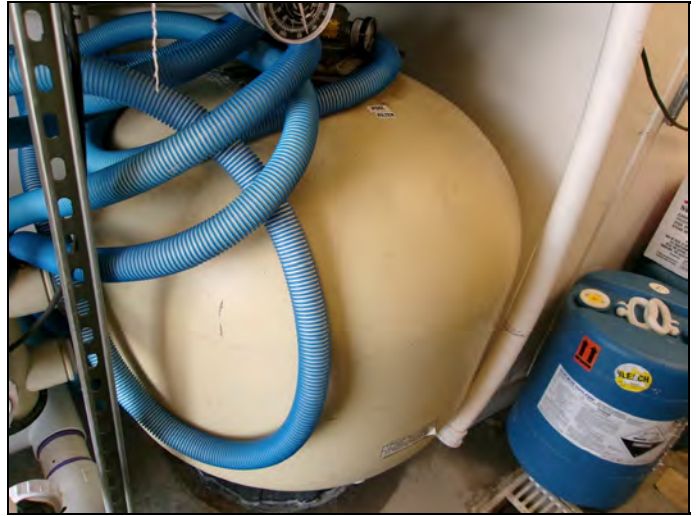
Comp #: 1107 Pool, Spa, & Splash Filters - Replace

Location: **Pool Equipment Room**

The filters are in working condition. We recommend funding to replace this component approximately every 12 - 15 years. Remaining life based on current age.

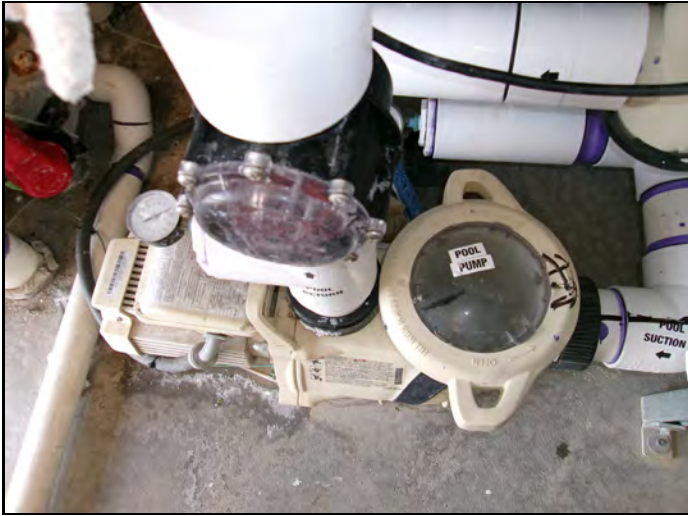
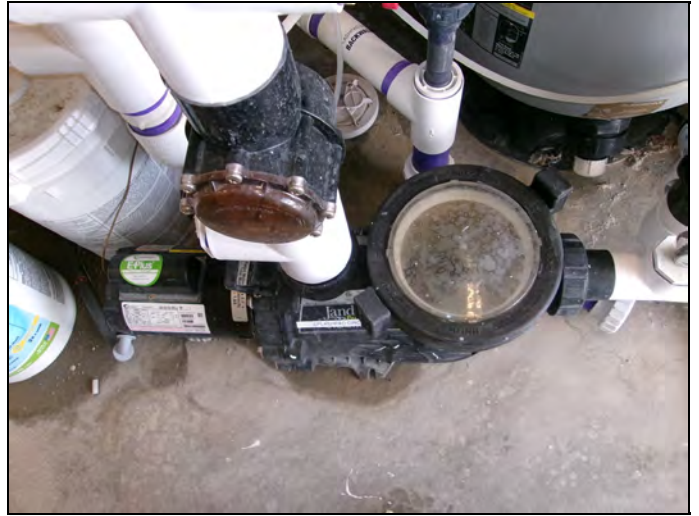
Comp #: 1110 Pool, Spa, & Splash Pumps - Replace

Location: **Pool Equipment Room**

The pumps are in working condition. We recommend funding to replace this component approximately every 8 - 10 years. Remaining life based on current age.

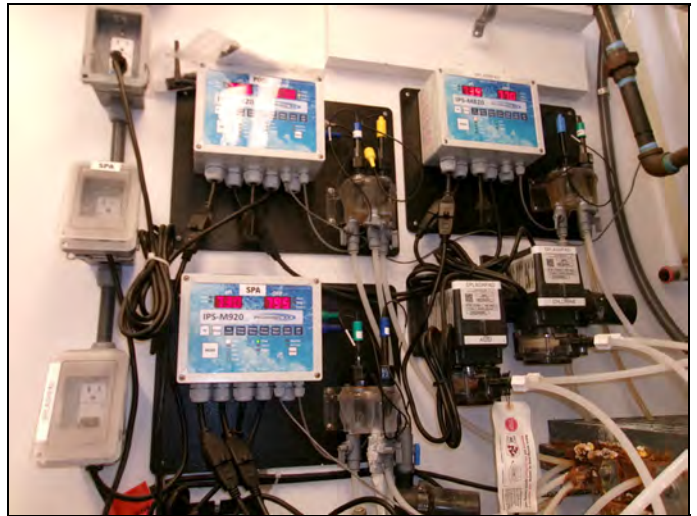
Comp #: 1111 Chemical Controller Systems - Replace

Location: Pool Equipment Room

The chemical controller systems are in working condition. We recommend funding to replace this component approximately every 10 - 12 years. Remaining life based on current age.

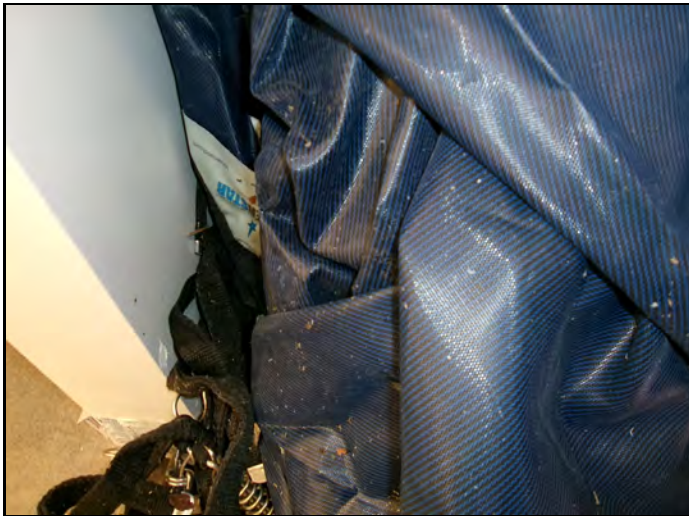
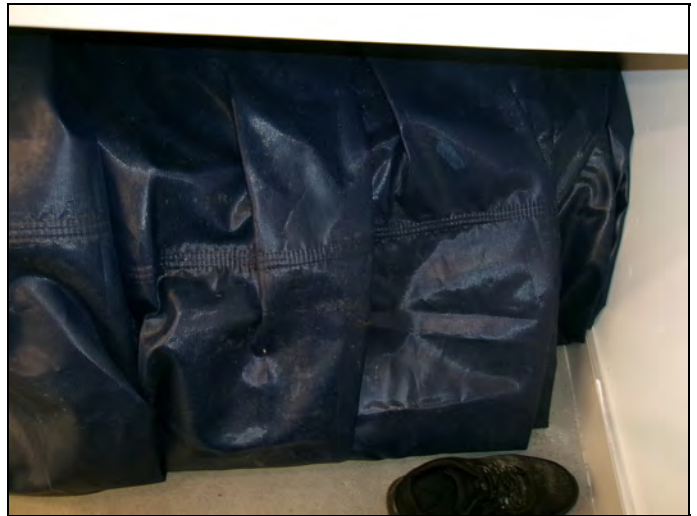
Comp #: 1112 Pool Cover - Replace

Location: **Pool Area**

The pool cover appears to be in good condition. We recommend funding to replace this component approximately every 10 years. Remaining life based on current age.

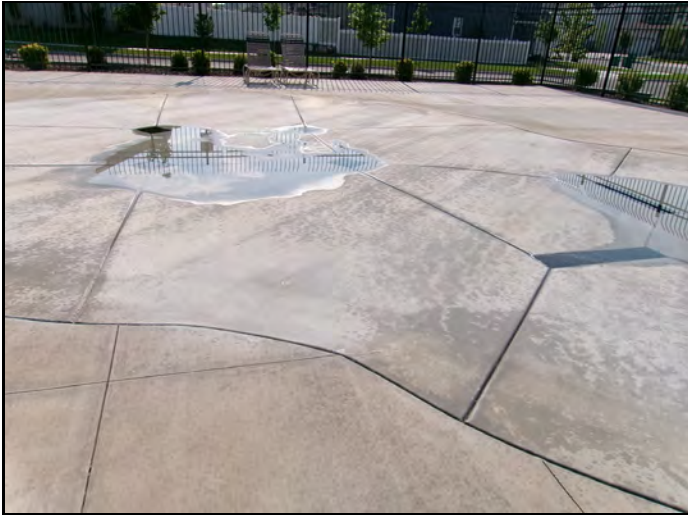
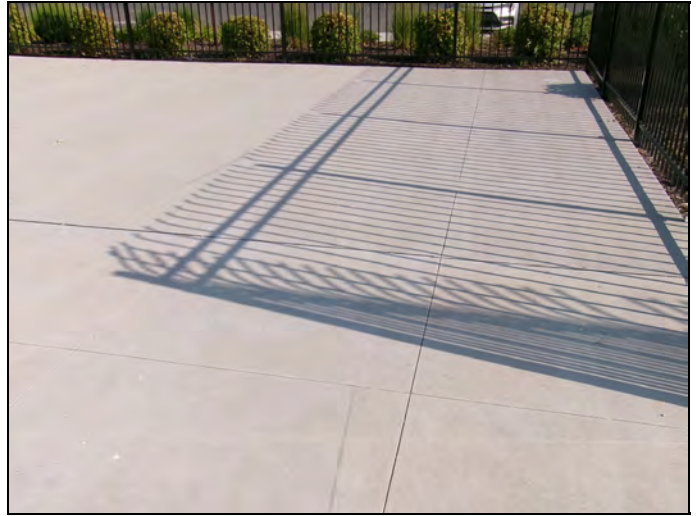
Comp #: 1116 Pool & Splash Pad Deck - Replace

Location: **Pool Area**

The pool and splash pad deck is in good condition. We recommend funding to replace this component approximately every 40 - 50 years. Remaining life based on current age.

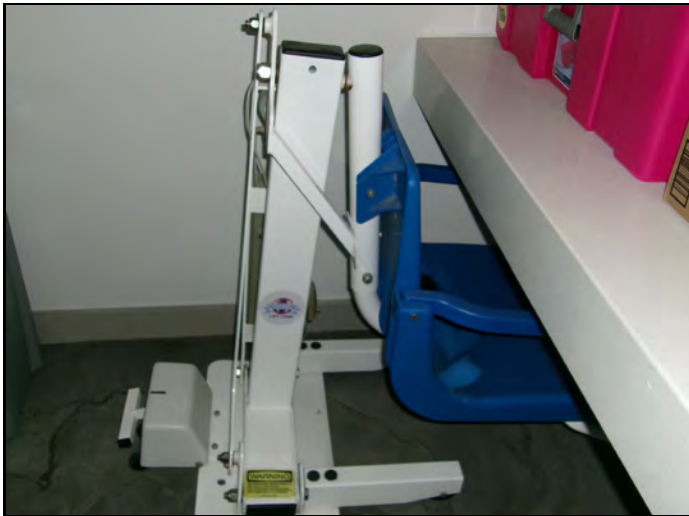
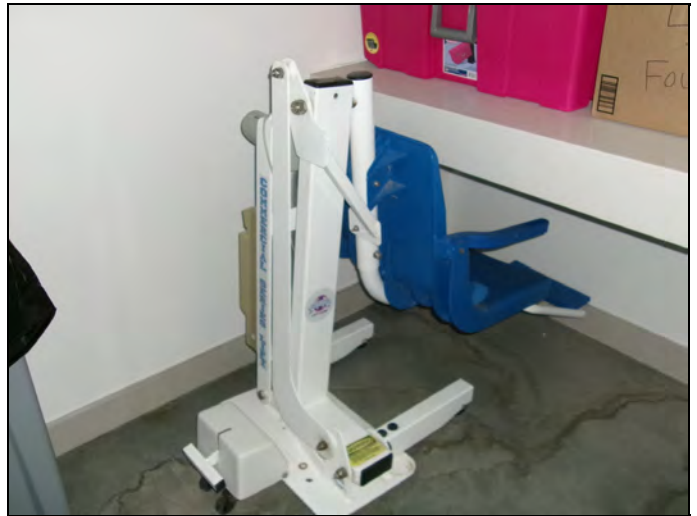
Comp #: 1120 Pool ADA Lift - Replace

Location: **Pool Area**

The pool lift appears to be in working condition. We recommend funding to replace this component approximately every 10 - 12 years. Remaining life based on current age.

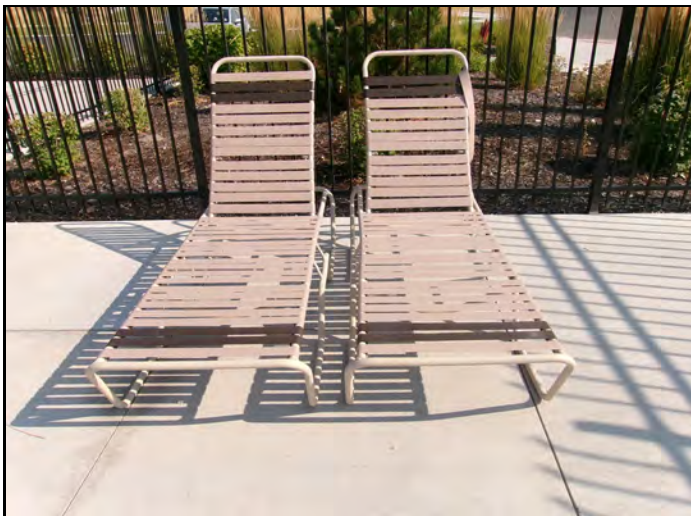
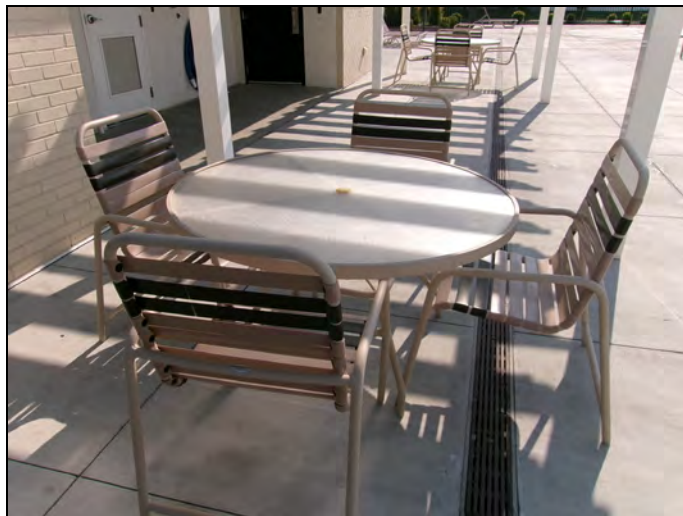
Comp #: 1121 Pool Furniture - Replace

Location: **Pool Area**

The pool furniture is in good condition. We recommend funding an allowance to make replacements to this component approximately every 6 years. Remaining life based on current age.

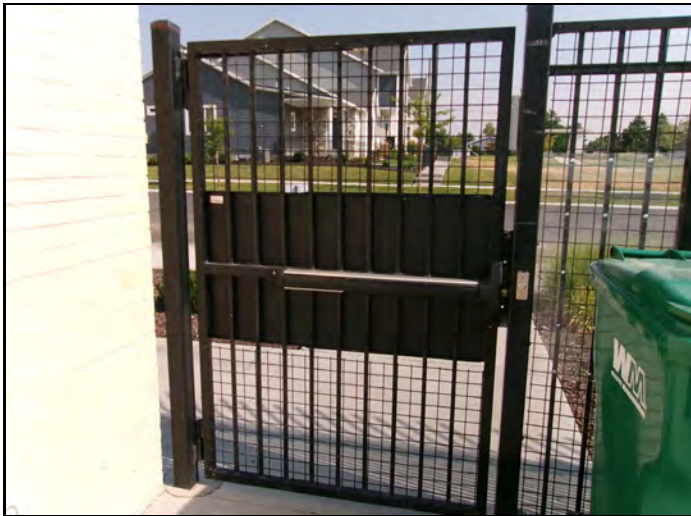
Comp #: 1190 Pool Gate - Replace

Location: **Pool Area**

The pool gates are in good condition. We recommend funding to completely replace this component approximately every 25 - 30 years. Remaining life based on current age.

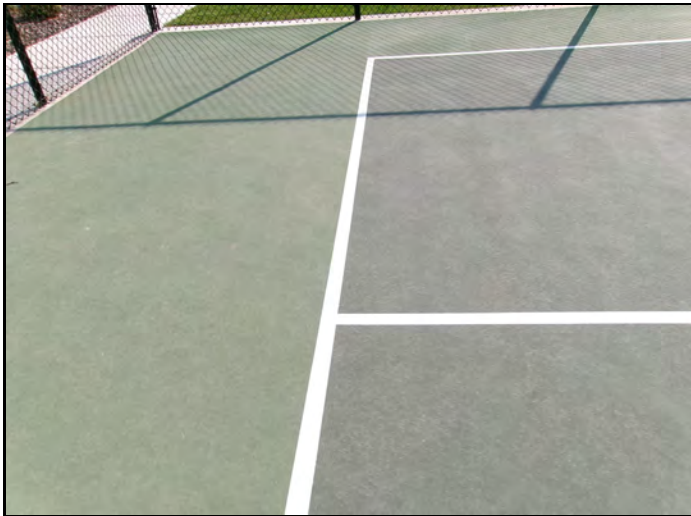
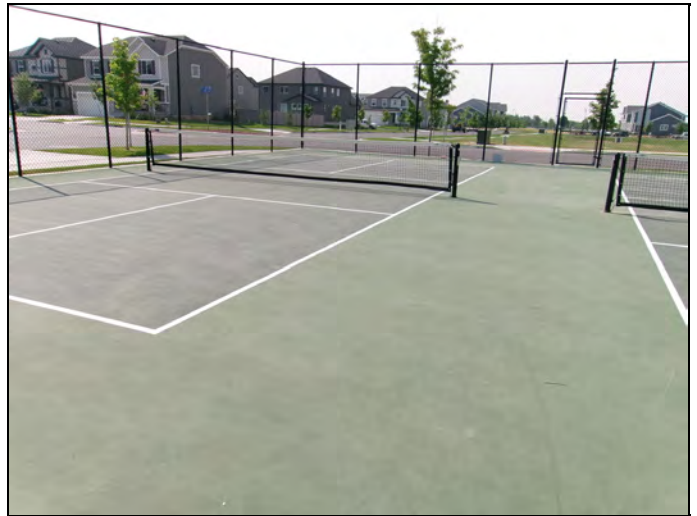
Comp #: 1201 Pickleball Courts - Resurface

Location: **Common Area**

The tennis court surface is in good condition. We recommend funding to resurface this component approximately every 8 - 10 years. Remaining life based on current age.

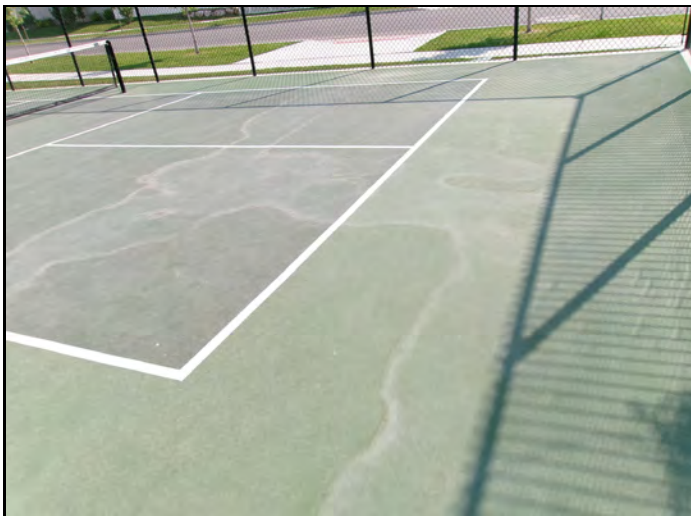
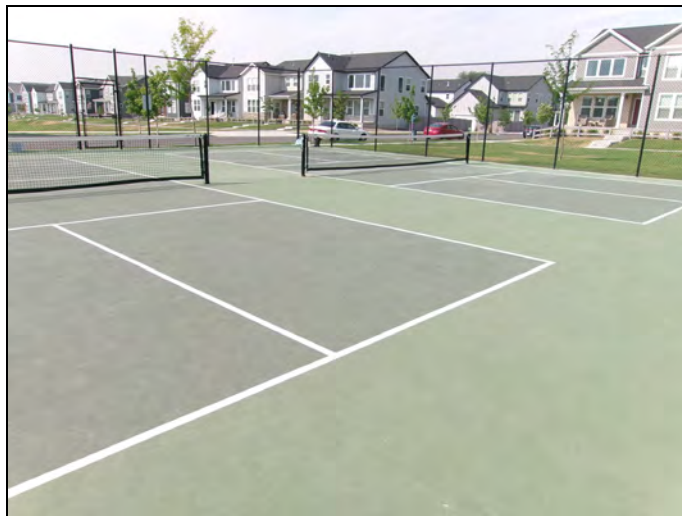
Comp #: 1203 Pickleball Courts - Replace

Location: **Common Area**

The tennis court is in good condition. We recommend funding to replace this component approximately every 40 - 50 years. Remaining life based on current age.

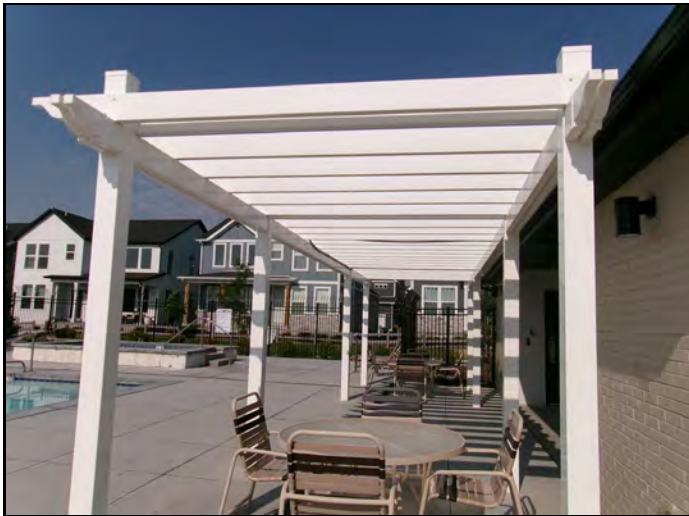
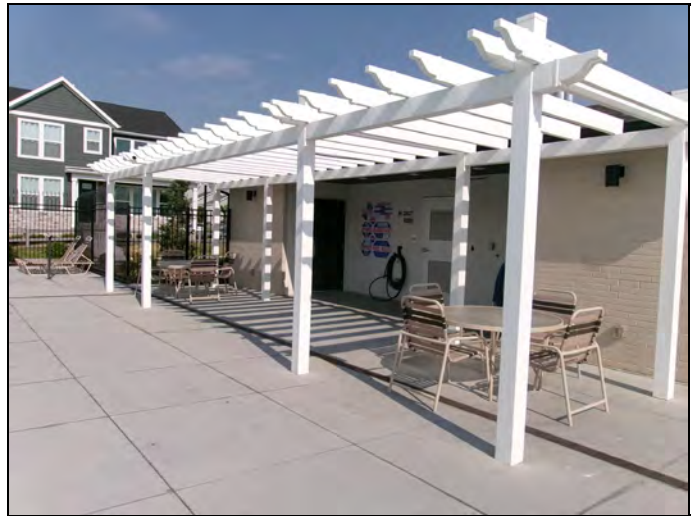
Comp #: 1309 Pergola - Replace

Location: **Pool Area**

The pergola is in good condition. We recommend funding to replace this component approximately every 25 - 30 years. Remaining life based on current age.

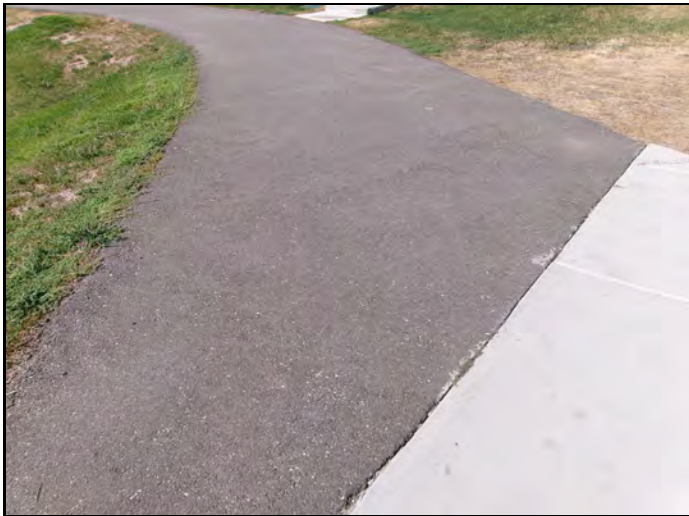
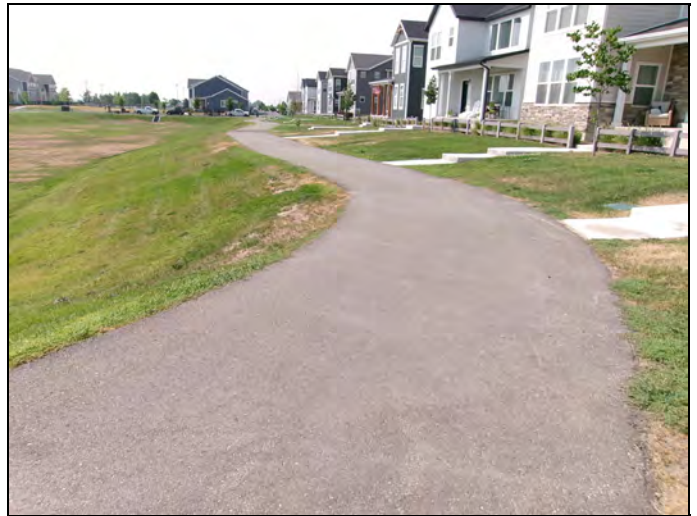
Comp #: 1312 Asphalt Trail - Repair/Seal

Location: **Common Area**

The asphalt trail repair/seal is in poor condition. We recommend funding to repair/seal this component approximately every 6 years. Remaining life based on current condition.

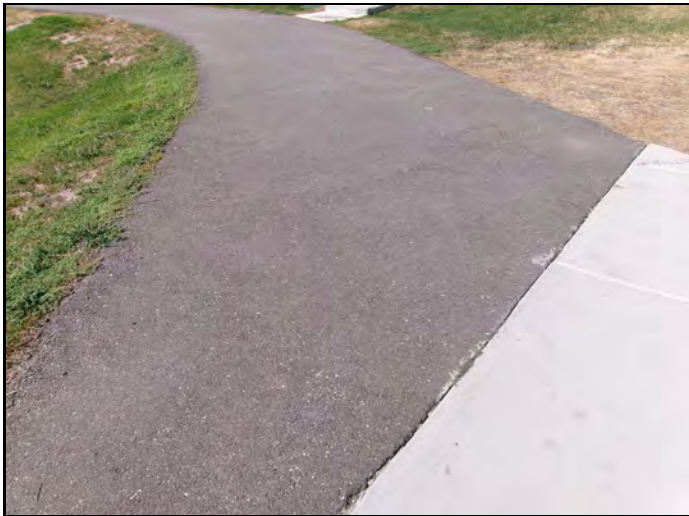
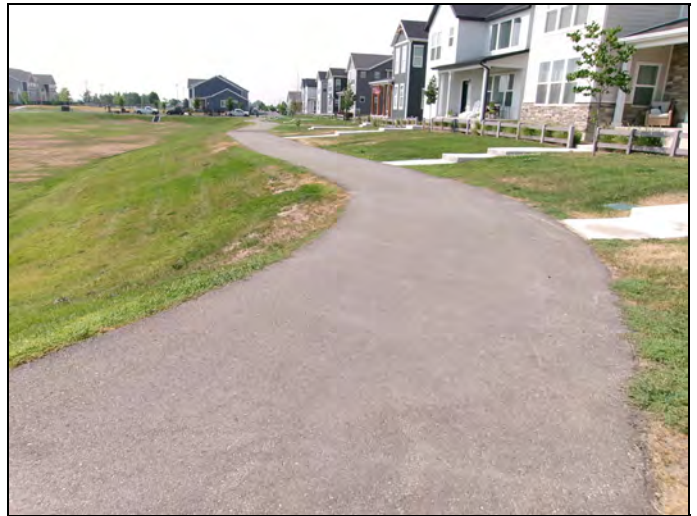
Comp #: 1390 Asphalt Trail - Replace

Location: **Common Area**

The asphalt trail is generally in good condition. We recommend funding to replace this component approximately every 25 - 30 years. Remaining life based on current age.

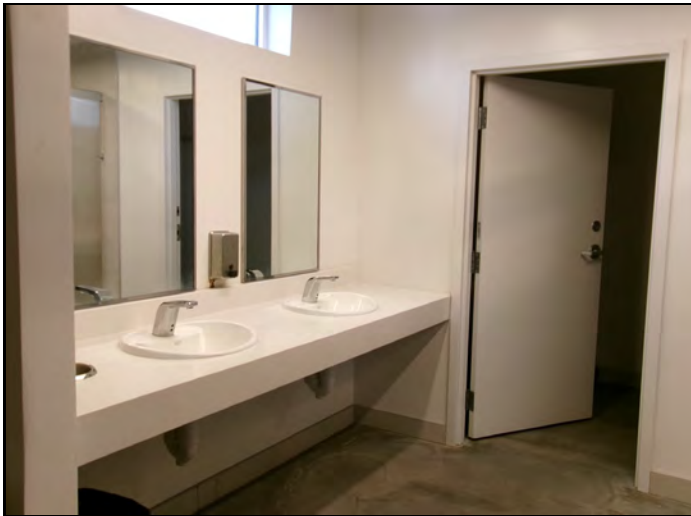
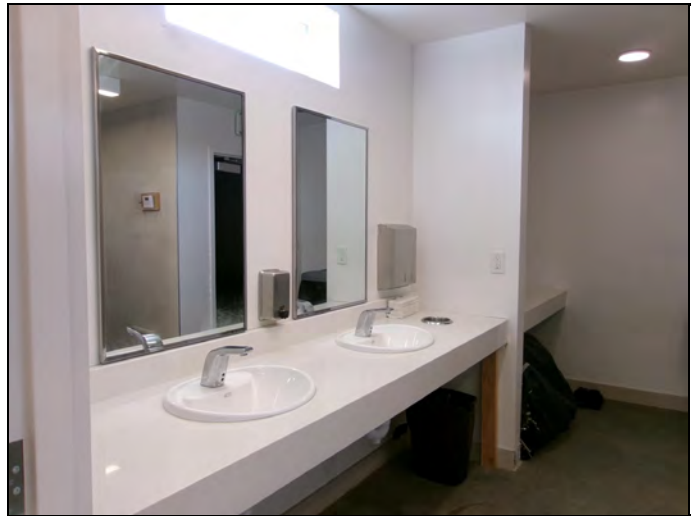
Comp #: 1413 Restrooms - Remodel

Location: **Pool Building**

The restrooms are in good condition. We recommend funding to remodel this component approximately every 20 years. Remaining life based on current age.

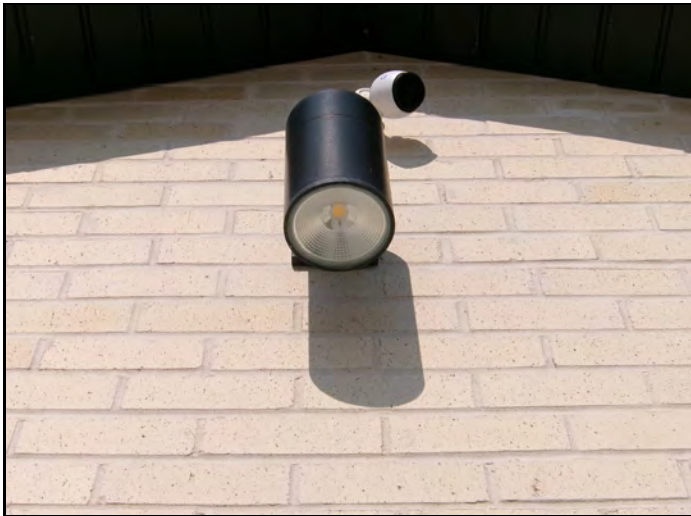
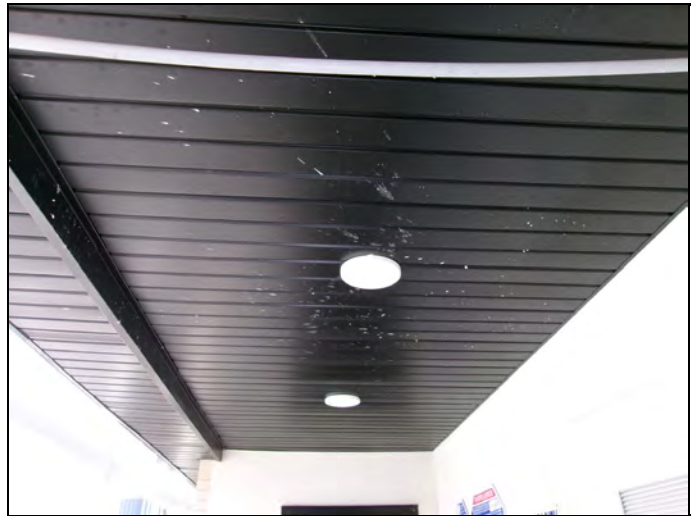
Comp #: 1602 Exterior Light Fixtures - Replace

Location: **Pool House**

Due to the minimal cost of replacing this component, reserve funding is not appropriate. Replace as necessary as an operating expense.

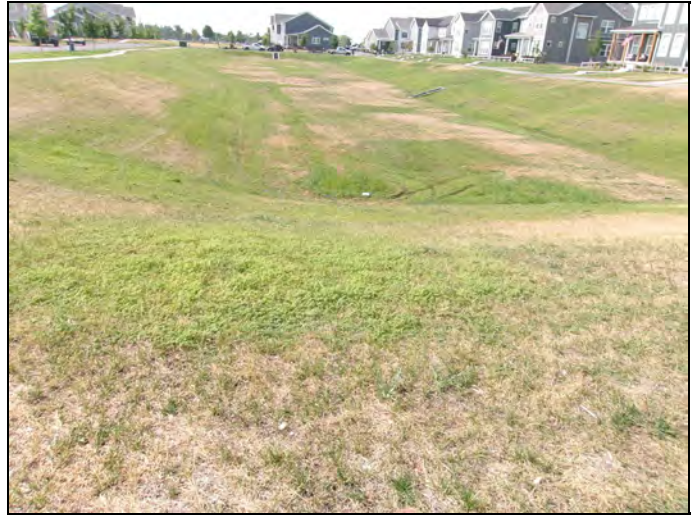
Comp #: 1812 Landscaping & Irrigation System - Renovate

Location: **Common Area**

The landscaping and irrigation system appear to be in good to fair condition. We recommend funding for an allowance to renovate this component approximately every 20 years. Remaining life based on current age.

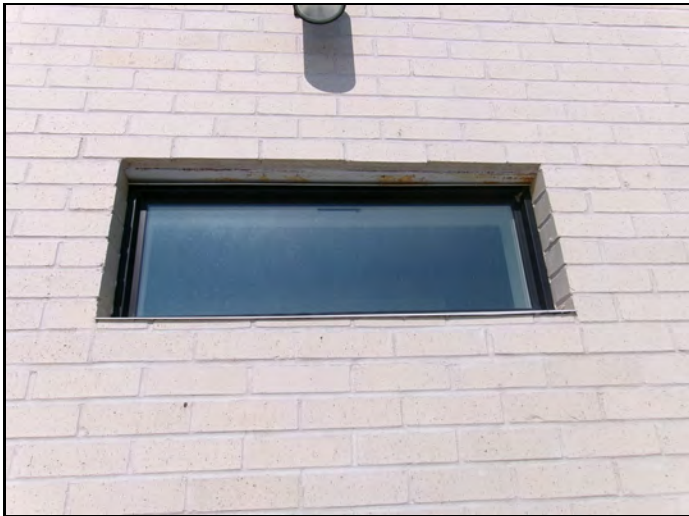
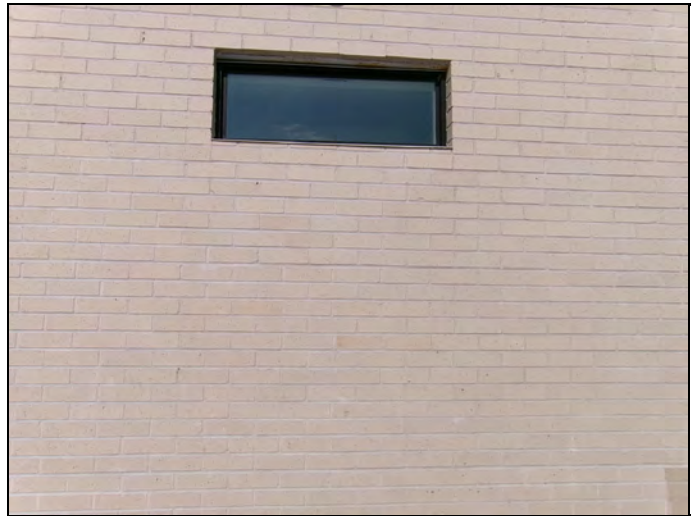
Comp #: 2303 Windows - Replace

Location: **Pool Building**

Due to the minimal cost of replacing this component, reserve funding is not appropriate. Replace as necessary as an operating expense.

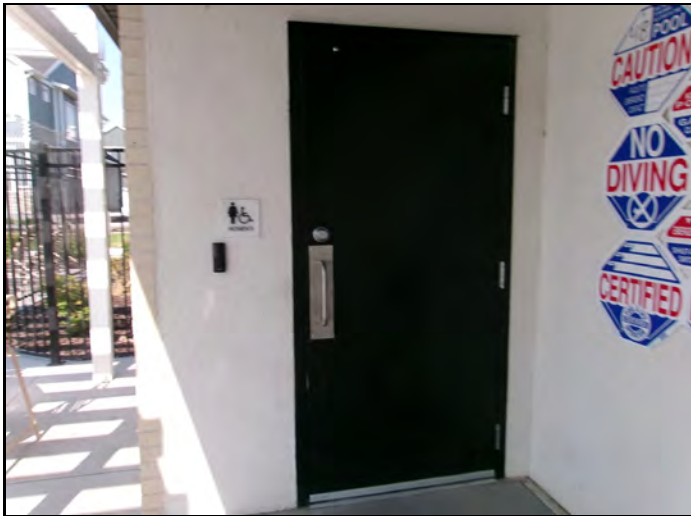
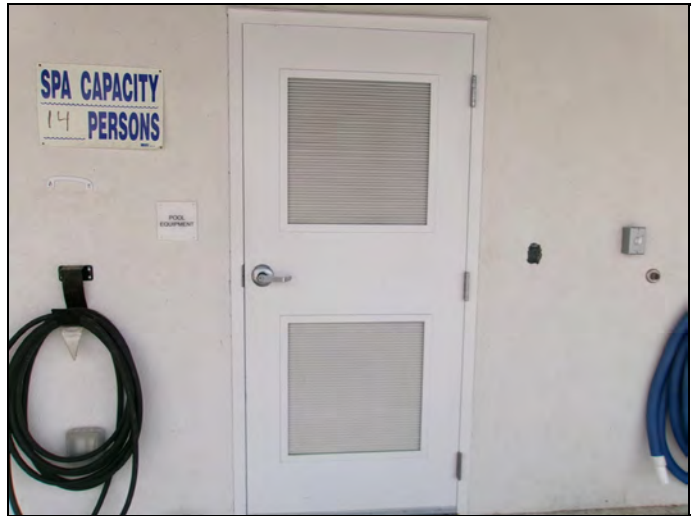
Comp #: 2304 Exterior Doors - Replace

Location: Pool Building

The doors are in good condition. We recommend funding to replace this component approximately every 40 - 50 years. Remaining life based on current age.
