# Antelope Village

## Level 2 Reserve Study

| <b>Type of Study</b> | <b>Update w / Site Visit</b> |
| <b>Date of Property Inspection</b> | <b>9/5/2024</b> |

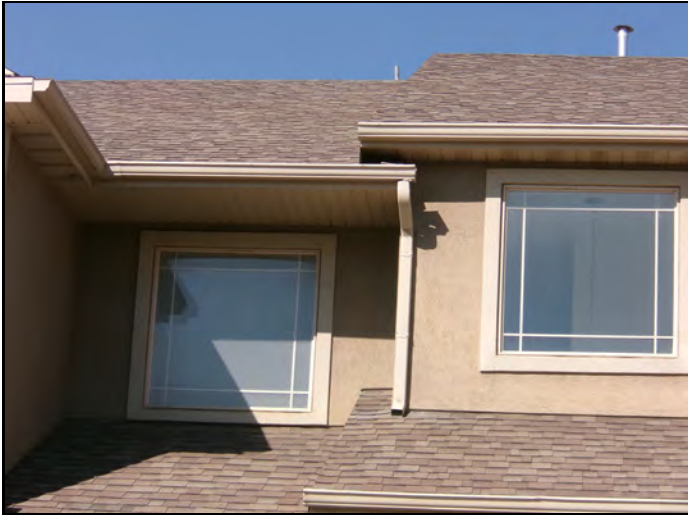
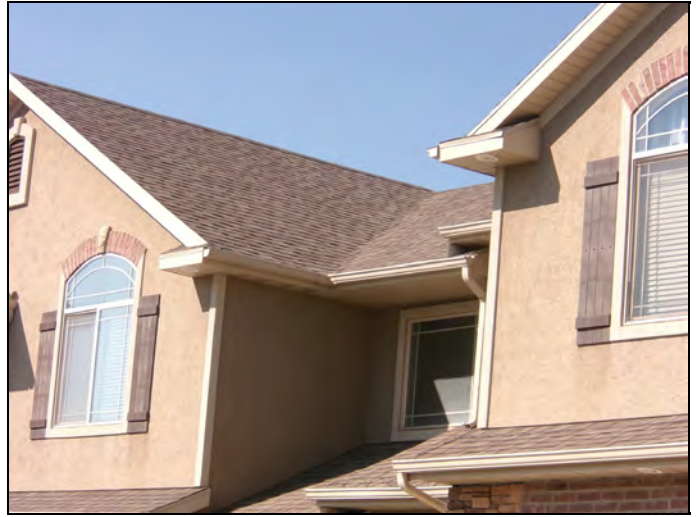
Comp #: 105    Roofs - Replace

The roofs appear to be in good to fair condition. We recommend funding to replace this component approximately every 20 - 25 years. Remaining life based on current age.

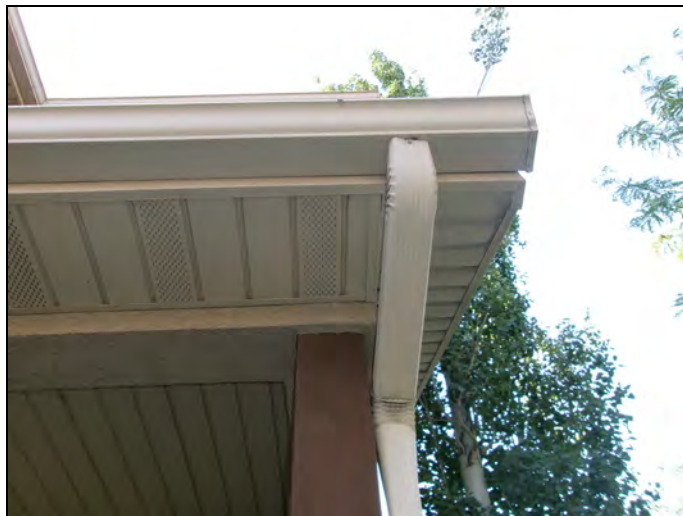
Comp #: 120 Rain Gutters/Downspouts - Replace

The rain gutters and downspouts appear to be in good to fair condition. We recommend funding to replace this component approximately every 25 - 30 years. Remaining life based on current age.

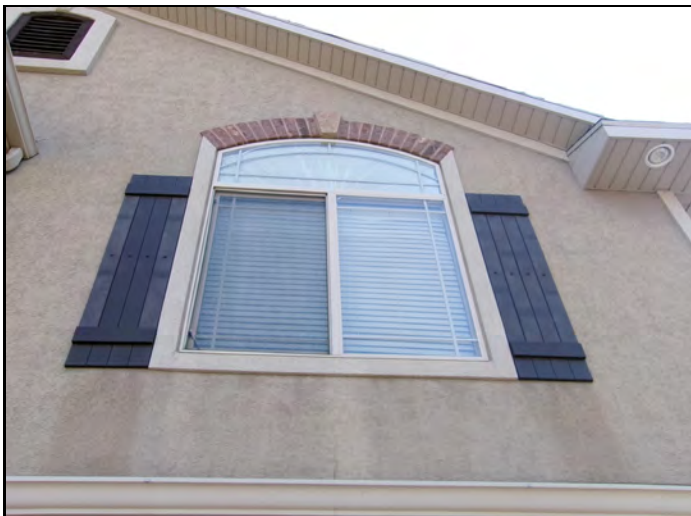
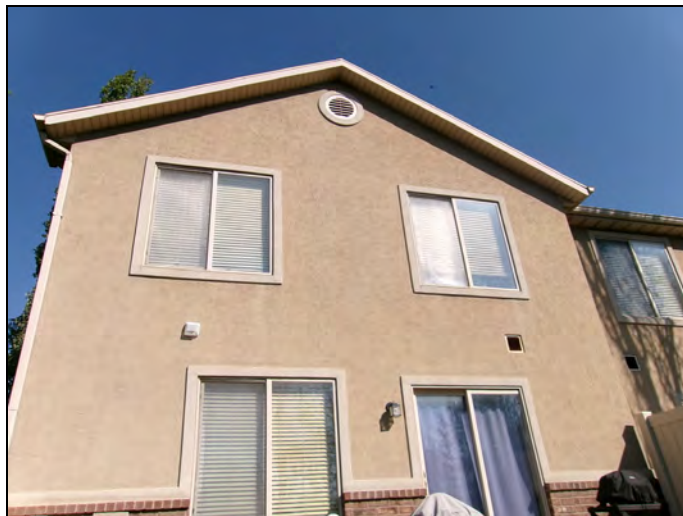
Comp #: 201 Stucco Surfaces - Repair/Repaint

The stucco surfaces appear to be in fair condition. We recommend funding to repair/repaint this component approximately every 12 - 15 years. Remaining life based on current age and condition.

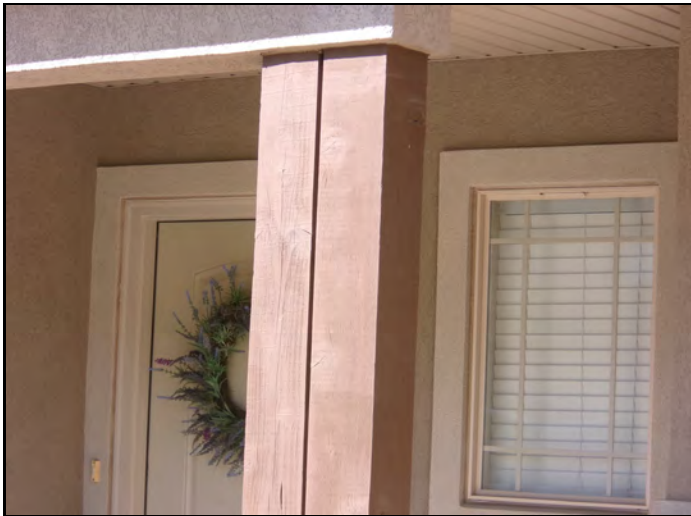
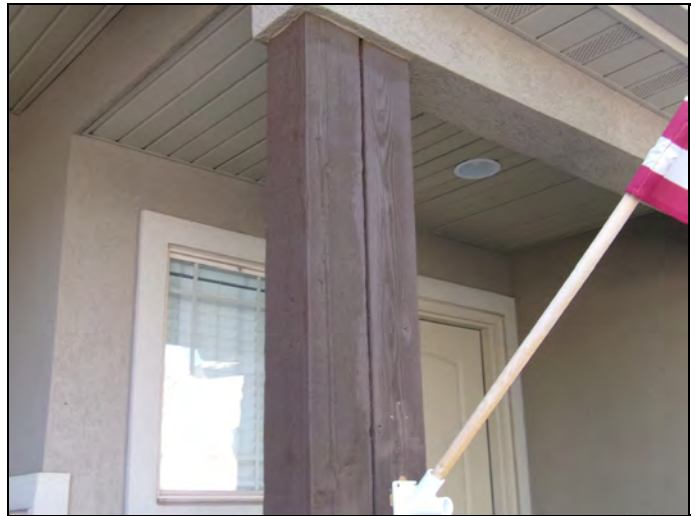
Comp #: 202    Porch Poles - Repaint

The painted wood surfaces are in good to fair condition. We recommend funding to repaint this component approximately every 4 - 6 years. Remaining life based on current condition.

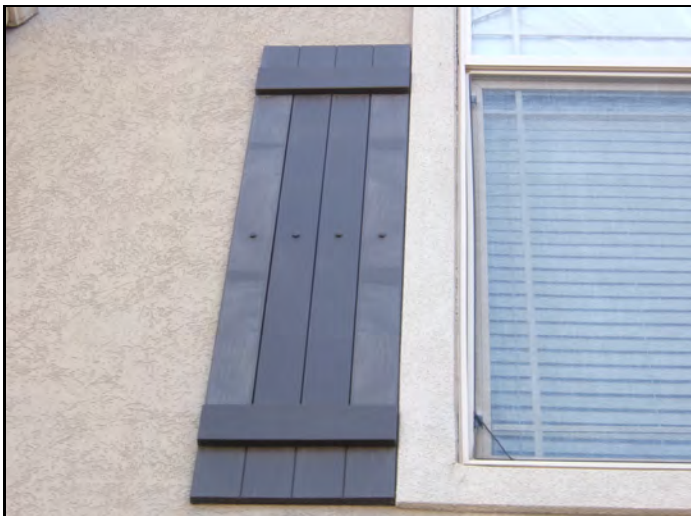
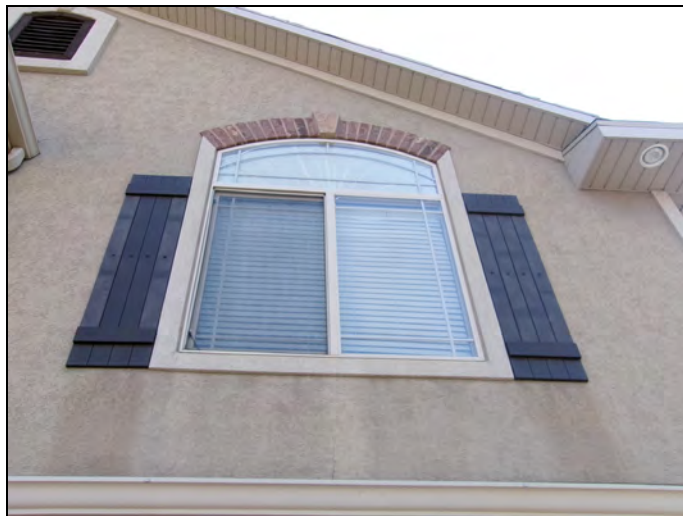
Comp #: 219 Faux Shutters - Repaint

The painted surfaces are in good to fair condition. We recommend funding to repaint this component approximately every 6 years. Remaining life based on current age.

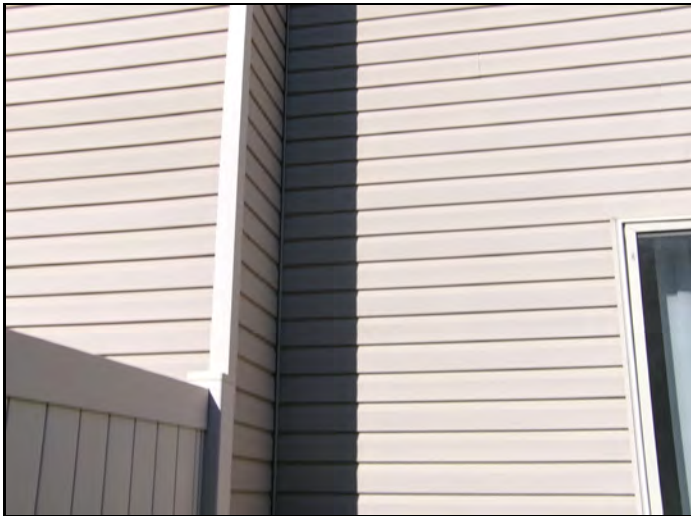
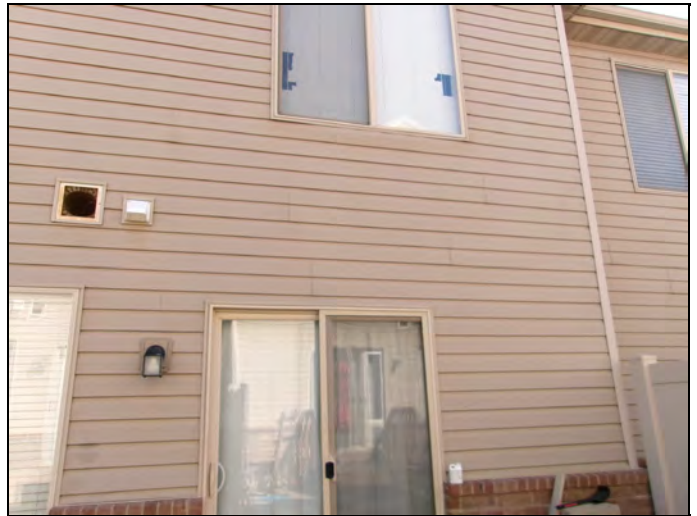
Comp #: 302 Vinyl Siding - Replace

The vinyl siding is in good condition. We recommend funding to replace this component approximately every 40 - 50 years. Remaining life based on current age.

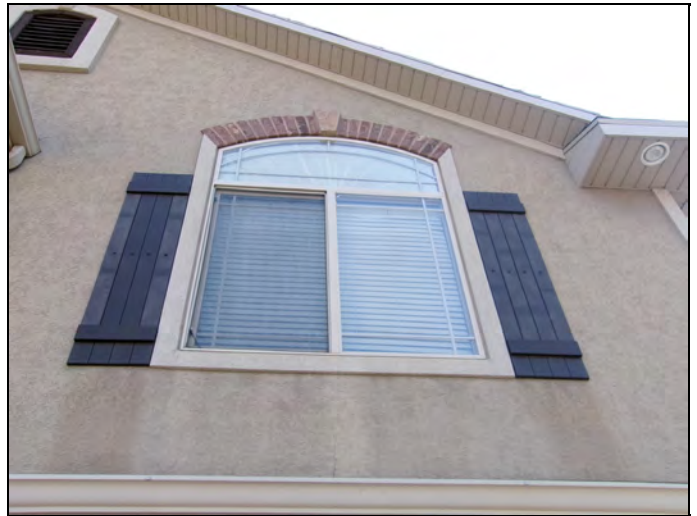
Comp #: 390 Faux Shutters - Replace

The faux shutters are in good condition. We recommend funding to replace this component approximately every 20 - 30 years. Remaining life based on current age.

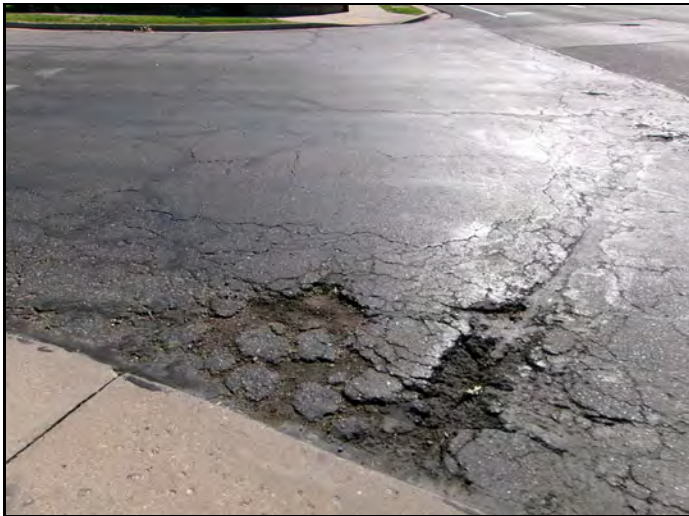
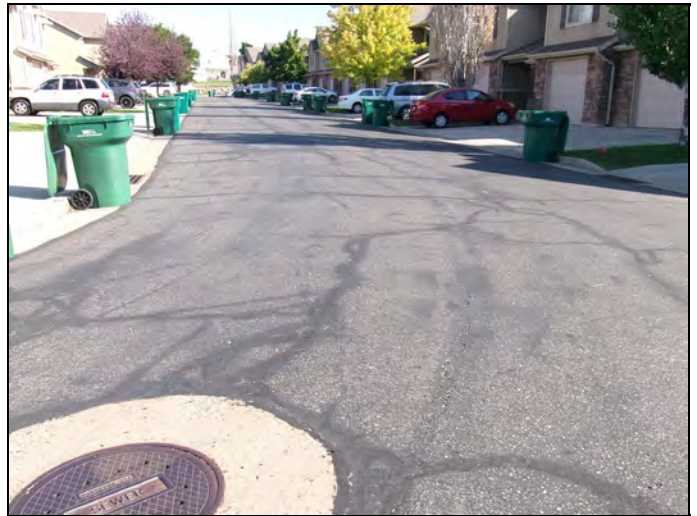
Comp #: 401 Asphalt - Major Rehab

The asphalt surfaces are generally in fair condition. We recommend funding for a major rehab of this component approximately every 25 - 30 years. Remaining life based on current age.

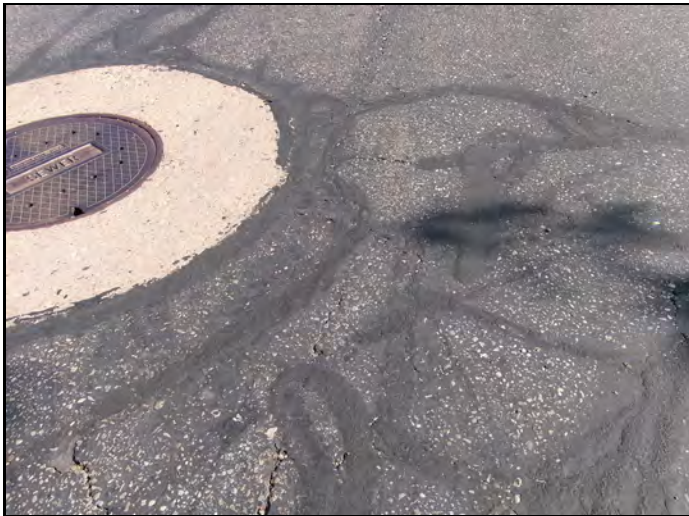
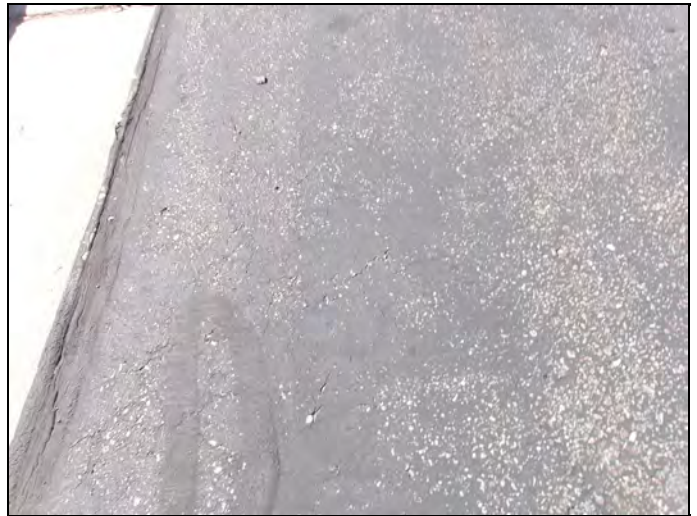
Comp #: 402 Asphalt - Seal Coat

The asphalt seal coat is in poor condition. We recommend funding to seal this component approximately every 3 - 5 years. Remaining life based on current condition.

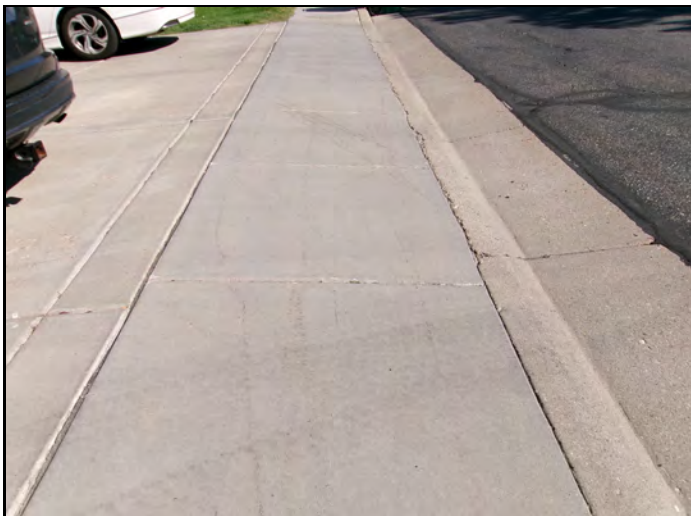
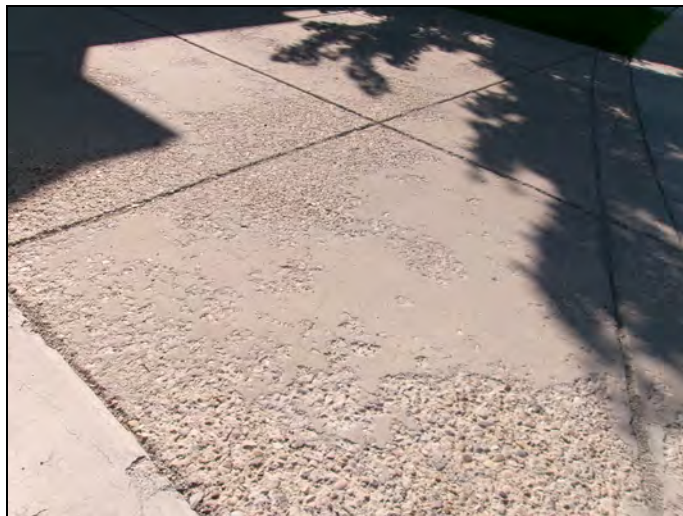
Comp #: 403 Concrete - Repair/Replace

The concrete is in good to fair condition. This component has an extended useful life under normal conditions. We recommend funding to make repairs and partially replace this component approximately every 10 years. Remaining life based on current age.

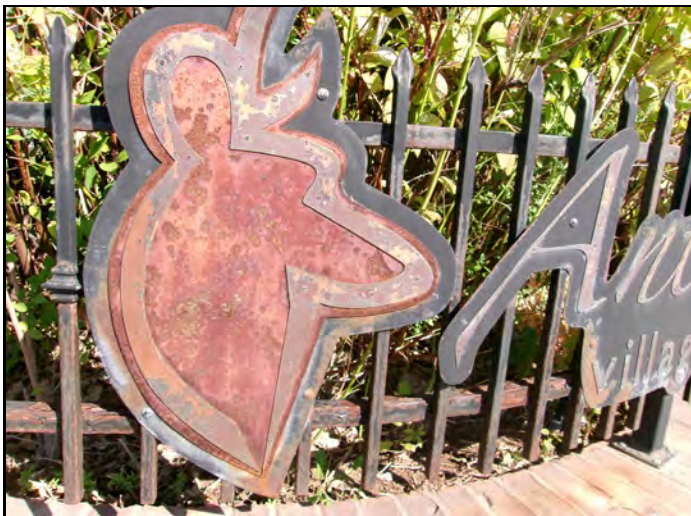
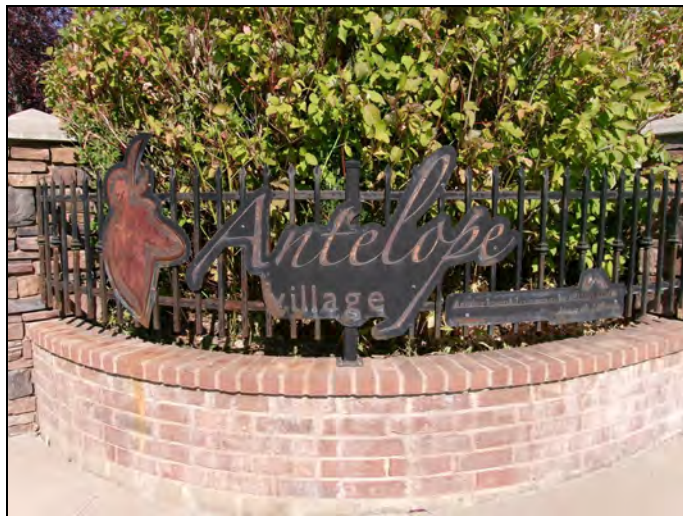
Comp #: 801 Community Signs - Replace

The community signs are in fair condition. We recommend funding to replace this component approximately every 15 - 20 years. Remaining life is based on current age and condition.

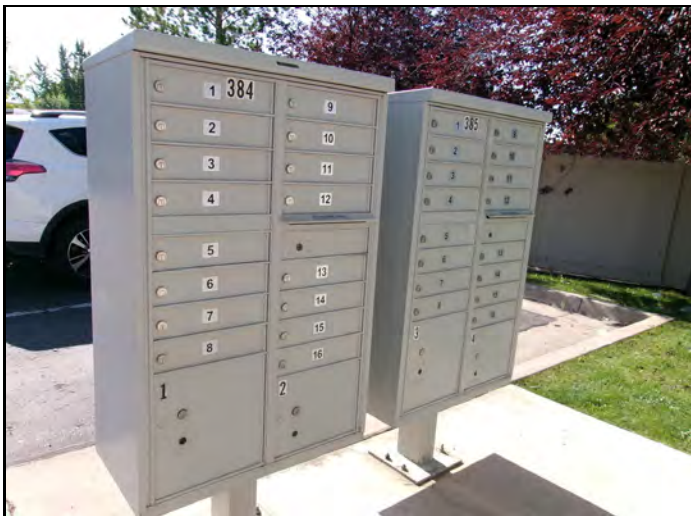
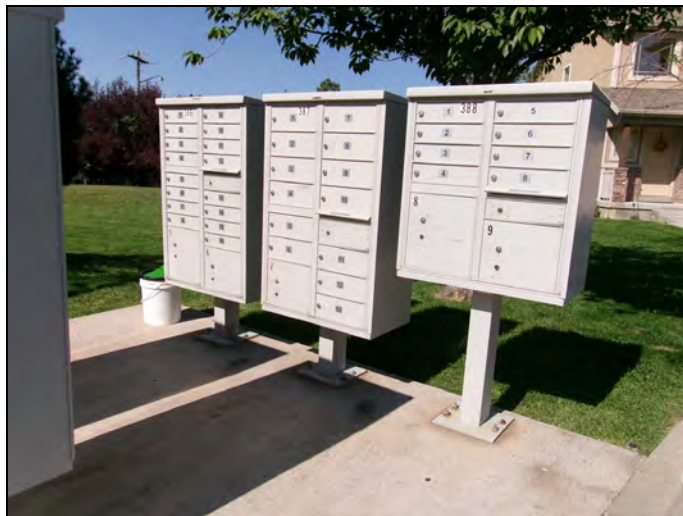
Comp #: 803 Mailboxes - Replace

The mailboxes are in good to fair condition. We recommend funding to replace this component approximately every 20 - 25 years. Remaining life based on current age.

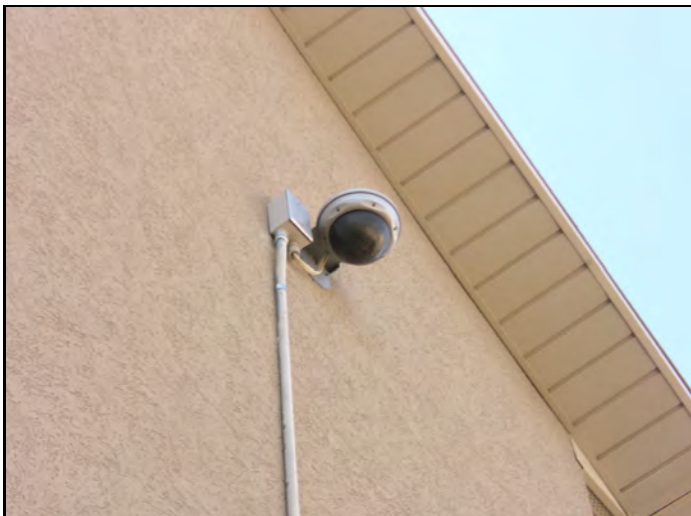
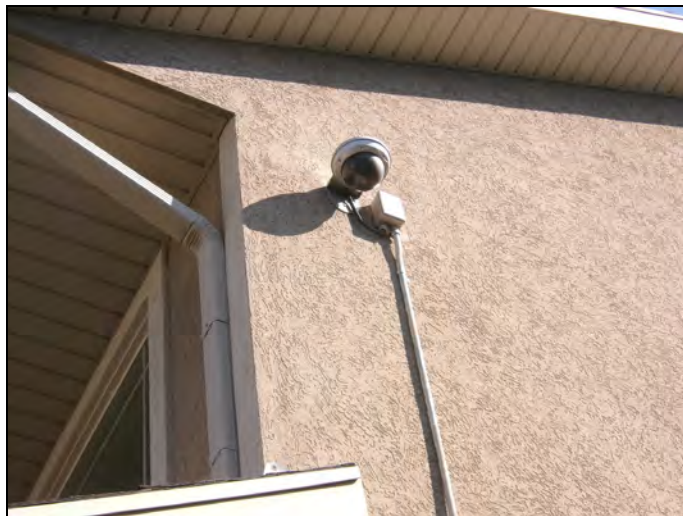
Comp #: 903 Security Camera System - Replace

The security camera system is in working condition. We recommend funding to replace this component approximately every 10 - 12 years. Remaining life based on current age.

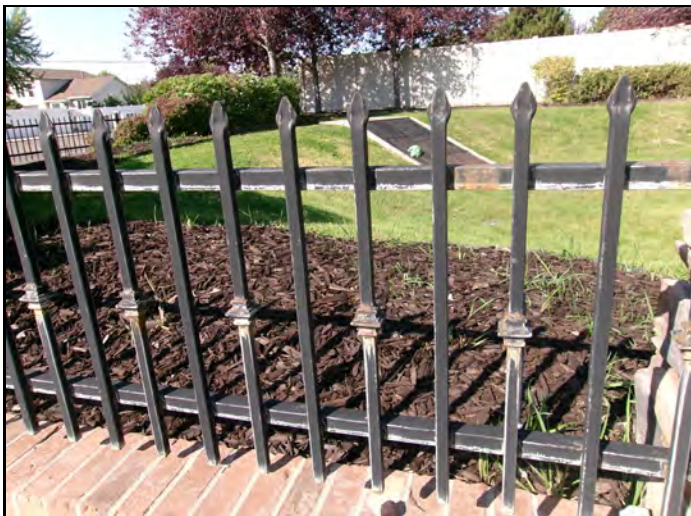
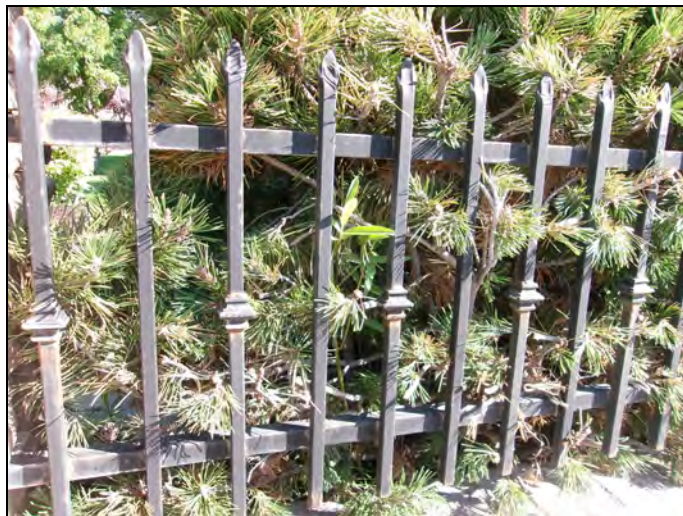
Comp #: 1002 Metal Fencing - Replace

The metal fencing is in good to fair condition. We recommend funding to replace this component approximately every 40 - 50 years. Remaining life based on current age.

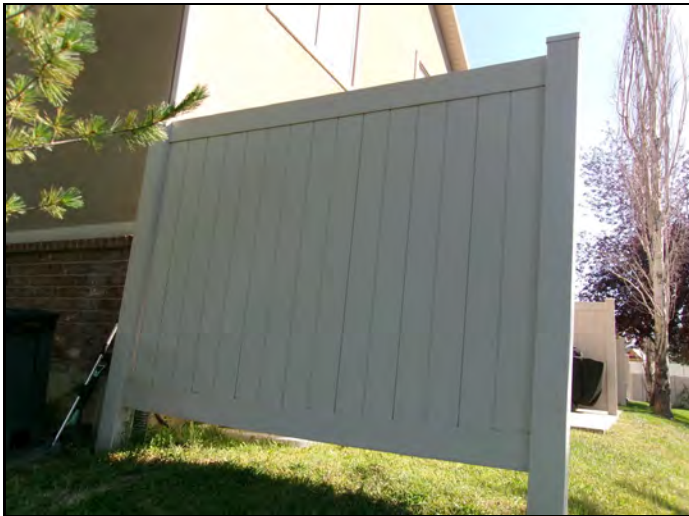
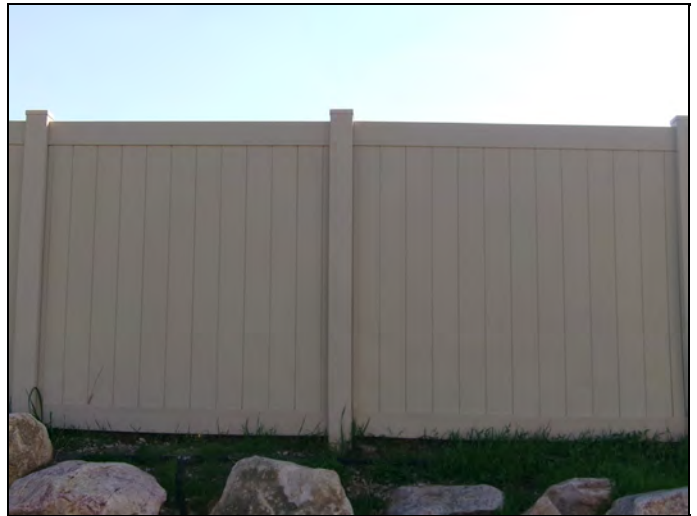
Comp #: 1008 Vinyl Fencing & Railing - Replace

The vinyl fencing and railing is in good to fair condition. We recommend funding to replace this component approximately every 25 - 30 years. Remaining life based on current age.

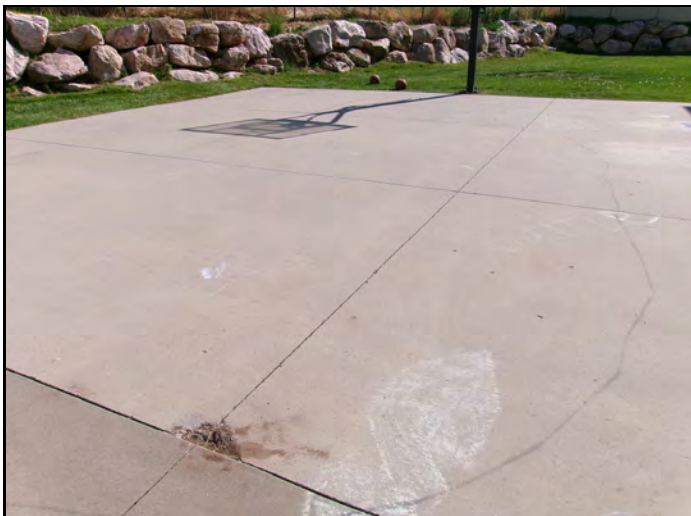
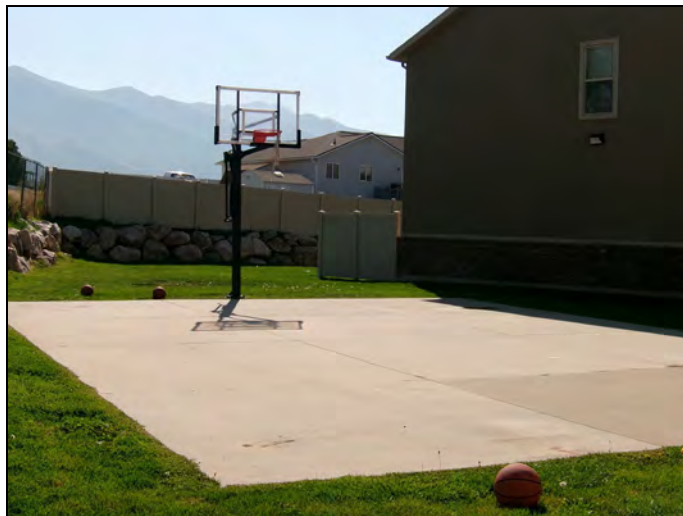
Comp #: 1206 Basketball Court - Replace

The basketball court is in good to fair condition. We recommend funding to replace this component approximately every 40 - 50 years. Remaining life based on current age.

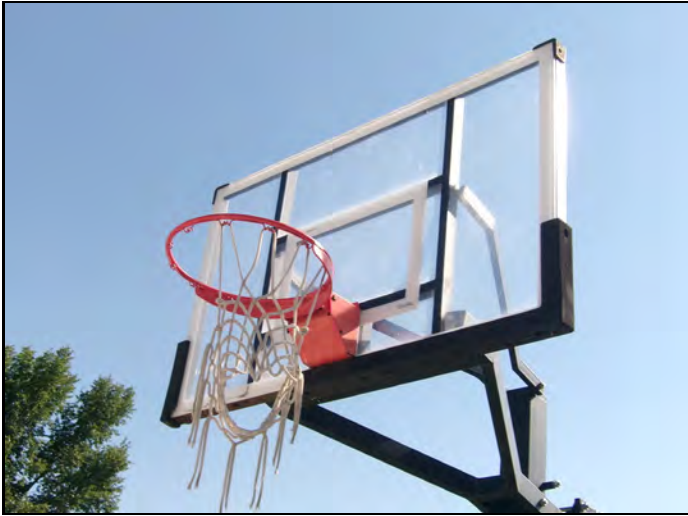
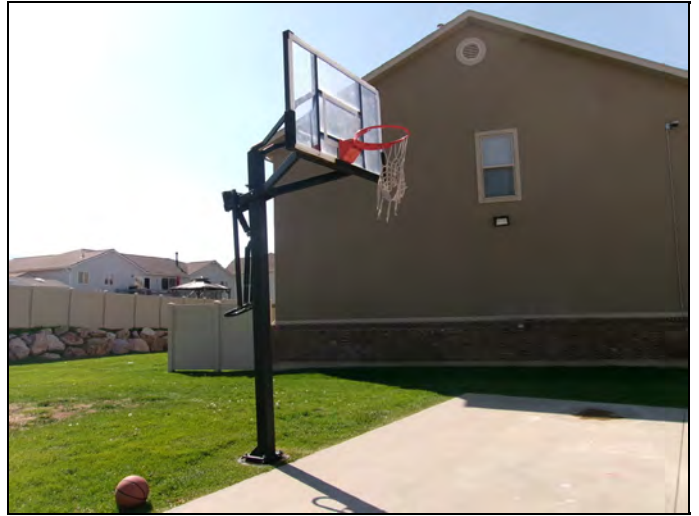
Comp #: 1207 Basketball Equipment - Replace

The basketball equipment is in fair condition. We recommend funding to replace this component approximately every 10 - 15 years. Remaining life is based on current age.

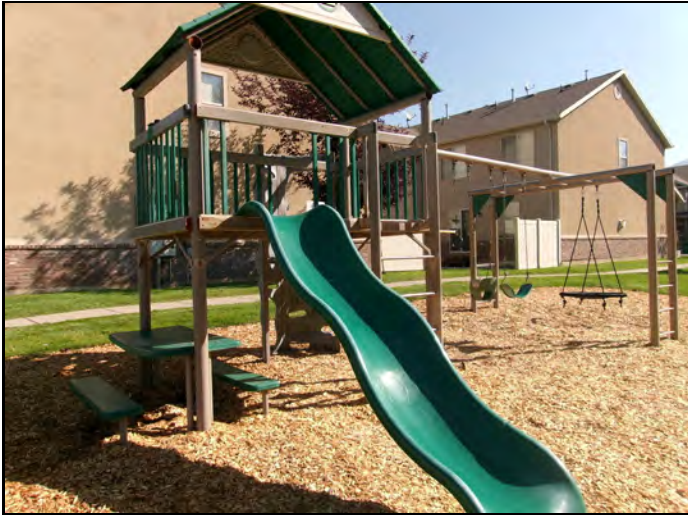
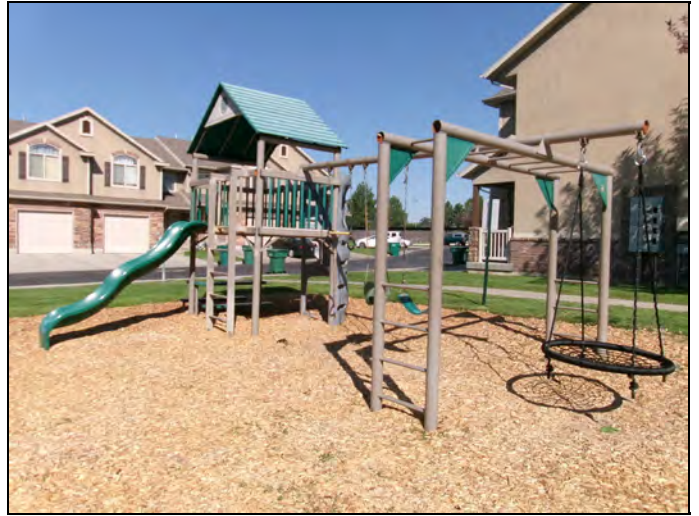
Comp #: 1301 Play Structure - Replace

The play structure is in fair condition. We recommend funding to replace this component approximately every 15 - 20 years. Remaining life based on current age.

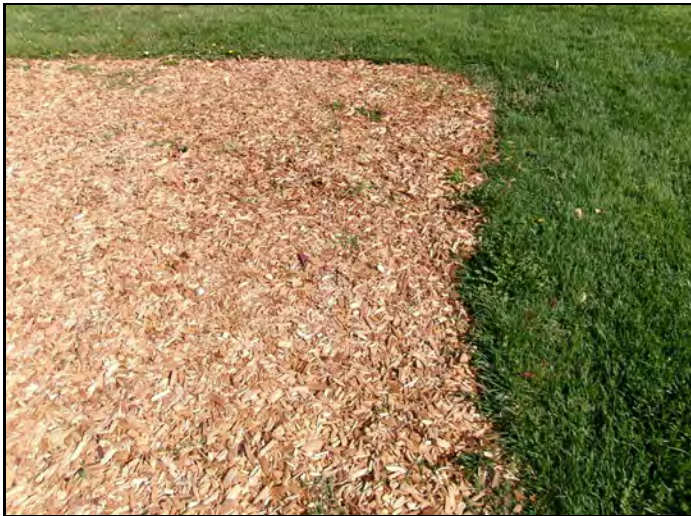
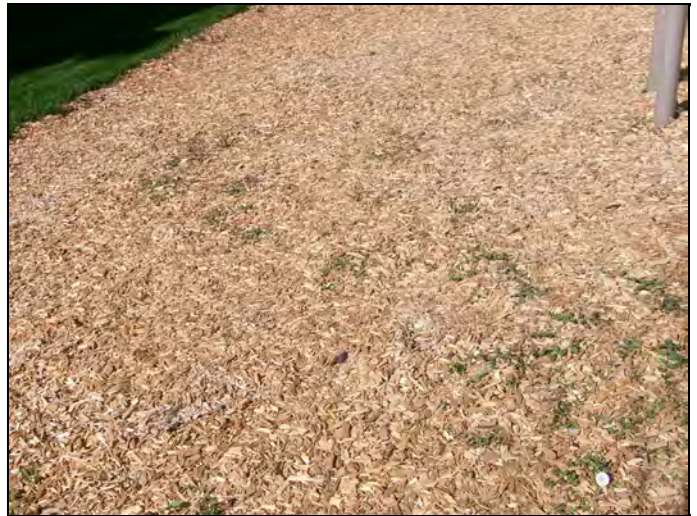
Comp #: 1303 Play Area Groundcover - Refill

The play area groundcover is in good condition. We recommend funding to refill this component approximately every 3 - 5 years. Remaining life is based on current age.

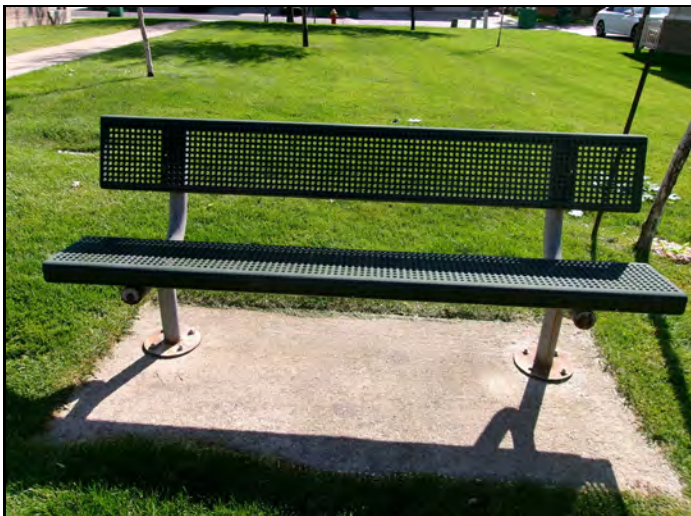
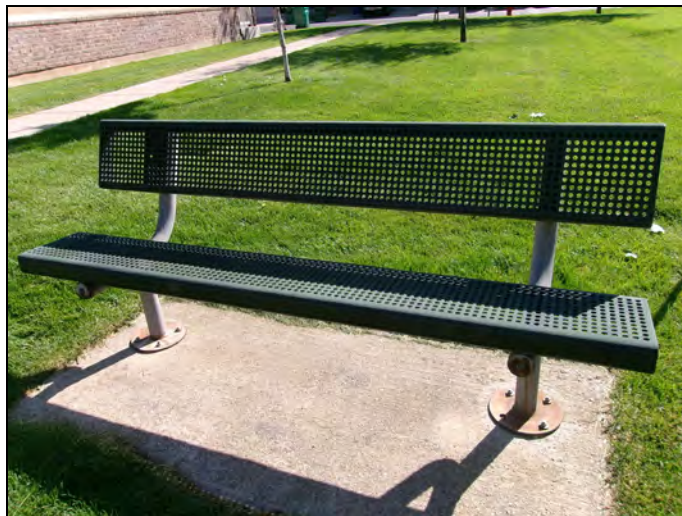
Comp #: 1307 Bench - Replace

Due to the minimal cost of replacing this component, reserve funding is not appropriate. Replace as necessary as an operating expense.

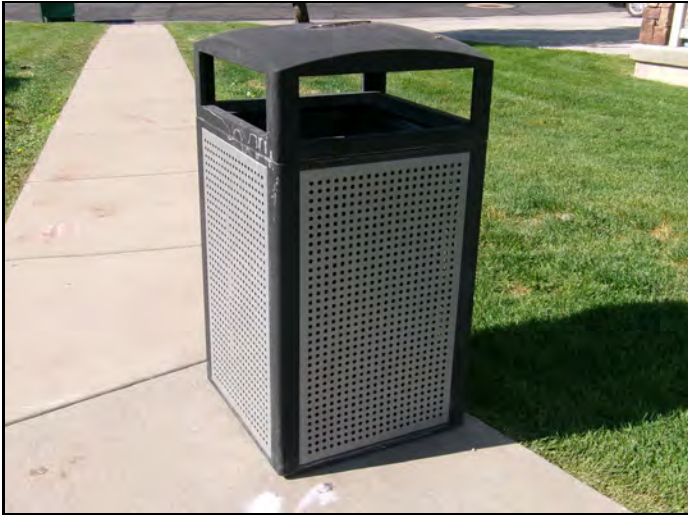
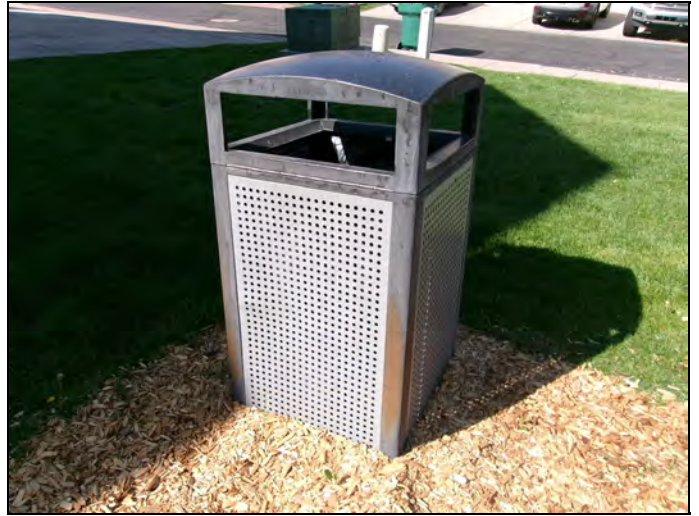
Comp #: 1308 Trash Receptacles - Replace

Due to the minimal cost of replacing this component, reserve funding is not appropriate. Replace as necessary as an operating expense.

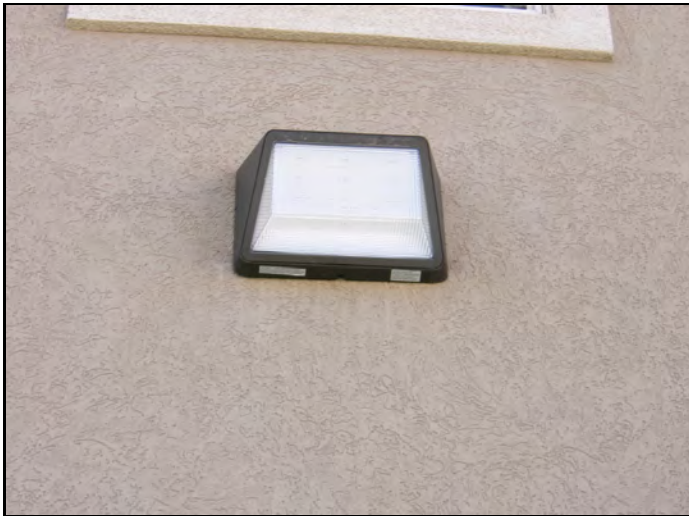
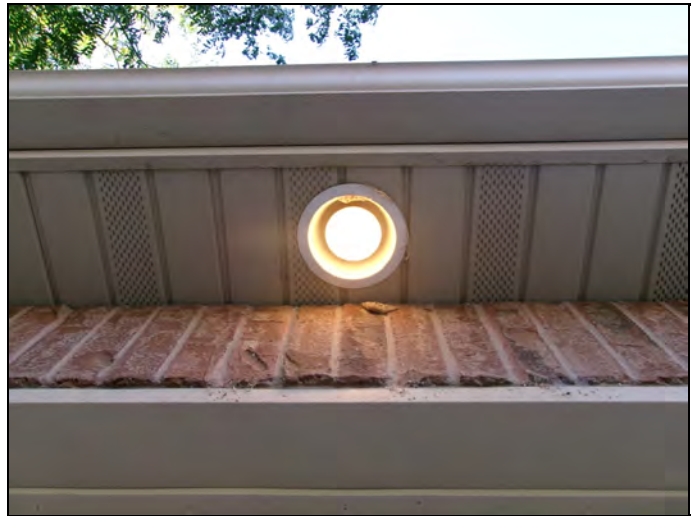
## Comp #: 1602 Exterior Light Fixtures - Replace

The exterior light fixtures are in good to fair condition. We recommend funding to replace this component approximately every 16 - 20 years. Remaining life based on current age and condition.

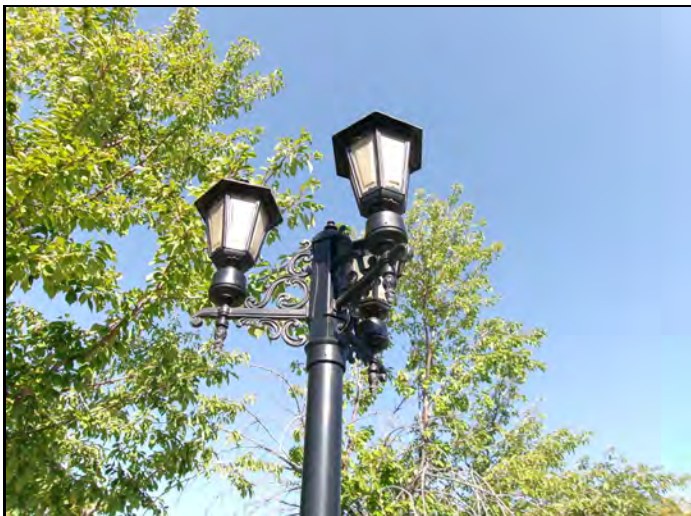
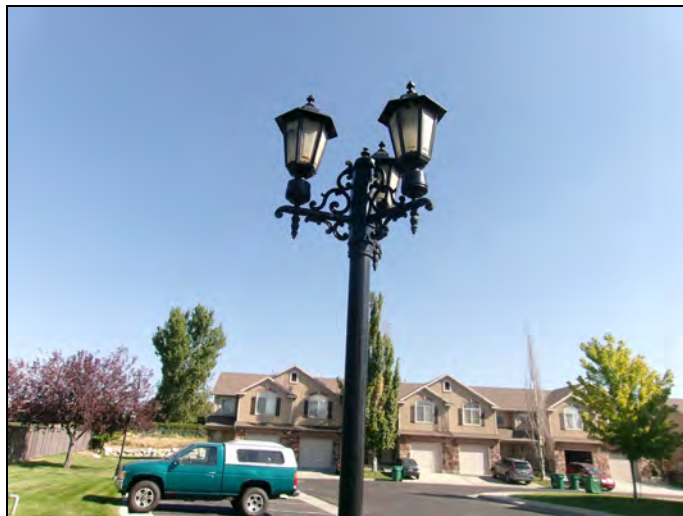
## Comp #: 1604 Pole Lights - Replace

The pole lights are in fair condition. We recommend funding to replace these pole light fixtures, poles and to refurbish the electrical approximately every 16 - 20 years. Remaining life based on current age and condition.

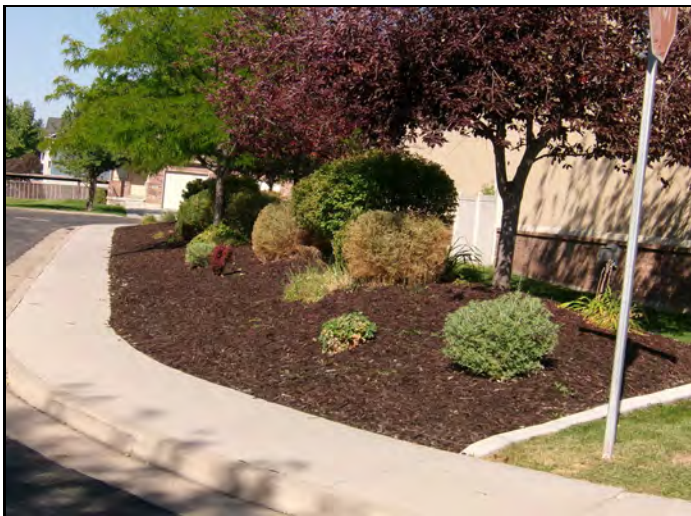
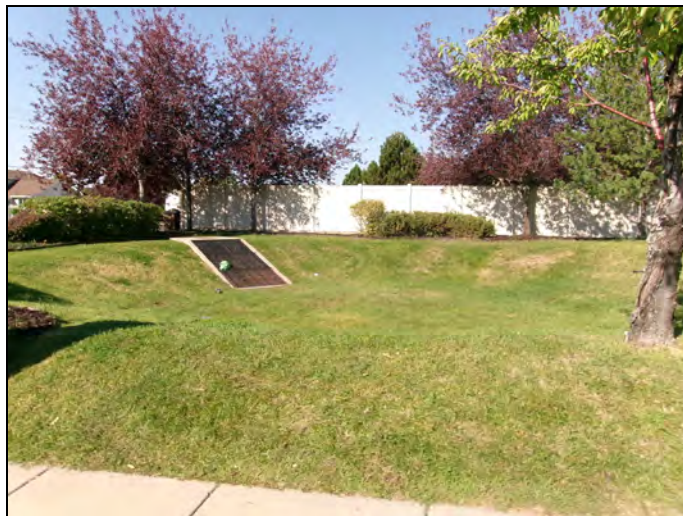
Comp #: 1812 Landscaping & Irrigation System - Renovate

The landscaping and irrigation system appear to be in good to fair condition. We recommend funding for an allowance to renovate this component approximately every 20 years. Remaining life based on current age and condition.
