# Greyhawk HOA

## Level 2 Reserve Study

**Report Period – 01/01/2026 – 12/31/2026**

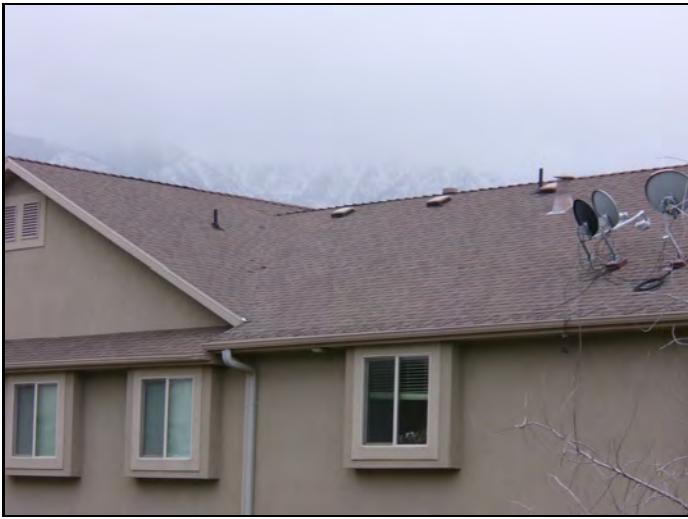
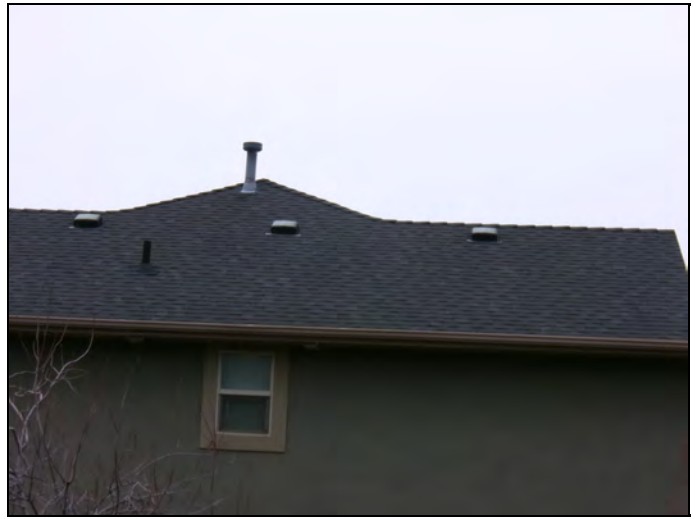
Comp #: 105    Roofs - 2009-11 - Replace

The roofs appear to be in fair condition. We recommend funding to replace this component approximately every 20 - 25 years. Remaining life based on current age.

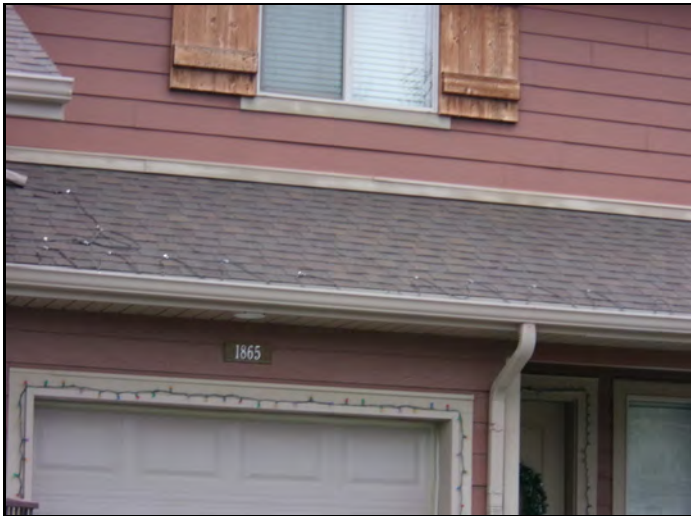
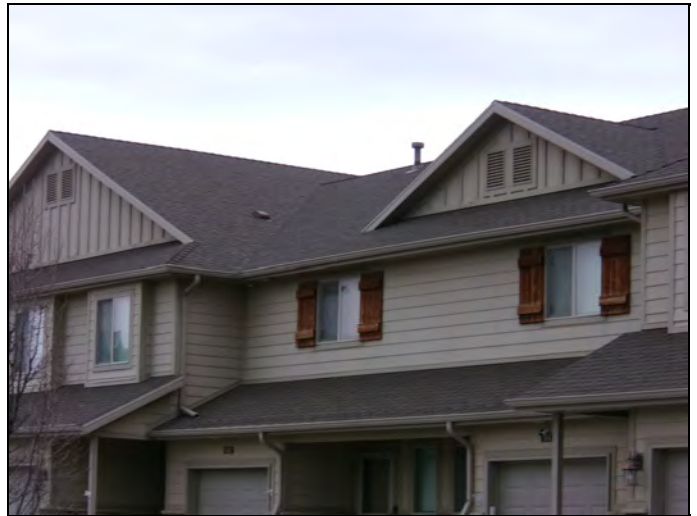
Comp #: 105    Roofs - 2012-14 - Replace

The roofs appear to be in good to fair condition. We recommend funding to replace this component approximately every 20 - 25 years. Remaining life based on current age.

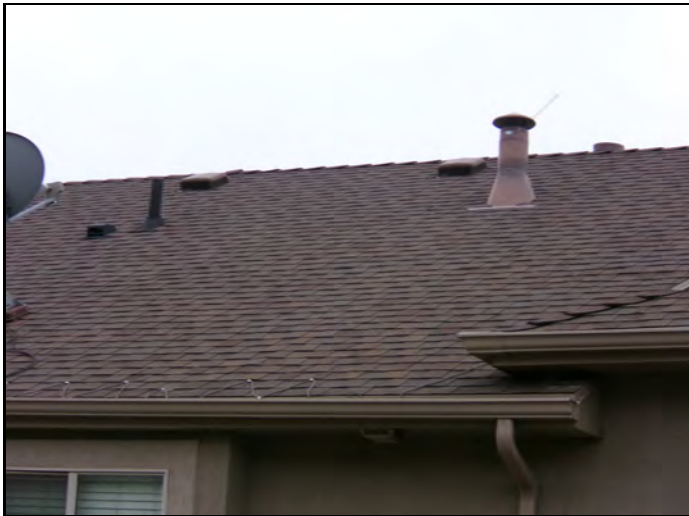
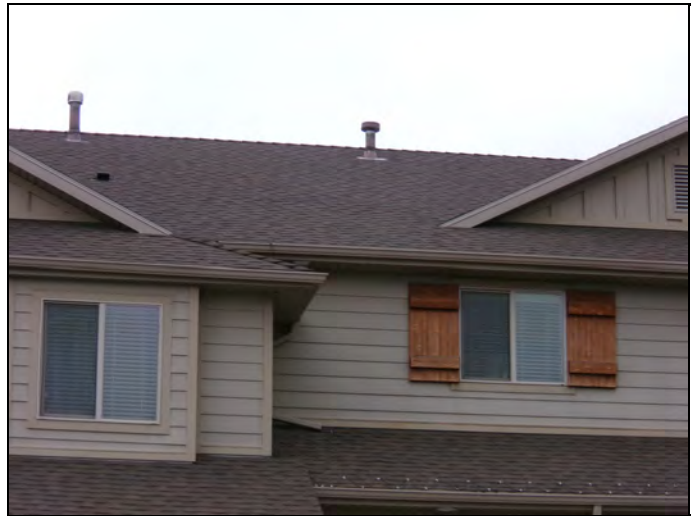
Comp #: 105    Roofs - 2015-17 - Replace

The roofs appear to be in good condition. We recommend funding to replace this component approximately every 20 - 25 years. Remaining life based on current age.

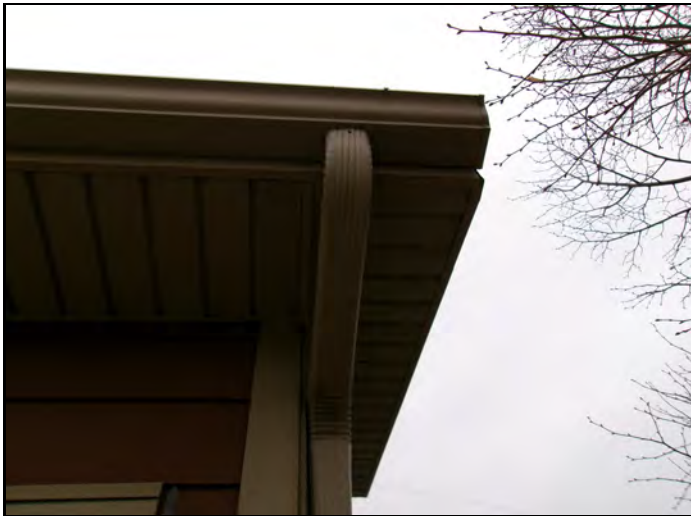
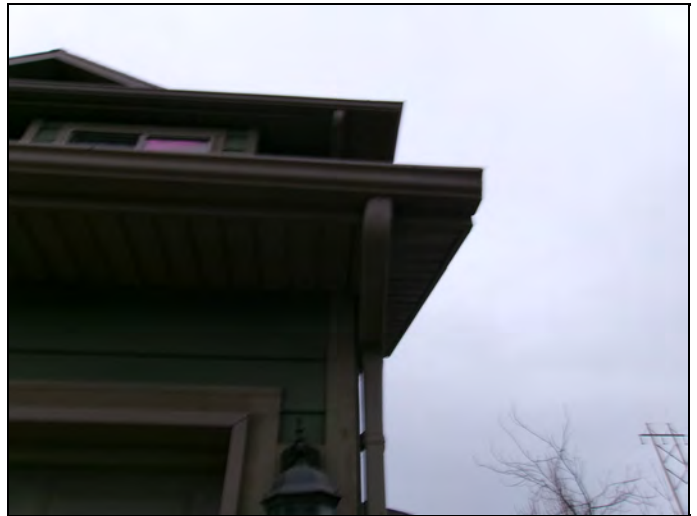
Comp #: 120 Rain Gutters/Downspouts - 2009-11 - Replace

The rain gutters and downspouts appear to be in fair condition. We recommend funding to replace this component approximately every 25 - 30 years. Remaining life based on current age.

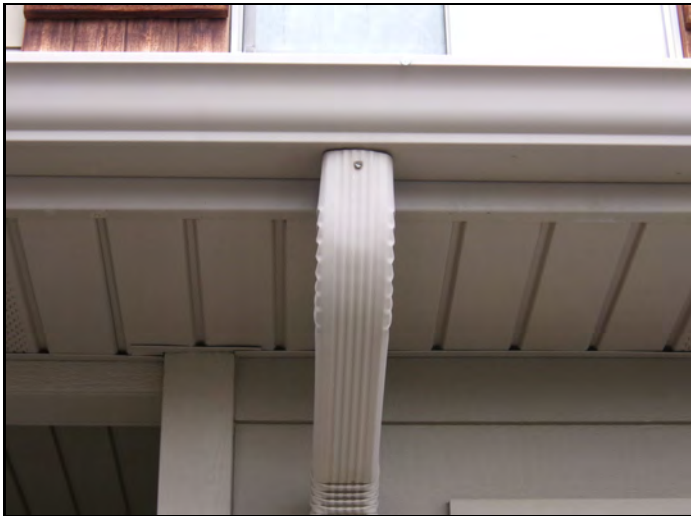
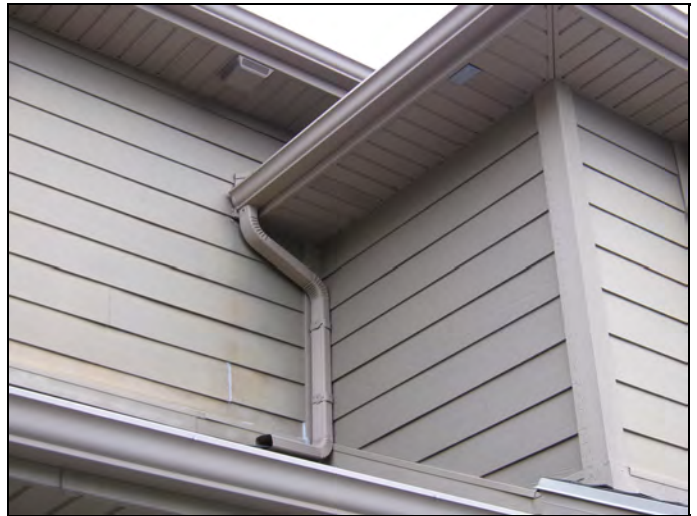
Comp #: 120 Rain Gutters/Downspouts - 2012-14 - Replace

The rain gutters and downspouts appear to be in good to fair condition. We recommend funding to replace this component approximately every 25 - 30 years. Remaining life based on current age.

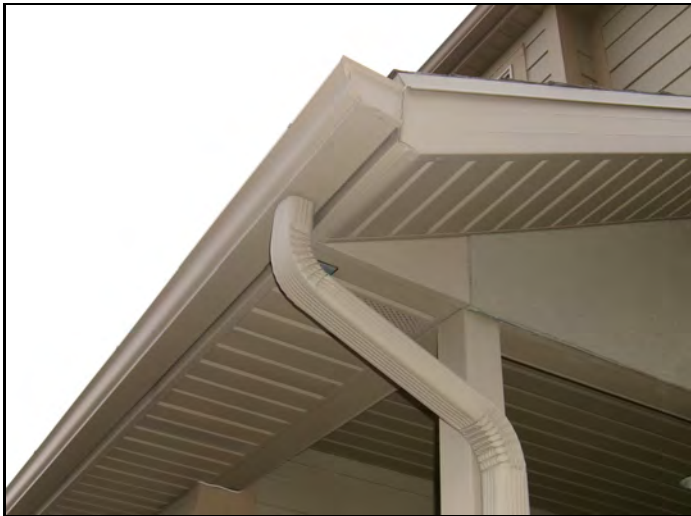
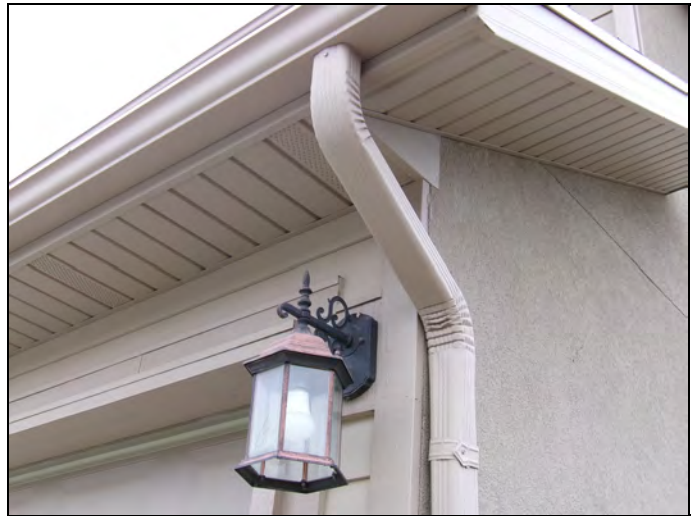
Comp #: 120 Rain Gutters/Downspouts - 2015-17 - Replace

The rain gutters and downspouts appear to be in good to fair condition. We recommend funding to replace this component approximately every 25 - 30 years. Remaining life based on current age.

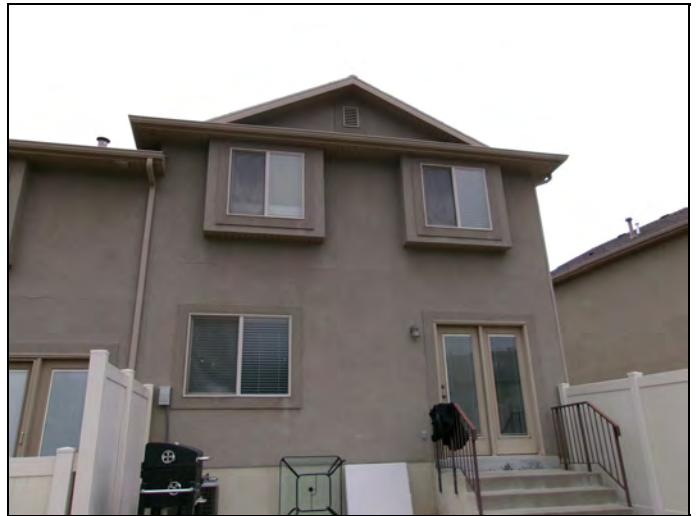
Comp #: 201 Stucco Surfaces - 2009-11 - Repair/Repaint

The stucco surfaces appear to be in fair condition. We recommend funding to repair/repaint this component approximately every 12 - 15 years. Remaining life based on current age and condition.

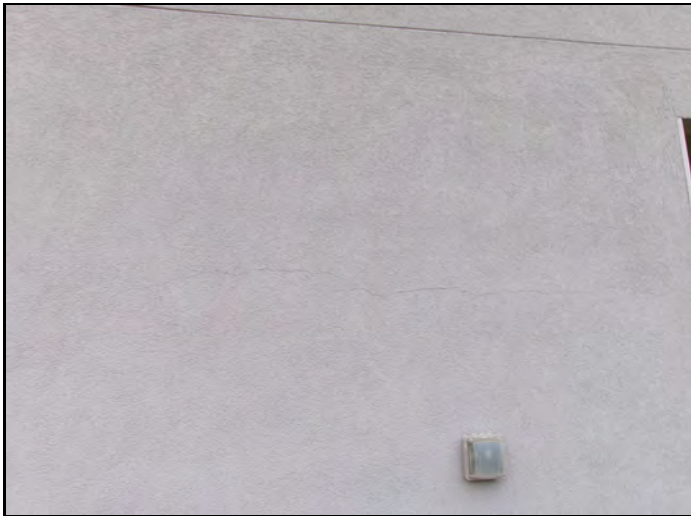
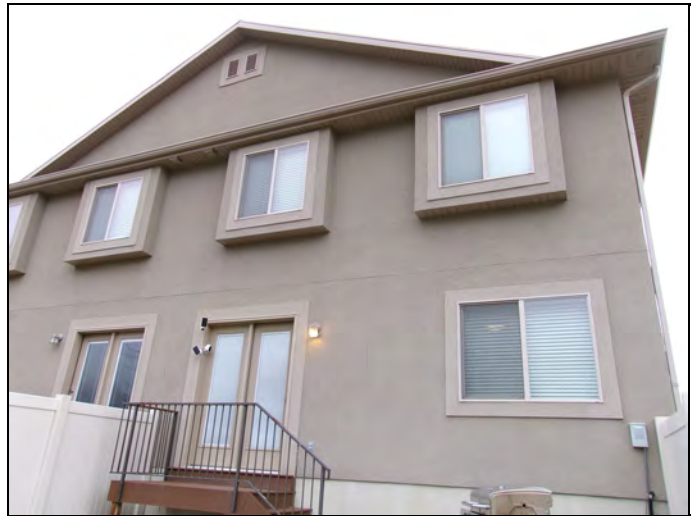
Comp #: 201 Stucco Surfaces - 2012-14 - Repair/Repaint

The stucco surfaces appear to be in good to fair condition. We recommend funding to repair/repaint this component approximately every 12 - 15 years. Remaining life based on current age.

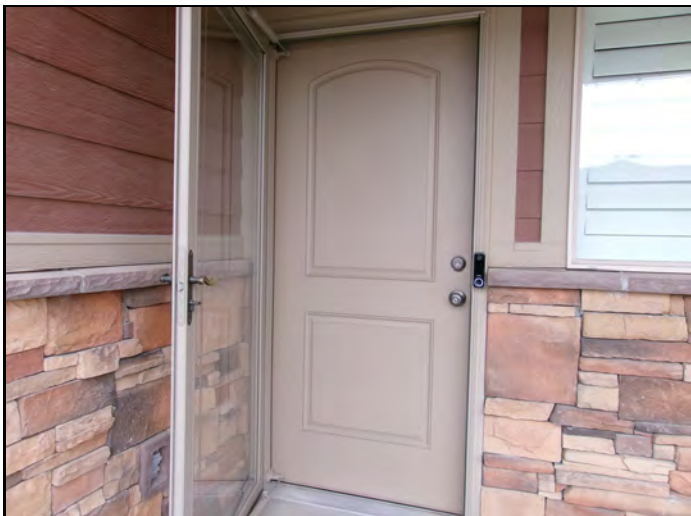
Comp #: 204 Front Doors - 2009-11 - Repaint

The painted door surfaces are in fair to poor condition. We recommend funding to repaint this component approximately every 8 - 10 years. Remaining life based on current condition.

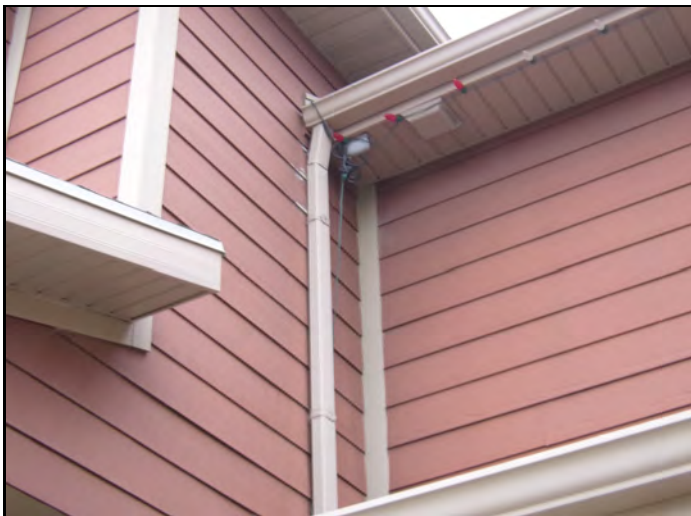
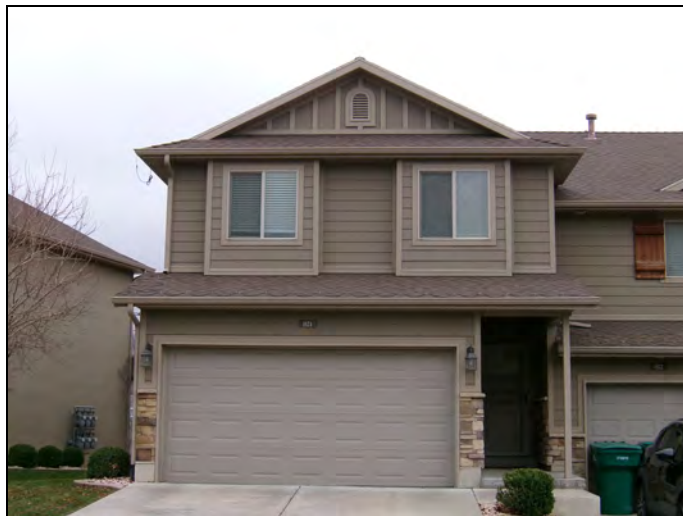
Comp #: 215 Siding - 2009-11 - Repair/Repaint

The siding painted surfaces appear to be in fair to poor condition. We recommend funding to repair/repaint this component approximately every 8 - 10 years. Remaining life is based on current condition.

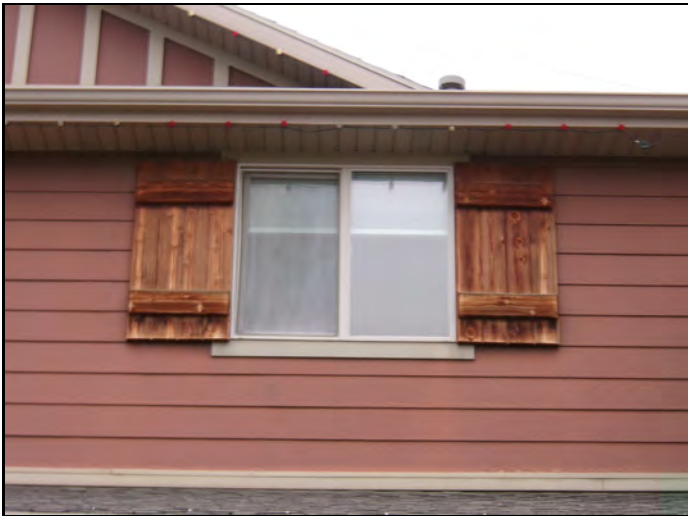
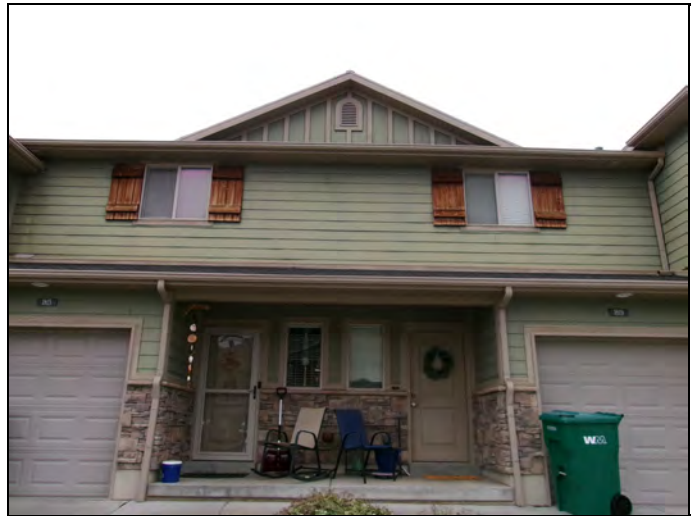
Comp #: 390 Shutters - 2009-11 - Replace

The shutters are in fair condition. We recommend funding to replace this component approximately every 30 - 40 years. Remaining life based on current age.
