# Hampton on the Green

## Level 2 Reserve Study

**Report Period – 01/01/2025 – 12/31/2025**

| <b>Type of Study</b> | <b>Update w / Site Visit</b> |

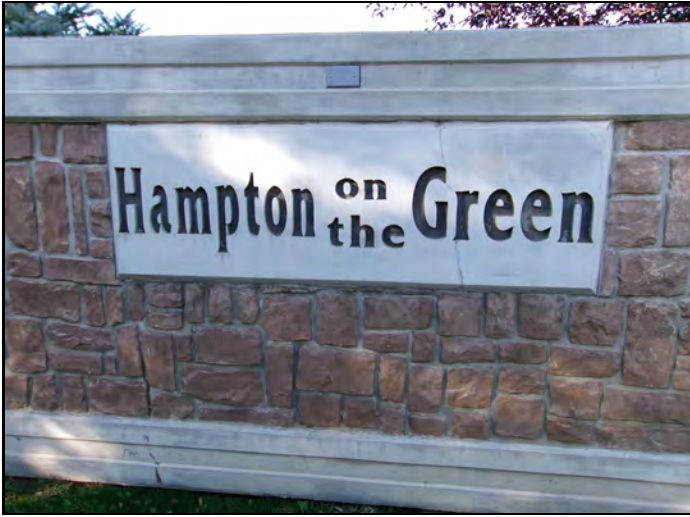
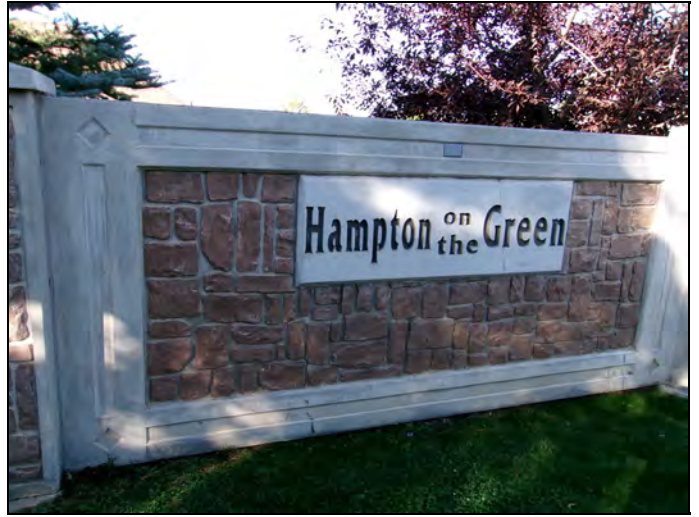
Comp #: 801 Monument Signs - Refurbish

The monument signs are in good condition. We recommend funding to refurbish this component approximately every 15 - 20 years. Remaining life is based on current age.

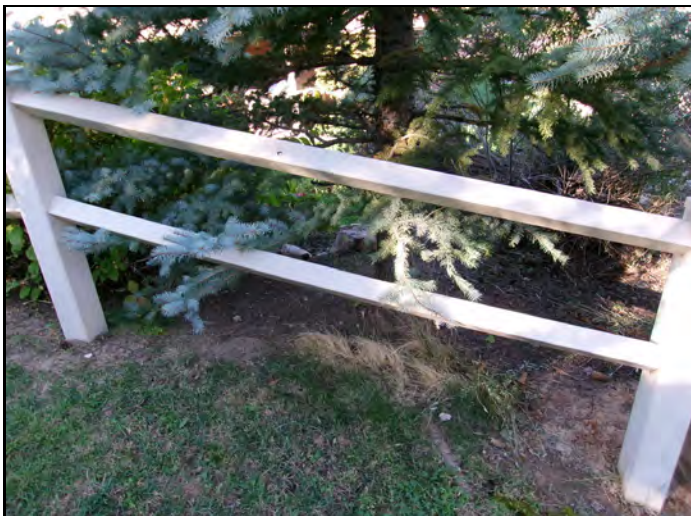
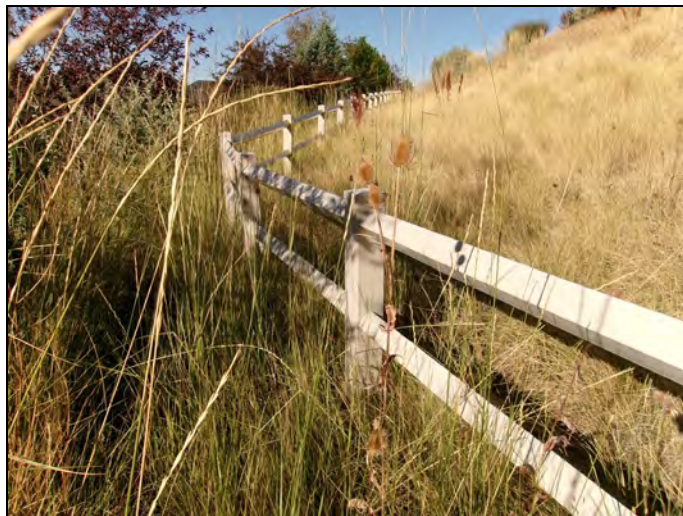
Comp #: 1008 Vinyl Fencing - Replace

The vinyl fencing is in good condition. We recommend funding to replace this component approximately every 25 - 30 years. Remaining life based on current age.

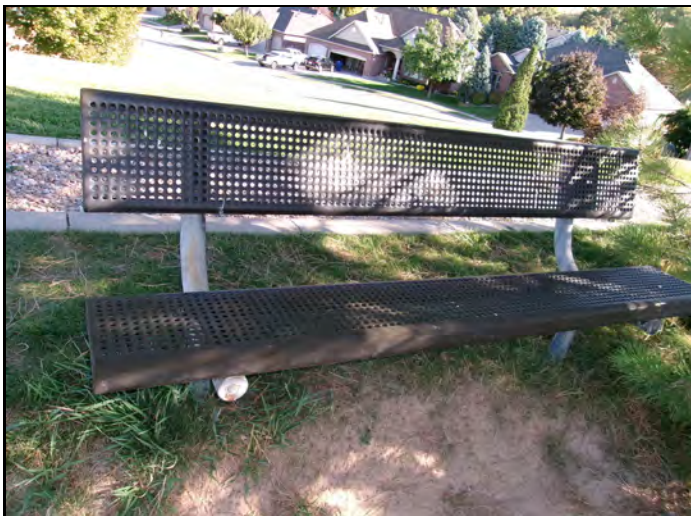
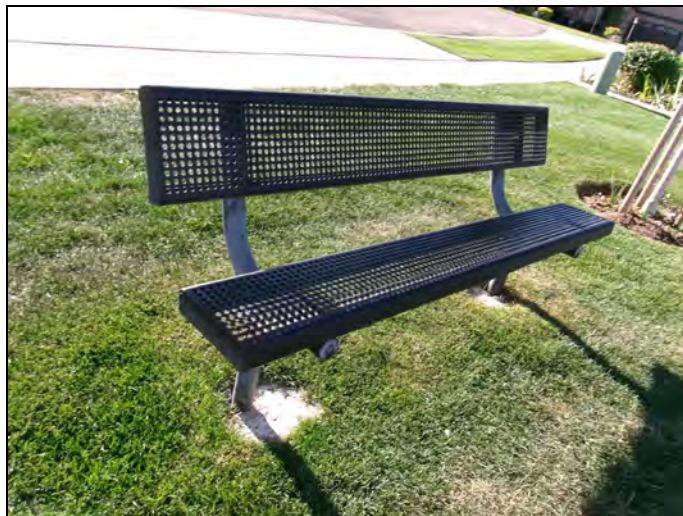
## Comp #: 1307 Benches - Replace

The benches are in fair condition. We recommend funding to replace this component approximately every 10 - 15 years. Remaining life based on current age and condition.

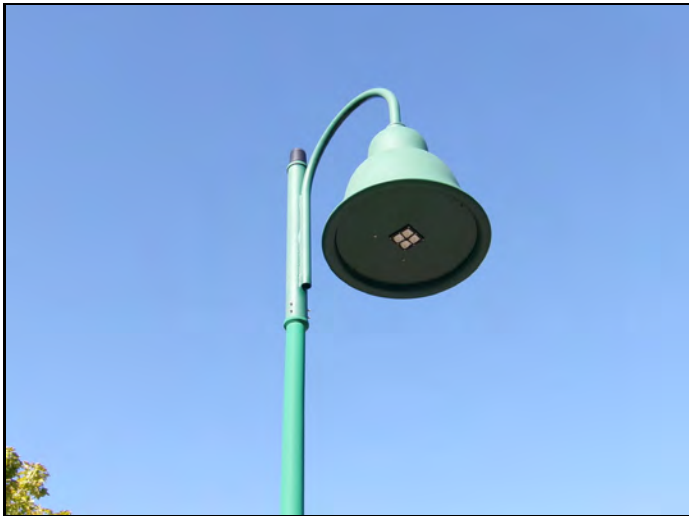
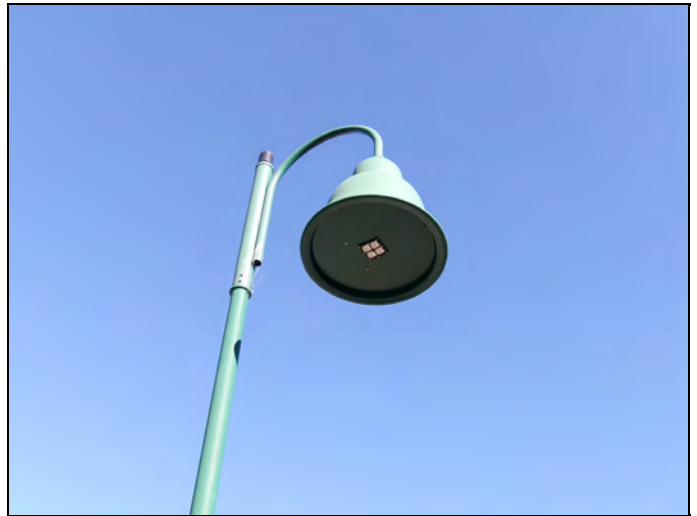
Comp #: 1609 Street Light Fixtures - Replace

The street light fixtures are in good condition. No expectation to replace the light poles. Paint poles as necessary as an operating expense. We recommend funding to replace this component approximately every 20 years. Remaining life based on current age.

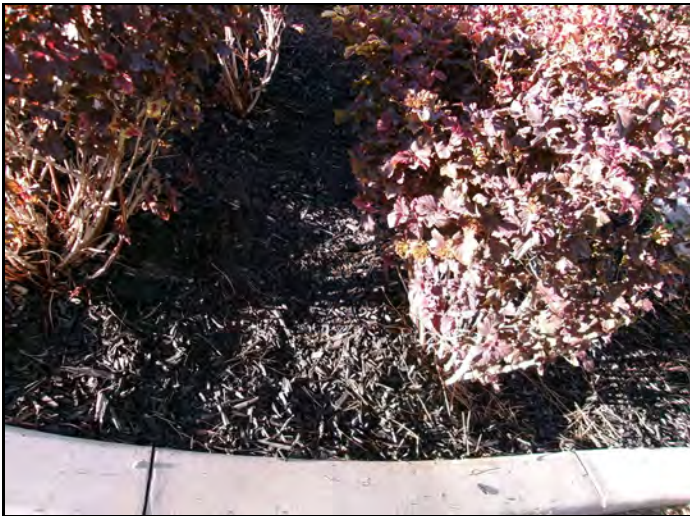
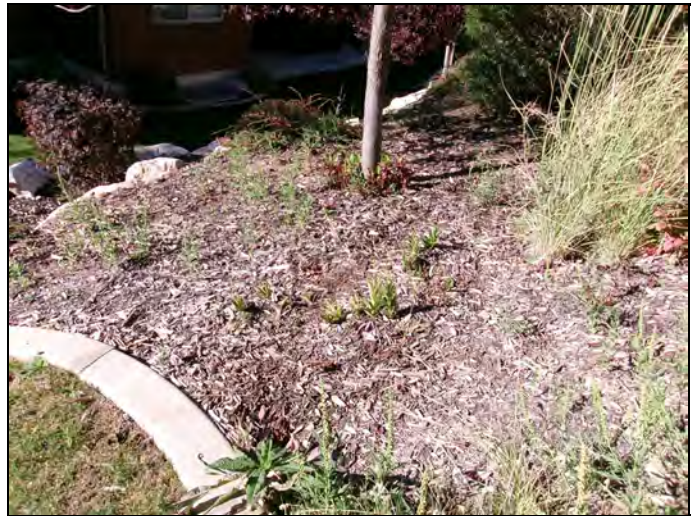
Comp #: 1801 Bark - Partial Replace

Research with the client reveals plans to partially replace this component each year.

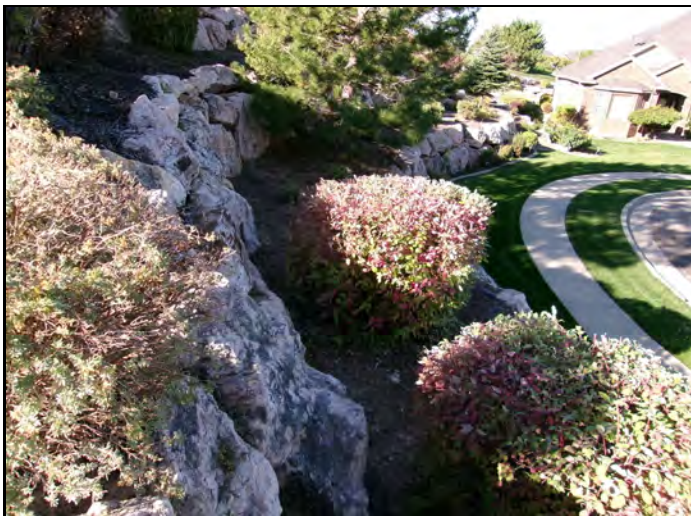
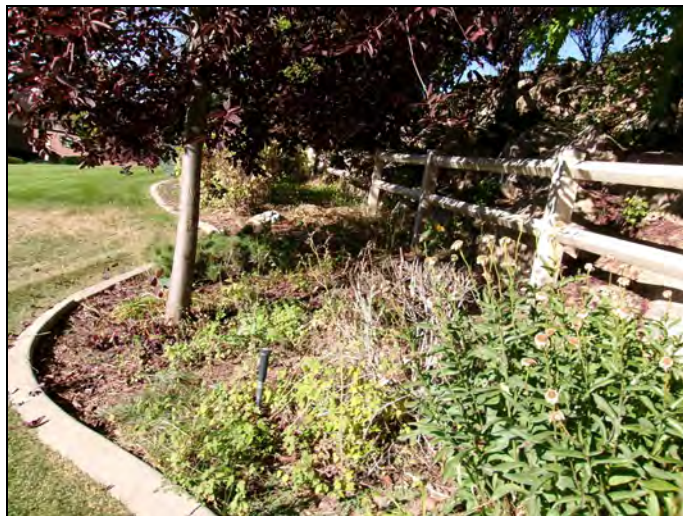
Comp #: 1802 Plant & Shrub - Partial Replace

Research with the client reveals plans to partially replace this component each year.

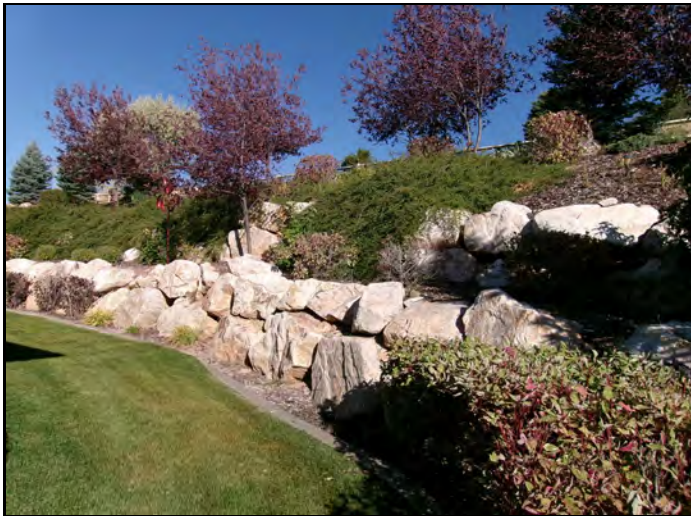
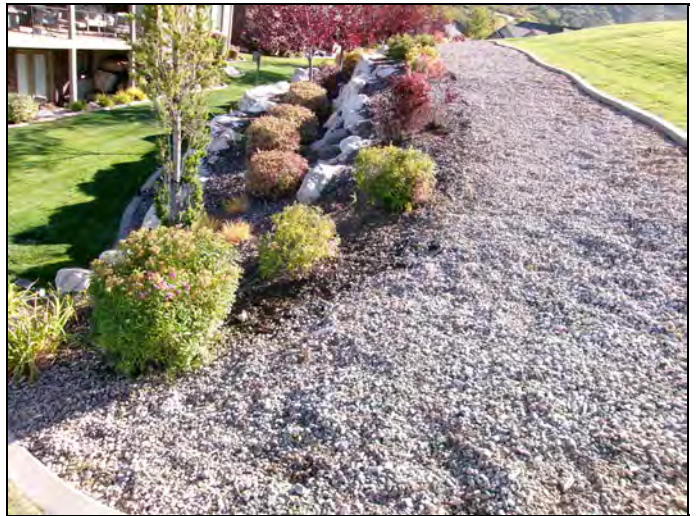
## Comp #: 1812 Landscaping & Irrigation System - Renovate

The landscaping and irrigation system appear to be in good condition. We recommend funding for an allowance to renovate this component approximately every 20 years. Remaining life based on current age.
