# North Pointe Condominiums

## Level 1 Reserve Study

**Report Period – 01/01/2026 – 12/31/2026**

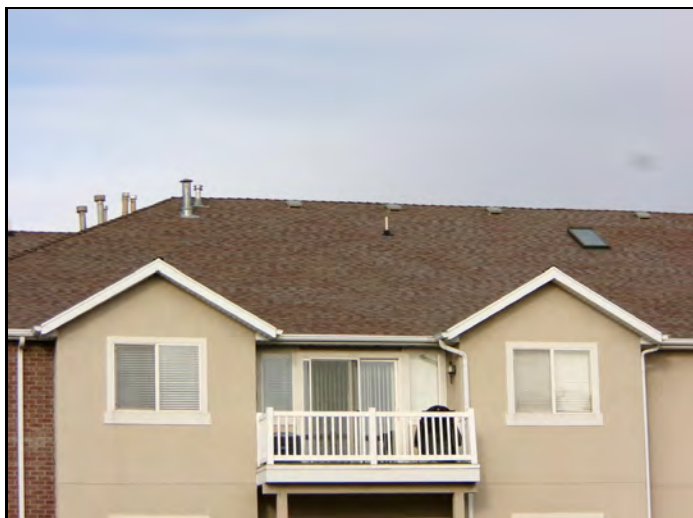
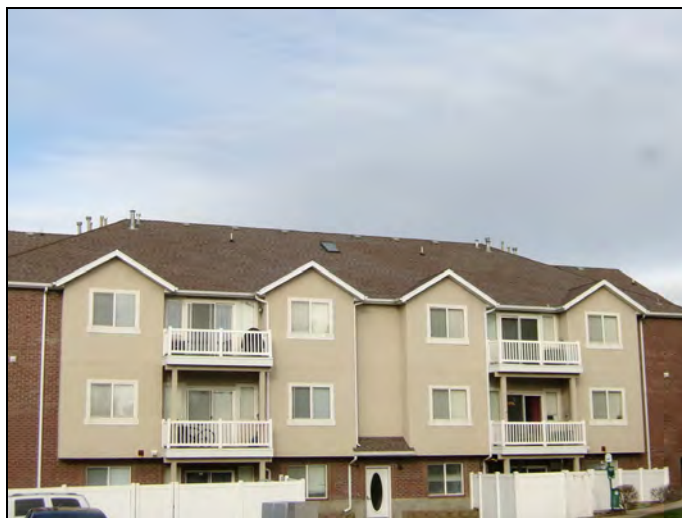
Comp #: 105    Roofs - 2003 - Replace

The roofs appear to be in fair condition. We recommend funding to replace this component approximately every 20 - 25 years. Remaining life based on current age.

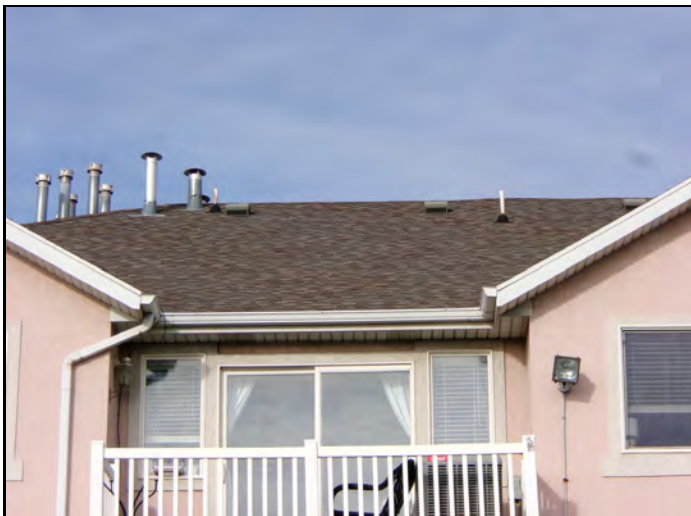
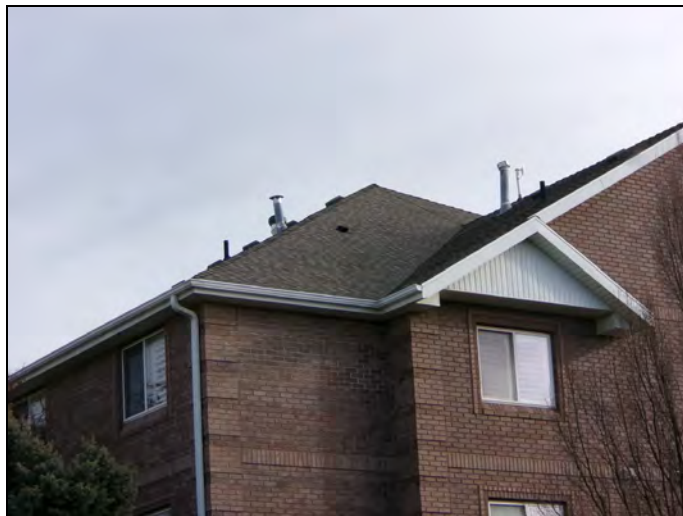
Comp #: 105    Roofs - 2010 - Replace

The roofs appear to be in fair condition. We recommend funding to replace this component approximately every 20 - 25 years. Remaining life based on current age.

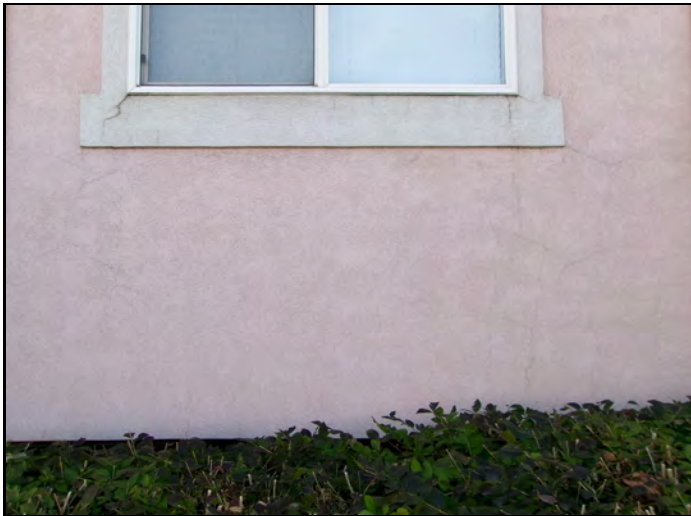
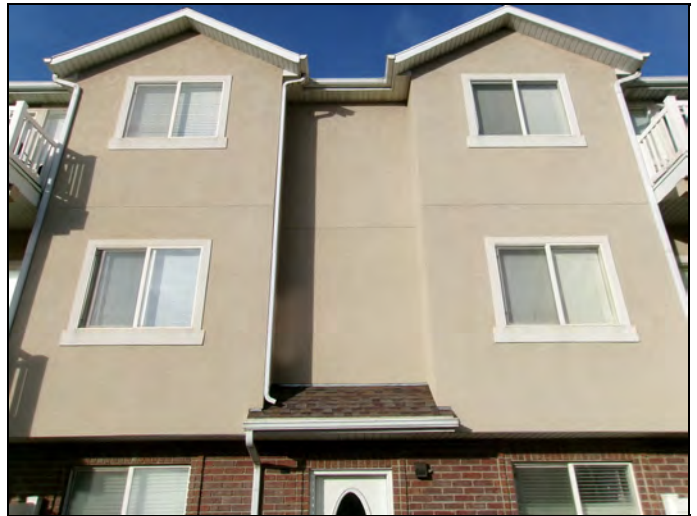
Comp #: 201 Stucco Surfaces - Repair/Repaint

The stucco surfaces appear to be in good to fair condition. We recommend funding to repair/repaint this component approximately every 12 - 15 years. Remaining life based on current age.

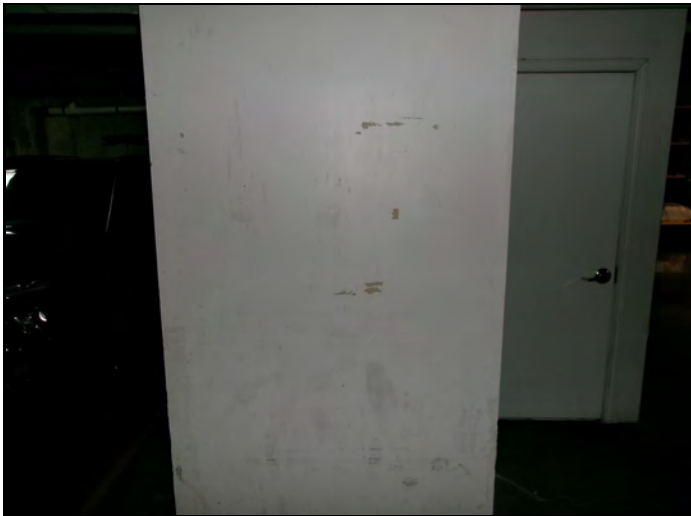
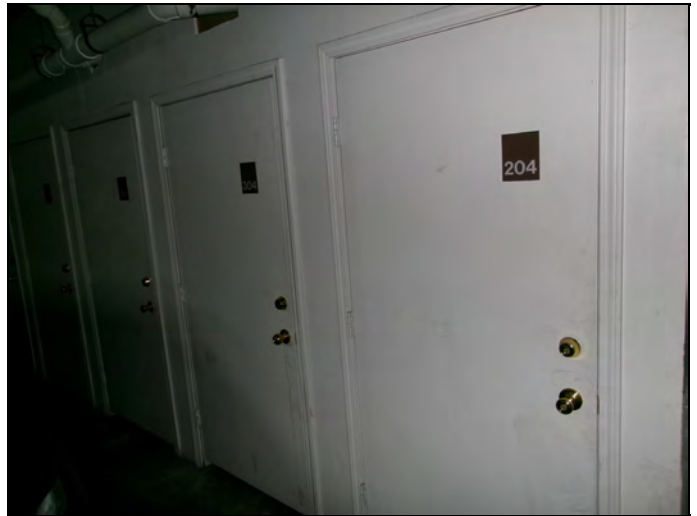
Comp #: 203 Garage Walls/Surfaces - Repair/Repaint

The painted surfaces are in fair condition. We recommend funding to repair/repaint this component approximately every 10 - 12 years. Remaining life based on current age and condition.

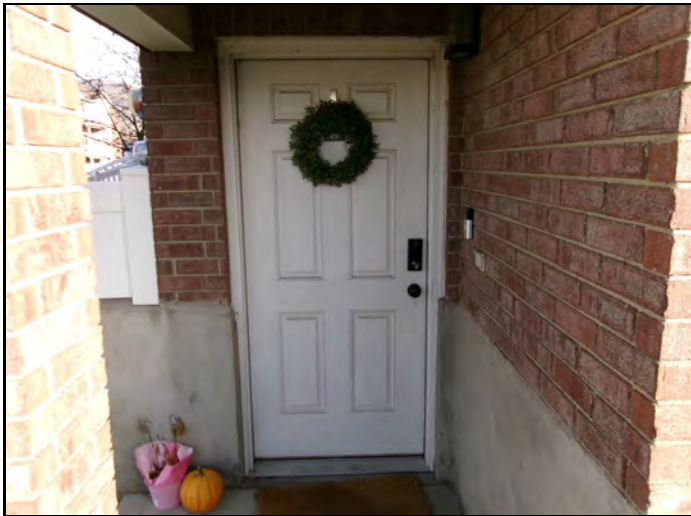
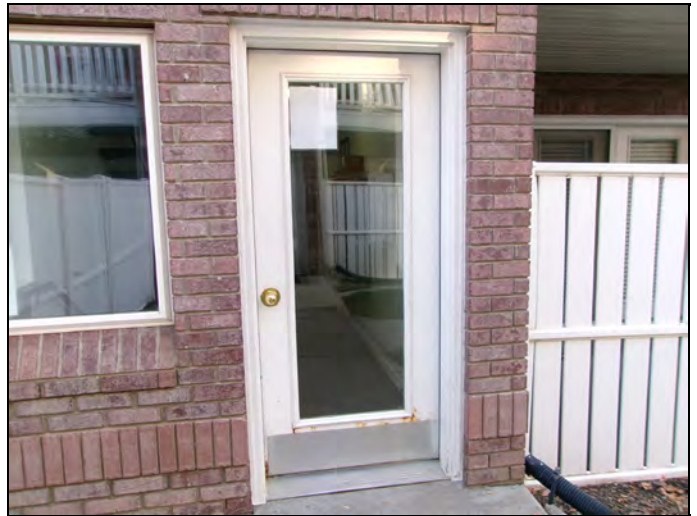
Comp #: 204 Doors - Repaint

The painted door surfaces are in fair condition. We recommend funding to repaint this component approximately every 8 - 10 years. Remaining life based on current age and condition.

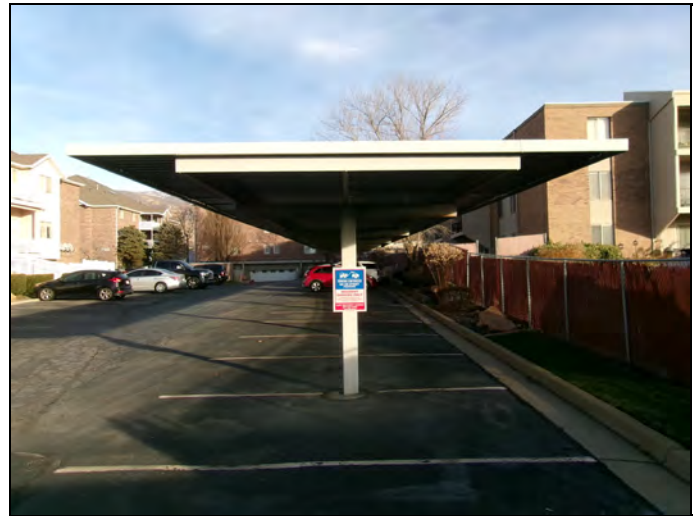
Comp #: 223 Carports - Repaint

The paint on the carport structure is in poor condition. We recommend funding to repaint this component approximately every 10 - 15 years. Remaining life based on current condition.

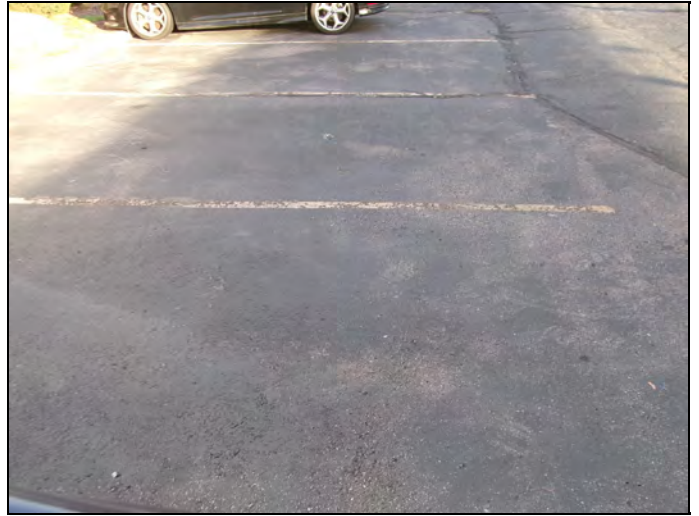
Comp #: 402 Asphalt - Seal Coat

The asphalt seal coat is in poor condition. We recommend funding to seal this component approximately every 3 - 5 years. Remaining life based on current condition.

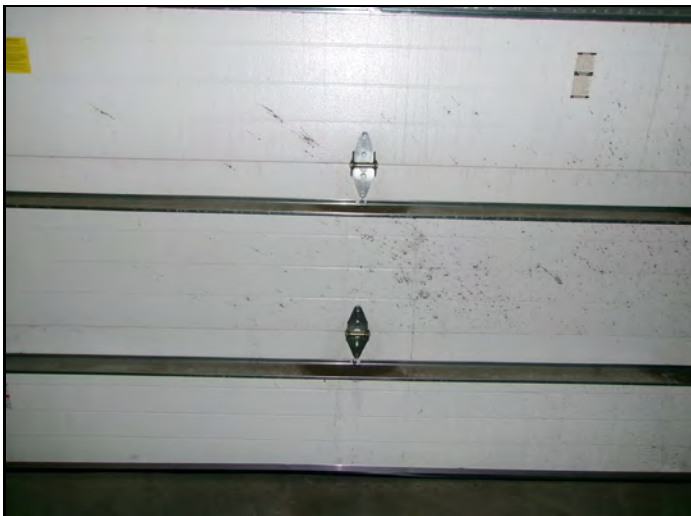
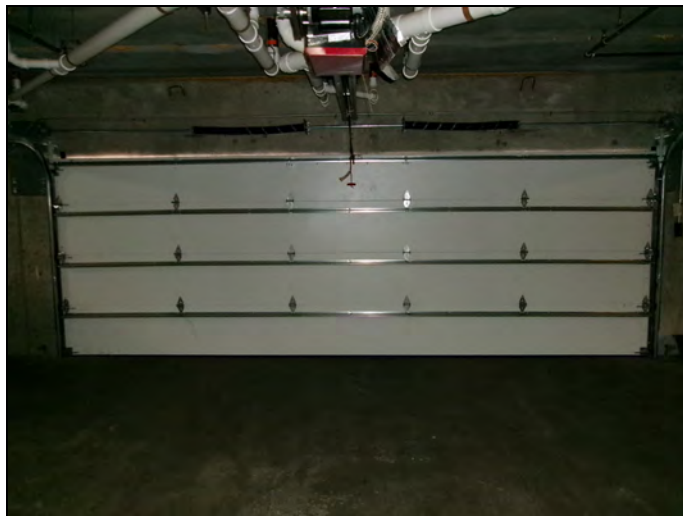
Comp #: 502 Garage Door - Replace

The garage doors are in working condition. We recommend funding to replace this component approximately every 20 years. Remaining life based on current age and condition.

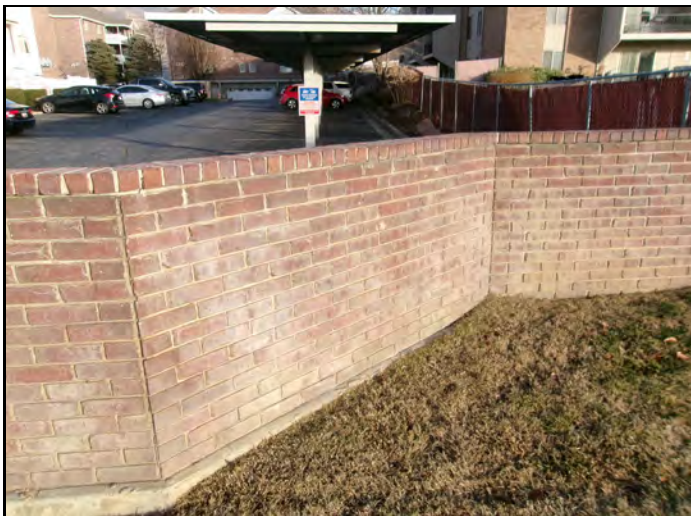
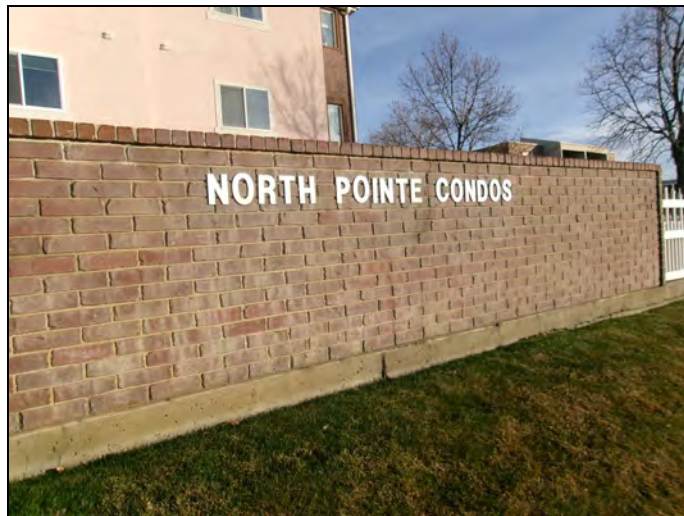
Comp #: 1005 Brick Walls - Replace

This component should have an extended useful life under normal conditions. Repair as necessary as an operating expense. No reserve funding necessary.

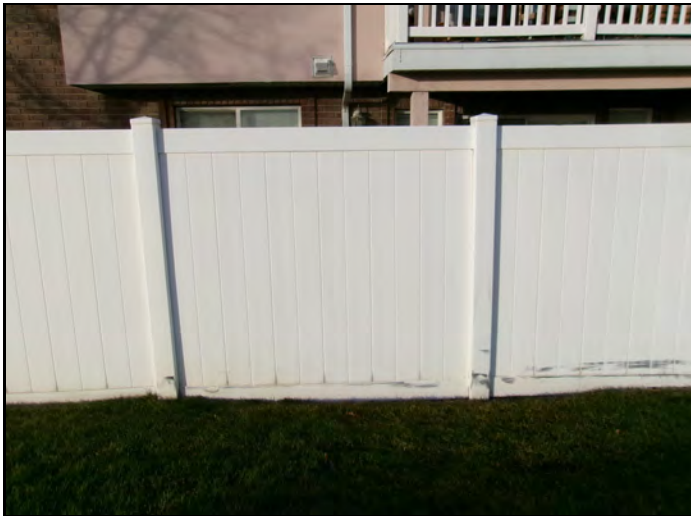
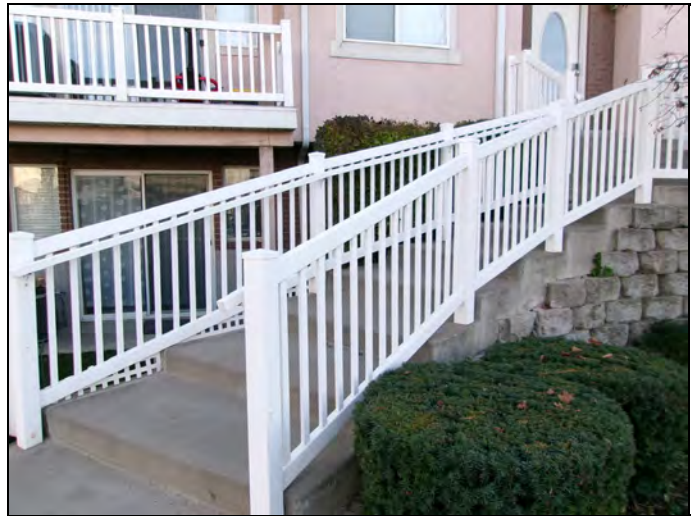
Comp #: 1008 Vinyl Fencing & Railing - Replace

The vinyl fencing appears to be in fair condition. We recommend funding to replace this component approximately every 25 - 30 years. Remaining life based on current age.

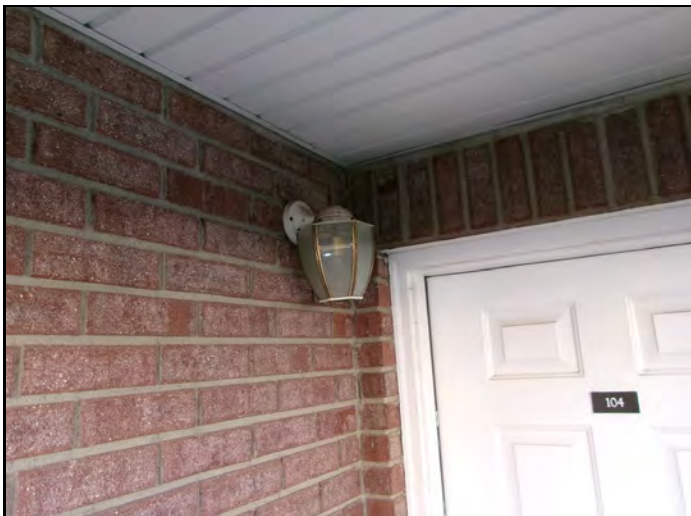
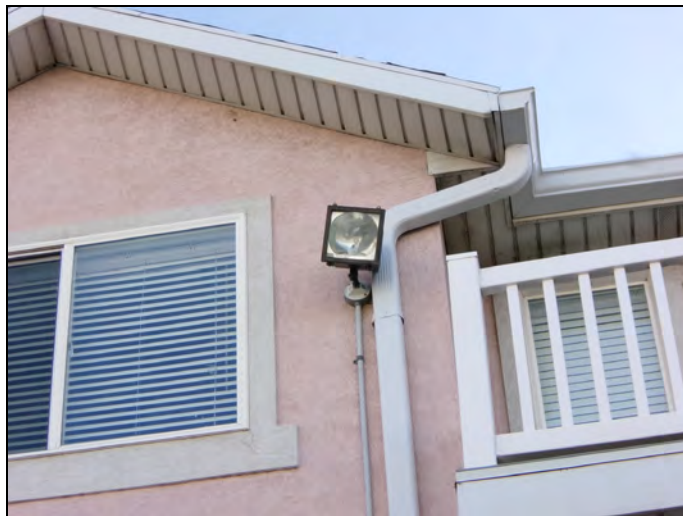
## Comp #: 1602 Exterior Light Fixtures - Replace

The exterior light fixtures are in fair condition. We recommend funding to replace this component approximately every 16 - 20 years. Remaining life based on current age and condition.
