# South Ogden Meadow

## Level 1 Reserve Study

**Report Period – 01/01/2025 – 12/31/2025**

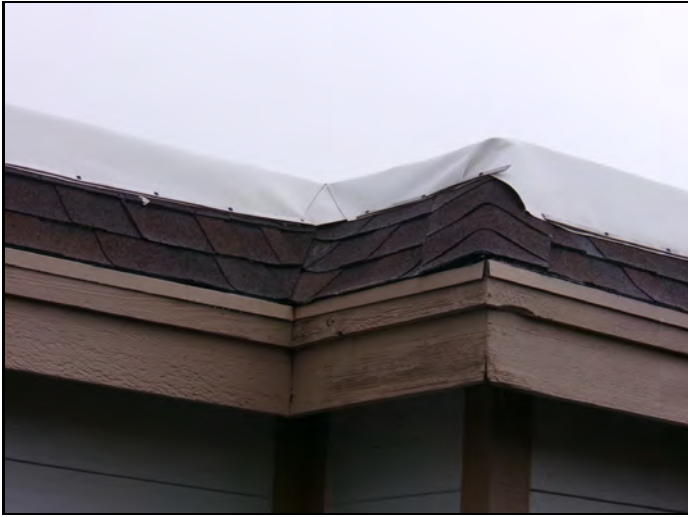
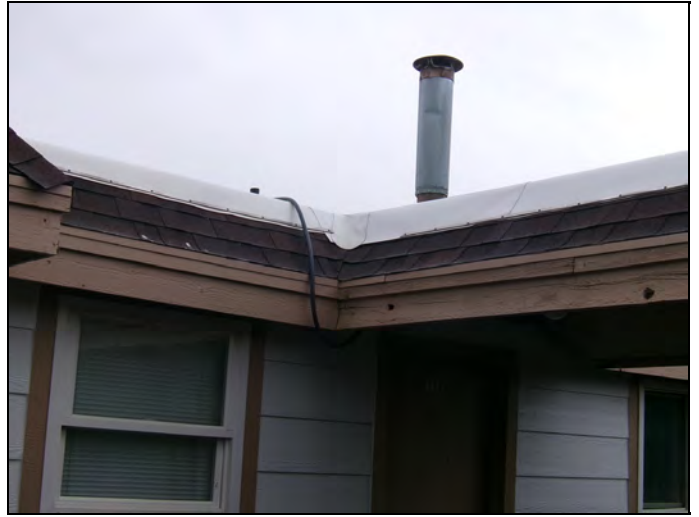
Comp #: 104 Flat Roof - Bldg 1 - Replace

*Location:* **Building Roof**

*Quantity:* **Approx. 6,585 SF**

Unable to inspect this component at the time of the site visit. We recommend funding to replace this component approximately every 20 - 25 years. Remaining life based on current age.

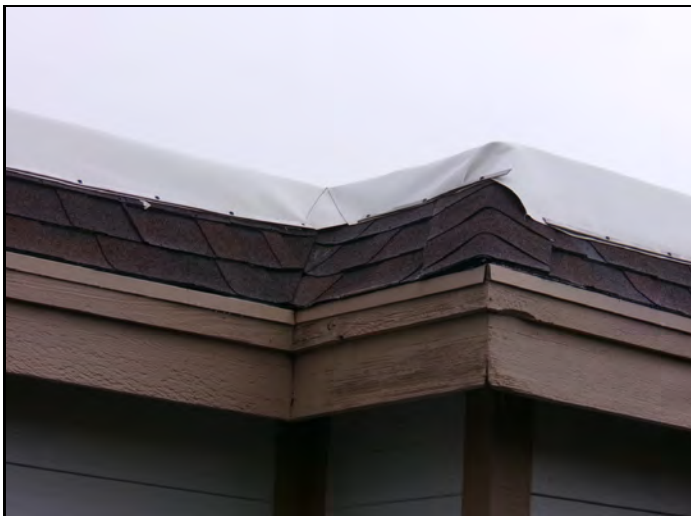
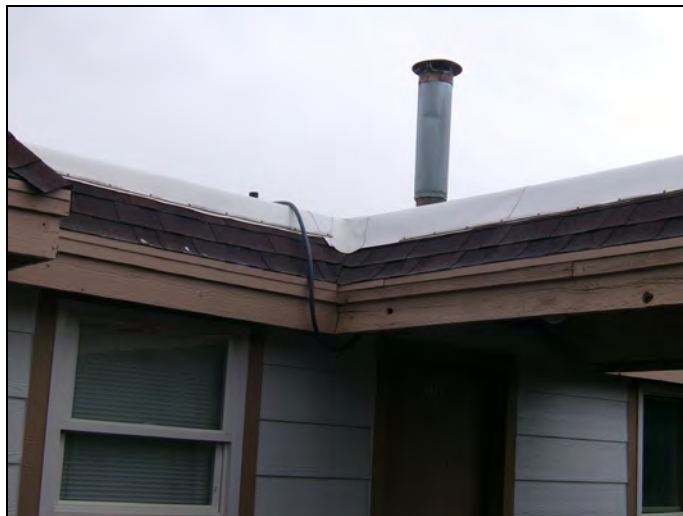
Comp #: 104 Flat Roofs - Bldgs 2-4 - Replace

*Location:* **Building Roofs**

*Quantity:* **Approx. 21,800 SF**

Unable to inspect this component at the time of the site visit. We recommend funding to replace this component approximately every 20 - 25 years. Remaining life based on current age.

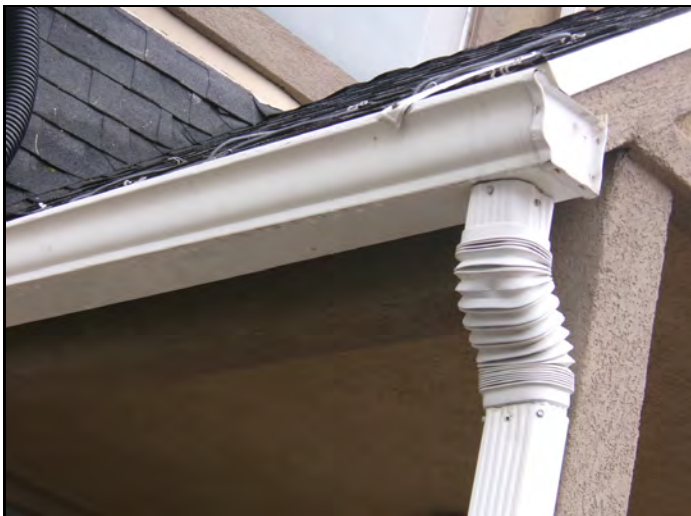
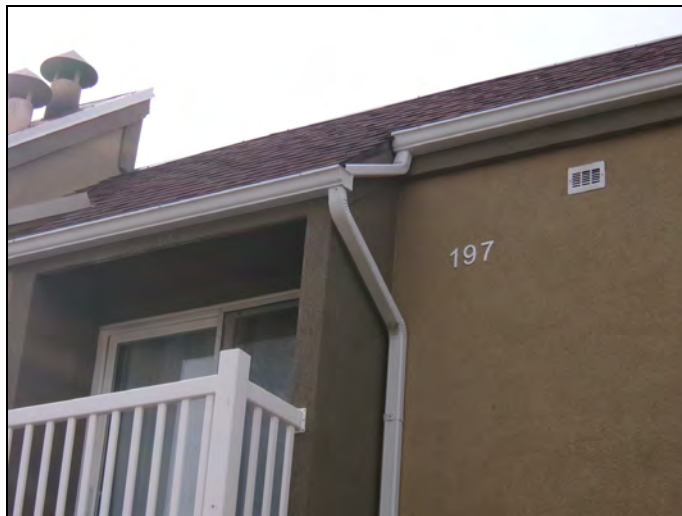
Comp #: 120 Rain Gutters/Downspouts - Replace

*Location:* **Building Exterior**

*Quantity:* **Approx. 3,270 LF**

The rain gutters and downspouts are in fair condition. We recommend funding to replace this component approximately every 25 - 30 years. Remaining life based on current age and condition.

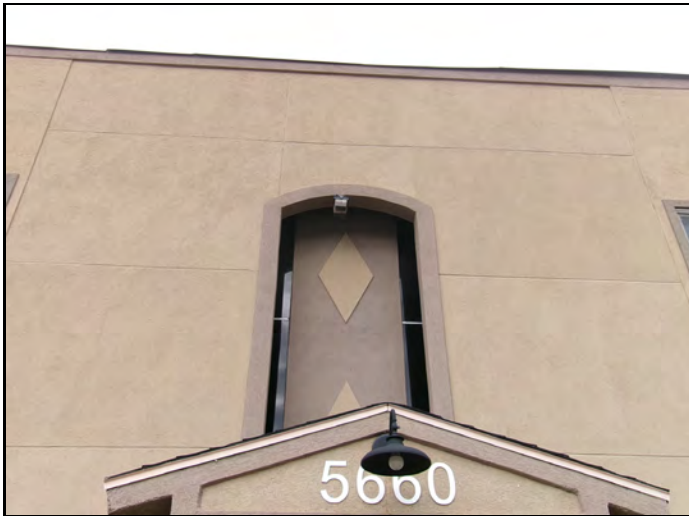
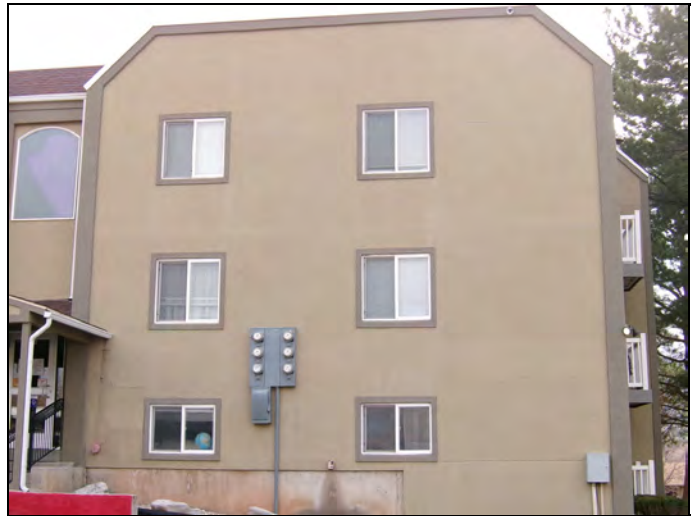
Comp #: 201 Stucco Surfaces - Repair/Repaint

*Location:* **Building Exteriors**

*Quantity:* **Approx. 54,095 SF**

The stucco surfaces are generally in fair condition. We recommend funding to repair/repaint this component approximately every 12 - 15 years. Remaining life based on current age and condition

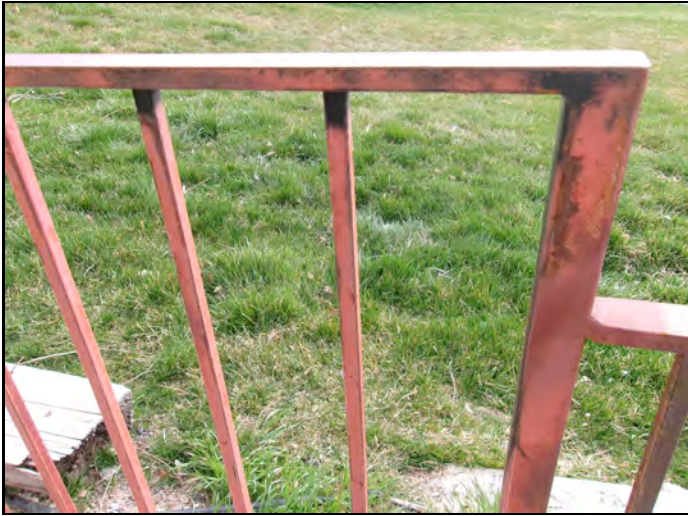
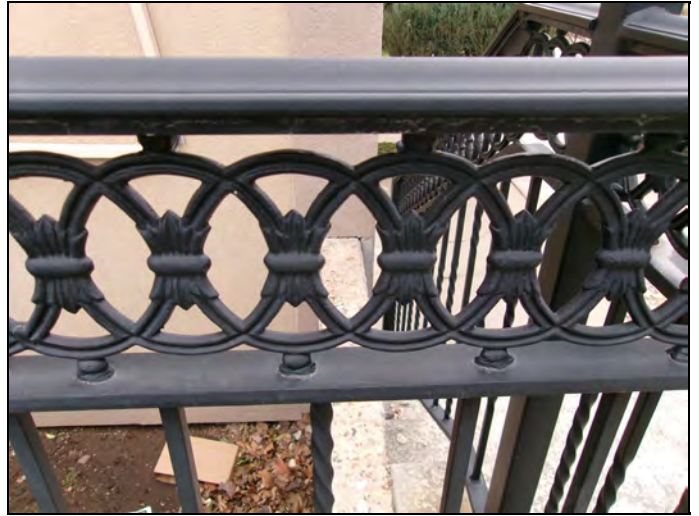
Comp #: 207 Metal Railing - Repaint

*Location:* **Common Area**

*Quantity:* **Approx. 550 LF**

The painted metal fencing surfaces are in fair to poor condition. We recommend funding to repaint this component approximately every 6 years. Remaining life based on current condition.

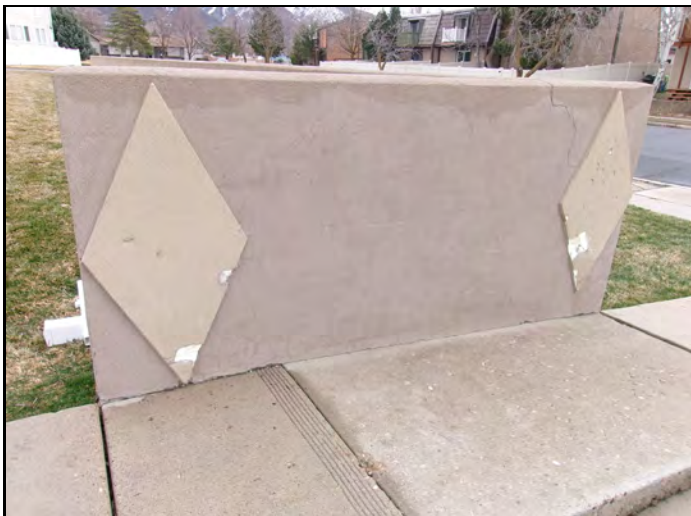
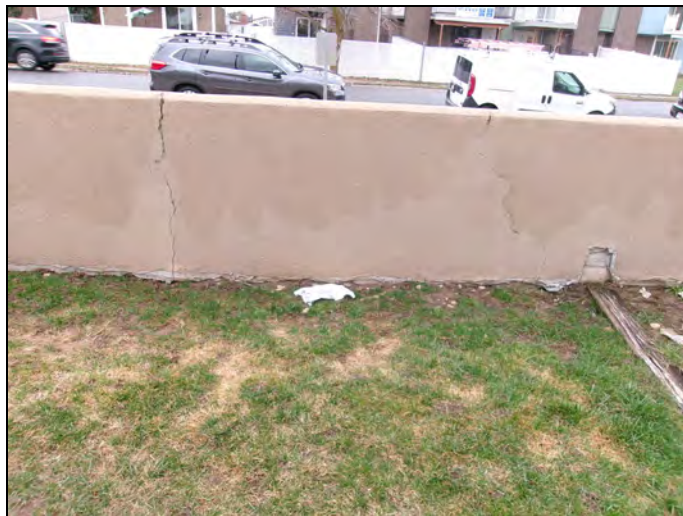
Comp #: 208 Stucco Covered Wall - Repair/Repaint

*Location:* **Common Area**

*Quantity:* **Approx. 220 LF**

The stucco covered wall surfaces are in fair to poor condition. We recommend funding to repair/repaint this component approximately every 10 - 12 years. Remaining life based on current condition

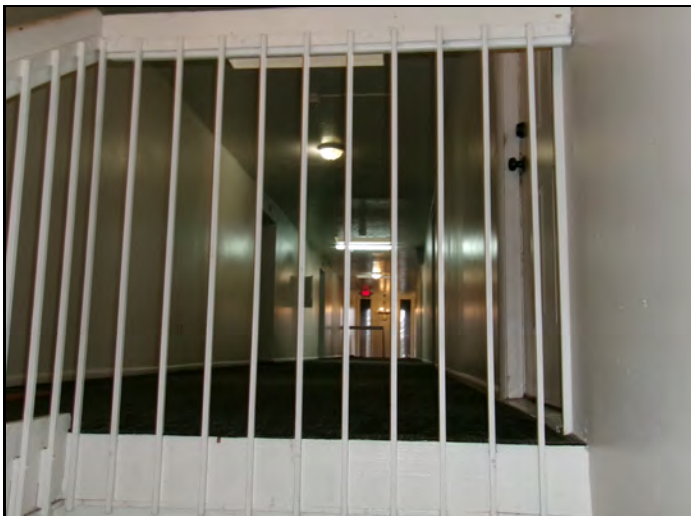
Comp #: 212 Metal Surfaces - Repaint

*Location:* **Building Railing**

*Quantity:* **Approx. 460 LF**

The painted metal railing surfaces are in fair condition. We recommend funding to paint this component approximately every 6 years. Remaining life based on current condition.

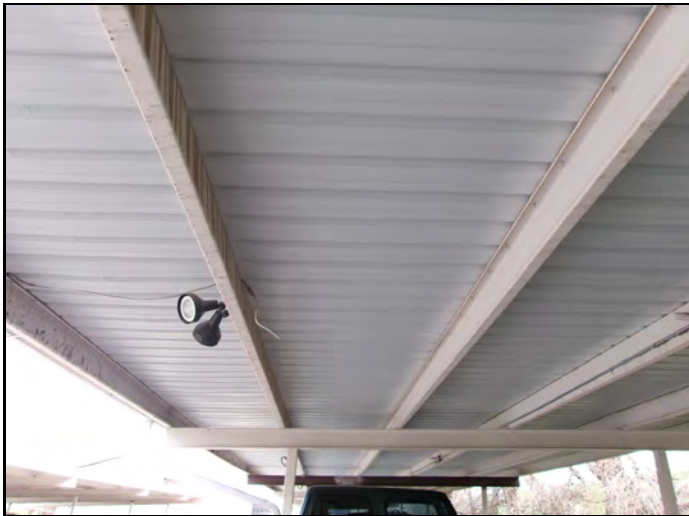
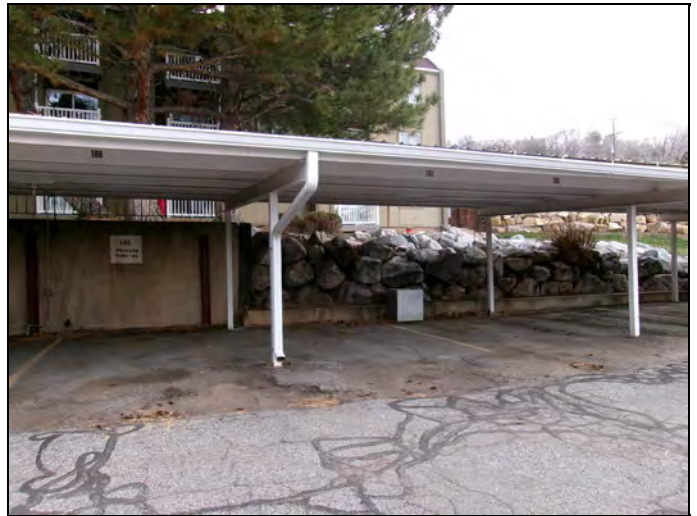
Comp #: 223 Carports - Repaint

*Location:* **Common Area**

*Quantity:* **(7) Carports**

The paint on the carport structure is in fair condition. We recommend funding to repaint this component approximately every 10 - 15 years. Remaining life based on current condition.

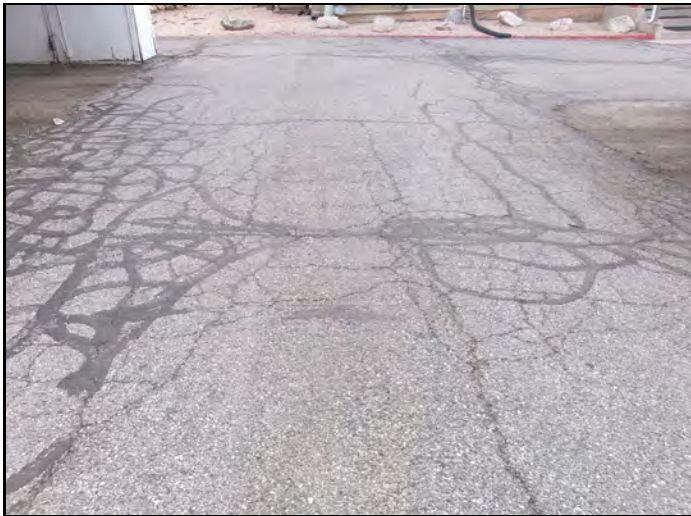
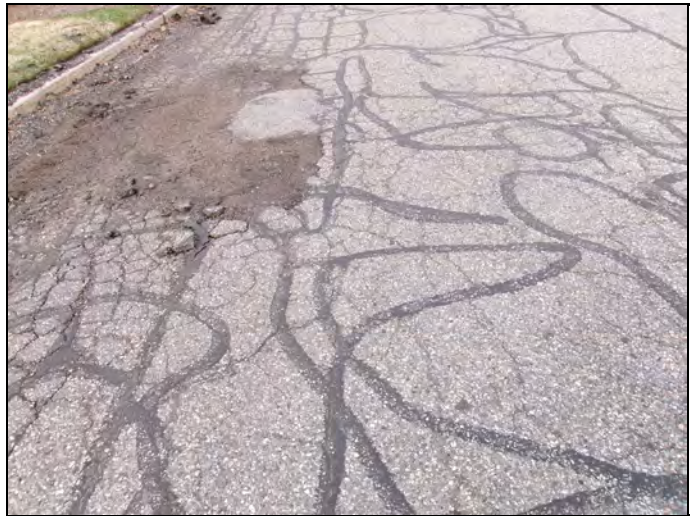
Comp #: 401 Asphalt - 2024 - Major Rehab

*Location:* **Community Streets**

*Quantity:* **Approx. 52,240 SF**

Research with the client reveals this component is being completed in 2024. We recommend funding for a major rehab of this component approximately every 25 - 30 years. Remaining life based on current age.

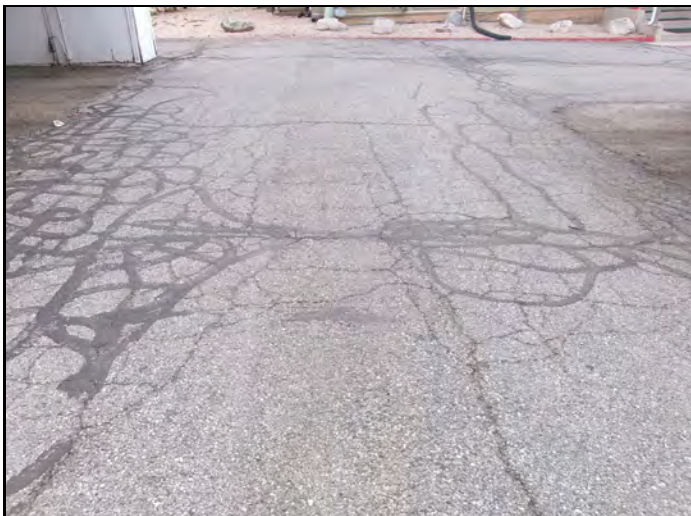
Comp #: 401 Asphalt - 2025 - Major Rehab

*Location:* **Community Streets**

*Quantity:* **Approx. 40,710 SF**

Research with the client reveals this component is being completed in 2025. We recommend funding for a major rehab of this component approximately every 25 - 30 years. Remaining life based on current age.

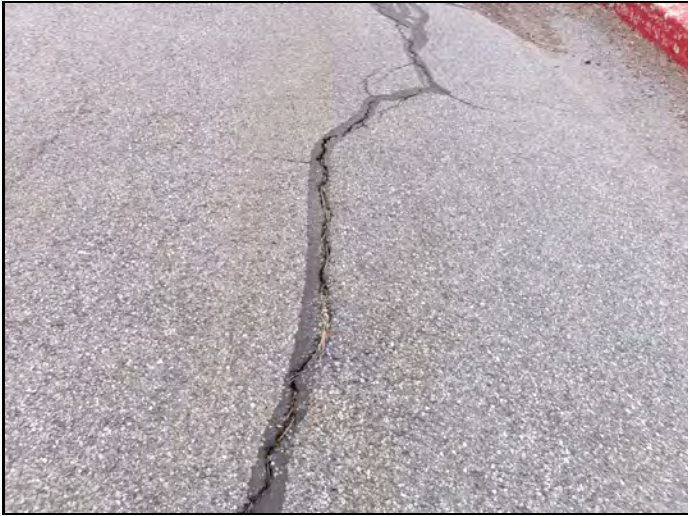
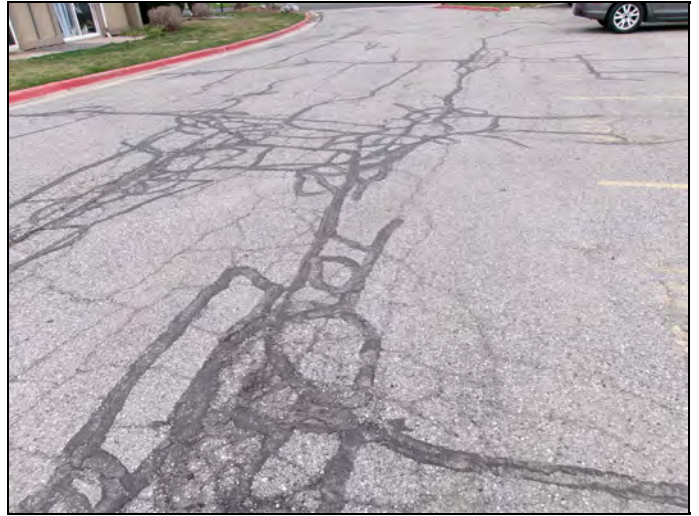
Comp #: 402 Asphalt - Seal Coat

*Location:* **Community Streets**

*Quantity:* **Approx. 92,950 SF**

Research with the client reveals this component will be replaced in 2024-2025. We recommend funding to seal this component approximately every 3 - 5 years. Remaining life based on current age.

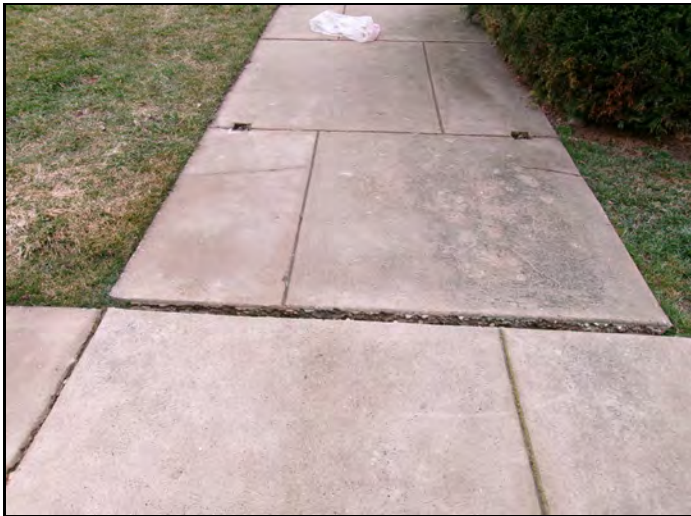
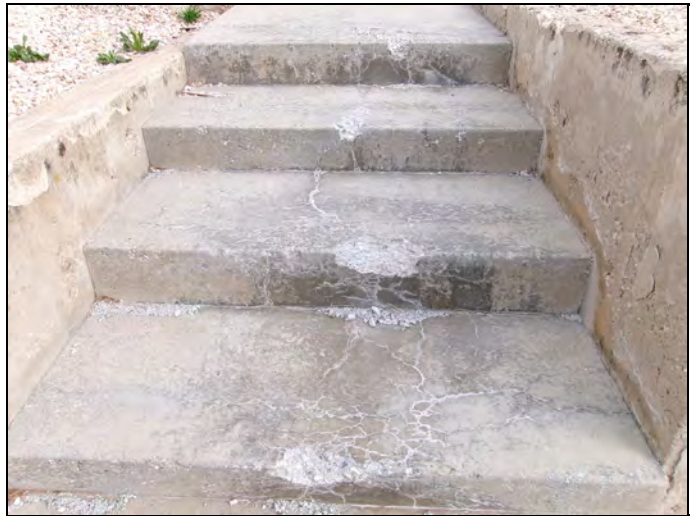
Comp #: 403 Concrete - Partial Repair/Replace

*Location:* **Common Area**

*Quantity:* **Minimal SF**

The concrete is generally in good to fair condition. This component has an extended useful life under normal conditions. We recommend funding to make repairs and partially replace this component approximately every 10 years. Remaining life based on current condition.

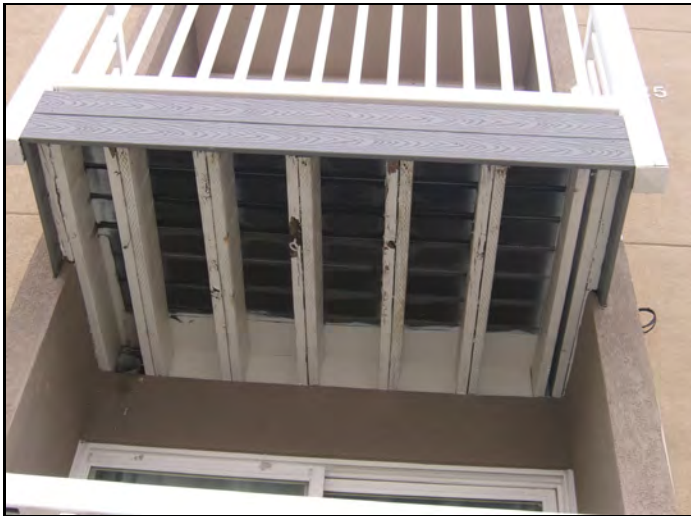
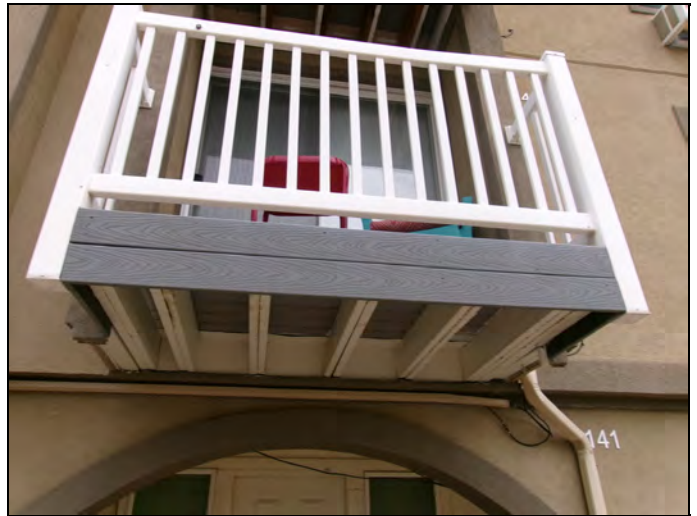
Comp #: 604 Balcony Decks - Resurface

*Location:* **Building Exterior**

*Quantity:* **Approx. 2,960 SF**

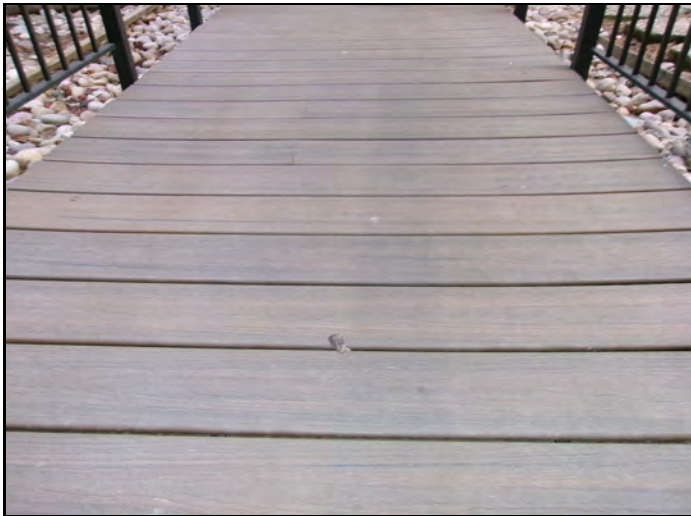
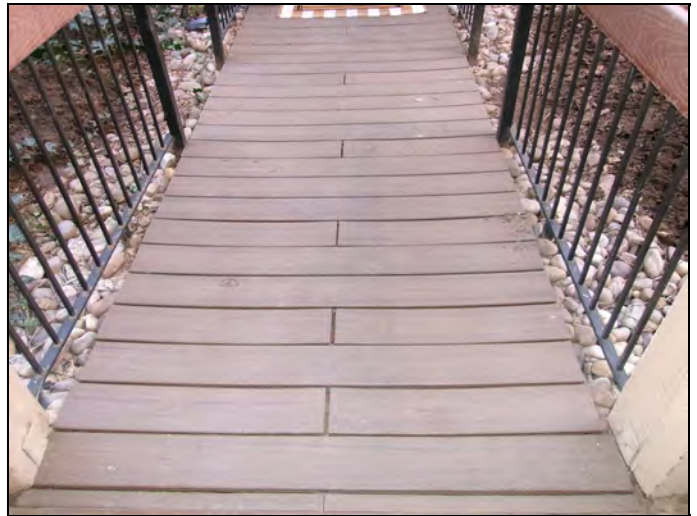
Comp #: 609 Composite Decking - Replace

*Location:* **Buildings 3, & 4**

*Quantity:* **Approx. 1,890 SF**

The composite decking is in good to fair condition. We recommend funding to replace this component approximately every 25 - 30 years. Remaining life based on current condition.

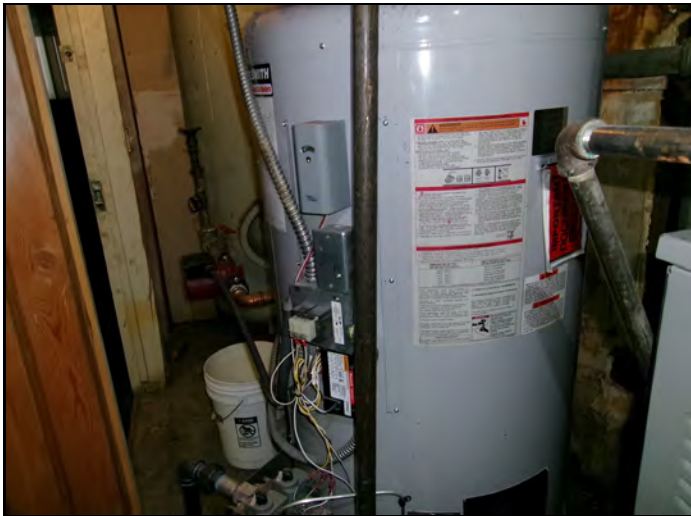
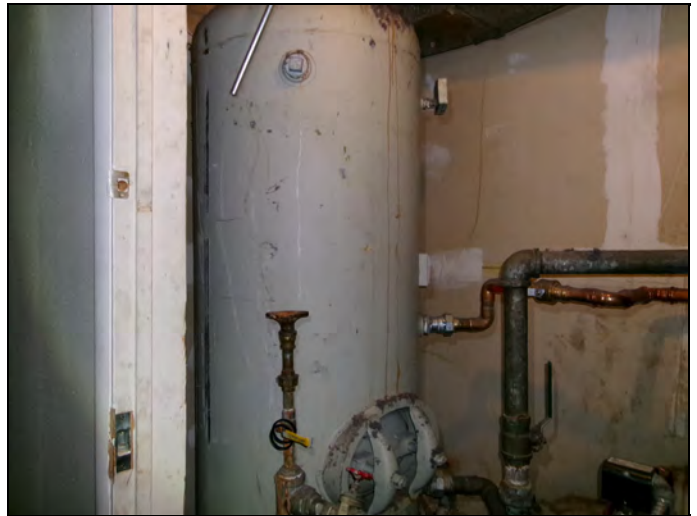
Comp #: 702 Boiler System - Replace

*Location:* **Building 2**

*Quantity:* **(1) Building**

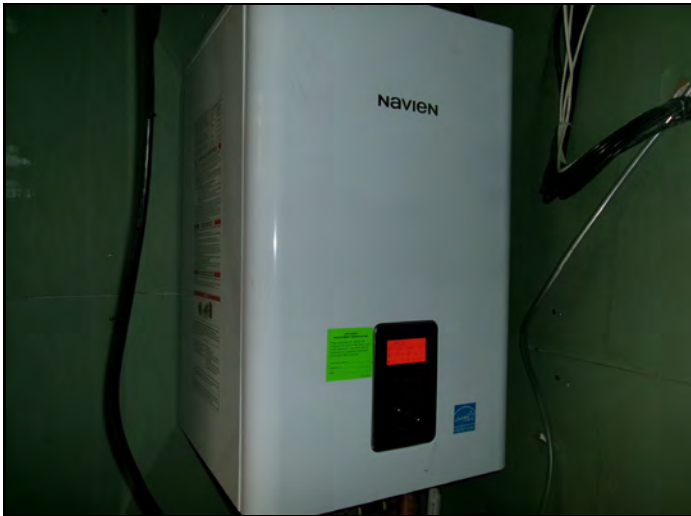
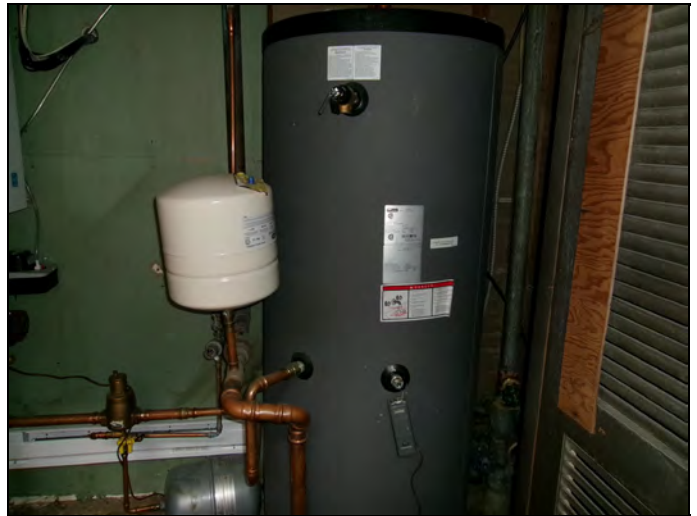
## Comp #: 703 Water Heaters - Replace

*Location:* **Buildings 3, & 4**

*Quantity:* **(2) Buildings**

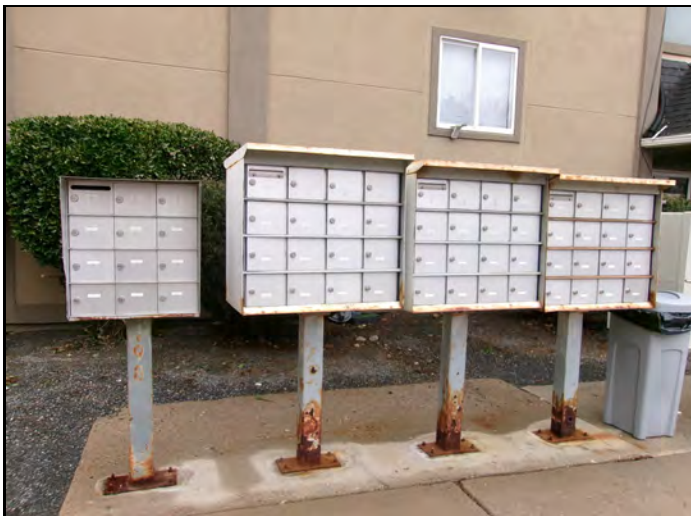
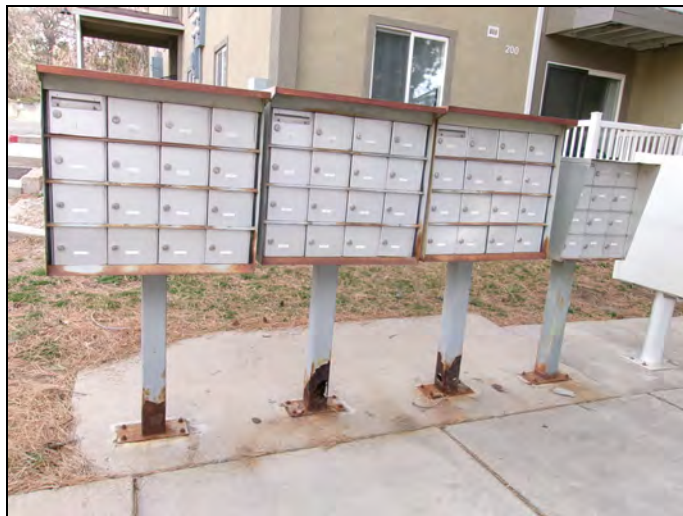
Comp #: 803 Mailboxes - Replace

*Location:* **Common Area**

*Quantity:* **(12) Clusters**

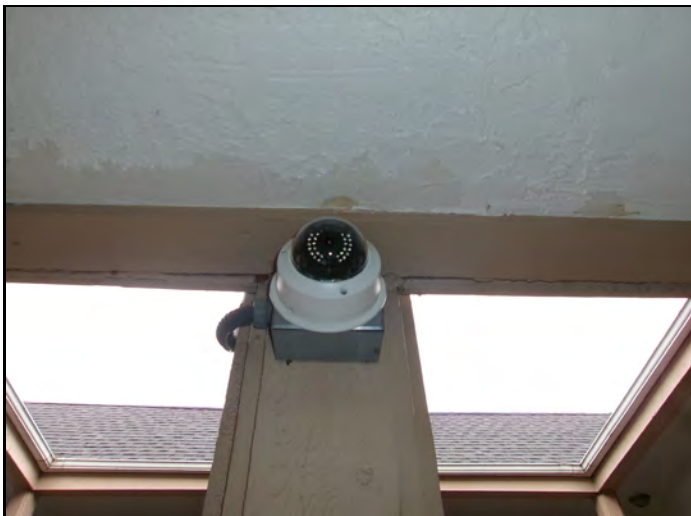
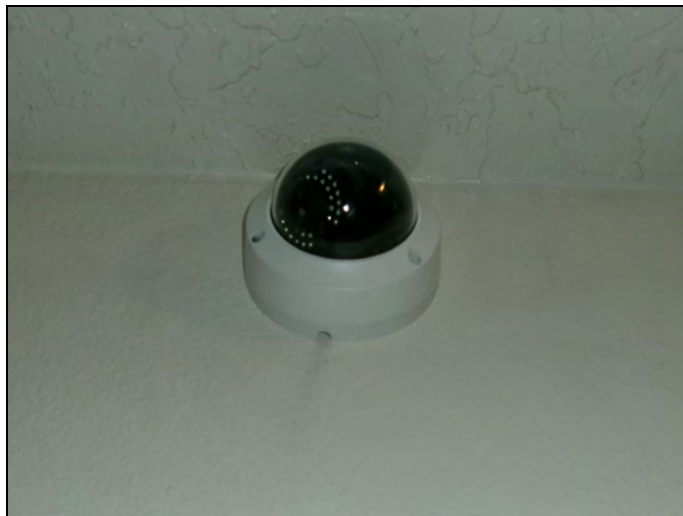
Comp #: 903 Security Camera Systems - Replace

*Location:* **Building Exterior**

*Quantity:* **(4) Systems**

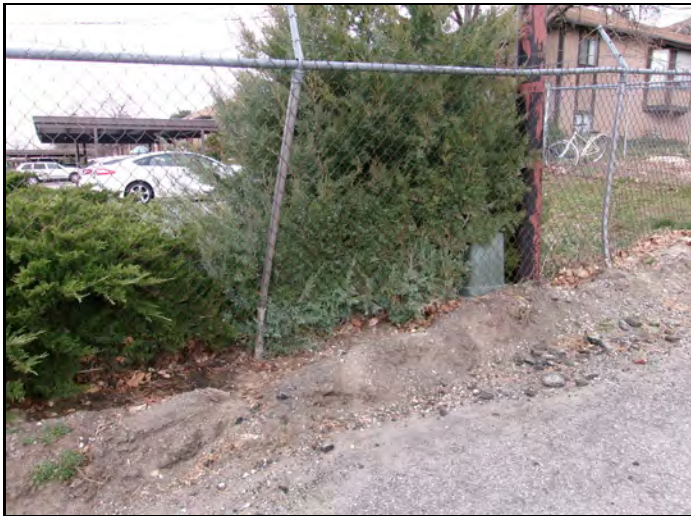
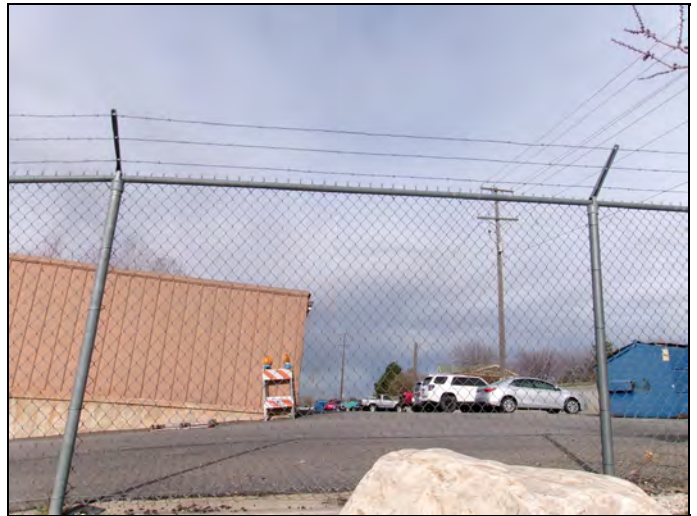
Comp #: 1003 Chain Link Fencing - Replace

*Location:* **Community Perimeter**

*Quantity:* **Approx. 575 LF**

The chain link fencing is in fair condition. We recommend funding to replace this component approximately every 30 - 40 years. Remaining life based on current age and condition.

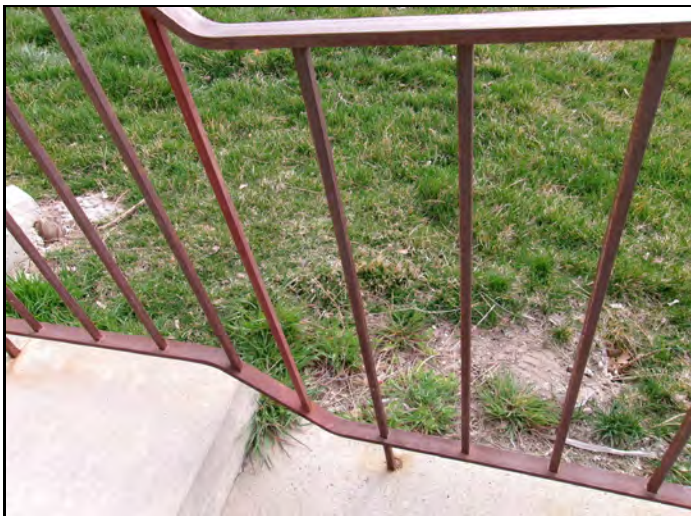
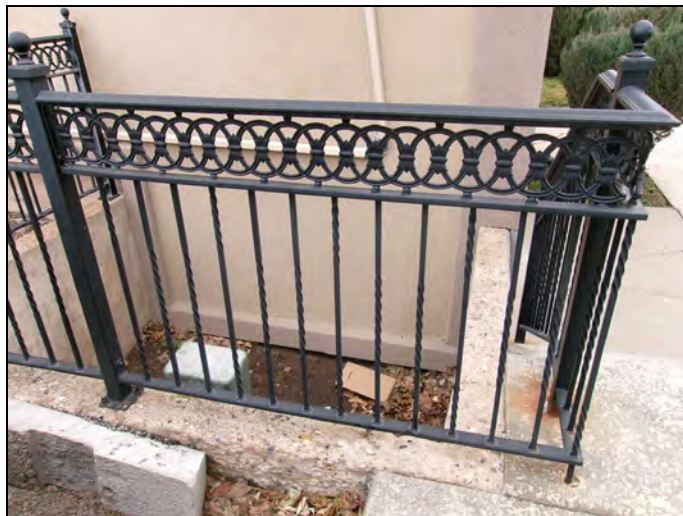
## Comp #: 1090 Metal Railing - Replace

*Location:* **Common Area**

*Quantity:* **Approx. 550 LF**

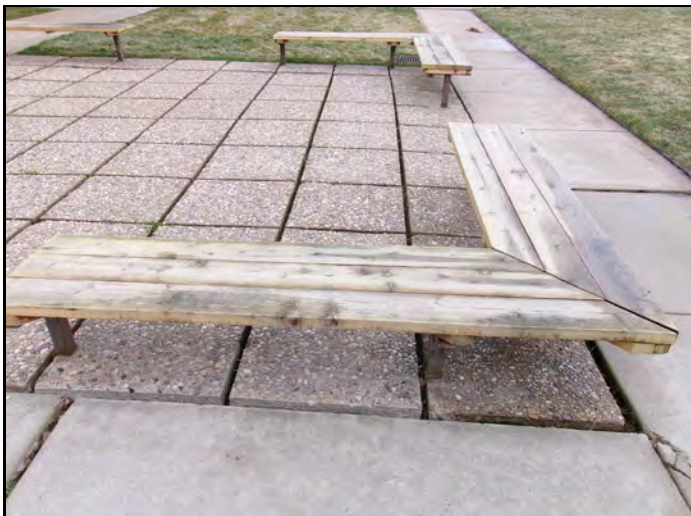
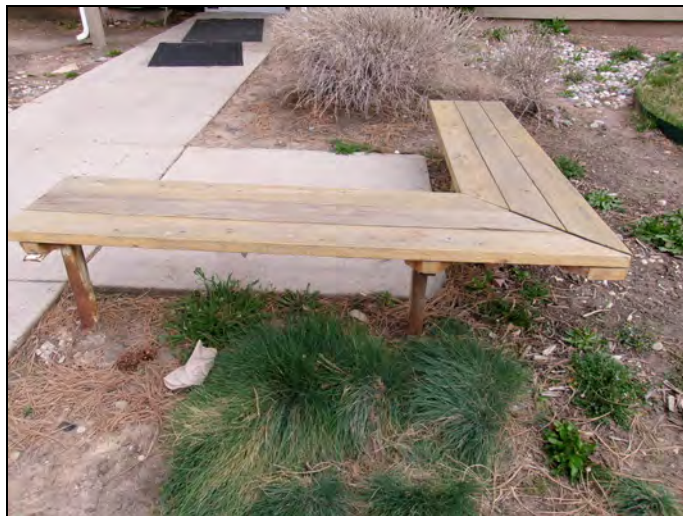
Comp #: 1307 Benches - Repaint/Replace

*Location:* **Common Area**

*Quantity:* **(6) Benches**

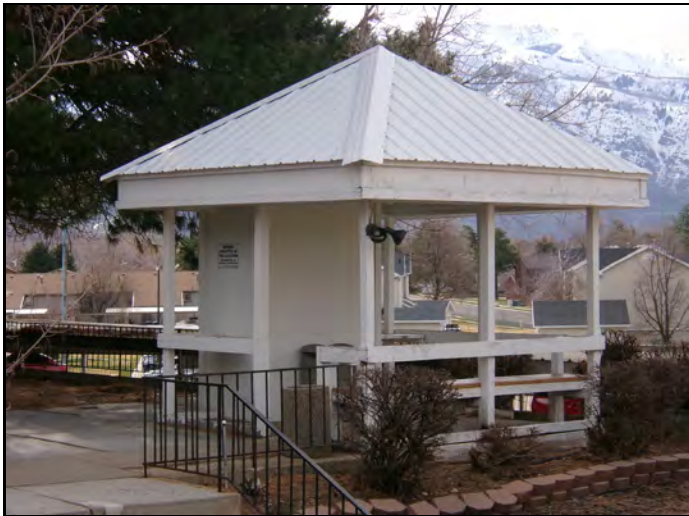
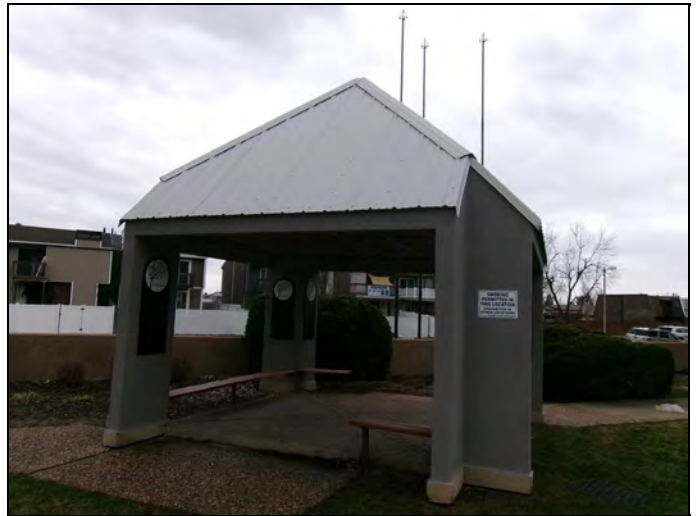
## Comp #: 1309 Pavilions - Refurbish

*Location:* **Common Area**

*Quantity:* **(2) Pavilions**

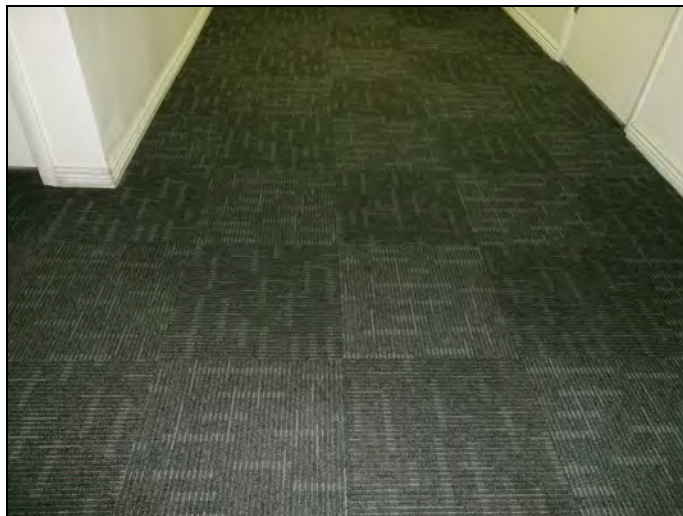
Comp #: 1501 Carpeting - Replace

*Location:* **Building Hallways**

*Quantity:* **Approx. 9,645 SF**

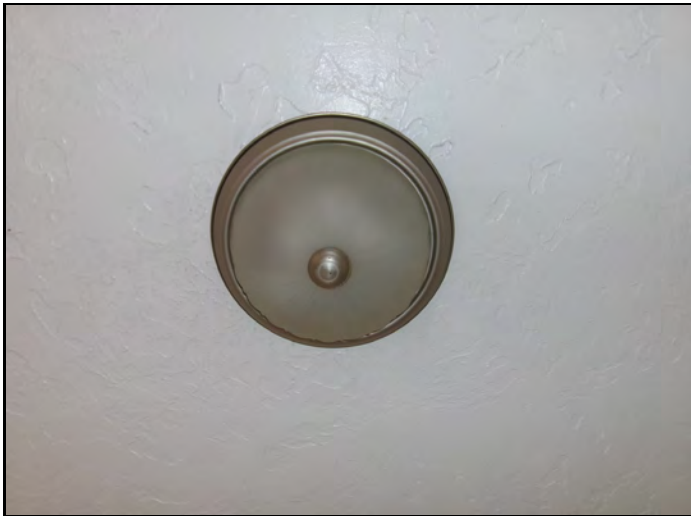
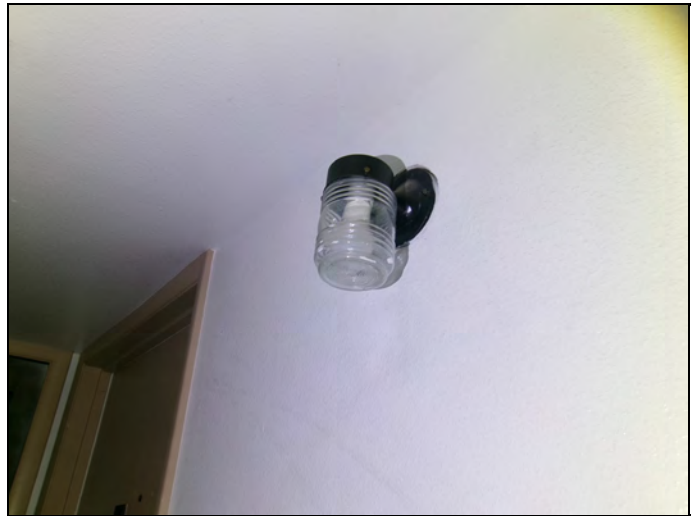
Comp #: 1601 Interior Light Fixtures - Replace

*Location:* **Building Hallways**

*Quantity:* **(180) Fixtures**

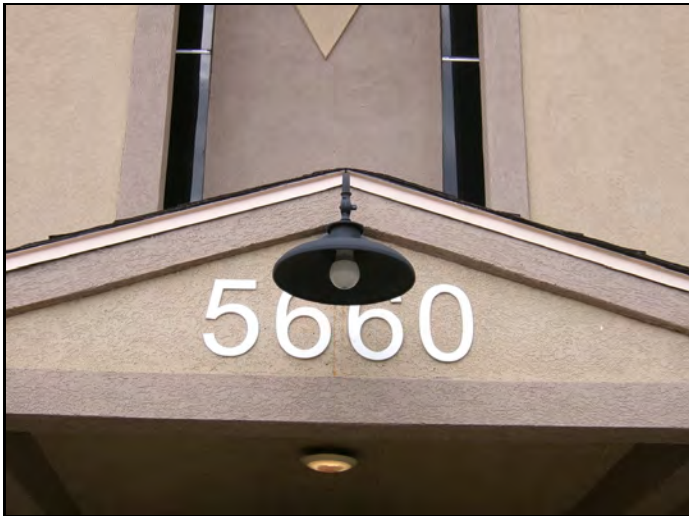
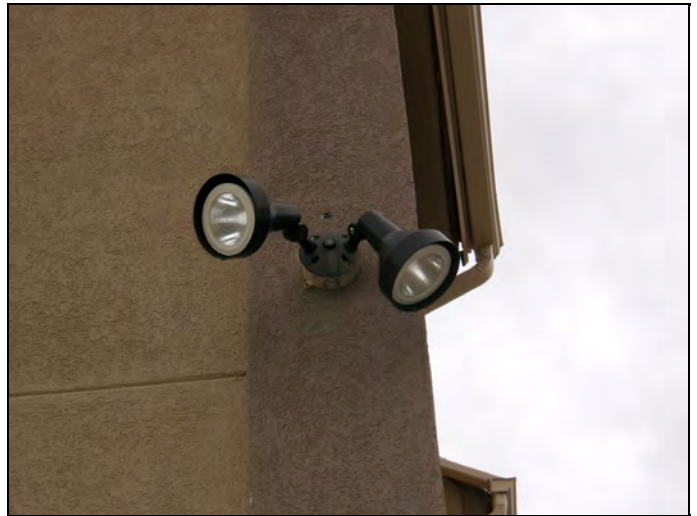
Comp #: 1602 Exterior Light Fixtures - Replace

*Location:* **Building Exteriors**

*Quantity:* **(27) Fixtures**

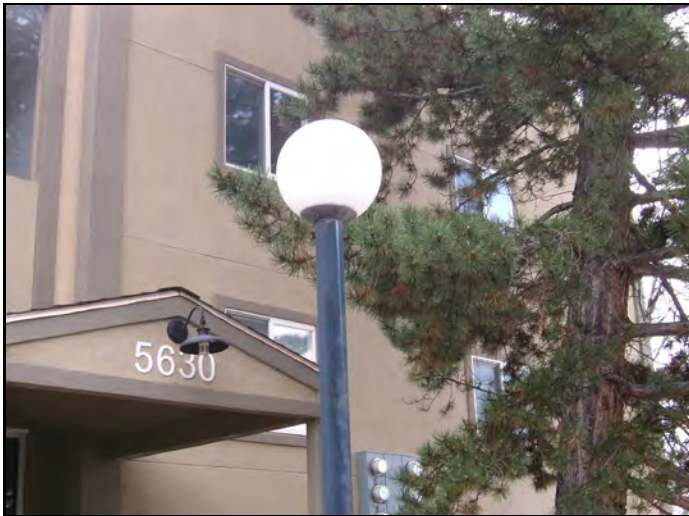
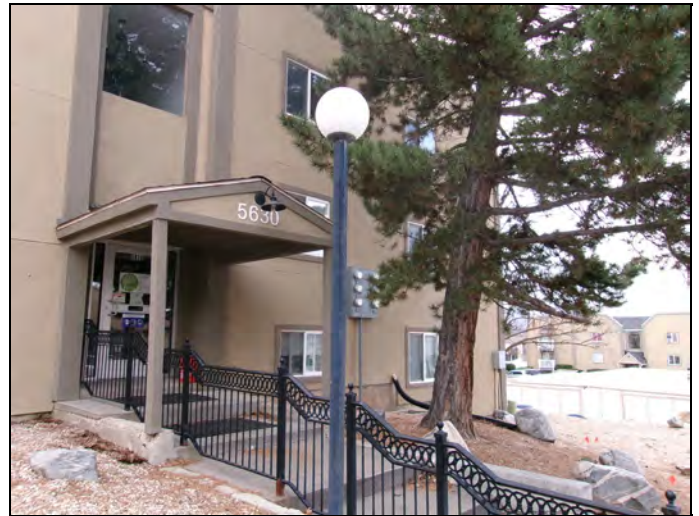
Comp #: 1604 Pole Light - Replace

*Location:* **Common Area**

*Quantity:* **(1) Pole Light**

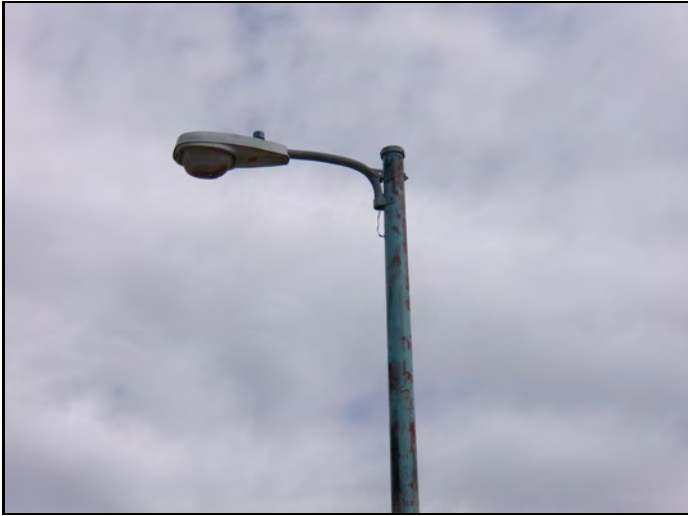
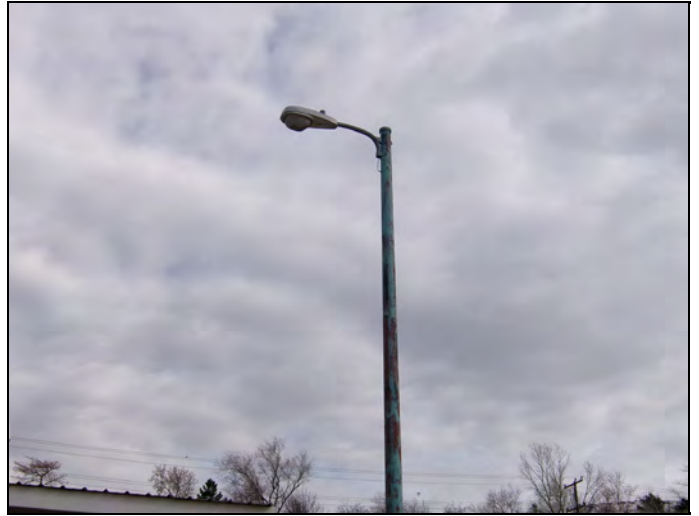
Comp #: 1609 Street Light Fixtures - Replace

*Location:* **Community Streets**

*Quantity:* **(2) Fixtures**

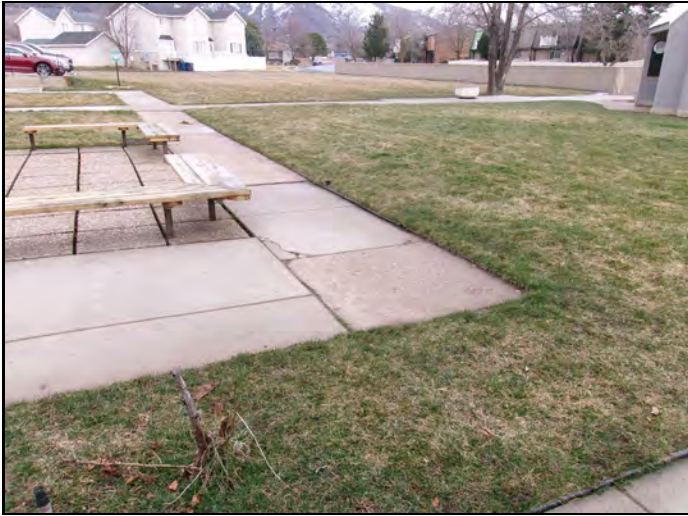
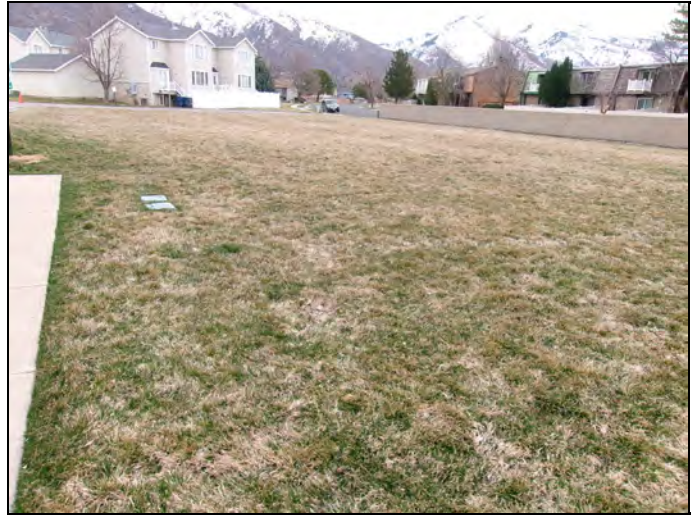
Comp #: 1812 Landscaping & Irrigation System - Renovate

*Location:* **Common Area**

*Quantity:* **Extensive SF**

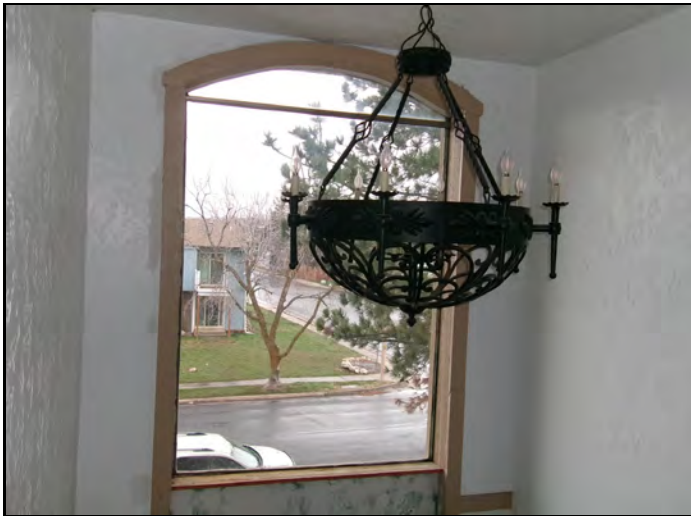
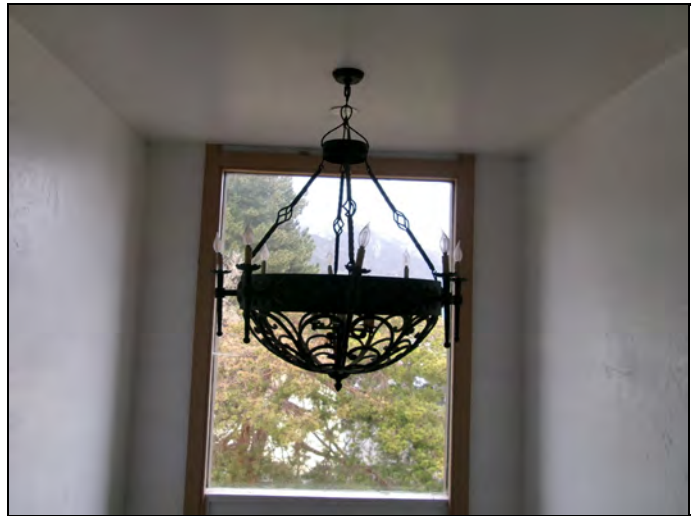
## Comp #: 2303 Windows - Replace

*Location:* **Building Common Areas**

*Quantity:* **(6) Windows**

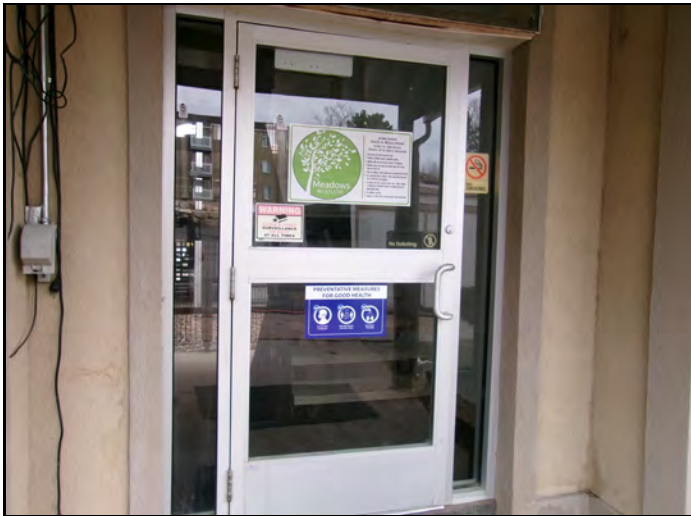
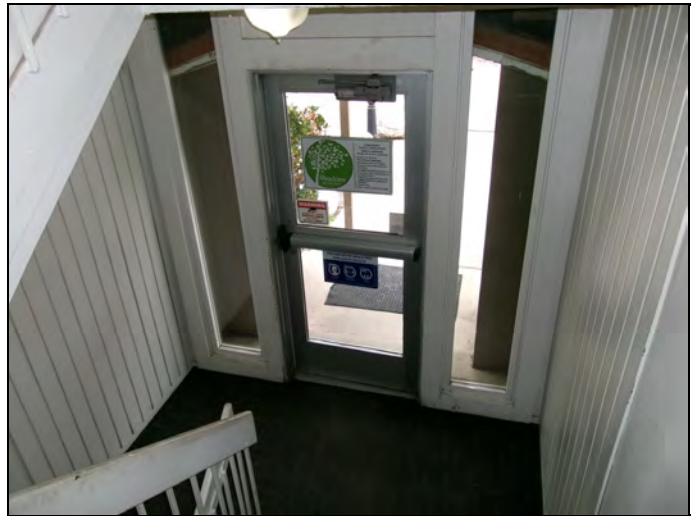
## Comp #: 2304 Exterior Doors - Repair

*Location:* **Building Common Areas**

*Quantity:* **(12) Doors**
