Knollwood Condo Association

Level 2 Reserve Study

Report Period – 01/01/2021 – 12/31/2021

Type of Study	Update w/Site Visit
Date of Property Inspection	10/22/2020
Prepared By	Dale Gifford
Analysis Method	Cash Flow
Funding Goal	Full Funding

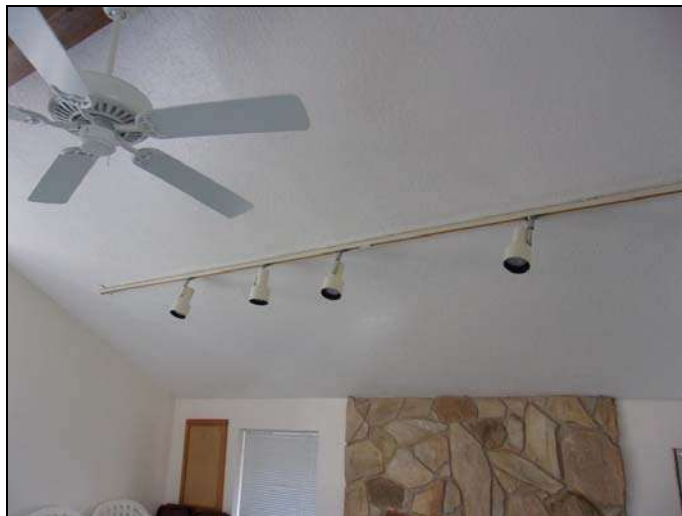
Comp #: 216 Interior Surfaces - Repaint

The interior painted surfaces are in fair condition. We recommend funding to repaint this component approximately every 10 years. Remaining life based on current age and condition.
