Spring View Farms HOA

Level 1 Reserve Study

Report prepared on – Monday, May 01, 2023

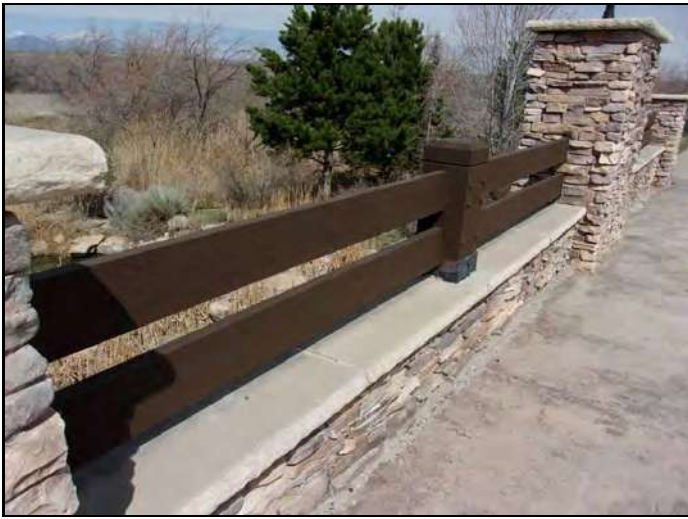
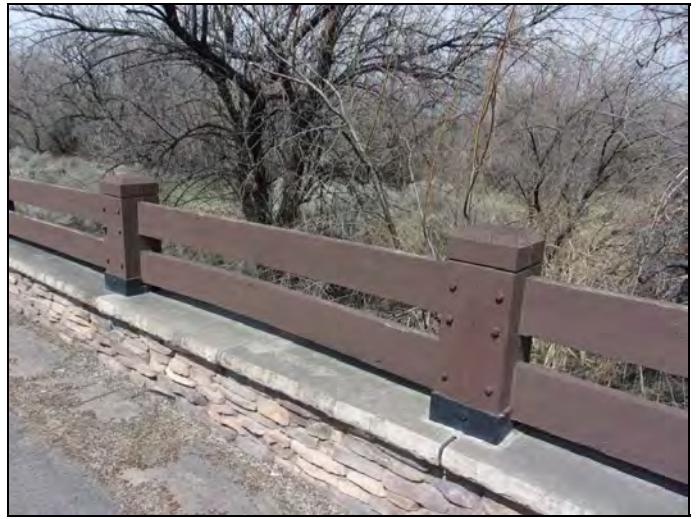
Comp #: 209 Wood Railing - Repaint

90 LF - South Entrance, East Side
80 LF - Walking Trail Bridge, East Side

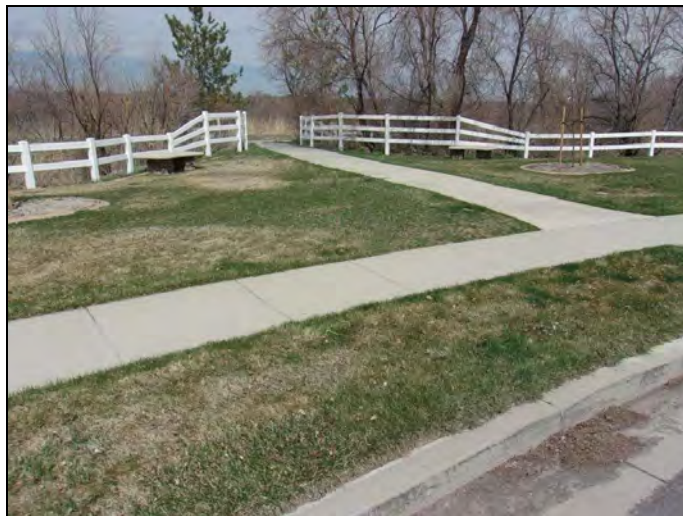
Comp #: 1812 Landscaping & Irrigation System - Renovate

The association's significant reserve projects are secondary water pump system east replace (Comp# 714), secondary water pump system west replace (Comp# 715), landscaping and irrigation system renovate (Comp# 1812), and entrance water pump system replace (Comp# 713). The fiscal significance of these components is approximately 26%, 26%, 11%, and 9% respectively (see page 9). A component's significance is calculated by dividing its replacement cost by its useful life. In this way, not only is a component's replacement cost considered but also the frequency of occurrence. These components most significantly contribute to the total monthly reserve contribution. As these components have a high level of fiscal significance the association should properly maintain them to ensure they reach their full useful lives.
