# Millstone Manor Condo Association

## Level 2 Reserve Study

**Report Period – 01/31/2026 – 12/31/2026**

## Executive Summary – Millstone Manor Condo Association – ID # 10612

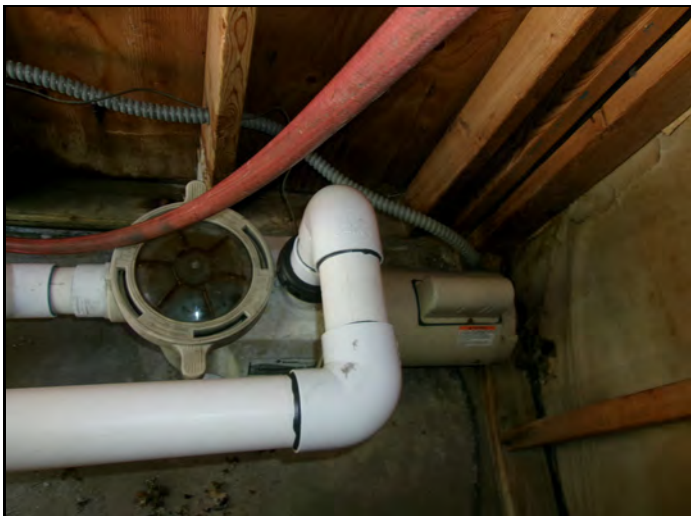
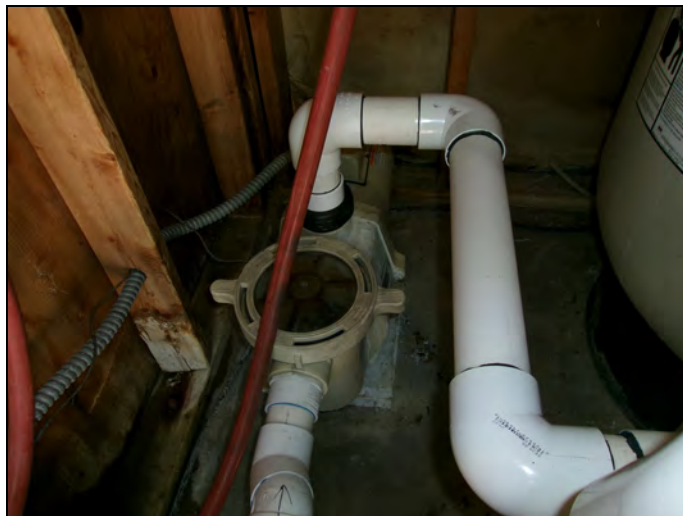
Comp #: 1110 Pool Pump - Replace

The pool pump is in working condition. We recommend funding to replace this component approximately every 8 - 10 years. Remaining life based on current age and condition.

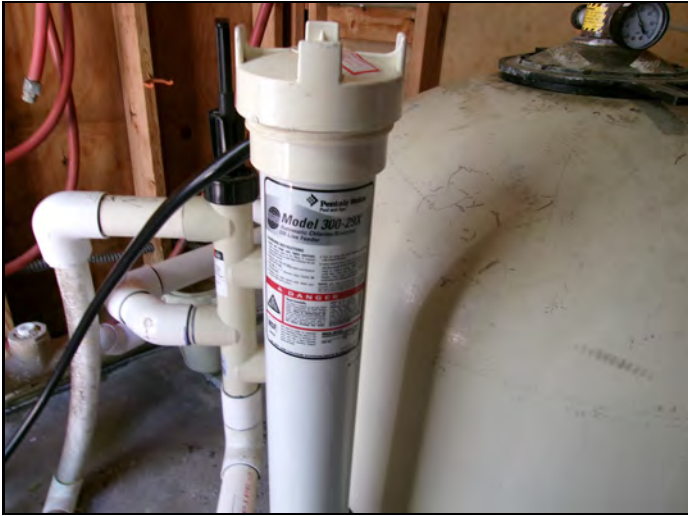
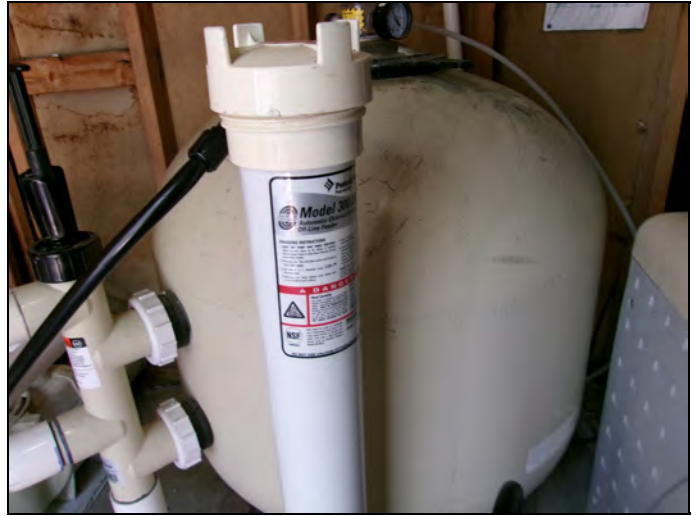
Comp #: 1111 Pool Chemical Feeder - Replace

Due to the minimal cost associated with replacing this component, reserve funding is not appropriate. Replace as necessary as an operating expense.

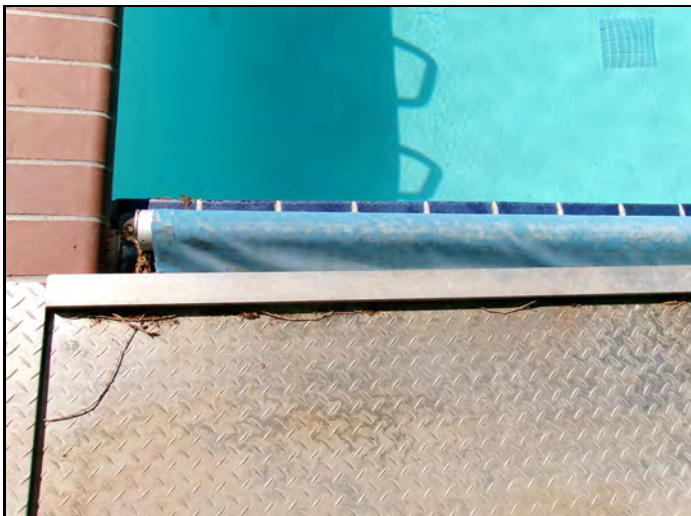
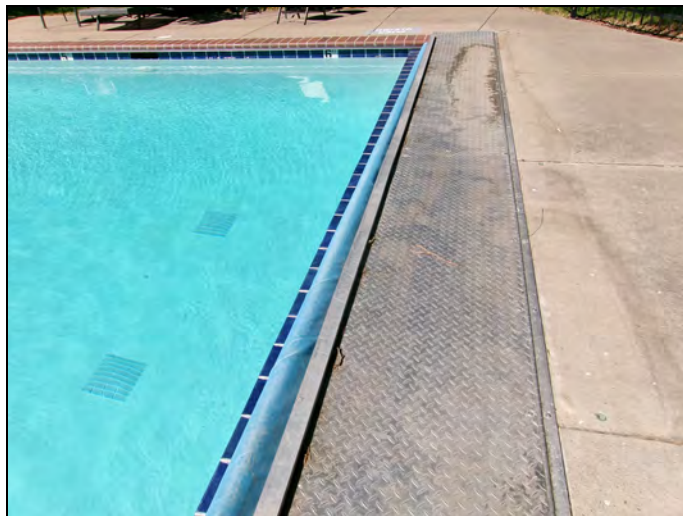
## Comp #: 1112 Pool Cover - Replace

Unable to inspect this component at the time of the site visit. We recommend funding to replace this component approximately every 10 years. Remaining life based on current age.

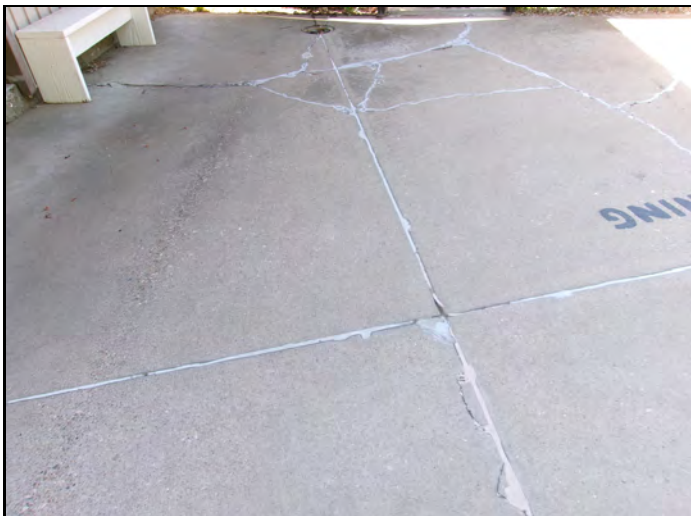
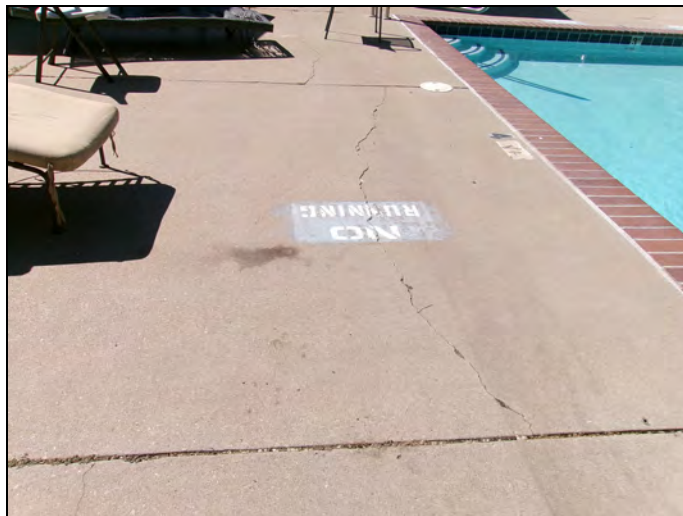
## Comp #: 1116 Pool Deck - Replace

The pool deck is in fair condition. We recommend funding to replace this component approximately every 40 - 50 years. Remaining life based on current age.

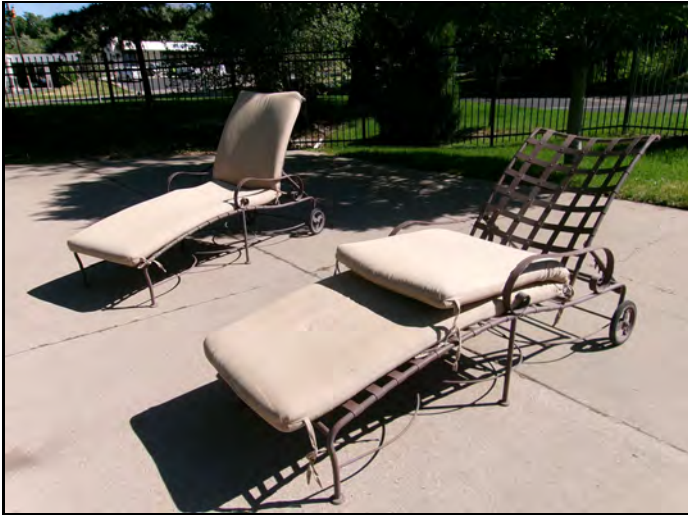
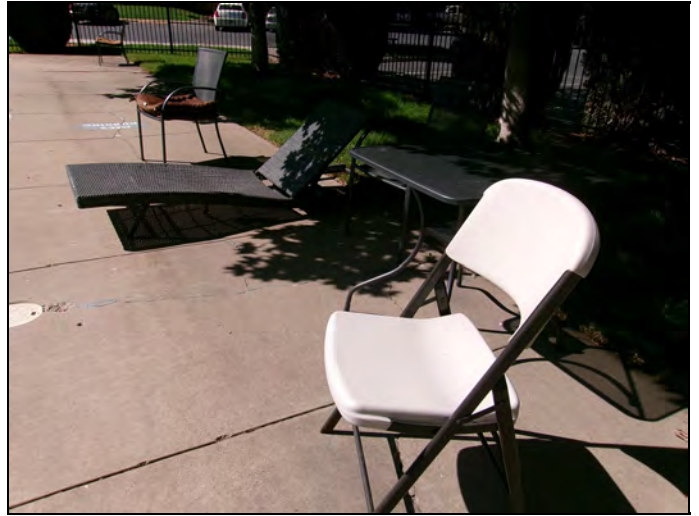
Comp #: 1121 Pool Furniture - Replace

Due to the minimal replacement cost associated with this component, reserve funding is not appropriate. Replace as necessary as an operating expense.

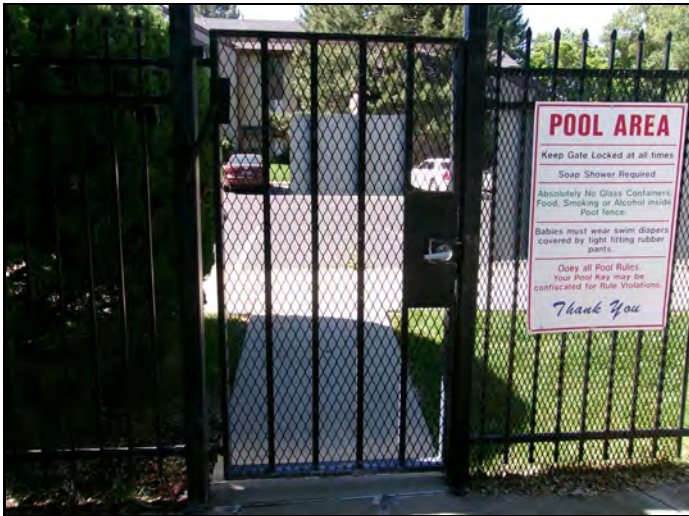
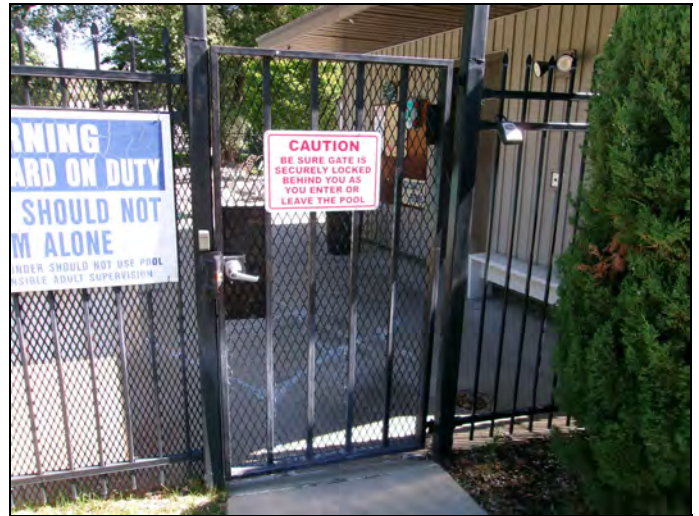
Comp #: 1190 Pool Gate - Replace

The pool gates are in fair condition. We recommend funding to completely replace this component approximately every 25 - 30 years. Remaining life based on current condition.

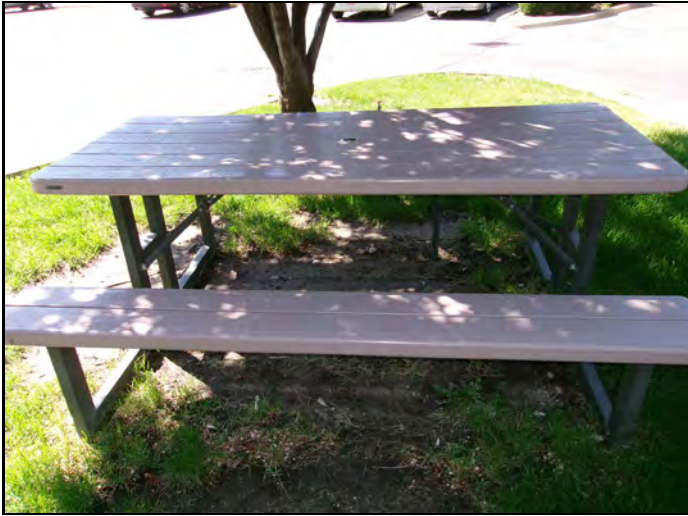
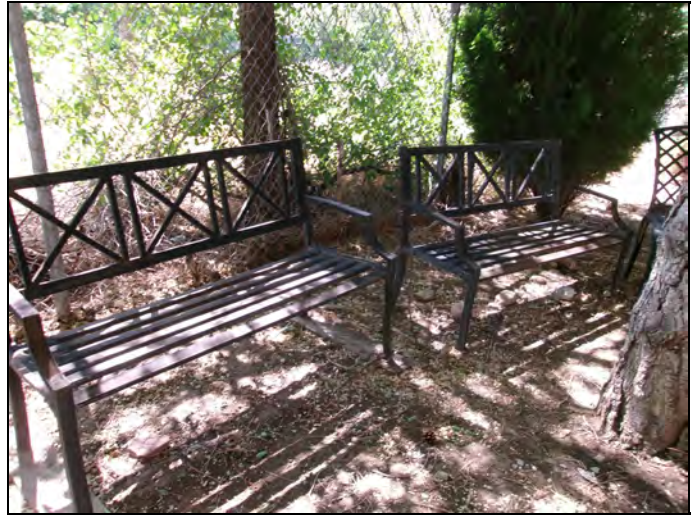
Comp #: 1305 Park Furniture - Replace

Due to the minimal replacement cost associated with replacing this component, reserve funding is not appropriate. Replace as necessary as an operating expense.

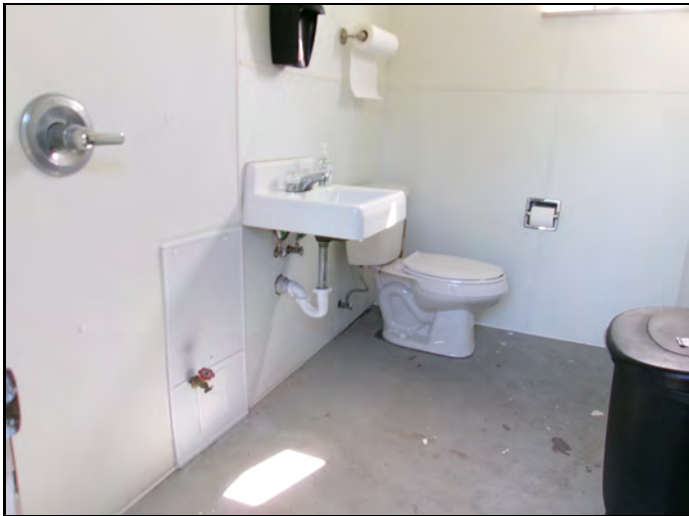
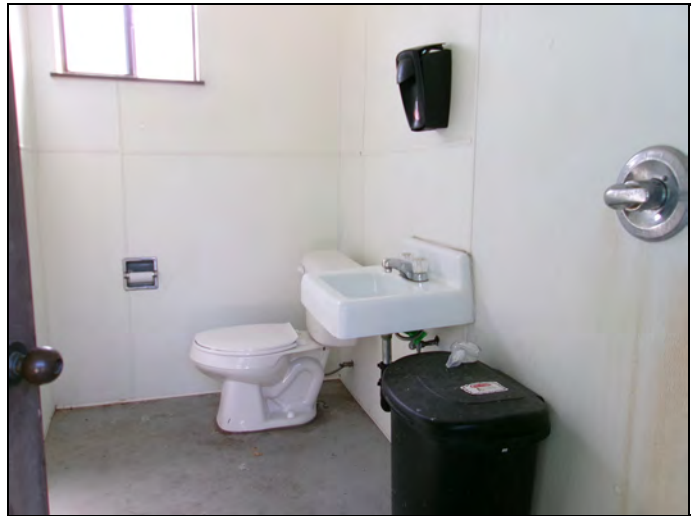
## Comp #: 1413 Restrooms - Remodel

The restrooms are in fair condition. We recommend funding to remodel this component approximately every 20 years. Remaining life based on current age and condition.

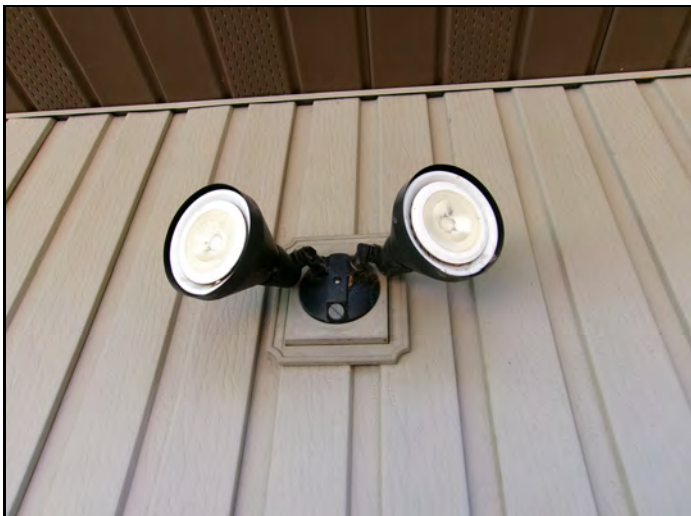
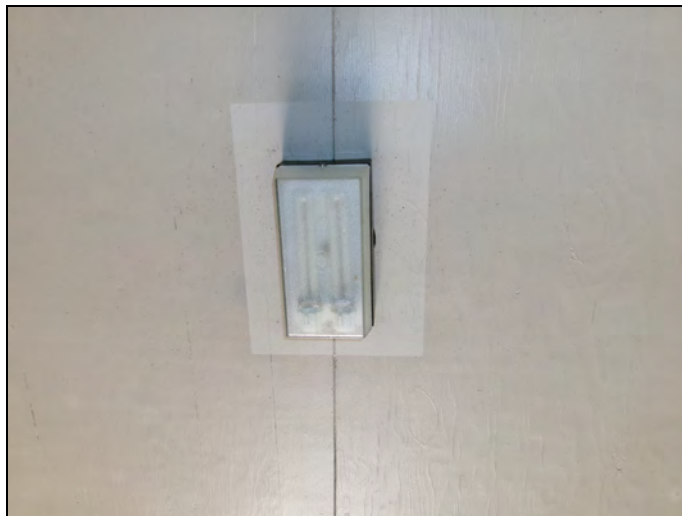
Comp #: 1602 Exterior Light Fixtures - Replace

The exterior light fixtures are in good to fair condition. We recommend funding to replace this component approximately every 16 - 20 years. Remaining life based on current age and condition.

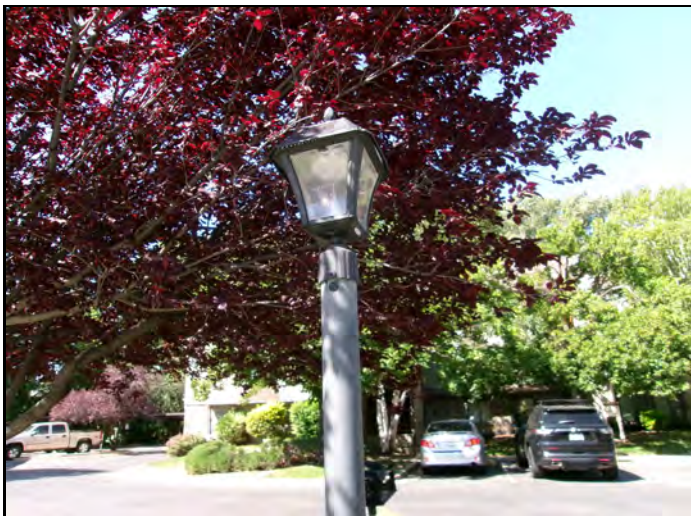
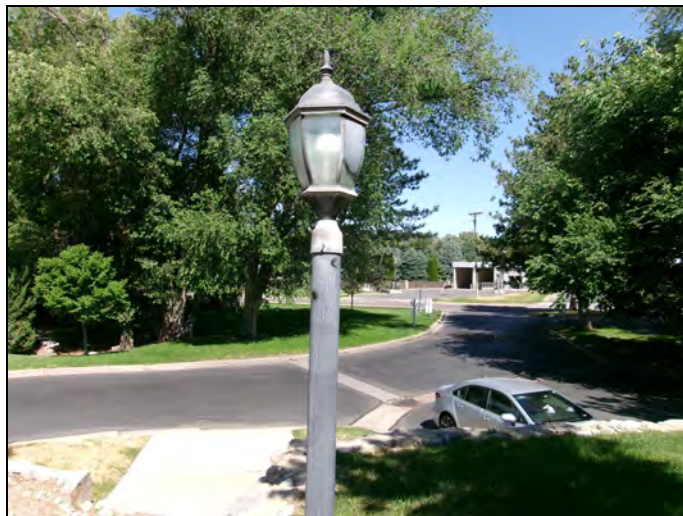
## Comp #: 1604 Pole Lights - Replace

The pole lights are in fair condition. We recommend funding to replace these pole light fixtures, poles and to refurbish the electrical approximately every 16 - 20 years. Remaining life based on current age.

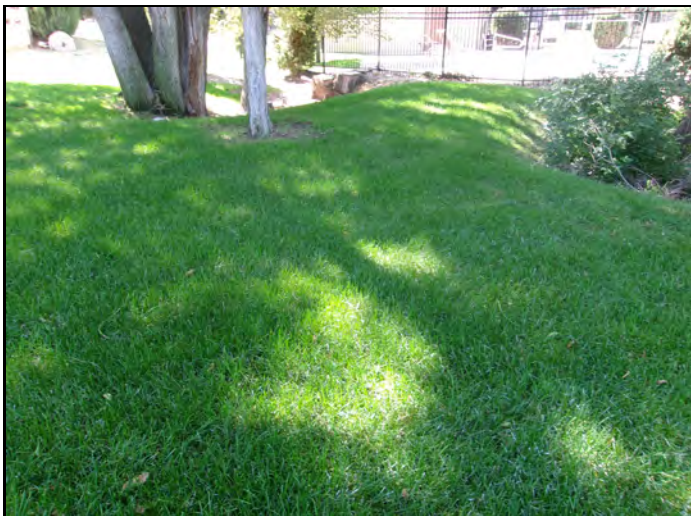
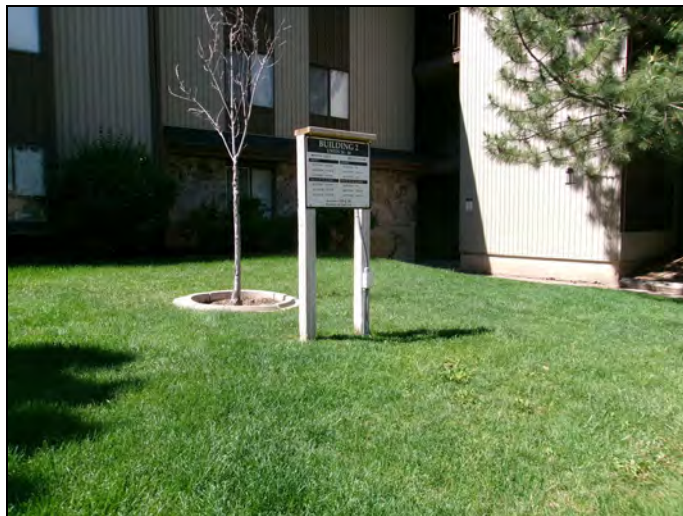
Comp #: 1812 Landscaping & Irrigation System - Renovate

The landscaping and irrigation system appear to be in good to fair condition. We recommend funding for an allowance to renovate this component approximately every 20 years. Remaining life based on current age and condition.

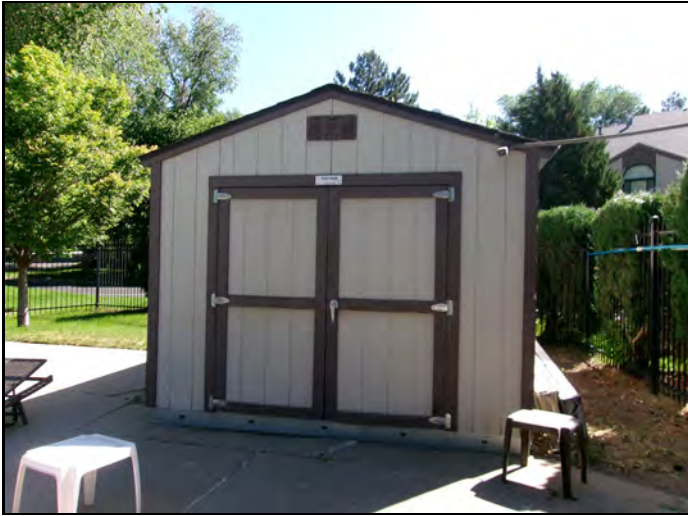
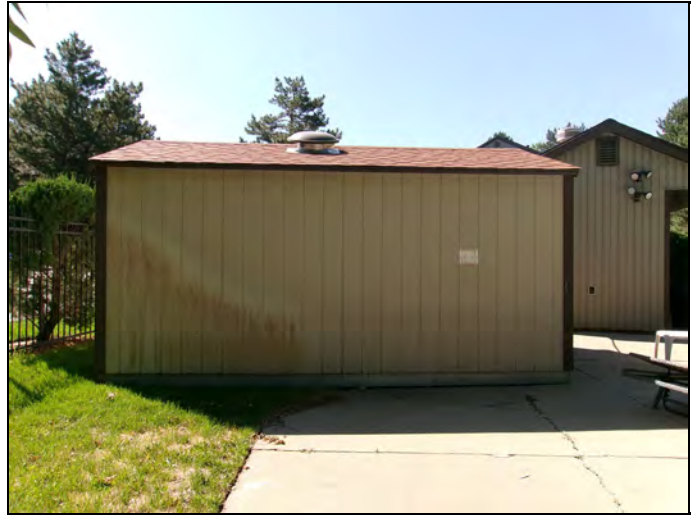
Comp #: 2301 Shed - Replace

The shed is in good to fair condition. We recommend funding to replace this component approximately every 25 - 30 years. Remaining life is based on current age.

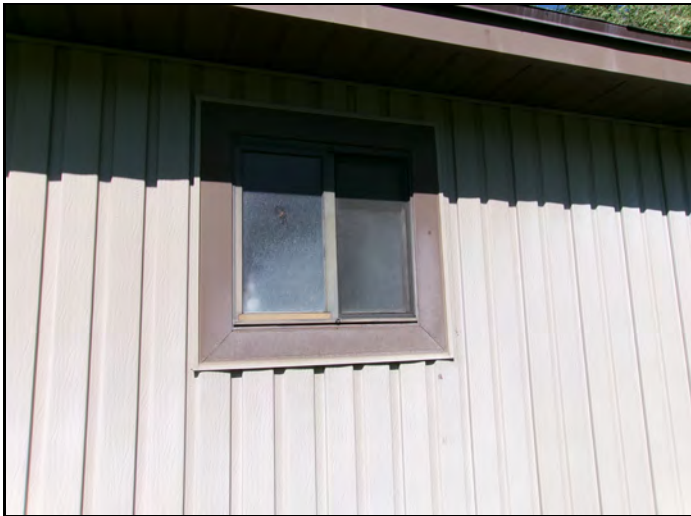
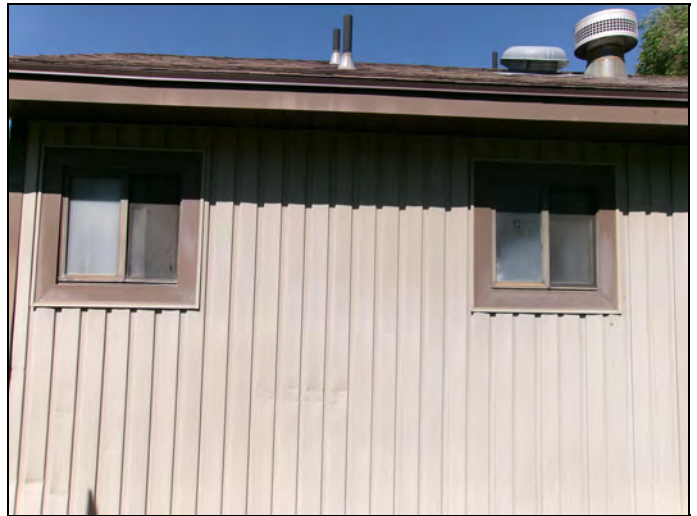
Comp #: 2303 Windows - Replace

Due to the minimal cost of replacing this component, reserve funding is not appropriate. Replace as necessary as an operating expense.

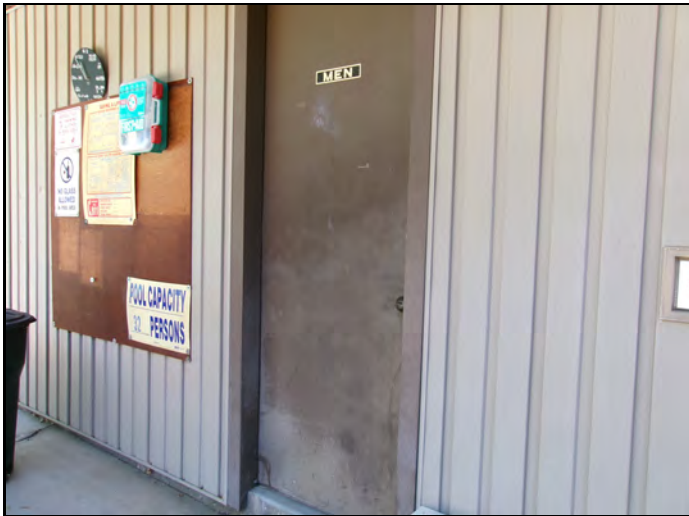
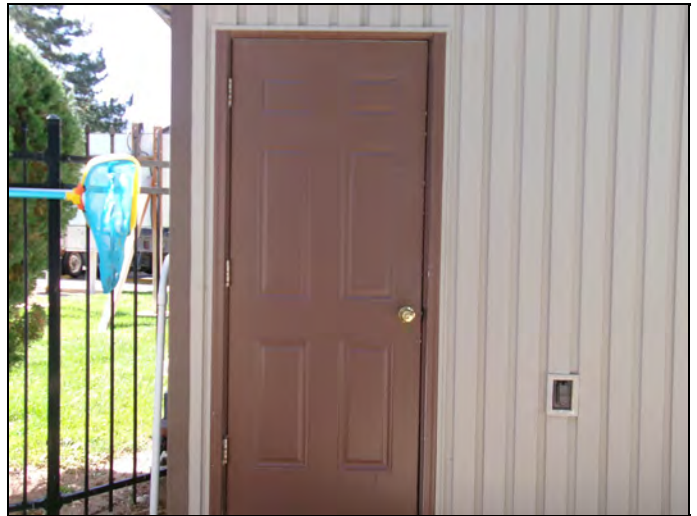
## Comp #: 2304 Exterior Doors - Replace

The doors are in fair condition. We recommend funding to replace this component approximately every 40 - 50 years. Remaining life based on current age.
