# **The Terraces at Holladay Condominiums**

## **Level 2 Reserve Study**

**Report Period – 01/01/2025 – 12/31/2025**

| <b>Date of Property Inspection</b> | <b>7/17/2024</b> |

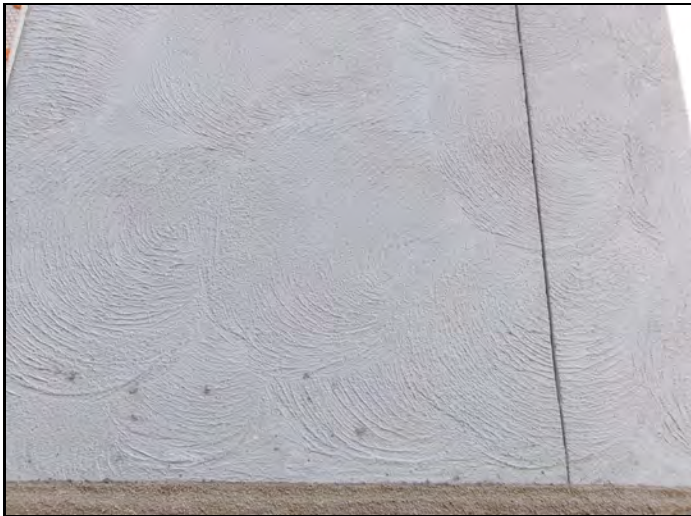
Comp #: 604 Walkways - 3rd Floor - Resurface

The walkway surfaces are in good condition. We recommend funding to resurface this component approximately every 15 - 20 years. Remaining life based on current age.

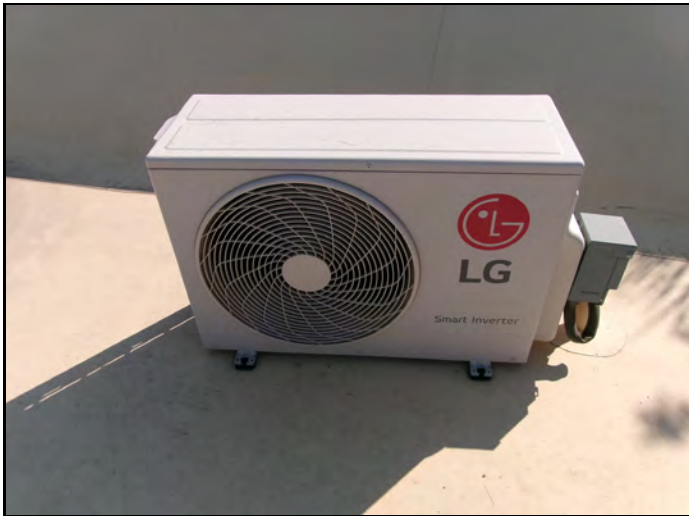
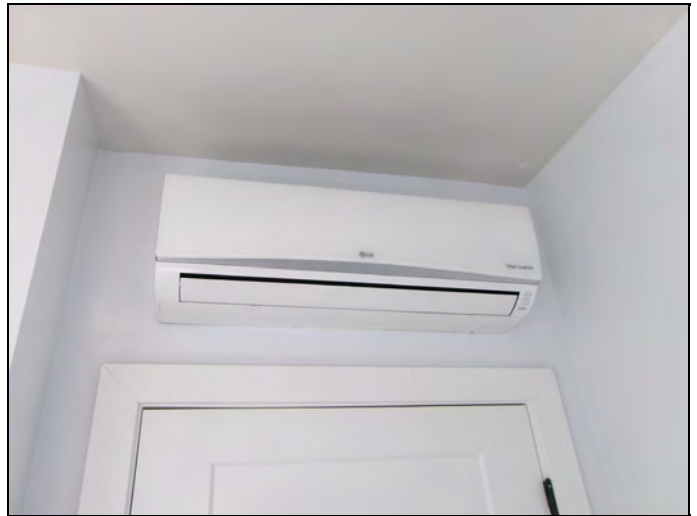
Comp #: 705 HVAC Ductless Split Systems - Replace

The HVAC systems are in working condition. We recommend replacing this component approximately every 20 years. Remaining life based on current age.

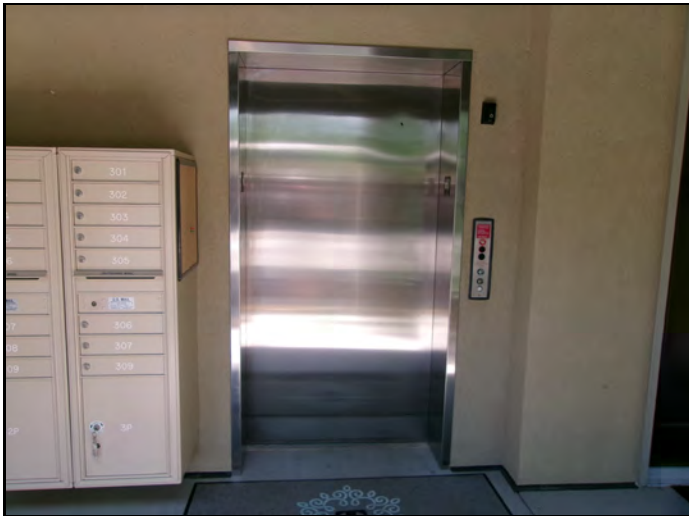
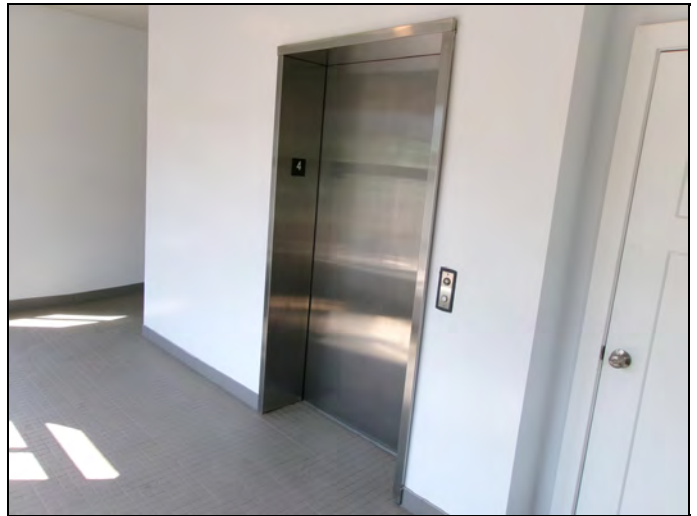
Comp #: 707 Elevators - Modernize

The elevator is in working condition. We recommend funding to modernize this component approximately every 25 - 30 years. Modernization consists of controller replacement, door package upgrade, and control panel replacement. Remaining life based on current age.

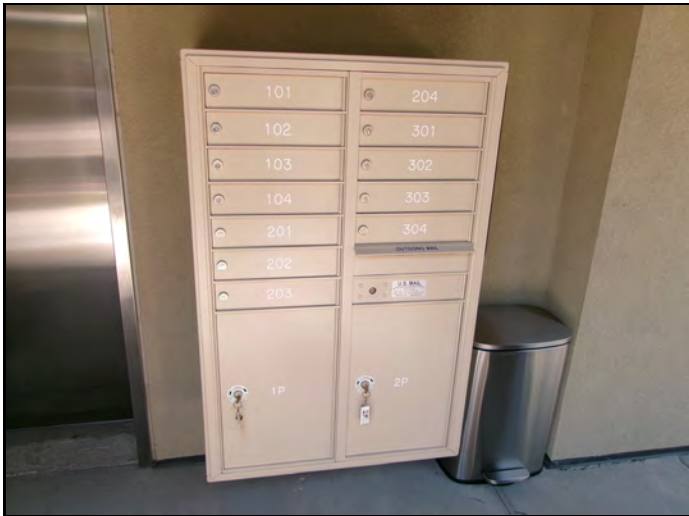
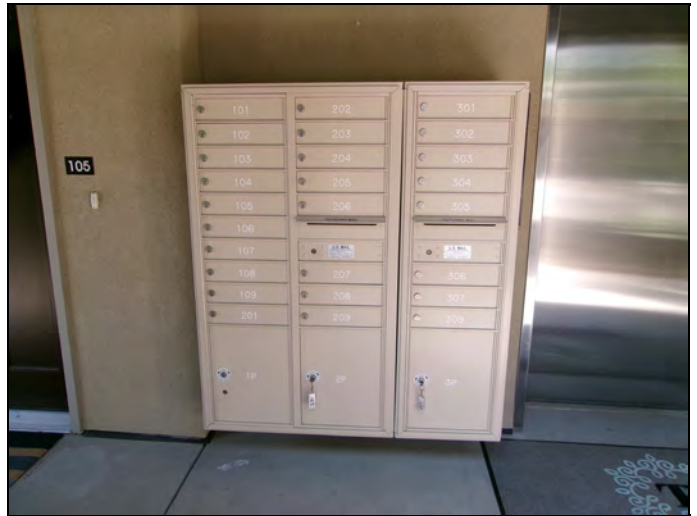
Comp #: 803 Mailboxes - Replace

The mailboxes are in good condition. We recommend funding to replace this component approximately every 20 - 25 years. Remaining life based on current age.

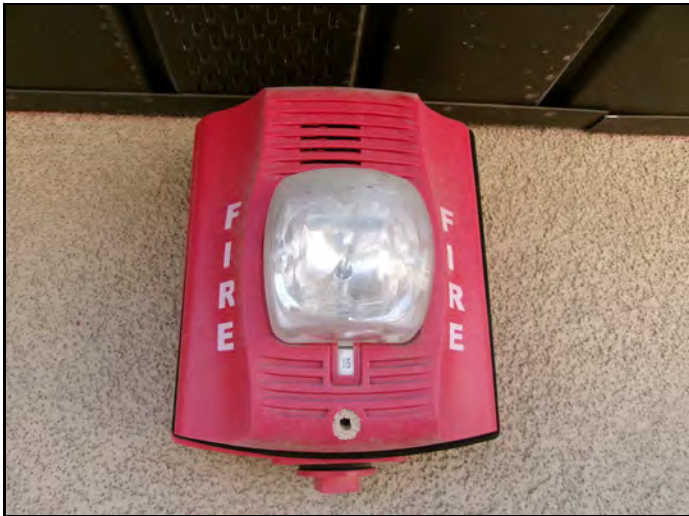
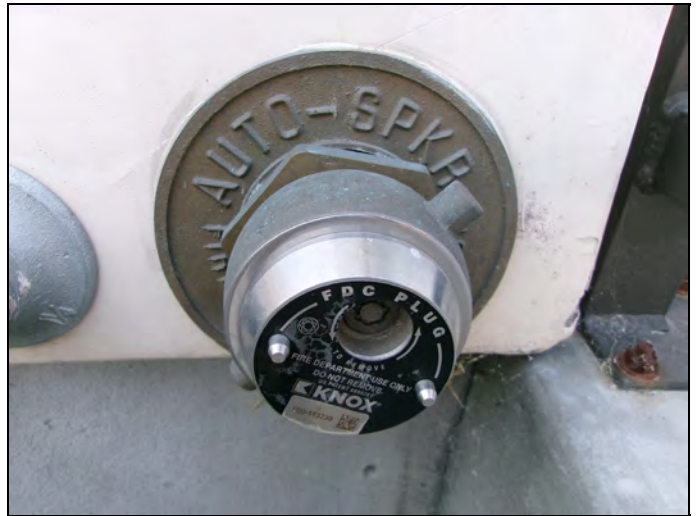
Comp #: 901 Fire Protection Systems - Renovate

The fire protection system is in working condition. We recommend funding for an allowance to renovate this component approximately every 15 - 20 years. Remaining life based on current age.

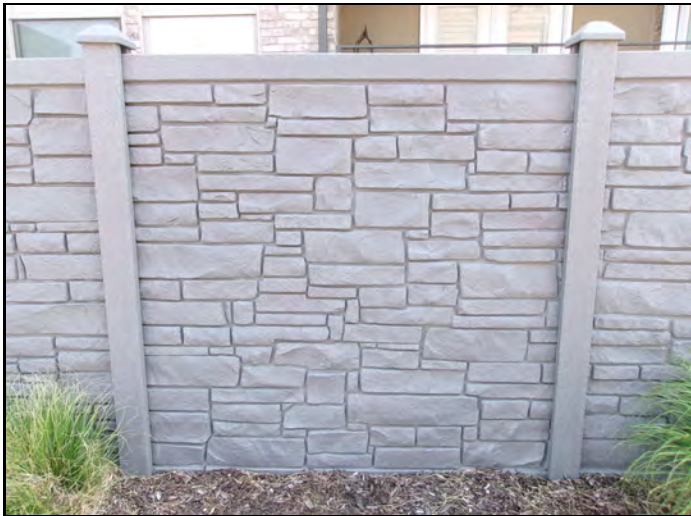
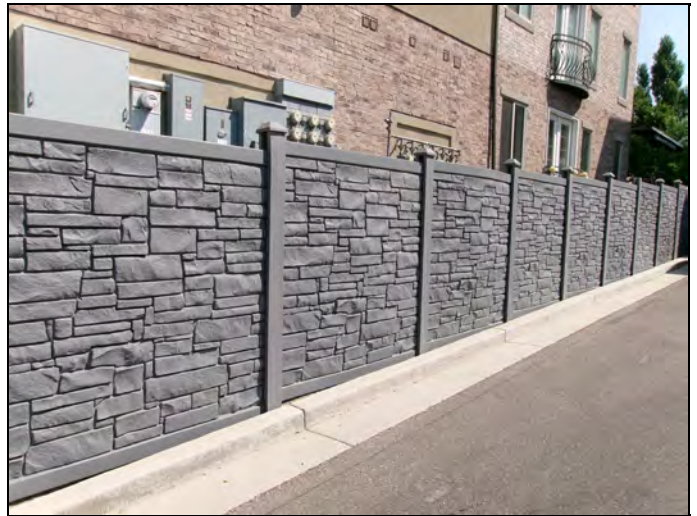
Comp #: 1008 SimTek Fencing - Replace

The SimTek fencing is in good condition. We recommend funding to replace this component approximately every 40 - 50 years. Remaining life based on current age.

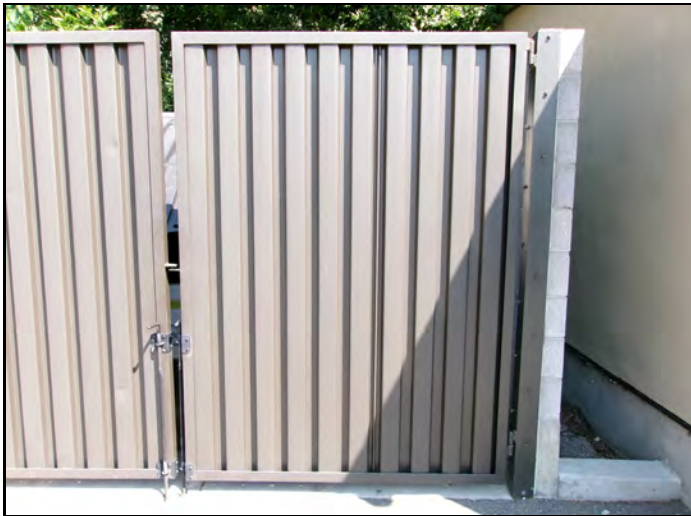
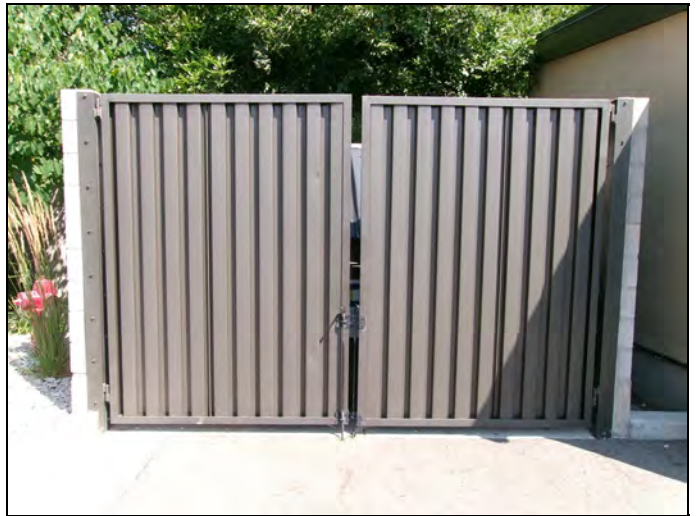
Comp #: 1010 Dumpster Gates - Replace

The dumpster gates are in good condition. We recommend funding to replace these gates approximately every 25 - 30 years. Remaining life based on current age.

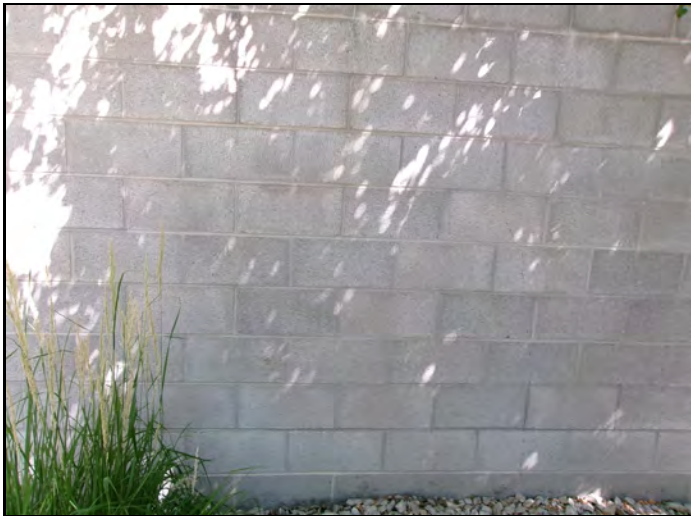
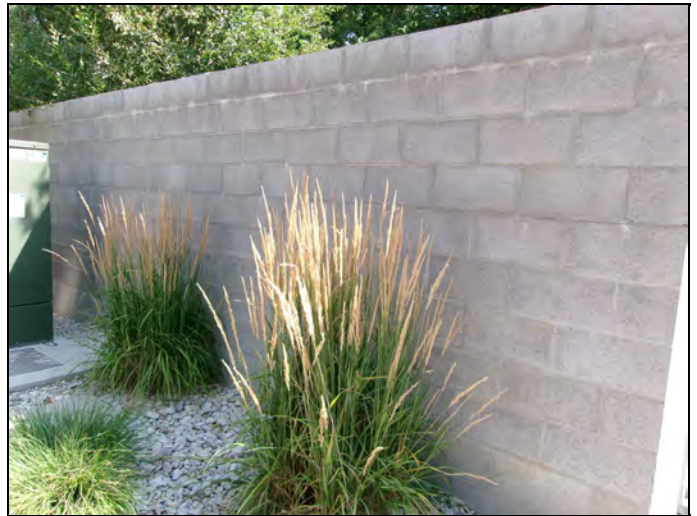
Comp #: 1012 Block Wall - Replace

This type of component should have an extended useful life under normal conditions. Reserve funding is not appropriate.

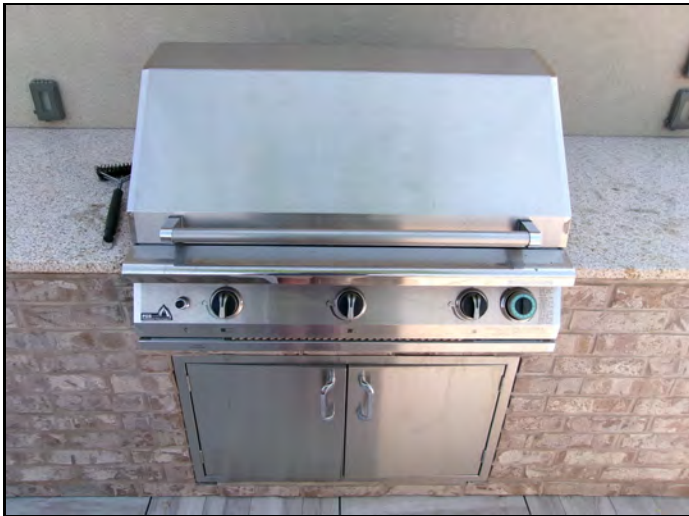
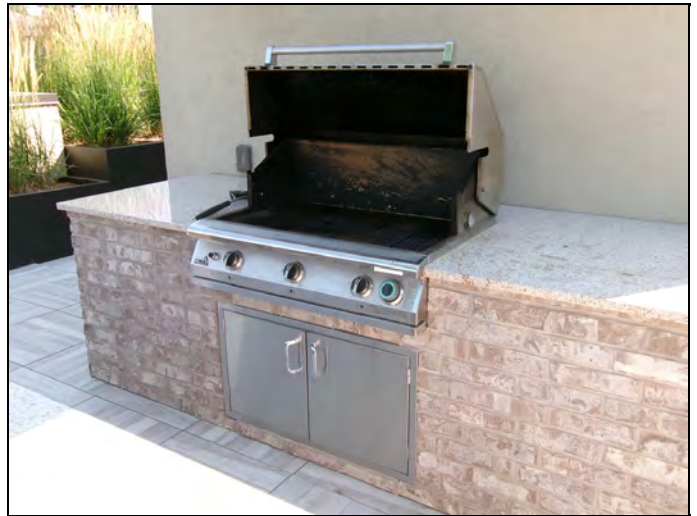
Comp #: 1305 Roof Barbecue Grills - Replace

The barbecue grill is in working condition. We recommend funding to replace this component approximately every 8 - 10 years. Remaining life based on current age.

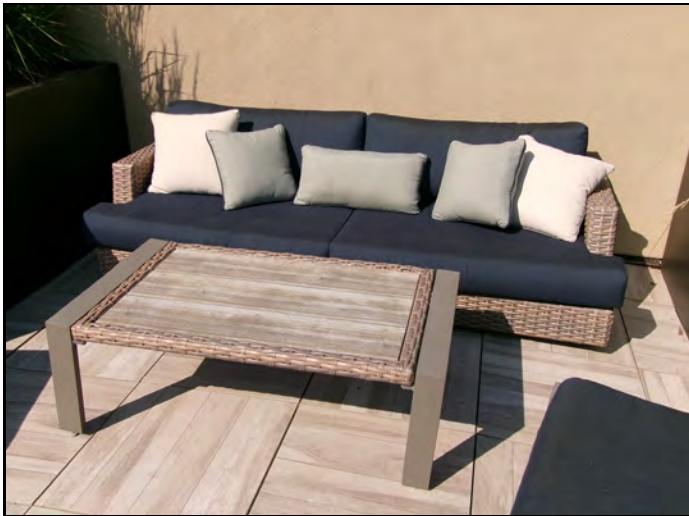
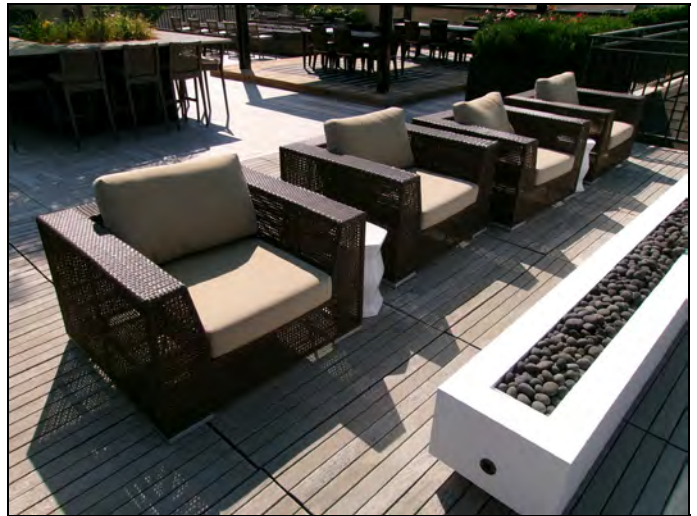
## Comp #: 1306 Roof Patio Furniture - Partial Replace

The patio furniture is in good to fair condition. We recommend funding to partially replace this component approximately every 10 years. Remaining life based on current age.

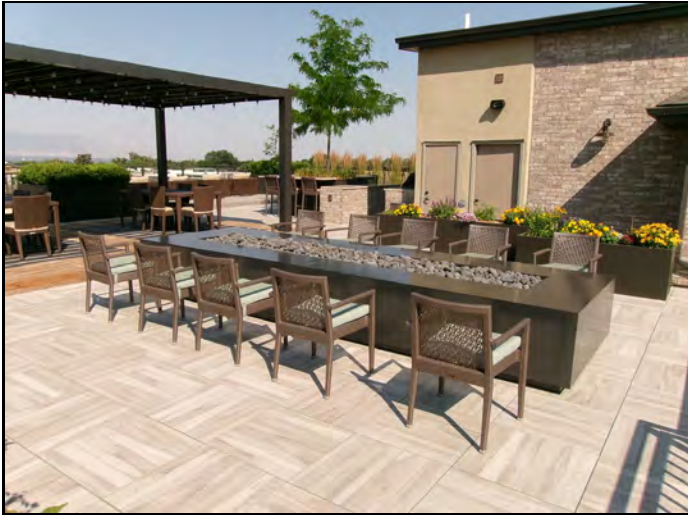
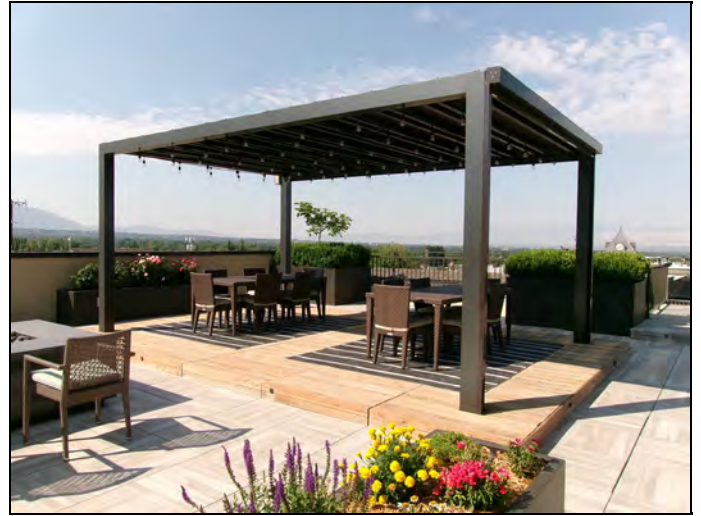
Comp #: 1390 Roof Patio - Remodel

The roof patio area is in good to fair condition. We recommend funding to remodel this component approximately every 20 years. Remaining life based on current age.

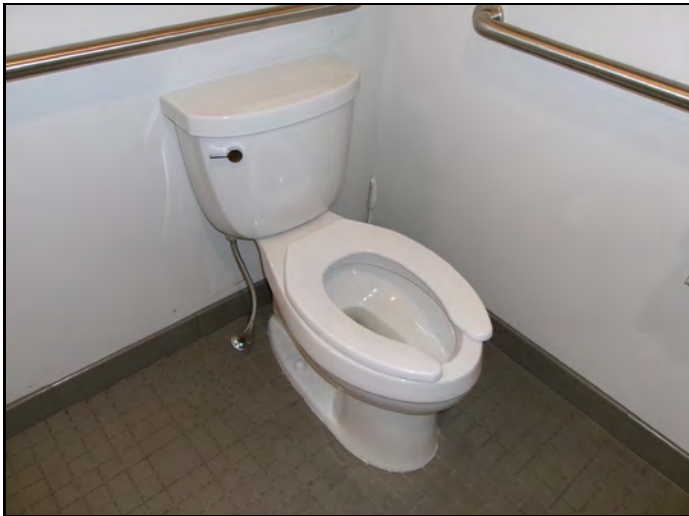
## Comp #: 1413 Restroom - Remodel

The restroom is in in good to fair condition. We recommend funding to remodel this component approximately every 20 years. Remaining life based on current age.

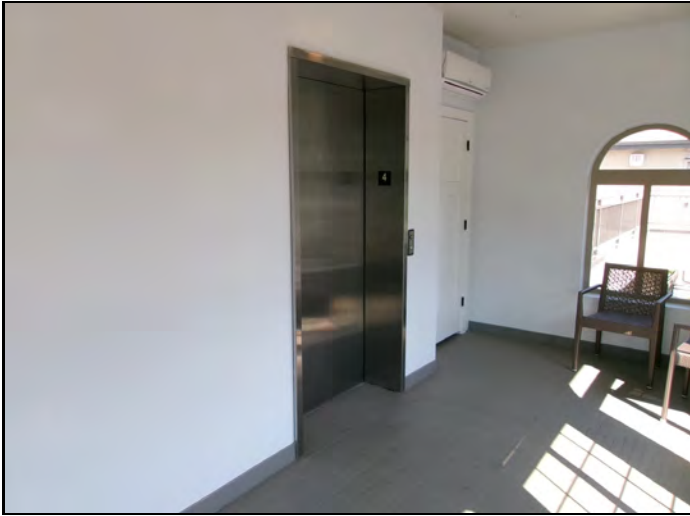
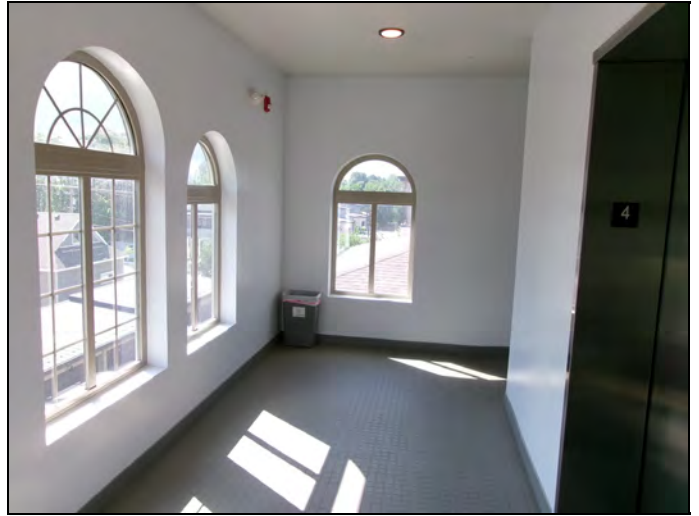
Comp #: 1415 Elevator Lobby - Remodel

The elevator lobby is in good condition. We recommend funding to remodel this component approximately every 20 years. Remaining life based on current age.

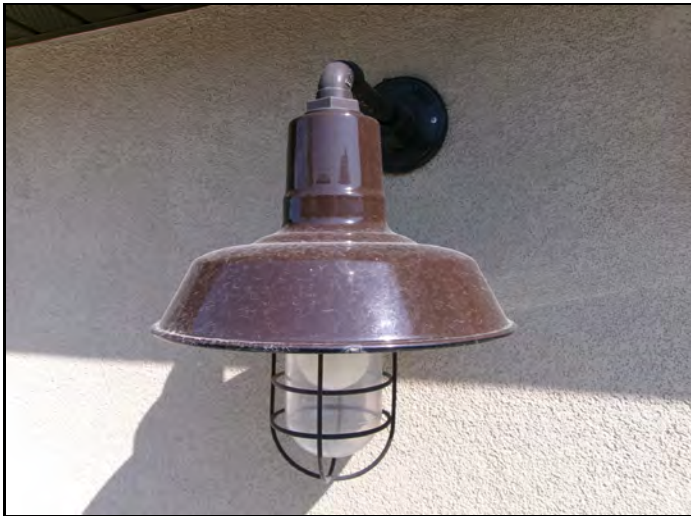
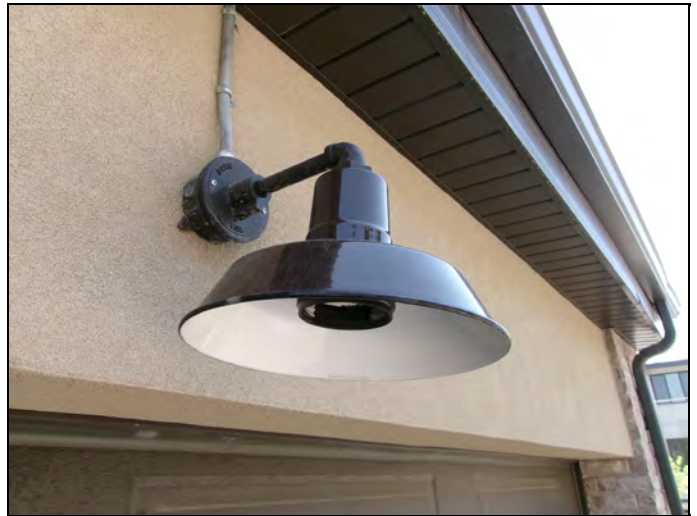
Comp #: 1602 Exterior Light Fixtures - Replace

The exterior light fixtures are in good condition. We recommend funding to replace this component approximately every 16 - 20 years. Remaining life based on current age.

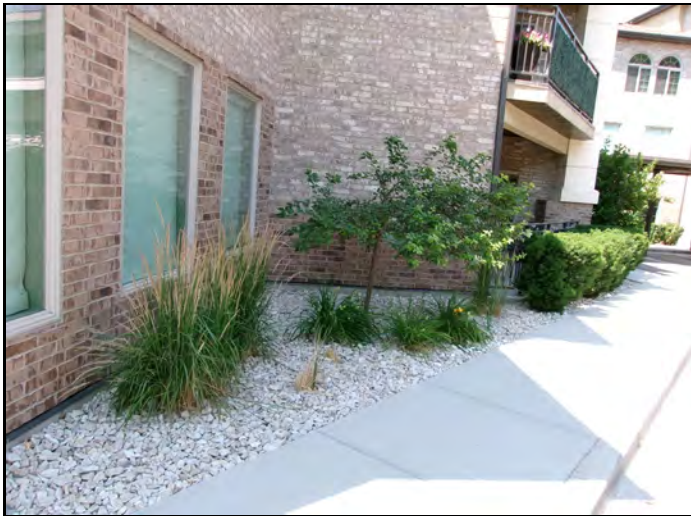
## Comp #: 1812 Landscaping & Irrigation System - Renovate

The landscaping and irrigation system are in good condition. We recommend funding for an allowance to renovate the landscaping and irrigation system approximately every 20 years. Remaining life based on current age.

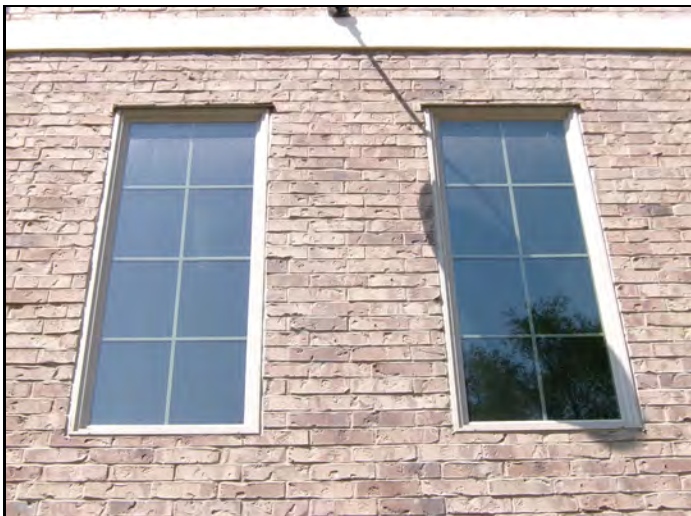
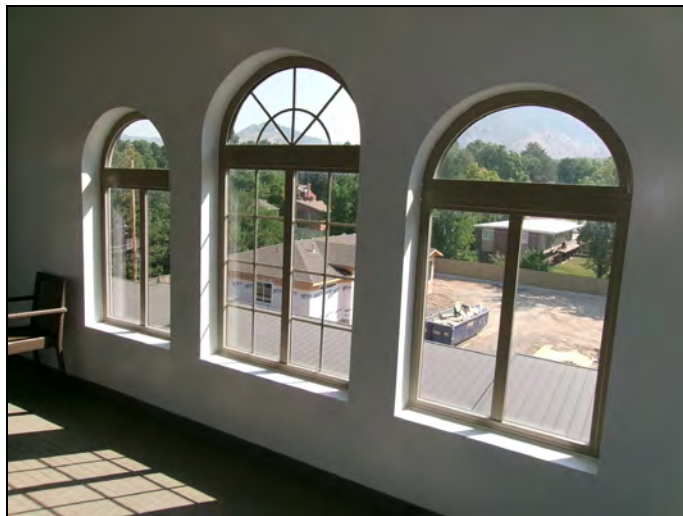
## Comp #: 2303 Windows - Replace

The windows are in good condition. We recommend funding to replace this component approximately every 40 - 50 years. Remaining life based on current age.
