Sycamore Place

Level 1 Reserve Study

Client Reference Number	19061
Property Type	Townhouse
Number of Units	135
Fiscal Year End	12/31

Executive Summary – Sycamore Place - ID # 19061

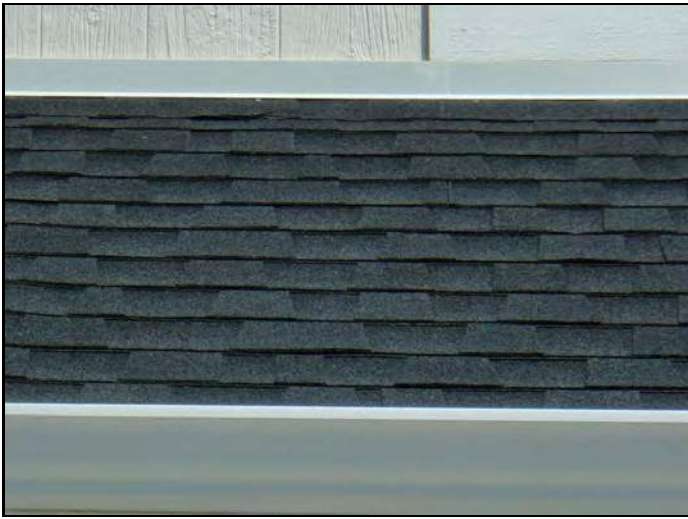
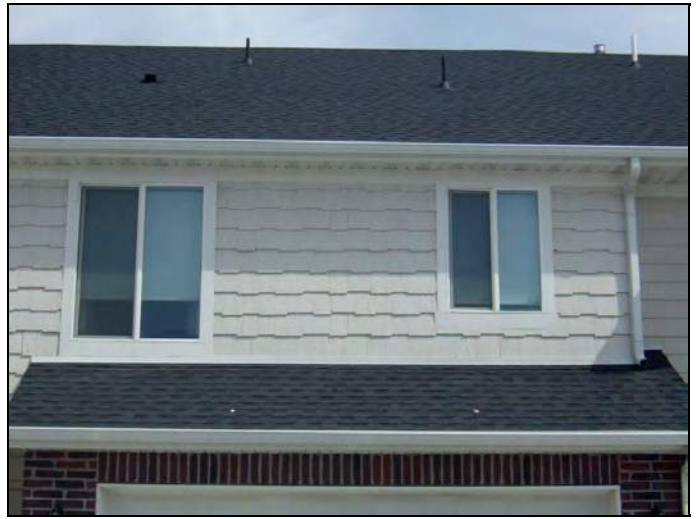
Comp #: 105 Roofs - Replace

Location: **Building Roofs**

The roofs are in good condition. We recommend funding to replace this component approximately every 20 - 25 years. Remaining life based on current age.

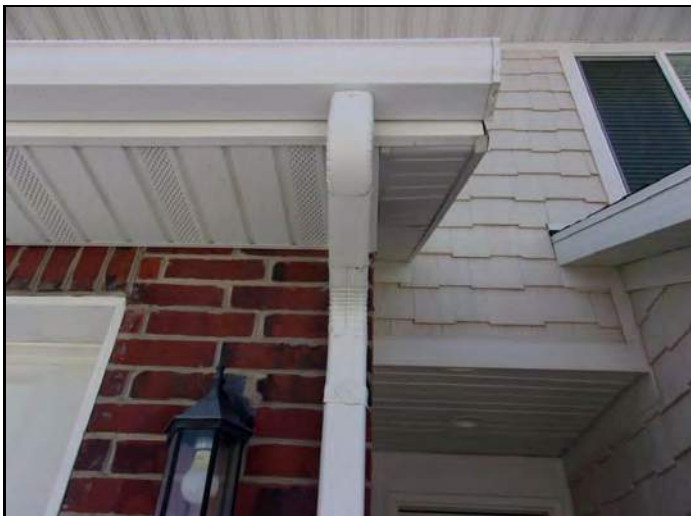
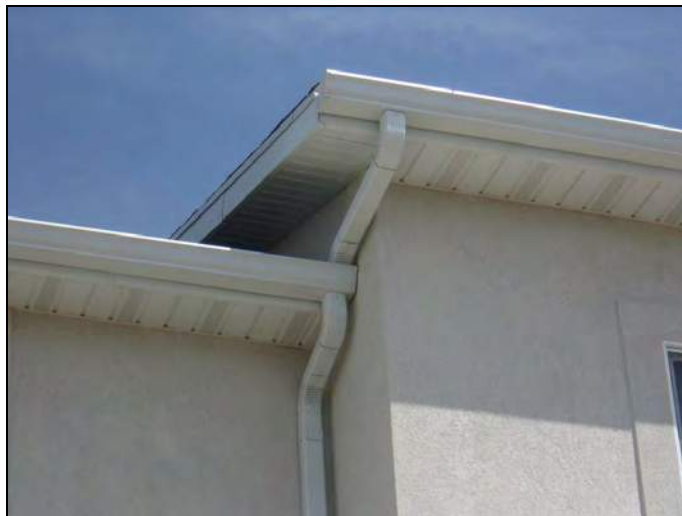
Comp #: 120 Rain Gutters/Downspouts - Replace

Location: **Building Exteriors**

The rain gutters and downspouts are in good condition. We recommend funding to replace this component approximately every 25 - 30 years. Remaining life based on current age.

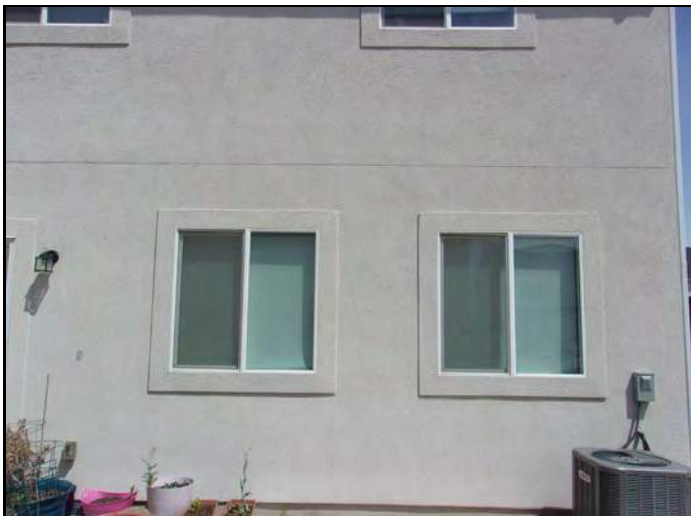
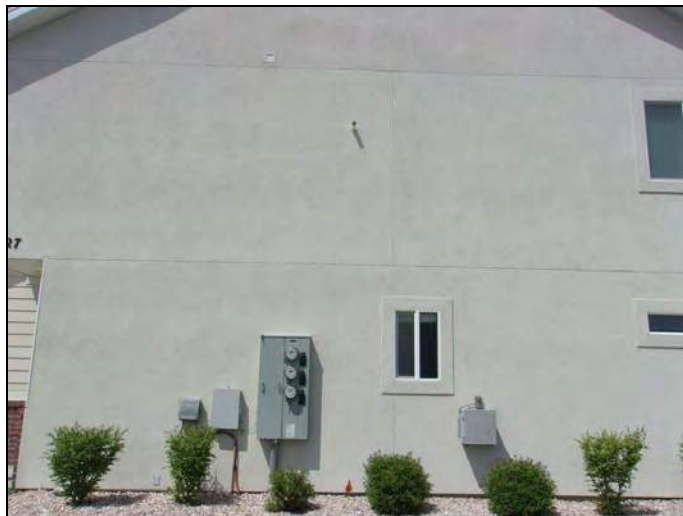
Comp #: 201 Stucco Surfaces - Repair/Repaint

Location: **Building Exteriors**

The stucco surfaces are in good condition. We recommend funding to repair/repaint this component approximately every 12 - 15 years. Remaining life based on current age.

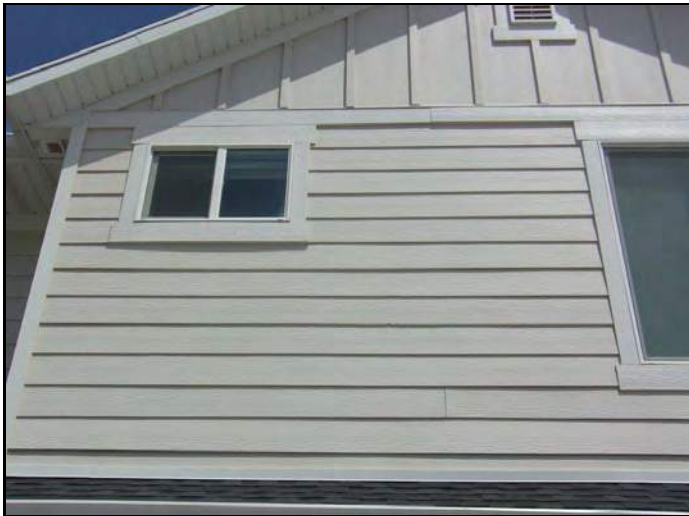
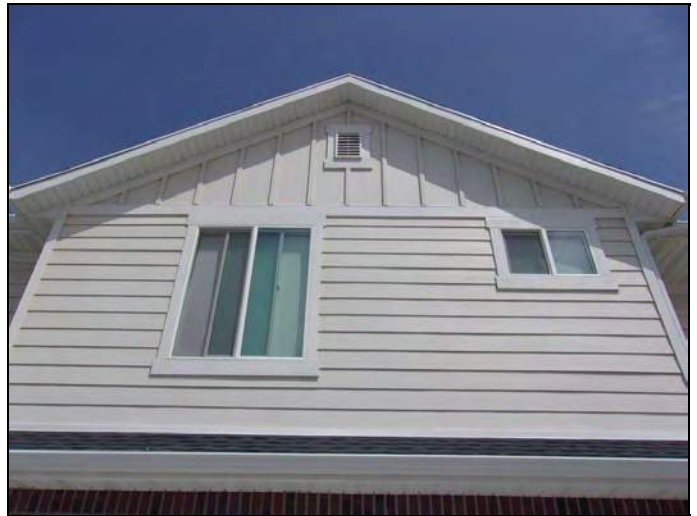
Comp #: 215 Siding - Repair/Repaint

Location: **Building Exteriors**

The siding painted surfaces are in good condition. We recommend funding to repair/repaint this component approximately every 8 - 10 years. Remaining life is based on current age.

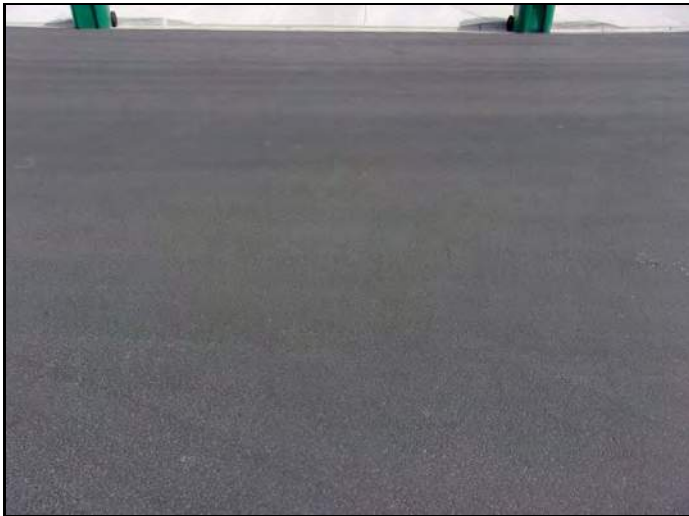
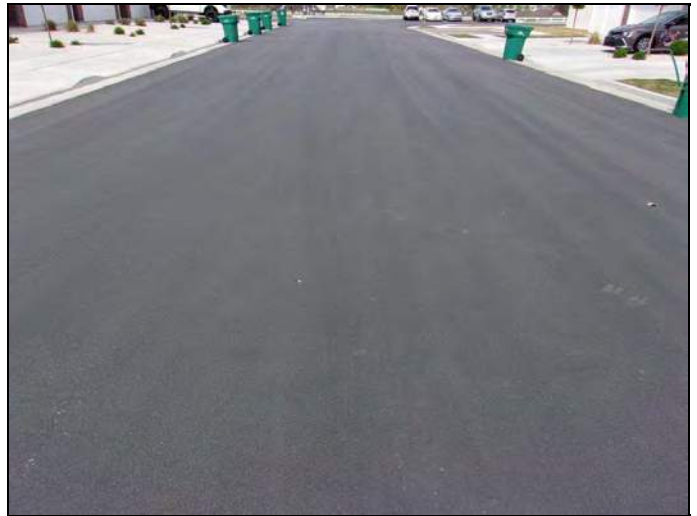
Comp #: 401 Asphalt - Major Rehab

Location: **Community Streets**

The asphalt surfaces are in good condition. We recommend funding for a major rehab of this component approximately every 25 - 30 years. Remaining life based on current age.

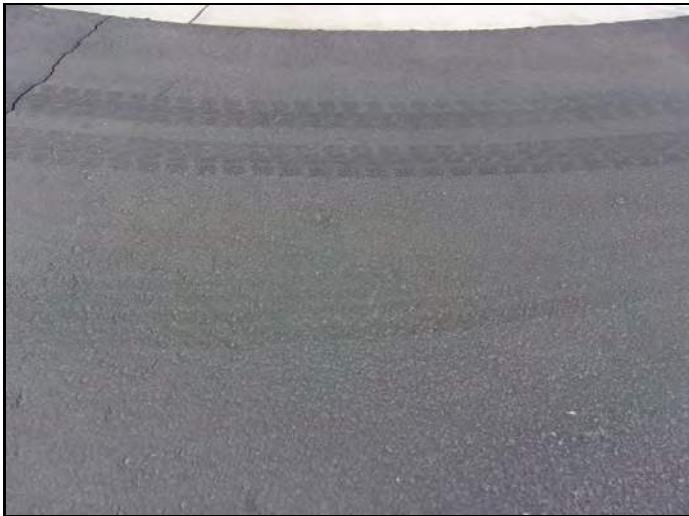
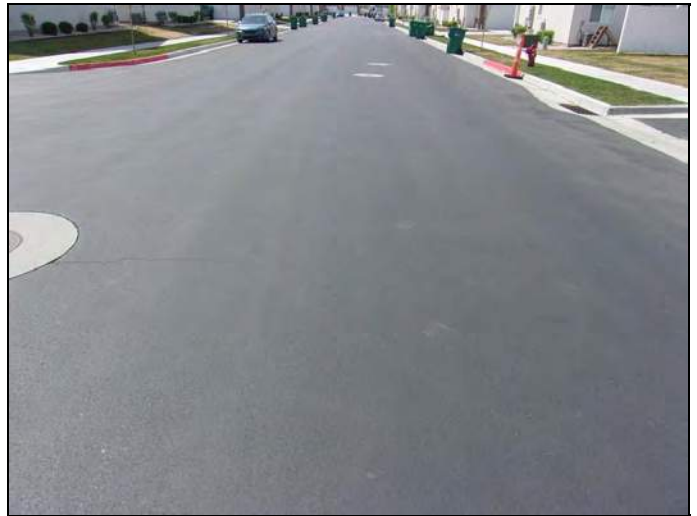
Comp #: 402 Asphalt - Seal Coat

Location: **Community Streets**

The asphalt seal coat is in good condition. We recommend funding to seal this component approximately every 3 - 5 years. Remaining life based on current age.

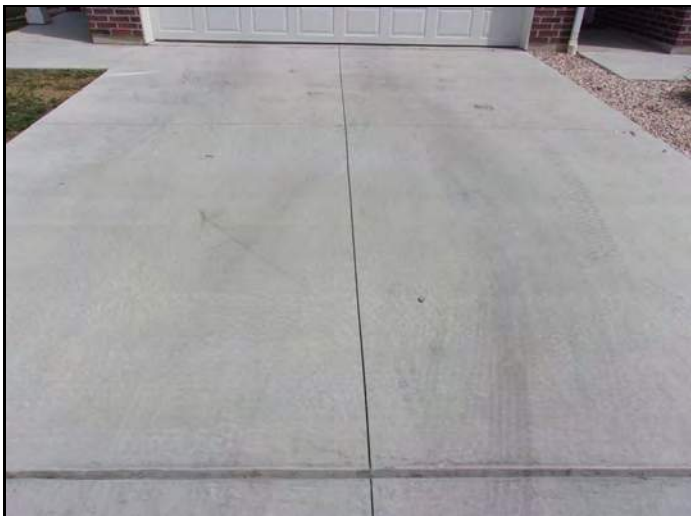
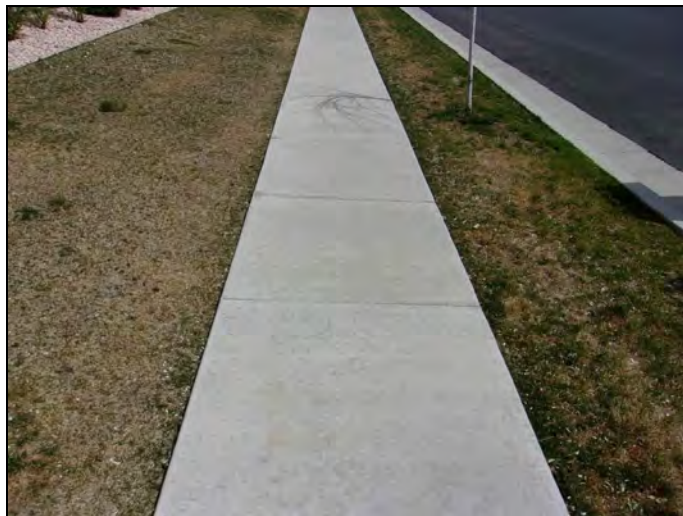
Comp #: 403 Concrete - Partial Repair/Replace

Location: **Common Area**

The concrete is in good condition. This component has an extended useful life under normal conditions. We recommend funding to make repairs and partially replace this component approximately every 10 years. Remaining life based on current age.

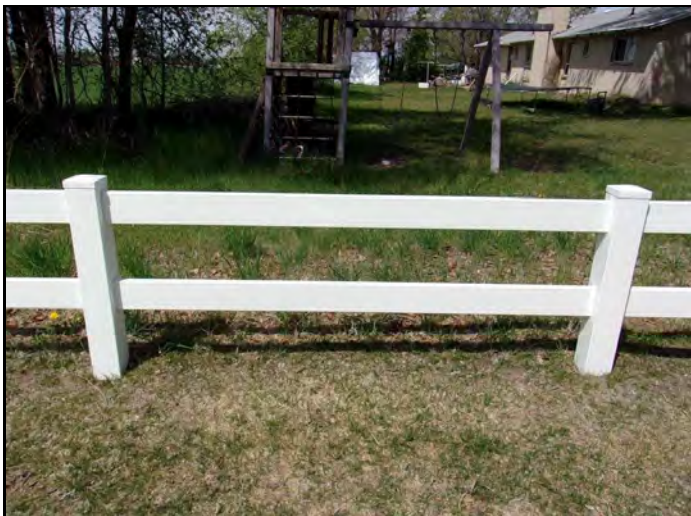
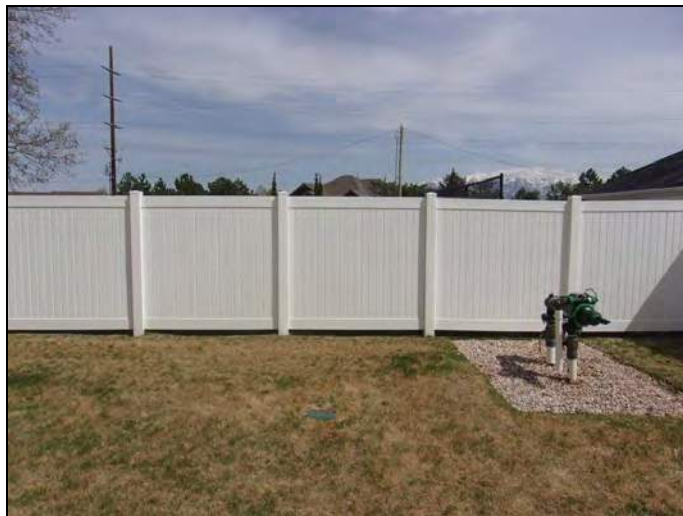
Comp #: 1008 Vinyl Fencing - Replace

Location: Common Areas & Patio Screens

The vinyl fencing is in good condition. We recommend funding to replace this component approximately every 25 - 30 years. Remaining life based on current age.

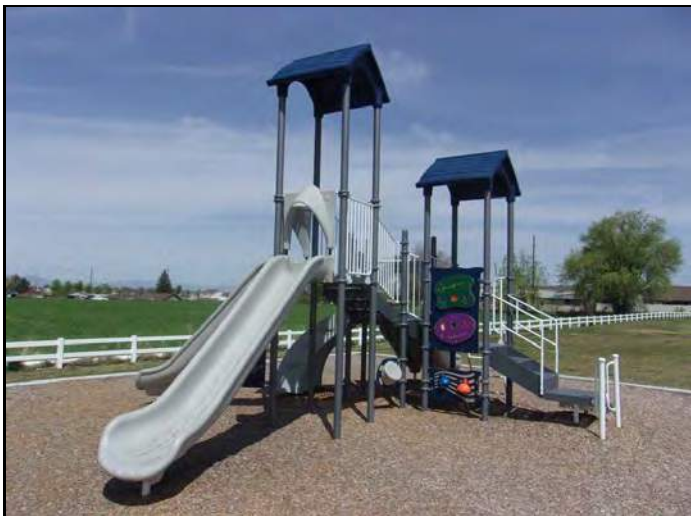
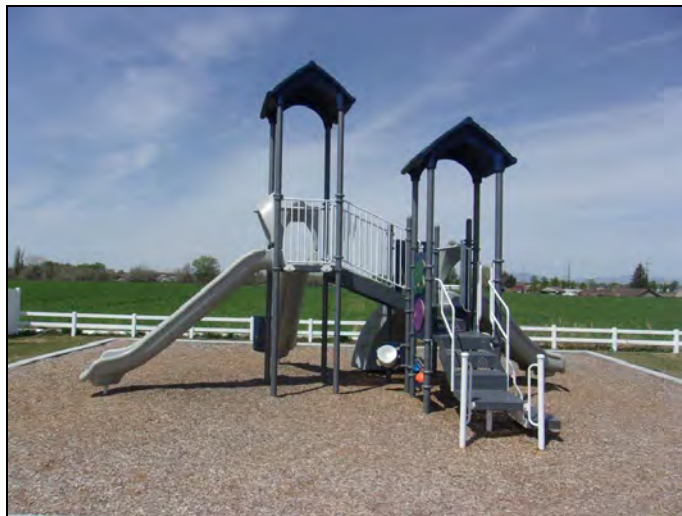
Comp #: 1301 Play Structure - Replace

Location: **Play Area**

The play structure is in good condition. We recommend funding to replace this component approximately every 20 - 25 years. Remaining life based on current age.

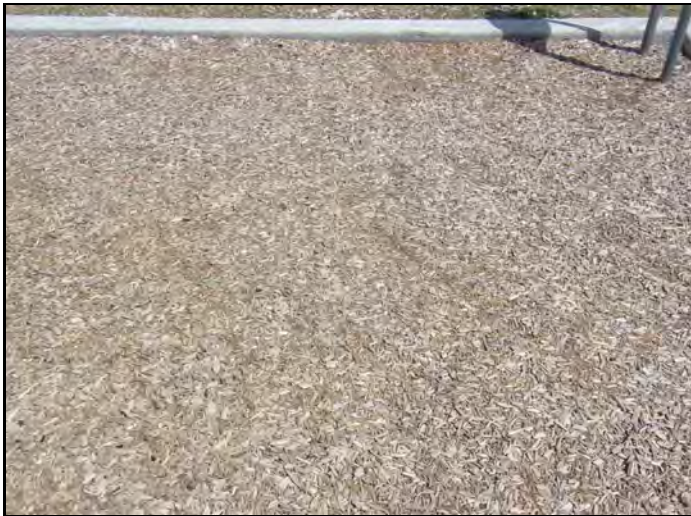
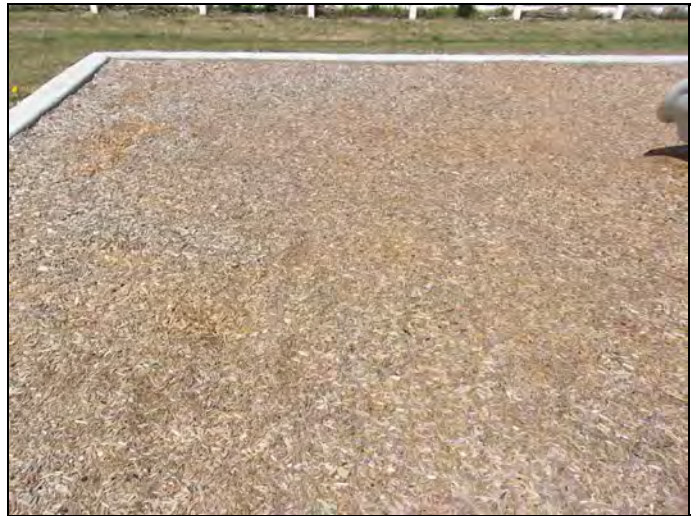
Comp #: 1303 Play Area Groundcover - Refill

Location: **Play Area**

The play area groundcover is in good condition. We recommend funding to refill this component approximately every 3 - 5 years. Remaining life is based on current age.

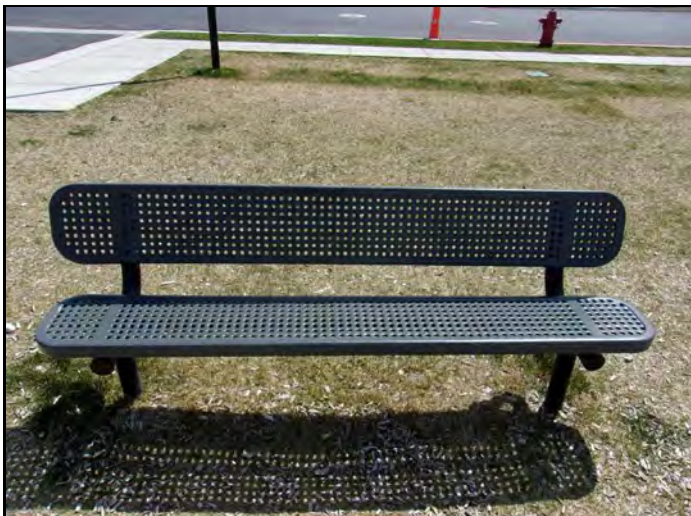
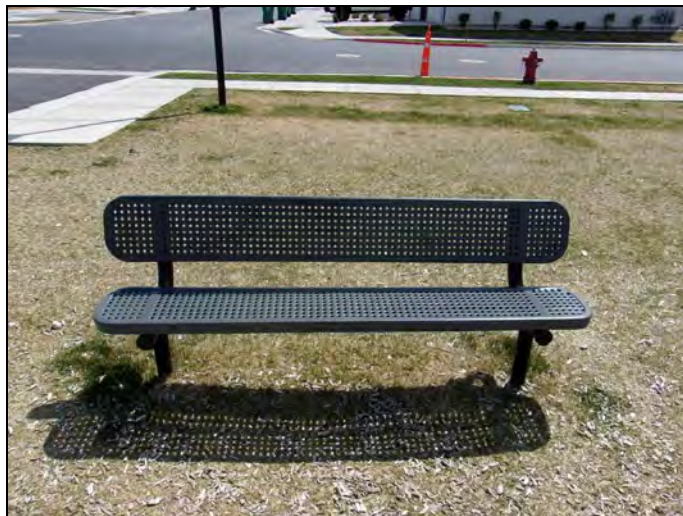
Comp #: 1307 Benches - Replace

Location: **Pickleball Court & Play Area**

The benches are in good condition. We recommend funding to replace this component approximately every 10 - 15 years. Remaining life based on current age.

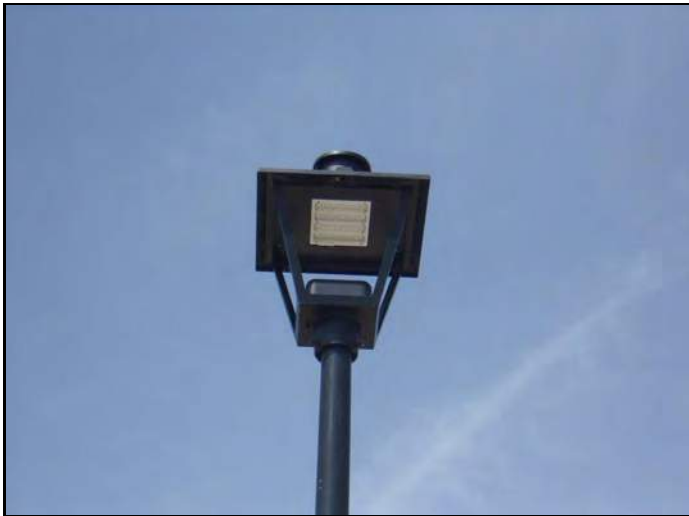
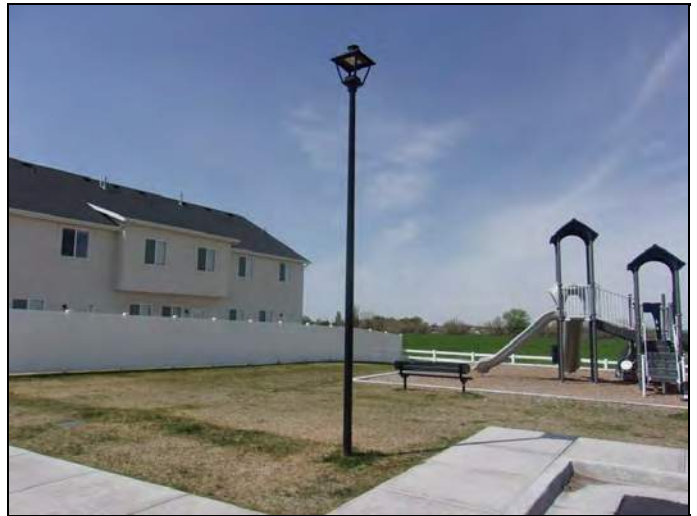
Comp #: 1609 Street Light Fixtures - Replace

Location: **Community Streets**

The street light fixtures are in good condition. No expectation to replace the light poles. Paint poles as necessary as an operating expense. We recommend funding to replace this component approximately every 20 years. Remaining life based on current age.

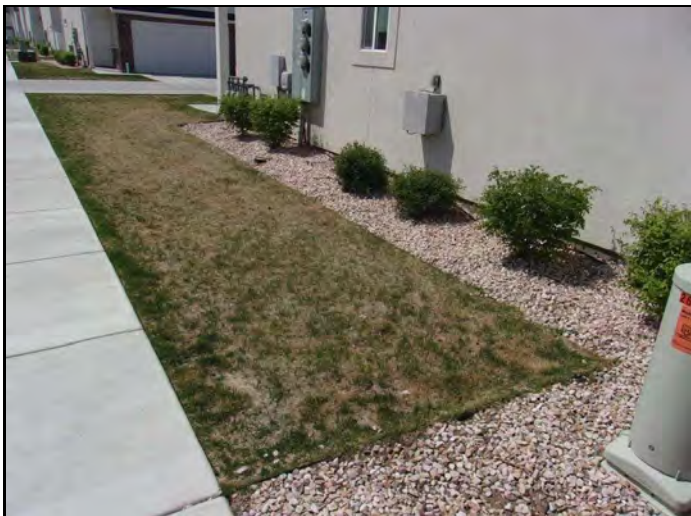
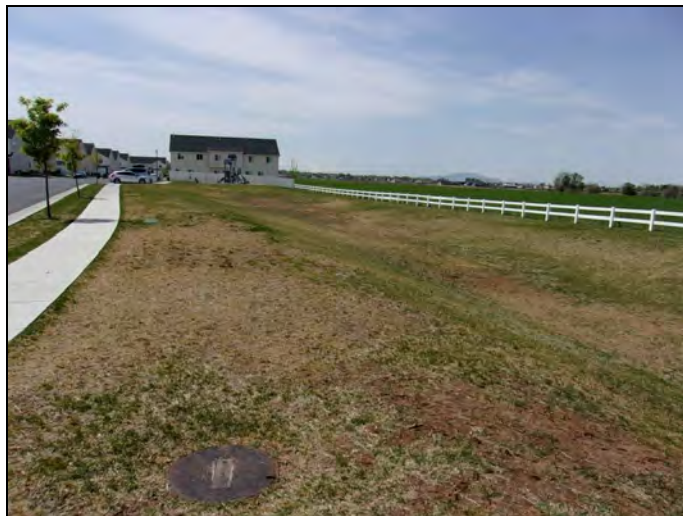
Comp #: 1812 Landscaping & Irrigation System - Renovate

Location: **Common Area**

The landscaping and irrigation system are in good to fair condition. We recommend funding for an allowance to renovate this component approximately every 20 years. Remaining life based on current age.
