# South Hills POD 4

## Level 1 Reserve Study

**Report Period – 01/01/2023 – 12/31/2023**

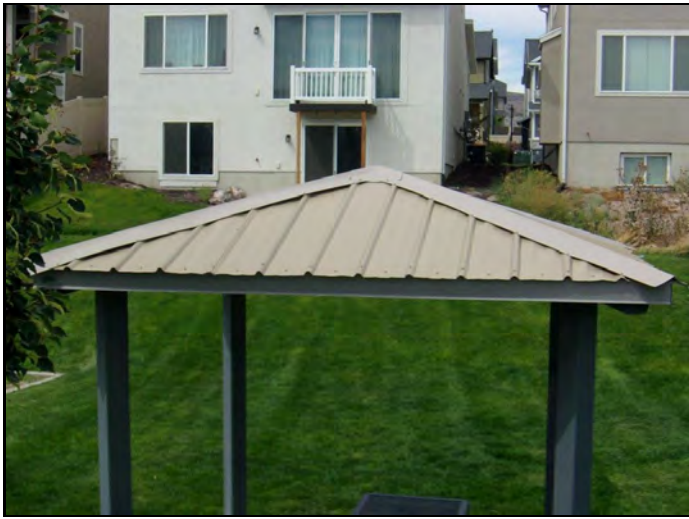
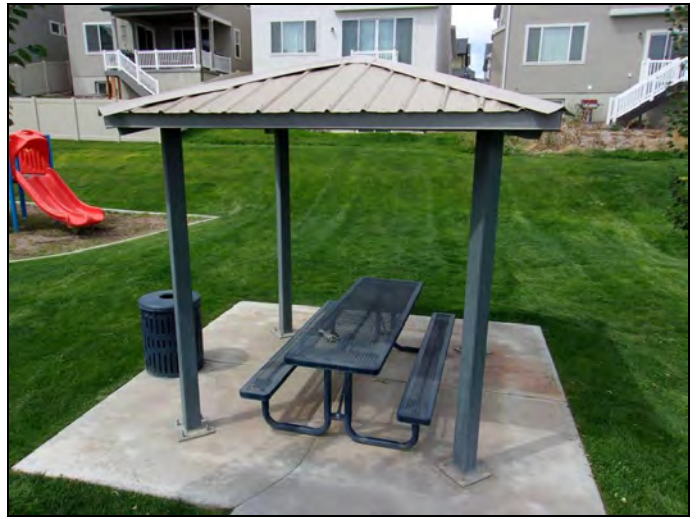
Comp #: 108 Pavilion Roof - Replace

Due to the minimal cost of replacing this component, reserve funding is not appropriate. Replace as necessary as an operating expense.

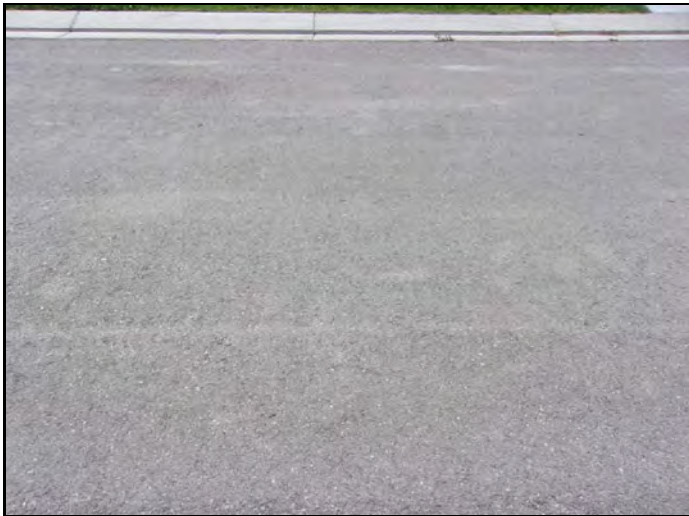
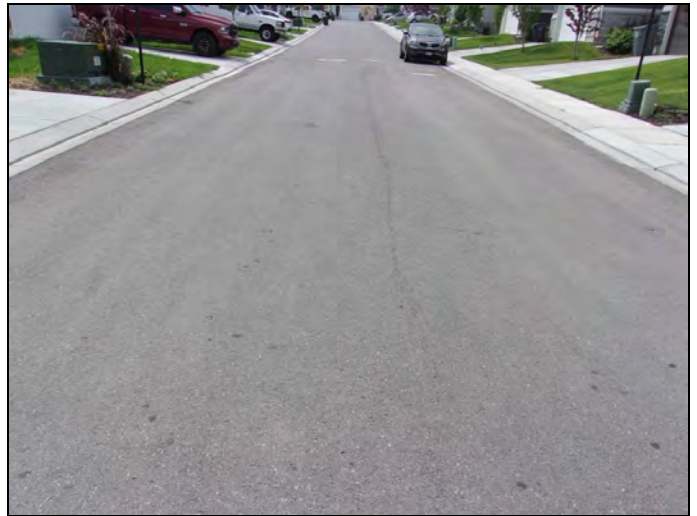
Comp #: 401 Asphalt - Major Rehab

The asphalt surfaces are in good condition. We recommend funding for a major rehab of this component approximately every 25 - 30 years. Remaining life based on current age.

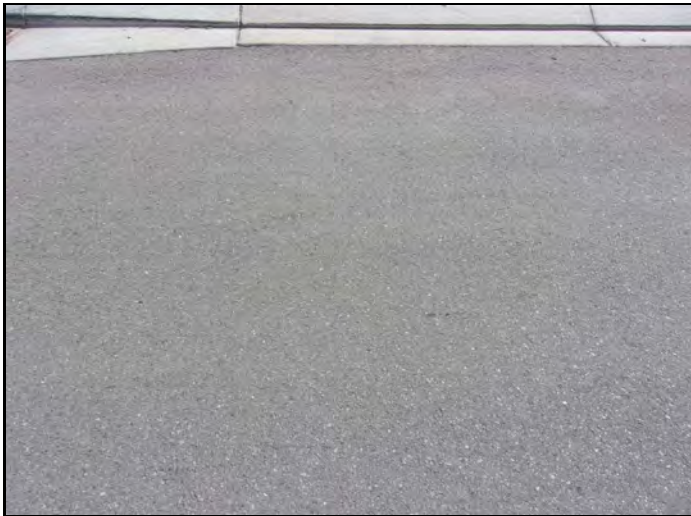
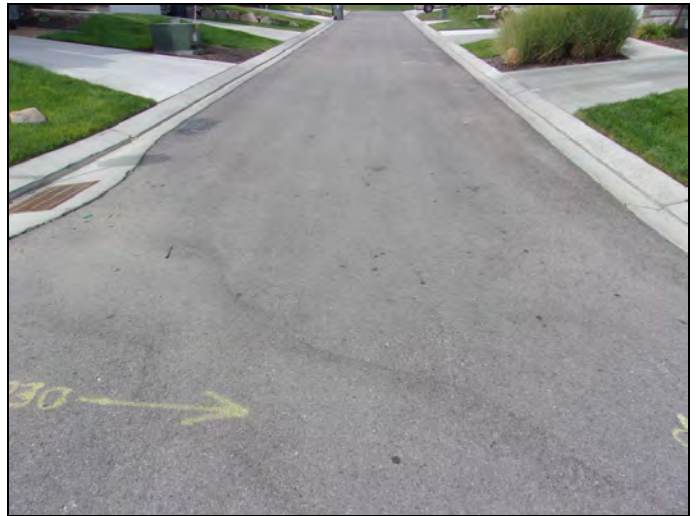
Comp #: 402 Asphalt - Seal Coat

The asphalt seal coat is in poor condition. We recommend funding to seal this component approximately every 3 - 5 years. Remaining life based on current condition.

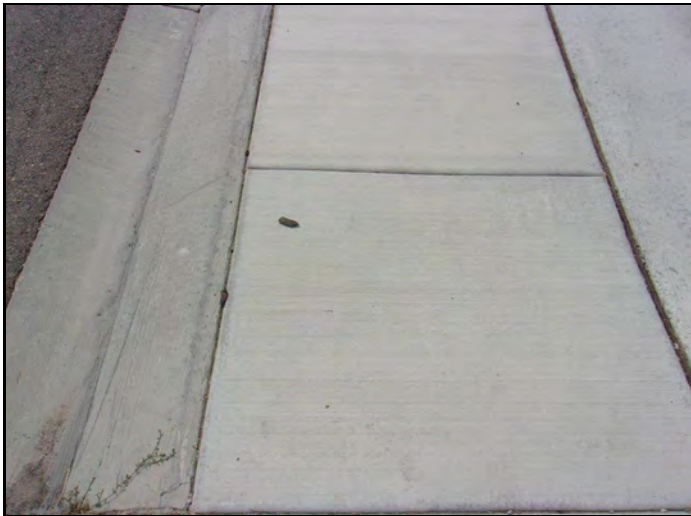
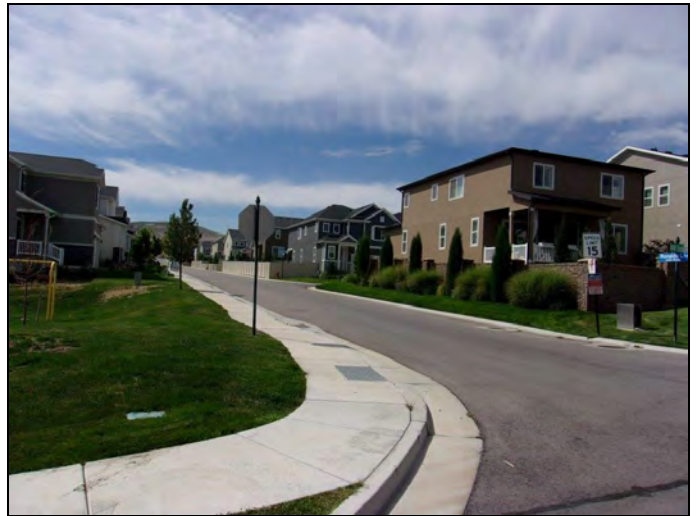
Comp #: 403 Concrete - Partial Repair/Replace

Due to the extended useful life and minimal cost of partially replacing this component, reserve funding is not appropriate. Replace as necessary as an operating expense.

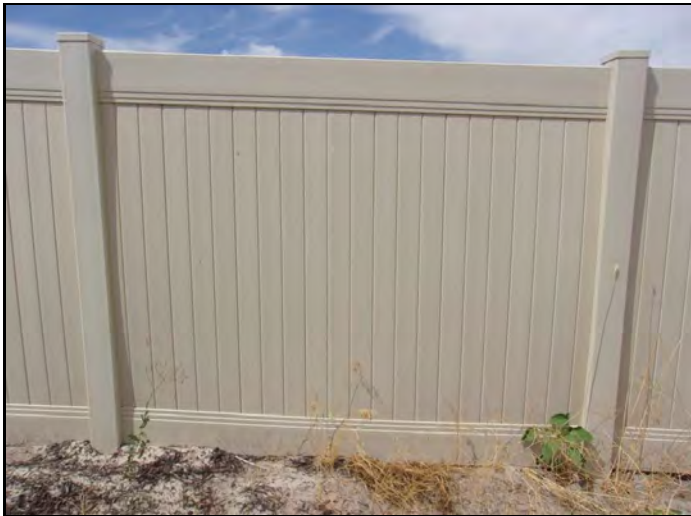
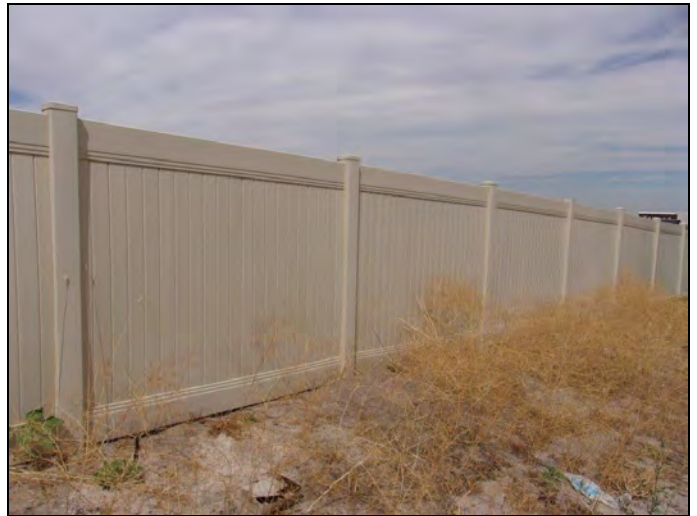
Comp #: 1008 Vinyl Fencing - Replace

The vinyl fencing is in good condition. We recommend funding to replace this component approximately every 25 - 30 years. Remaining life based on current age.

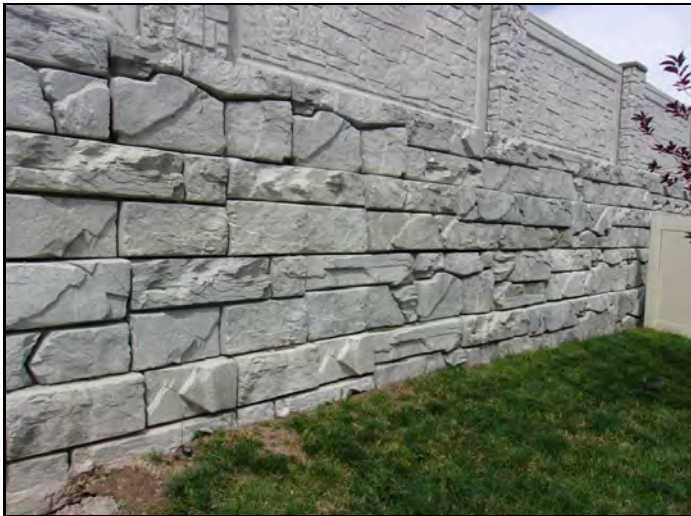
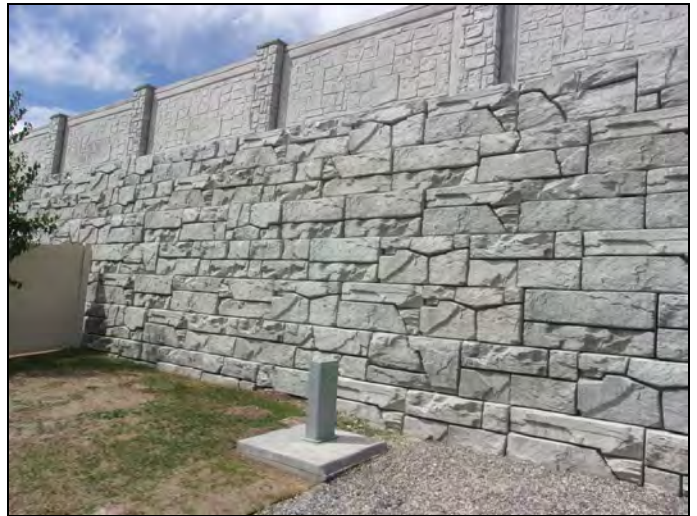
Comp #: 1011 Retaining Wall - Replace

This component has an extended useful life. Make repairs as necessary as an operating expense. No reserve funding necessary.

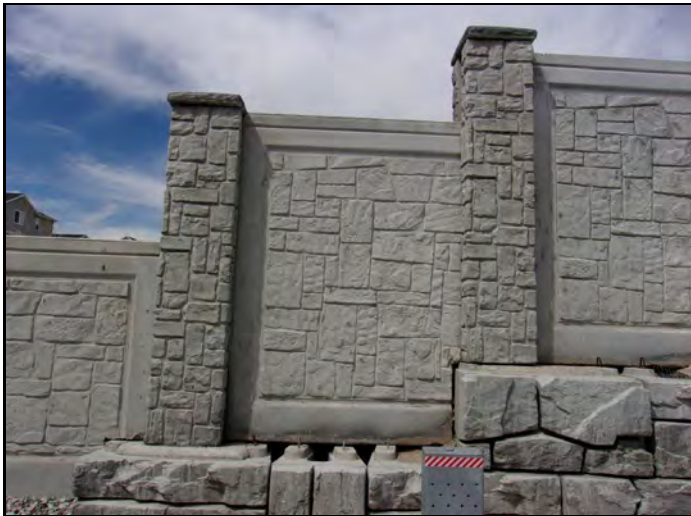
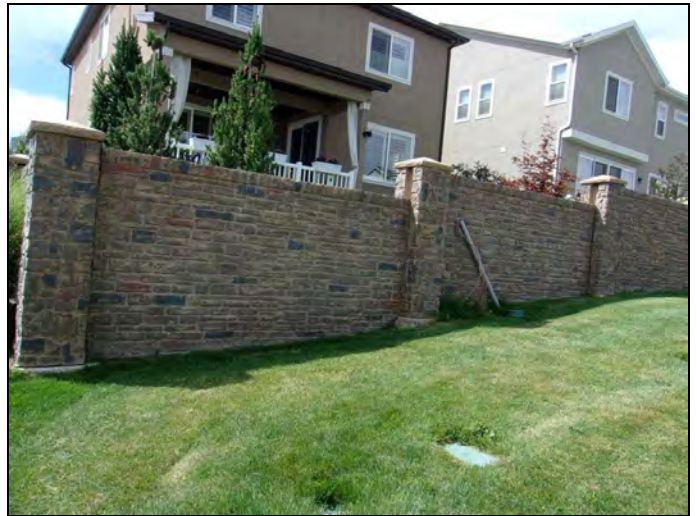
Comp #: 1012 Prefab Concrete Fence - Replace

This type of component should have an extended useful life under normal conditions. Reserve funding is not appropriate.

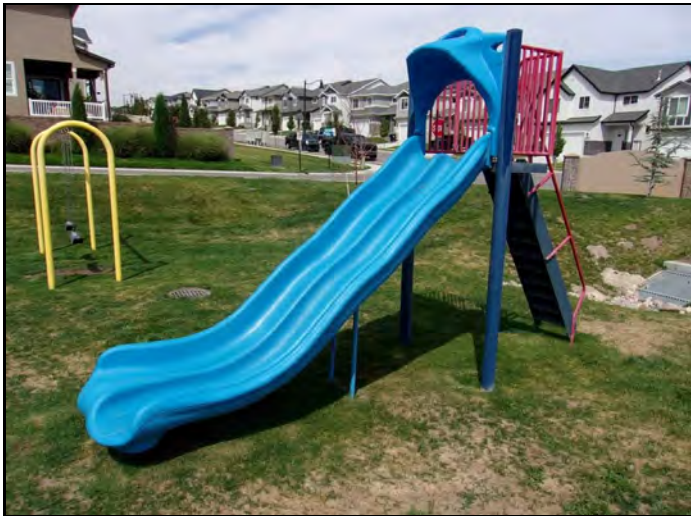
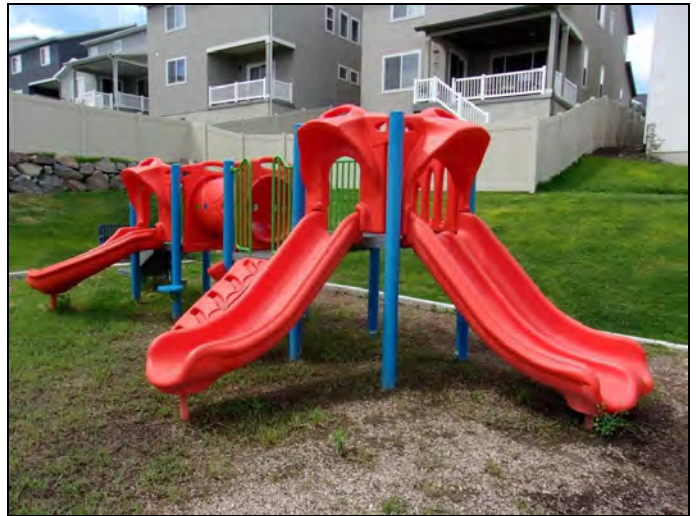
Comp #: 1301 Play Structures - Replace

The play structure is in good condition. We recommend funding to replace this component approximately every 20 - 25 years. Remaining life based on current age.

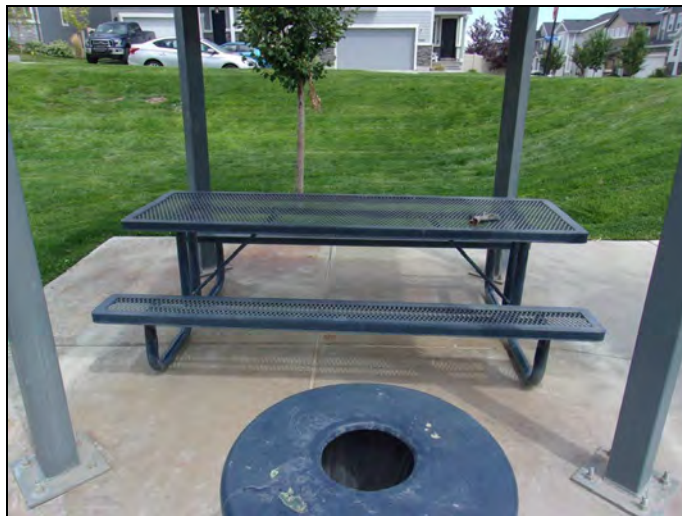
Comp #: 1306 Picnic Table - Replace

Due to the minimal cost of replacing this component, reserve funding is not appropriate. Replace as necessary as an operating expense.

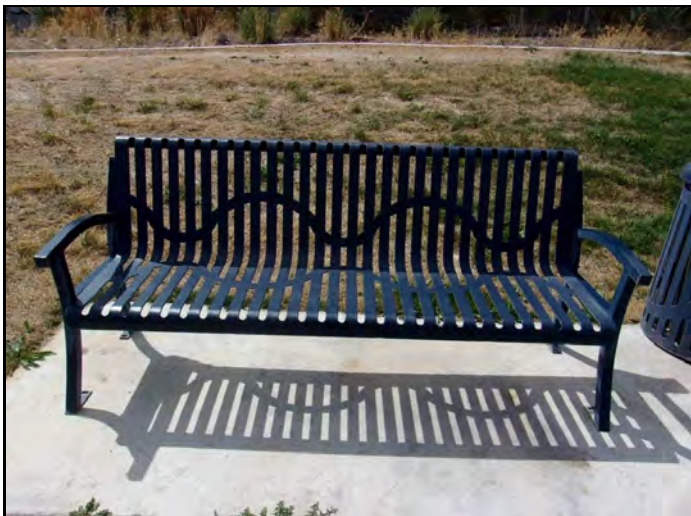
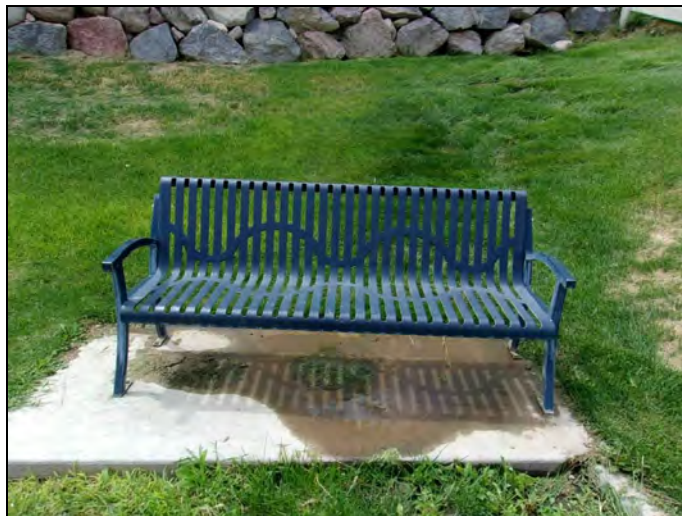
Comp #: 1307 Benches - Replace

Due to the minimal cost of replacing this component, reserve funding is not appropriate. Replace as necessary as an operating expense.

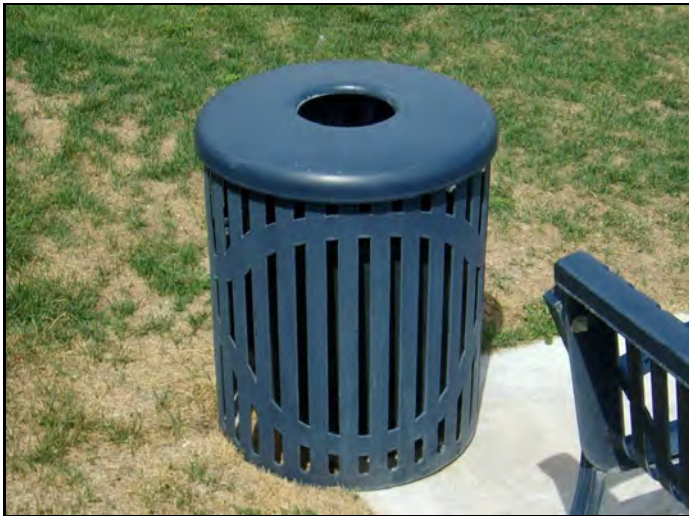
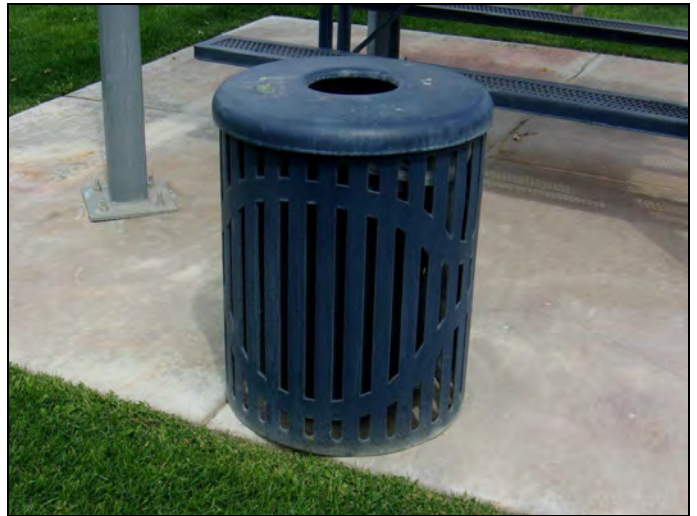
Comp #: 1308 Trash Receptacles - Replace

Due to the minimal cost of replacing this component, reserve funding is not appropriate. Replace as necessary as an operating expense.

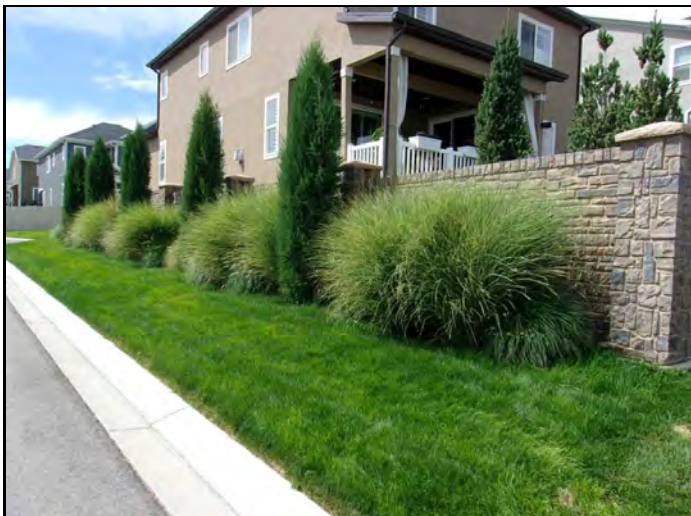
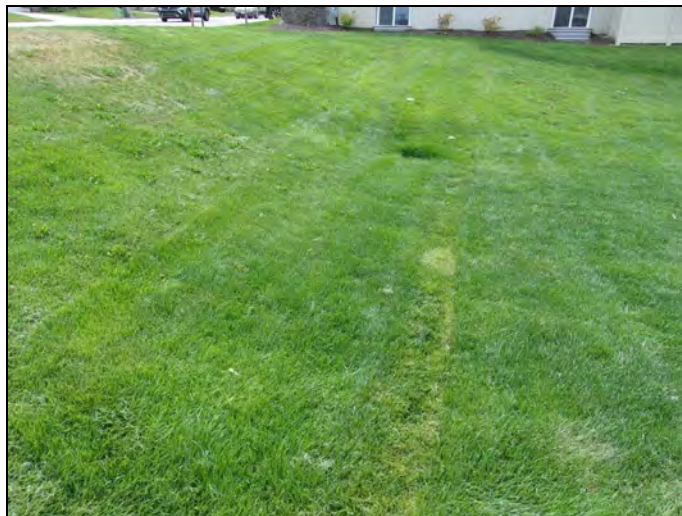
Comp #: 1812 Landscaping & Irrigation System - Renovate

The landscaping and irrigation system are in good to fair condition. We recommend funding for an allowance to renovate this component approximately every 20 years. Remaining life based on current age.
