Falcon Ridge Estates

Level 1 Reserve Study

Client Reference Number	12786
Property Type	Townhouse
Number of Units	32
Fiscal Year End	12/31

Type of Study	Full Study
Date of Property Inspection	05/12/2023
Prepared By	Dale Gifford
Analysis Method	Cash Flow
Funding Goal	Full Funding

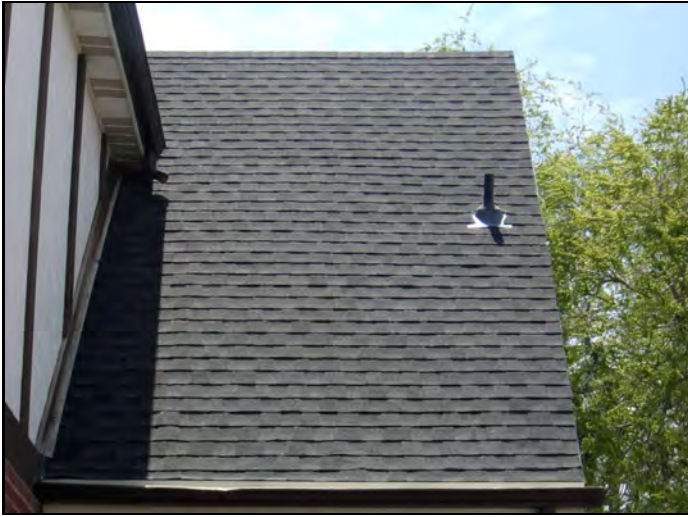
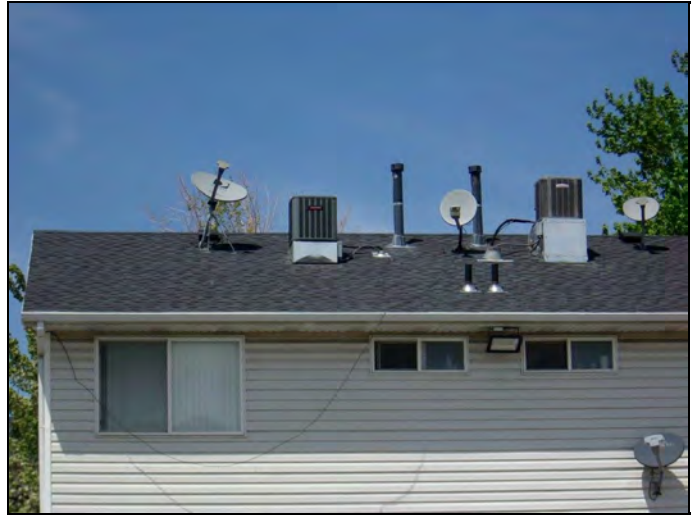
Comp #: 105 Roofs - Replace

Location: **Building Roofs**

The roofs are in good condition. We recommend funding to replace this component approximately every 20 - 25 years. Remaining life based on current age.

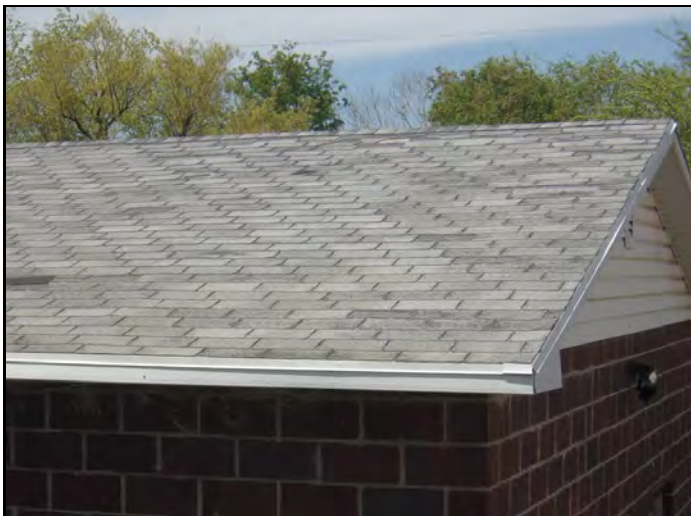
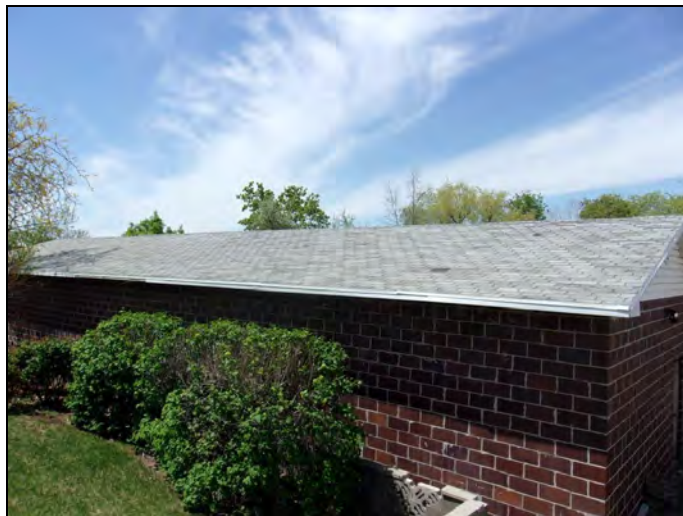
Comp #: 115 Storage Garage Roof - Replace

Location: **Storage Garage**

The roof is in fair to poor good condition. We recommend funding to replace this component approximately every 20 - 25 years. Remaining life based on current age.

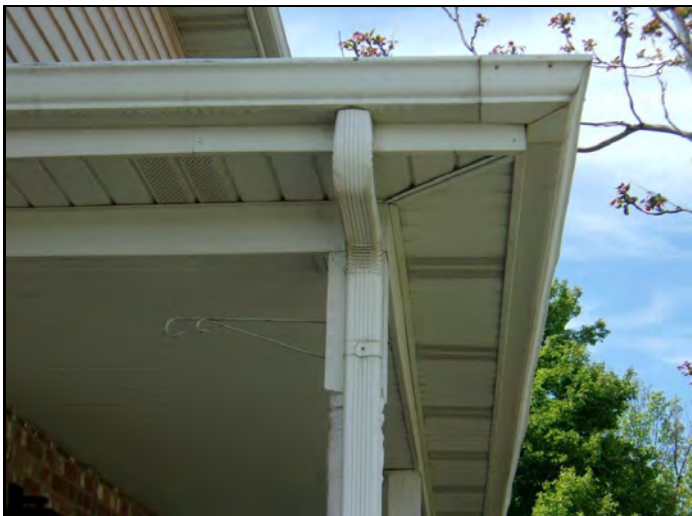
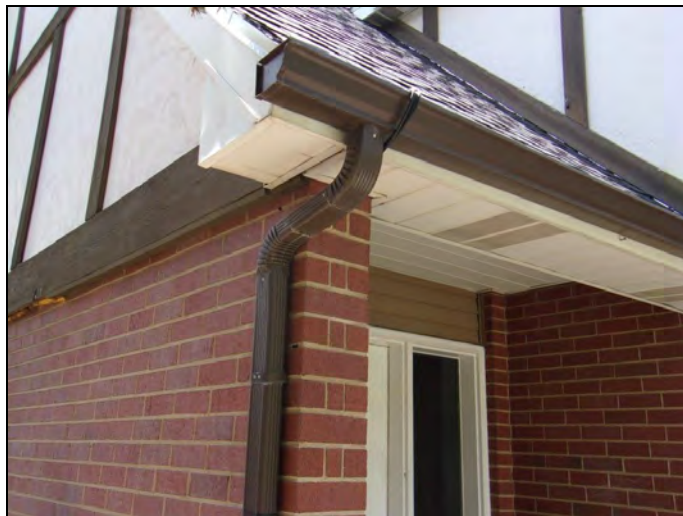
Comp #: 120 Rain Gutters/Downspouts - Replace

Location: **Building Exteriors**

The rain gutters and downspouts are generally in good to fair condition. We recommend funding to replace this component approximately every 25 - 30 years. Remaining life based on current age and condition.

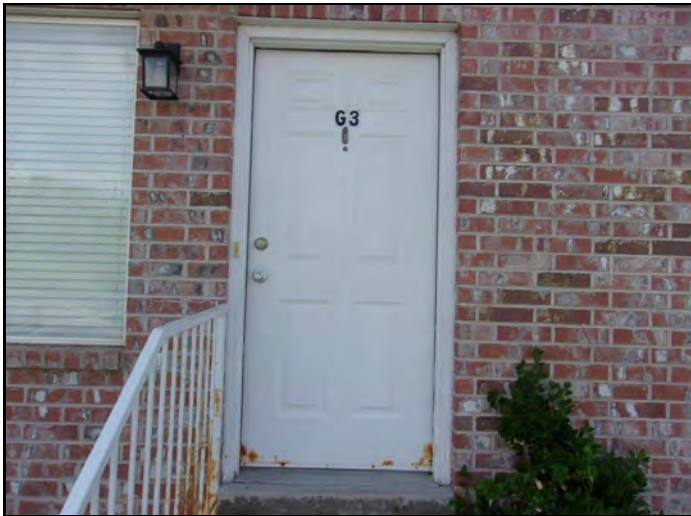
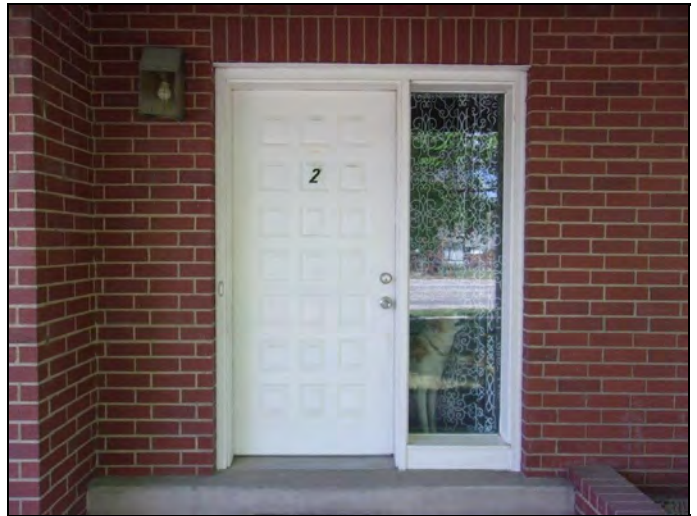
Comp #: 204 Front Doors - Repaint

Location: Unit Entrances

The painted door surfaces are generally in fair condition. We recommend funding to repaint this component approximately every 8 - 10 years. Remaining life based on average condition.

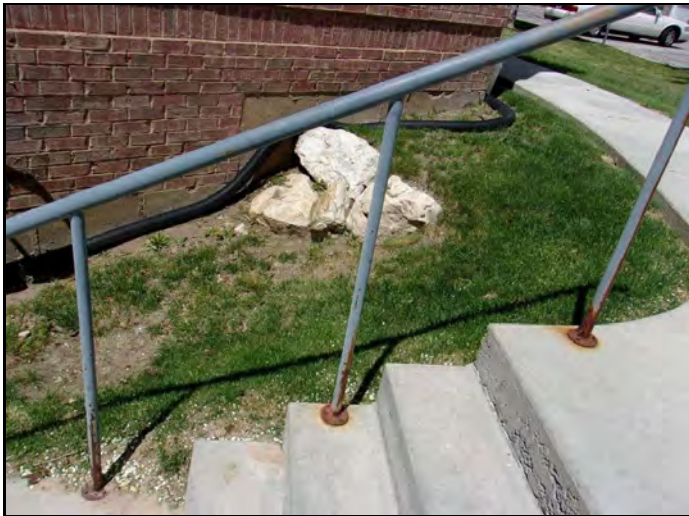
Comp #: 207 Metal Railing - Repaint

Location: **Sidewalks & Unit Entrances**

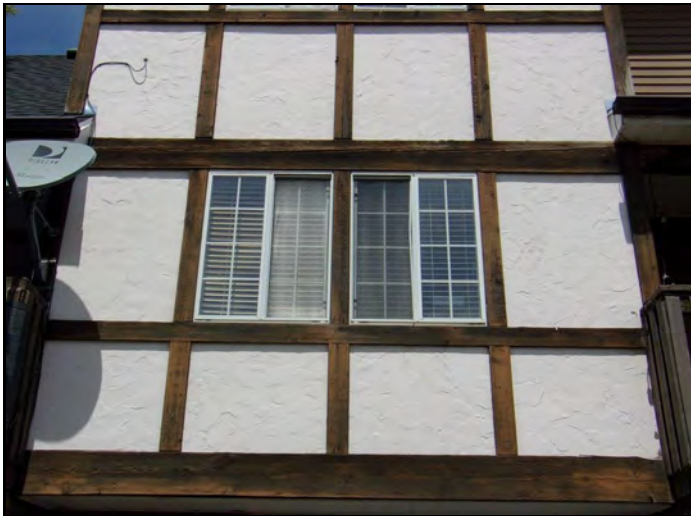
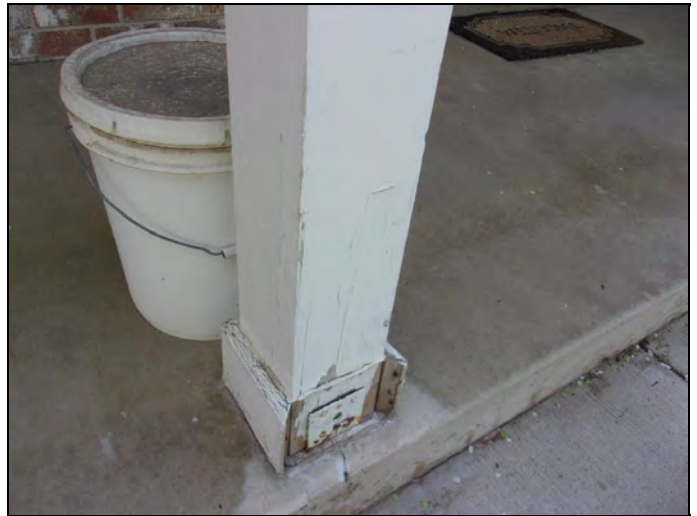
Comp #: 215 Building Exteriors - Repair/Repaint

Location: **Building Exteriors**

The building exterior painted surfaces are in fair to poor condition. We recommend funding to repair/repaint this component approximately every 6 - 8 years. Remaining life is based on current condition.

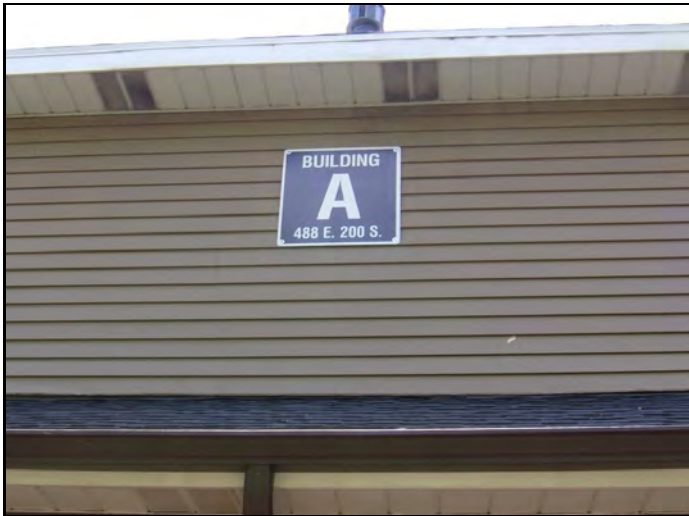
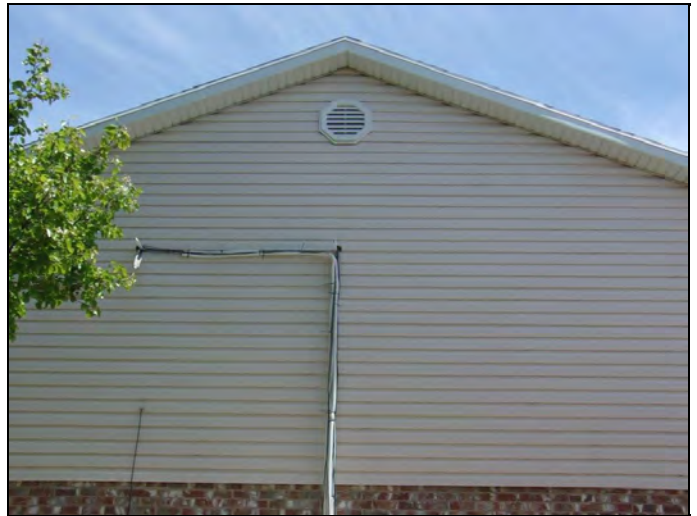
Comp #: 302 Vinyl Siding - Replace

Location: **Building Exteriors**

The vinyl siding is in good to fair condition. We recommend funding to replace this component approximately every 40 - 50 years. Remaining life based on current age.

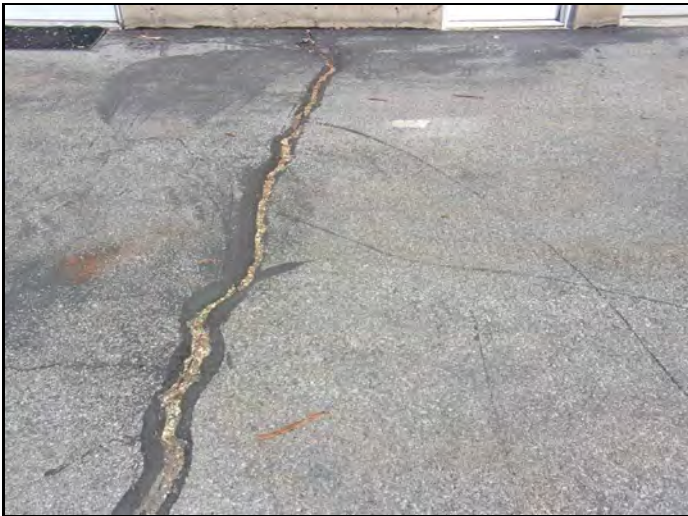
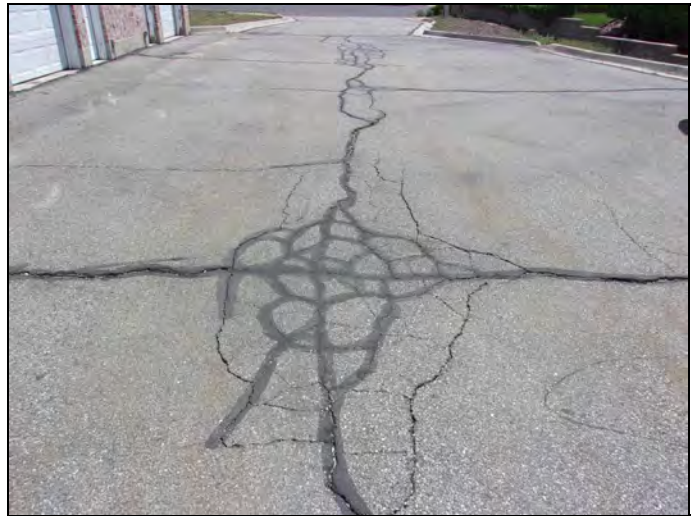
Comp #: 401 Asphalt - Major Rehab

Location: **Community Streets**

The asphalt surfaces are in fair condition. We recommend funding for a major rehab of this component approximately every 25 - 30 years. Remaining life based on current age.

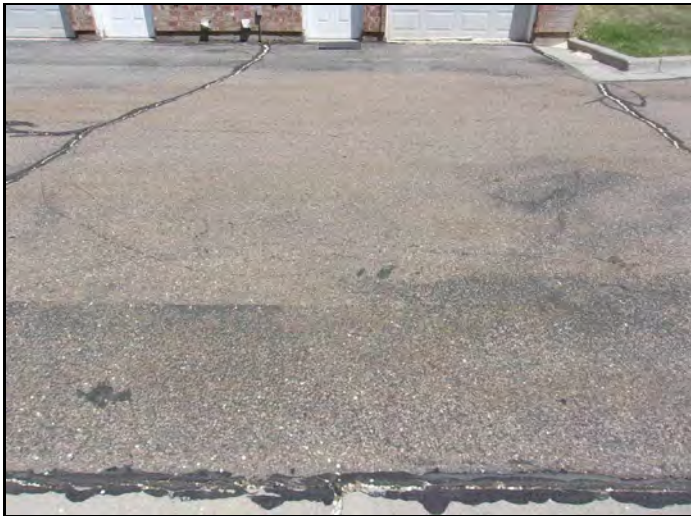
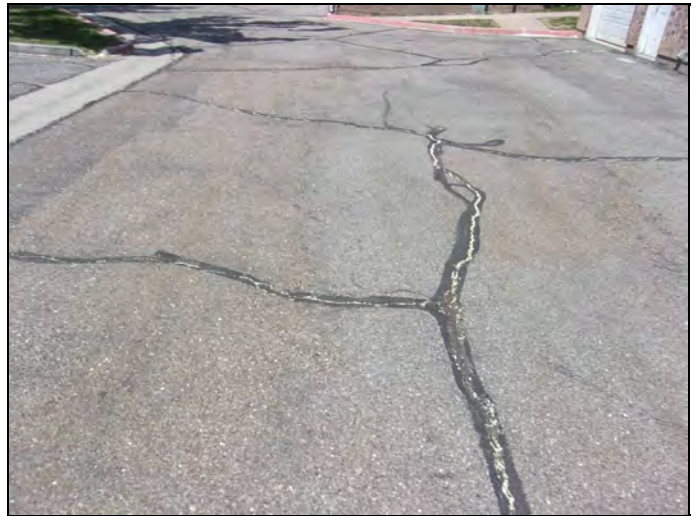
Comp #: 402 Asphalt - Seal Coat

Location: **Community Streets**

The asphalt seal coat is in poor condition. We recommend funding to seal this component approximately every 3 - 5 years. Remaining life based on current condition.

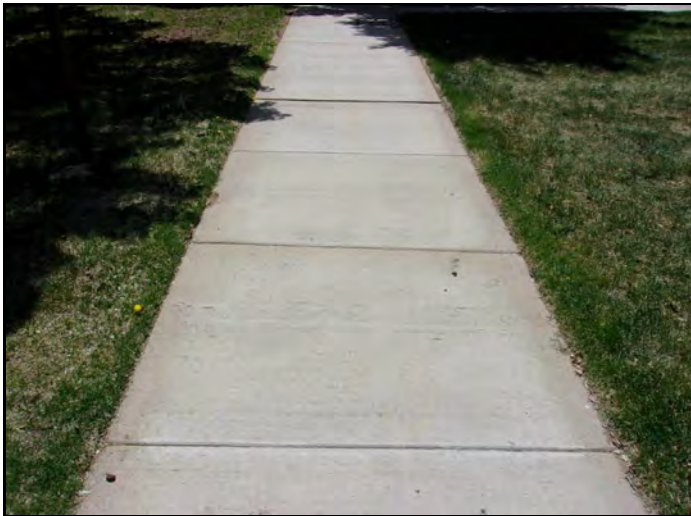
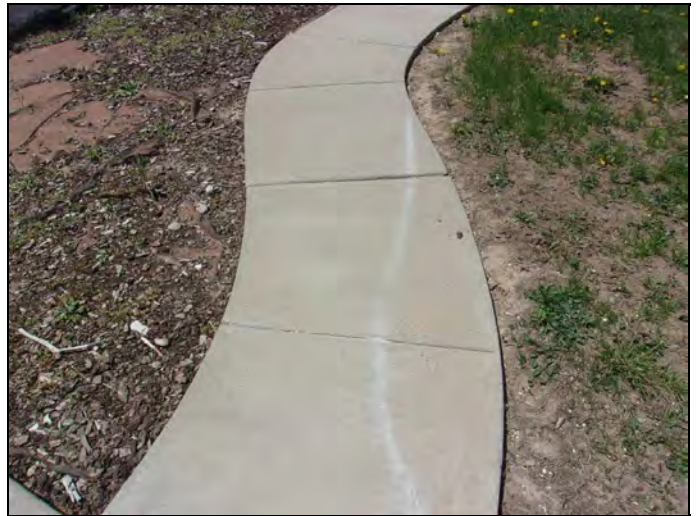
Comp #: 403 Concrete - Partial Repair/Replace

Location: **Sidewalks**

The concrete is generally in good condition. This component has an extended useful life under normal conditions. We recommend funding to make repairs and partially replace this component approximately every 10 years. Remaining life based on current age.

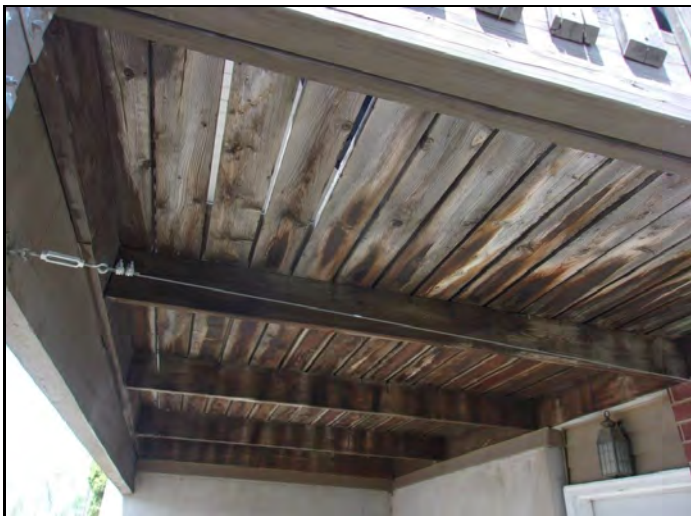
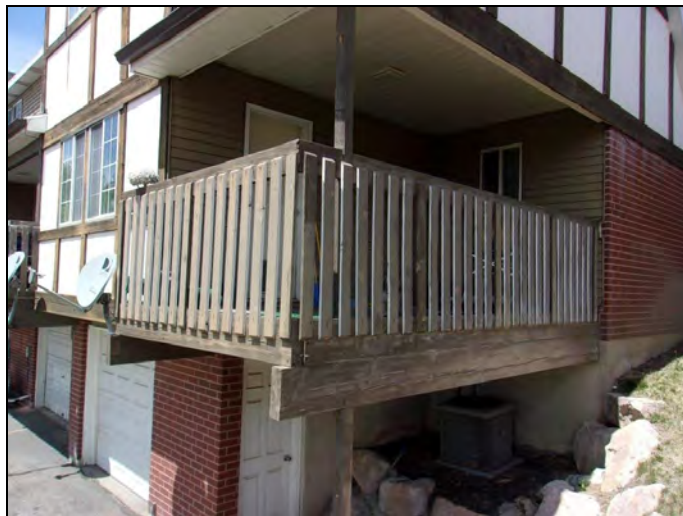
Comp #: 607 Wood Balconies - Replace

Location: **Buildings A & B**

The balconies are in fair condition. We recommend funding to replace this component every 20 - 30 years. Remaining life based on current condition.

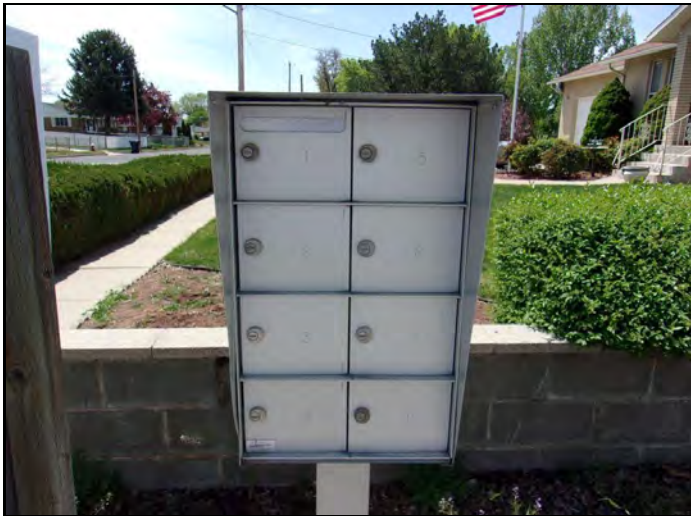
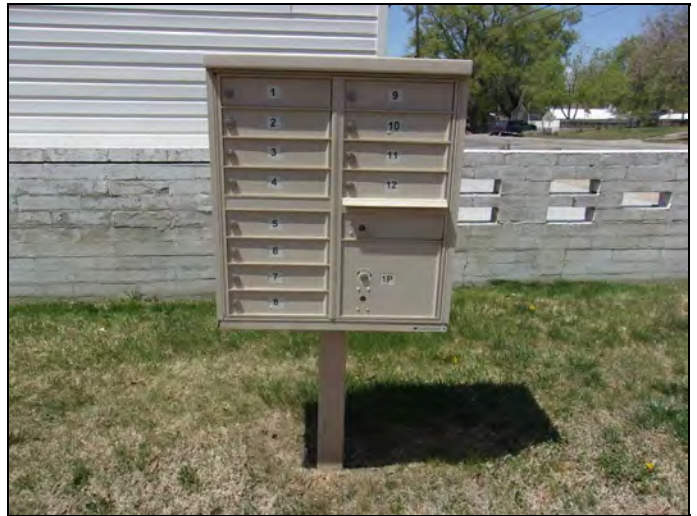
Comp #: 803 Mailboxes - Replace

Location: **Common Area**

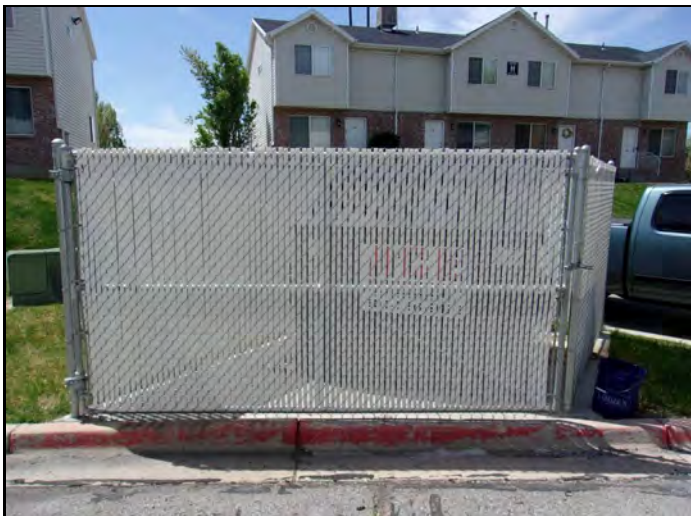
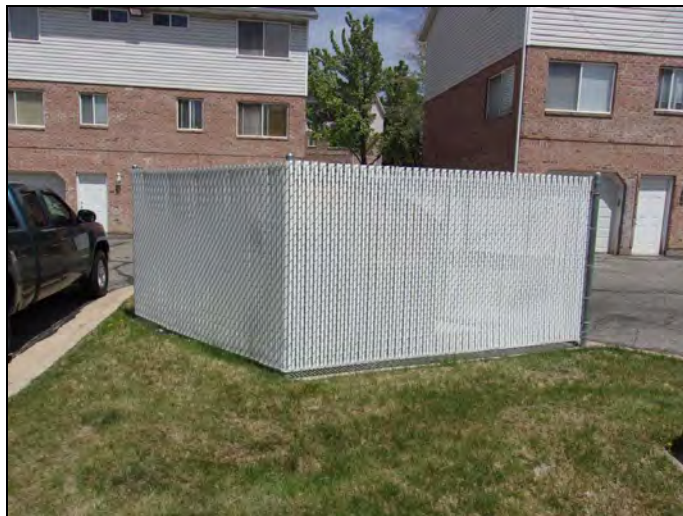
Comp #: 1010 Dumpster Enclosures - Replace

Location: Common Area

The dumpster enclosure gates are in good condition. We recommend funding to replace this component approximately every 25 - 30 years. Remaining life based on current age.

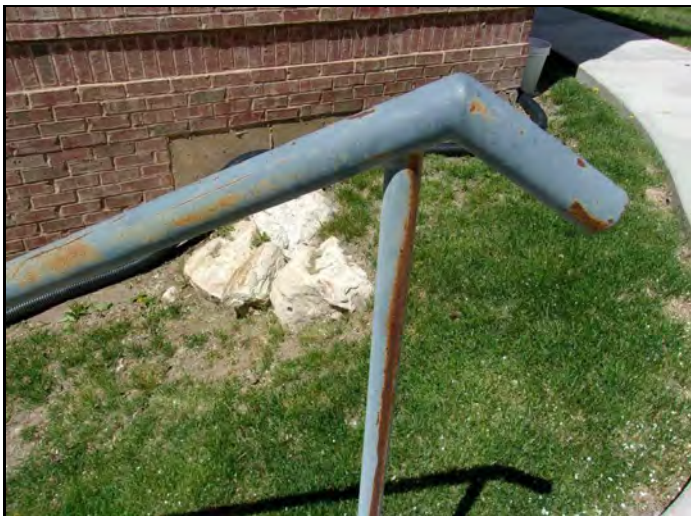
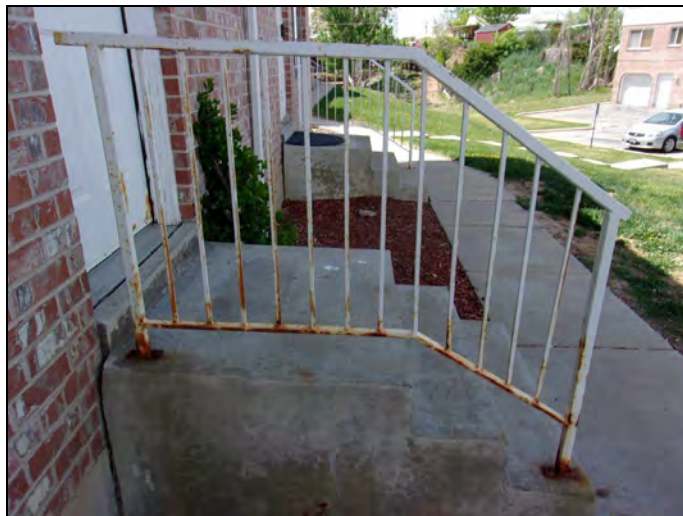
Comp #: 1090 Metal Railing - Replace

Location: **Common Area & Unit Entrances**

The metal railing is in fair to poor condition. We recommend funding to replace this component approximately every 40 - 50 years. Remaining life based on current age and condition.

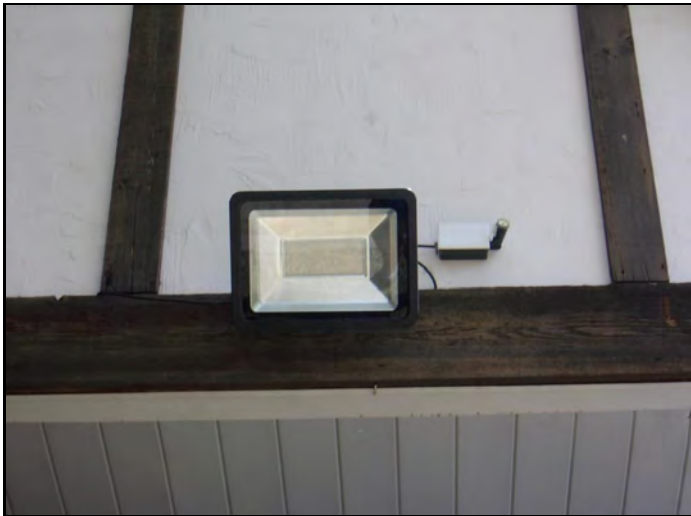
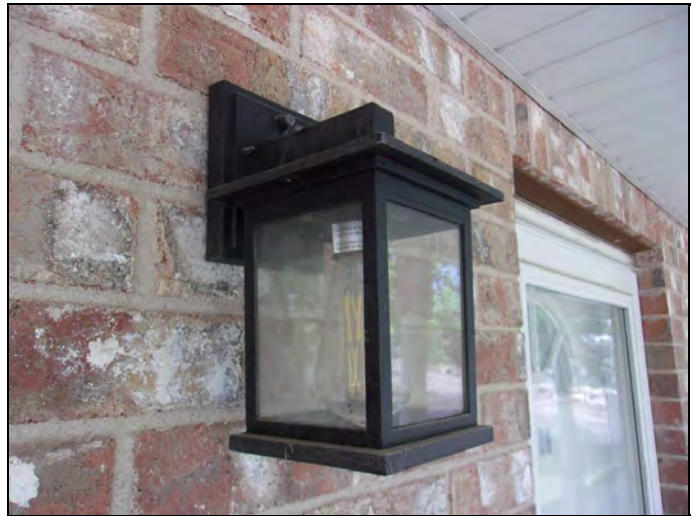
Comp #: 1602 Exterior Light Fixtures - Newer - Replace

Location: **Building Exteriors**

The exterior light fixtures are in good condition. We recommend funding to replace this component approximately every 16 - 20 years. Remaining life based on current age.

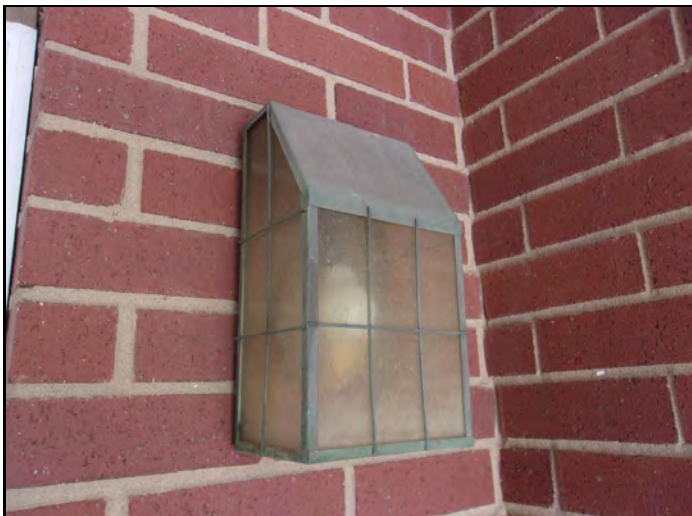
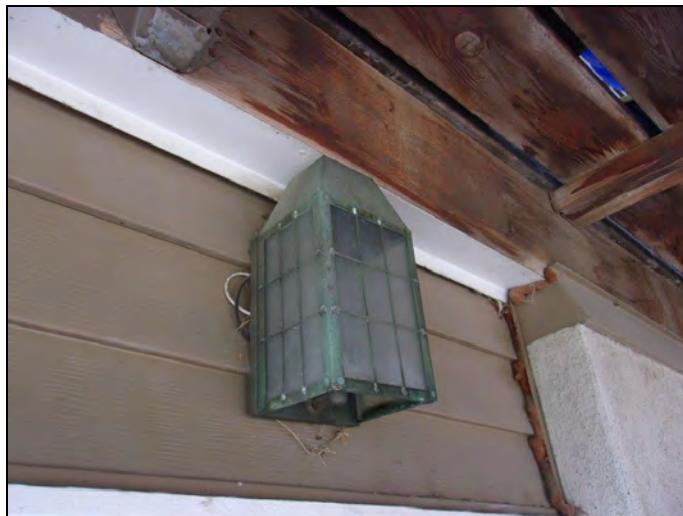
Comp #: 1602 Exterior Light Fixtures - Older - Replace

Location: **Building Exteriors**

The exterior light fixtures are in fair to poor condition. We recommend funding to replace this component approximately every 16 - 20 years. Remaining life based on current age and condition.

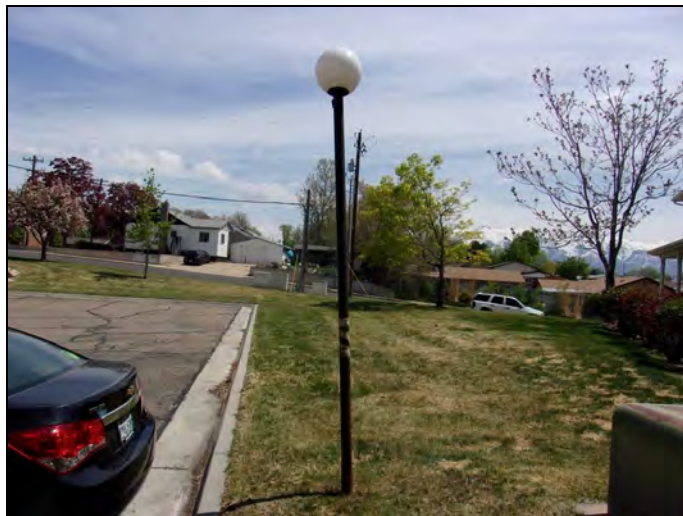
Comp #: 1604 Pole Lights - Replace

Location: **Adjacent to Buildings A & B**

The pole lights are in fair to poor condition. We recommend funding to replace these pole light fixtures, poles and to refurbish the electrical approximately every 16 - 20 years. Remaining life based on current age.

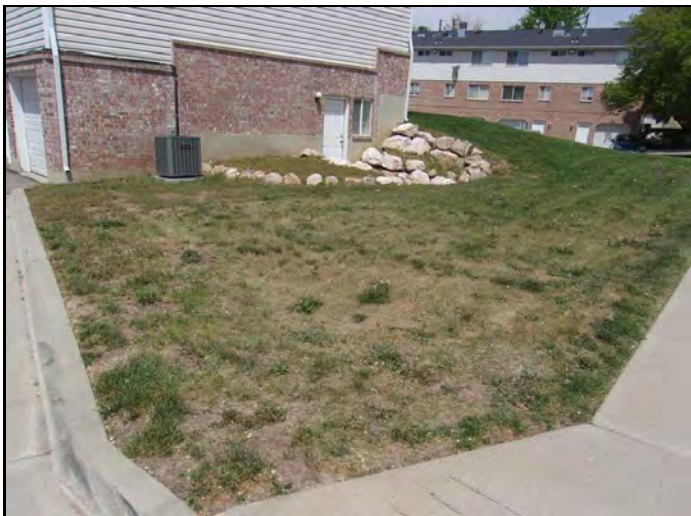
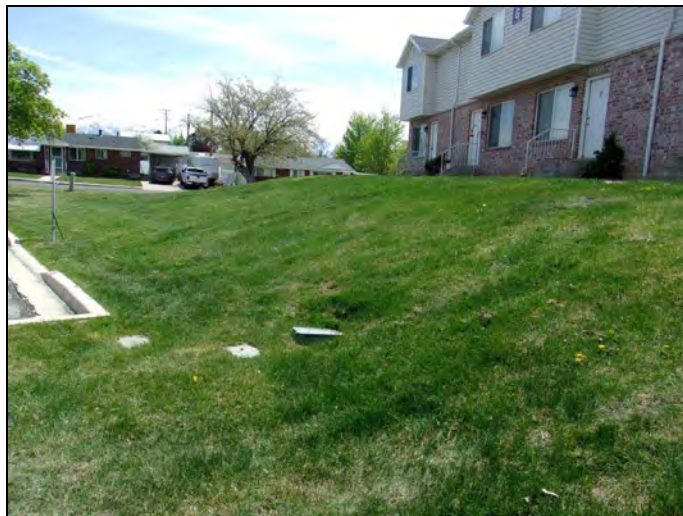
Comp #: 1812 Landscaping & Irrigation System - Renovate

Location: **Common Area**

The landscaping and irrigation system appear to be in fair to poor condition. We recommend funding for an allowance to renovate this component approximately every 20 years. Remaining life based on current age.
