The Maples at Jordan Hills

Level 1 Reserve Study

Report Period – 01/01/2021 – 12/31/2021

Executive Summary – The Maples at Jordan Hills - ID # 12651

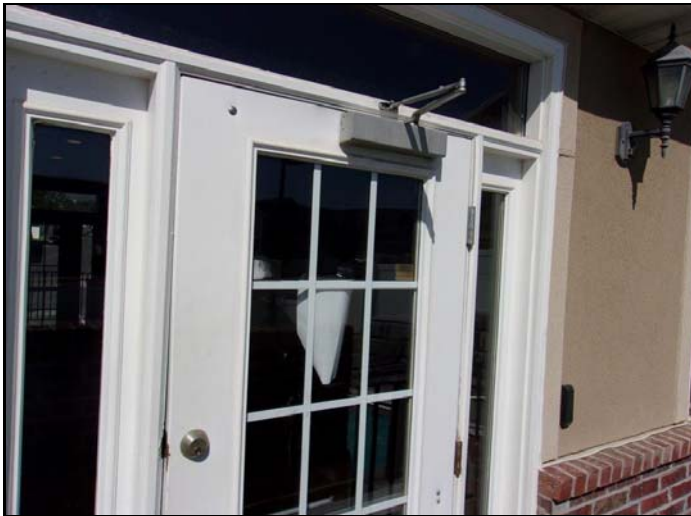
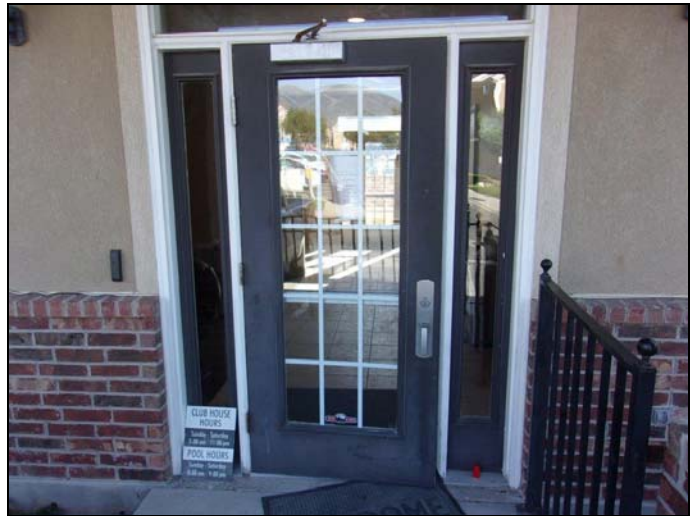
Comp #: 204 Clubhouse Doors - Repaint

Location: **Clubhouse**

Quantity: **(4) Doors**

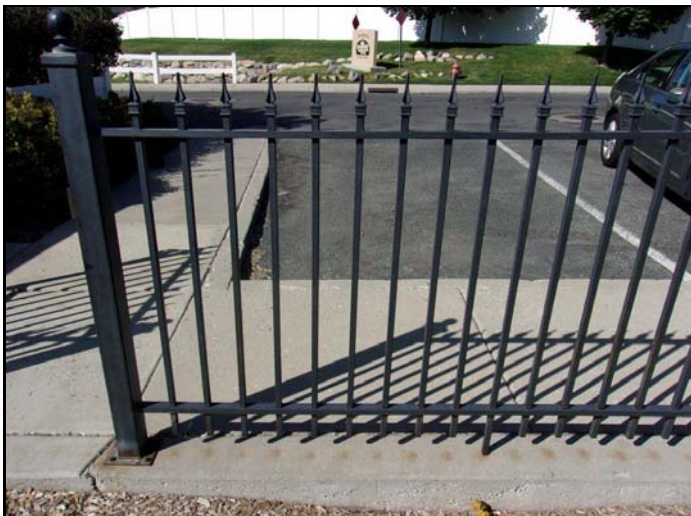
Comp #: 207 Metal Fencing - Repaint

Location: Clubhouse Area

Quantity: Approx 245 Linear ft.

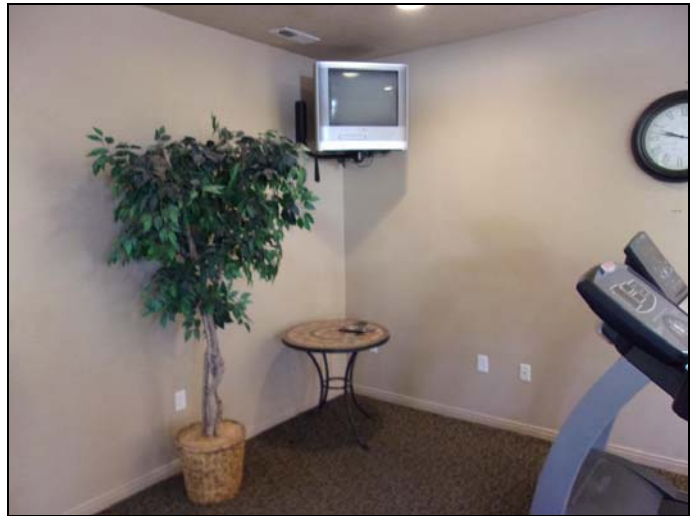
Comp #: 216 Interior Surfaces - Repaint

Location: Clubhouse Interior

Quantity: Approx 1,300 Sq.ft.

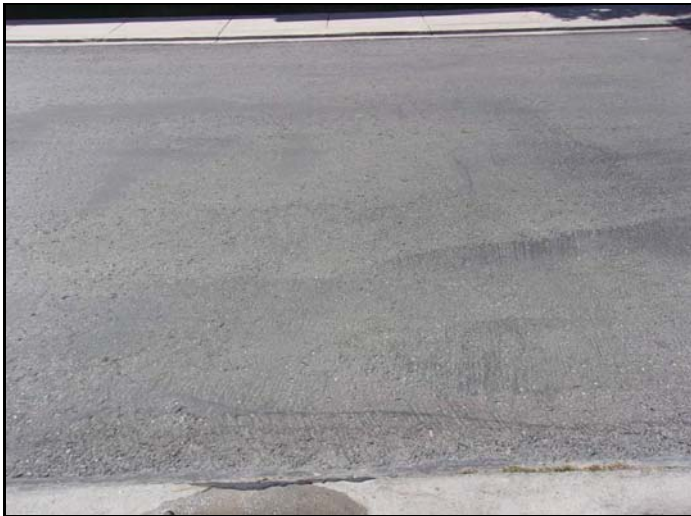
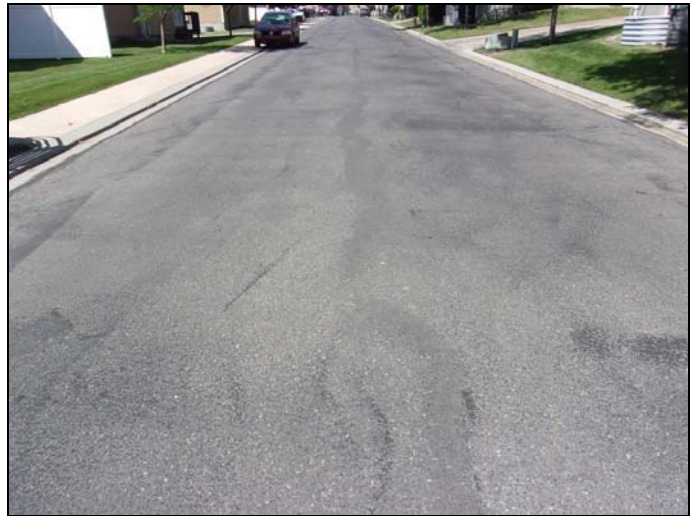
Comp #: 401 Asphalt - Major Rehab

Location: **Community Streets**

Quantity: **Approx 70,725 Sq.ft.**

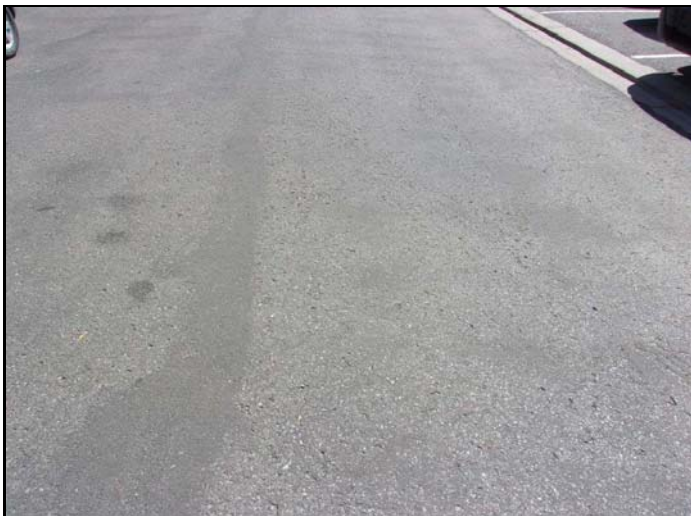
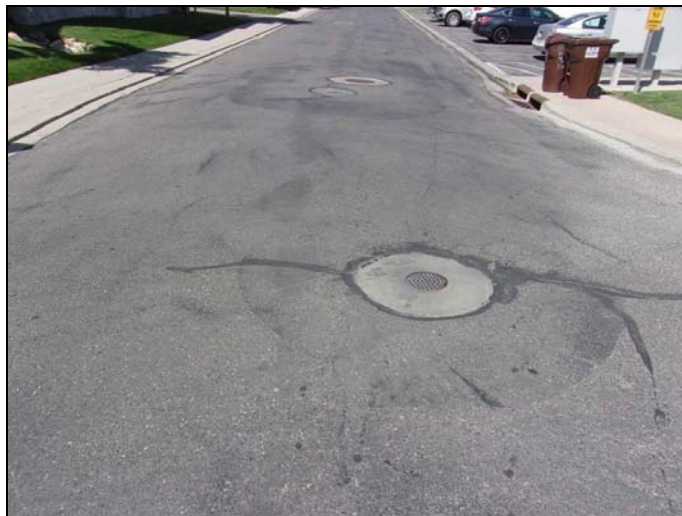
Comp #: 402 Asphalt - Seal Coat

Location: **Community Streets**

Quantity: **Approx 70,725 Sq.ft.**

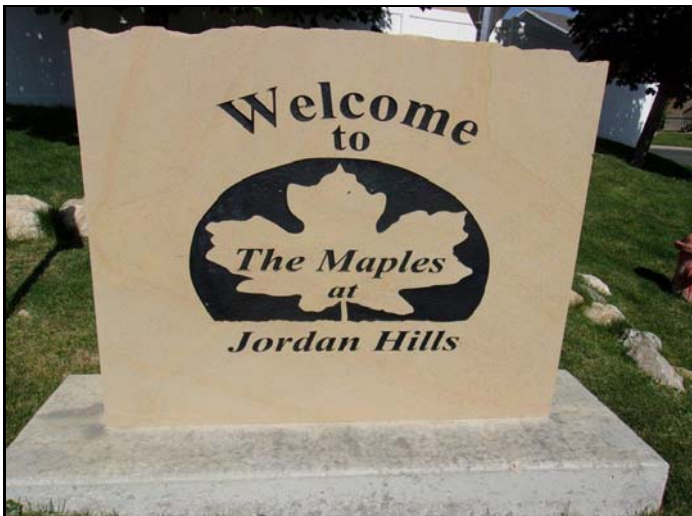
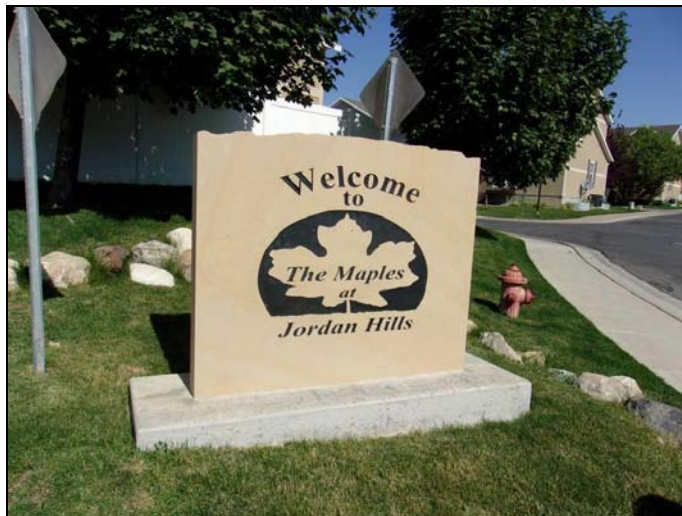
Comp #: 801 Monument Sign - Refurbish

Location: **Community Entrances**

Quantity: **(2) Monuments**

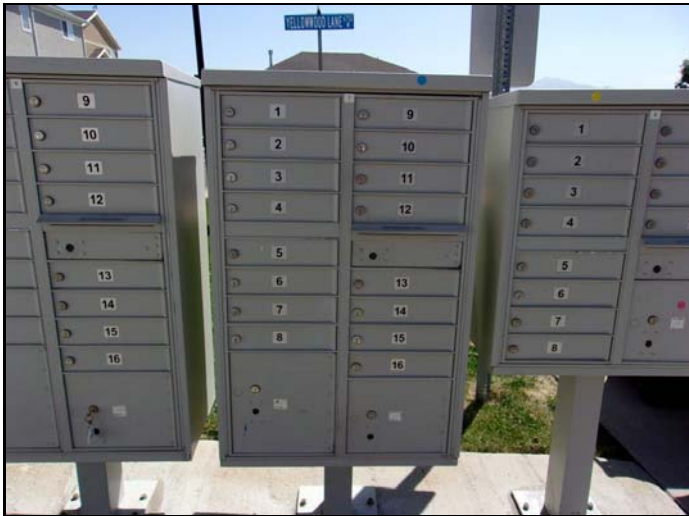
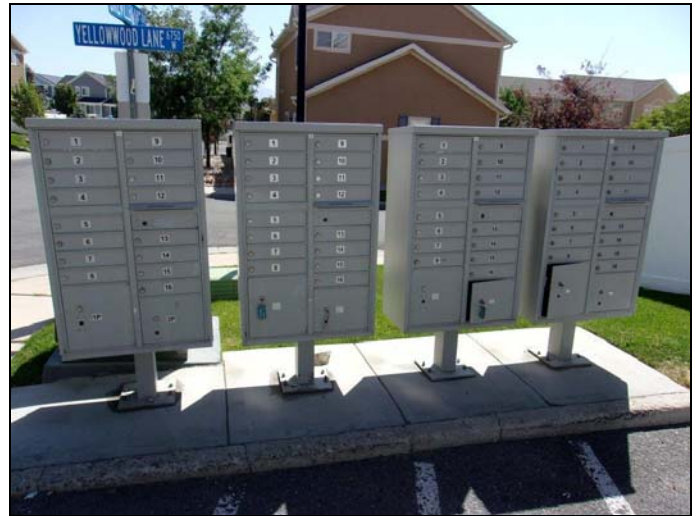
Comp #: 803 Mailboxes - Replace

Location: **Common Area**

Quantity: **(8) Clusters**

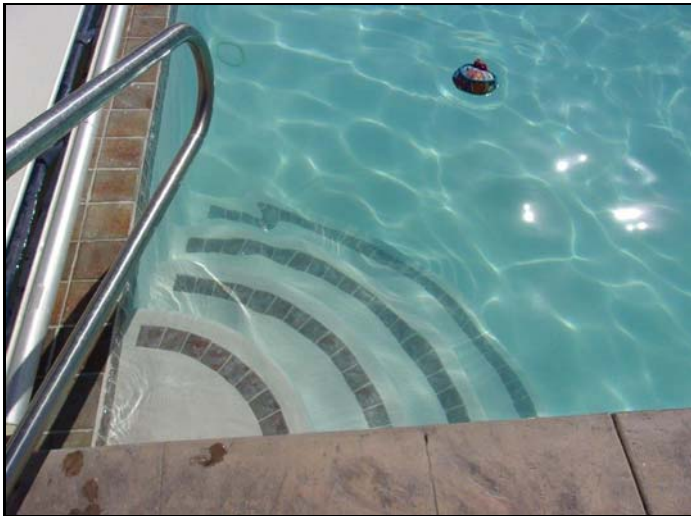
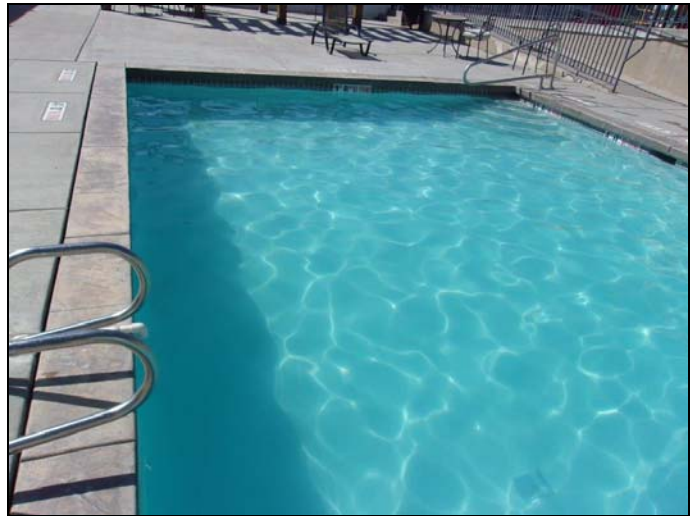
Comp #: 1101 Pool - Resurface

Location: **Pool Area**

Quantity: **(1) Pool**

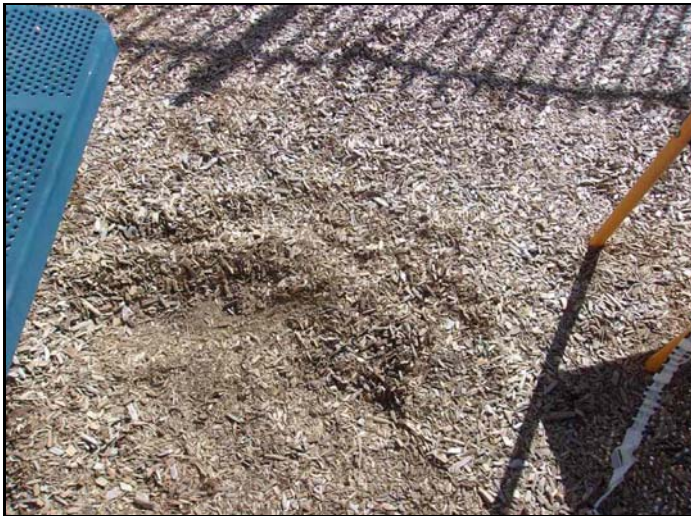
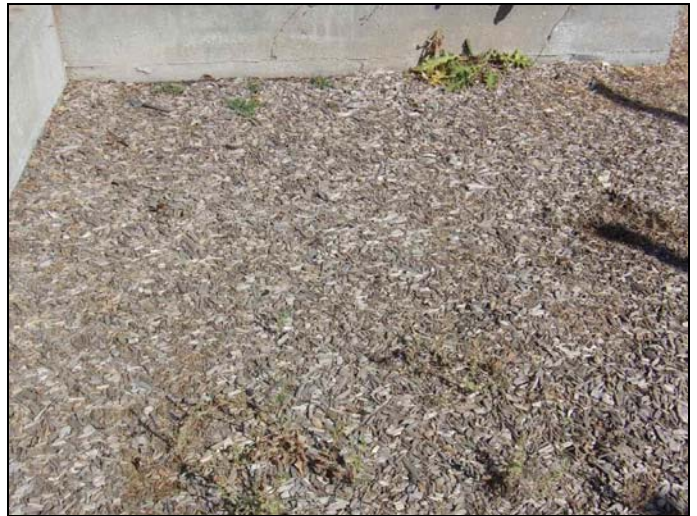
Comp #: 1303 Play Area Groundcover - Refill

Location: **Play Area**

Quantity: **Approx 895 Sq.ft.**

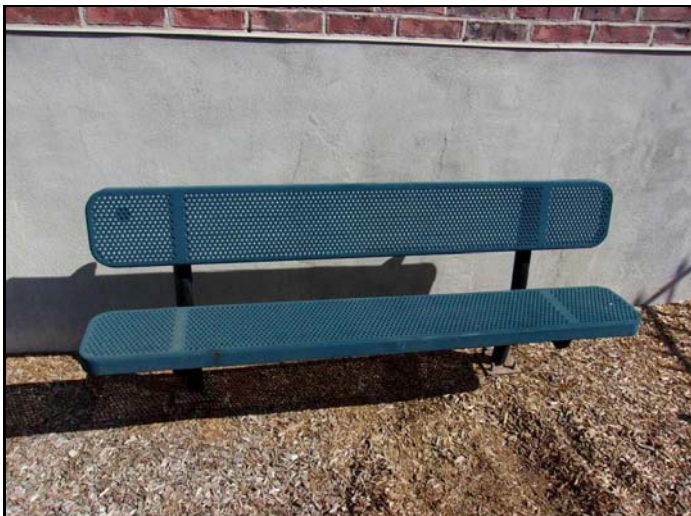
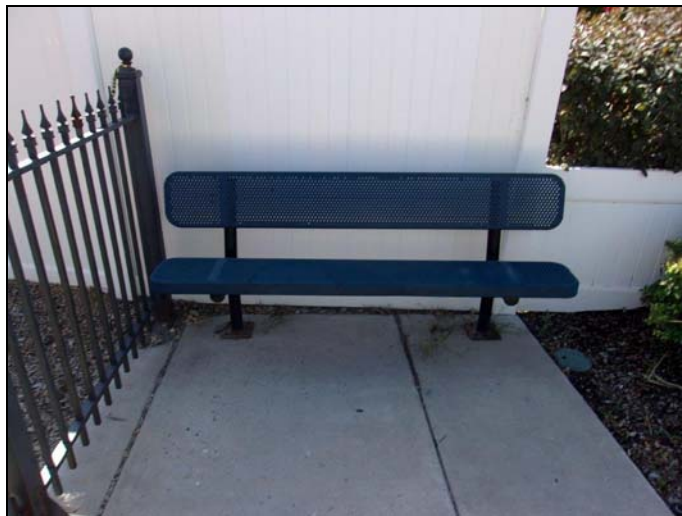
Comp #: 1307 Benches - Replace

Location: **Play Area**

Quantity: **(2) Benches**

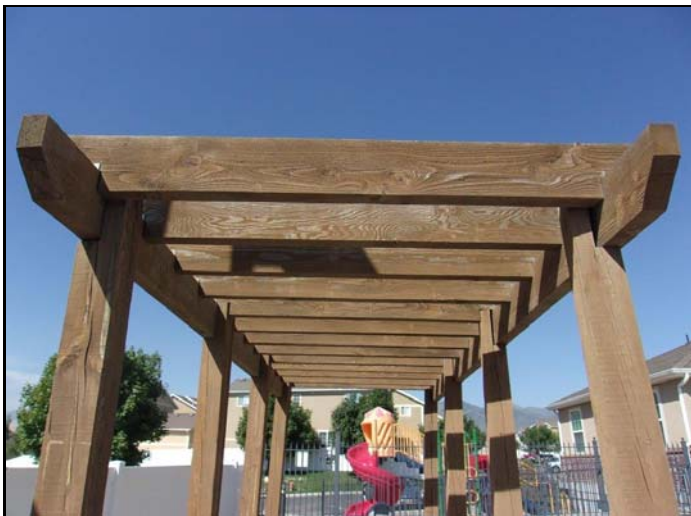
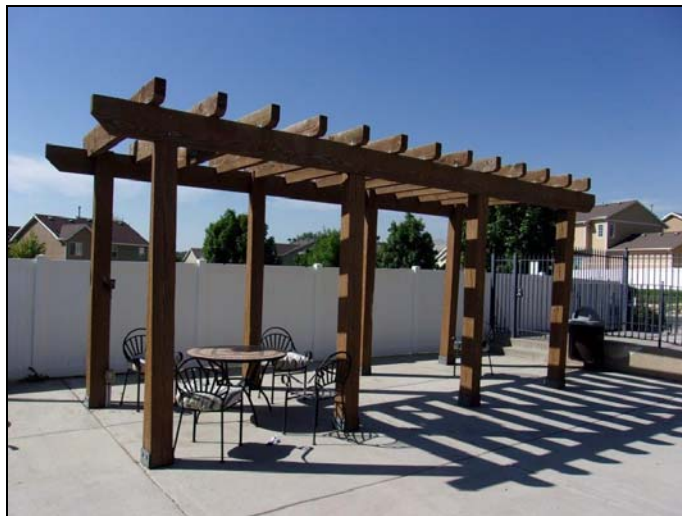
Comp #: 1309 Pergola - Replace

Location: **Pool Area**

Quantity: **(1) Structure**

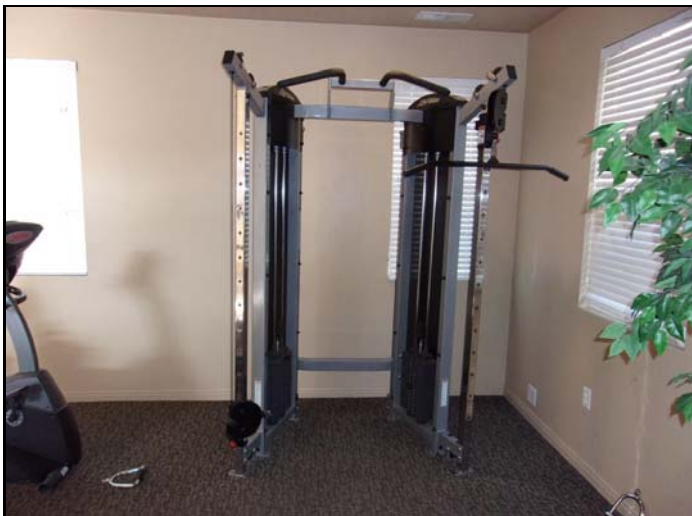
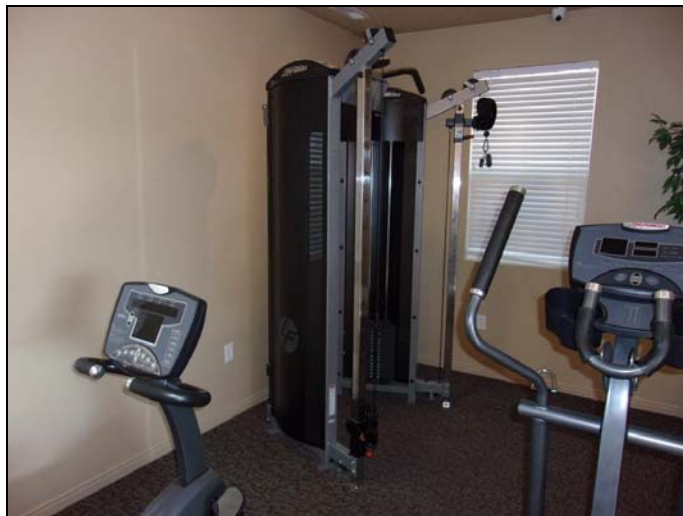
Comp #: 1406 Fitness Equipment - Replace

Location: Clubhouse Common Room

Quantity: (1) Piece

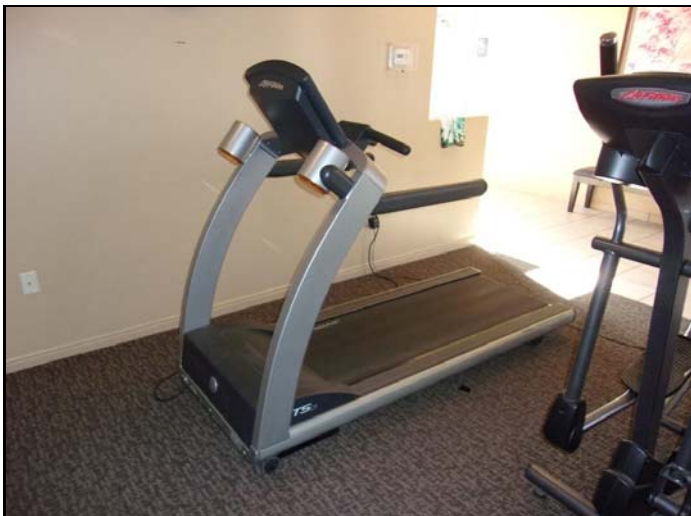
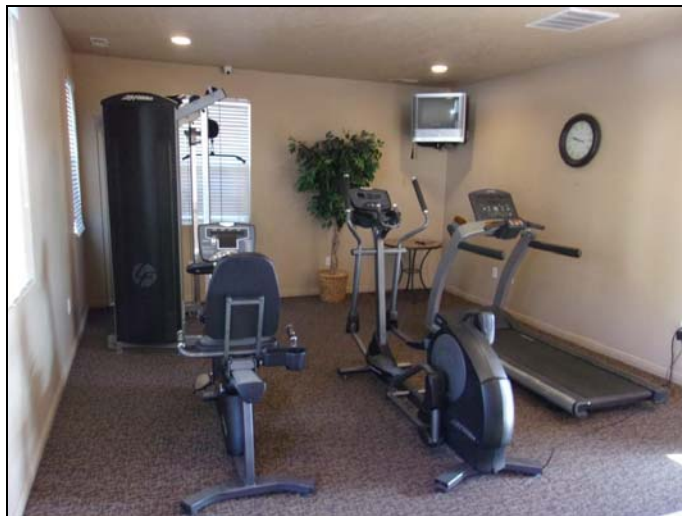
Comp #: 1407 Cardio Equipment - Replace

Location: Clubhouse Common Room

Quantity: (3) Pieces

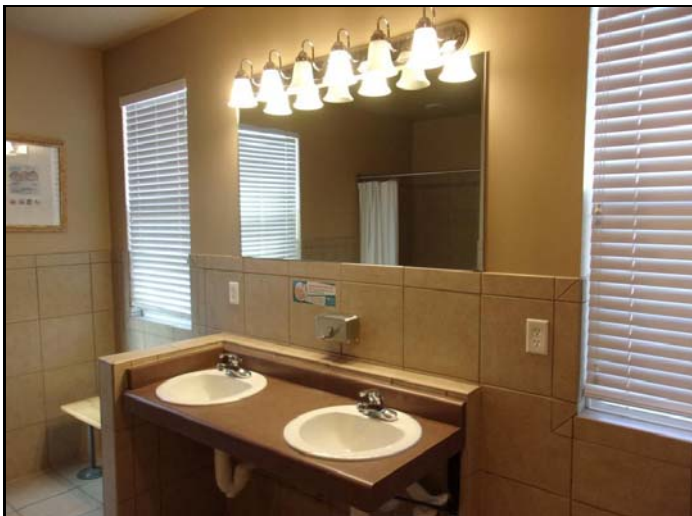
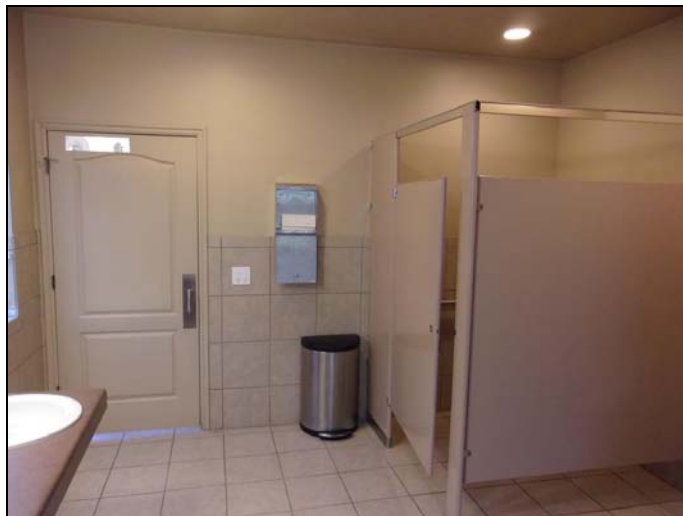
Comp #: 1413 Restrooms - Remodel

Location: **Clubhouse Interior**

Quantity: **(2) Restrooms**

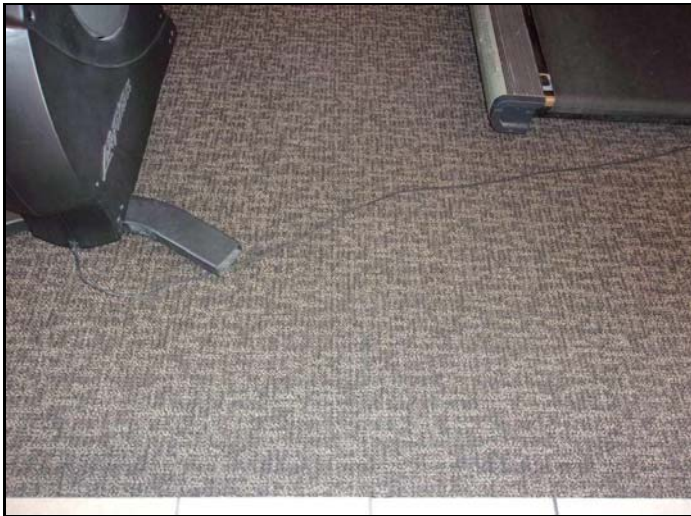
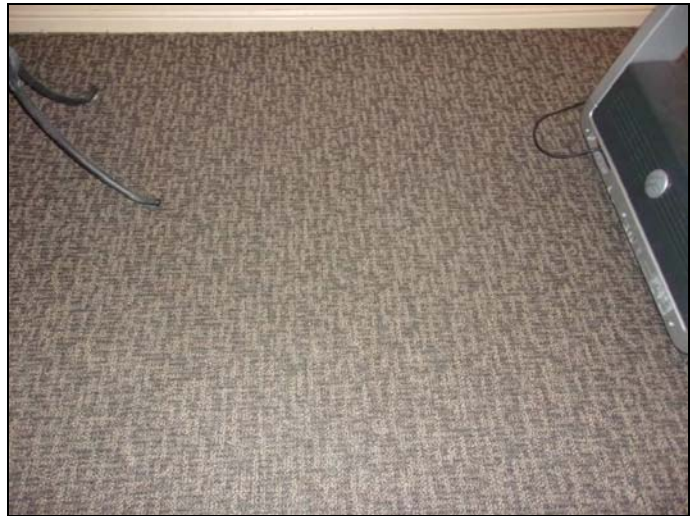
Comp #: 1501 Carpeting - Replace

Location: **Clubhouse Common Room**

Quantity: **Approx 240 Sq.ft.**

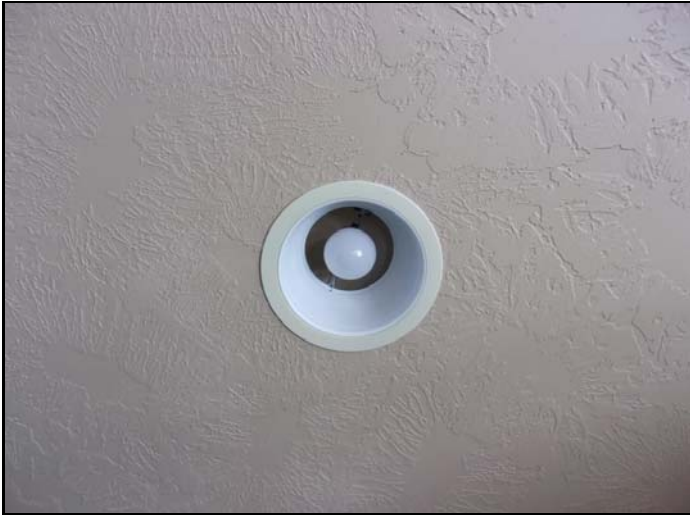
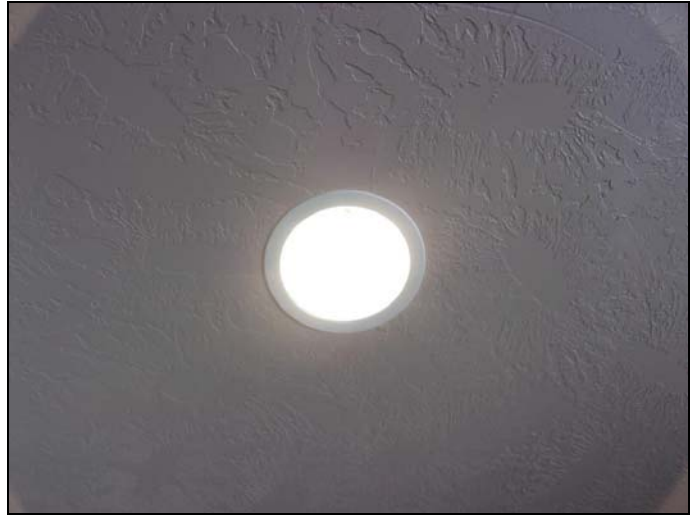
Comp #: 1601 Interior Light Fixtures - Replace

Location: Clubhouse Interior

Quantity: (22) Fixtures

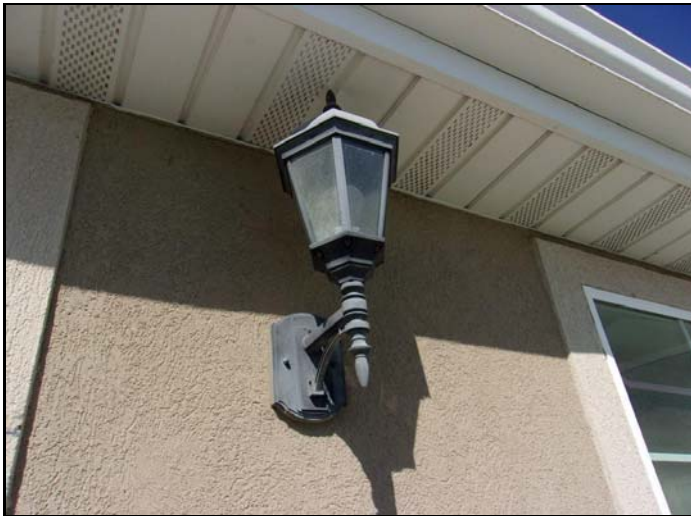
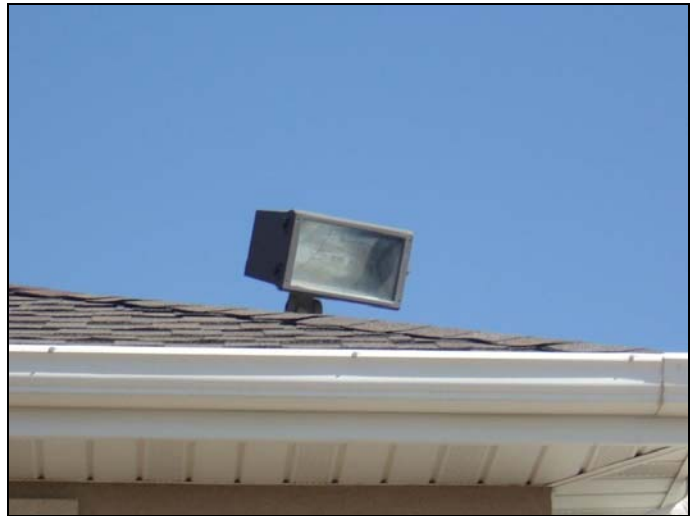
Comp #: 1602 Exterior Light Fixtures - Replace

The exterior light fixtures are in fair condition. We recommend funding to replace this component approximately every 16 - 20 years. Remaining life based on current age.

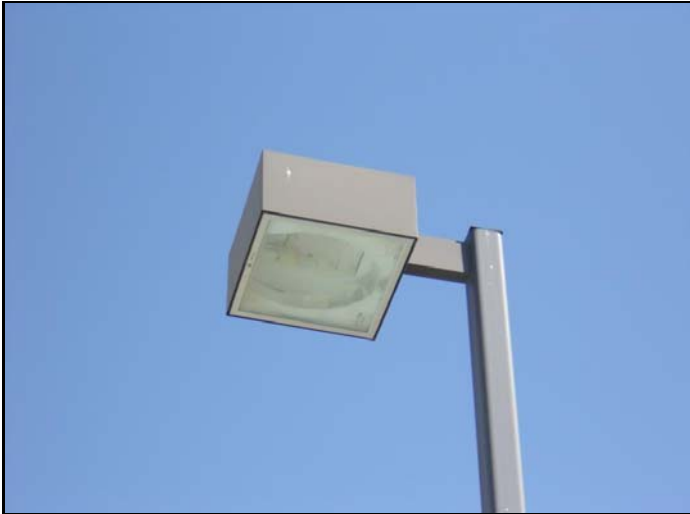
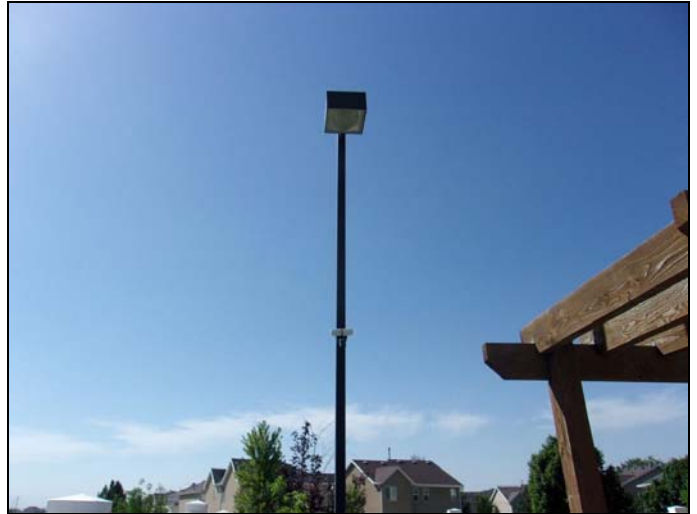
Comp #: 1606 Pool Light Fixtures - Replace

The pool light fixtures are in good condition. No expectation to replace the light poles. Paint poles as necessary as an operating expense. We recommend funding to replace this component approximately every 20 years. Remaining life based on current age.

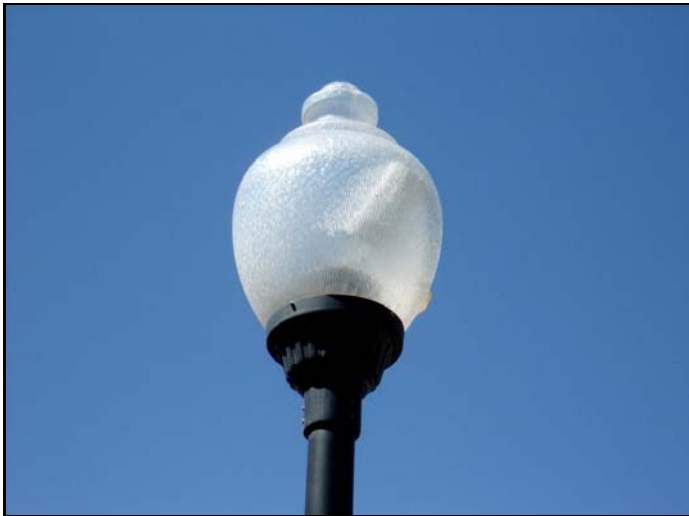
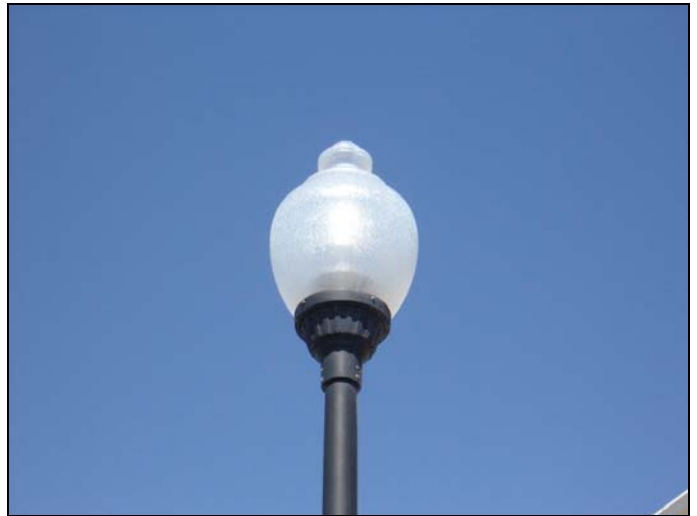
Comp #: 1609 Street Light Fixtures - Replace

The street light fixtures are in good condition. No expectation to replace the light poles. Paint poles as necessary as an operating expense. We recommend funding to replace this component approximately every 20 years. Remaining life based on current age.

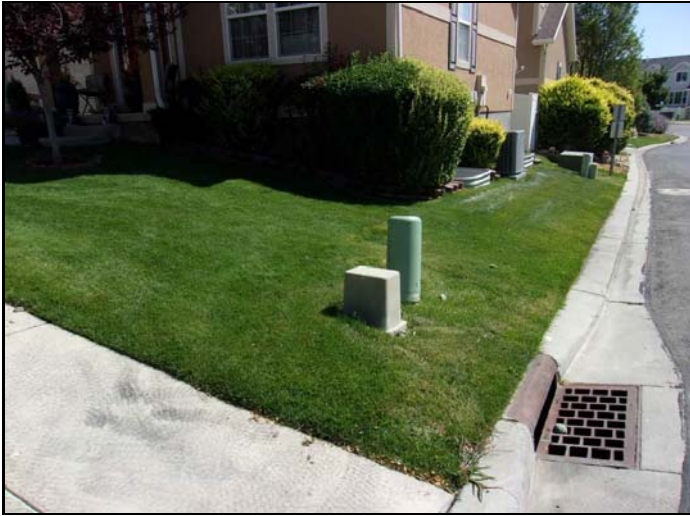
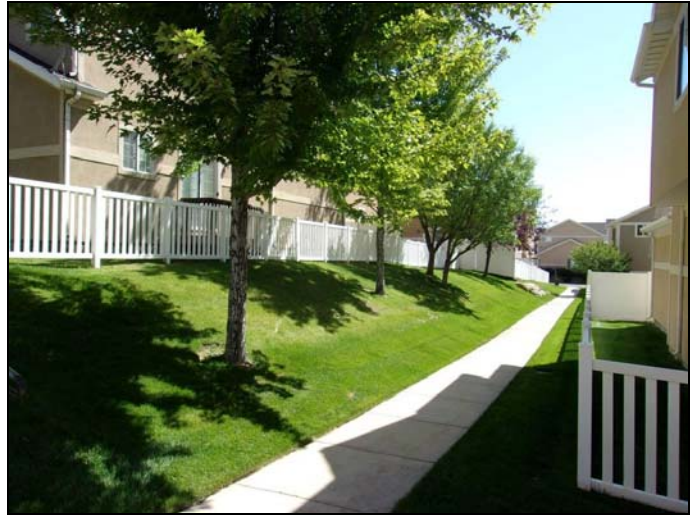
Comp #: 1812 Landscaping & Irrigation System - Renovate

The landscaping and irrigation system are in good condition. We recommend funding for an allowance to renovate the landscaping and irrigation system approximately every 20 years. Remaining life based on current age.

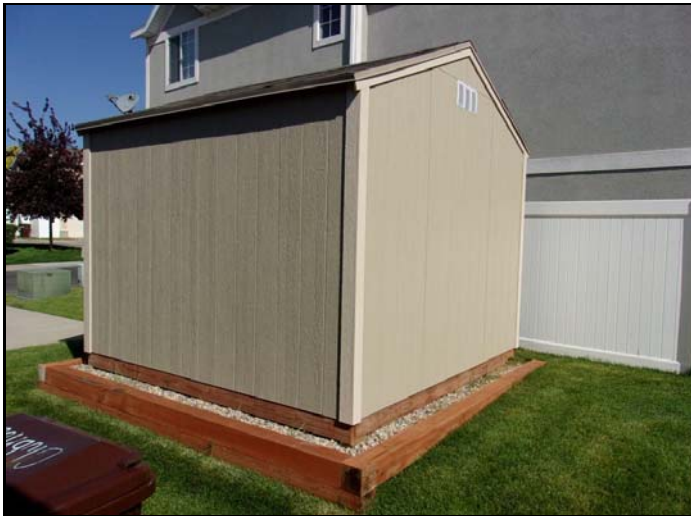
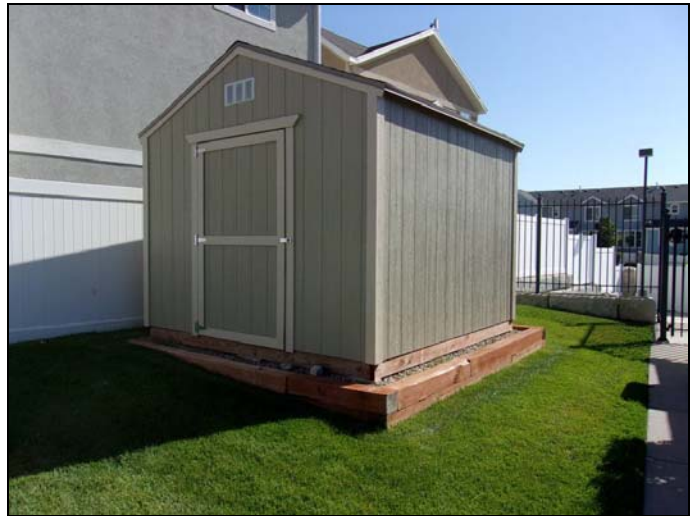
Comp #: 2301 Shed - Replace

The shed is in good condition. We recommend funding to replace this component approximately every 20 - 25 years. Remaining life is based on current age.
