Stoneybrook HOA

Level 2 Reserve Study

Client Reference Number	11190
Property Type	Condominium
Number of Units	48
Fiscal Year End	12/31

Type of Study	Update w/Site Visit
Date of Property Inspection	6/13/2019
Prepared By	Dale Gifford
Analysis Method	Cash Flow
Funding Goal	Full Funding

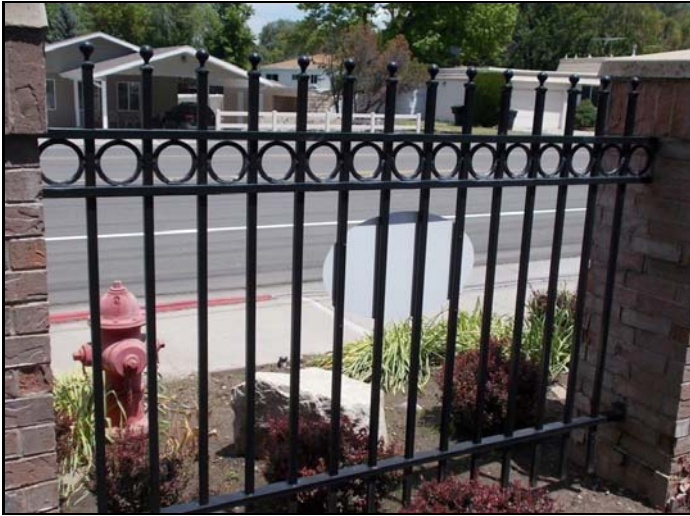
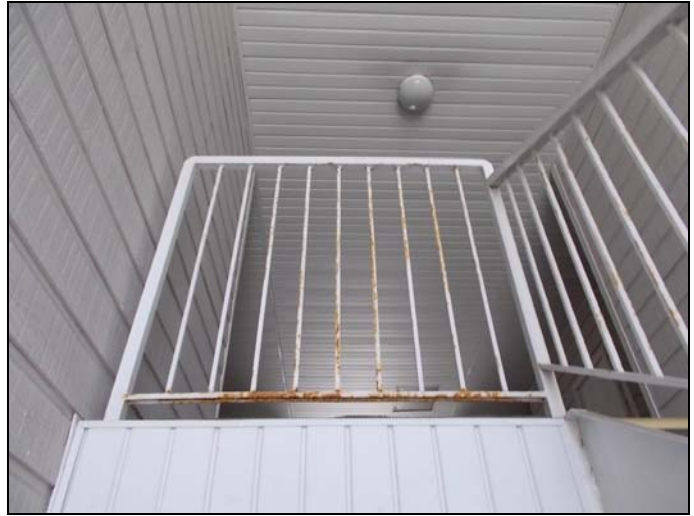
Comp #: 207 Metal Fencing & Railing - Repaint

Location: **Common Area**

Quantity: **Approx 615 Linear ft.**

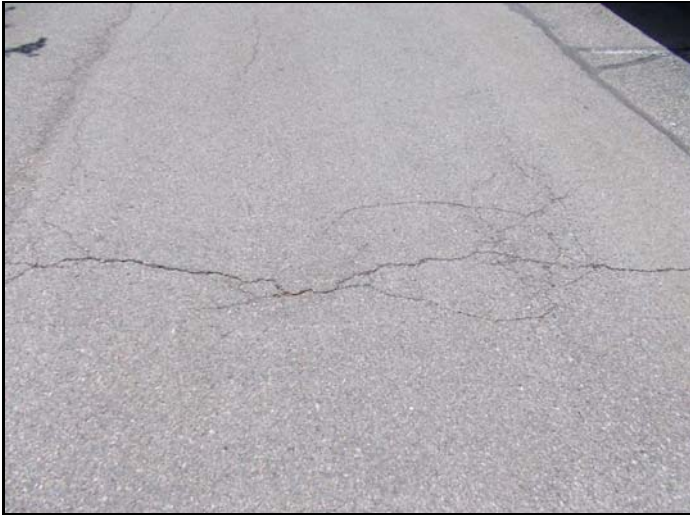
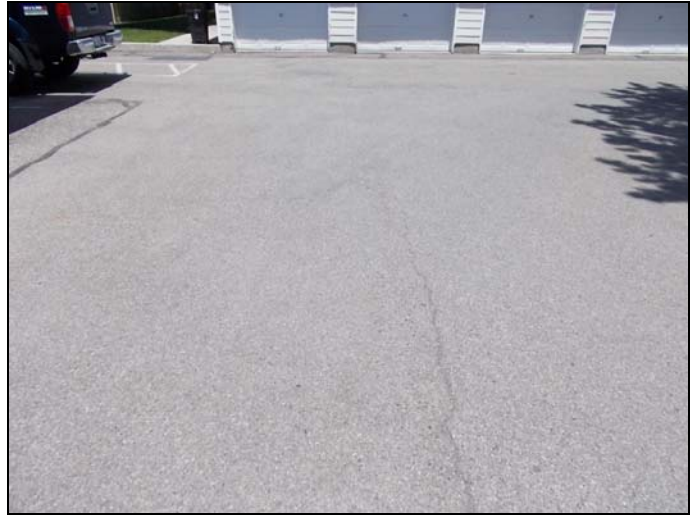
Comp #: 401 Asphalt - Center - Major Rehab

Location: **Community Streets**

Quantity: **Approx 18,800 Sq.ft.**

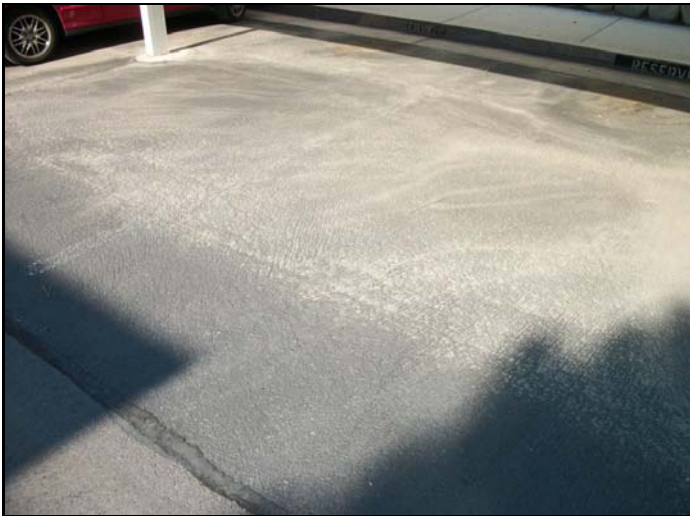
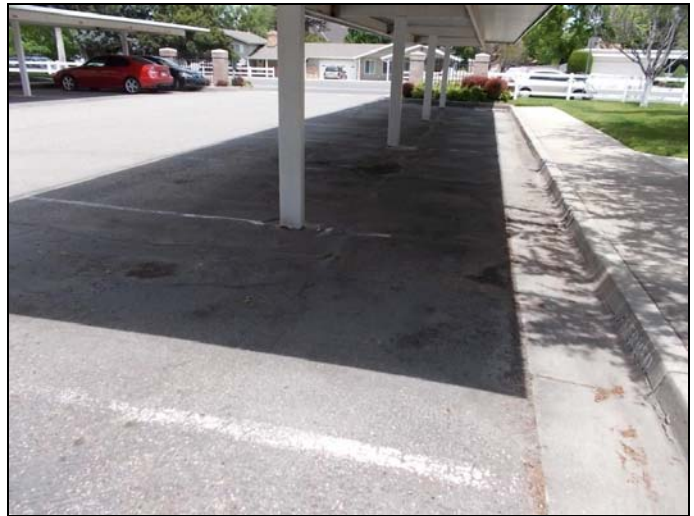
Comp #: 401 Asphalt - Major Rehab

Location: **Community Streets**

Quantity: **Approx 12,800 Sq.ft.**

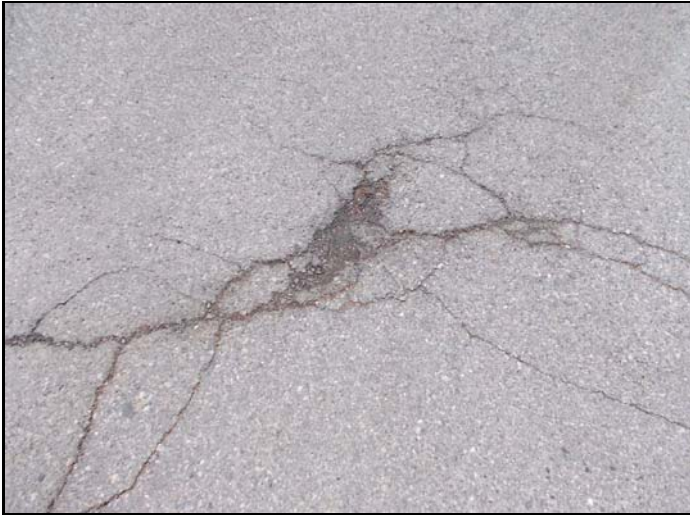
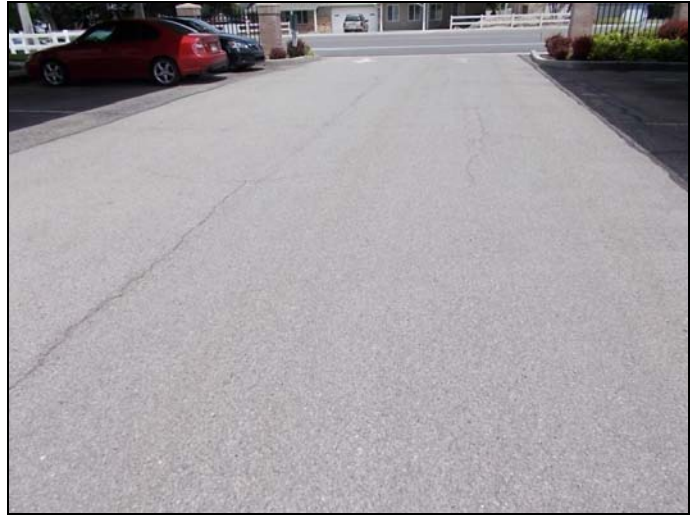
Comp #: 402 Asphalt - Seal Coat

Location: **Community Streets**

Quantity: **Approx 31,600 Sq.ft.**

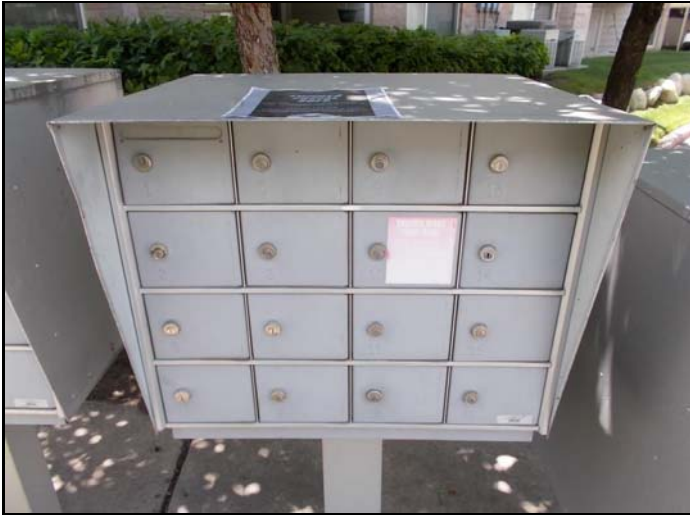
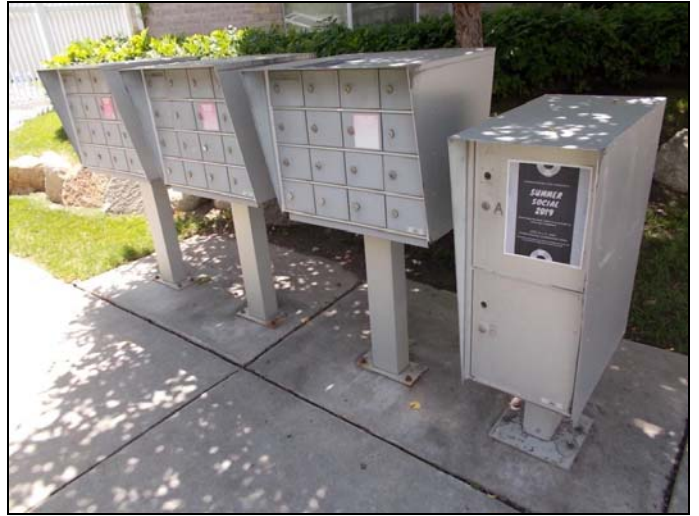
Comp #: 803 Mailboxes - Replace

Location: **Common area**

Quantity: **(4) Clusters**

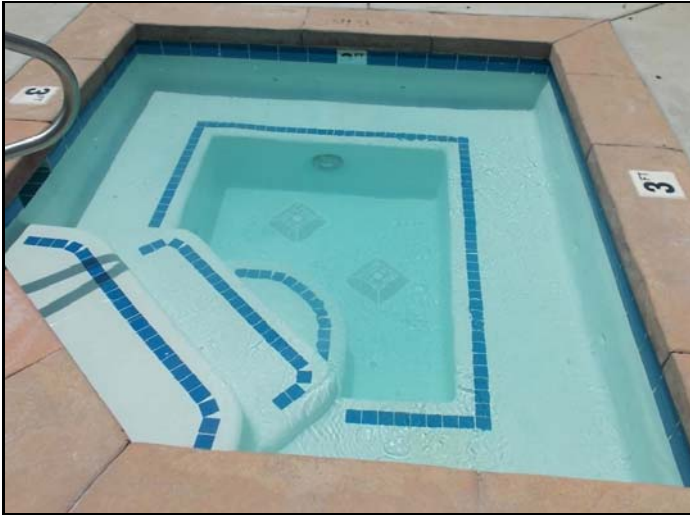
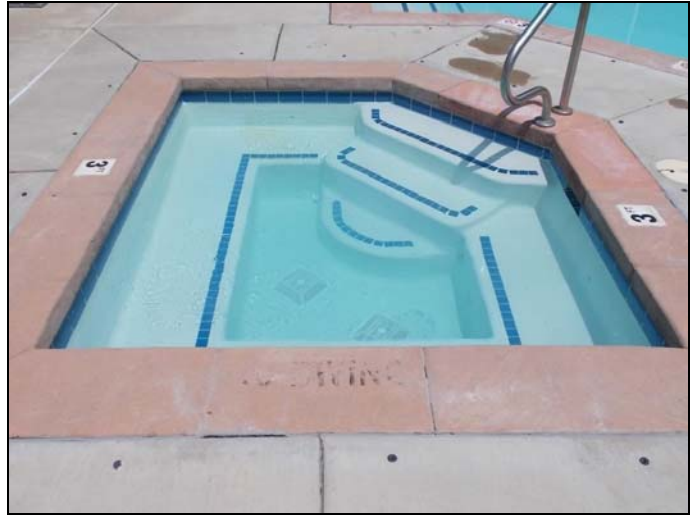
Comp #: 1102 Spa - Resurface

Location: **Pool Area**

Quantity: **(1) Spa**

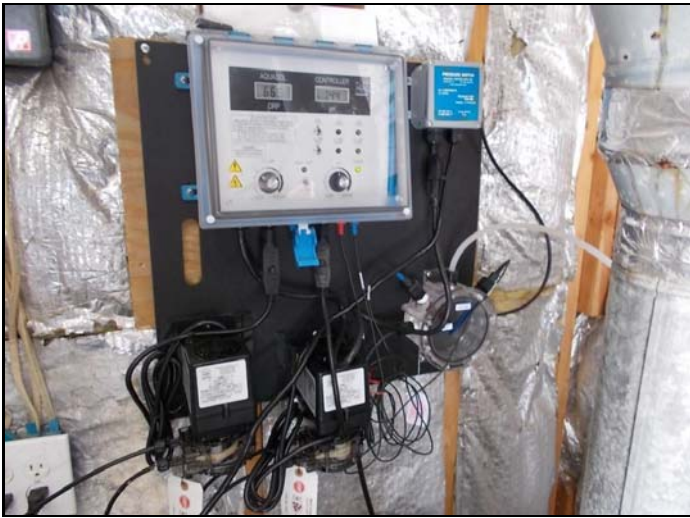
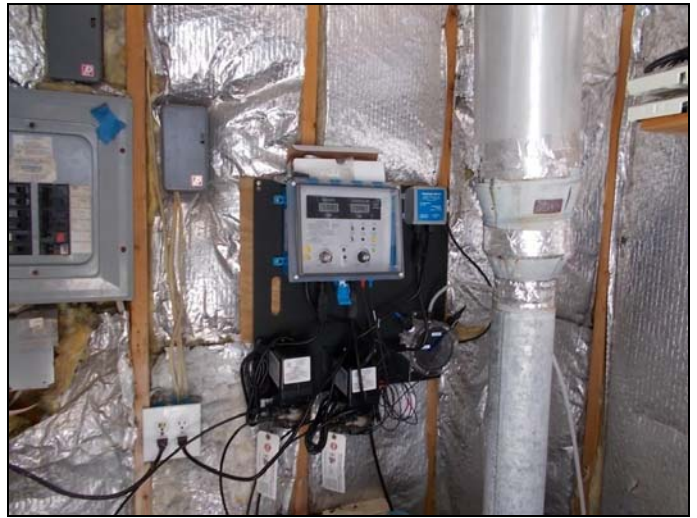
Comp #: 1111 Pool Chemical Controller System - Replace

Location: Pool Equipment Shed

Quantity: (1) System

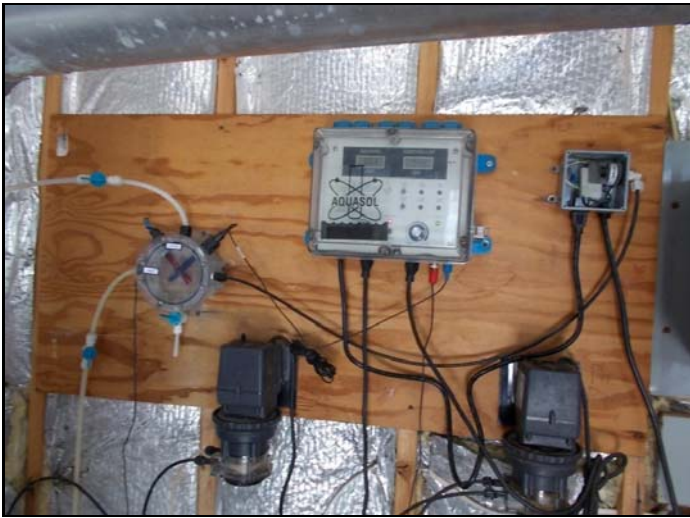
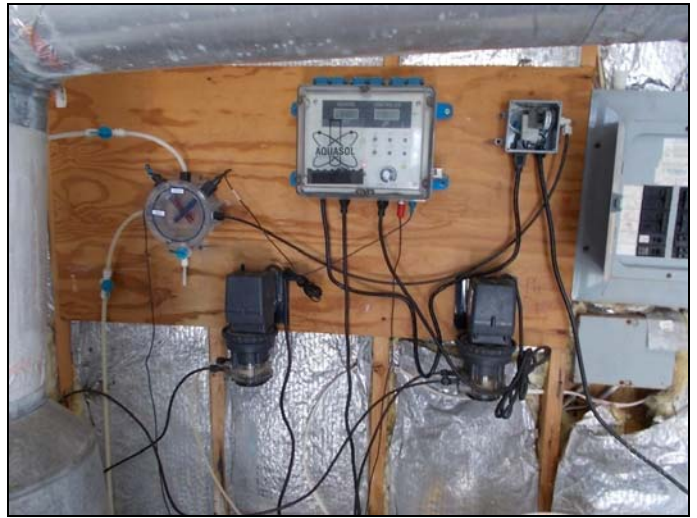
Comp #: 1111 Spa Chemical Controller System - Replace

Location: Pool Equipment Shed

Quantity: (1) System

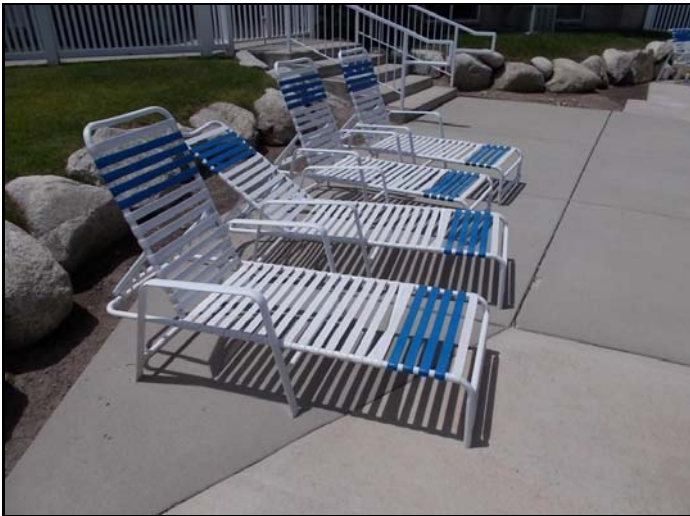
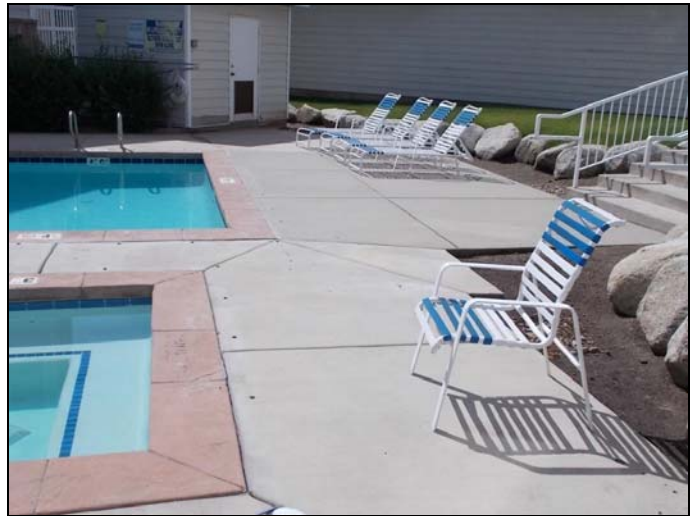
Comp #: 1121 Pool Furniture - Replace

Location: **Pool Area**

Quantity: **Assorted Pieces**

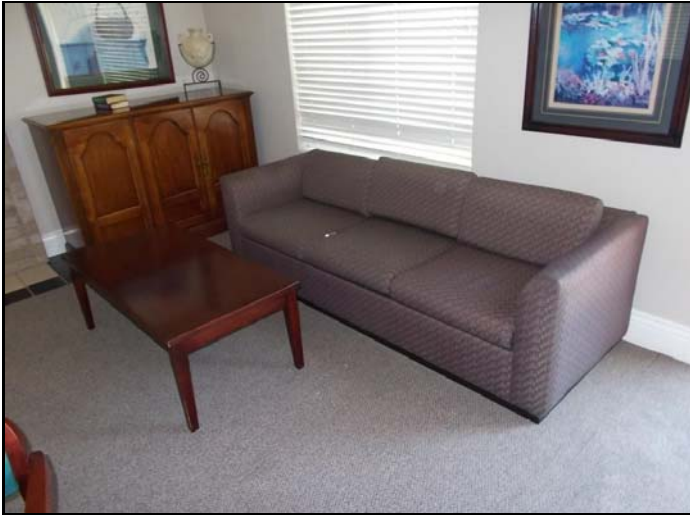
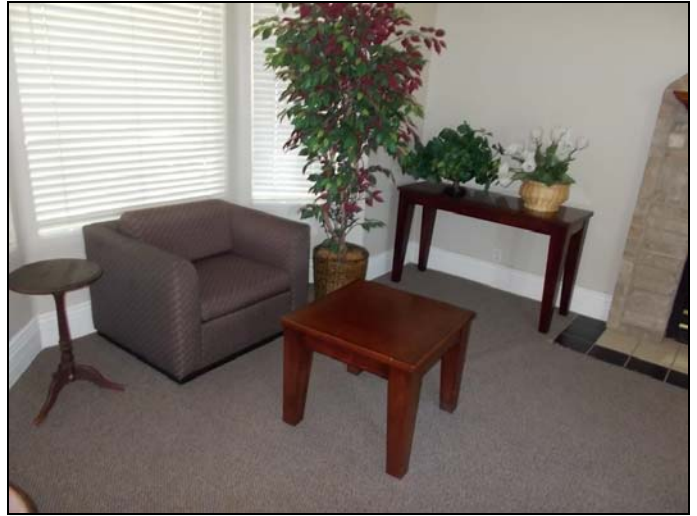
Comp #: 1405 Furniture - Replace

Location: **Clubhouse Interior**

Quantity: **Assorted Pieces**

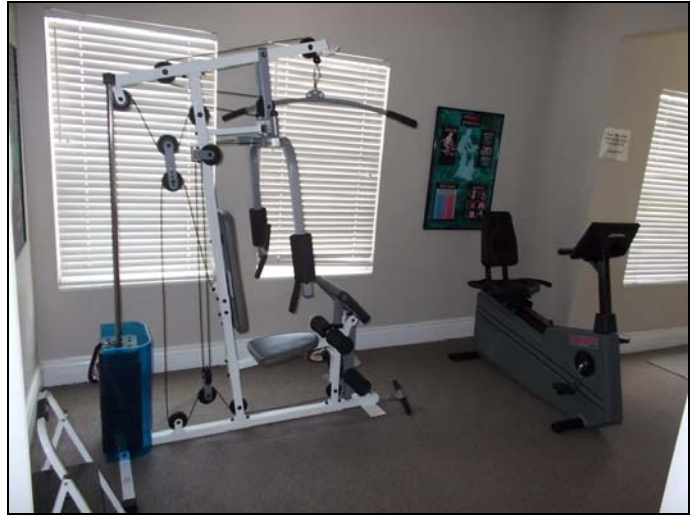
Comp #: 1406 Fitness Equipment - Replace

Location: **Clubhouse Fitness Room**

Quantity: **(1) Piece**

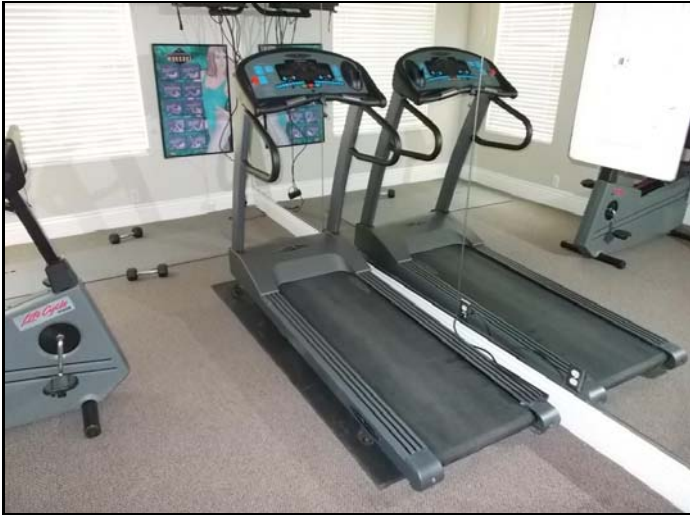
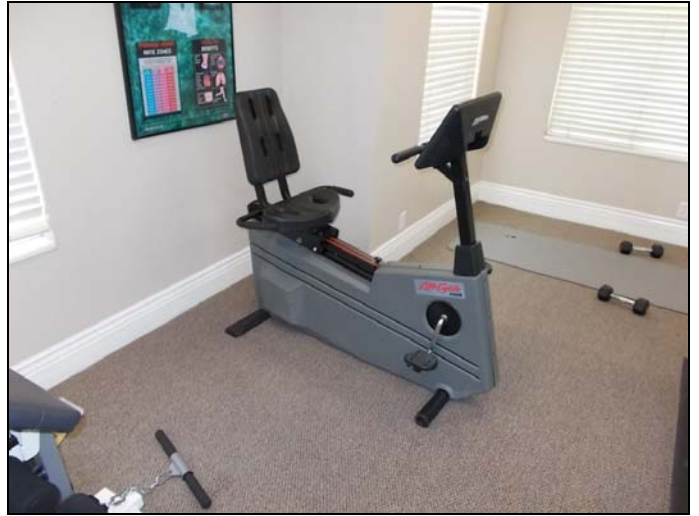
Comp #: 1407 Cardio Equipment - Replace

Location: Clubhouse Fitness Room

Quantity: (3) Pieces

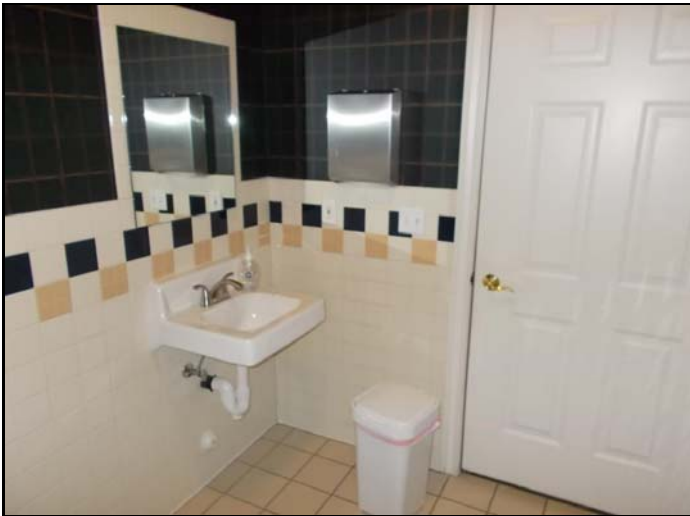
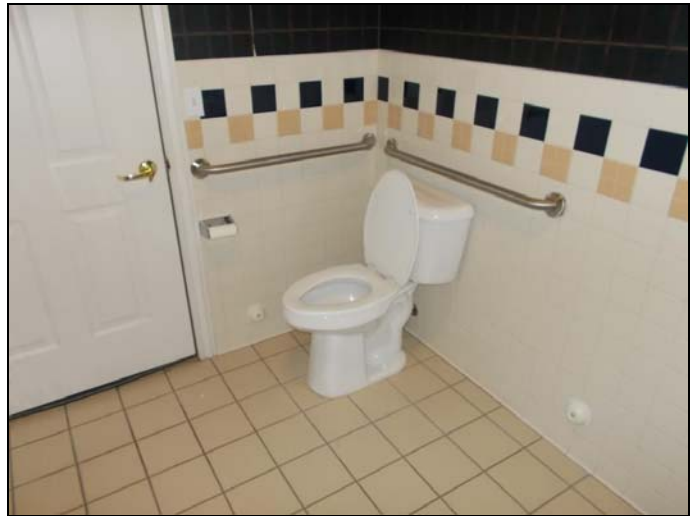
Comp #: 1413 Restroom - Remodel

Location: Clubhouse Interior

Quantity: (1) Restroom

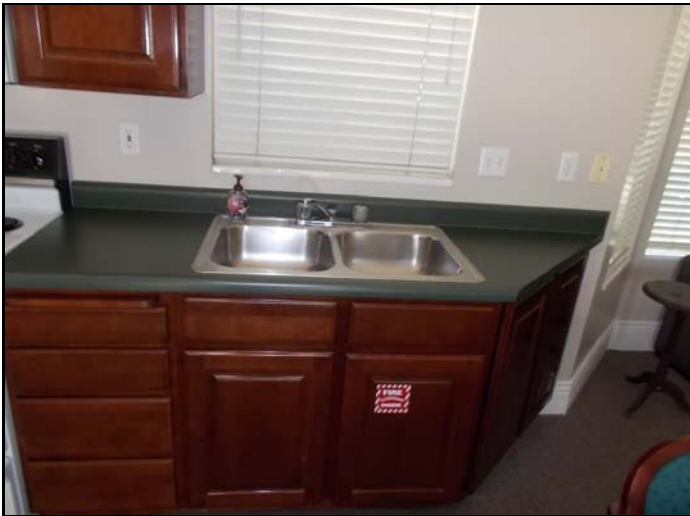
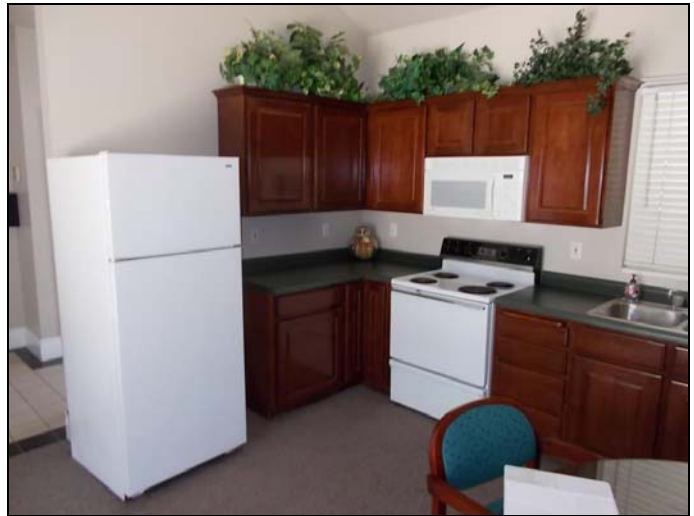
Comp #: 1417 Kitchen - Remodel

Location: Clubhouse Interior

Quantity: (1) Kitchen

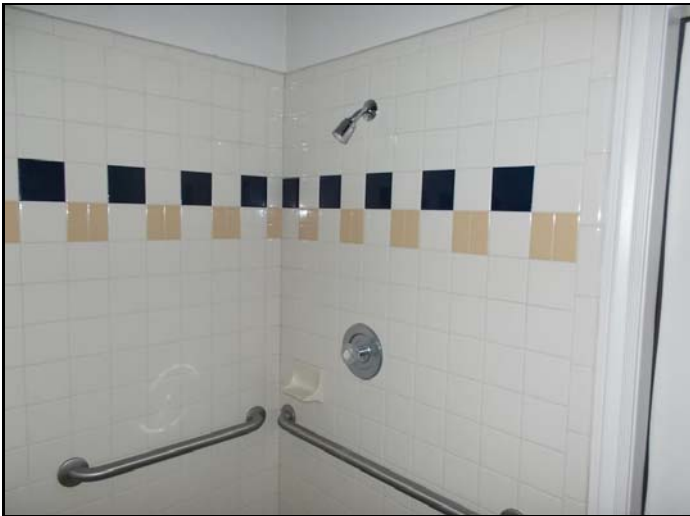
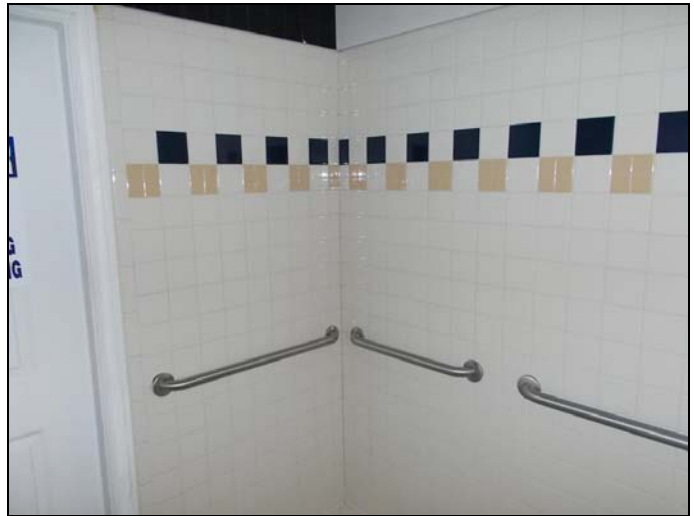
Comp #: 1490 Shower Room - Remodel

Location: Clubhouse Interior

Quantity: (1) Shower Room

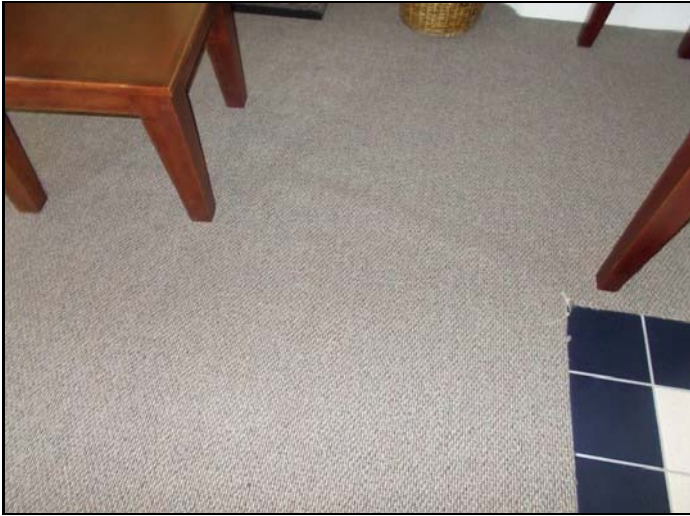
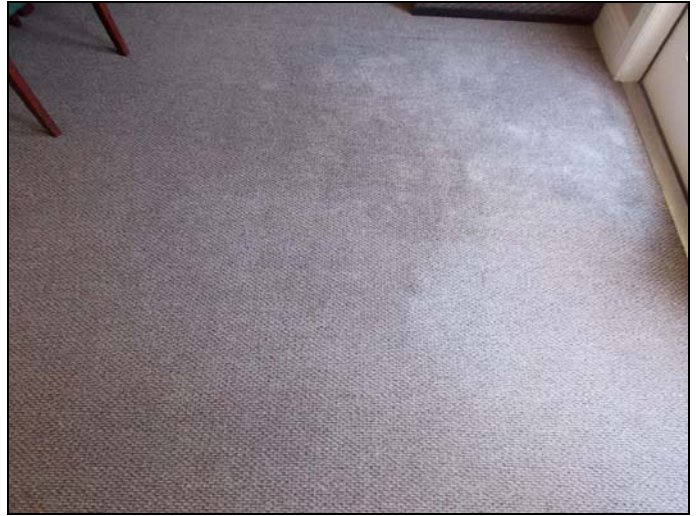
Comp #: 1501 Carpeting - Replace

The carpeting is in fair condition. We recommend funding to replace this component approximately every 8 - 10 years. Remaining life based on current condition.

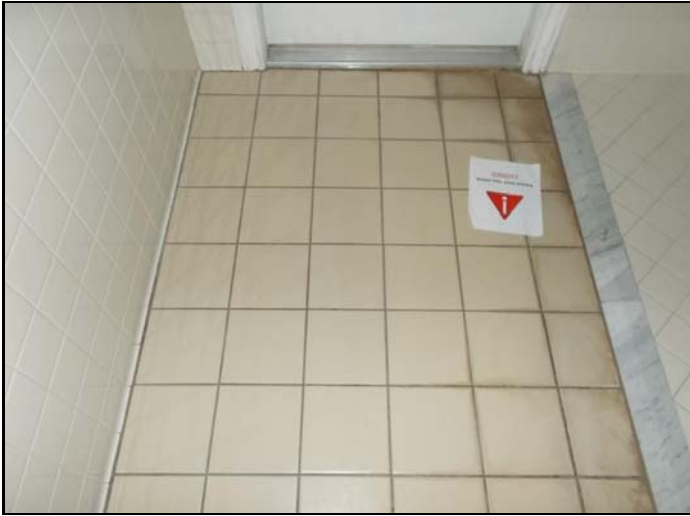
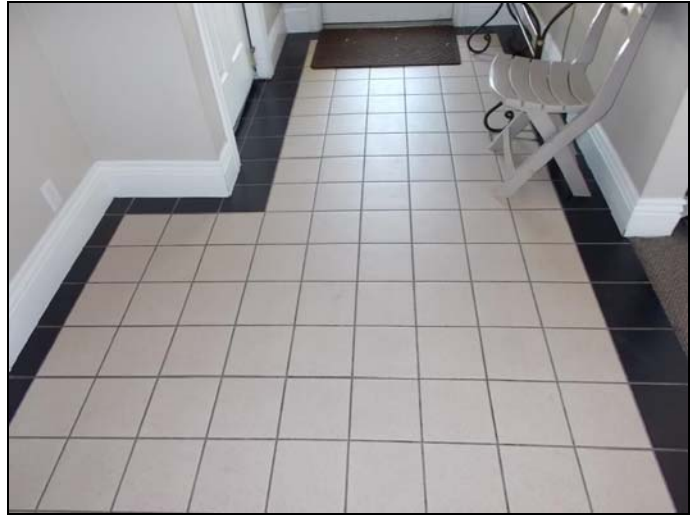
Comp #: 1503 Tile Flooring - Replace

The tile flooring is in good to fair condition. We recommend funding to replace this component approximately every 30 years. Remaining life based on current age.

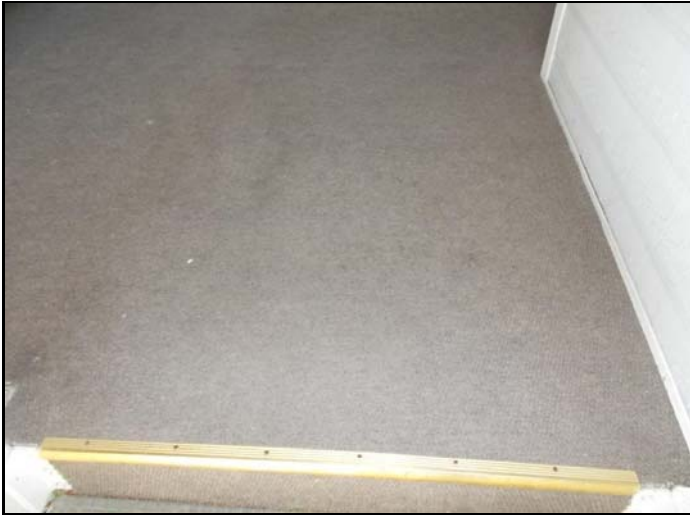
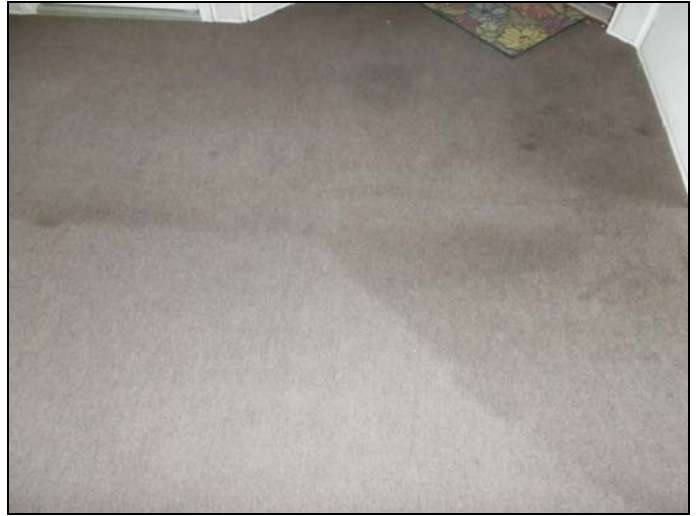
Comp #: 1507 Indoor/Outdoor Carpet - Replace

Research with the client reveals this component is being replaced in 2019. We recommend funding to replace this component approximately every 8 - 10 years. Remaining life based on current age.

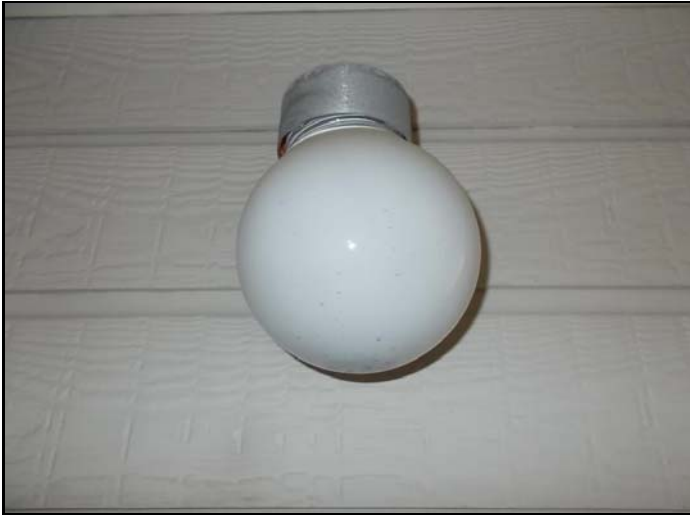
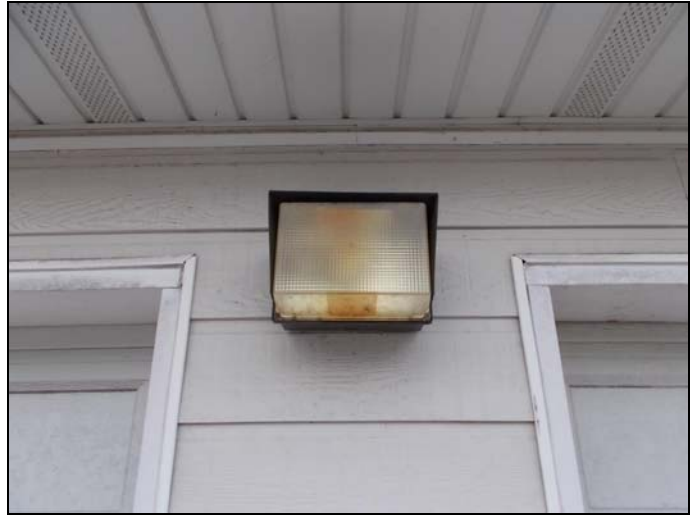
Comp #: 1602 Exterior Light Fixtures - Replace

The exterior light fixtures are in fair condition. We recommend funding to replace this component approximately every 16 - 20 years. Remaining life based on current age and condition.

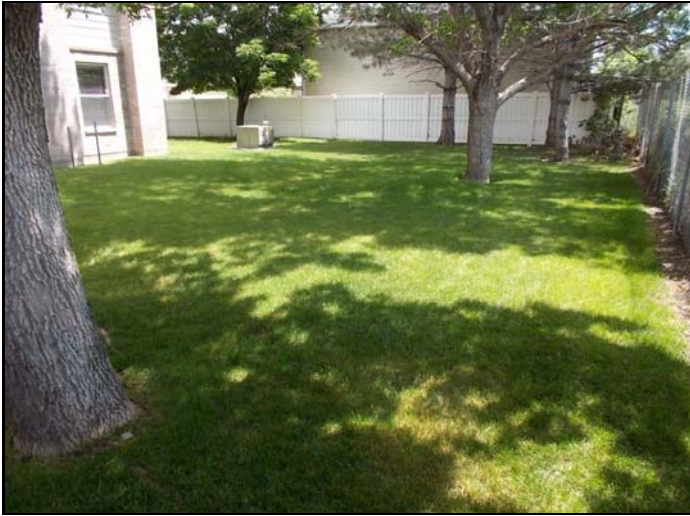
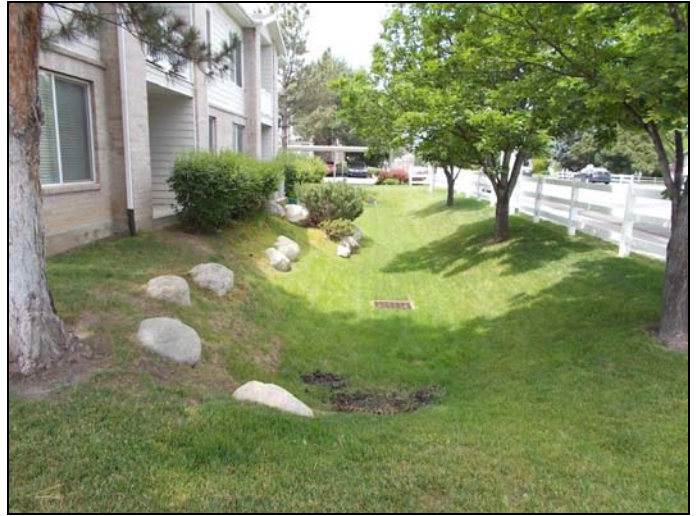
Comp #: 1812 Landscaping & Irrigation System - Renovate

The landscaping and irrigation system are in good to fair condition. We recommend funding for an allowance to renovate the landscaping and irrigation system approximately every 20 years. Remaining life based on current age.
